**Re: Brownfield Cleanup Program Application Package
Southside Plaza Site
Jamestown, New York**

Brownfield Cleanup Program Application

*Southside Plaza Site
Jamestown, New York*

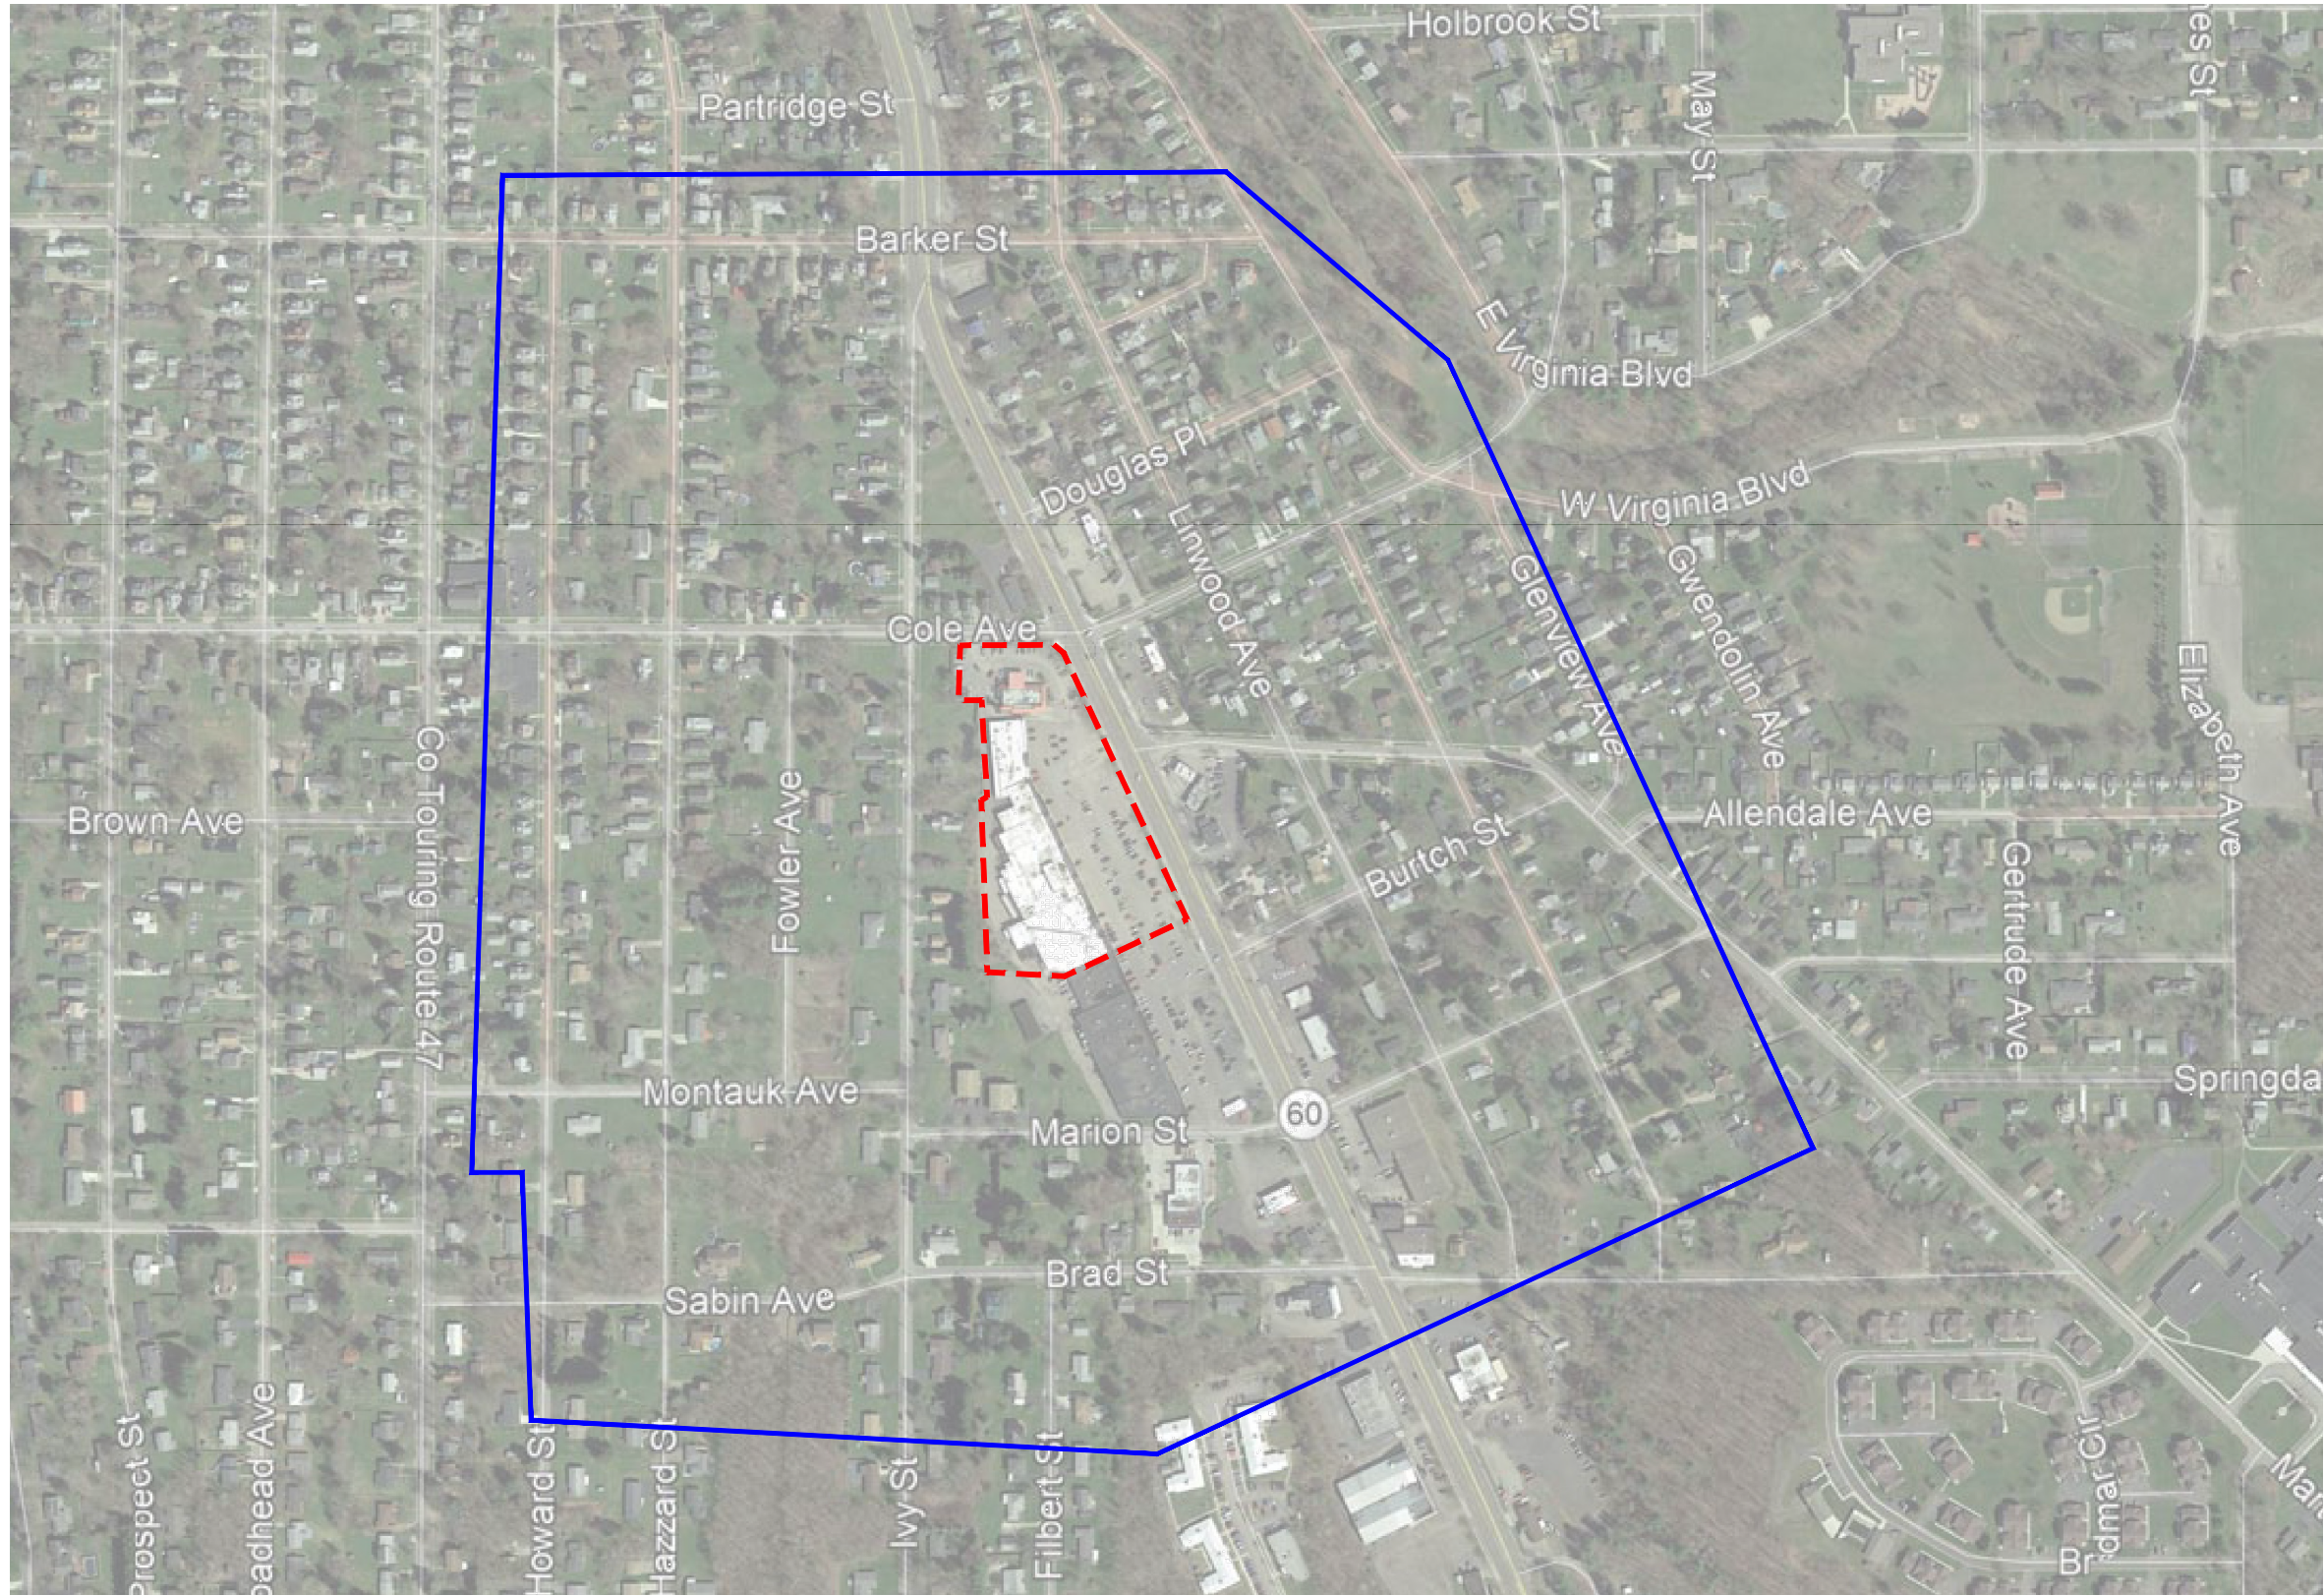
2. Is the required property map attached to the application? See Figures 2, 3 & 4 <input checked="" type="checkbox"/> Yes <input type="checkbox"/> No (application will not be processed without map)
