RE: Response to Letter of Incompleteness and Transmittal  
Brownfield Cleanup Application  
3821 River Road, Inc.  
Town of Tonawanda, New York  
BCP #C915003

# **Brownfield Cleanup Program (BCP) Table of Contents and Application Form**

3821 River Road  
Tonawanda, NY 14150

November 18, 2022  
Revised December 14, 2022

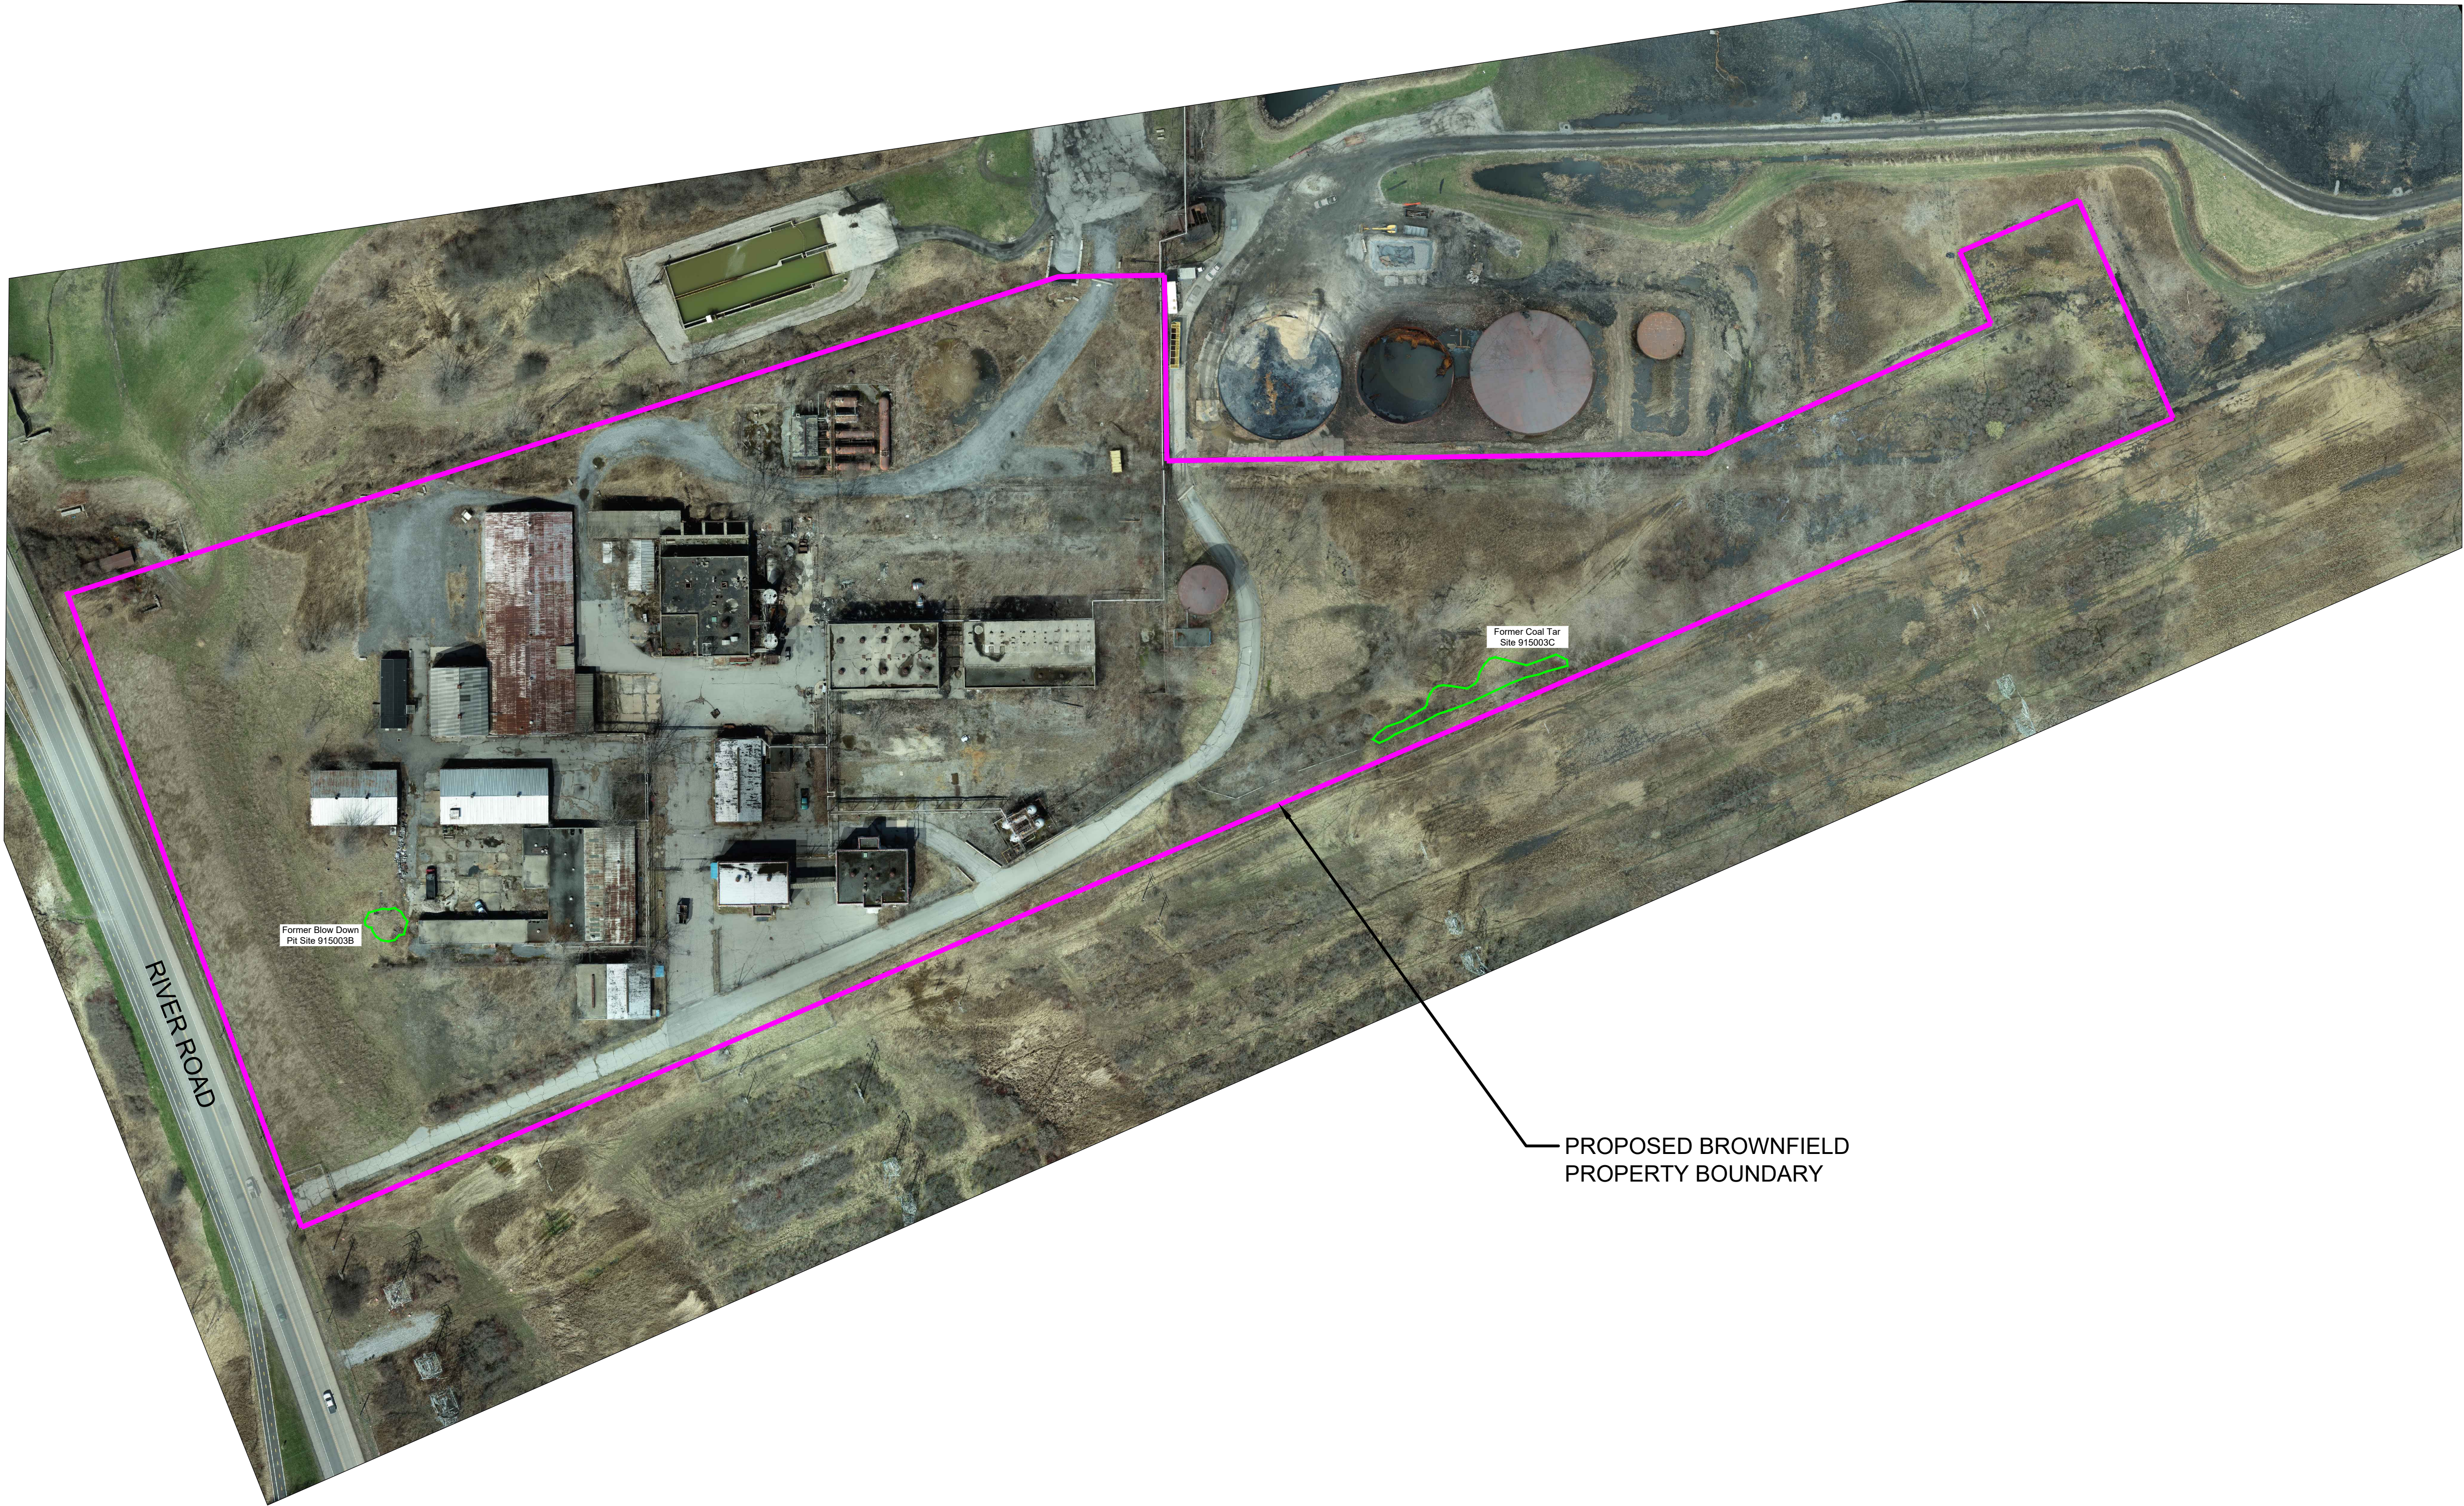
**SITE MAP**  
**AERIAL IMAGE - APRIL 2022**  
3821 RIVER ROAD  
TONAWANDA NEW YORK, 14150

The locations of the NYSDEC Inactive Hazardous Waste Sites 915003B (0.1-acres) and 915003C (0.07-acres) are shown on Figure 4 in Attachment-I-1. The remediated areas are within the limits of the BCP Site, but it is proposed that no site development or tangible tax credit apply to these areas.

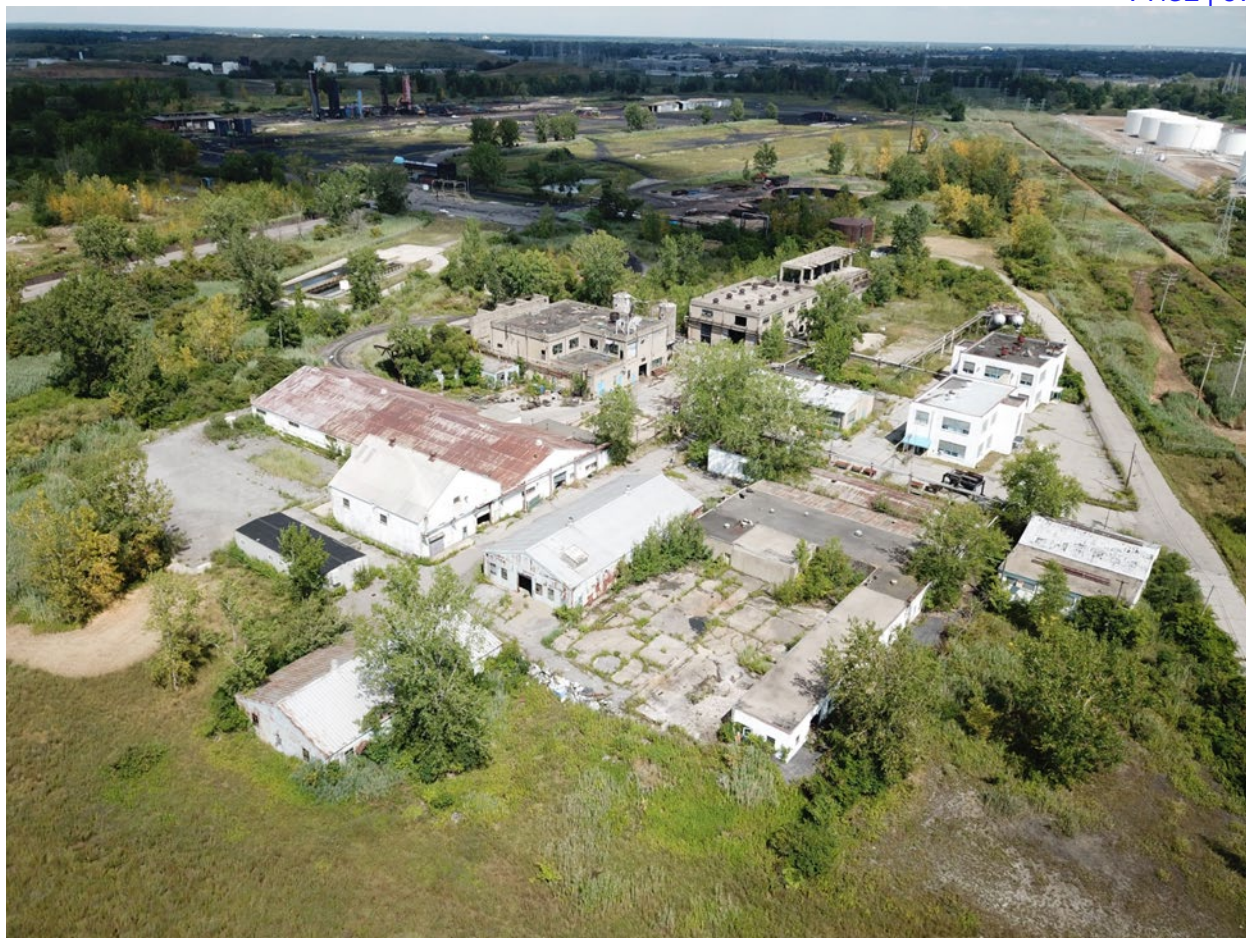
Photograph No. 1 – 3821 River Road, Looking Northeast across proposed BCP Site (State Superfund Site 109 is to the north [left] and the RITC BCP Site is to the east [top of photograph])

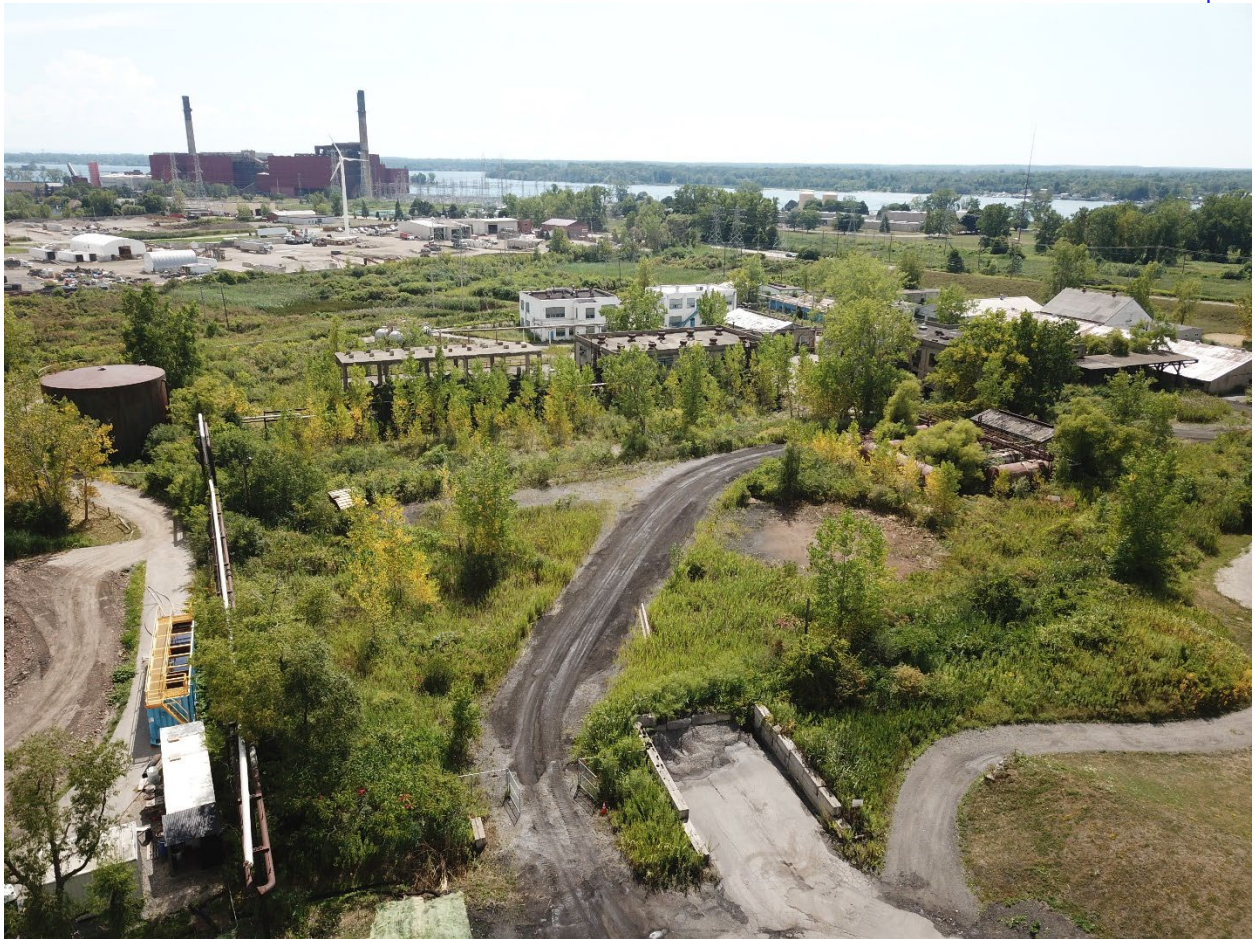
Photograph No. 2 – 3821 River Road looking South from gate on the RITC BCP Site

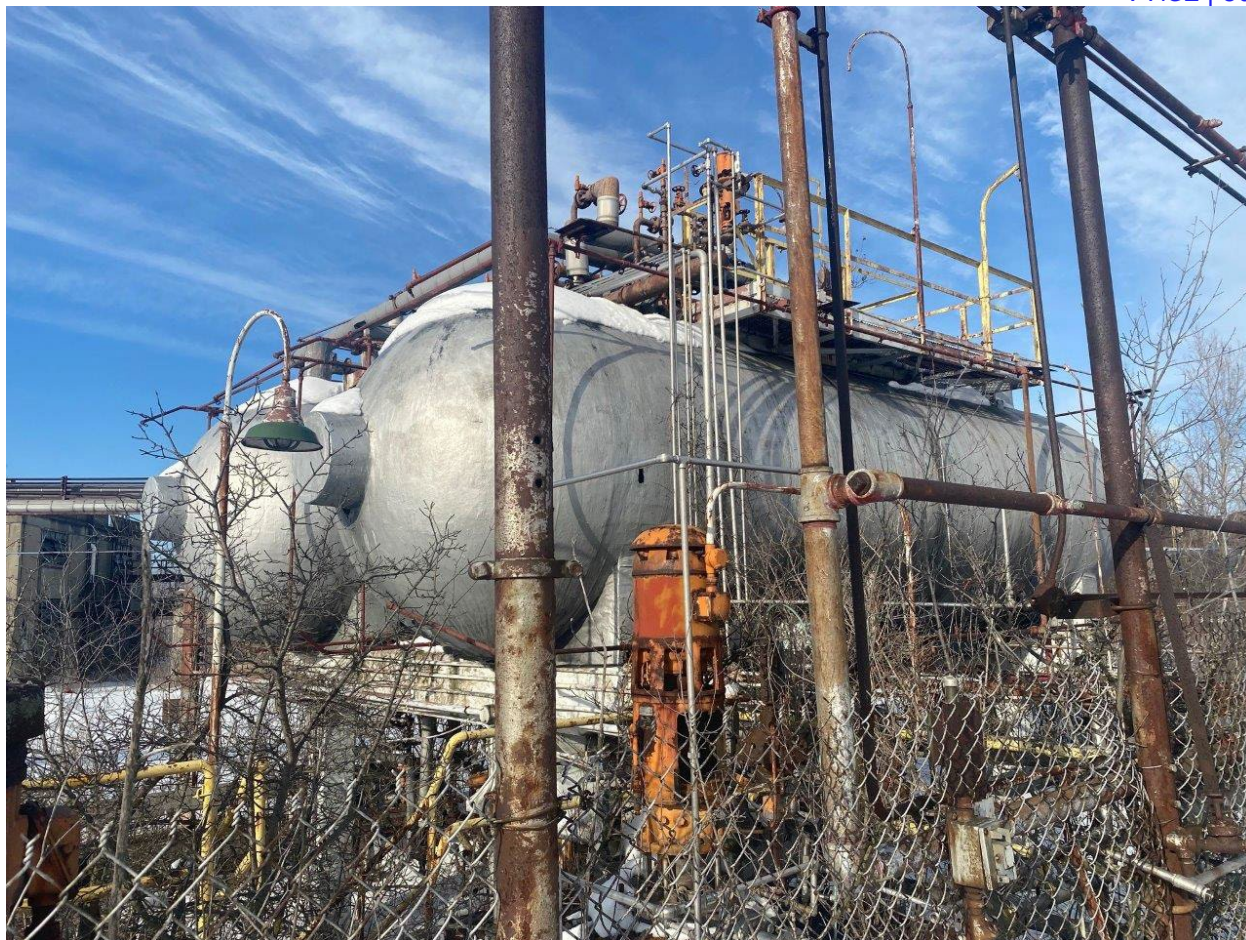
Photograph No. 3 – Abandoned Tanks (Northeast corner of AOI 2) – Note Fire Suppression Systems Surrounding Tank

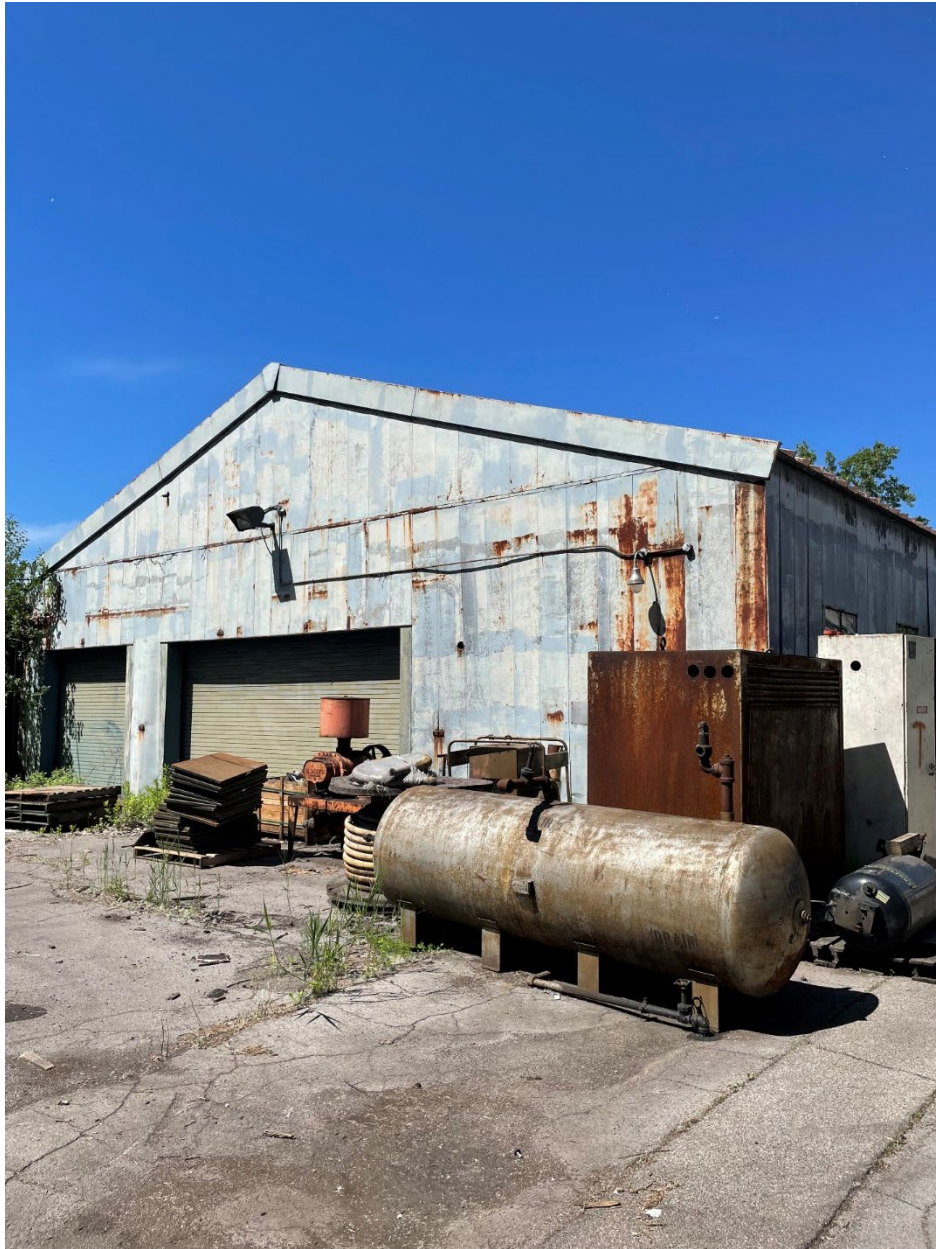
Photograph No. 4 – Abandoned Tanks and Equipment

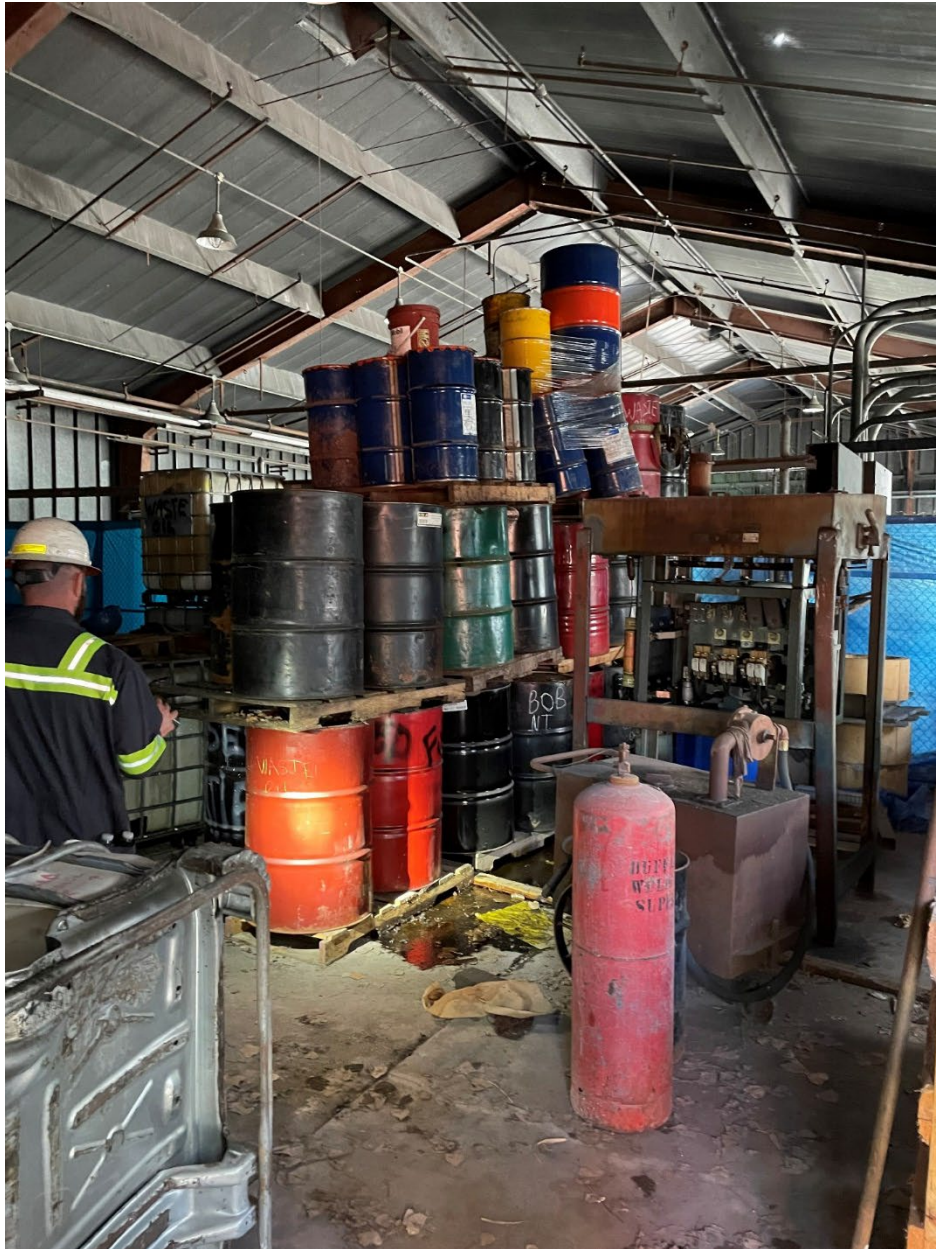
Photograph No. 5 – Unstable Accumulations of Abandoned Drums and Containers

- **Drums and Containers** – Drums and containers were abandoned throughout the site. The applicant has stabilized the drums and containers and moved them indoors, but there is potential that some may have leaked prior to the purchase of the property.

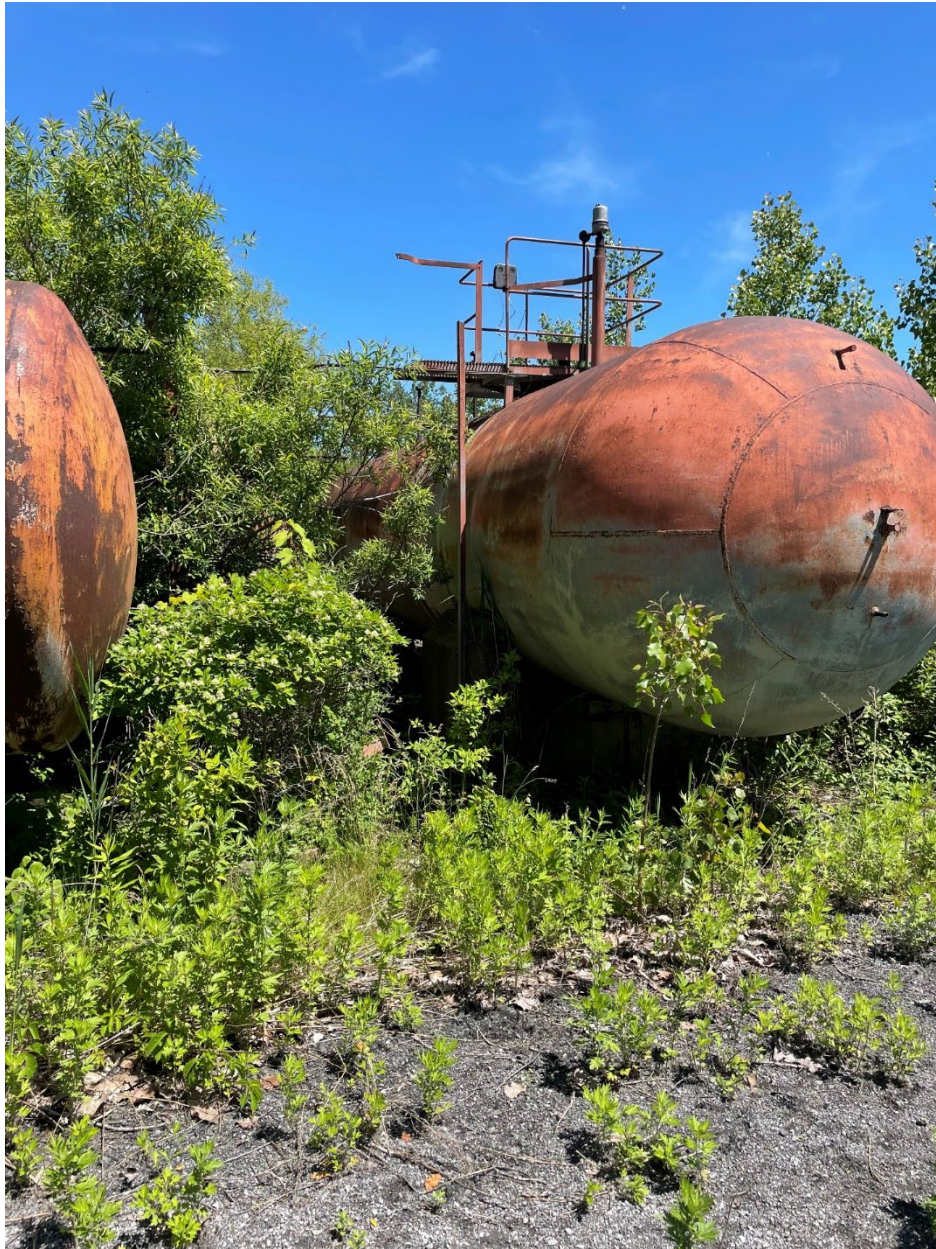
Photograph No. 6 – Abandoned Tanks

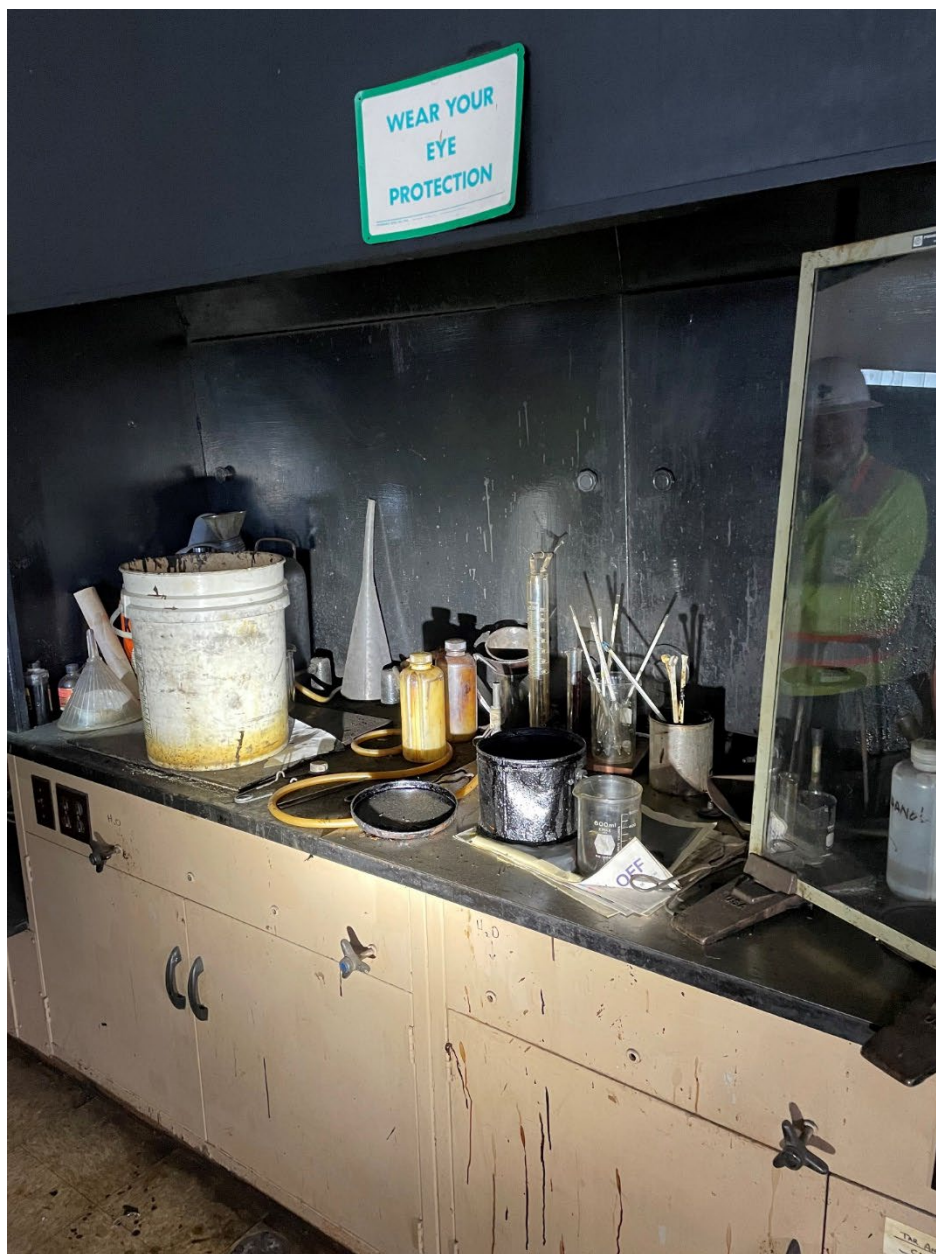
Photograph No. 7 – Abandoned Laboratory (1 of 2) – Chemicals Throughout

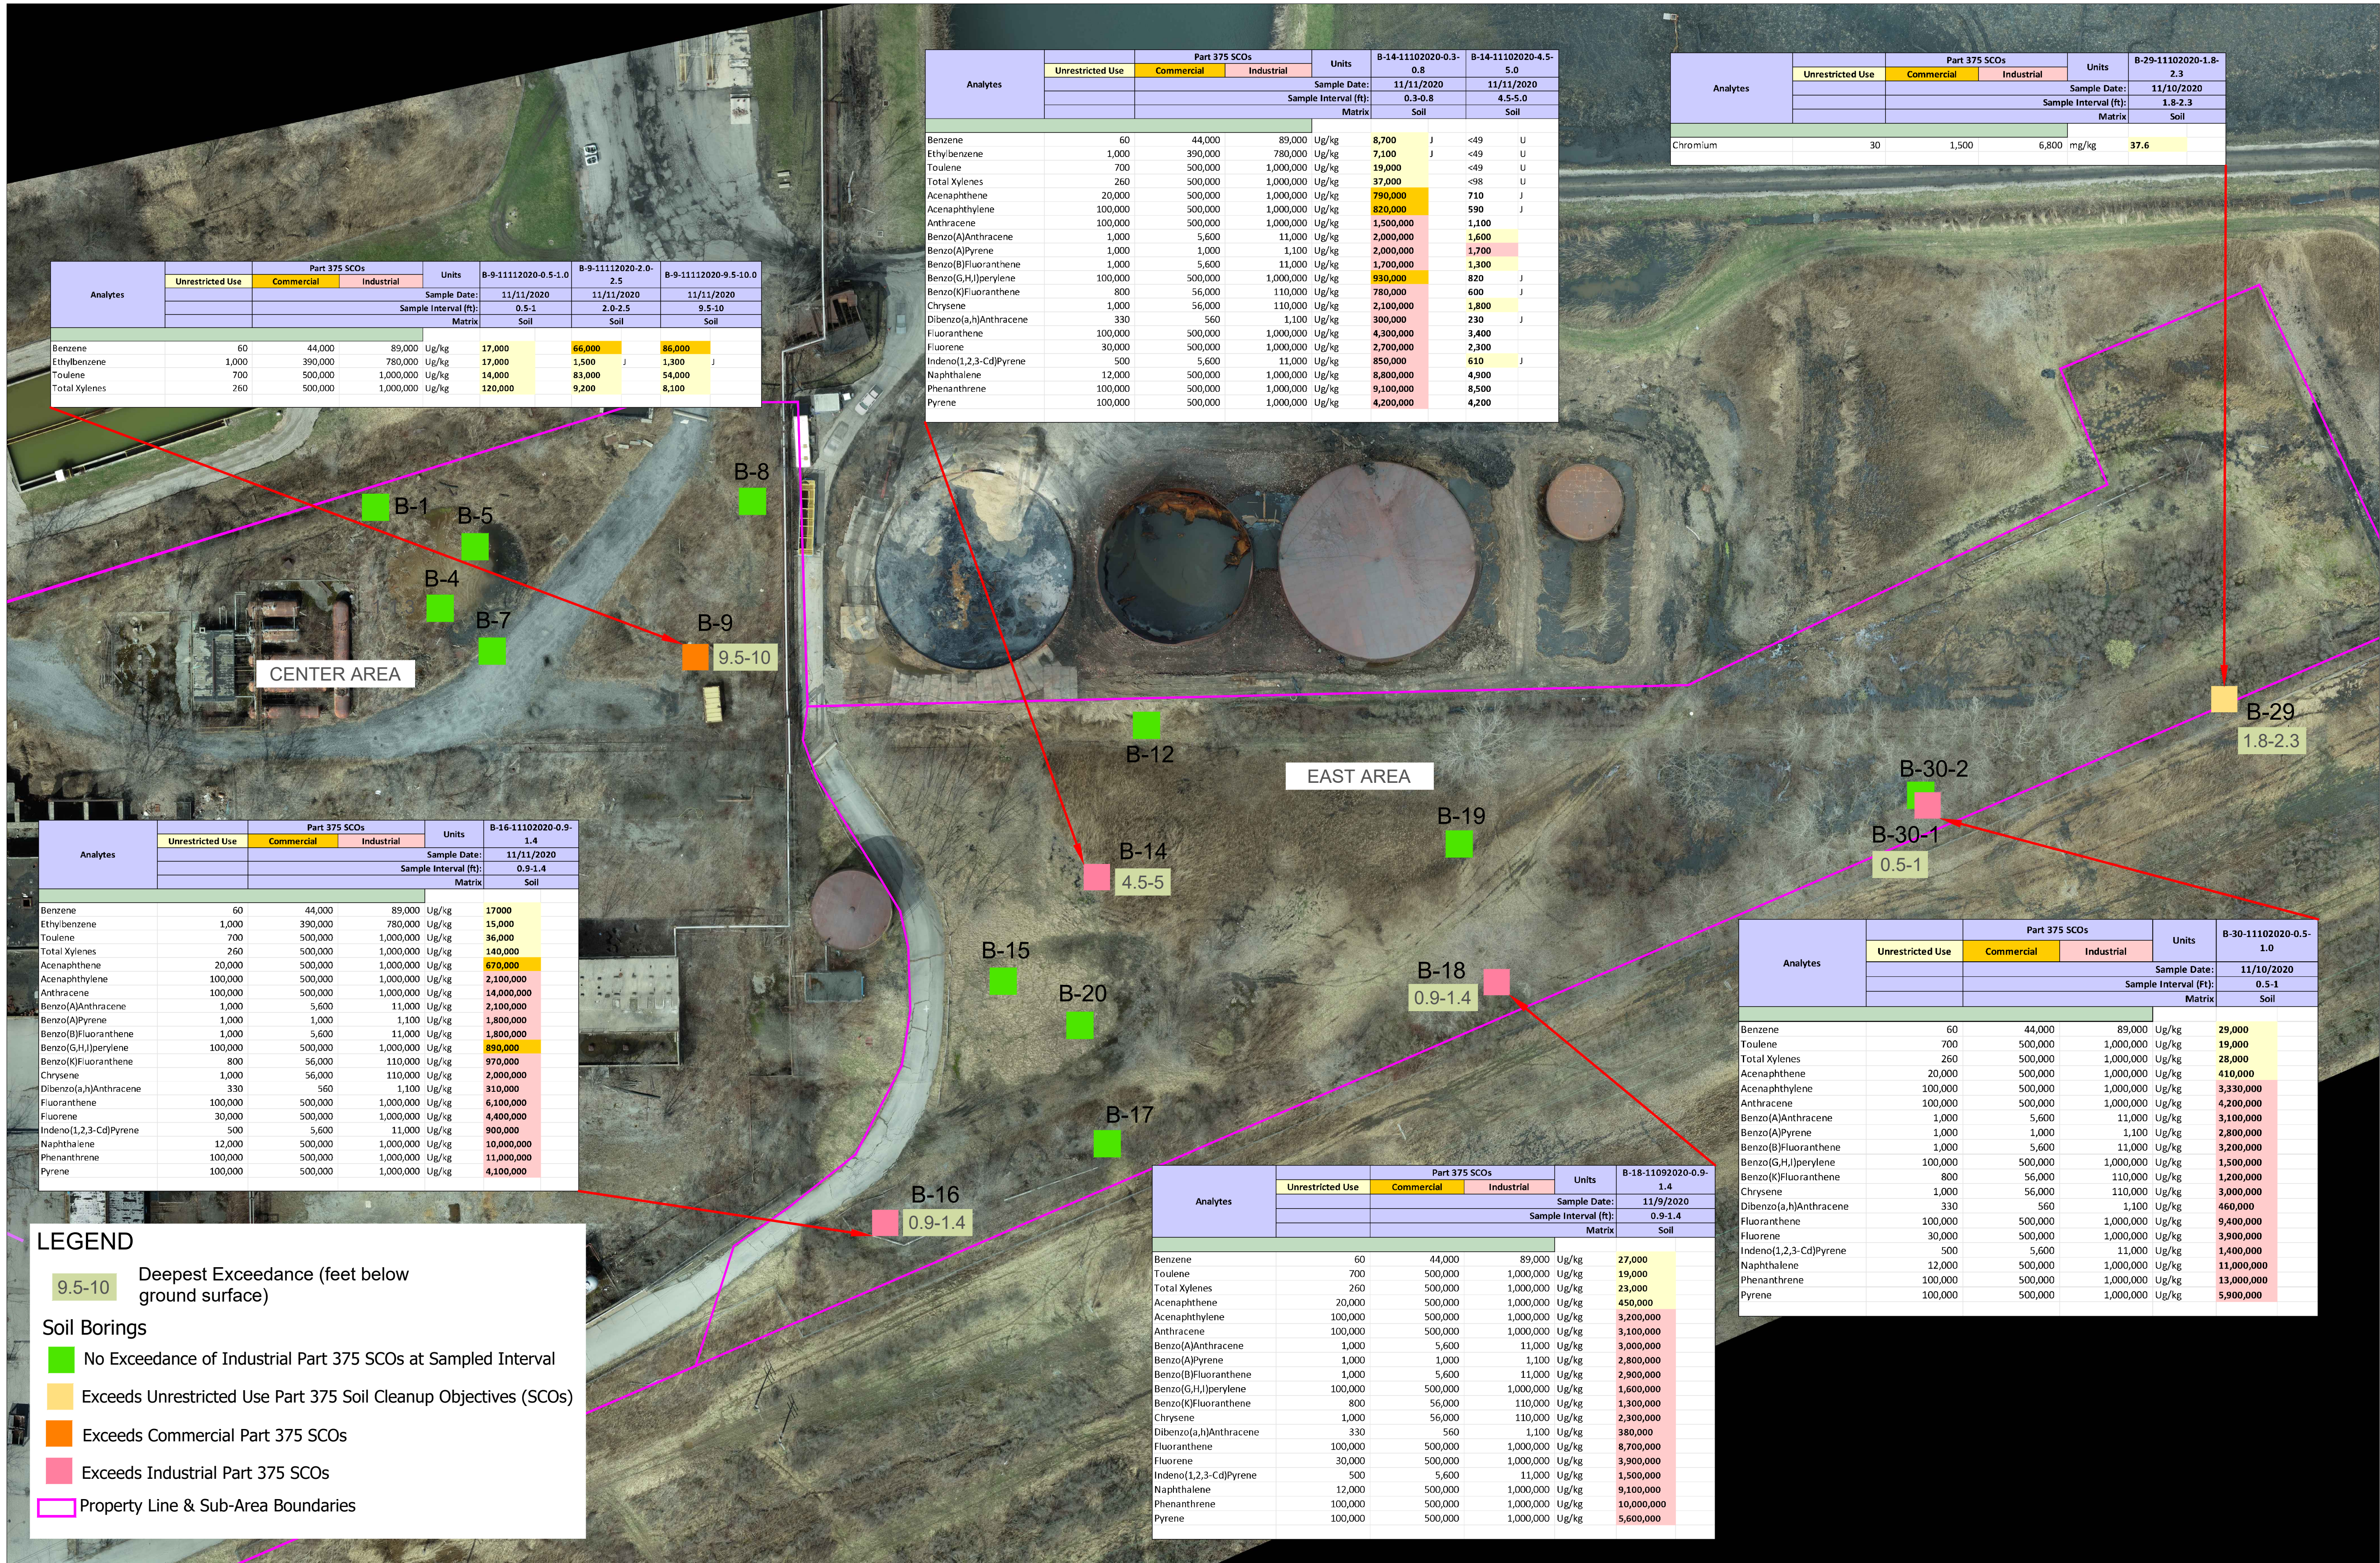
- No Exceedance of Industrial Part 375 SCO's at Sample Interval
- Exceeds Unrestricted Use Part 375 Soil Cleanup Objectives (SCO's)
- Exceeds Commercial Part 375 SCO's
- Exceeds Industrial Part 375 SCO's
- Property Line & Sub-Area Boundaries

Impacted media Figures; Figure 7 – Soil, Figure 8 – Groundwater, Figure 9 – Storm Sewer
