Re: Periodic Review Report

Buffalo Lakeside Commerce Park (CertainTeed Site)

Brownfield Cleanup Program Site #C915185

A Site inspection was conducted on April 17, 2015 in accordance with the Operation, Monitoring, and Maintenance Work Plan – Hanna Furnace Site, The Former Railroad Yard Area (Subparcel 1) dated February 2002. A Site map is provided as Figure 1. The completed inspection form is provided as Attachment 1. Photographs are provided as Attachment 2. The photograph locations are shown on Figure 1.

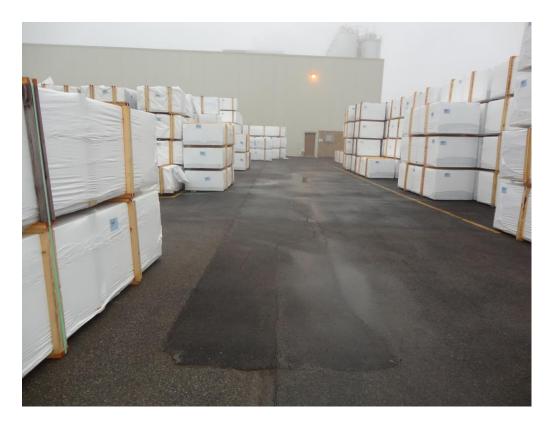
Photograph 1 – Area on east side of Storage Yard milled and repaved 2014

1. Annual Inspections were not completed/documented: CertainTeed did not document formal annual inspections as requested by the NYSDEC. The lack of formal annual inspections using the Environmental Inspection Form was an oversight on CertainTeed's part. Although formal annual inspections were not documented, CertainTeed has a regular maintenance program for the Site that includes inspecting and maintaining paved areas and landscaping. During regular maintenance activities in 2014, two areas of pavement settling were milled and repaved, deteriorated areas around two catch basins were replaced with concrete aprons, and a grass area on the east side of the Site at the base of the silos was newly paved. These activities are documented in Attachment 2, photographs 1 through 5.

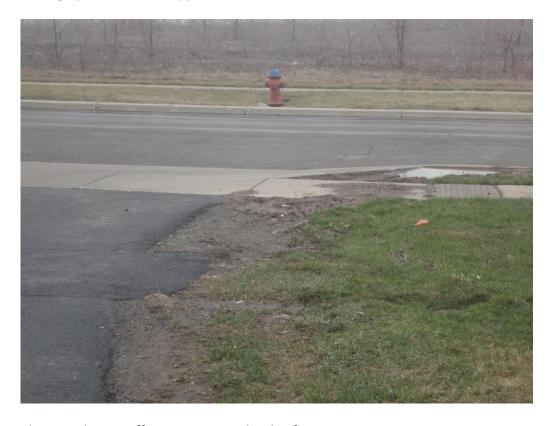
Photograph 6 – Traffic rutting on north side of main entrance apron

- 2. <u>Unintended Traffic Rutting</u>: Two areas of unintentional traffic rutting were observed. The first was on the north side of the main entrance apron (see Photograph #6), and appears to be a result of trucks turning left into the entrance from Ship Canal Parkway. The second area of rutting was in the grass at the southern end of the building (see Photograph #7). This rutting is believed to be a result of snow removal activities during the unprecedented snow storm in November 2014.

- <u>Corrective Action</u>: To address the rutting at the main entrance apron, CertainTeed will place topsoil and seed the area. A boulder or other large object will be placed on top of the repaired area to prevent trucks from driving over it. The ruts in the grass area at the south end of the building will be re-graded, covered with top soil and seeded.

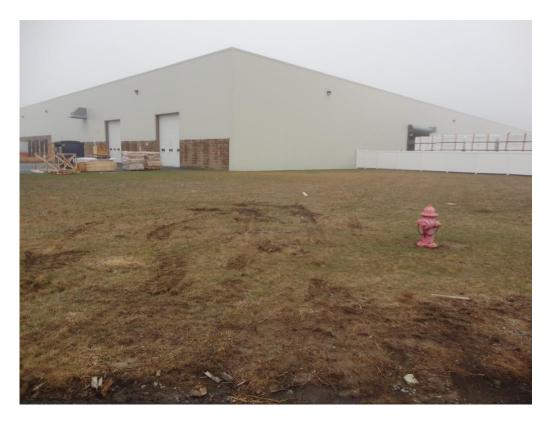
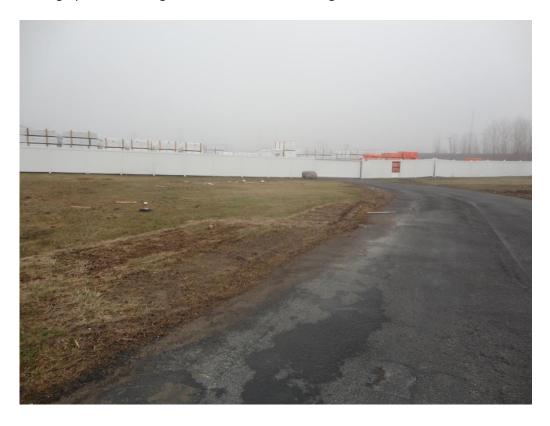
Photograph 7 – Ruts in grass at south end of building

Photograph 8 – Ruts in grass at south end of building

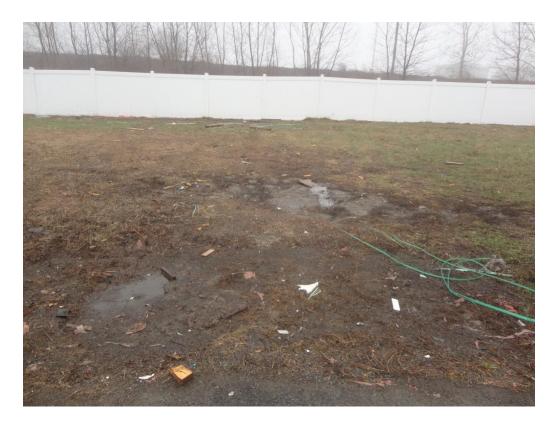
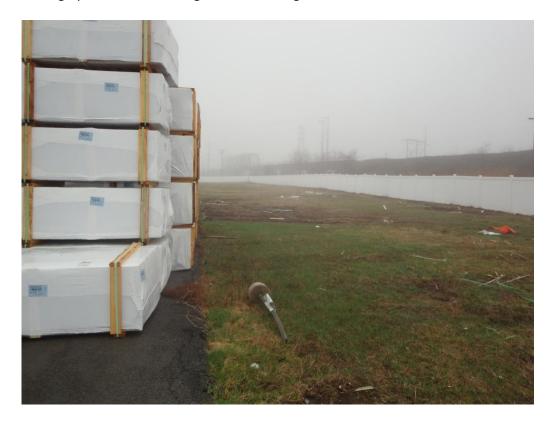
- 3. <u>Distressed Vegetation</u>: Areas of apparent distressed vegetation were observed along the southeast side of the Storage Yard between the paved area and the fence (see Photographs #9 and #10). Other areas of distressed vegetation were also observed along the sides of roads (see Photographs #11 through #13). All of the areas were locations where snow builds up during plowing. These areas had been snow covered until 4 weeks prior to the Site inspection, and had not had time to regenerate.

Photograph 9 – Distressed vegetation in Storage Yard

Photograph 10 – Distressed vegetation in Storage Yard

<u>Corrective Action</u>: Each of the areas identified as having distressed vegetation will be re-inspected by CertainTeed's Environmental Manager during a follow-up inspection to be conducted no later than June 5, 2015. Any areas that have not regenerated will be covered with top soil and seeded within two weeks of the follow-up inspection.

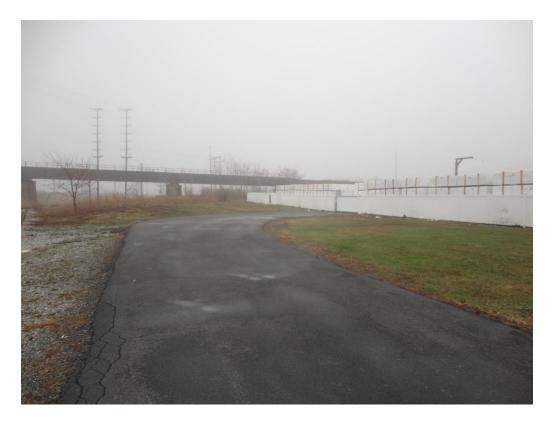
Photograph 13 – Distressed Vegetation on the south side of road and cracked asphalt pavement on the north side of road.

4. <u>Cracks in Pavement</u>: Areas of cracked or settled pavement were observed at locations on the north side of the road along the east side of the Site (see Photograph #13), at the main entrance (see Photograph #14), and in the Storage Yard (see Photographs #15 and #16).

<u>Corrective Action</u>: CertainTeed has a paving program scheduled for summer 2015 as part of its regular maintenance program. The areas of cracked pavement identified during the Site inspection will be repaired/repaved as part of the 2015 paving program.
