**2018 PERIODIC REVIEW REPORT  
BUFFALO LAKESIDE COMMERCE PARK  
(CertainTeed Site)  
BUFFALO, NEW YORK  
BROWNFIELD CLEANUP PROGRAM  
Site Number C915185**

April 23, 2018

Re: 2018 Periodic Review Report  
Buffalo Lakeside Commerce Park (CertainTeed Site)  
231 Ship Canal Parkway, Buffalo, New York  
Brownfield Cleanup Program Site (Number C915185)

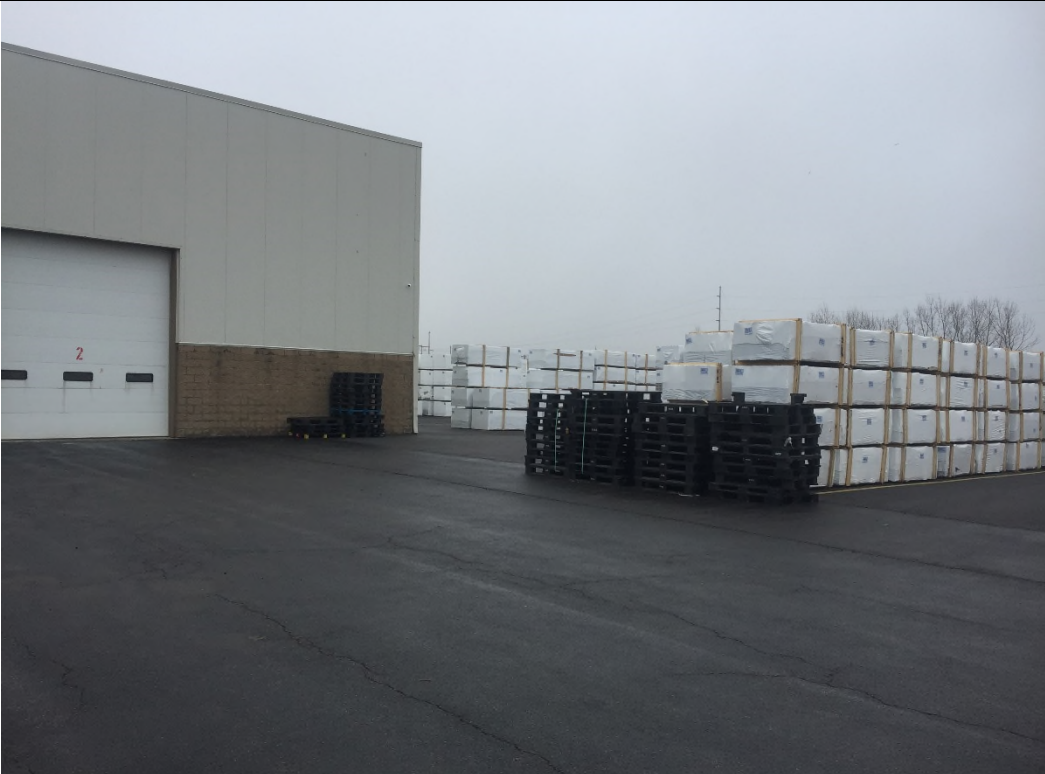
| <b>Photo No.</b><br>1 | <b>Date:</b><br>3-29-18 | | |

| <b>Direction Photo Taken:</b><br><br>Southeast | | | |
| <b>Description:</b><br><br>Paved area in front of SW loading area. | | | |

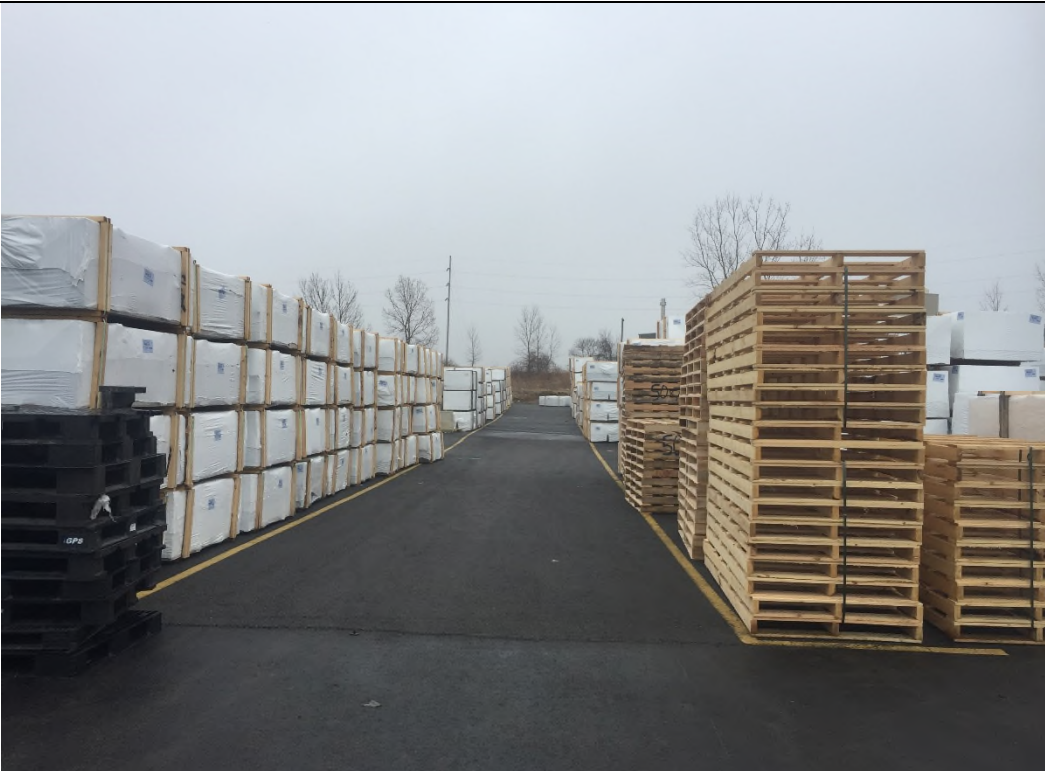
| <b>Photo No.</b><br>2 | <b>Date:</b><br>3-29-18 | |

| <b>Direction Photo Taken:</b><br><br>South | | |
| <b>Description:</b><br><br>SW exterior storage yard. | | |

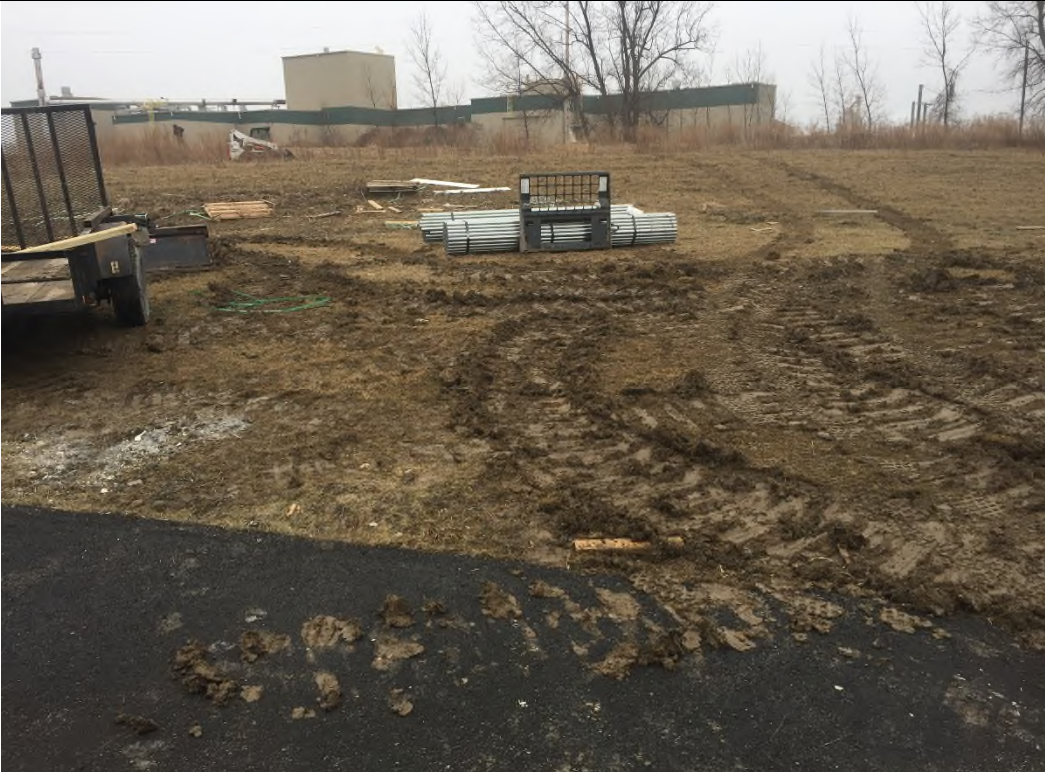
| <b>Description:</b><br><br>Disturbed grass cover caused by contractor preparing to install site perimeter fence. | | | |

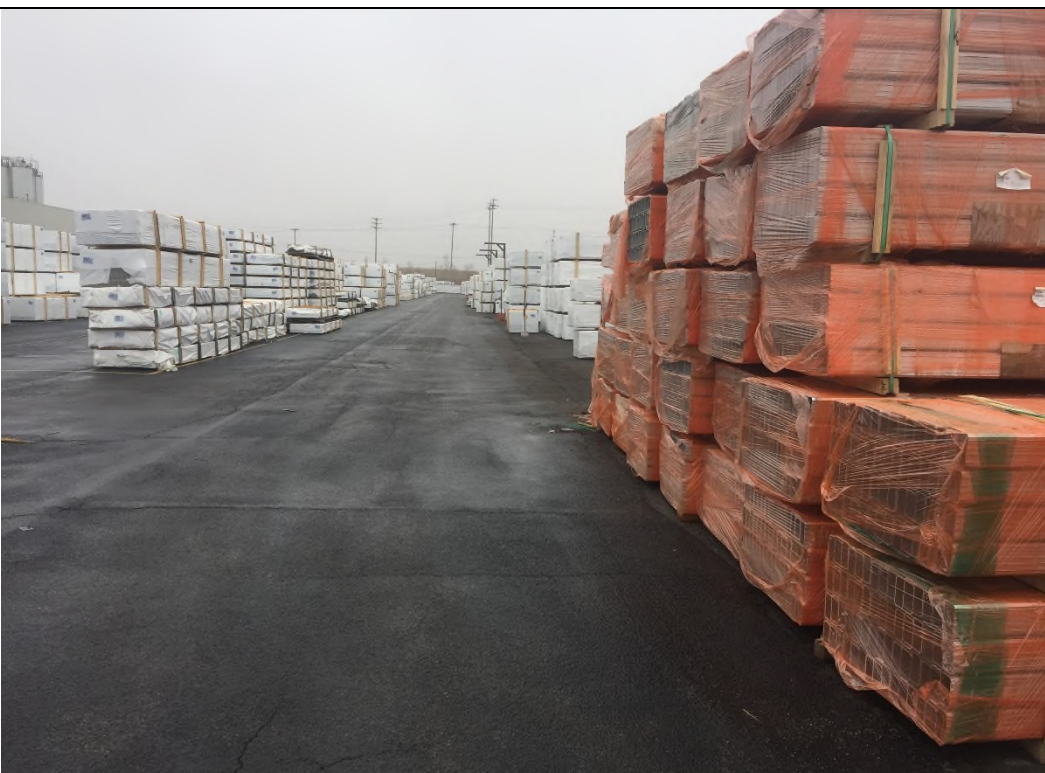
| <b>Direction Photo Taken:</b><br><br>East/northeast | | |
| <b>Description:</b><br><br>Paved rear storage area. | | |

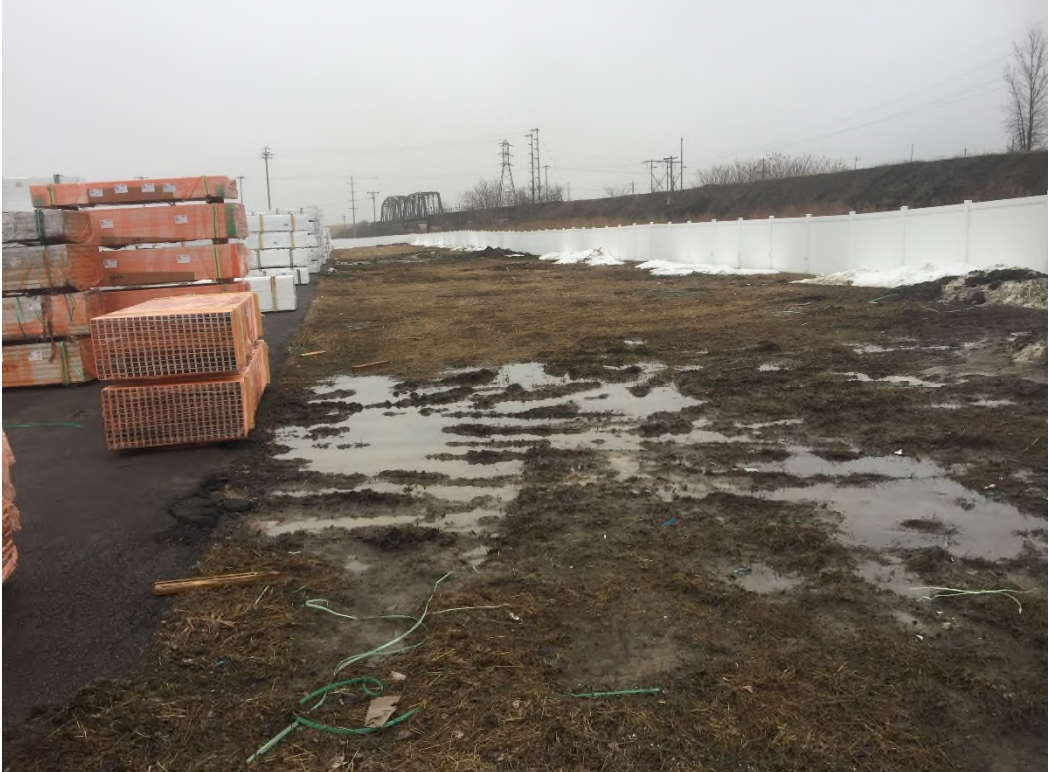
| <b>Photo No.</b><br>5 | <b>Date:</b><br>3-29-18 | | |

- Due to an oversight, annual inspections of the Site cover system were not conducted during 2016 and 2017.
- The vegetative cover of the soil cover system is damaged (ruts and bare spots) at several locations due mostly to trucks cutting corners and snow plow blades scraping off the grass cover.

| <b>Description:</b><br><br>Scarred grass cover at rear of storage area, caused by snow plow. | | | |

During the spring and summer of 2018, CertainTeed will repair identified ruts and grass bare spots. The next site inspection is planned for early fall (September/October) of 2018 to demonstrate the above improvements.

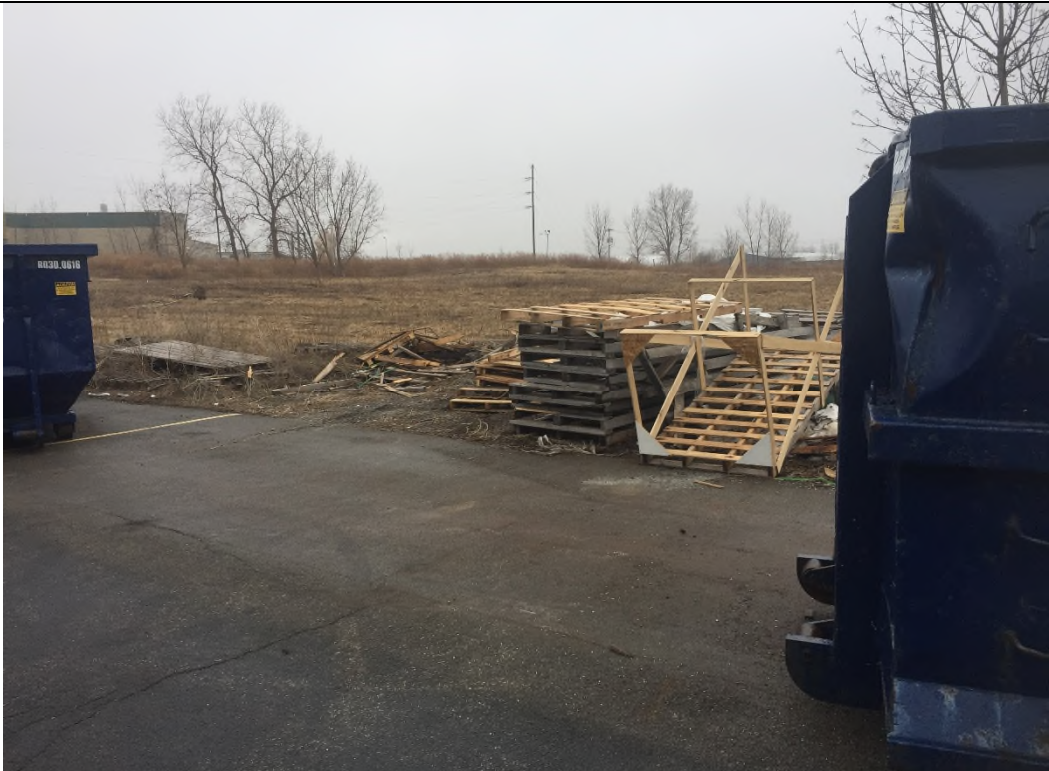
| <b>Photo No.</b><br>6 | <b>Date:</b><br>3-29-18 | |

| <b>Description:</b><br><br>Wooden pallet debris stored on grass cover. | | |

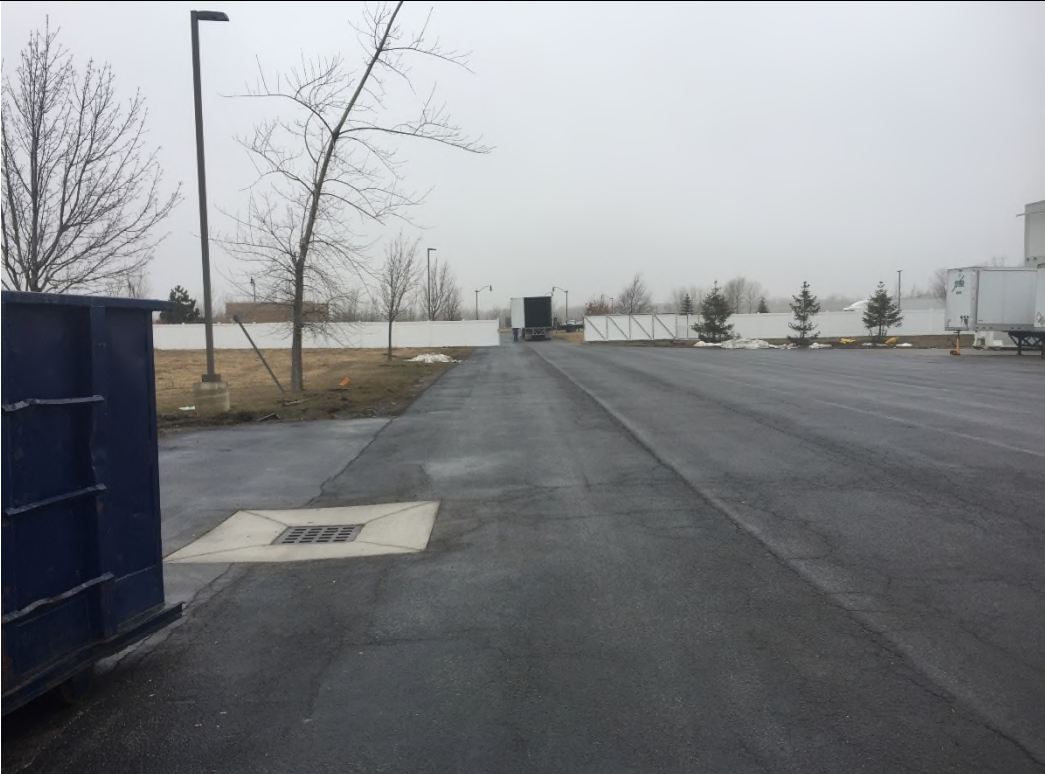
| <b>Photo No.</b><br>7 | <b>Date:</b><br>3-29-18 | | |

| <b>Direction Photo Taken:</b><br><br>Northwest | | | |
| <b>Description:</b><br><br>Paved truck drive area by loading docks. | | | |

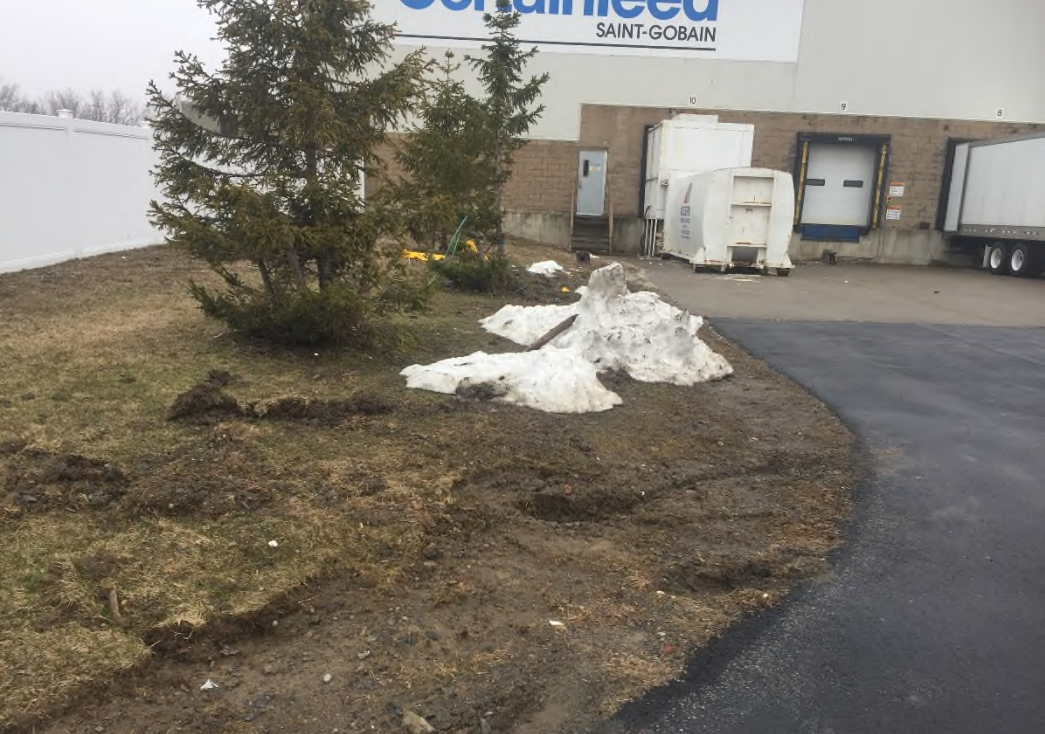
| <b>Photo No.</b><br>8 | <b>Date:</b><br>3-29-18 | |

| <b>Description:</b><br><br>Tire ruts caused by trucks cutting the corner. | | |

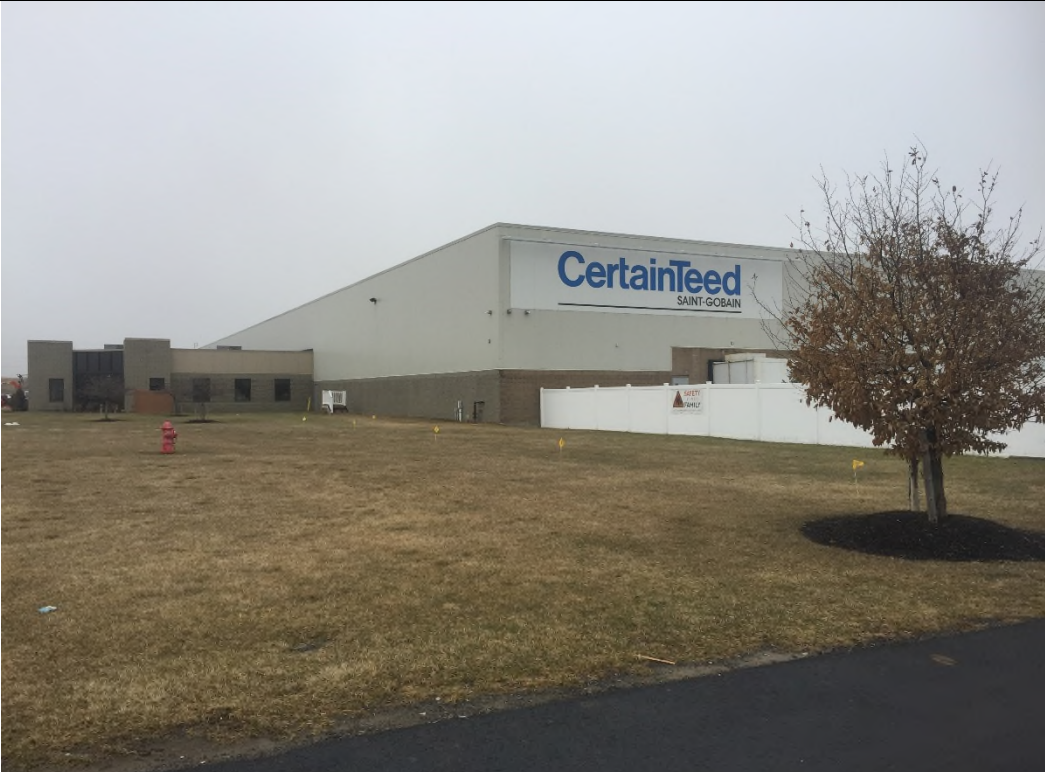
| <b>Photo No.</b><br>9 | <b>Date:</b><br>3-29-18 | | |

| <b>Direction Photo Taken:</b><br><br>Southeast | | | |
| <b>Description:</b><br><br>Western corner of the plant building. | | | |

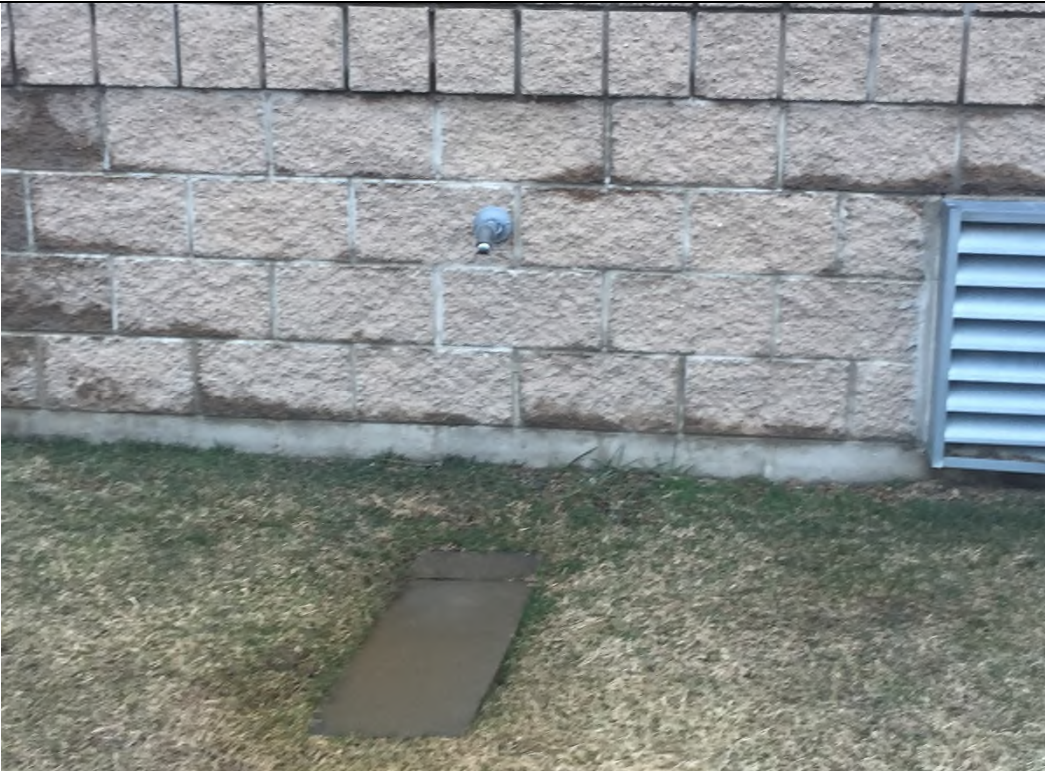
| <b>Photo No.</b><br>10 | <b>Date:</b><br>3-29-18 | |

| <b>Description:</b><br><br>Concrete pad placed to protect cover soil from high pressure water discharge from fire suppression building. | | |

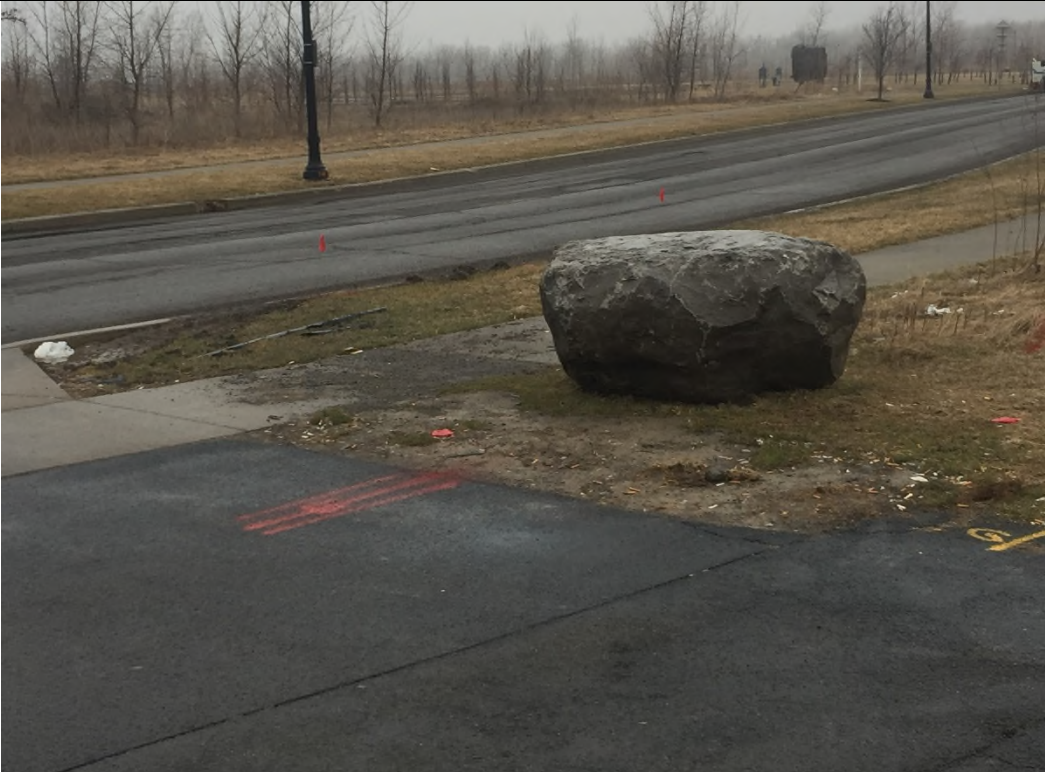
| <b>Photo No.</b><br>11 | <b>Date:</b><br>3-29-18 | | |

| <b>Description:</b><br><br>Bolder used to prevent trucks from cutting the corner at main entrance to Site. | | | |

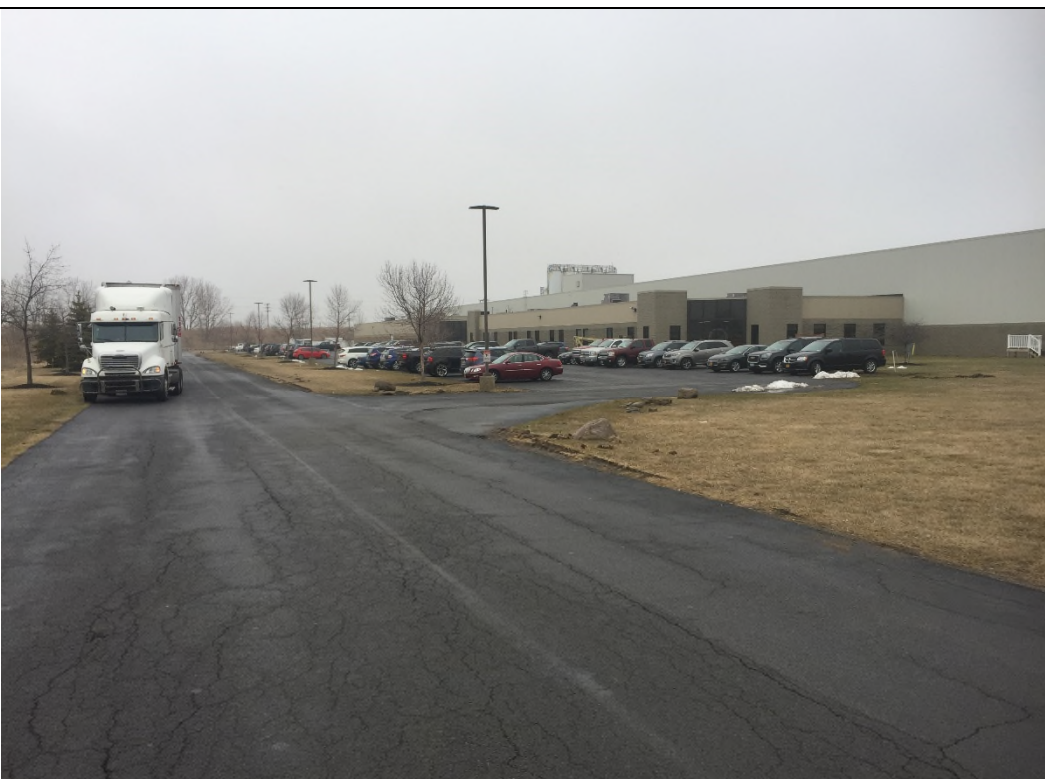
| <b>Photo No.</b><br>12 | <b>Date:</b><br>3-29-18 | |

| <b>Direction Photo Taken:</b><br><br>Northeast | | |
| <b>Description:</b><br><br>Main Site entrance road. | | |

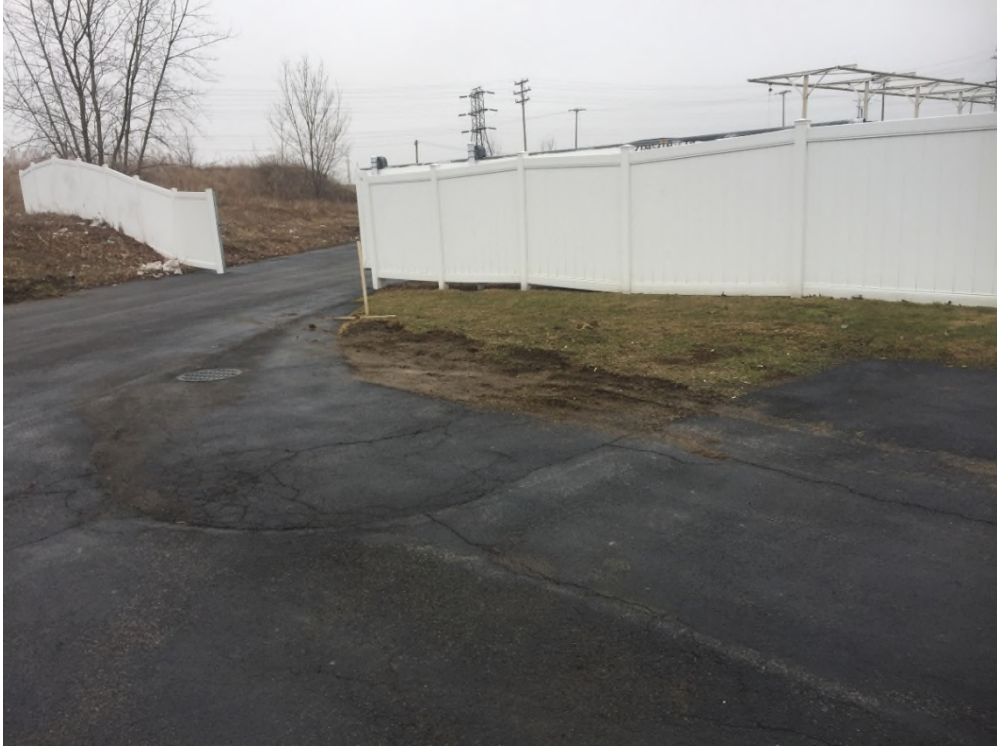
| <b>Photo No.</b><br>13 | <b>Date:</b><br>3-29-18 | | |

| <b>Description:</b><br><br>Northeastern entrance to fenced area east of building. Note erosion of grass from tires. | | | |

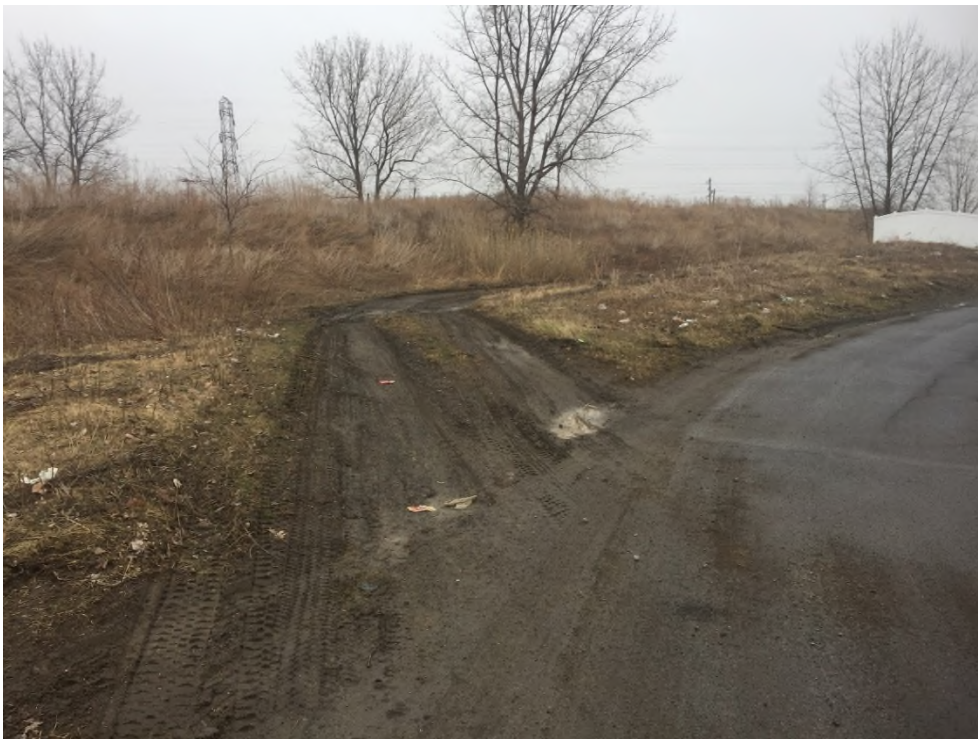
| <b>Photo No.</b><br>14 | <b>Date:</b><br>3-29-18 | |

| <b>Description:</b><br><br>Damaged grass cover caused by rail workers driving through Site to access rail line. | | |

CertainTeed is in the process of having a six-foot high PVC fence installed around the entire site perimeter. The fence posts are being driven, not drilled. Once installed, this fence will help to reduce trespassing and damage to the vegetative grass cover.

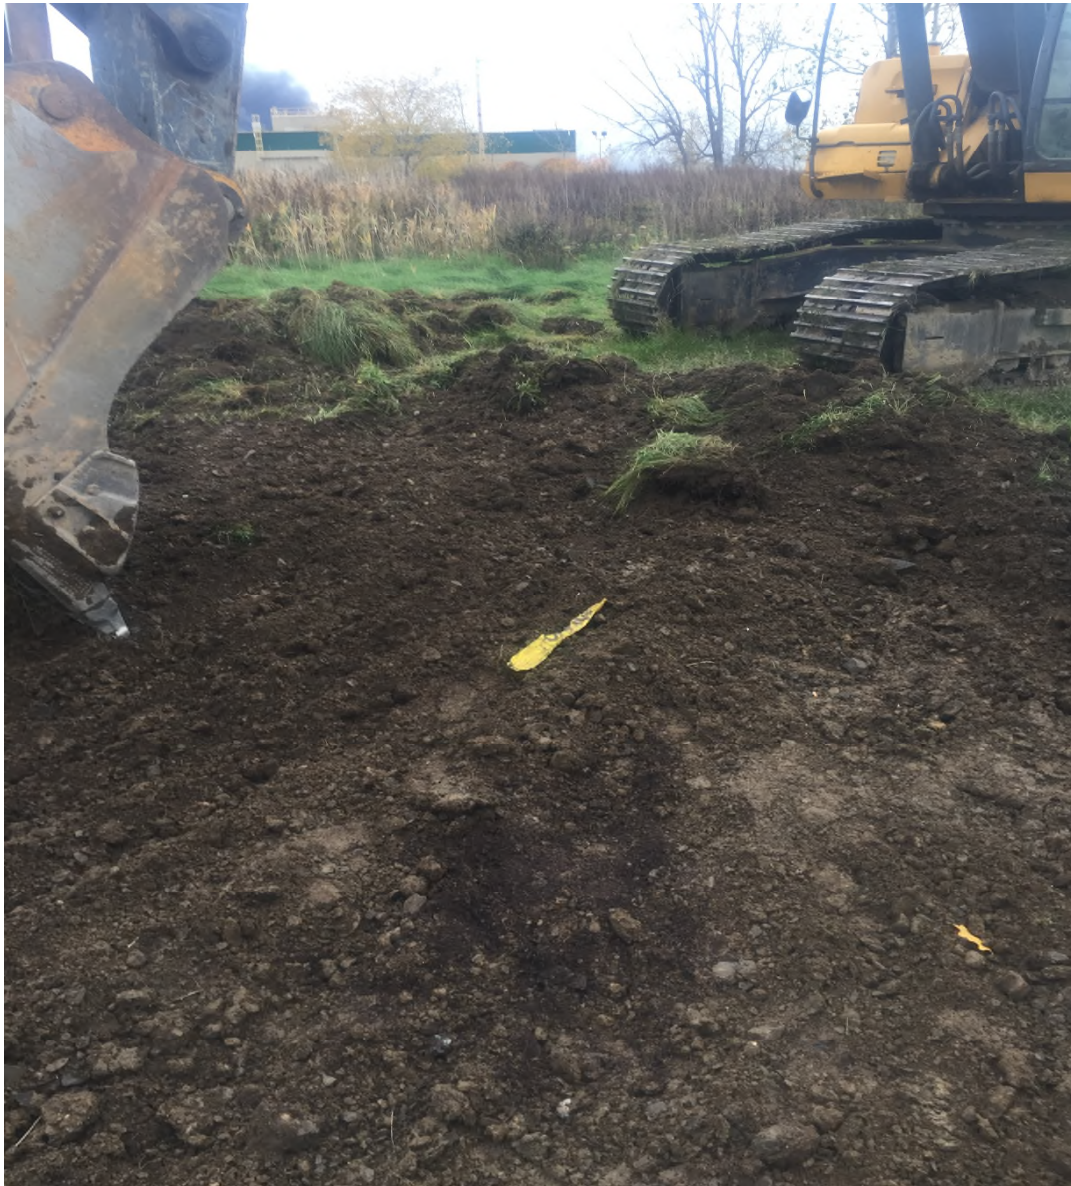
GZA observed Zoladz remove the 1-foot thick clean soil cover from the work site. The anticipated demarcation grid of yellow hazard tape was encountered at the interface between the clean cover soil and the underlying soil/fill material. The clean soil was stockpiled on site for later use as final cover. Once the clean cover soil was removed, a thin (<1 foot) of the underlying soil/fill was excavated to achieve the desired sub-grade elevations. GZA screened both the clean cover soil and the subsurface soil/fill during the excavation activities. Soil/fill was screened for VOCs by first placing the sample into a plastic Zip-Lock bag. A MiniRAE 3000 photoionization detector equipped with a 10.6 ev probe was used to measure the total VOCs in the screening sample. No elevated PID readings were detected in any of the excavated subsurface soil material.

**Exposed yellow demarcation tape.**

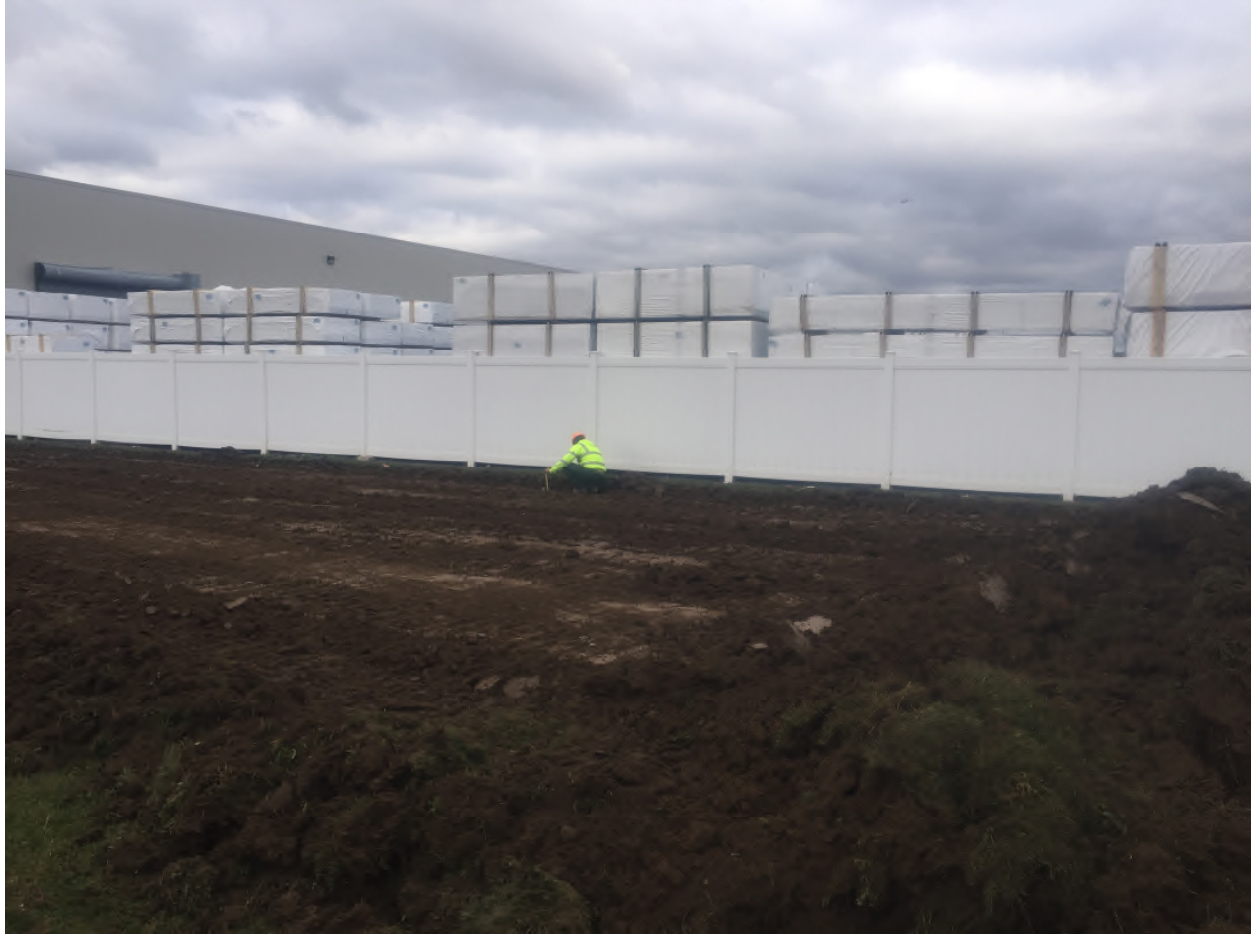
**Removal of clean cover soil.**

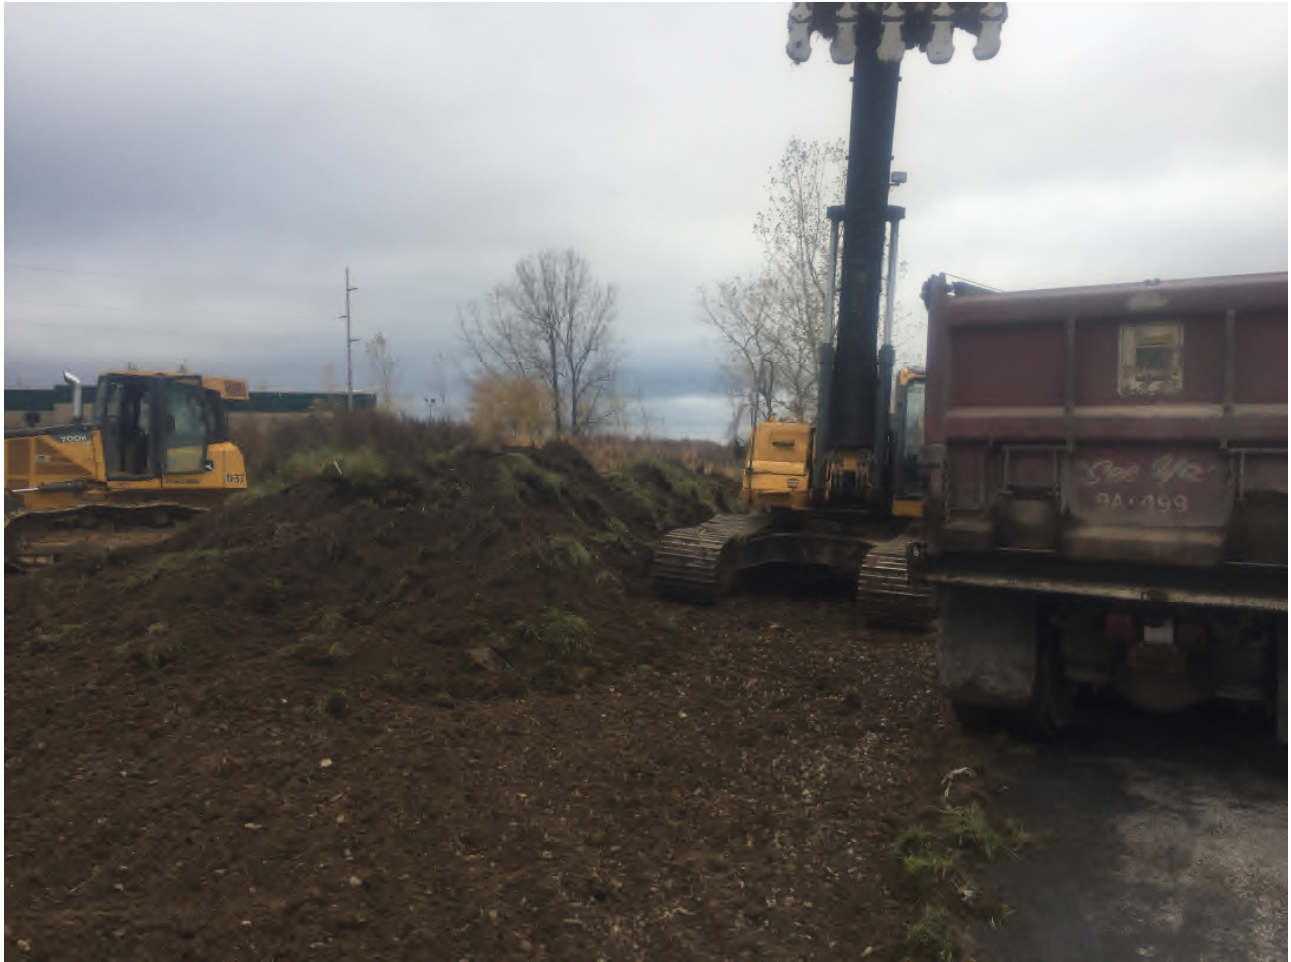
**Segregation of Clean cover soil for reuse.**

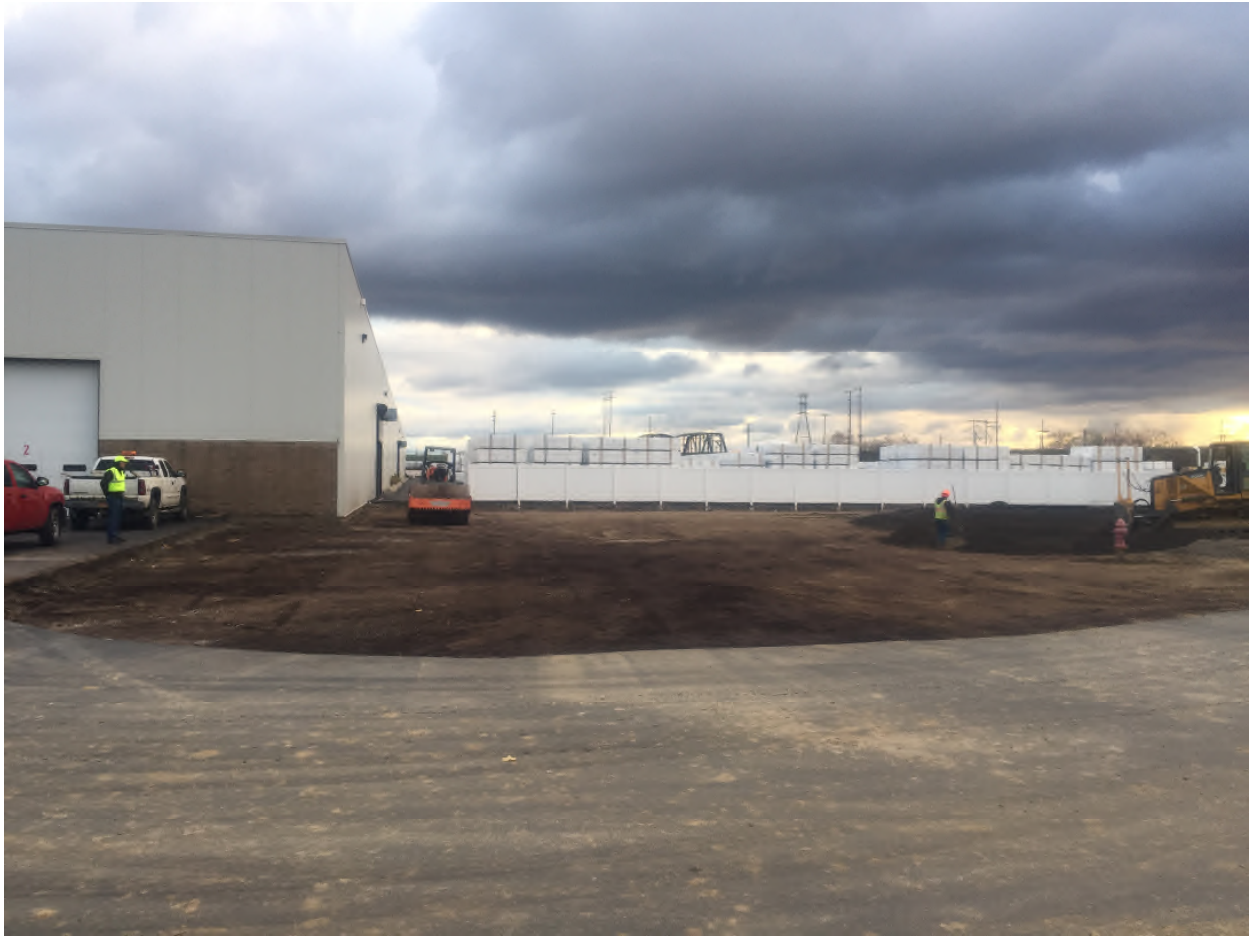
**Rolling subsurface soil/fill and placement of pre-pave stone layer**

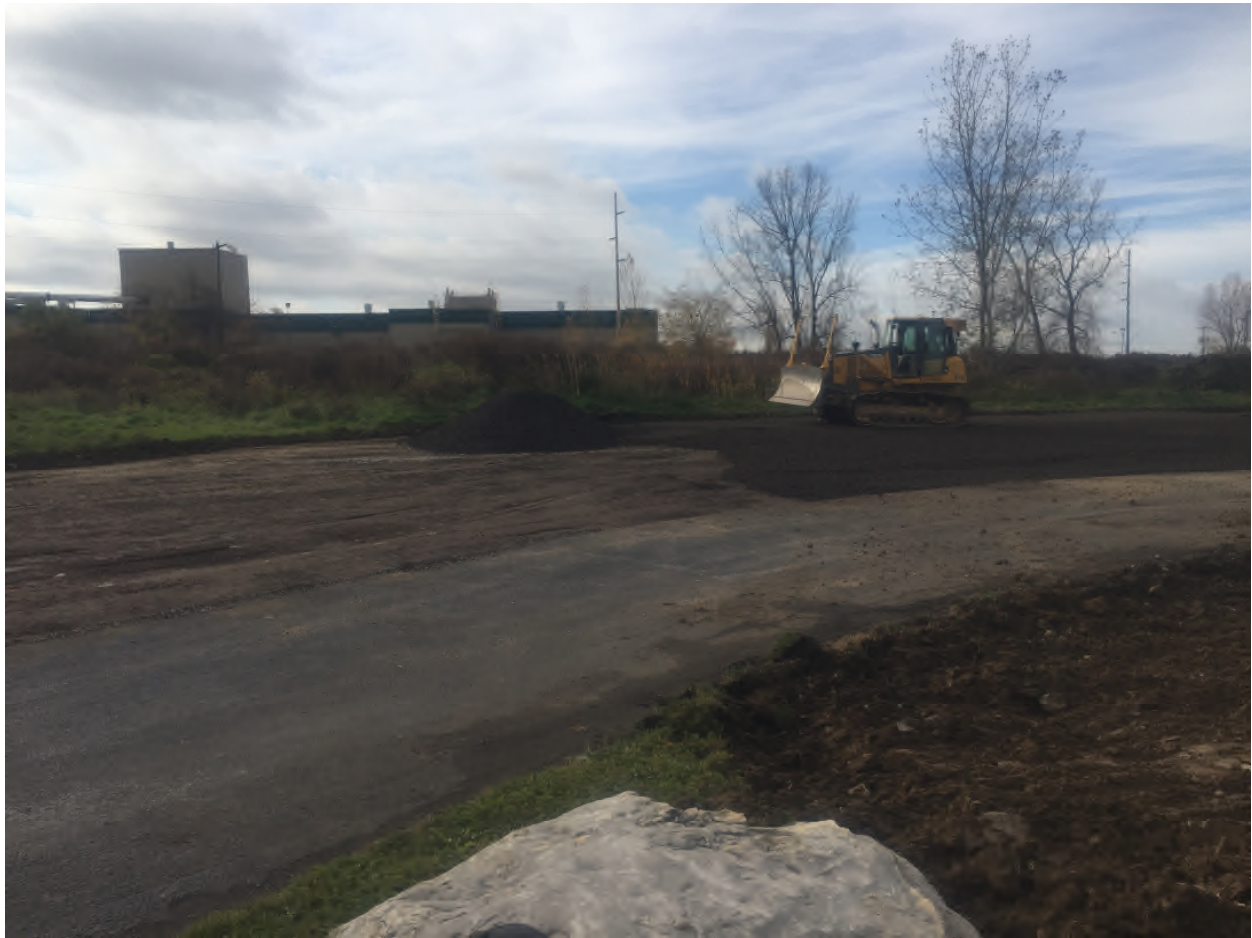
**Placement of pre-pave stone layer.**

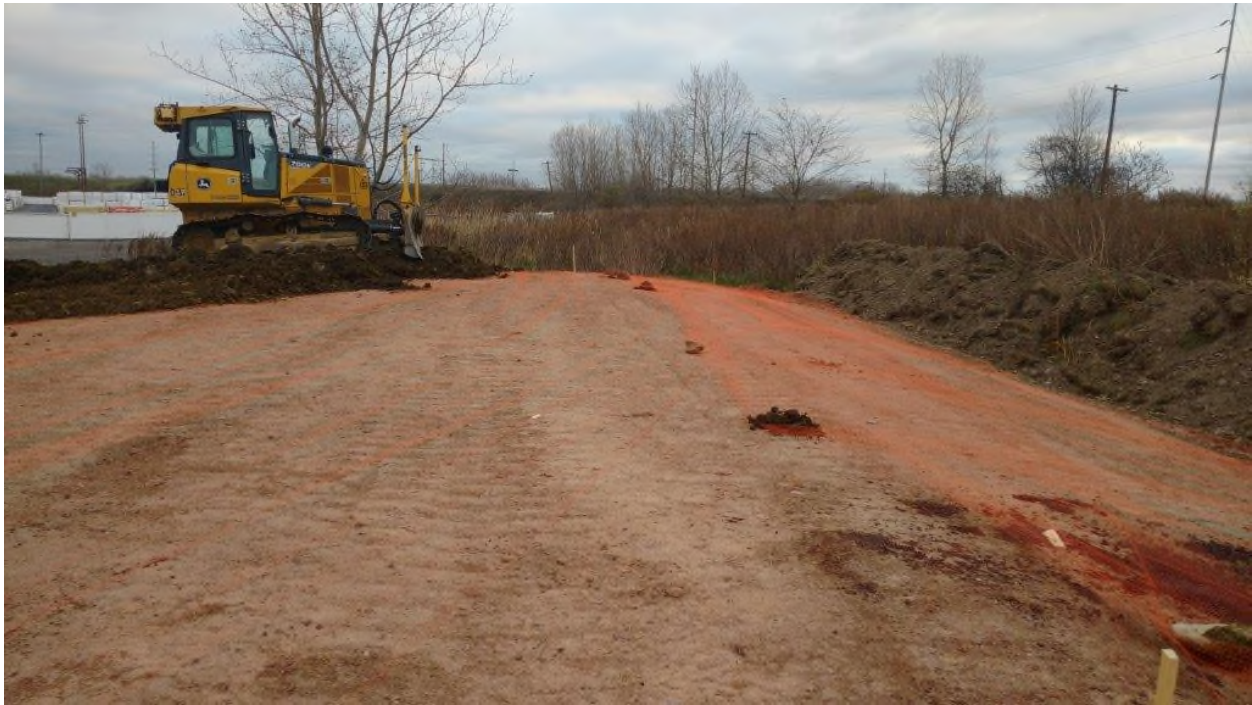
**Placement of clean soil cover onto new demarcation mesh.**

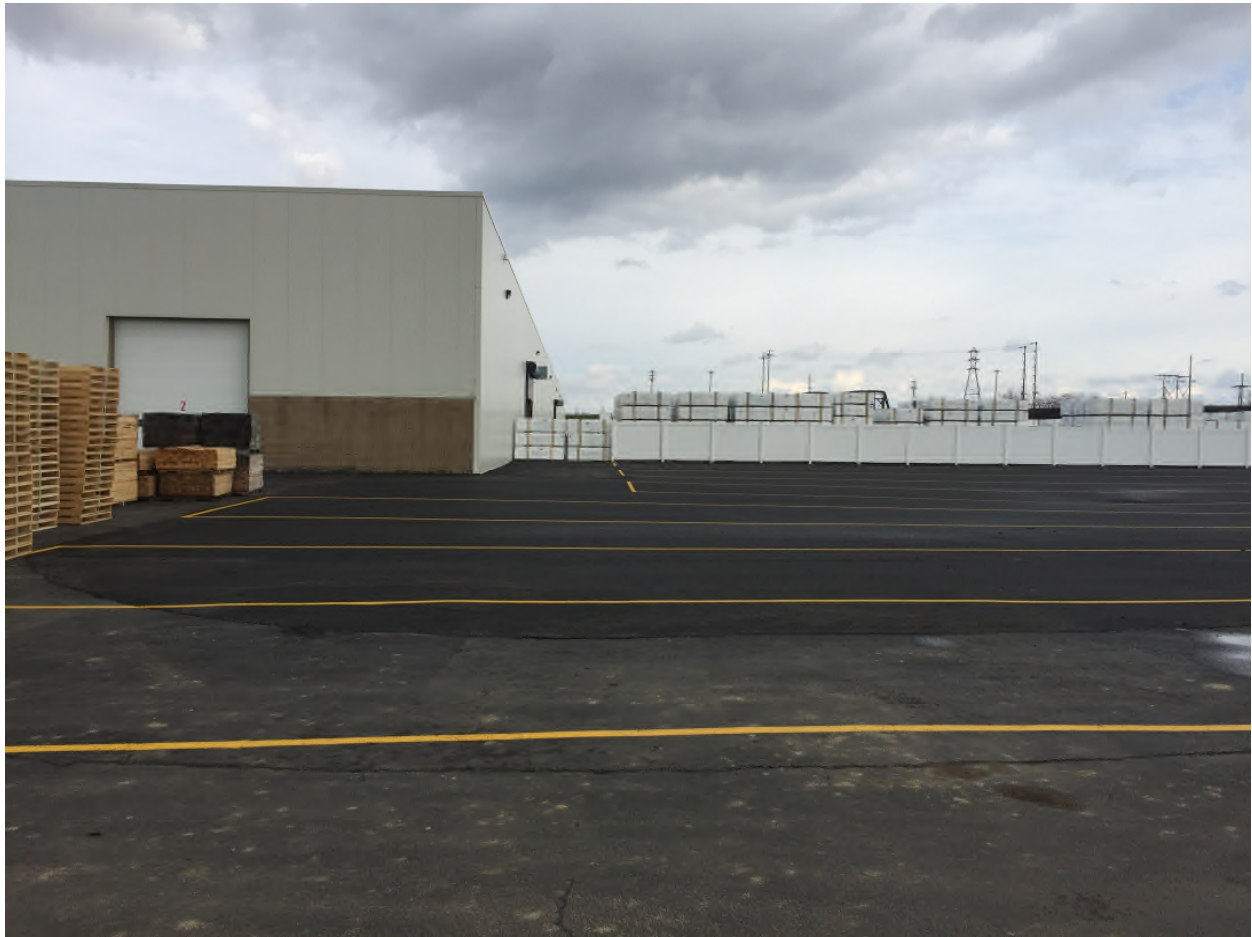
**Finished pavement, NE area.**

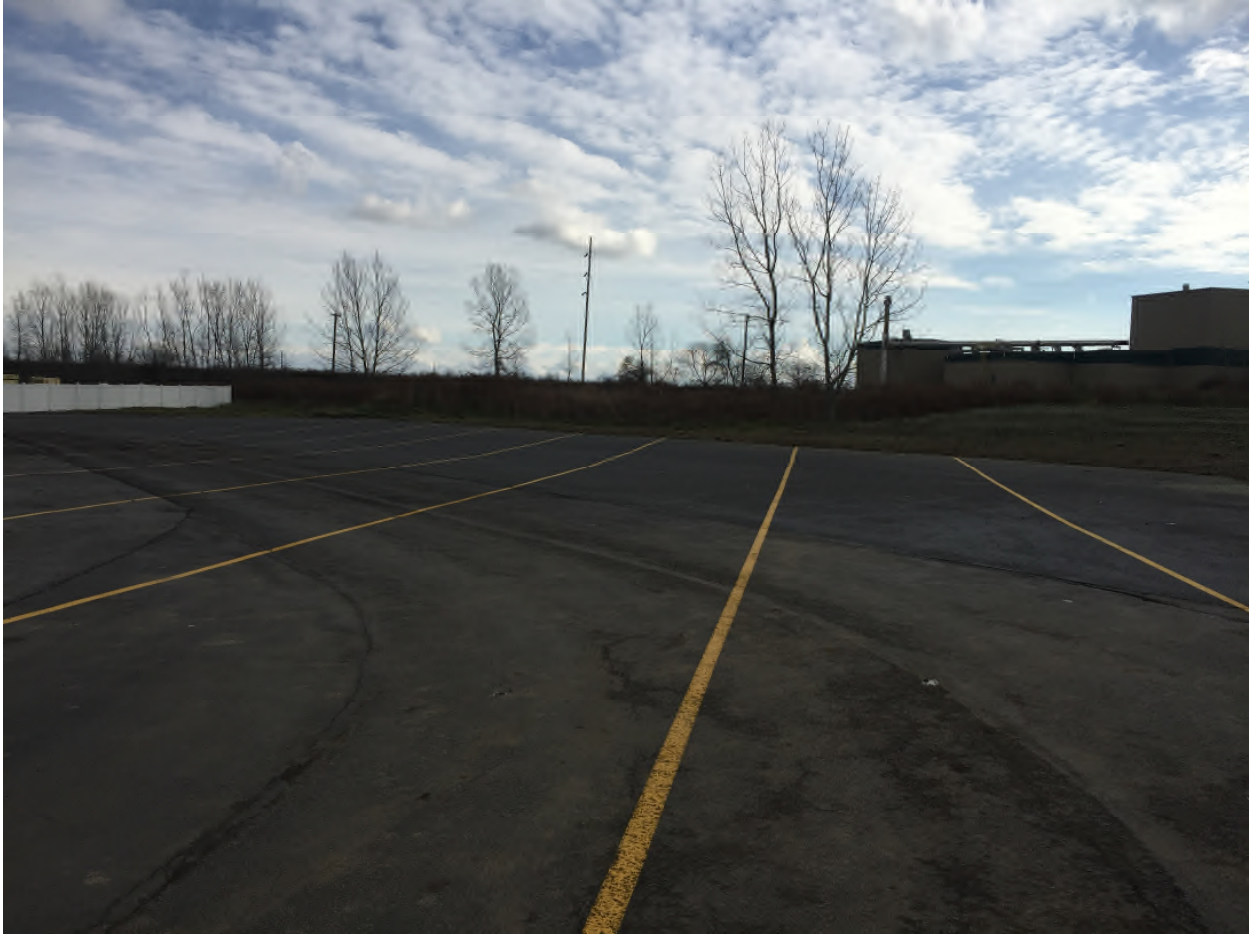
**Finished pavement, SW area.**

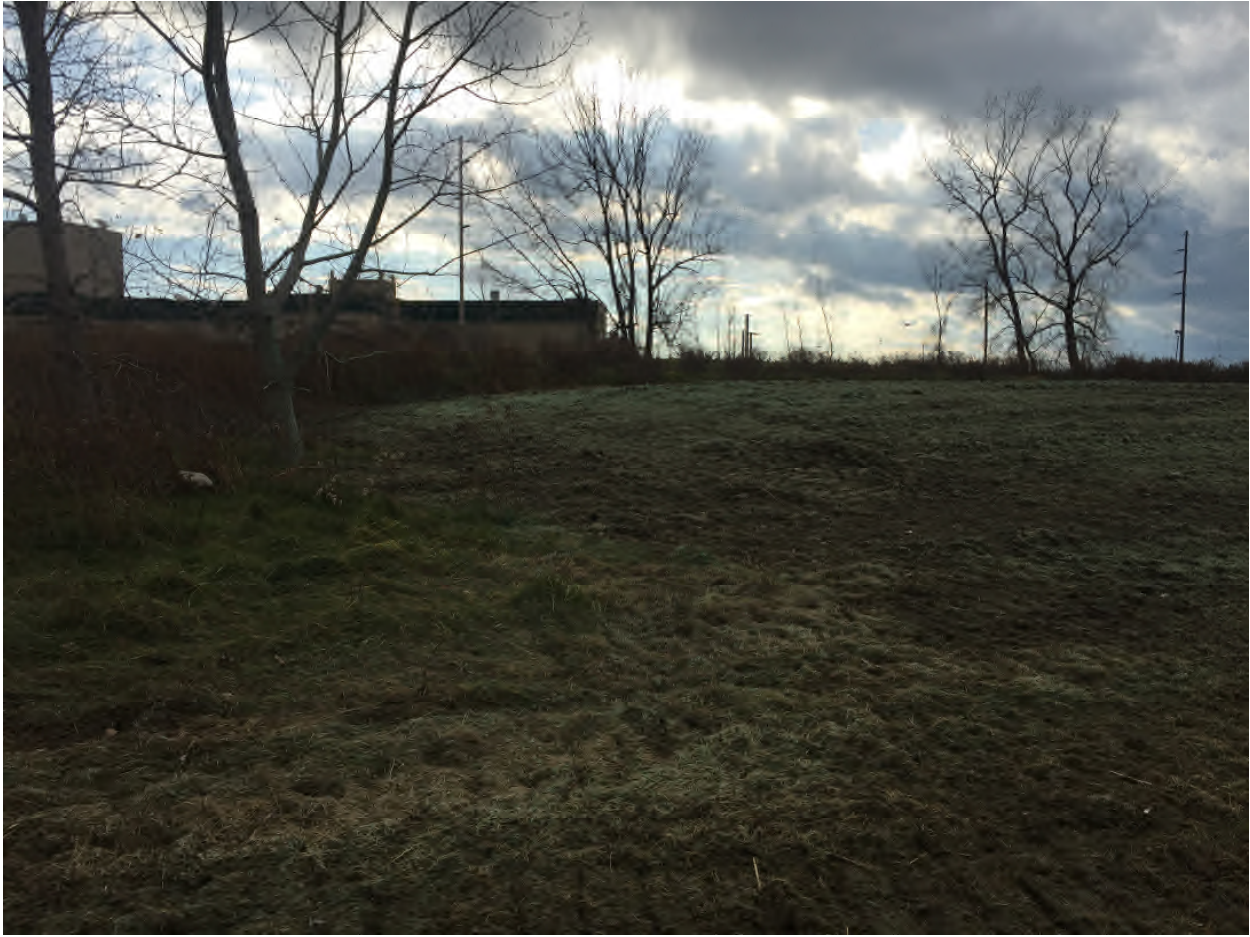
**Hydroseeded replaced clean soil cover.**
