# Periodic Review Report

**FORMER BUFFALO SERVICE CENTER, BURA WEST &  
4 NEW SEVENTH STREET SITES  
(SITE NOS. C915194, C915195, & C915203)**

**BUFFALO, NEW YORK**

June 2012  
Revised July 2012

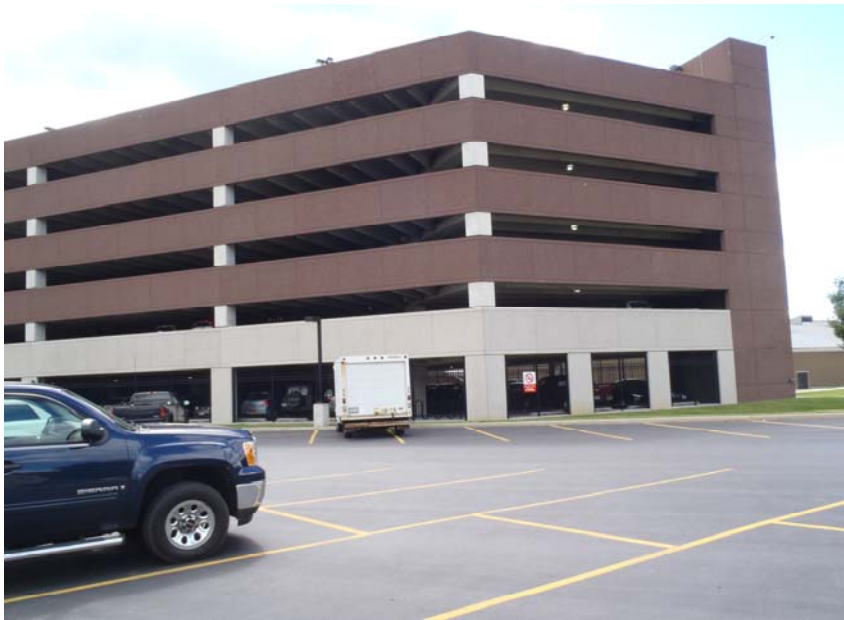
<b>Photo No.</b>  2	<b>Date</b>  06/05/12

<b>Direction Photo Taken:</b>		
<b>Description:</b> Site Conditions- East Side of Parking Garage

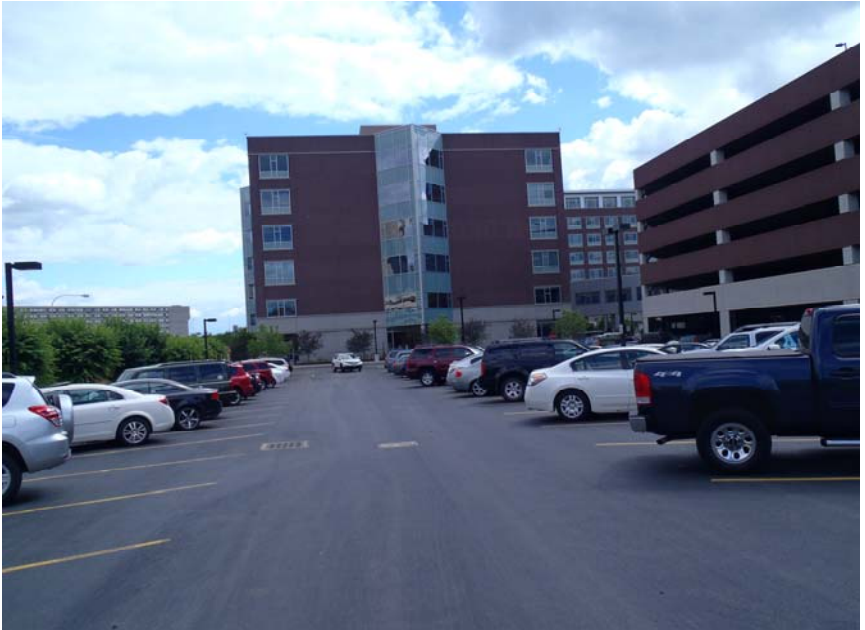
<b>Client Name:</b>		<b>Site Location:</b> 257 W Genesee Street, LLC Site Buffalo, NY	<b>Project No.:</b>
<b>Photo No.</b>  3	<b>Date</b>  06/05/12

<b>Direction Photo Taken:</b> South			
<b>Description:</b> Site Conditions- Office Building (looking South from New Seventh Street)

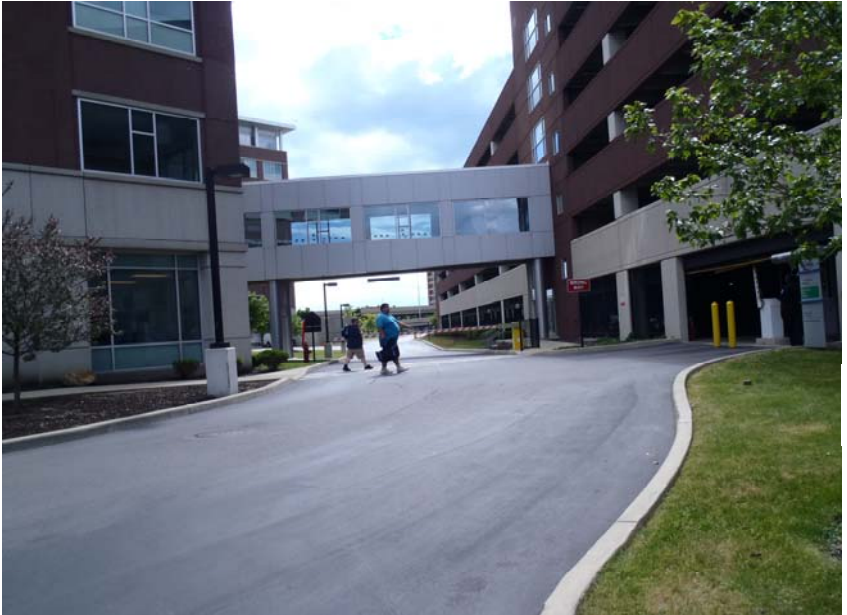
<b>Client Name:</b>		<b>Site Location:</b> 257 W Genesee Street, LLC Site Buffalo, NY	<b>Project No.:</b>
<b>Photo No.</b>  5	<b>Date</b>  06/05/12

<b>Direction Photo Taken:</b> West			
<b>Description:</b> Site Conditions- drive between garage and building complex, looking west

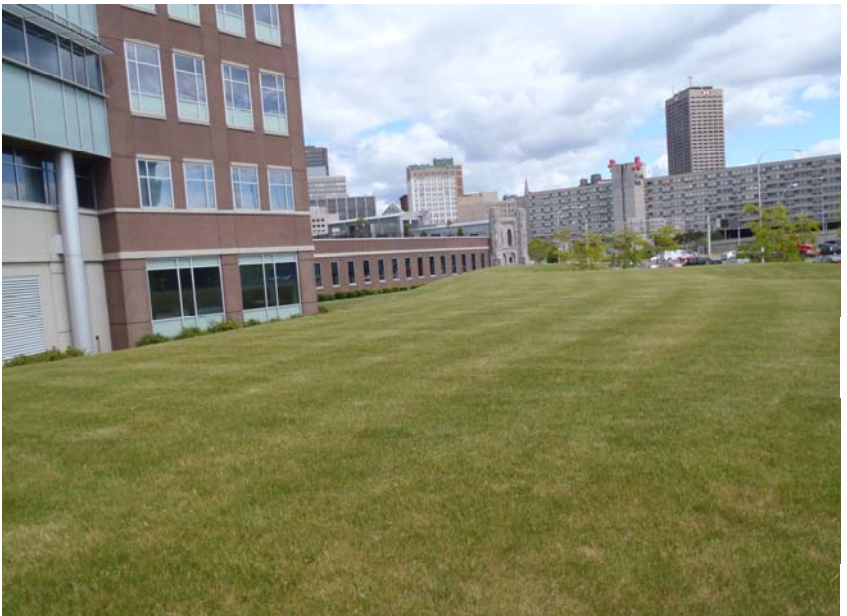
<b>Photo No.</b>  6	<b>Date</b>  06/05/12

<b>Direction Photo Taken:</b> South		
<b>Description:</b> Site Conditions- Berm area on 4th Street; looking south

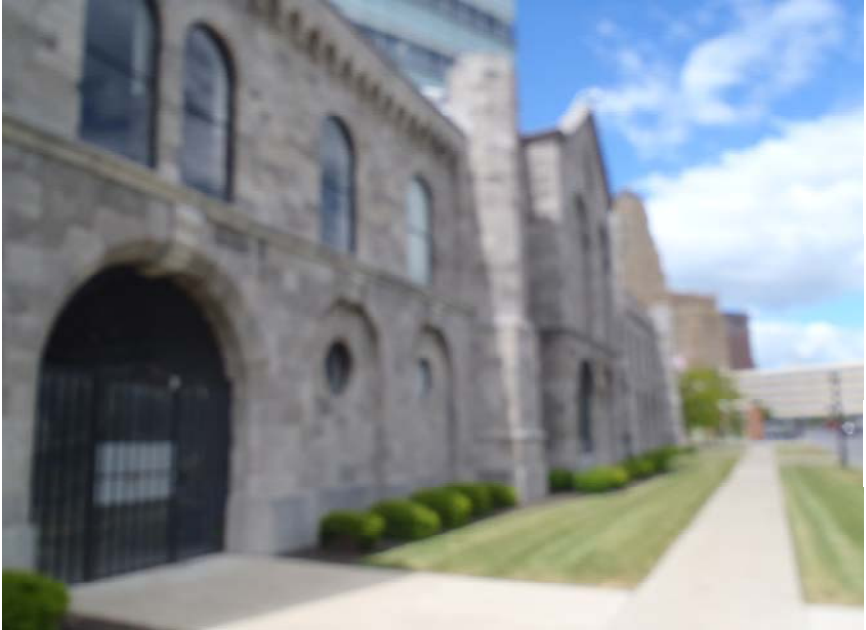
<b>Client Name:</b>		<b>Site Location:</b> 257 W Genesee Street, LLC Site Buffalo, NY	<b>Project No.:</b>
<b>Photo No.</b> 7	<b>Date</b> 06/05/12

<b>Direction Photo Taken:</b> East			
<b>Description:</b> Site Conditions - Building Façade; looking east along 257 W. Genesee

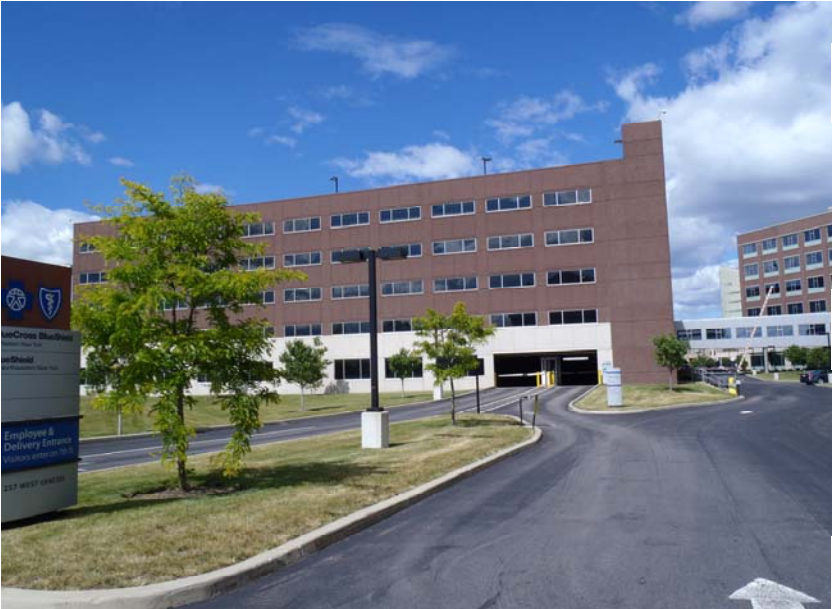
<b>Photo No.</b> 8	<b>Date</b> 06/05/12

<b>Direction Photo Taken:</b> East		
<b>Description:</b> Site Conditions- looking east at entrance to garage from Fourth Street

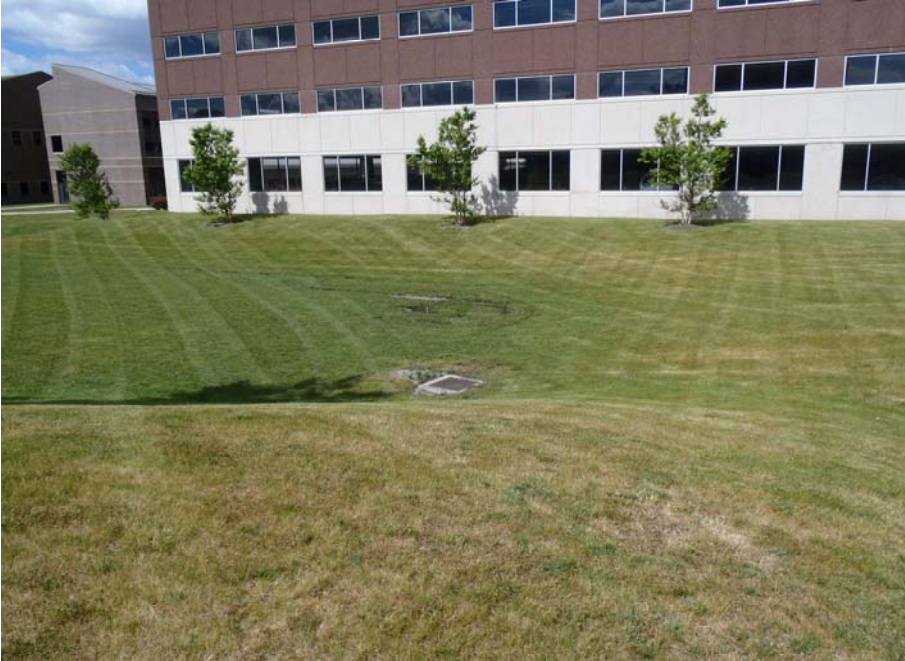
<b>Client Name:</b>		<b>Site Location:</b> 257 W Genesee Street, LLC Site Buffalo, NY	<b>Project No.:</b>
<b>Photo No.</b>  9	<b>Date</b>  06/05/12

<b>Direction Photo Taken:</b> East -Southeast			
<b>Description:</b> Site Conditions- Detention pond area looking east-southeast.

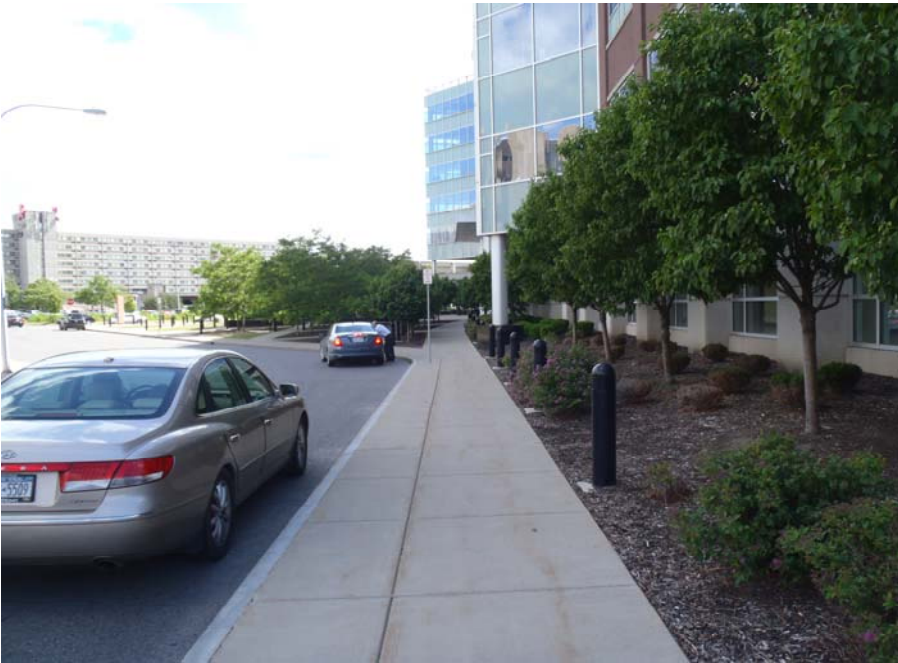
<b>Photo No.</b>  10	<b>Date</b>  06/05/12

<b>Direction Photo Taken:</b> South		
<b>Description:</b> Site Conditions- Courtyard area on New Seventh Street looking south
