Periodic Review Report

**FORMER BUFFALO SERVICE CENTER, BURA WEST &
4 NEW SEVENTH STREET SITES
(BCP SITE NOS. C915194, C915195, & C915203)**

BUFFALO, NEW YORK

June 2013

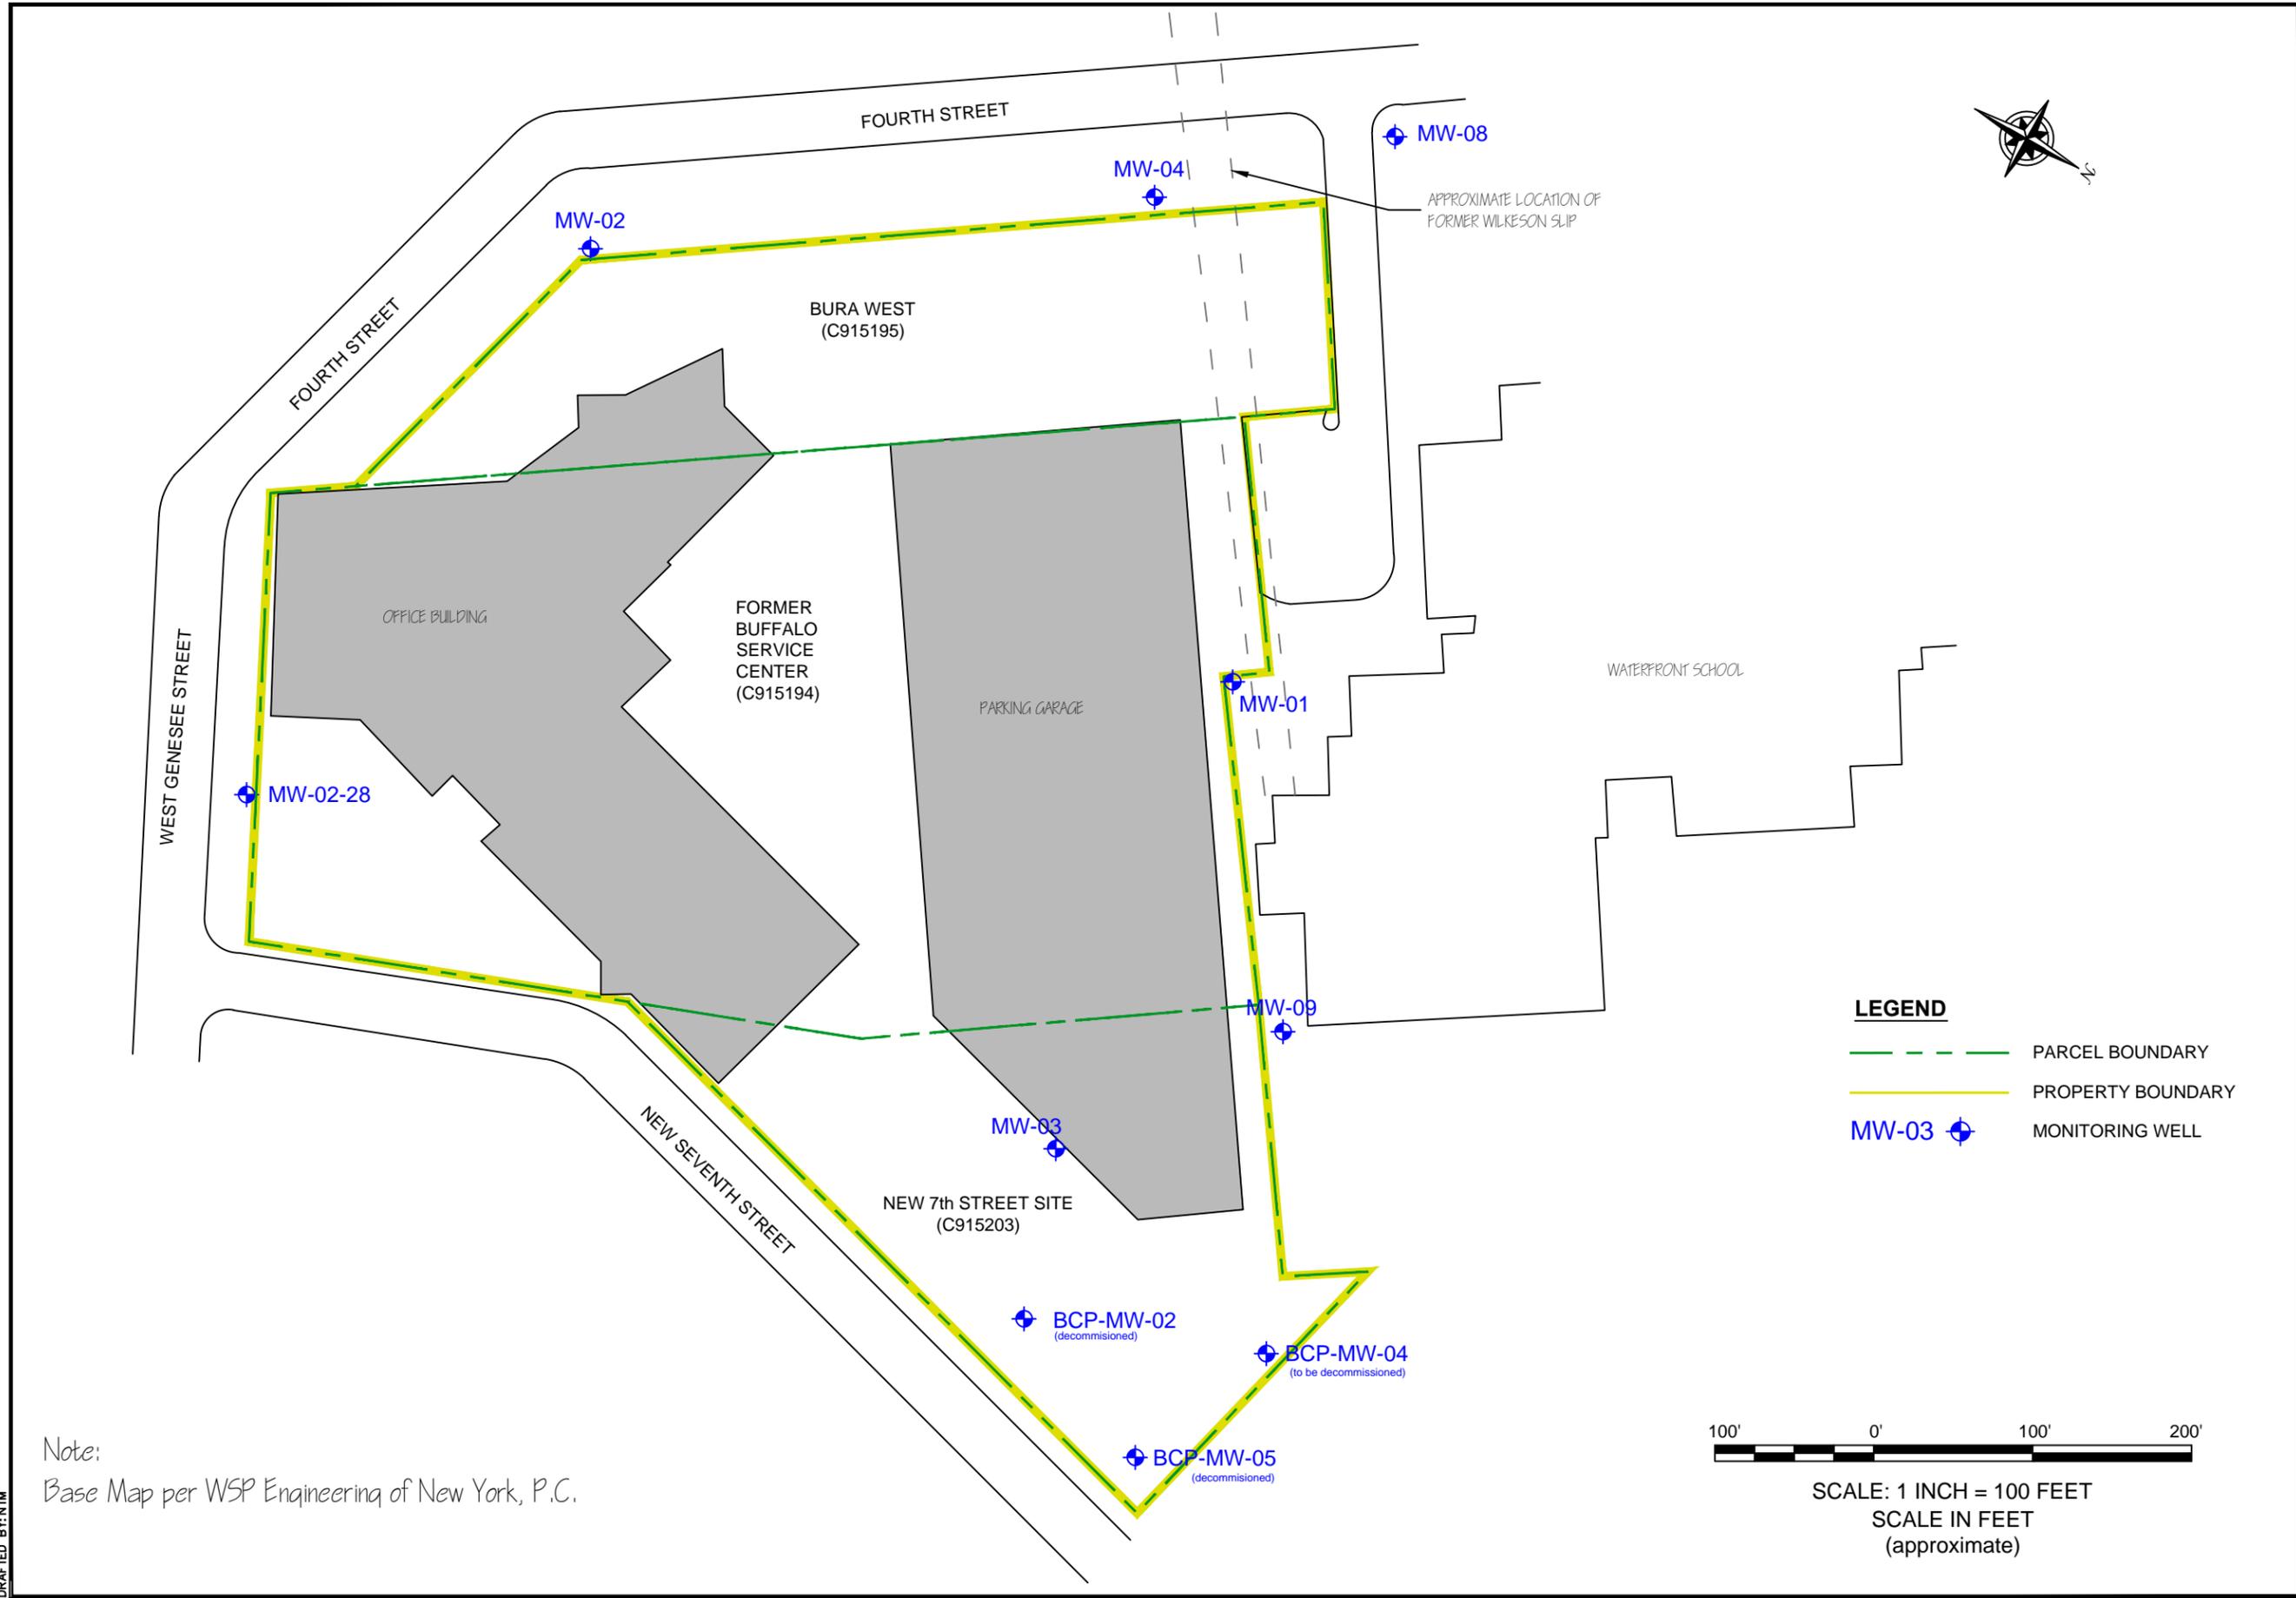
FIGURE 2

SITE PLAN

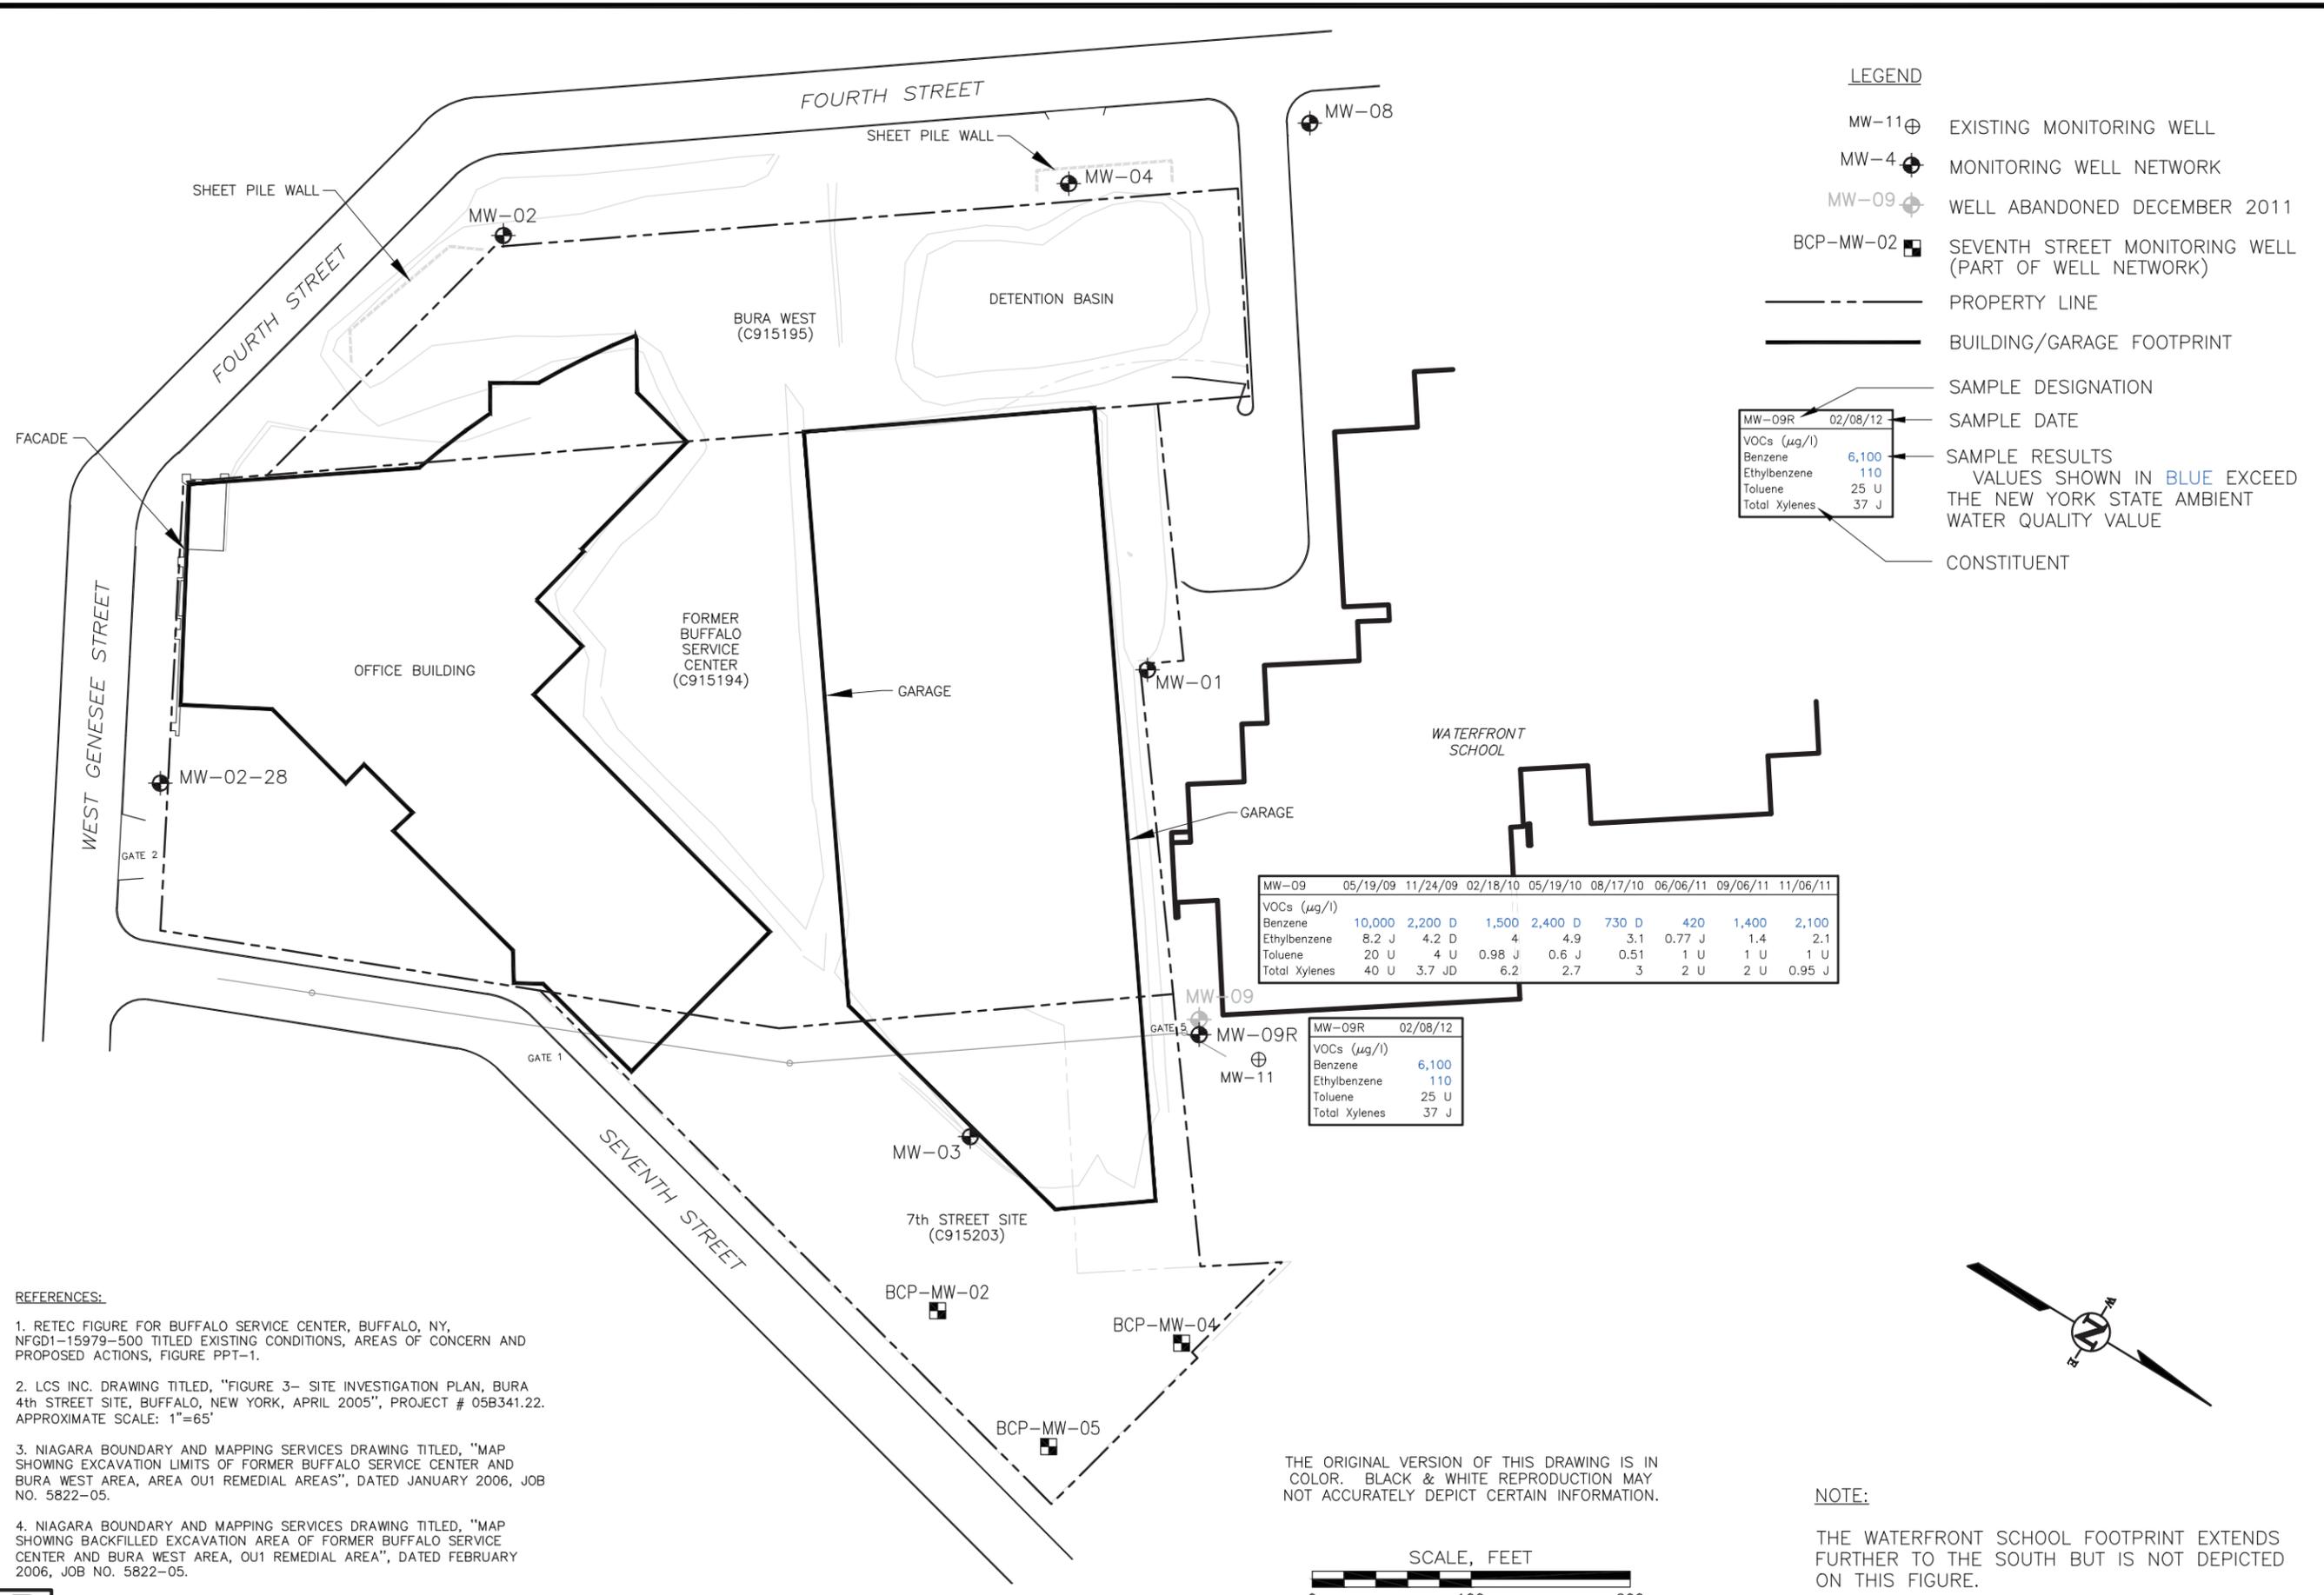
FIGURE 1
 PERFORMANCE MONITORING RESULTS

NOTE:
THE WATERFRONT SCHOOL FOOTPRINT EXTENDS FURTHER TO THE SOUTH BUT IS NOT DEPICTED ON THIS FIGURE.

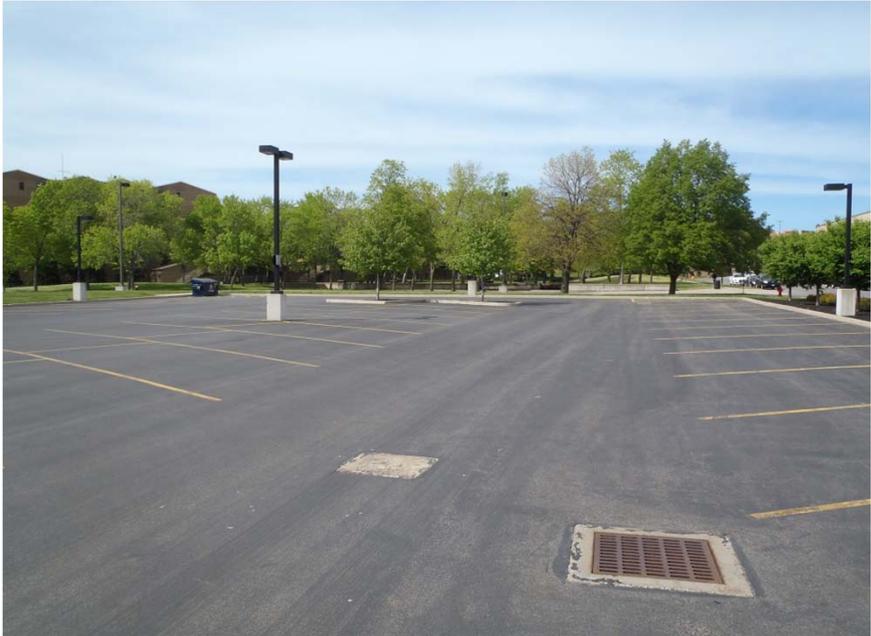
Client Name:		Site Location: 257 W Genesee Street, LLC Site Buffalo, NY	Project No.:
Photo No. 1	Date 05/17/13

Direction Photo Taken: North			
Description: Site Conditions - Visitor Surface Lot (looking north)

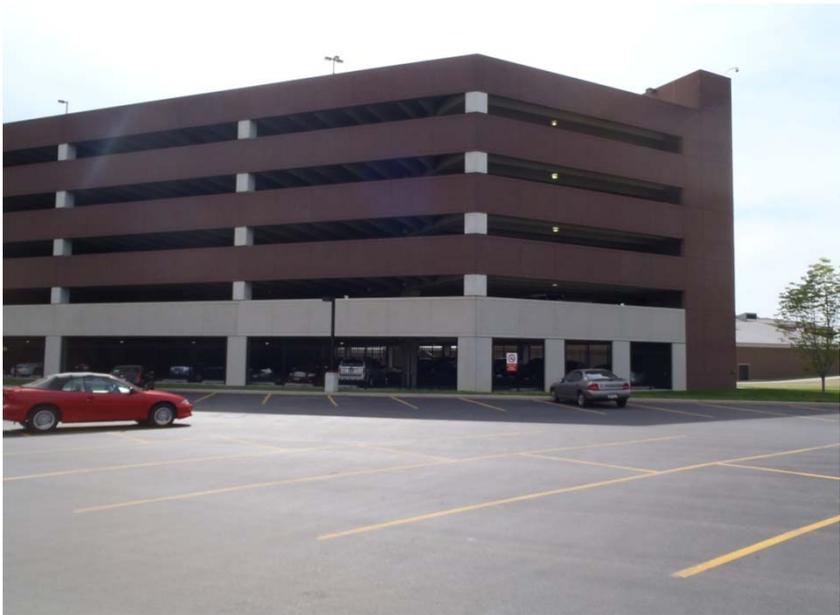
Photo No. 2	Date 05/17/13

Direction Photo Taken:		
Description: Site Conditions- East Side of Parking Garage

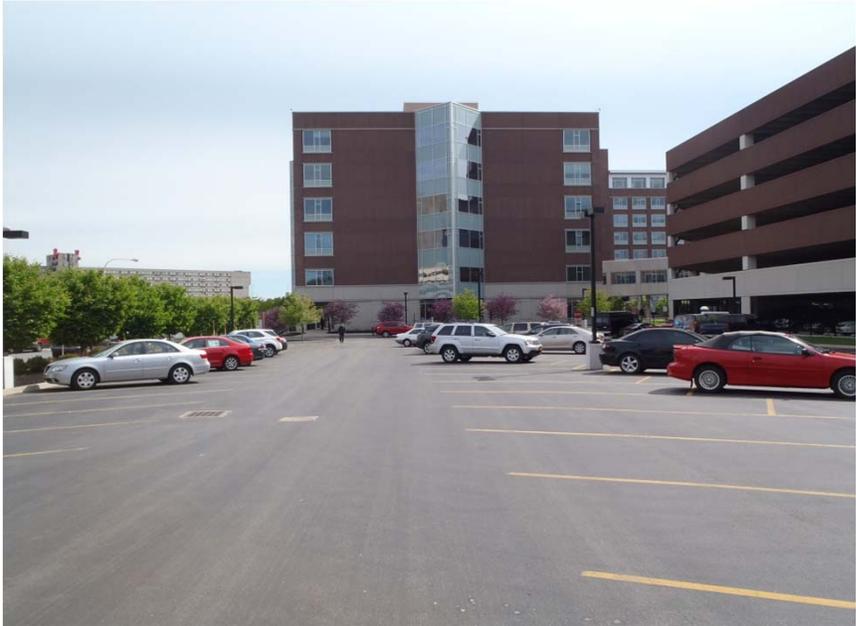
Client Name:		Site Location: 257 W Genesee Street, LLC Site Buffalo, NY	Project No.:
Photo No. 3	Date 05/17/13

Direction Photo Taken: South			
Description: Site Conditions- Office Building (looking South from New Seventh Street)

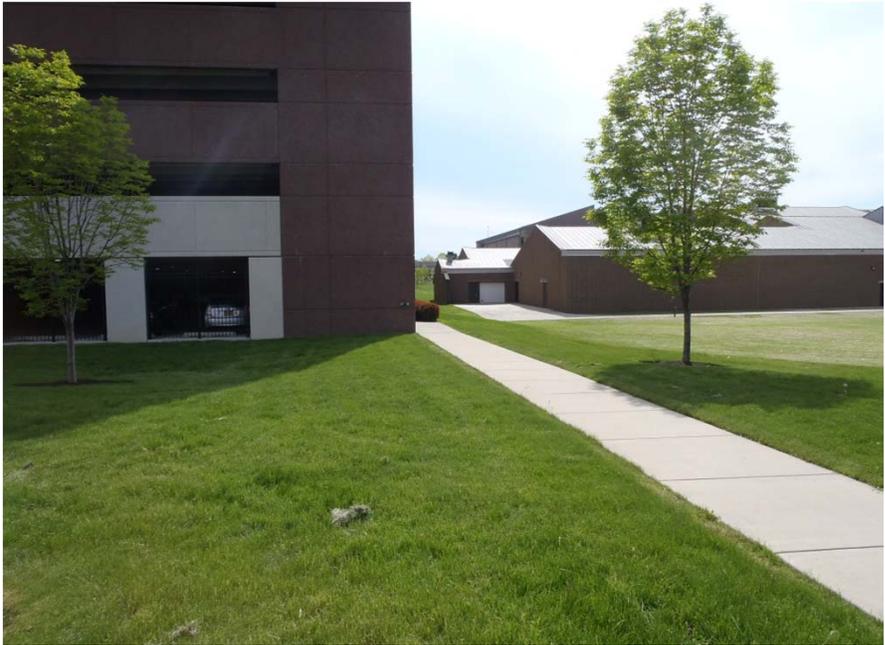
Photo No. 4	Date 05/17/13

Direction Photo Taken: Southwest			
Description: Northern Property Boundary (looking Southwest from New Seventh Street)

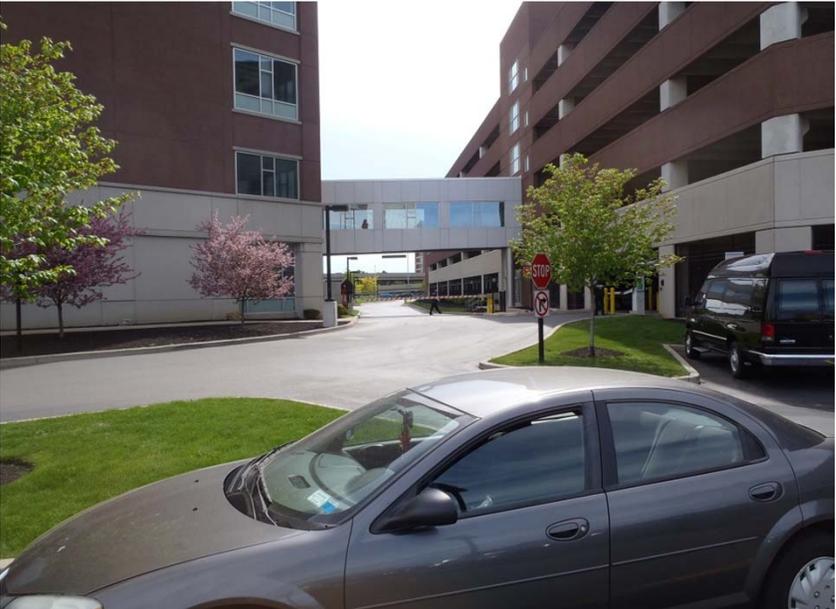
Client Name:		Site Location: 257 W Genesee Street, LLC Site Buffalo, NY	Project No.:
Photo No. 5	Date 05/17/13

Direction Photo Taken: West			
Description: Site Conditions- drive between garage and building complex, looking west

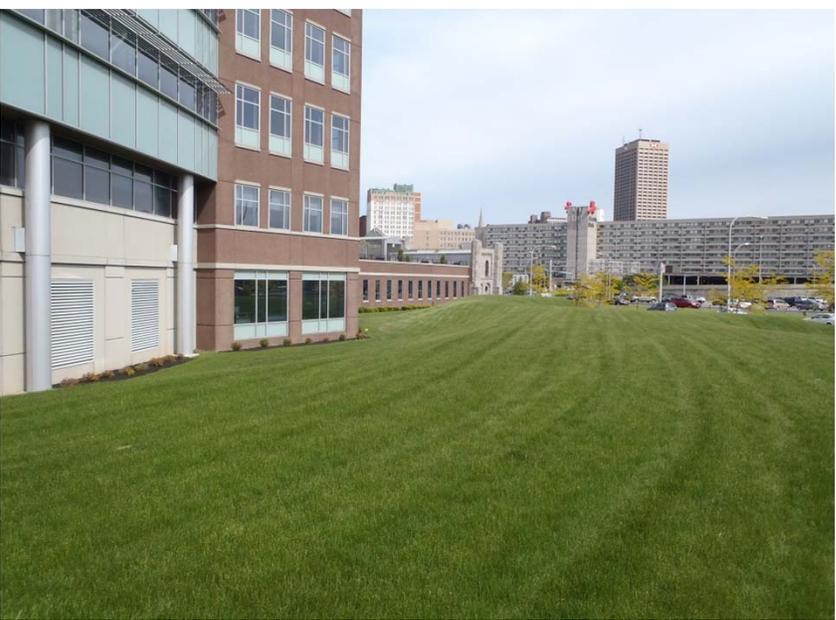
Photo No. 6	Date 05/17/13

Direction Photo Taken: South		
Description: Site Conditions- Berm area on 4th Street; looking south

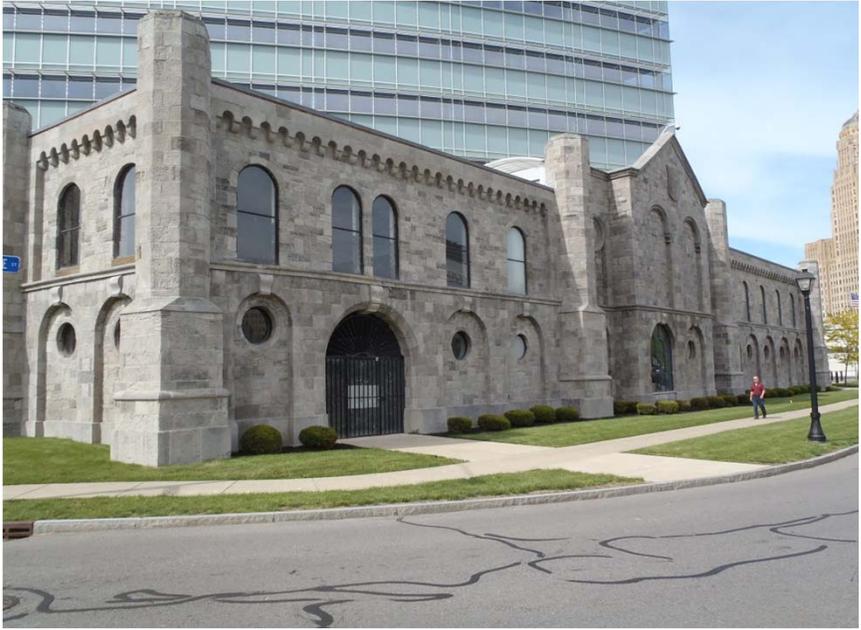
Client Name:		Site Location: 257 W Genesee Street, LLC Site Buffalo, NY	Project No.:
Photo No. 7	Date 05/17/13

Direction Photo Taken: East			
Description: Site Conditions - Building Façade; looking east along 257 W. Genesee

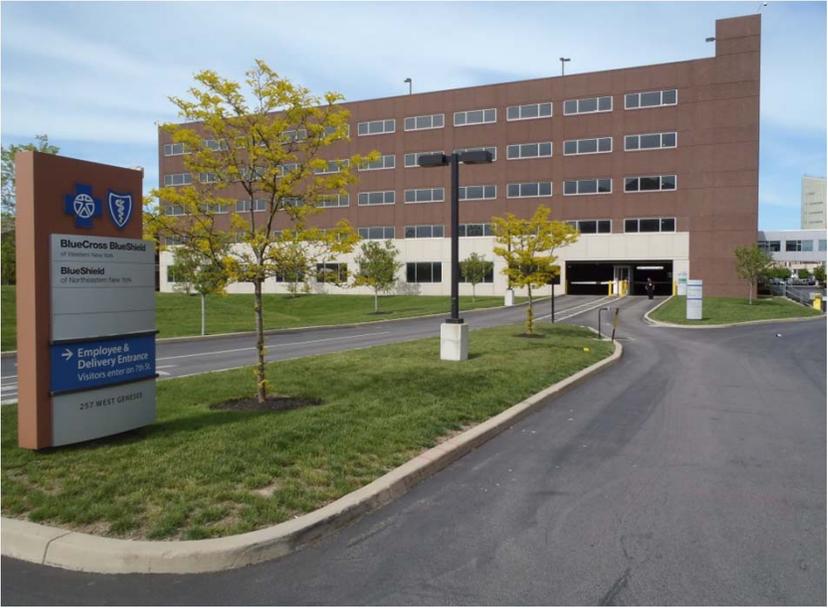
Photo No. 8	Date 05/17/13

Direction Photo Taken: East		
Description: Site Conditions- looking east at entrance to garage from Fourth Street

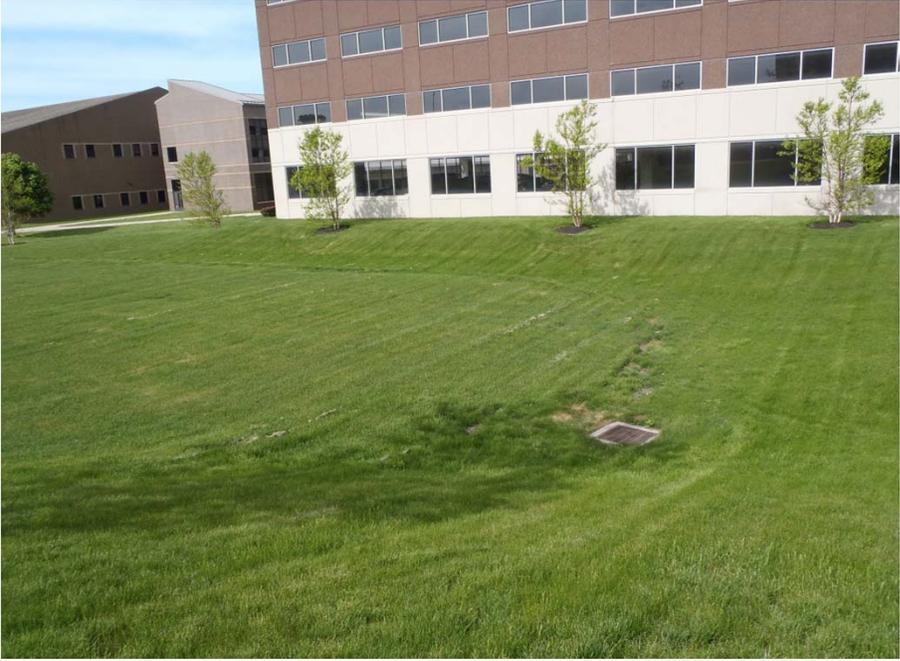
Client Name:		Site Location: 257 W Genesee Street, LLC Site Buffalo, NY	Project No.:
Photo No. 9	Date 05/17/13

Direction Photo Taken: East -Southeast			
Description: Site Conditions- Detention pond area looking east-southeast.

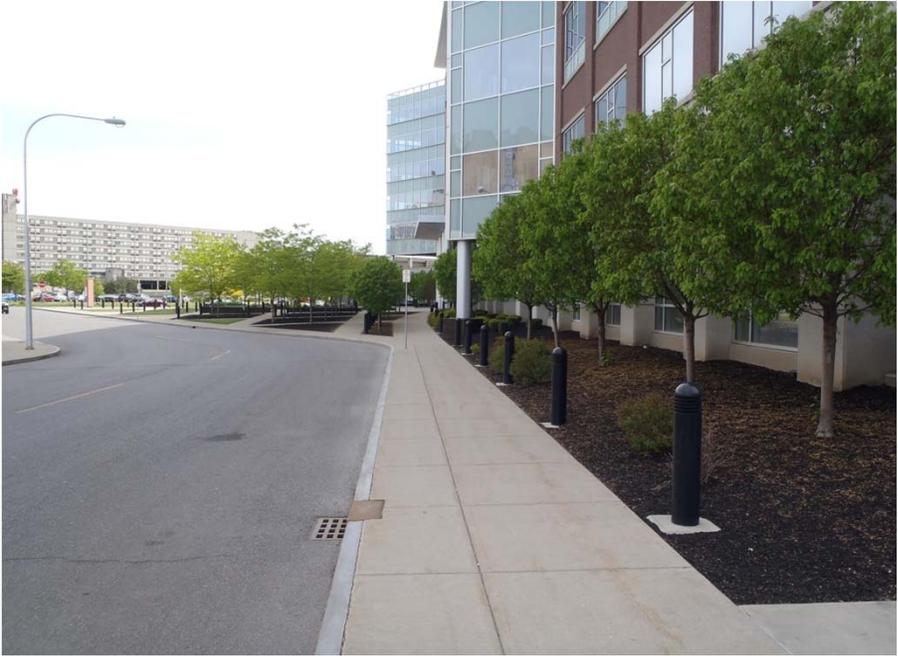
Photo No. 10	Date 05/17/13

Direction Photo Taken: South		
Description: Site Conditions- Courtyard area on New Seventh Street looking south
