# Periodic Review Report

**FORMER BUFFALO SERVICE CENTER, BURA WEST &  
4 NEW SEVENTH STREET SITES  
(BCP SITE NOS. C915194, C915195, & C915203)**

**BUFFALO, NEW YORK**

July 2014

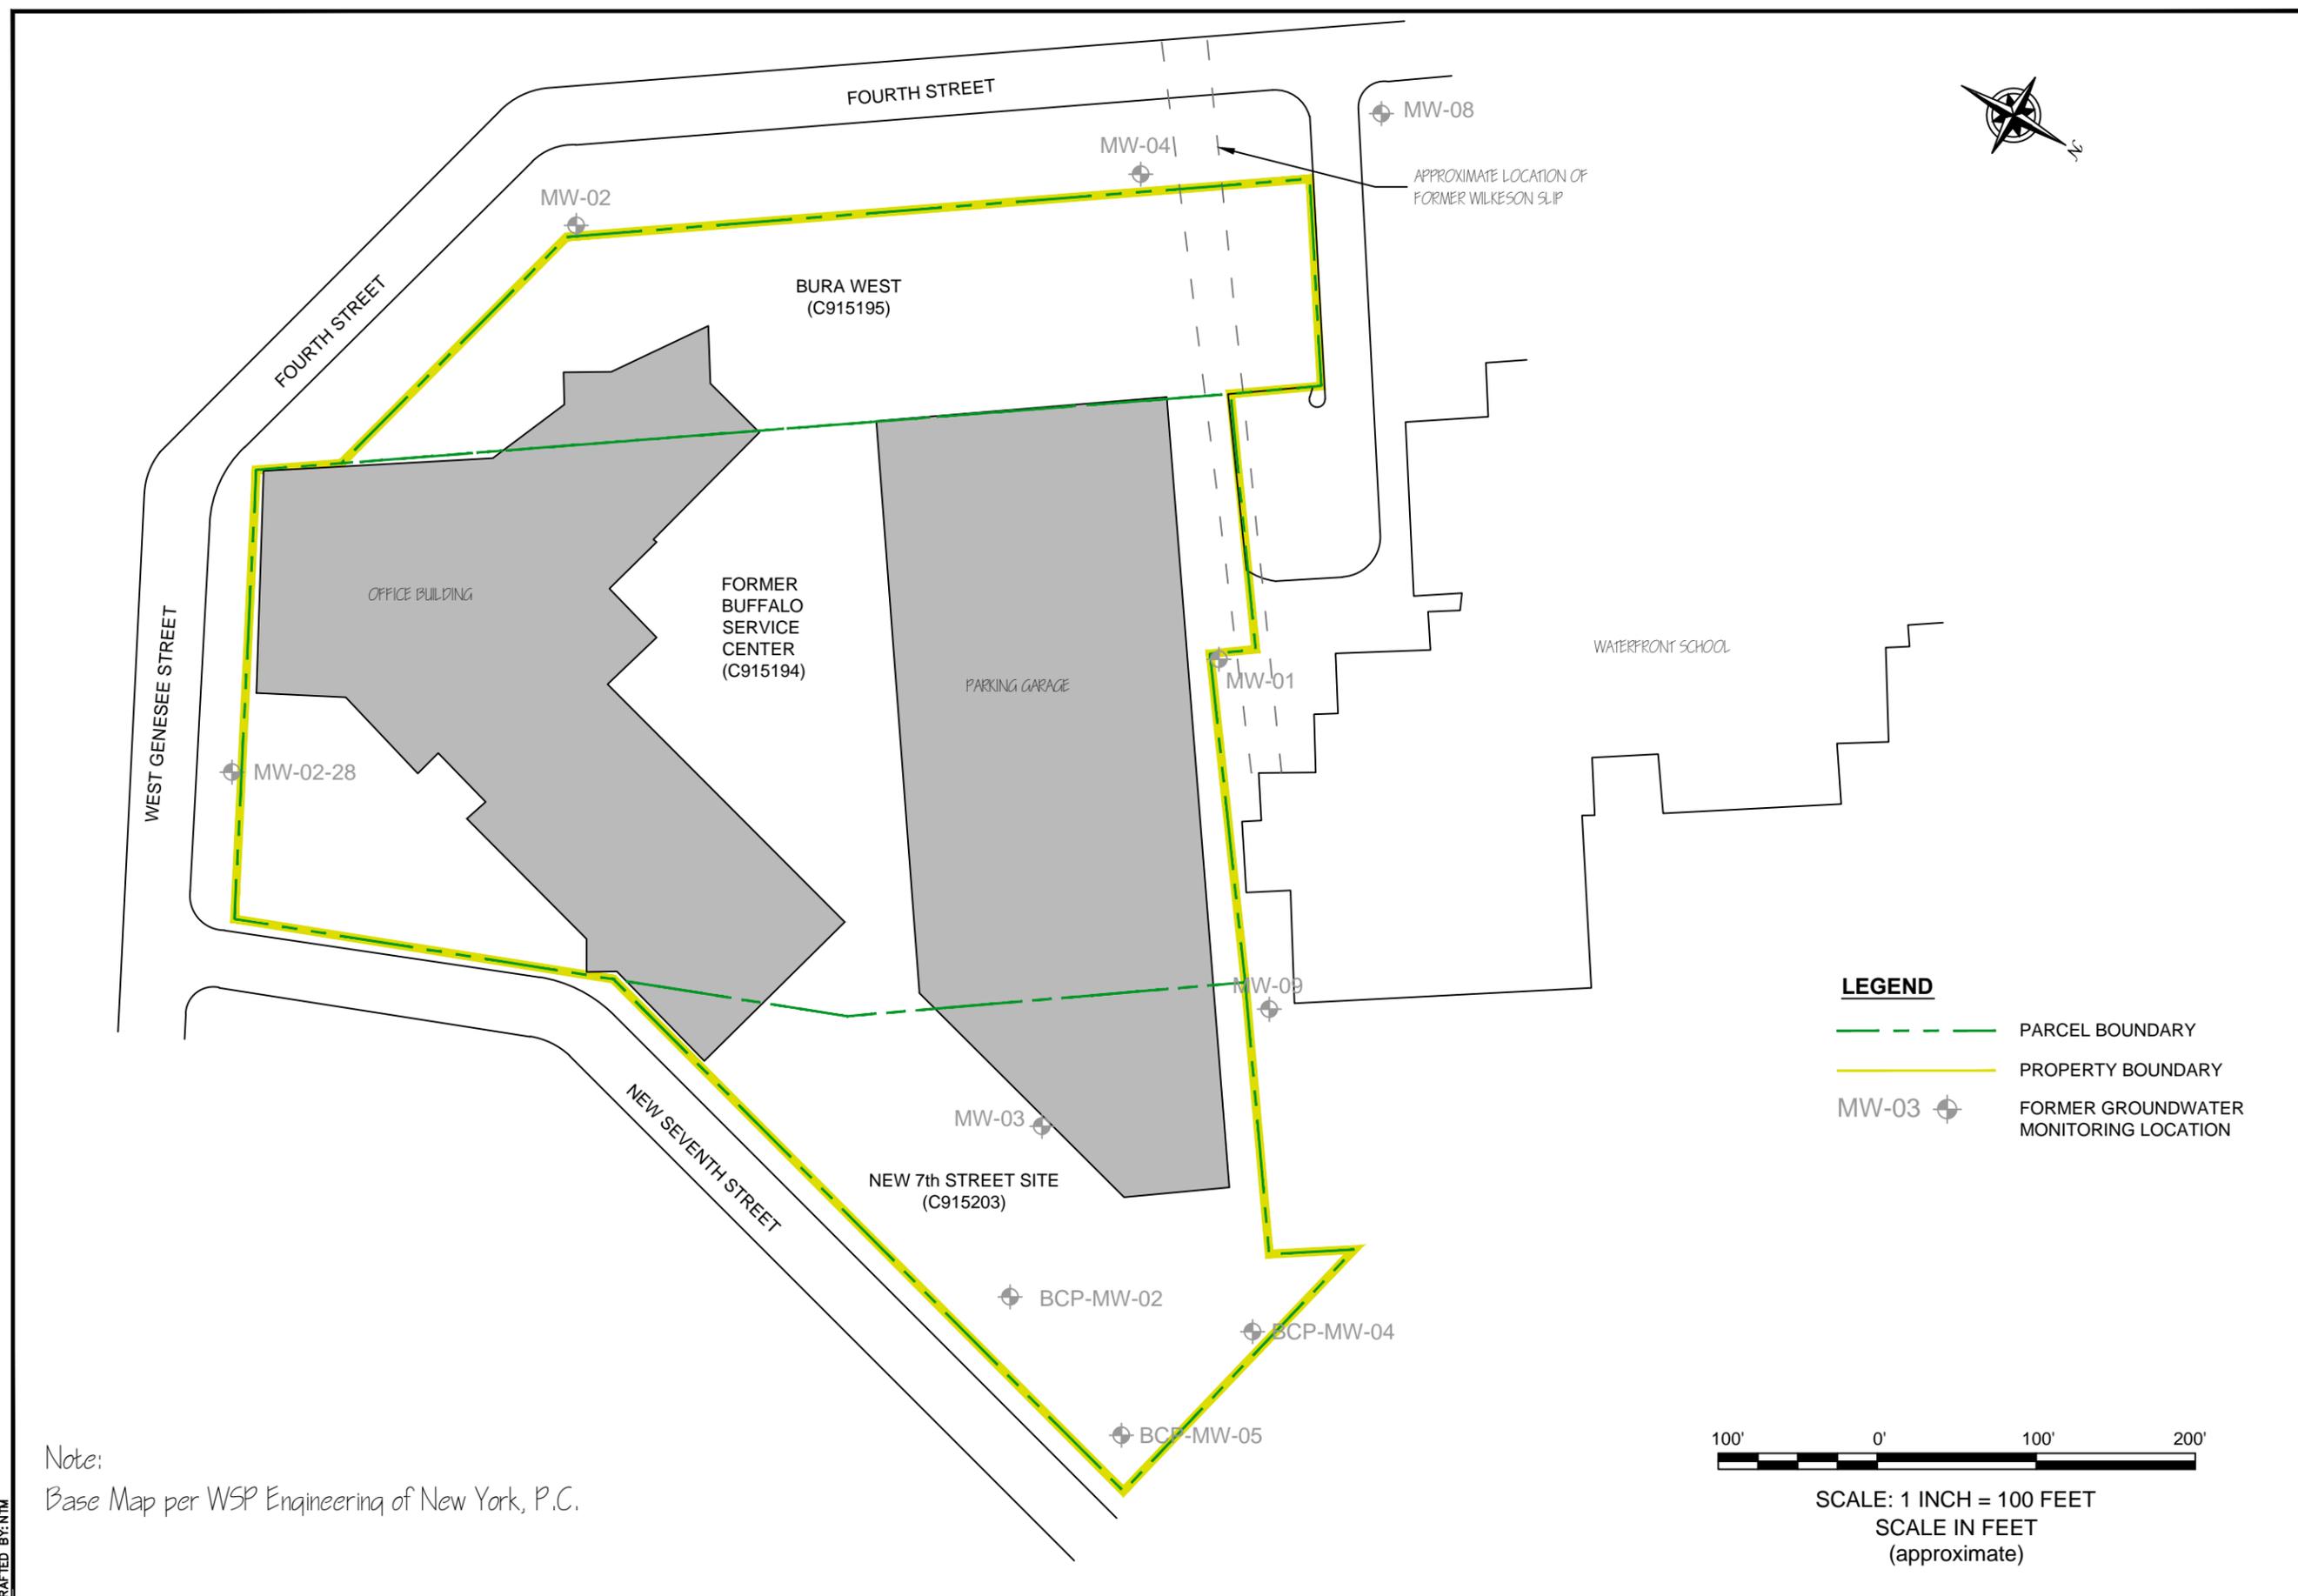
**FIGURE 2**

**SITE PLAN**

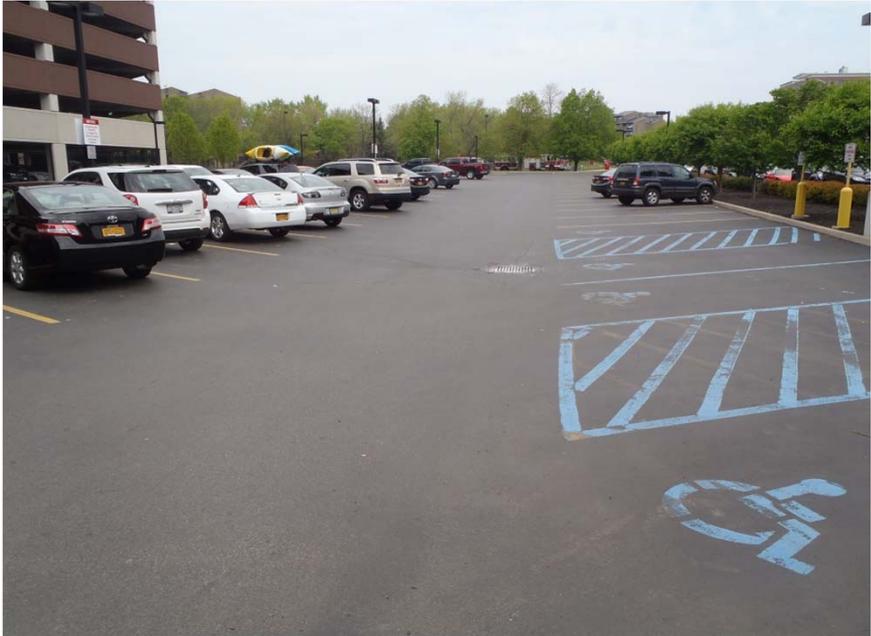
<b>Client Name:</b>		<b>Site Location:</b> 257 W Genesee Street, LLC Site Buffalo, NY	<b>Project No.:</b>
<b>Photo No.</b> 1	<b>Date</b> 05/27/14

<b>Direction Photo Taken:</b> North			
<b>Description:</b> Site Conditions - Visitor Surface Lot (looking north)

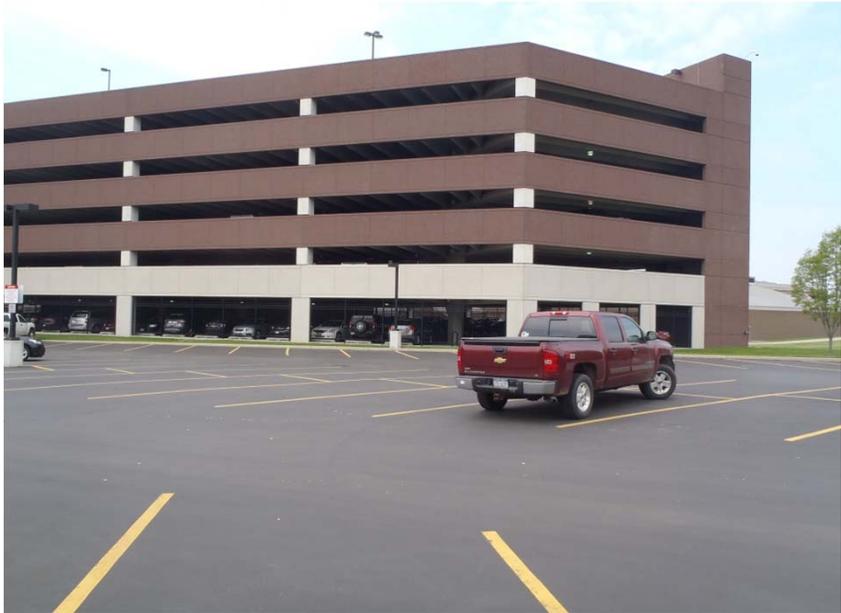
<b>Photo No.</b> 2	<b>Date</b> 05/27/14

<b>Direction Photo Taken:</b>		
<b>Description:</b> Site Conditions- East Side of Parking Garage

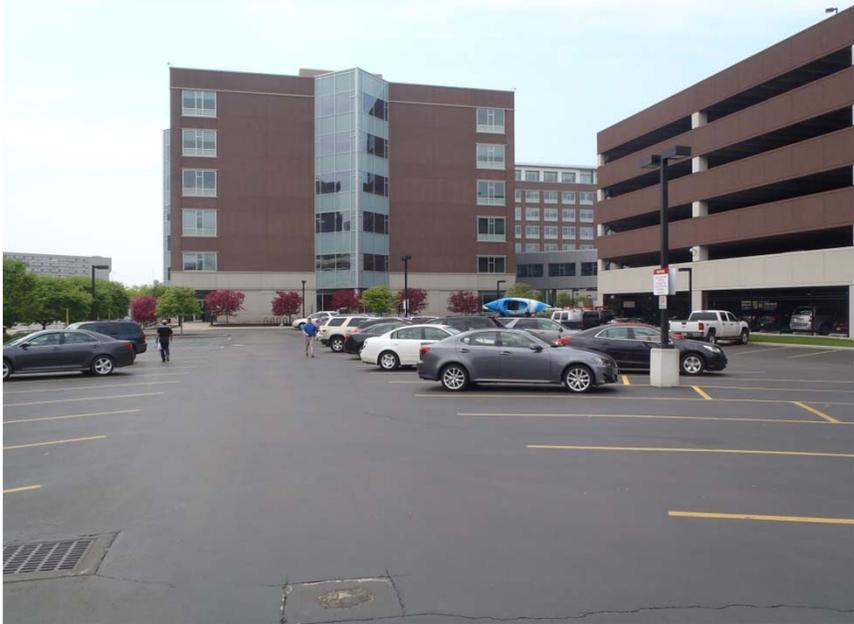
<b>Client Name:</b>		<b>Site Location:</b> 257 W Genesee Street, LLC Site Buffalo, NY	<b>Project No.:</b>
<b>Photo No.</b> 3	<b>Date</b> 05/27/14

<b>Direction Photo Taken:</b> South			
<b>Description:</b> Site Conditions- Office Building (looking South from New Seventh Street)

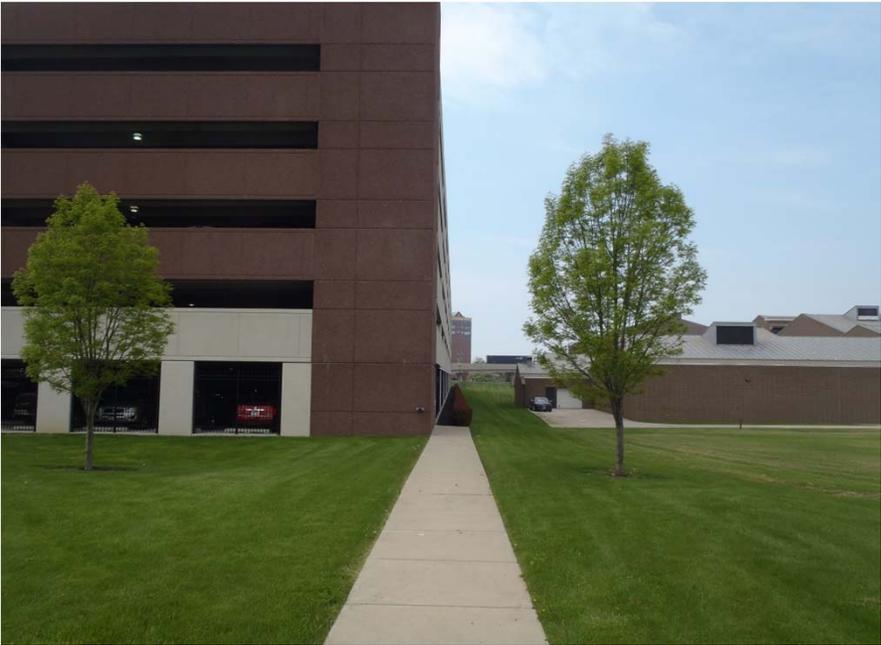
<b>Photo No.</b> 4	<b>Date</b> 05/27/14

<b>Direction Photo Taken:</b> Southwest			
<b>Description:</b> Northern Property Boundary (looking Southwest from New Seventh Street)

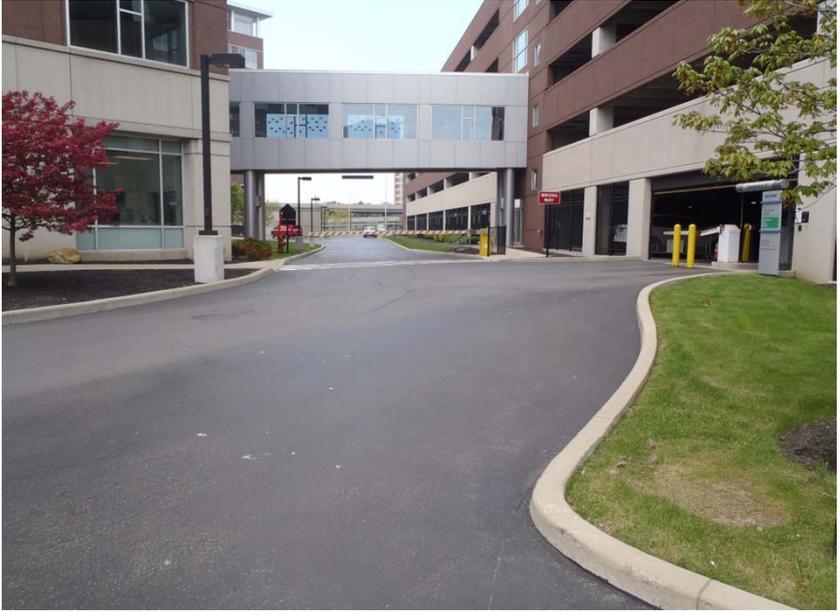
<b>Client Name:</b>		<b>Site Location:</b> 257 W Genesee Street, LLC Site Buffalo, NY	<b>Project No.:</b>
<b>Photo No.</b> 5	<b>Date</b> 05/27/14

<b>Direction Photo Taken:</b> West			
<b>Description:</b> Site Conditions- drive between garage and building complex, looking west

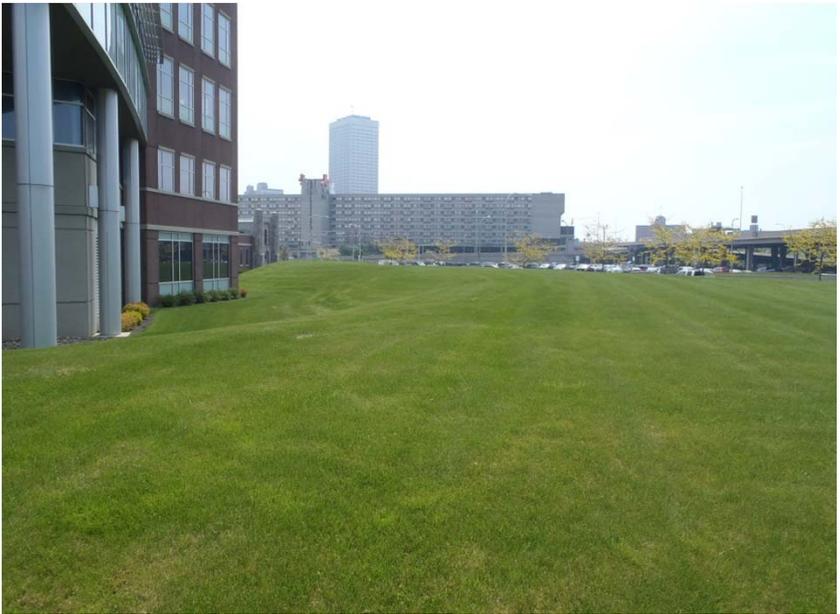
<b>Photo No.</b> 6	<b>Date</b> 05/27/14

<b>Direction Photo Taken:</b> South		
<b>Description:</b> Site Conditions- Berm area on 4th Street; looking south

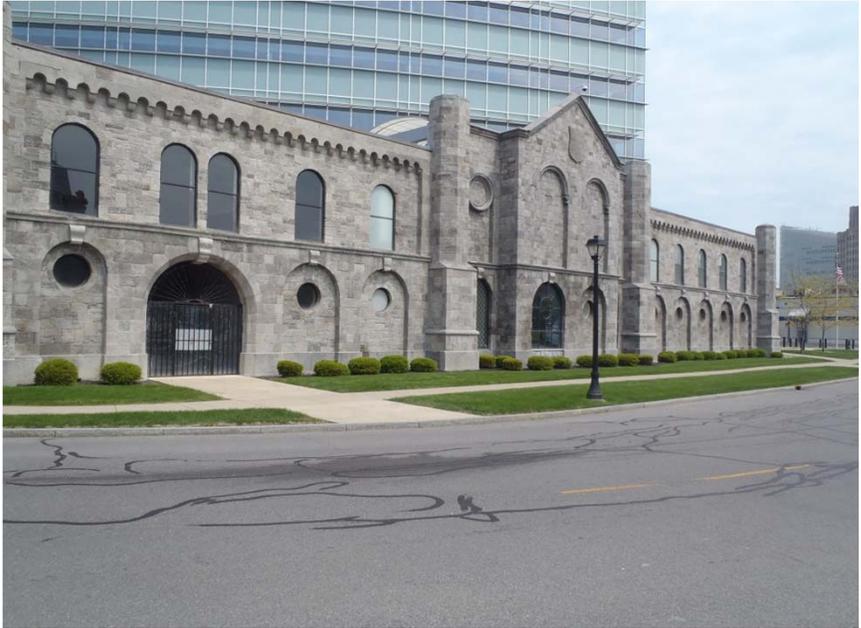
<b>Client Name:</b>		<b>Site Location:</b> 257 W Genesee Street, LLC Site Buffalo, NY	<b>Project No.:</b>
<b>Photo No.</b> 7	<b>Date</b> 05/27/14

<b>Direction Photo Taken:</b> East			
<b>Description:</b> Site Conditions - Building Façade; looking east along 257 W. Genesee

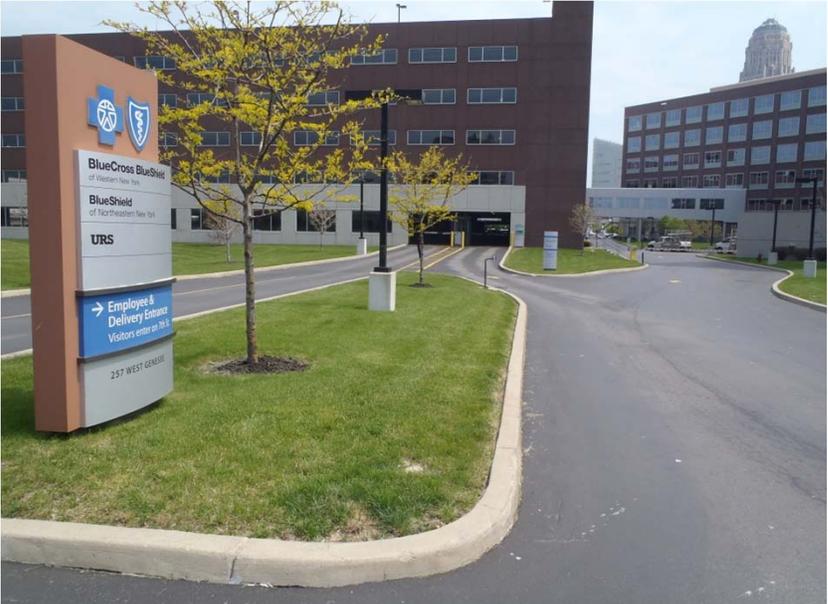
<b>Photo No.</b> 8	<b>Date</b> 05/27/14

<b>Direction Photo Taken:</b> East		
<b>Description:</b> Site Conditions- looking east at entrance to garage from Fourth Street

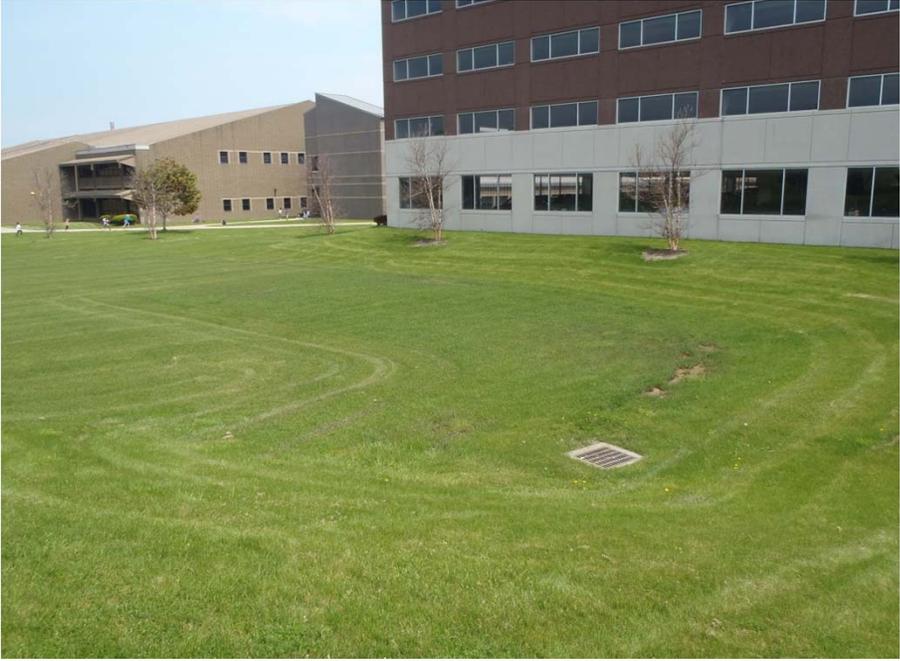
<b>Client Name:</b>		<b>Site Location:</b> 257 W Genesee Street, LLC Site Buffalo, NY	<b>Project No.:</b>
<b>Photo No.</b> 9	<b>Date</b> 05/27/14

<b>Direction Photo Taken:</b> East -Southeast			
<b>Description:</b> Site Conditions- Detention pond area looking east-southeast.

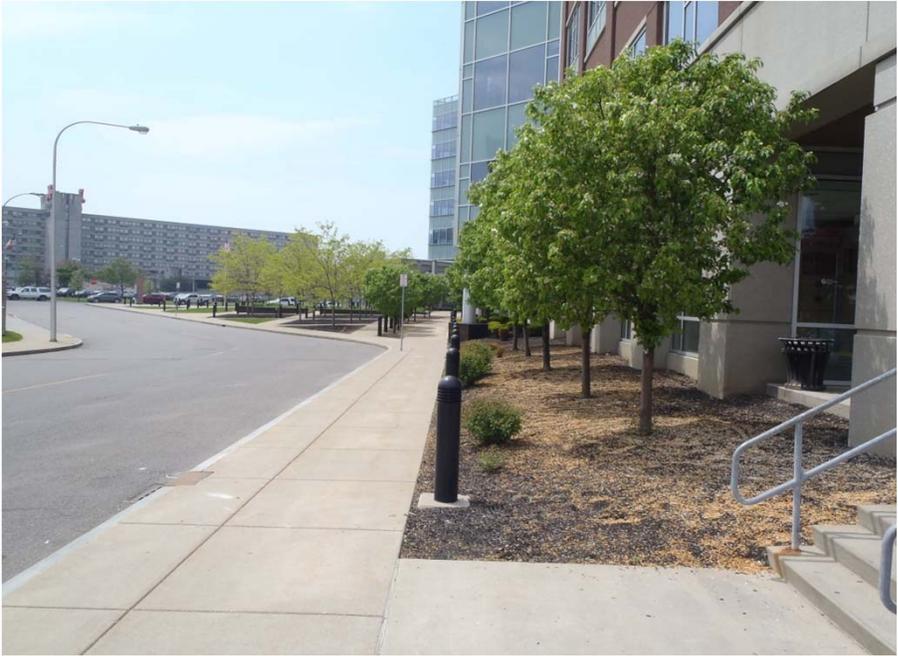
<b>Photo No.</b> 10	<b>Date</b> 05/27/14

<b>Direction Photo Taken:</b> South			
<b>Description:</b> Site Conditions- Courtyard area on New Seventh Street looking south
