Construction Completion Report

*Phase II Business Park
Site II-5, BCP Site No. C915198E
Lackawanna, New York*

0071-018-325

**CONSTRUCTION COMPLETION REPORT
FOR
PHASE II BUSINESS PARK
SITE II-5 (BCP Site No. C915198E)**

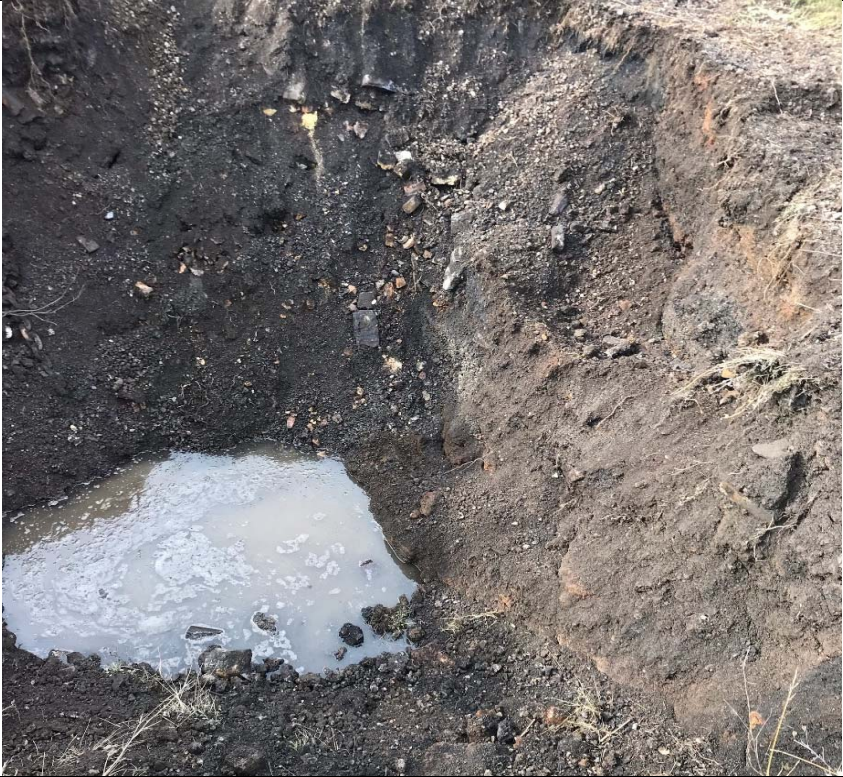
Client Name: Tecumseh Redevelopment Inc.		Site Location: Phase II Business Park Site II-5	Project No.: 0071-018-325
Photo No. 3	Date 11/09/18

Direction Photo Taken:			
Description: Hotspot H Excavation: Test Pit BPA2-TP-99A

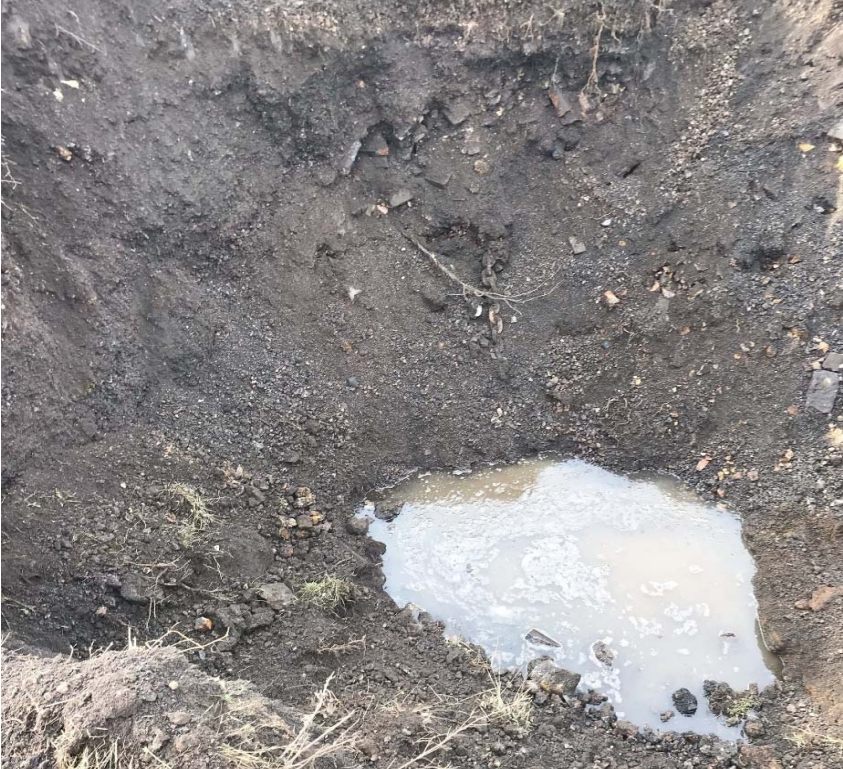
Photo No. 4	Date 11/09/18

Direction Photo Taken:			
Description: Hotspot H Excavation: Test Pit BPA2-TP-99A
