Periodic Review Report

*Tecumseh Phase III Business Park
Sites III-7 and III-8*

NYSDEC Site Nos. C915199G & C915199H

April 2015

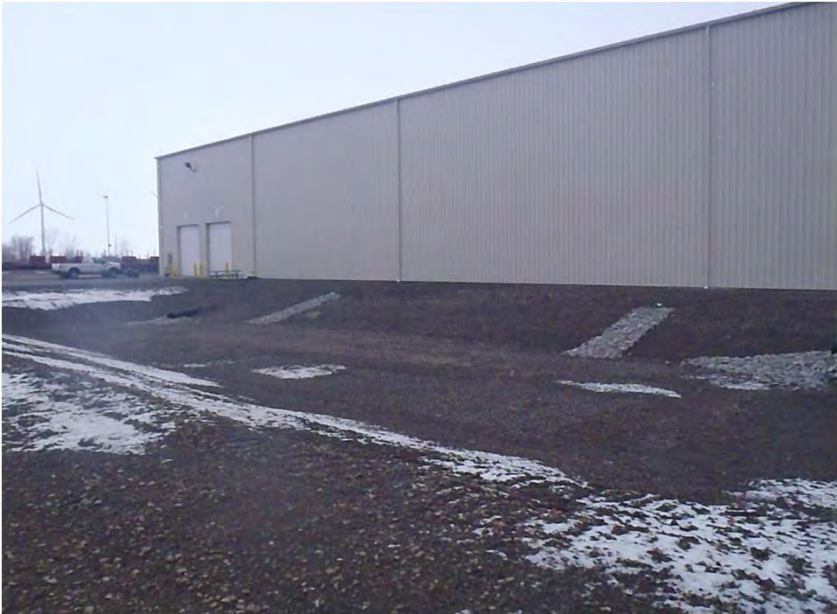
Photo No. 2	Date 03/27/15

Direction Photo Taken: Northwest			
Description: Infiltration Basin on south side of building.

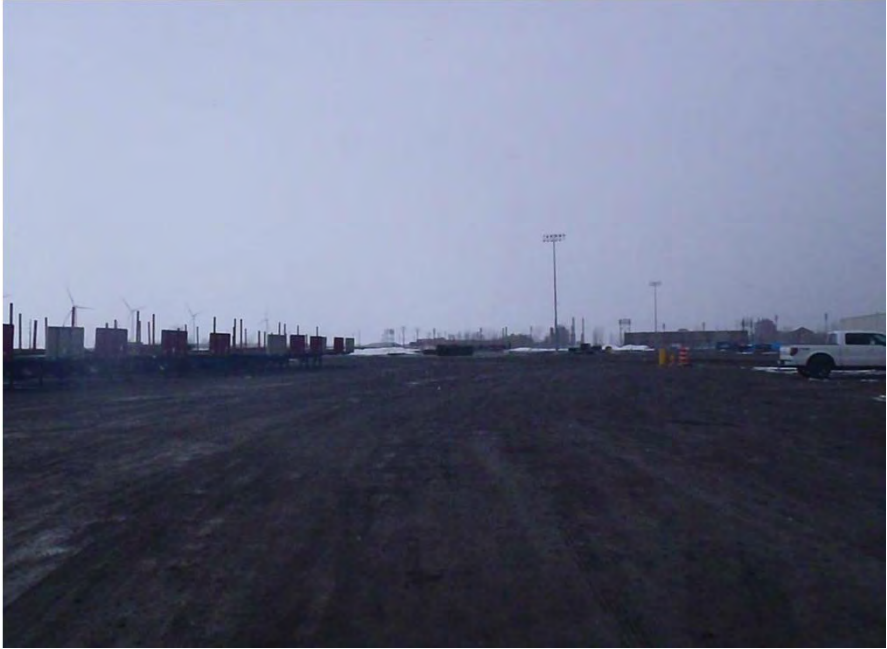
Client Name: Welded Tube USA		Site Location: Welded Tube - Lackawanna NY Phase III-7/8 Bus Park	Project No.:
Photo No. 3	Date 03/27/15

Direction Photo Taken: North			
Description: Laydown yard behind building

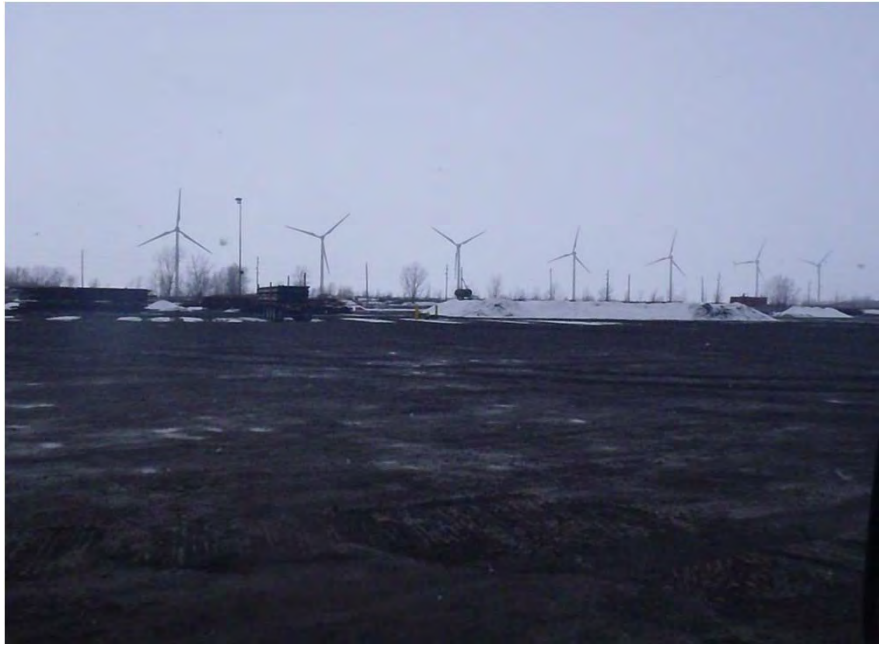
Photo No. 4	Date 03/27/15

Direction Photo Taken: West		
Description: Laydown yard behind building

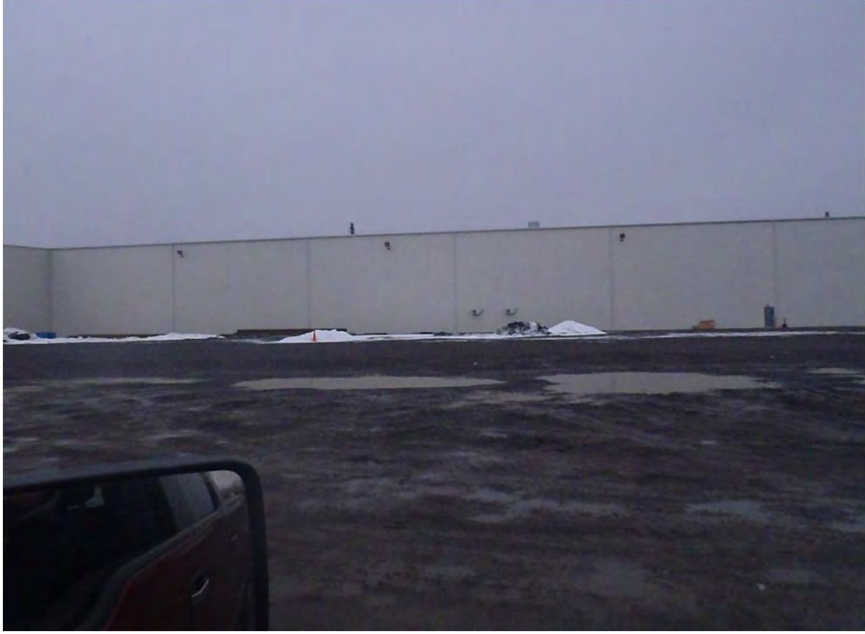
Client Name: Welded Tube USA		Site Location: Welded Tube - Lackawanna NY Phase III-7/8 Bus Park	Project No.:
Photo No. 5	Date 03/27/15

Direction Photo Taken: East			
Description: Back of Building

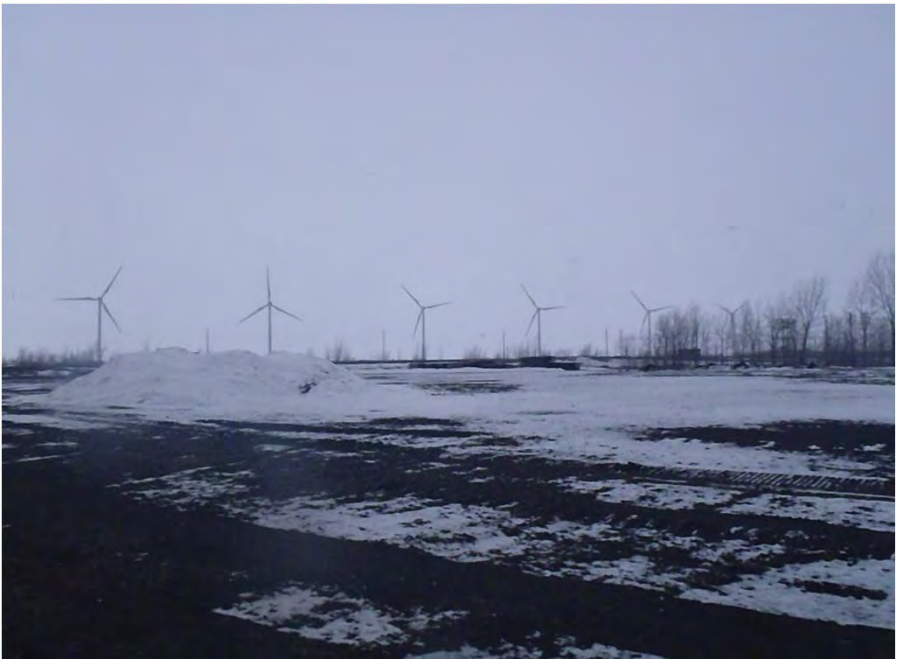
Client Name: Welded Tube USA		Site Location: Welded Tube - Lackawanna NY Phase III-7/8 Bus Park	Project No.:
Photo No. 6	Date 03/27/15

Direction Photo Taken: North			
Description: Expansion parcel

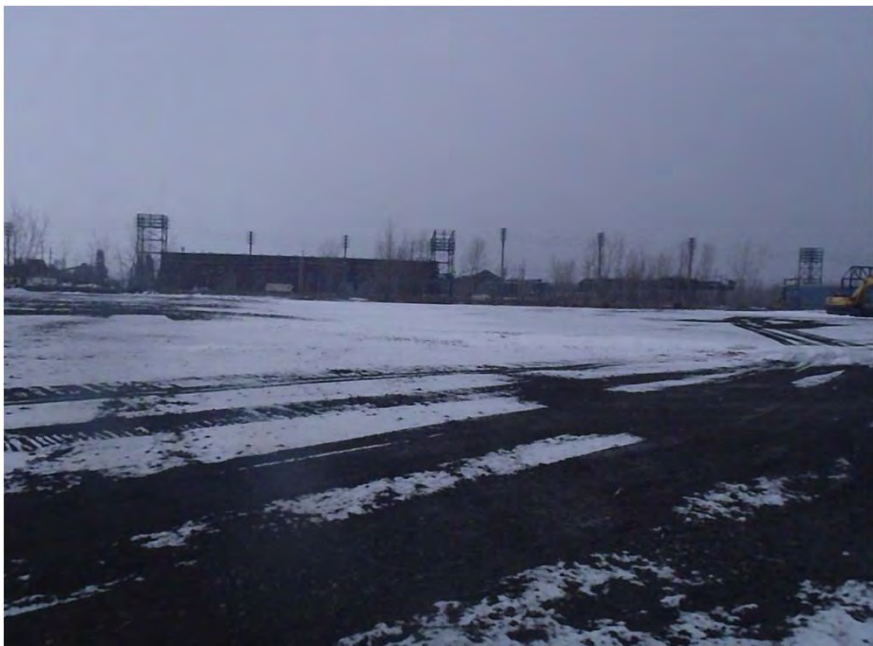
Photo No. 7	Date 03/27/15

Direction Photo Taken: West		
Description: Expansion parcel

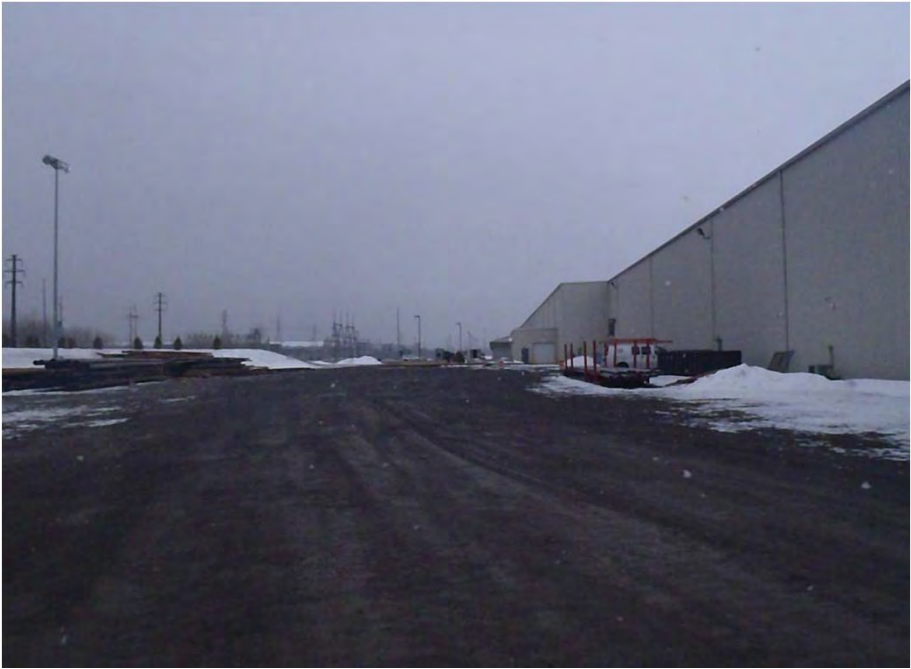
Client Name: Welded Tube USA		Site Location: Welded Tube - Lackawanna NY Phase III-7/8 Bus Park	Project No.:
Photo No. 10	Date 03/27/15

Direction Photo Taken: South			
Description: Front of building

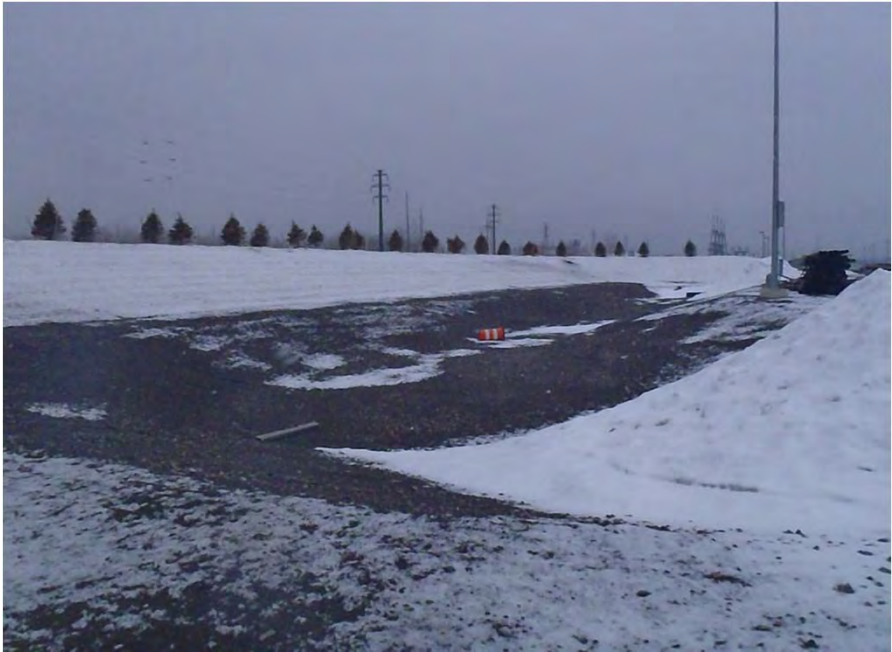
Photo No. 11	Date 03/27/15

Direction Photo Taken: Southeast		
Description: Infiltration Basin east of building.

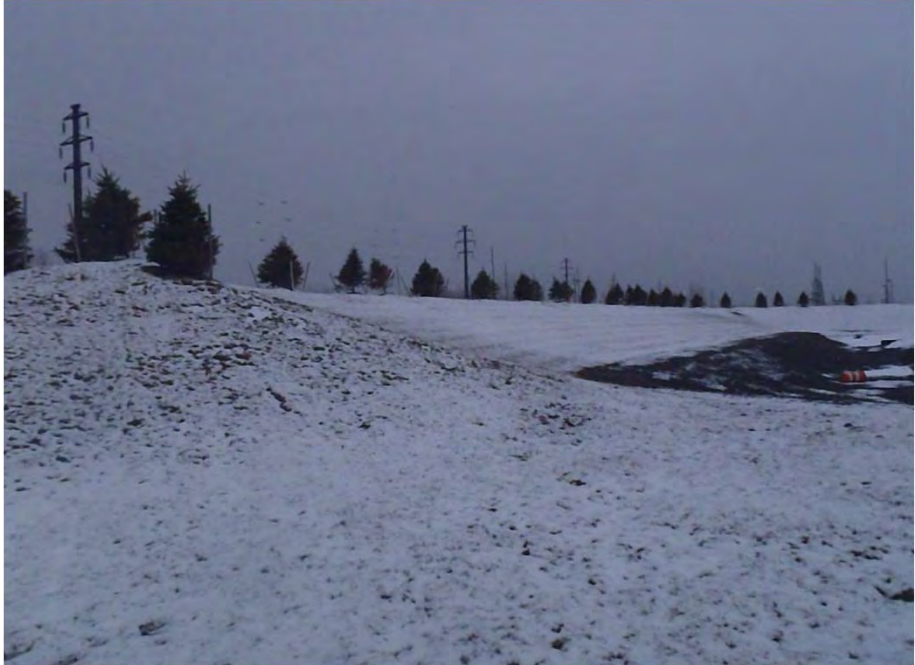
Client Name: Welded Tube USA		Site Location: Welded Tube - Lackawanna NY Phase III-7/8 Bus Park	Project No.:
Photo No. 12	Date 03/27/15

Direction Photo Taken: South			
Description: Berm east of building.

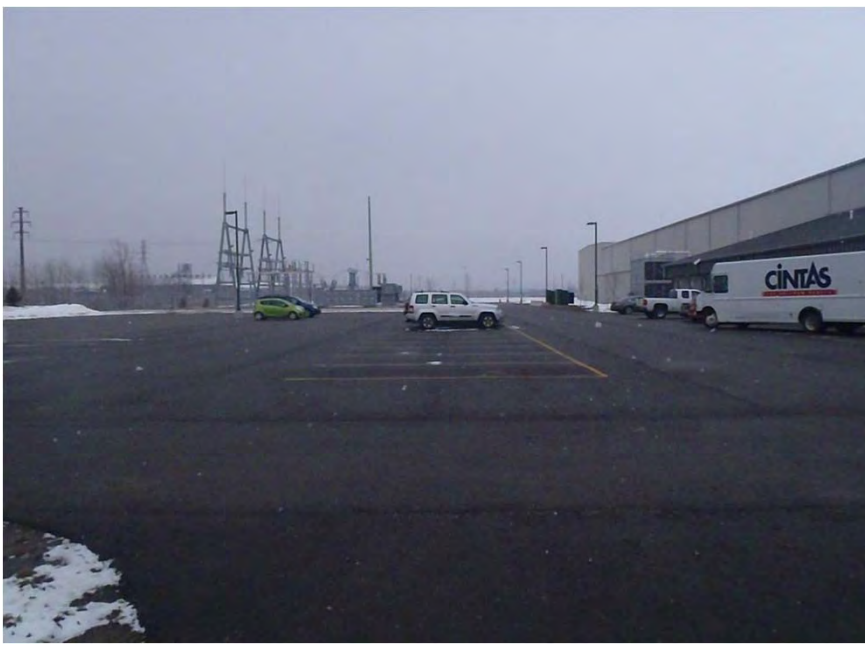
Photo No. 13	Date 03/27/15

Direction Photo Taken: Southeast		
Description: Parking lot east of building.

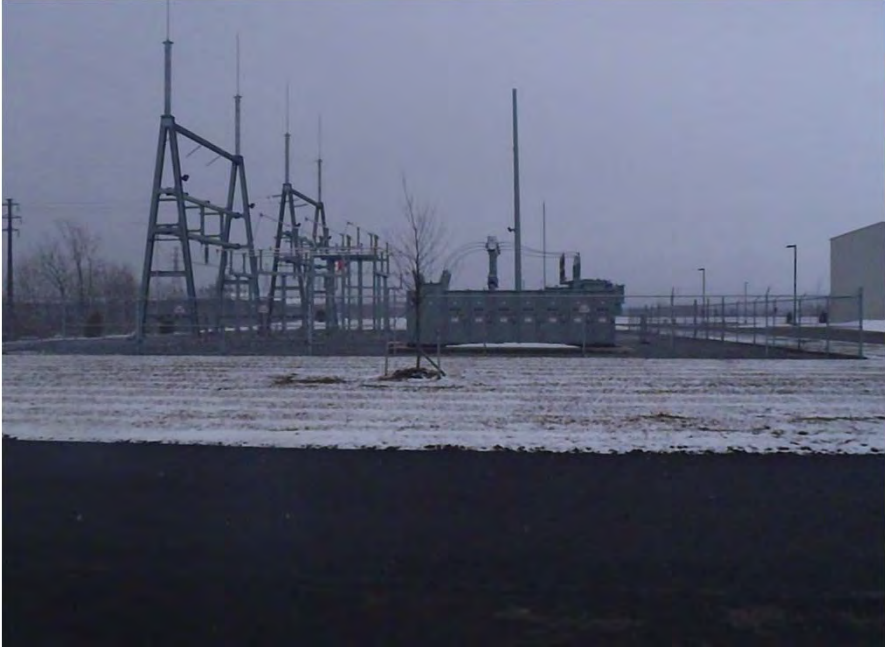
Client Name: Welded Tube USA		Site Location: Welded Tube - Lackawanna NY Phase III-7/8 Bus Park	Project No.:
Photo No. 14	Date 03/27/15

Direction Photo Taken: South			
Description: Transformer pad area.
