**UNDERGROUND PIPE REMOVAL
WORK PLAN**

**Buffalo Terminal
Location No. 31-010
Buffalo, New York**

March 4, 2004

ROUX ASSOCIATES, INC.
209 Shafter Street
Islandia, New York 11749

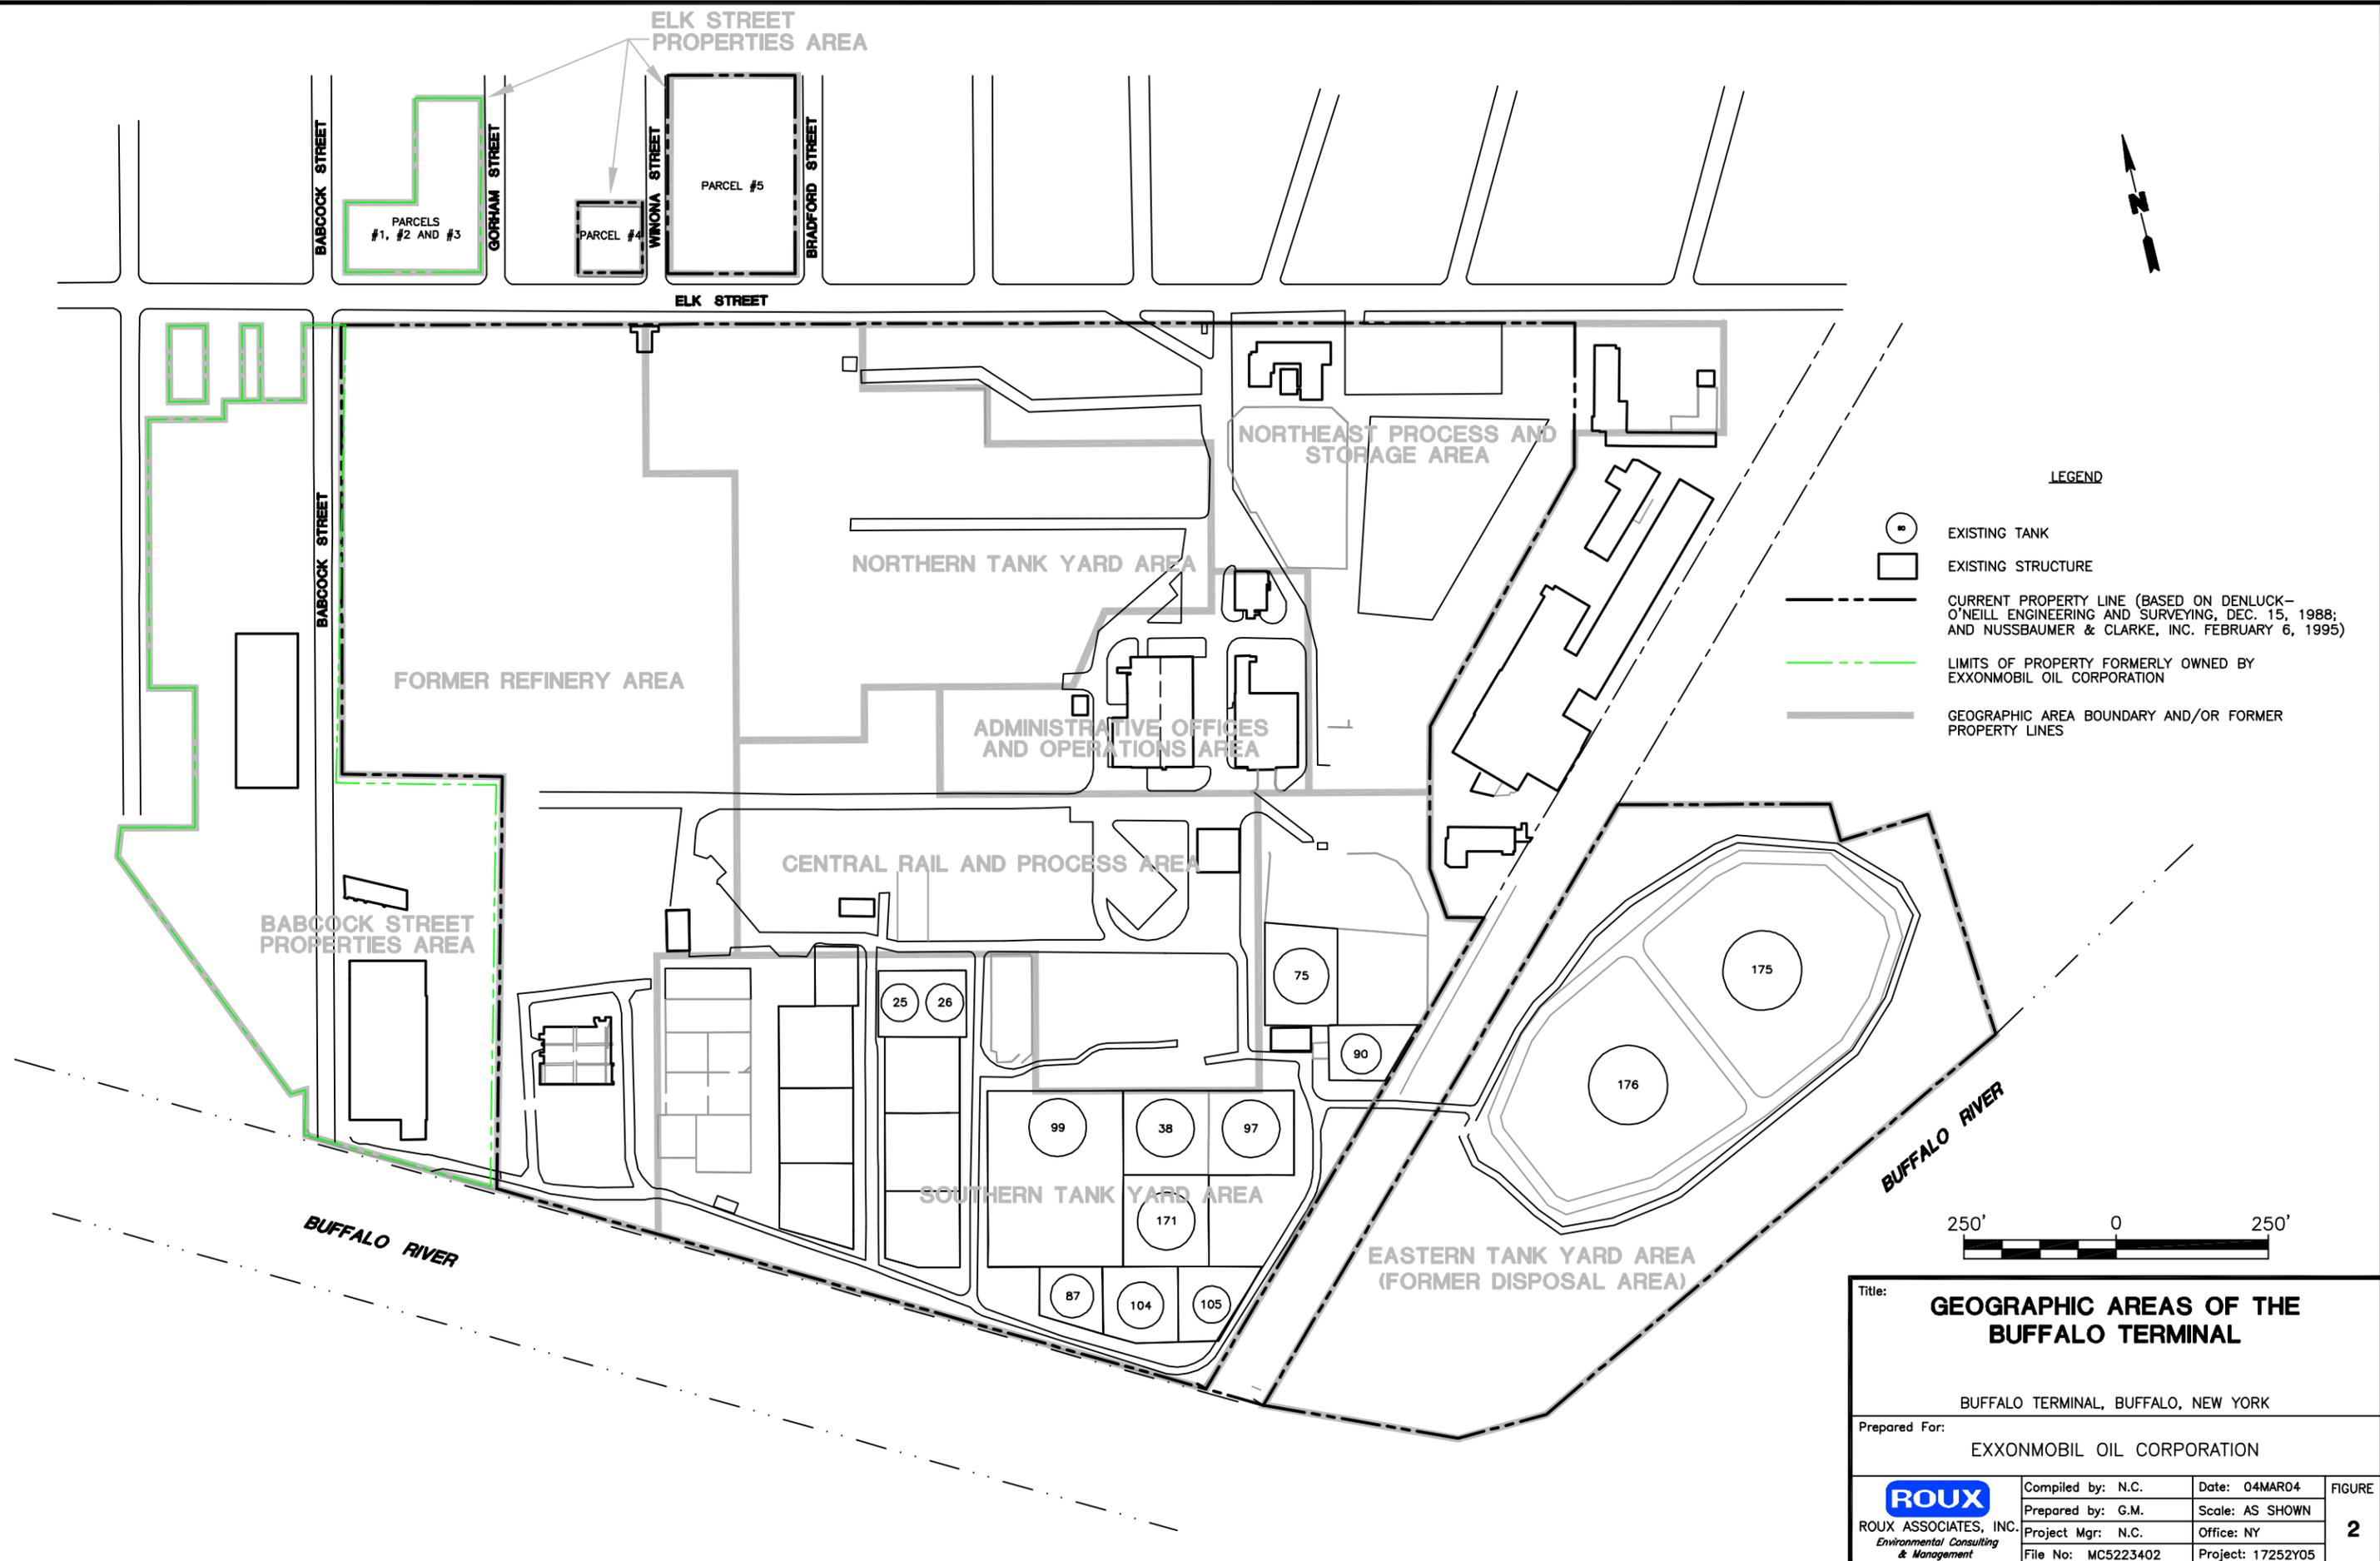
Title: **GEOGRAPHIC AREAS OF THE BUFFALO TERMINAL**
