**RE: Post-Construction Summary Report  
Operable Unit 3 (OU-3)  
Buckeye Terminals, LLC  
Buffalo Terminal  
625 Elk Street  
Buffalo, New York 14210  
NYSDEC Site Number C915201D**

# Post-Construction Summary Report

Buffalo Terminal – Operable Unit 3  
625 Elk Street  
Buffalo, New York 14210  
NYSDEC Site Number C915201D

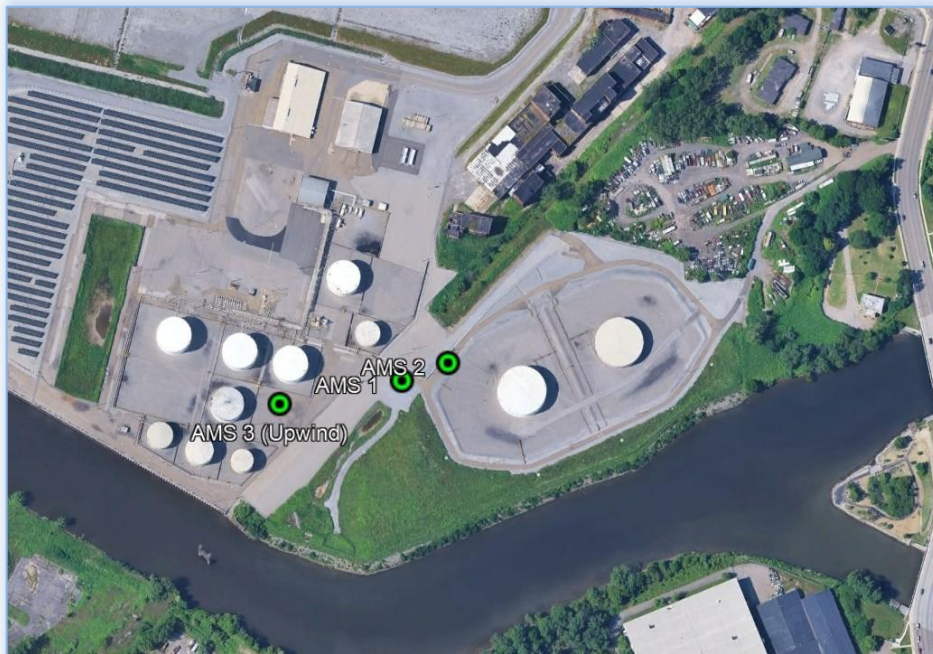
Station	Latitude	Longitude
AMS 1	42.862030	-78.830820
AMS 2	42.862160	-78.830360
AMS 3 (Upwind)	42.861860	-78.832040

**Notes for Report:** Operable Unit 3 (OU-3) CAMP monitoring was initiated at 8:00 am. and ended at 3:45 pm. The weather was cloudy included temperatures in the 30°Fs, with winds coming in from the southwest.

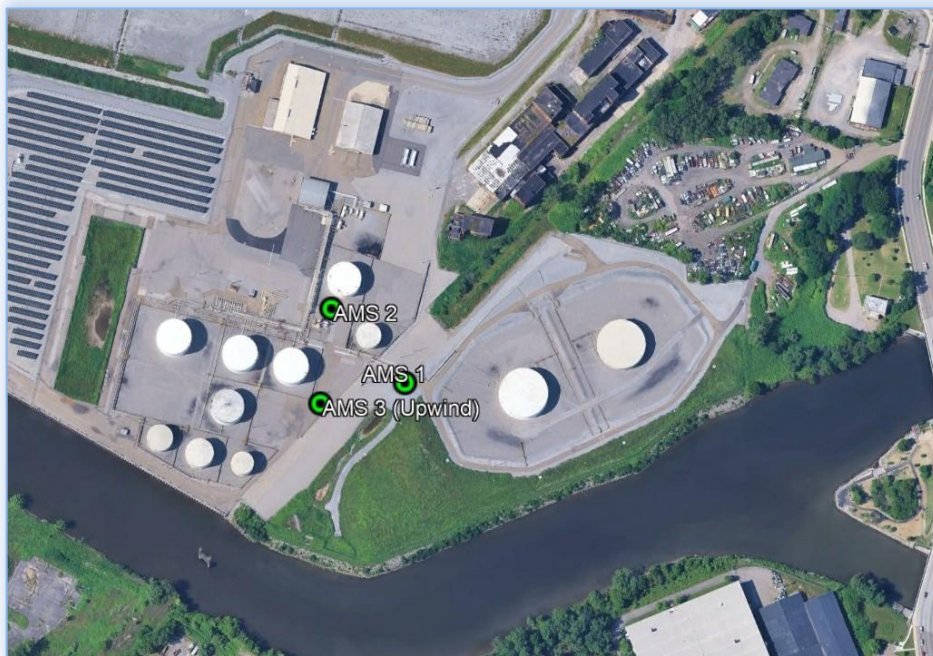
Station	Latitude	Longitude
AMS 1	42.862030	-78.830800
AMS 2	42.862570	-78.831530
AMS 3 (Upwind)	42.861880	-78.831640

**Notes for Report:** Operable Unit 3 (OU-3) CAMP monitoring was initiated at 8:10 am. and ended at 12:50 pm. The weather was sunny included temperatures ranging from 30°Fs to the 50°Fs, with winds coming in from the south.

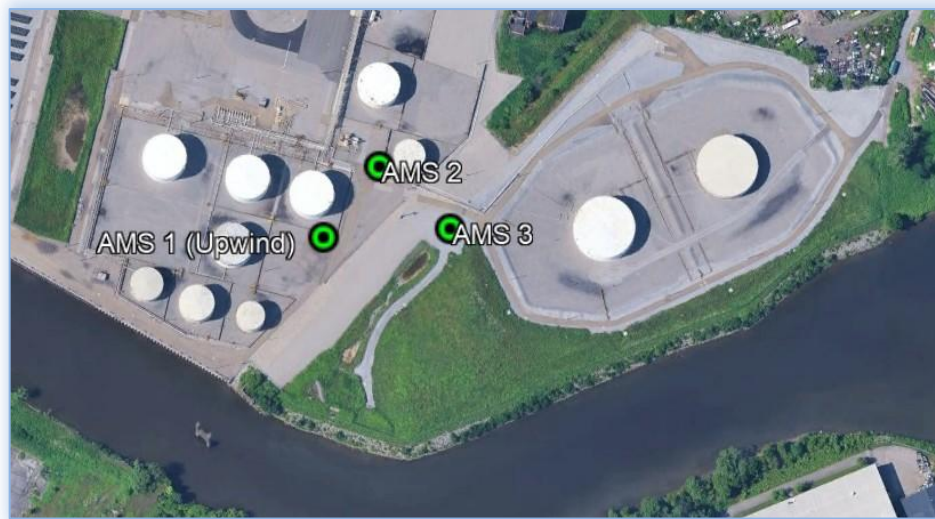
Station	Latitude	Longitude
AMS 1 (Upwind)	42.861900	-78.831840
AMS 2	42.862270	-78.831460
AMS 3	42.861950	-78.830840

**Notes for Report:** Operable Unit 3 (OU-3) CAMP monitoring was initiated at 7:55 am. and ended at 10:30 am. The weather was cloudy with temperatures ranging from 30°Fs to the 40°Fs and winds from the south.

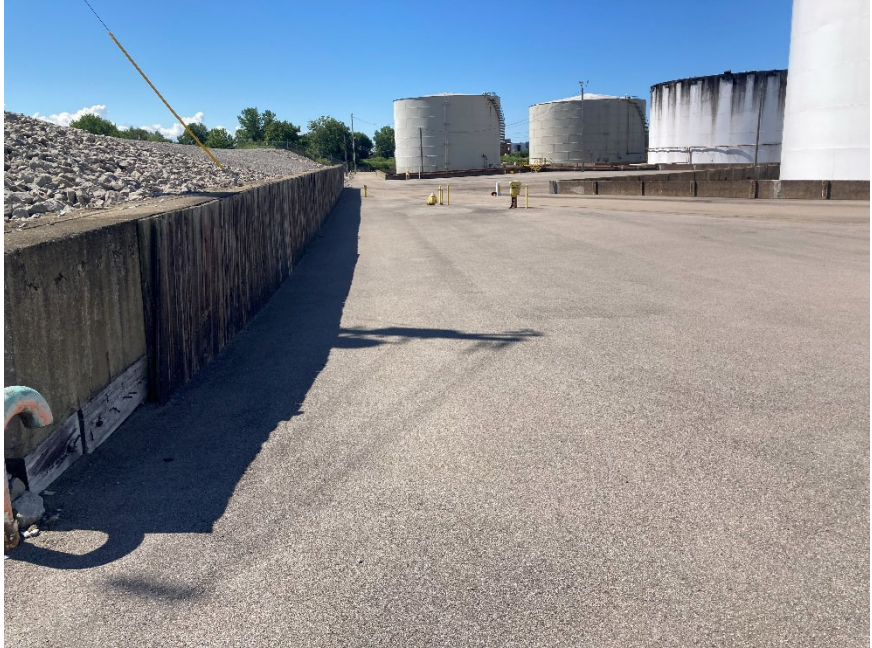
<b>Site Name: Buffalo Terminal - OU-3</b>		<b>Site Location: 625 Elk Street, Buffalo, NY</b>
<b>Photo #:</b>	1

<b>Comments:</b>	<p>Proposed OU-3 trenching area for the new subgrade fire suppression piping installation.</p> <p>View is to the southwest.</p> <p>Photo taken on August 26, 2025.</p>

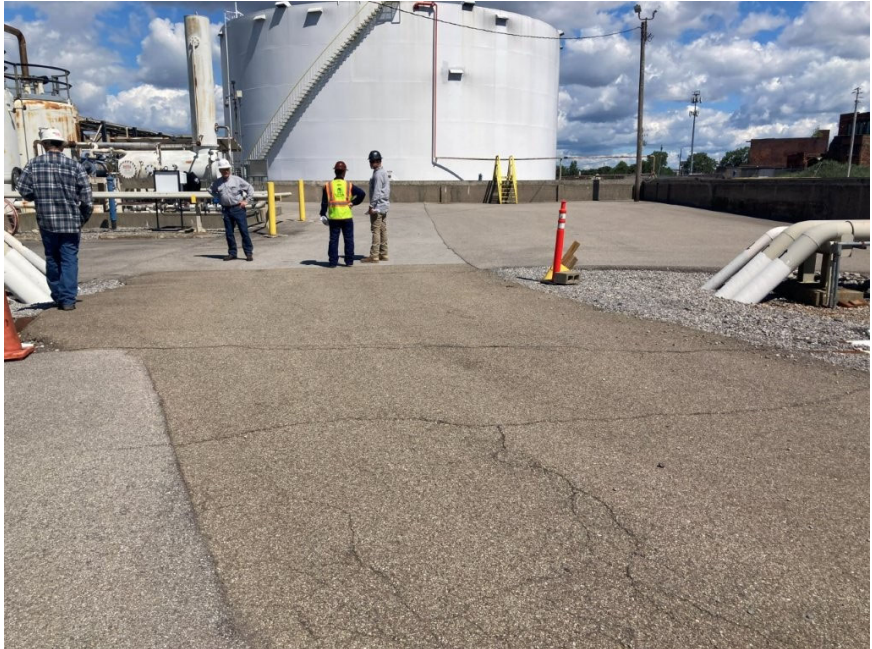
<b>Site Name: Buffalo Terminal - OU-3</b>		<b>Site Location: 625 Elk Street, Buffalo, NY</b>	
<b>Photo #:</b>	4

<b>Comments:</b>	Proposed trench location across the OU-3 driveway between Tank 90 and Tank 97.  View is to the north.  Photo taken on August 26, 2025.

On December 17, 2025, a section of existing asphalt pavement was sawcut and removed from the OU-3 driveway (between Tank 90 and Tank 97) for the placement of a new section of shallow subgrade fire suppression piping. Plans in the OU-3 EWP called for this piping to be installed above grade with a cross-over ramp; however, due to the necessity to sleeve the fire suppression pipe, Buckeye determined that the new piping should be installed below grade to provide protection of the new piping and to prevent a raised bump in the roadway that would likely become damaged over time. Excavation of this area in the OU-3 driveway proceeded with the same requirements as the initial planned trench as described in the OU-3 EWP.

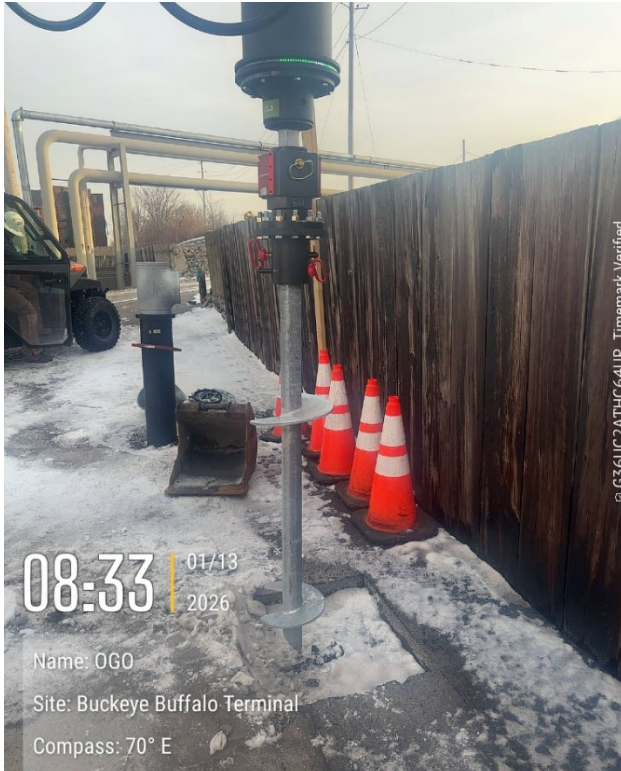
<b>Site Name: Buffalo Terminal - OU-3</b>		<b>Site Location: 625 Elk Street, Buffalo, NY</b>
<b>Photo #:</b>	19	
<b>Comments:</b>	<p>Installation of OU-3 helical pier number #1 (HP-1) positioned along the concrete retaining wall near the OU-3/OU-4 boundary.</p> <p>View is to the east.</p> <p>Photo taken on January 13, 2026.</p>

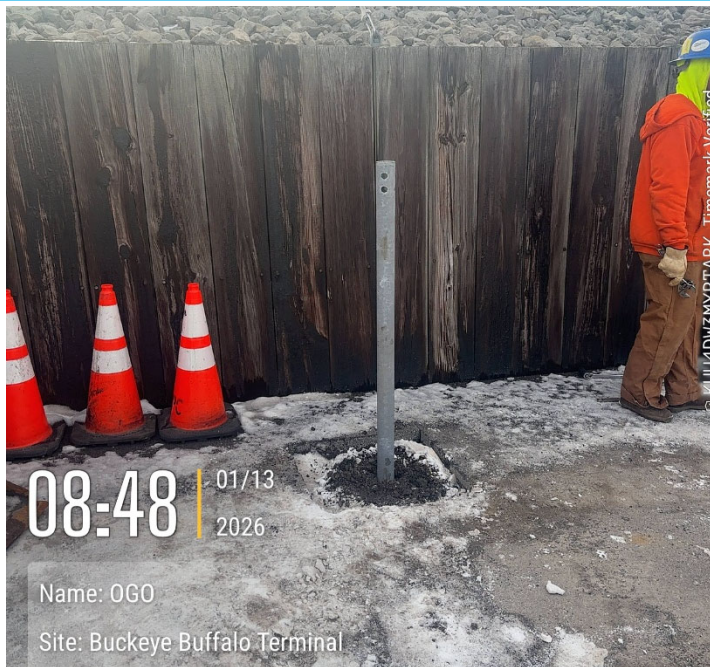
<b>Site Name: Buffalo Terminal - OU-3</b>		<b>Site Location: 625 Elk Street, Buffalo, NY</b>
<b>Photo #:</b>	20	
<b>Comments:</b>	<p>Completed installation of OU-3 HP-1 positioned along the concrete retaining wall near the OU-3/OU-4 boundary.</p> <p>View is to the south.</p> <p>Photo taken on January 13, 2026.</p>
