**2021-2022 PERIODIC REVIEW REPORT**  
HYDRO-AIR COMPONENTS, INC. PROPERTY  
FORMER STEELFIELDS AREA IV BCP SITE (#C915204)  
100 RITTLING BLVD.  
BUFFALO, NEW YORK

by  
Haley & Aldrich of New York  
Rochester, New York

File No. 0129356-011  
August 2022

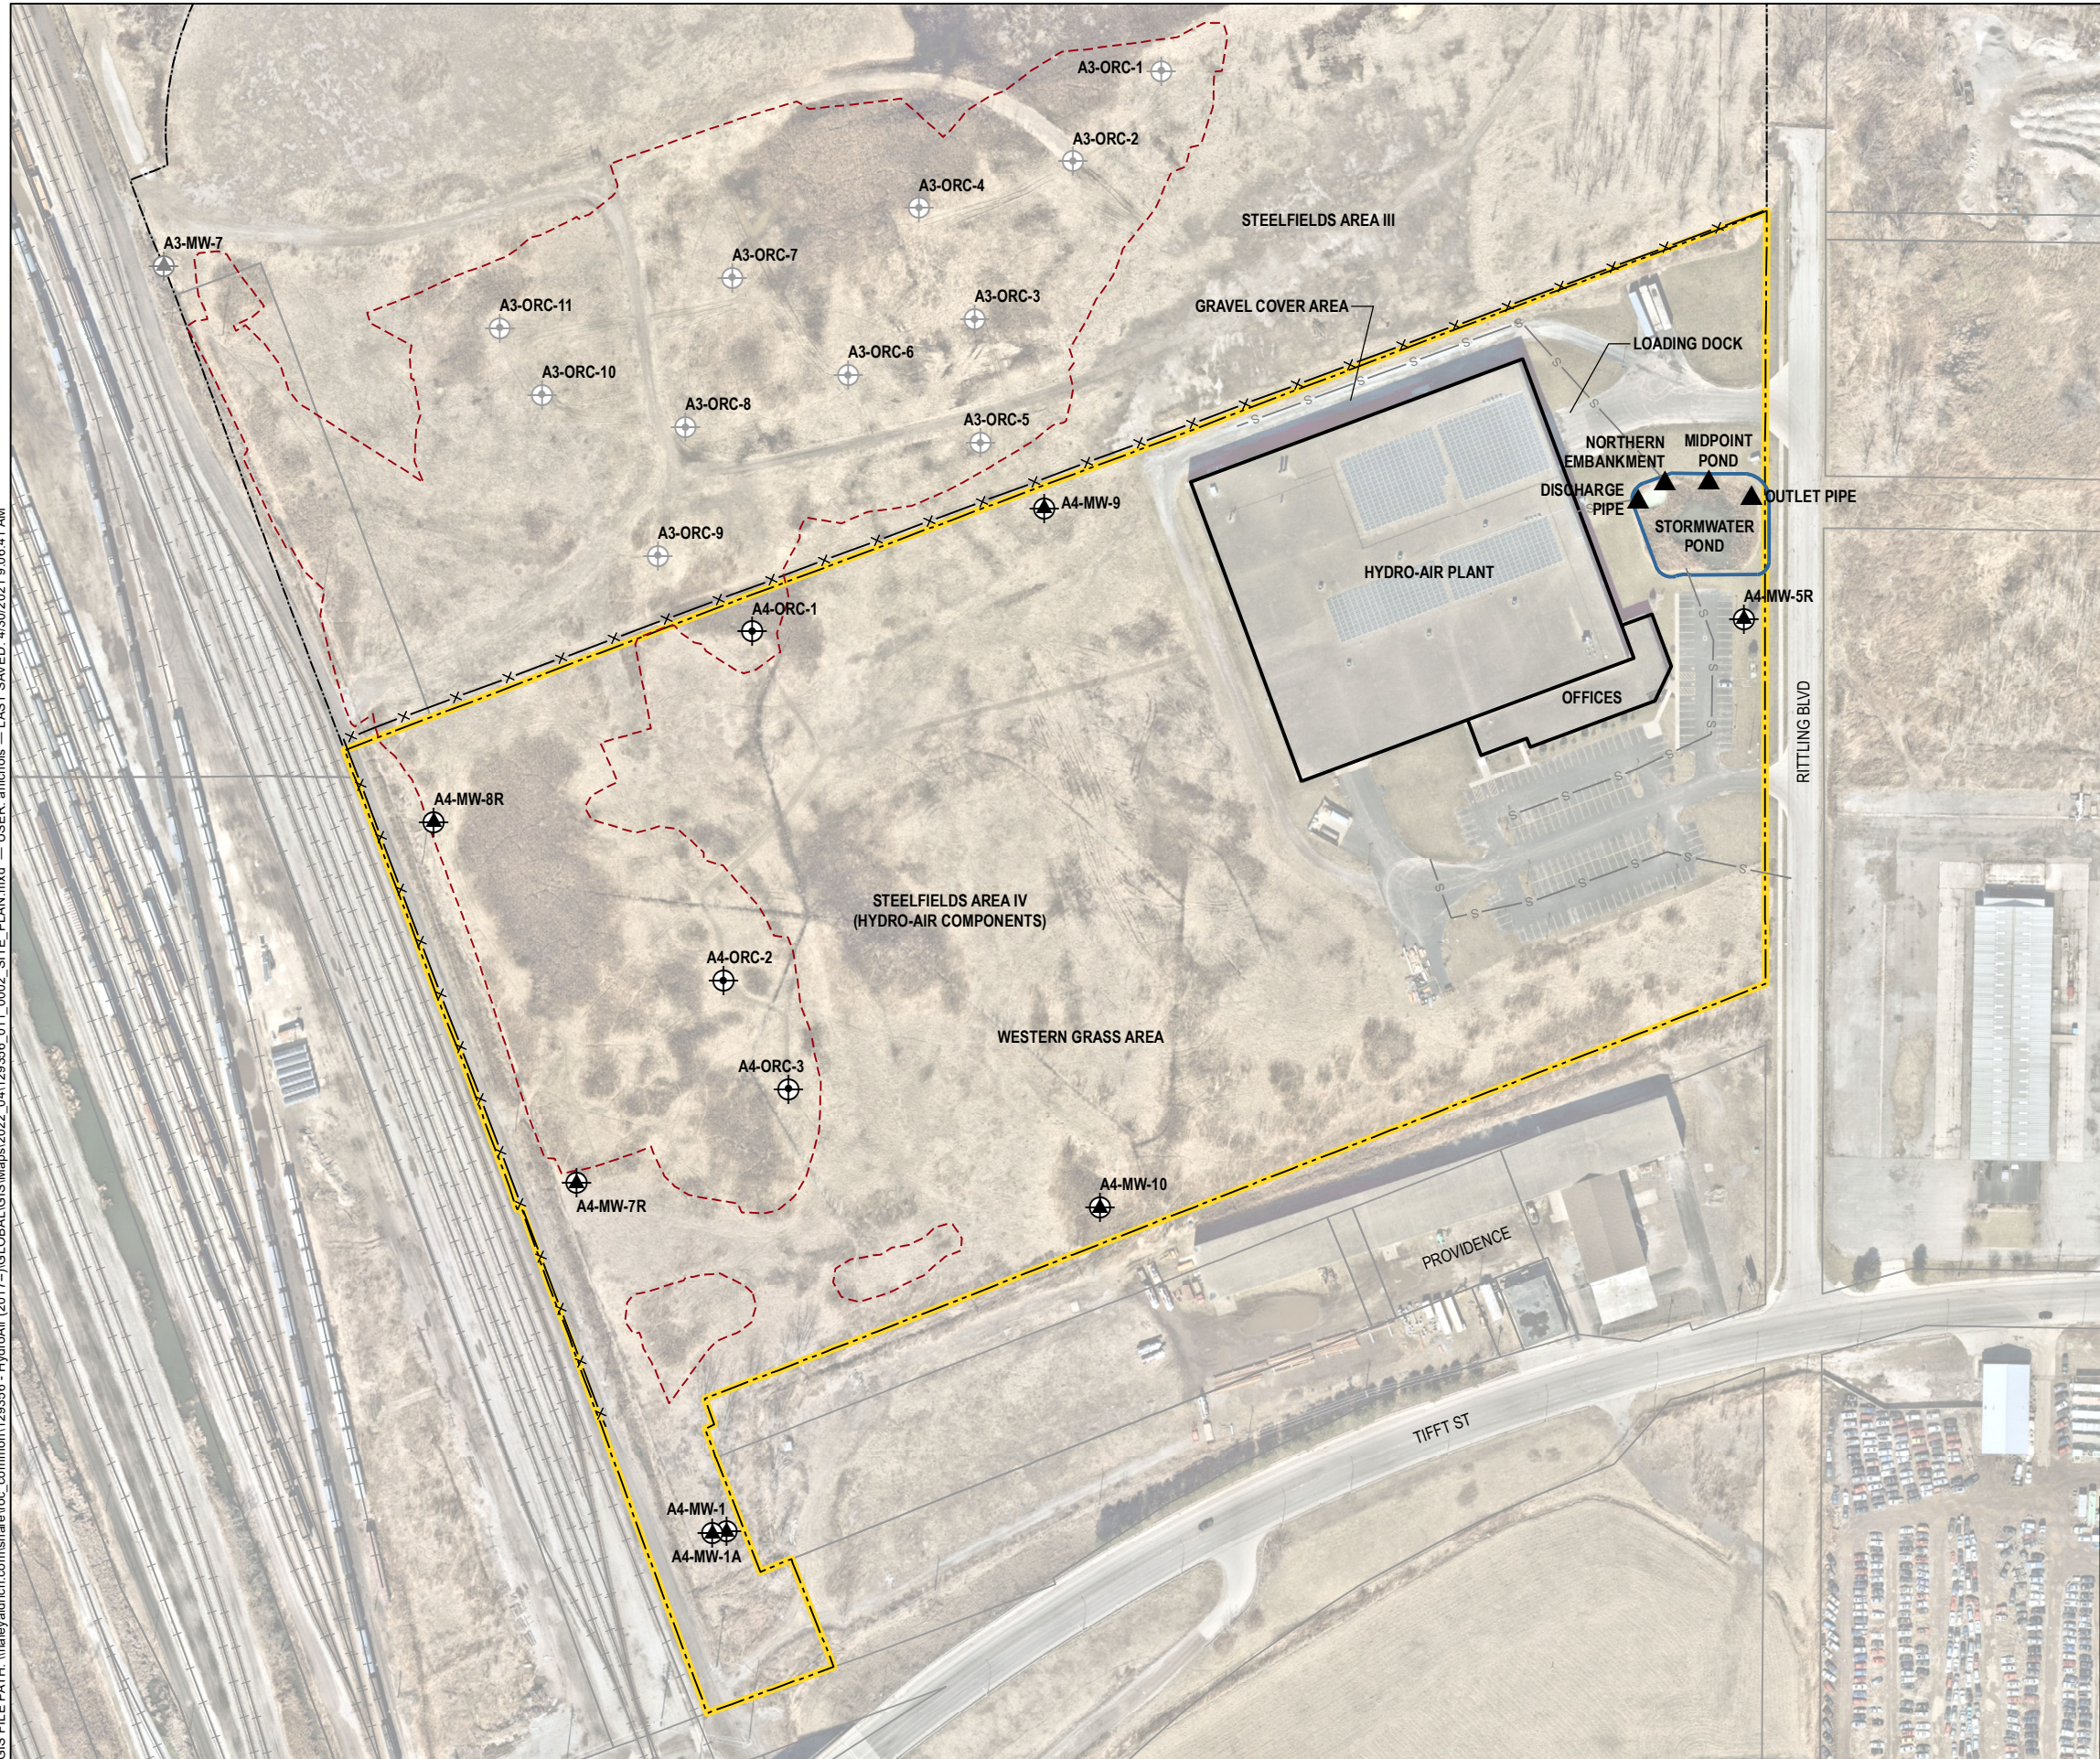
FIGURE 2

Prior to 2010, groundwater that had been in contact with soils from beneath the cover system was observed accumulating in the northeastern loading dock area of the Site building (see Figure 2). Subsequent to corrective measures that were put into place per the NYSDEC-approved Corrective Measures Work Plan, groundwater has not accumulated in the northeastern loading dock area. The reconfiguration of the loading dock pump system (setting to automatic pumping and raising the float

Site stormwater pond water quality (pH and temperature) conditions were monitored monthly at four sampling locations (see Figure 2) by Hydro-Air staff. Stormwater pond monitoring data are summarized in Table V. The results of the pond monitoring appear generally consistent with the findings from previous sampling events, and measured pH values within the Northern Embayment and Main Pond did not exceed NYSDEC TOGS 1.1.1 ambient water quality guidance values of pH 8.5 (guidance value) during the PRR monitoring period.

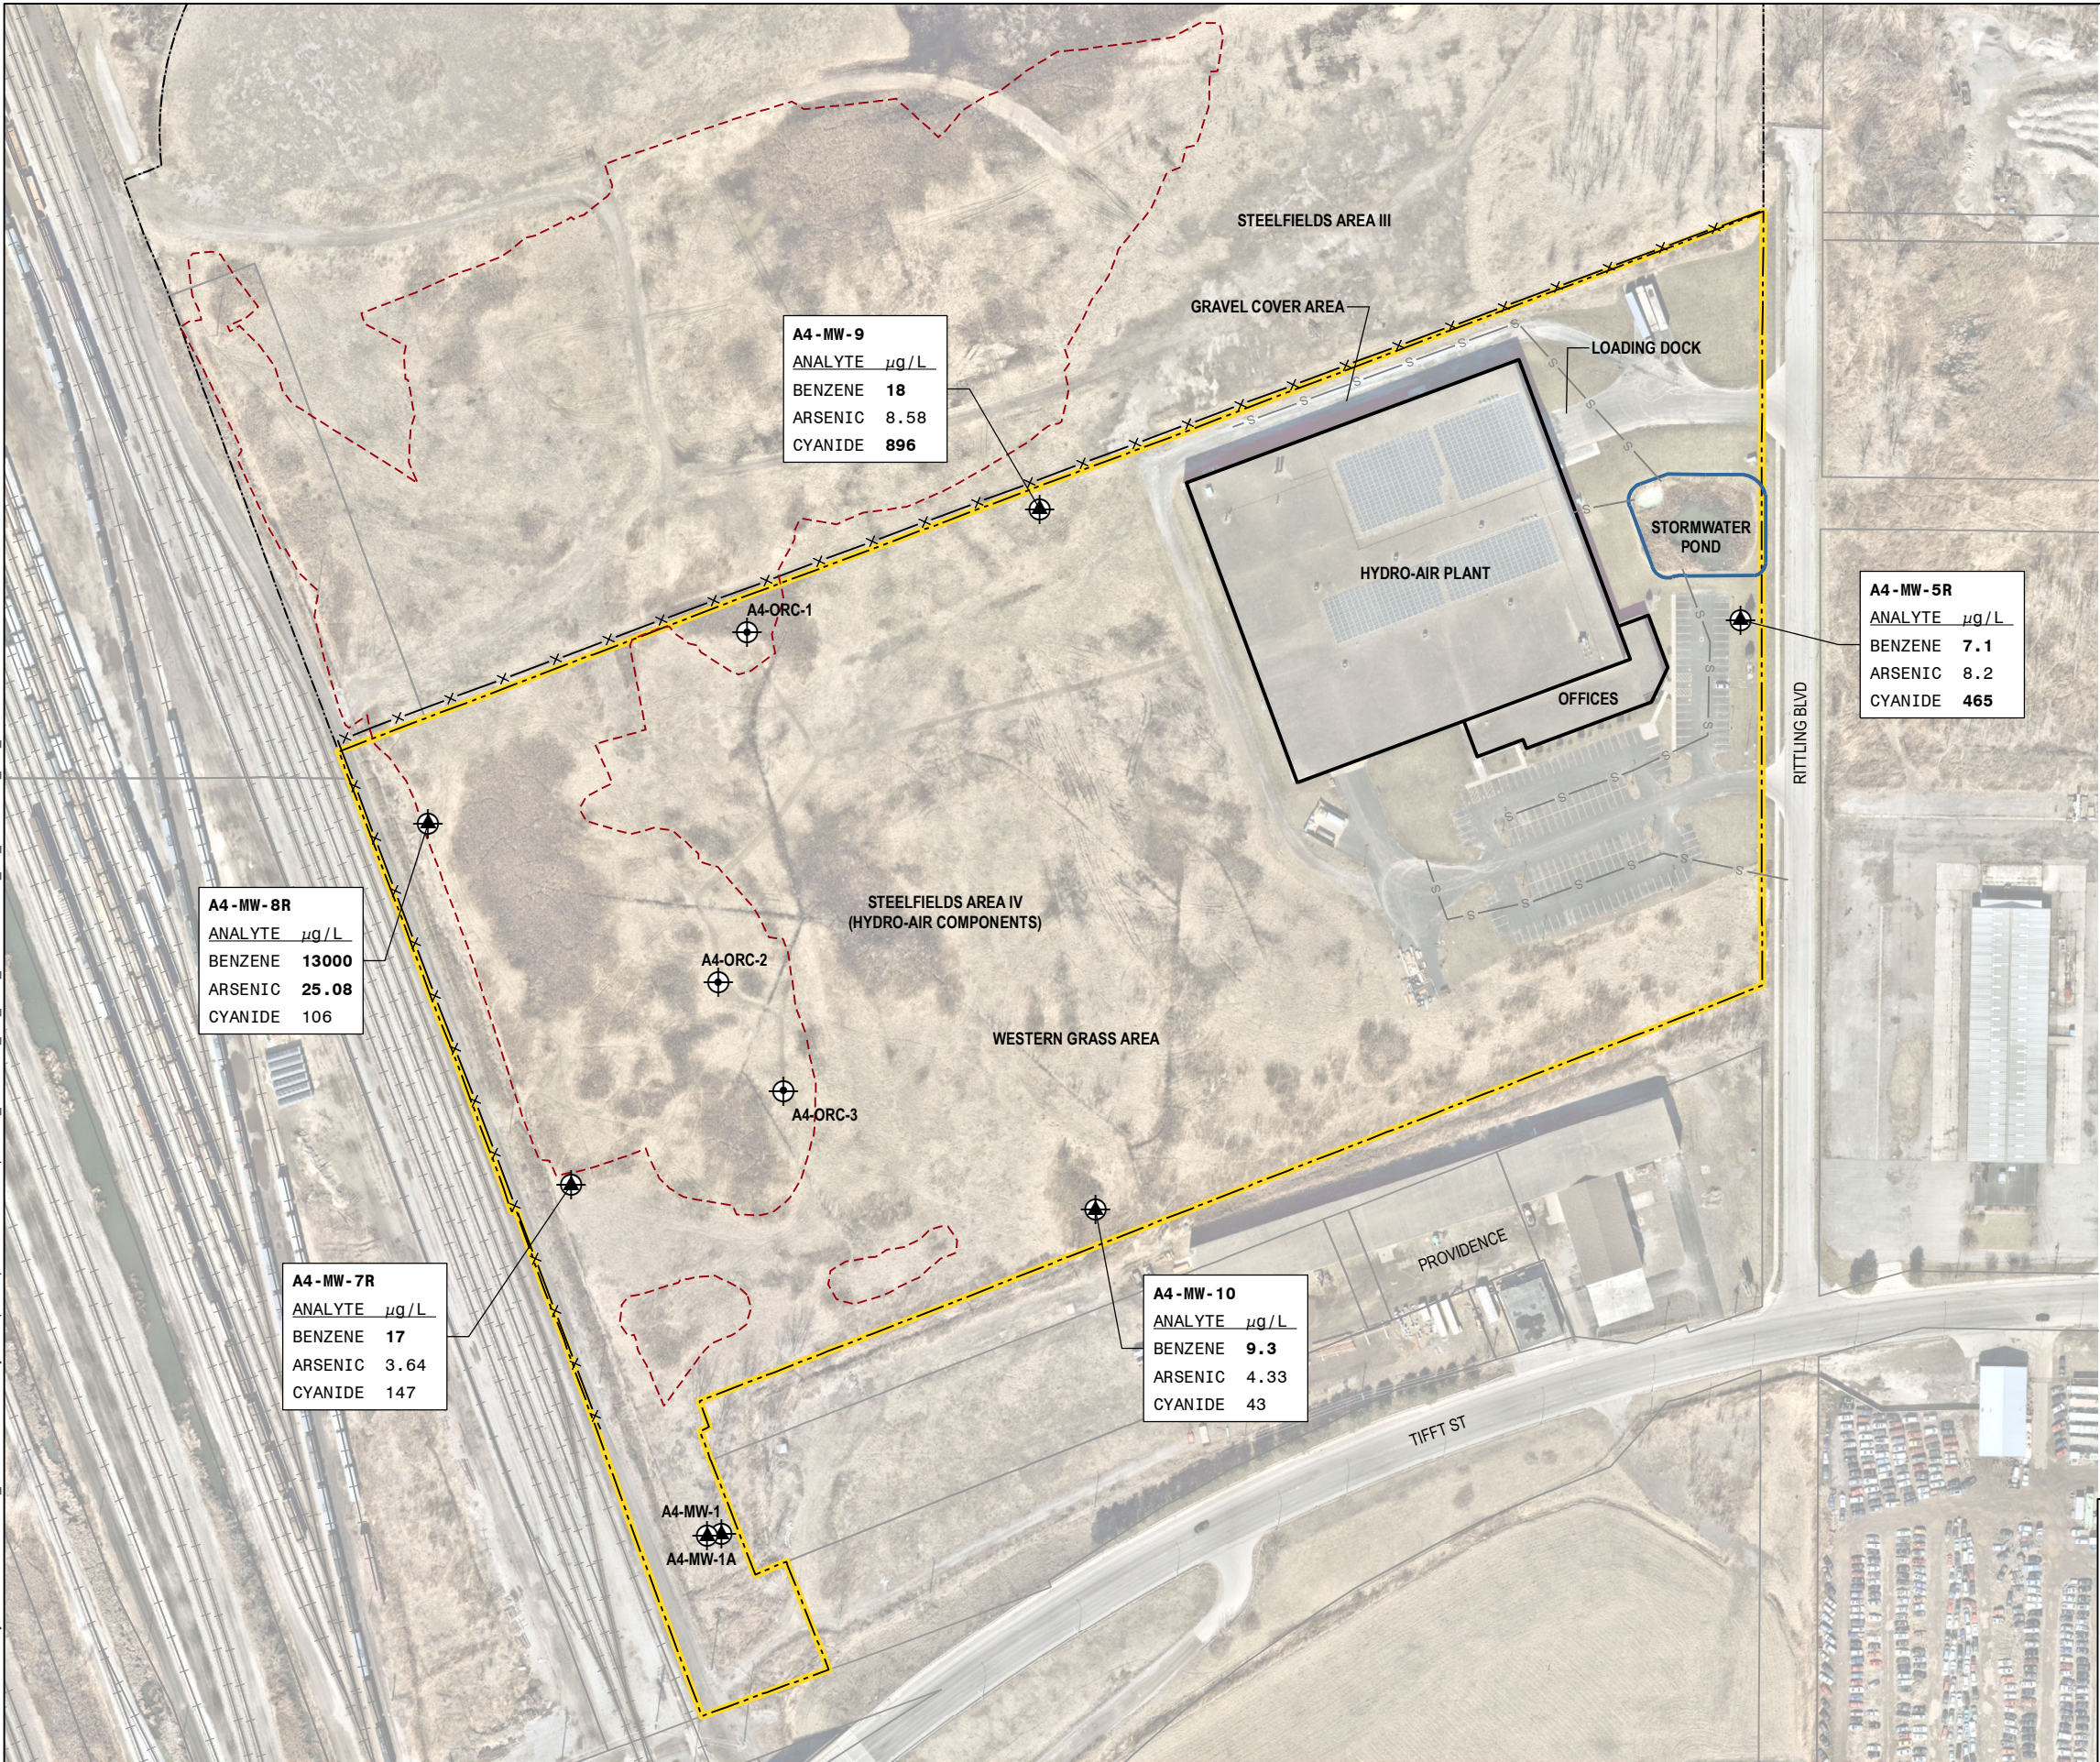
GIS FILE PATH: \\haleyaldrich.com\share\roc\_common\1129356 - HydroAir (2017-)\GLOBAL\GIS\Maps\2022\_04\129356\_011\_0004\_PARAMETERS\_OF\_INTEREST\_JUL\_2021.mxd — USER: anichols — LAST SAVED: 4/19/2022 4:43:52 PM

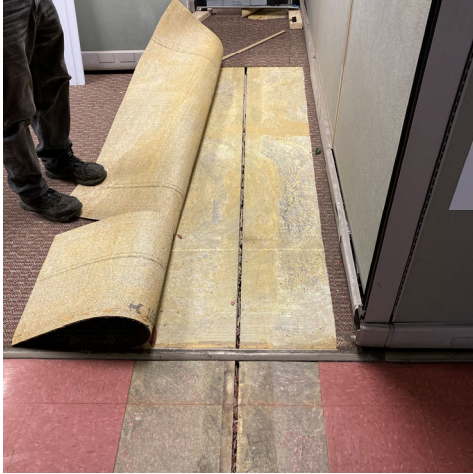
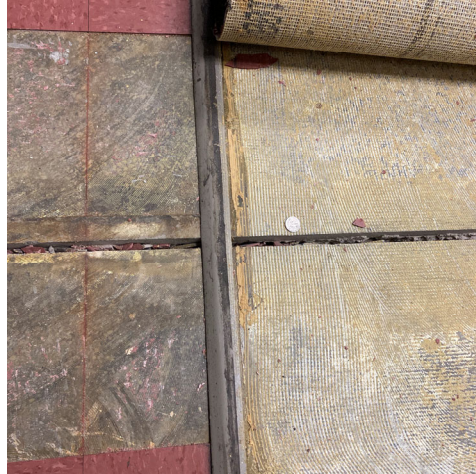
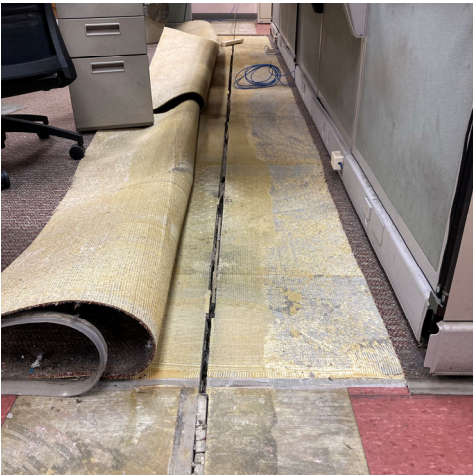
During the previous 2020-2021 PRR inspection, floor cracks were observed in the walkway floor tiles within the western portions of the Site office areas. The cracks observed in the floor tiles also appeared to extend underneath adjacent carpeted flooring. In March 2022, Hydro-Air personnel removed selected linoleum floor tiles and adjacent carpeting to assess the condition of the underlying floor slab in the areas of cracking. Haley & Aldrich and Hydro-Air personnel observed unanticipated expansion joint separation, with selected joints open up to 5 inches below the concrete slab surface. The expansion joint separation appears to cause the overlying linoleum tiles to stretch and ultimately rip.

***Photo 1: Expansion joint separation underneath office linoleum tile and carpeting.***

***Photo 2: Expansion joint separation underneath office linoleum tile and carpeting.***

***Photo 3: Expansion joint separation underneath office linoleum tile and carpeting.***

***Photo 4: Expansion joint separation underneath office linoleum tile and carpeting.***

Although apparently not adversely impacting sub-slab vacuum, cracks continue to be observed (see the photo log in Appendix D) in the linoleum tile and underlying concrete slab in the western portions of the Hydro-Air offices. Cracks observed during the previous 2020-2021 PRR reporting period appeared to extend underneath adjacent carpeted flooring. In March 2022, during the 2021-2022 PRR reporting period, Hydro-Air personnel removed selected linoleum floor tiles and adjacent carpeting to assess the condition of the underlying floor slab. Haley & Aldrich and Hydro-Air personnel observed unanticipated expansion joint separation, with selected joints open up to 5 inches below the concrete slab surface. Hydro-Air personnel filled the expansion joints hydraulic cement and sealed the joint surfaces with self-leveling polyurethane caulk. Hydro-Air intends to continue monitoring the linoleum floors throughout the office areas and will seal cracks if the linoleum rips and cracks greater than ¼-inch appear.

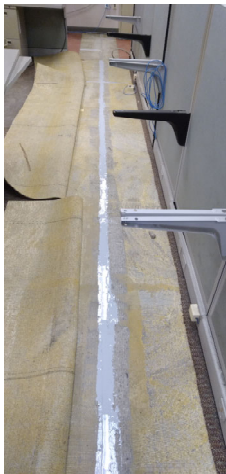
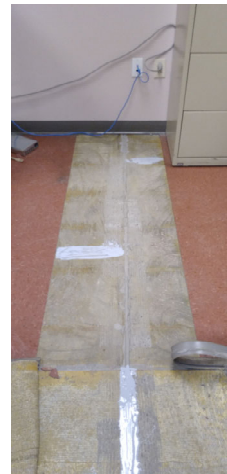
***Photo 5: Expansion joint sealing in office area.***

***Photo 6: Expansion joint sealing in office area.***

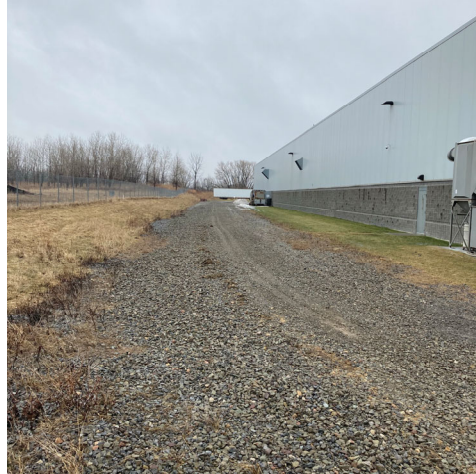
Prior to 2012, evidence of surfacing groundwater from beneath the gravel cover areas on the northern end of the Site was evident (see Figure 2). As a voluntary corrective measure, the gravel cover on the northern portion of the access road was enhanced in 2012 by the placement of additional gravel (an additional 9 to 11 inches). In January 2021, standing water was observed in compacted areas on the gravel roadway between the Site building and northern Site boundary following a period of rainfall and snowmelt. The condition was likely related to the recent rainfall/snow melt/localized groundwater recharge. To limit the potential for future temporary ponding under similar conditions, Hydro-Air imported approximately 88 tons of #2 crushed limestone and elevated the compacted areas and re-graded the roadway. Hydro-Air monitored the road conditions throughout the 2021-2022 reporting period and did not observe prolonged unanticipated standing water conditions.

***Photo 8: Gravel road along north side of site building***

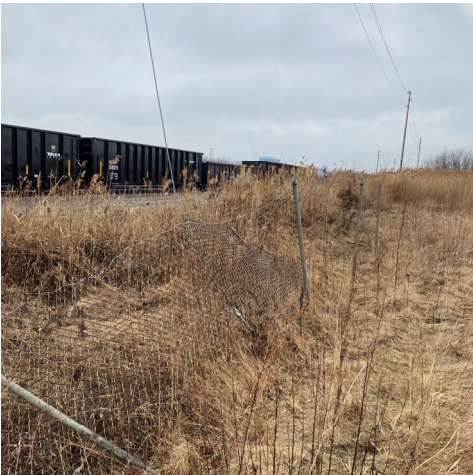
The chain link fencing along the western boundary of the Site was observed in disrepair during the 2021-2022 PRR inspection. According to Hydro-Air personnel, the fencing was not damaged by Hydro-Air, and may have been damaged during maintenance by others along the utility right-of-way corridor traversing the western Site boundary. The damaged fence continues to provide a substantial impediment to trespassers, and Hydro-Air personnel have not observed evidence of consistent trespassing along the western Site boundary.

***Photo 9: Fencing along western site boundary.***

During the previous 2020-2021 PRR inspection, chain link fencing along the western boundary of the Site was observed in disrepair. This observation was noted in the Environmental Inspection Form included in Appendix C of the 2020-2021 PRR. In the 24 May 2021 acceptance of the 2020-2021 PRR and IC/EC Certification, the NYSDEC requested the fencing be repaired, with the maintenance activities noted within the 2021-2022 PRR.

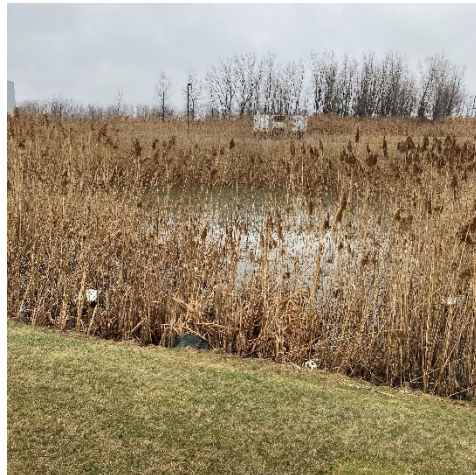
***Photo 10: Stormwater pond.***

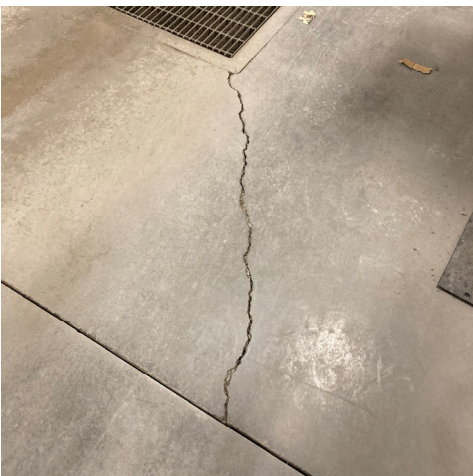
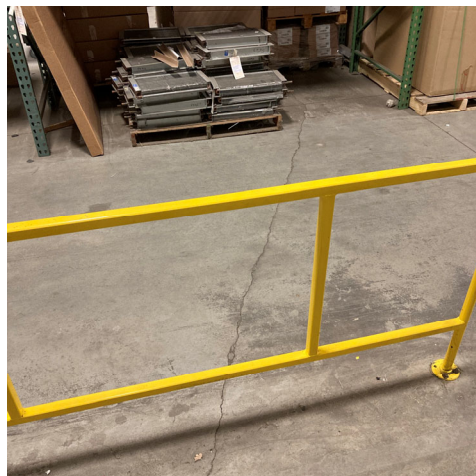
Minor surficial floor cracks continue to be observed in select areas of the Site manufacturing space. These cracks do not appear to have expanded since the 2020-2021 PRR reporting period.

***Photo 11: Minor floor cracking in manufacturing space.***

***Photo 12: Minor floor cracking in manufacturing space.***

- Any building cover cracks, that are not surficial, should be repaired in order to maintain the cover system and proper operation of the SSDS system. Are any of the cracks not surficial? All observed cracks in the manufacturing space are surficial.
