2022-2024 PERIODIC REVIEW REPORT
HYDRO-AIR COMPONENTS, INC. PROPERTY
FORMER STEELFIELDS AREA IV BCP SITE (#C915204)
100 RITTLING BLVD.
BUFFALO, NEW YORK

File No. 0129356-014
August 2024

Subject: Hydro-Air Components, Inc. Property
Former Steelfields Area IV BCP Site; NYSDEC Site #C915204
2022-2024 Periodic Review Report & Institutional Controls/
Engineering Controls Certification
100 Rittling Blvd.
Buffalo, New York

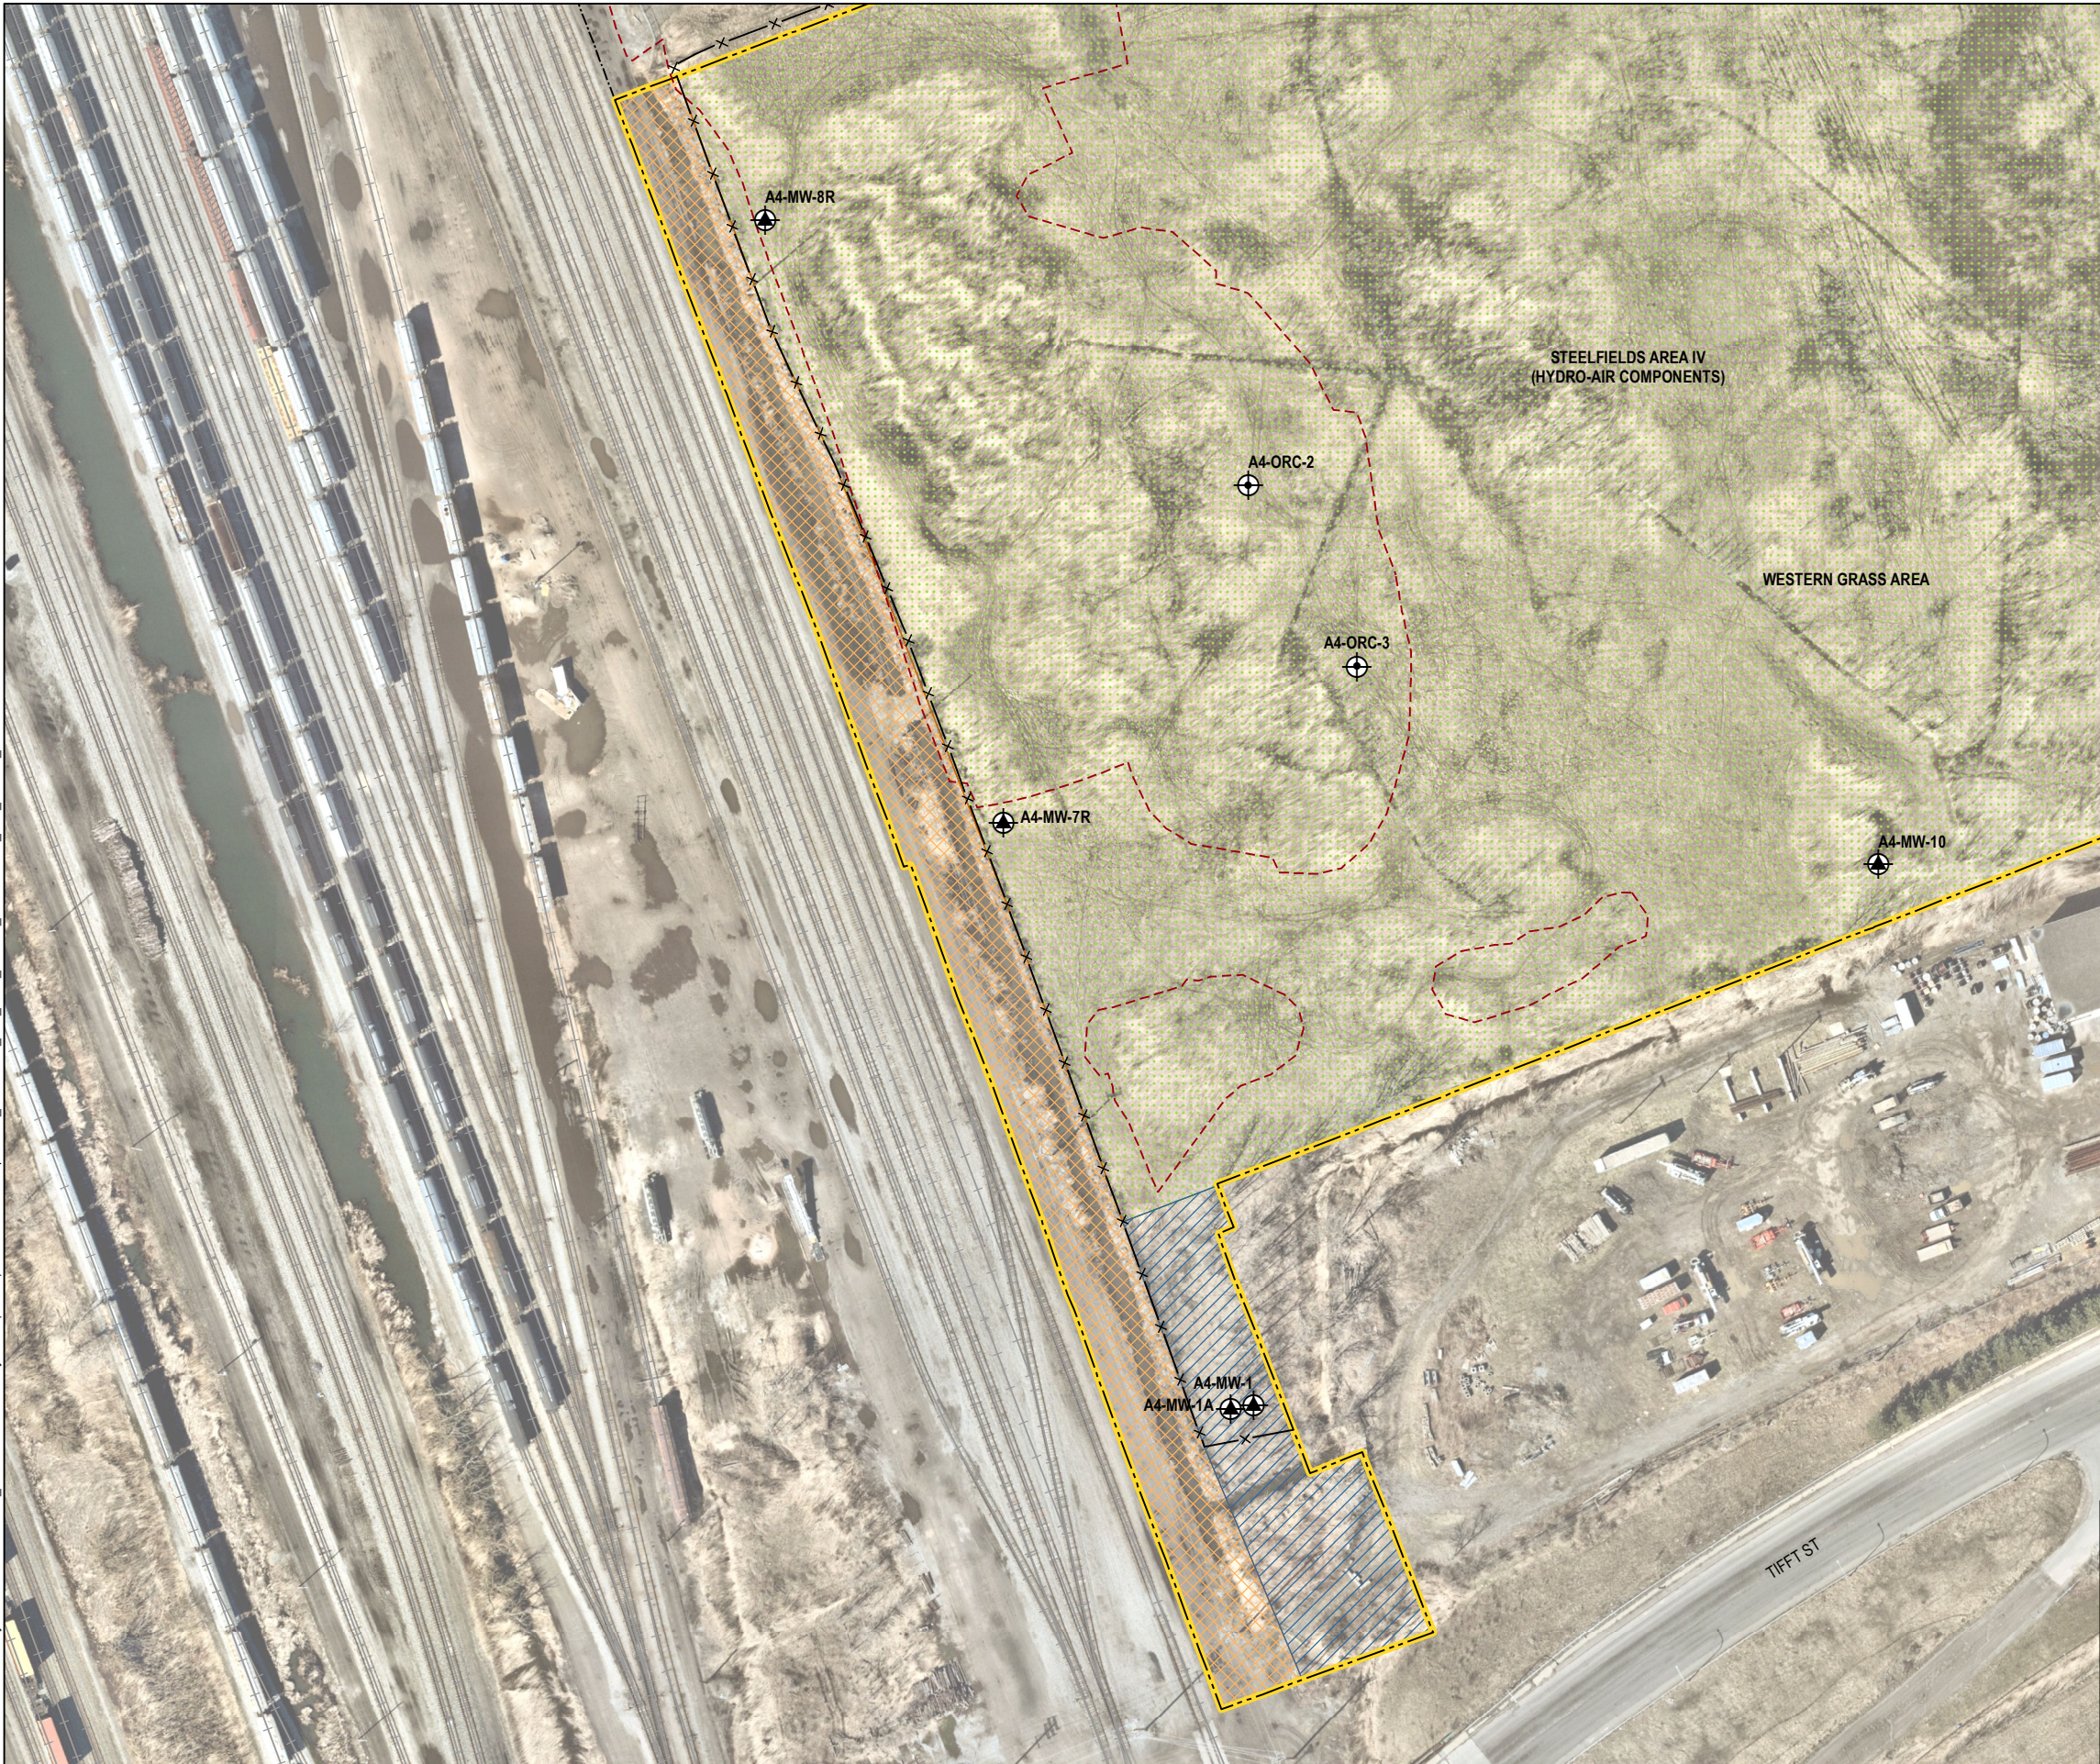
FIGURE 3

During the same visit, Haley & Aldrich of New York observed that the southwest corner of the Site (see Figure 3) was not covered with one foot of imported soil/fill as described in the FER.

During the March 2023 Site engineering controls inspection, Haley & Aldrich of New York observed that the Site areas within the NiMo and BRPRR easements, as well as areas in the southwest corner of the Site, did not appear to be covered with 12 inches of imported soil/fill as described in the FER (see Figure 3). Haley & Aldrich of New York also observed piles of excavated soil/fill materials, including slag, refractory brick, ash, and/or other anthropogenic fill materials, placed along, and on top of, the fence line and cover materials immediately to the east of the NiMo easement, which had destroyed lengthy sections of the fence line. These piles were reported by the BRPRR to have been generated by BRPRR during periodic maintenance of a drainage ditch within the BRPRR/NiMo easements conducted by the railroad. The piles of excavated material extended onto the land east of the fence line covered by 12 inches of imported materials.

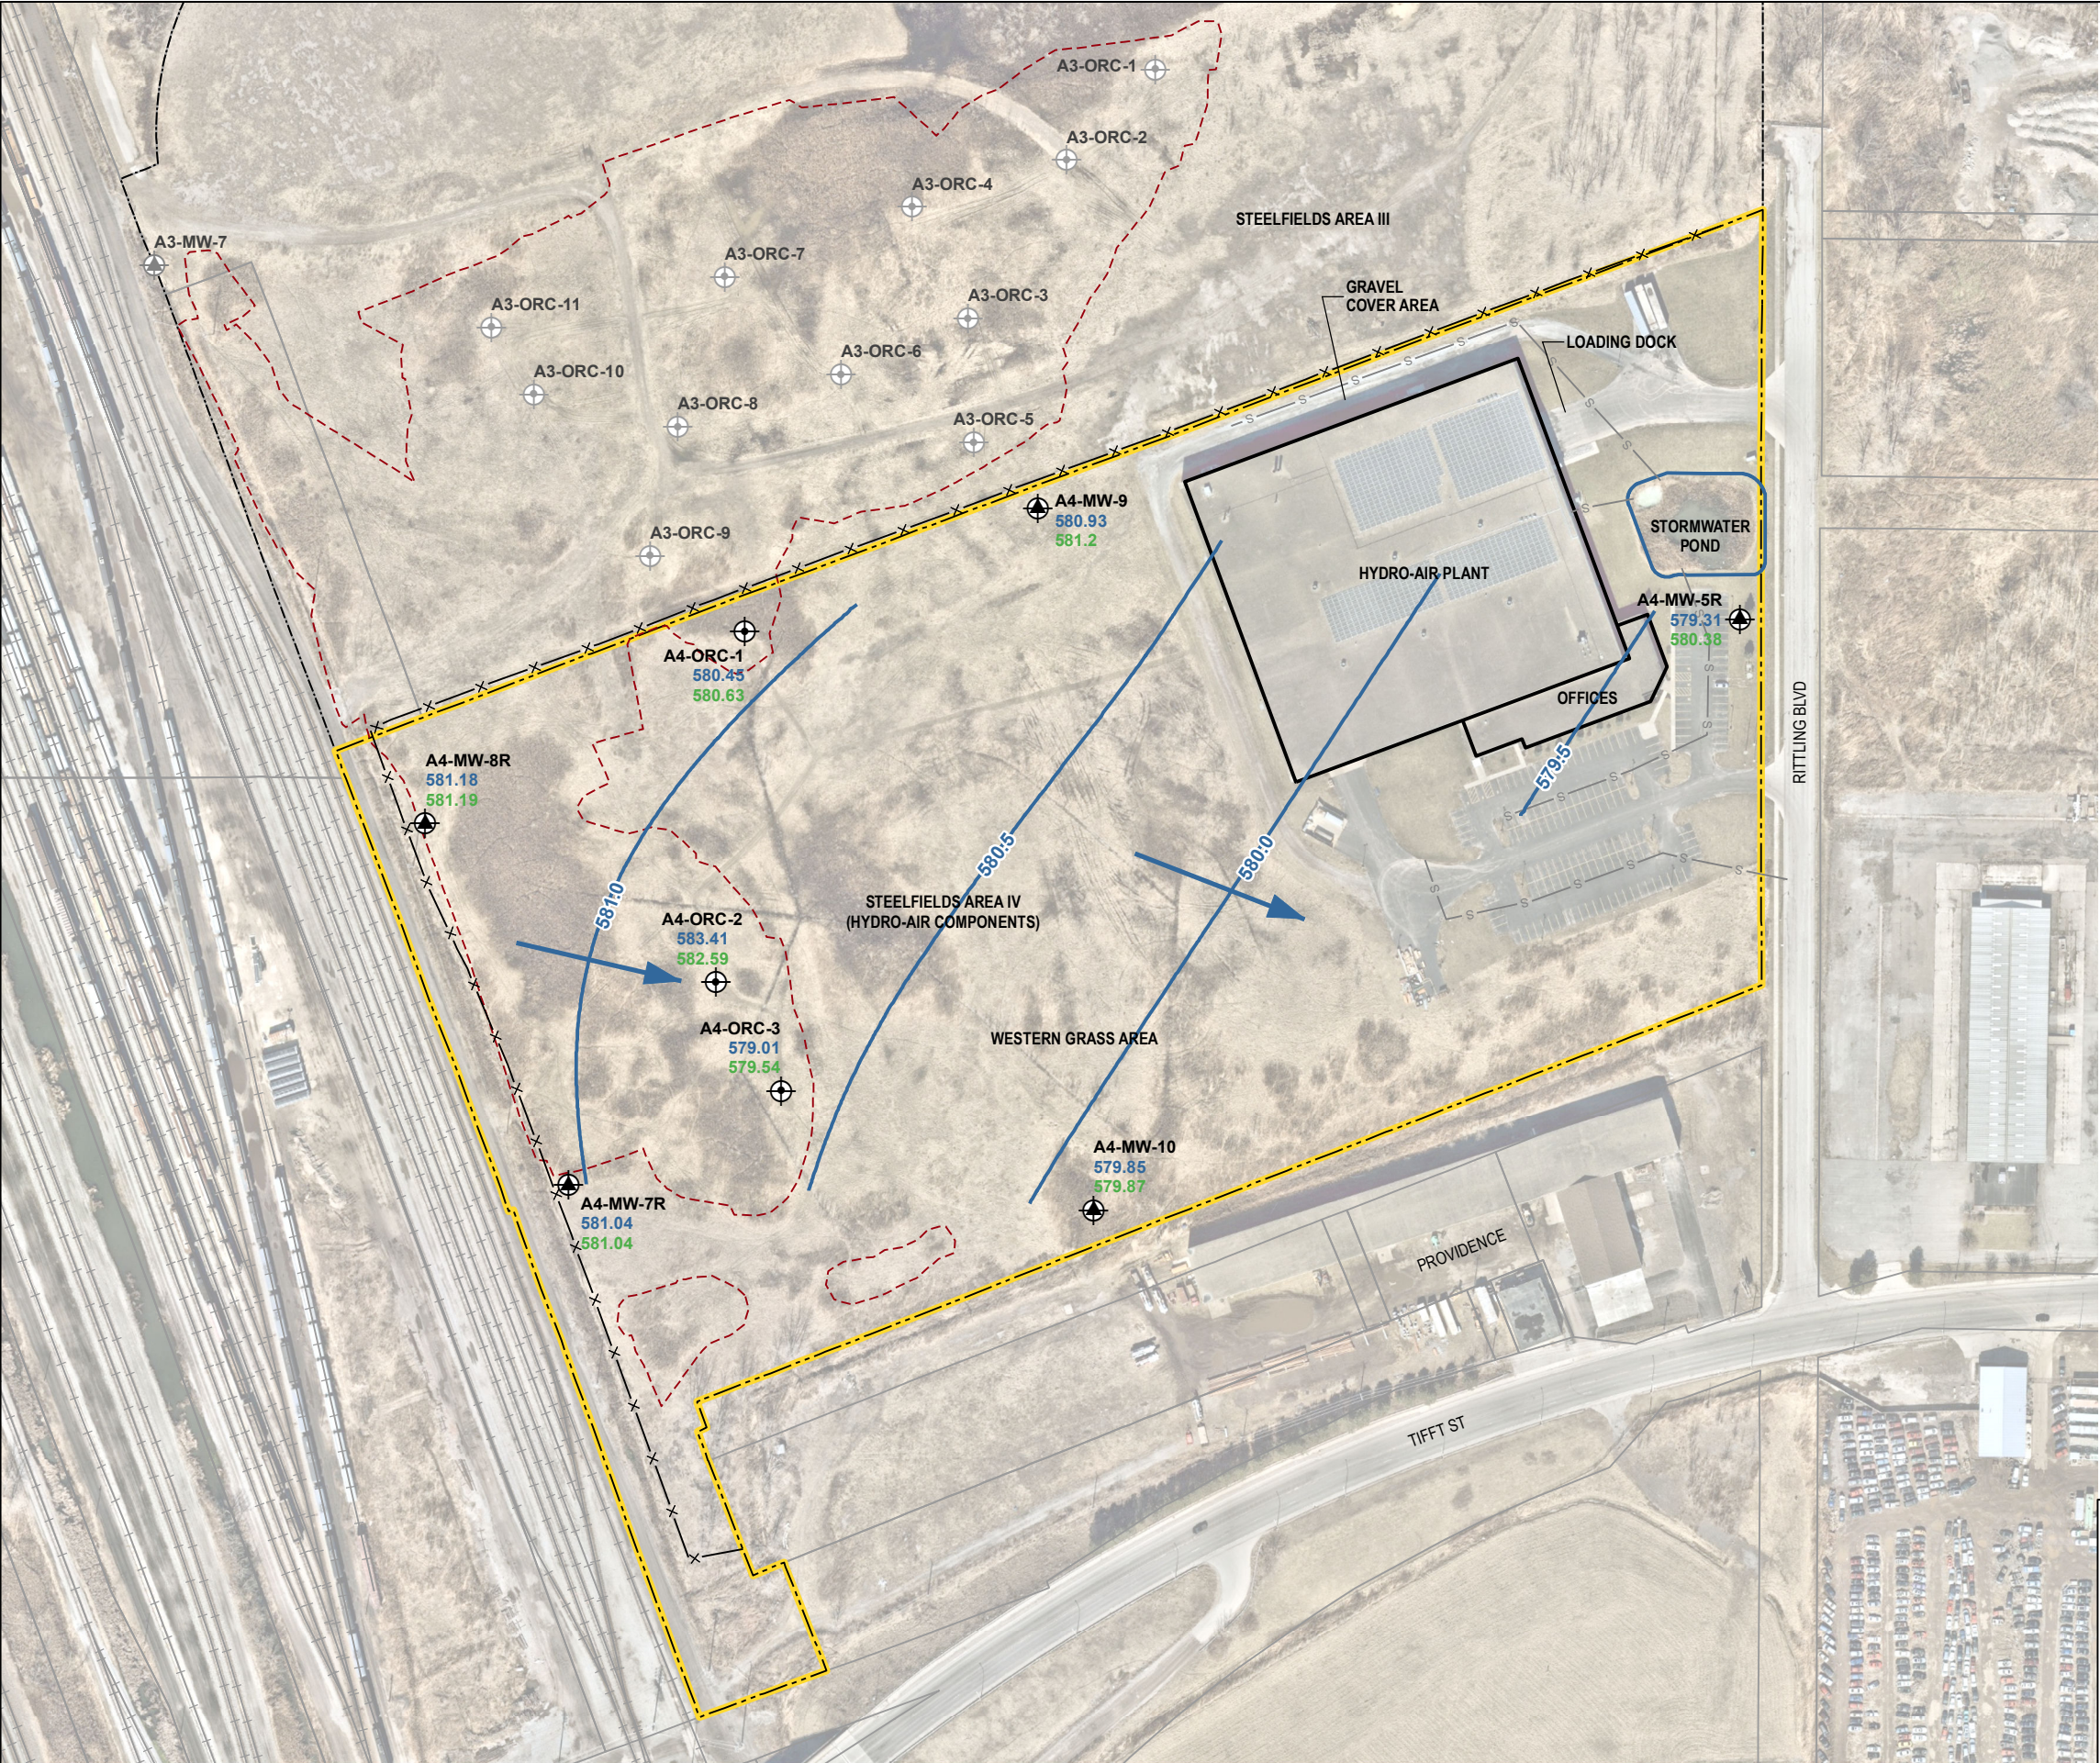
FIGURE 4

The groundwater contour map included as Figure 4 was prepared using the static groundwater elevations measured at the 5 monitoring wells on 27-28 July 2022. Current and historical groundwater elevation data are included in Table IV. Due to anomalous groundwater elevation readings at the ORC wells (specifically mounding in the vicinity of A4-ORC-2), these elevations were excluded from contouring. Groundwater mounding around ORC well A4-ORC-2 has been observed in prior years and may be influenced by the backfilling in portions of the Site. Consistent with previous monitoring periods, groundwater elevations indicate that shallow groundwater flow is generally to the southeast across the Site.

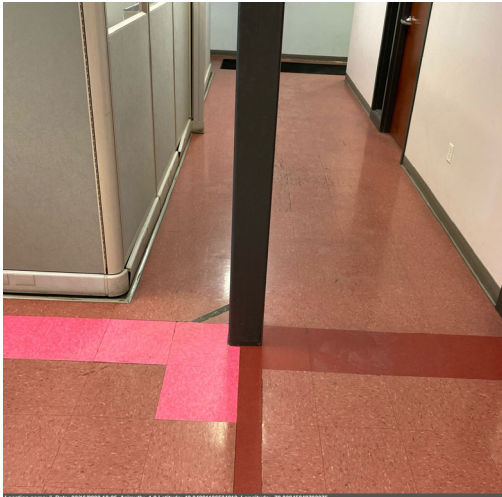
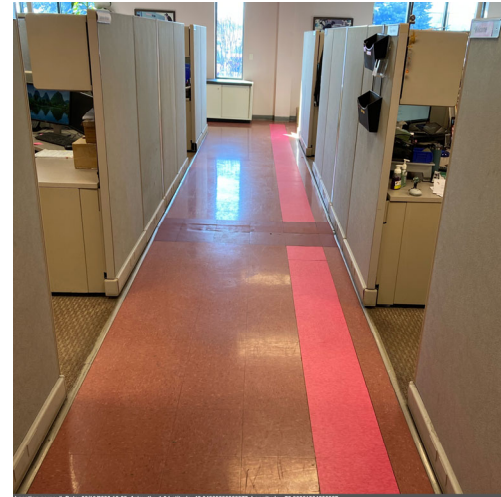
Photo 1: Linoleum tiles placed over repaired floor cracks in office hallway (March 2023)

Photo 2: Linoleum tiles placed over repaired floor cracks in office hallway (March 2023)

During the 2022-2024 PRR period, Hydro-Air personnel repaired floor cracks observed in linoleum floor tiles and ceramic bathroom tiles within the western portions of the Site office areas. Observed cracks were filled with hydraulic cement and the joint surfaces were sealed with self-leveling polyurethane caulk. Damaged linoleum floor tiles were replaced, and the floors subsequently covered with carpeting in 2023. Photographs of the linoleum floor repairs and carpeting are included in Appendix D.

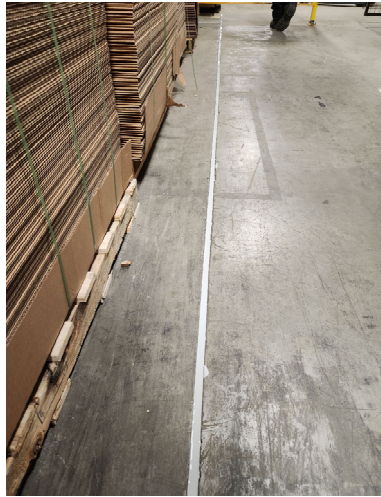
During the March 2023 PRR Site visit, an apparent expanding floor crack and several enlarged expansion joints were observed within the concrete floor of the Site manufacturing space. The expanding floor crack was located near the southeast corner of the facility paint booth. The observed crack and enlarged expansion joints were filled with hydraulic cement and the joint surfaces were sealed with self-leveling polyurethane caulk. Evidence of additional cracking or floor joint expansion was not observed during the March 2024 Site visit. Photographs of the crack sealing activities are included in Appendix D.

Photo 5: Polyurethane caulking in floor slab expansion joint with greater than 0.5 inches of expansion (March 2023)

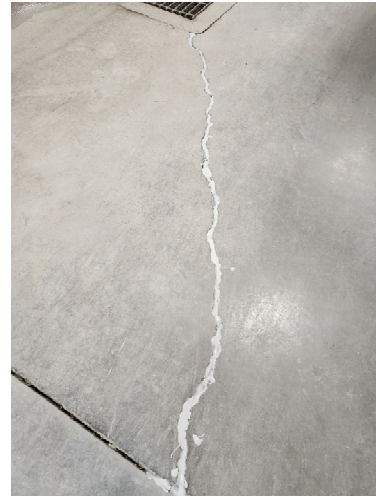
Photo 6: Polyurethane caulking in floor slab crack near paint booth (March 2023)

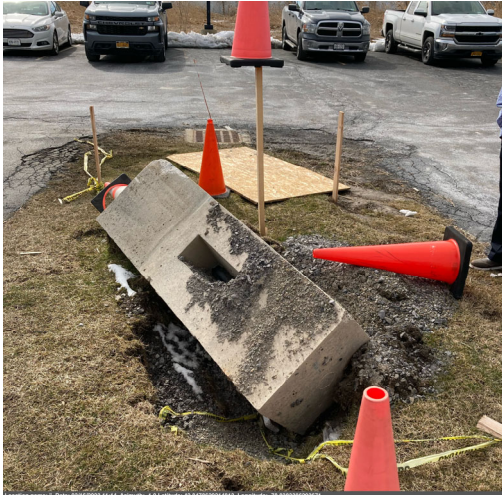
During the March 2023 Site engineering controls inspection, a light post located in the Site parking lot south of the Site building office areas was observed to have been knocked down. Subsurface soils surrounding the damaged concrete light post base were exposed, representing a temporary breach of the Site cover system in the parking lot area.

Photo 9: Parking lot light post and foundation damaged by vehicle (March 2023)

Hydro-Air’s contractor, Ferguson Electric, replaced the light post on 24 August 2023. Ferguson Electric removed the damaged light post and base and excavated apparent previously imported stone and topsoil from around the light post to a depth of approximately 4 feet below ground surface. Ferguson Electric temporarily stockpiled the stone and topsoil on polyethylene sheeting on the asphalt parking lot adjacent to the excavation. Haley & Aldrich of New York did not observe evidence of contamination during the excavation activities. Additionally, screening of the excavated soils/stone with a photoionization detector (PID) did not detect elevated concentrations of volatile constituents (i.e. > 5 parts per million). Because evidence of contaminated soils was not observed, the stone and topsoil were reused by Ferguson Electric to backfill the light post excavation. Approximately 1 additional cubic yard of stone previously imported to the Site and stockpiled was also used to backfill the excavation to final grade. The stockpiled stone was imported to the Site in 2021 under NYSDEC approval to repair the gravel driveway along the northern side of the Site building (see Section 2.1.1.3, below). Following the light post replacement activities, the breached cover system in the vicinity of the light post is considered repaired in accordance with the SMP.

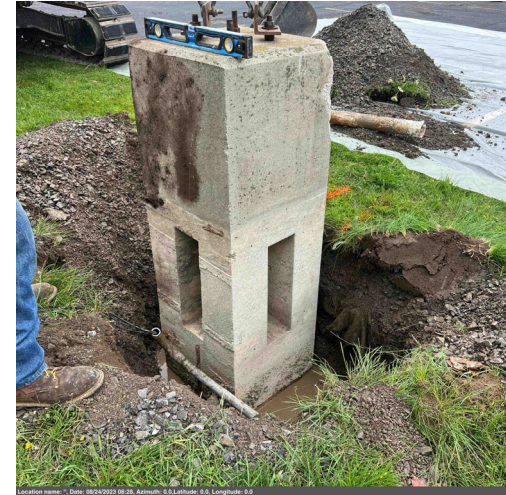
Photo 10: Light post replacement (August 2023).

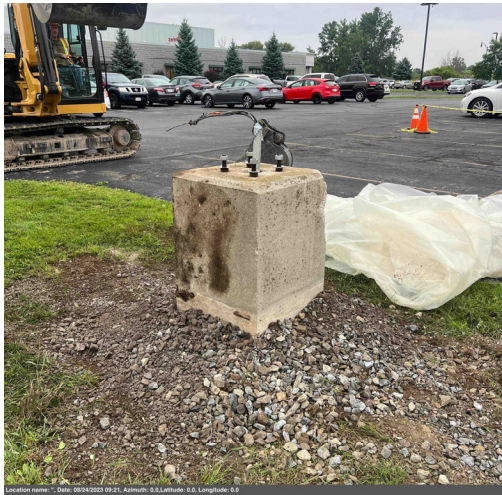
Photo 11: Light post foundation backfilled with excavated material and previously imported stone (August 2023)

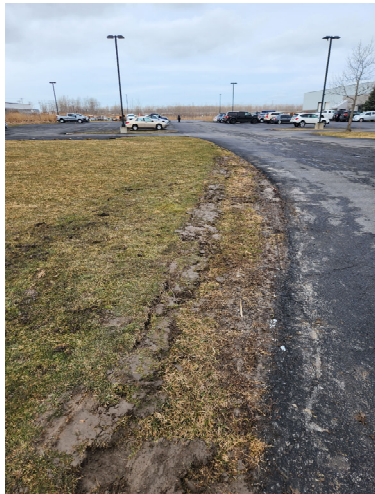
During the March 2024 Site engineering controls inspection, minor snowplow damage was observed to grassy areas adjacent to the Site parking lots. Snow plowing activities in winter 2024 appeared to “peel back” the upper sod surface in these areas adjacent to existing parking lot roadways. The sod was recovered and put back in place in April 2024 to repair the surface cover.

Photo 15: Driveway snowplow damage repair with existing sod (March 2023)

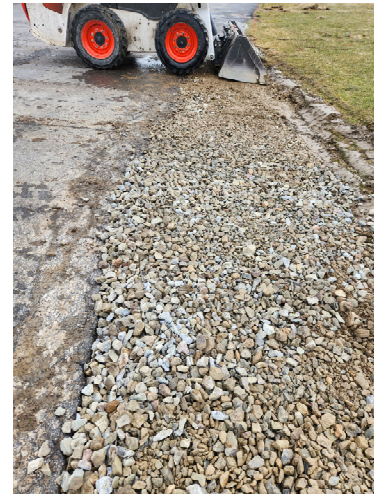
Photo 16: Parking lot/driveway rut repair/filling with previously imported stone.

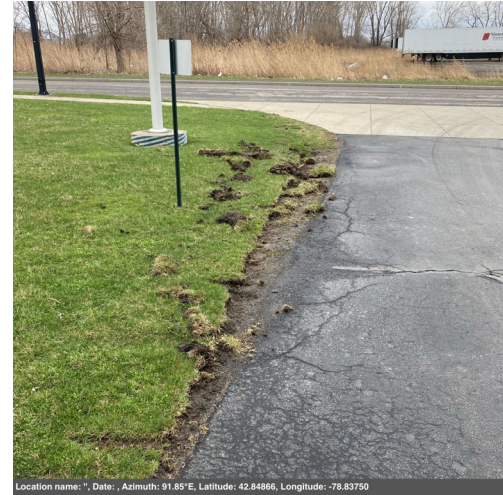
Photo 18: Driveway snowplow damage of surficial sod to be repaired in spring 2024 (March 2024).

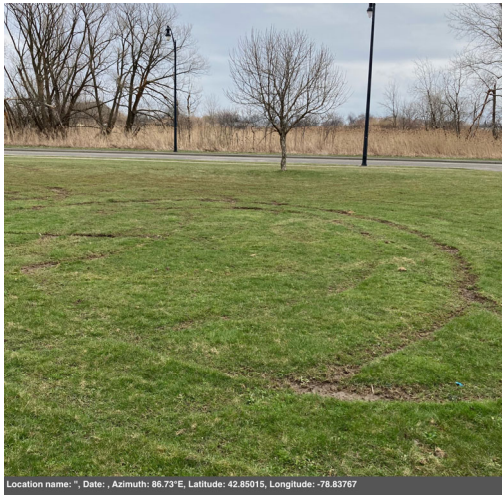
Photo 19: Evidence of motor vehicle use on lawn in northeast corner of site (March 2024)

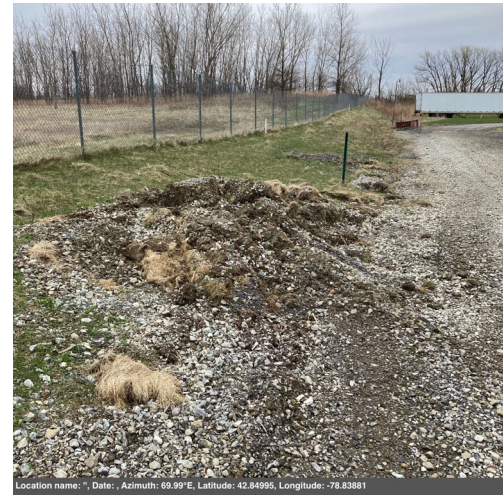
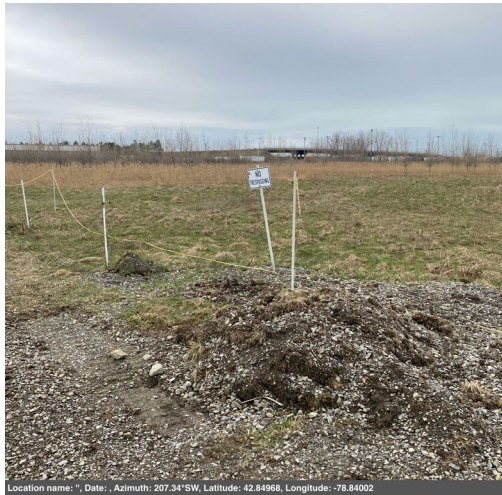
Winter 2024 snowplow activities also resulted in piles of gravel accumulating along the gravel road along the northern end of the Site. The gravel was previously placed above the existing cover system to prevent groundwater surfacing in this area of the Site (see Section 2.1.1.4) and does not represent a breaching of site cover conditions.

Photo 20: Pile of road gravel at end of driveway as a result of winter snow plowing (March 2024).

Photo 21: Pile of road gravel at end of driveway as a result of winter snow plowing and damaged no trespassing barrier (March 2024)

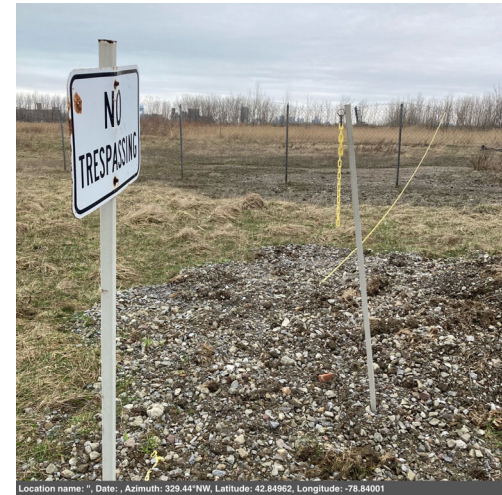
Photo 22: Damaged "no trespassing" barrier along northern driveway (March 2024).

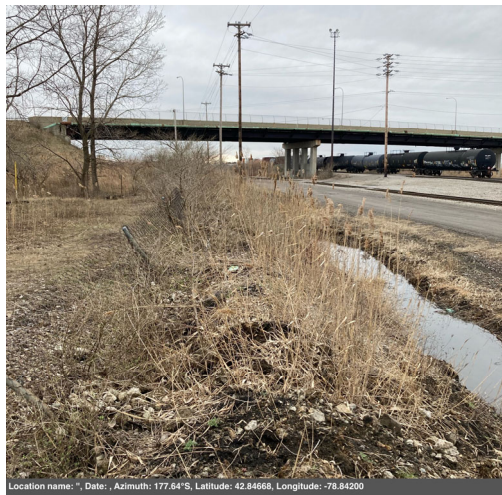
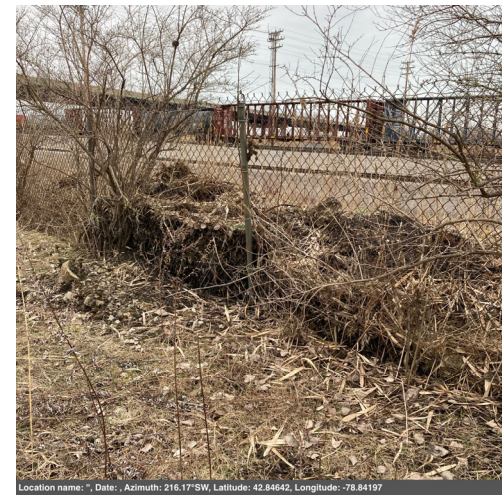
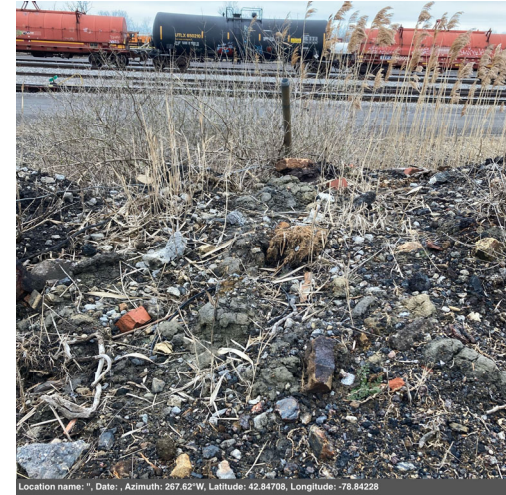
Haley & Aldrich of New York also observed piles of waste soil/fill materials, including slag, refractory brick, ash, and/or other anthropogenic fill materials, placed along and on top of the Fence Line which had destroyed lengthy sections of the fence. The piles of excavated material extended onto the Site cover system located east of the Fence Line where 12 inches of imported cover is present. BRPRR representatives indicate these piles were generated during periodic maintenance of a drainage ditch within the BRPRR/NiMo easements conducted by the Railroad. Hydro-Air was not aware of the periodic maintenance of the ditch by the BRPRR.

Photo 23: Fill excavated from drainage ditch and piled along western fence line (March 2024).

Photo 24: Fill excavated from drainage ditch and piled along western fence line (March 2024).

Photo 26: Fill excavated from drainage ditch and piled along western fence line (March 2024).

Based upon the apparently missing Site cover system in the southwest corner and the piles of excavated materials on top of the fence line and cover system to the east of the NiMo easement and per request of the NYSDEC on 17 May 2024, this PRR is being submitted while Haley & Aldrich of New York, on behalf of Hydro-Air, is working on a Corrective Measures Work Plan (CMWP) for the repairs/maintenance of the Site cover system.

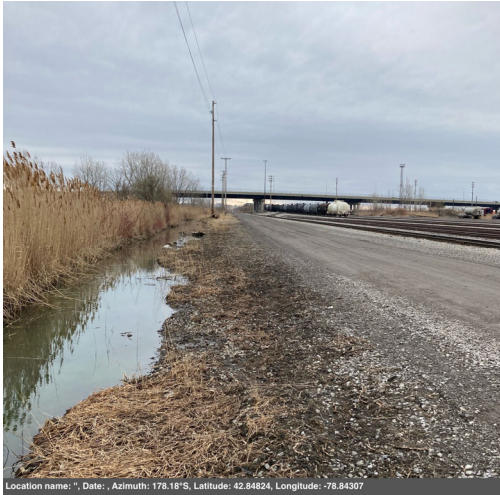
During the March 2023 Site engineering controls inspection, Haley & Aldrich of New York observed that soil beneath the NiMo power lines in the Easements Area located west of a fence line generally marking the western edge of the current Site cover system (“Fence Line”), referred to as “western grass area” shown in Figure 2, did not appear covered with 12 inches of imported soil/fill, as was described in the Final Engineering Report (FER) prepared by Benchmark for the Site, dated November 2007. This area includes a 30-foot-wide railroad track easement reserved by the BRPRR to use, maintain and remove Track T-RB2A(1), and a partially overlapping 40-foot-wide utility easement granted to NiMo. These approximate boundaries of these easement areas are shown on Figure 3.

Photo 25: NIMO and BRPRR easement areas along western site boundary (March 2024).

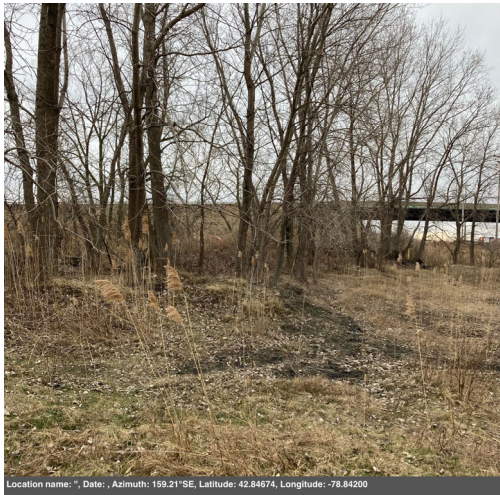
Based on the aforementioned observations, Site cover does not exist in the southwest corner of the Site and as a result, the certification of all of the Site IC/ECs cannot be made. However, the inspections found that the active sub-slab depressurization system (ASD) and the gasketed stormwater conveyance piping were in place and properly operating, that the ORC socks were in place as required, and that groundwater and the stormwater pond monitoring had occurred in accordance with the SMP.

Photo 27: Southwestern corner of site.
