2024-2025 PERIODIC REVIEW REPORT
HYDRO-AIR COMPONENTS, INC. PROPERTY
FORMER STEELFIELDS AREA IV BCP SITE (#C915204)
100 RITTLING BLVD.
BUFFALO, NEW YORK

File No. 0129356-018
July 2025

Subject: Hydro-Air Components, Inc. Property
Former Steelfields Area IV BCP Site; NYSDEC Site #C915204
2024-2025 Periodic Review Report & Certification of
Institutional Controls/Engineering Controls
100 Rittling Blvd.
Buffalo, New York

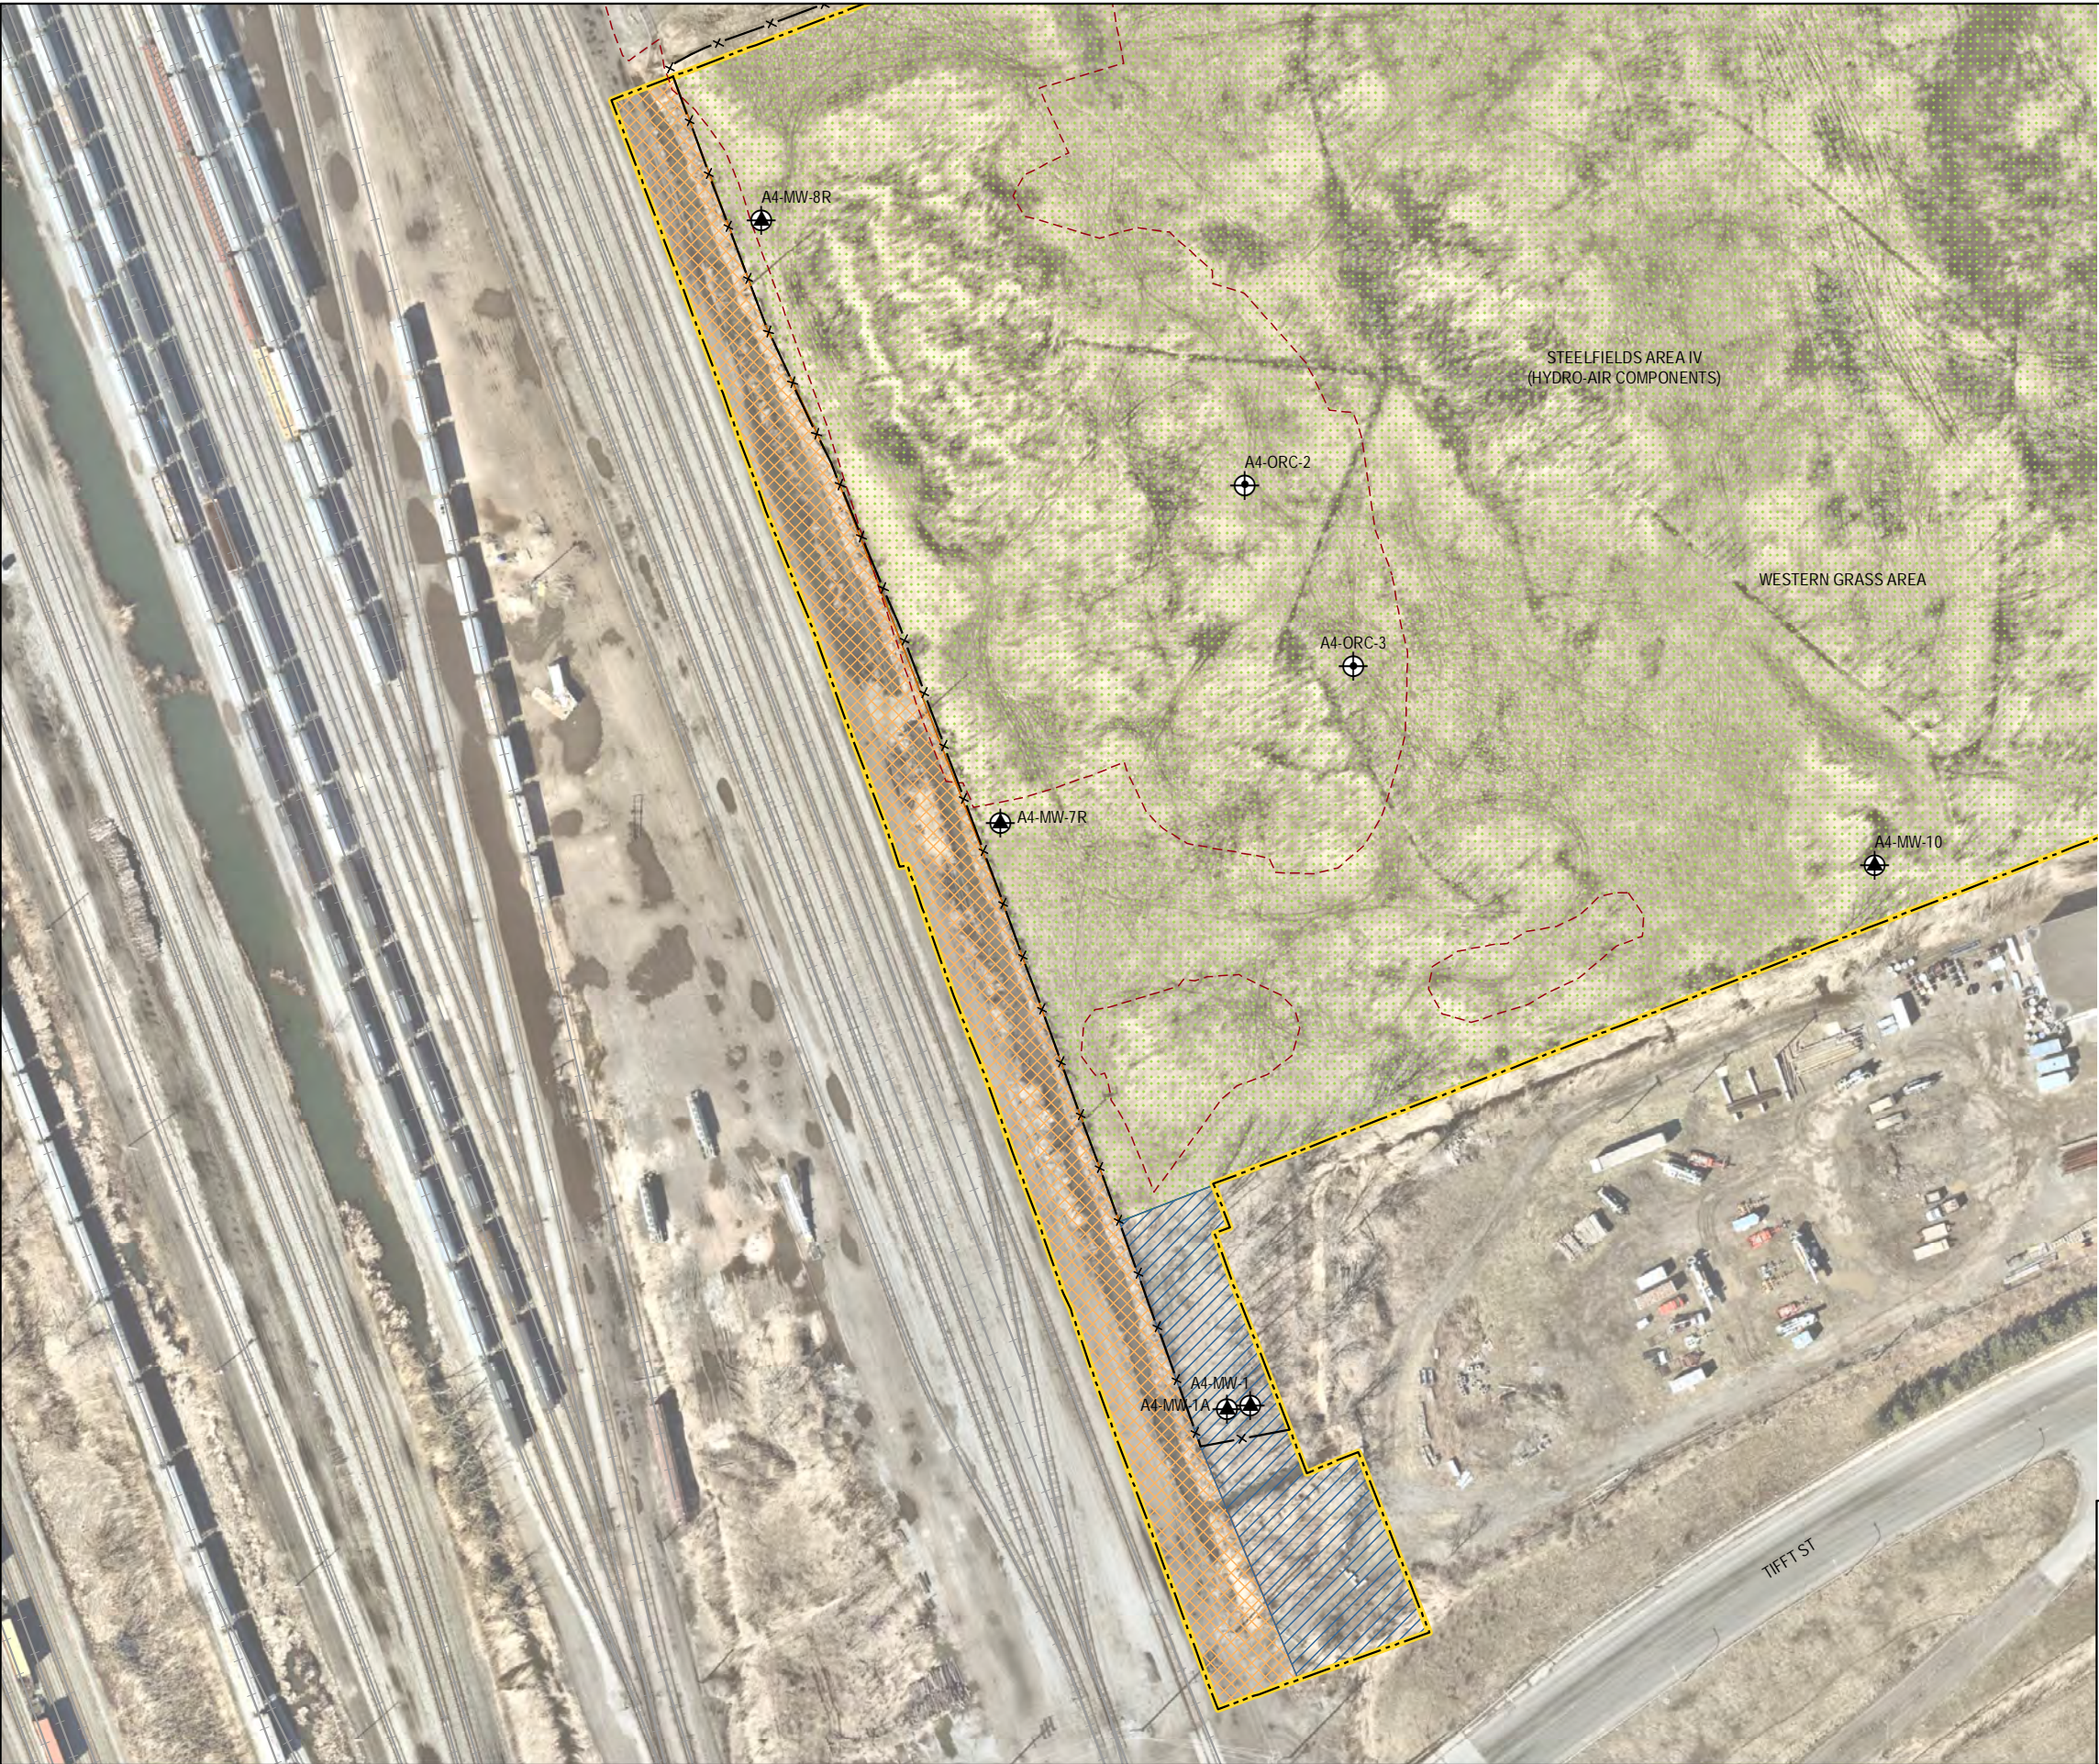
FIGURE 3

During Site engineering controls inspections conducted between 2023 and 2025, Haley & Aldrich of New York observed that the Site areas within the NiMo and BRPRR easements, as well as areas in the southwest corner of the Site, did not appear to be covered with 12 inches of imported soil/fill as described in the FER (see Figure 4). Haley & Aldrich of New York also observed piles of excavated soil/fill materials, including slag, refractory brick, ash, and/or other anthropogenic fill materials, placed along, and on top of, the Fence Line and cover materials immediately to the east of the NiMo easement, which had destroyed lengthy sections of the Fence Line. These piles were reported by the BRPRR to have been generated by BRPRR during periodic maintenance of a drainage ditch within the BRPRR/NiMo easements conducted by the railroad. The piles of excavated material extended onto the land east of the Fence Line covered by 12 inches of imported materials.

Based on the aforementioned observations, Site cover does not exist in the southwest corner of the Site, (see Figures 3 and 4) and as a result, the certification of all of the Site ICs/ECs cannot be made. Based upon the apparently missing Site cover system in the southwest corner and the piles of excavated materials on top of the Fence Line and cover system to the east of the NiMo easement and per NYSDEC correspondence from May 17, 2024 and September 3, 2024, this PRR is being submitted while Haley & Aldrich of New York, on behalf of Hydro-Air, is working on a Corrective Measures Work Plan (CMWP) for the repairs and maintenance of the Site cover system.

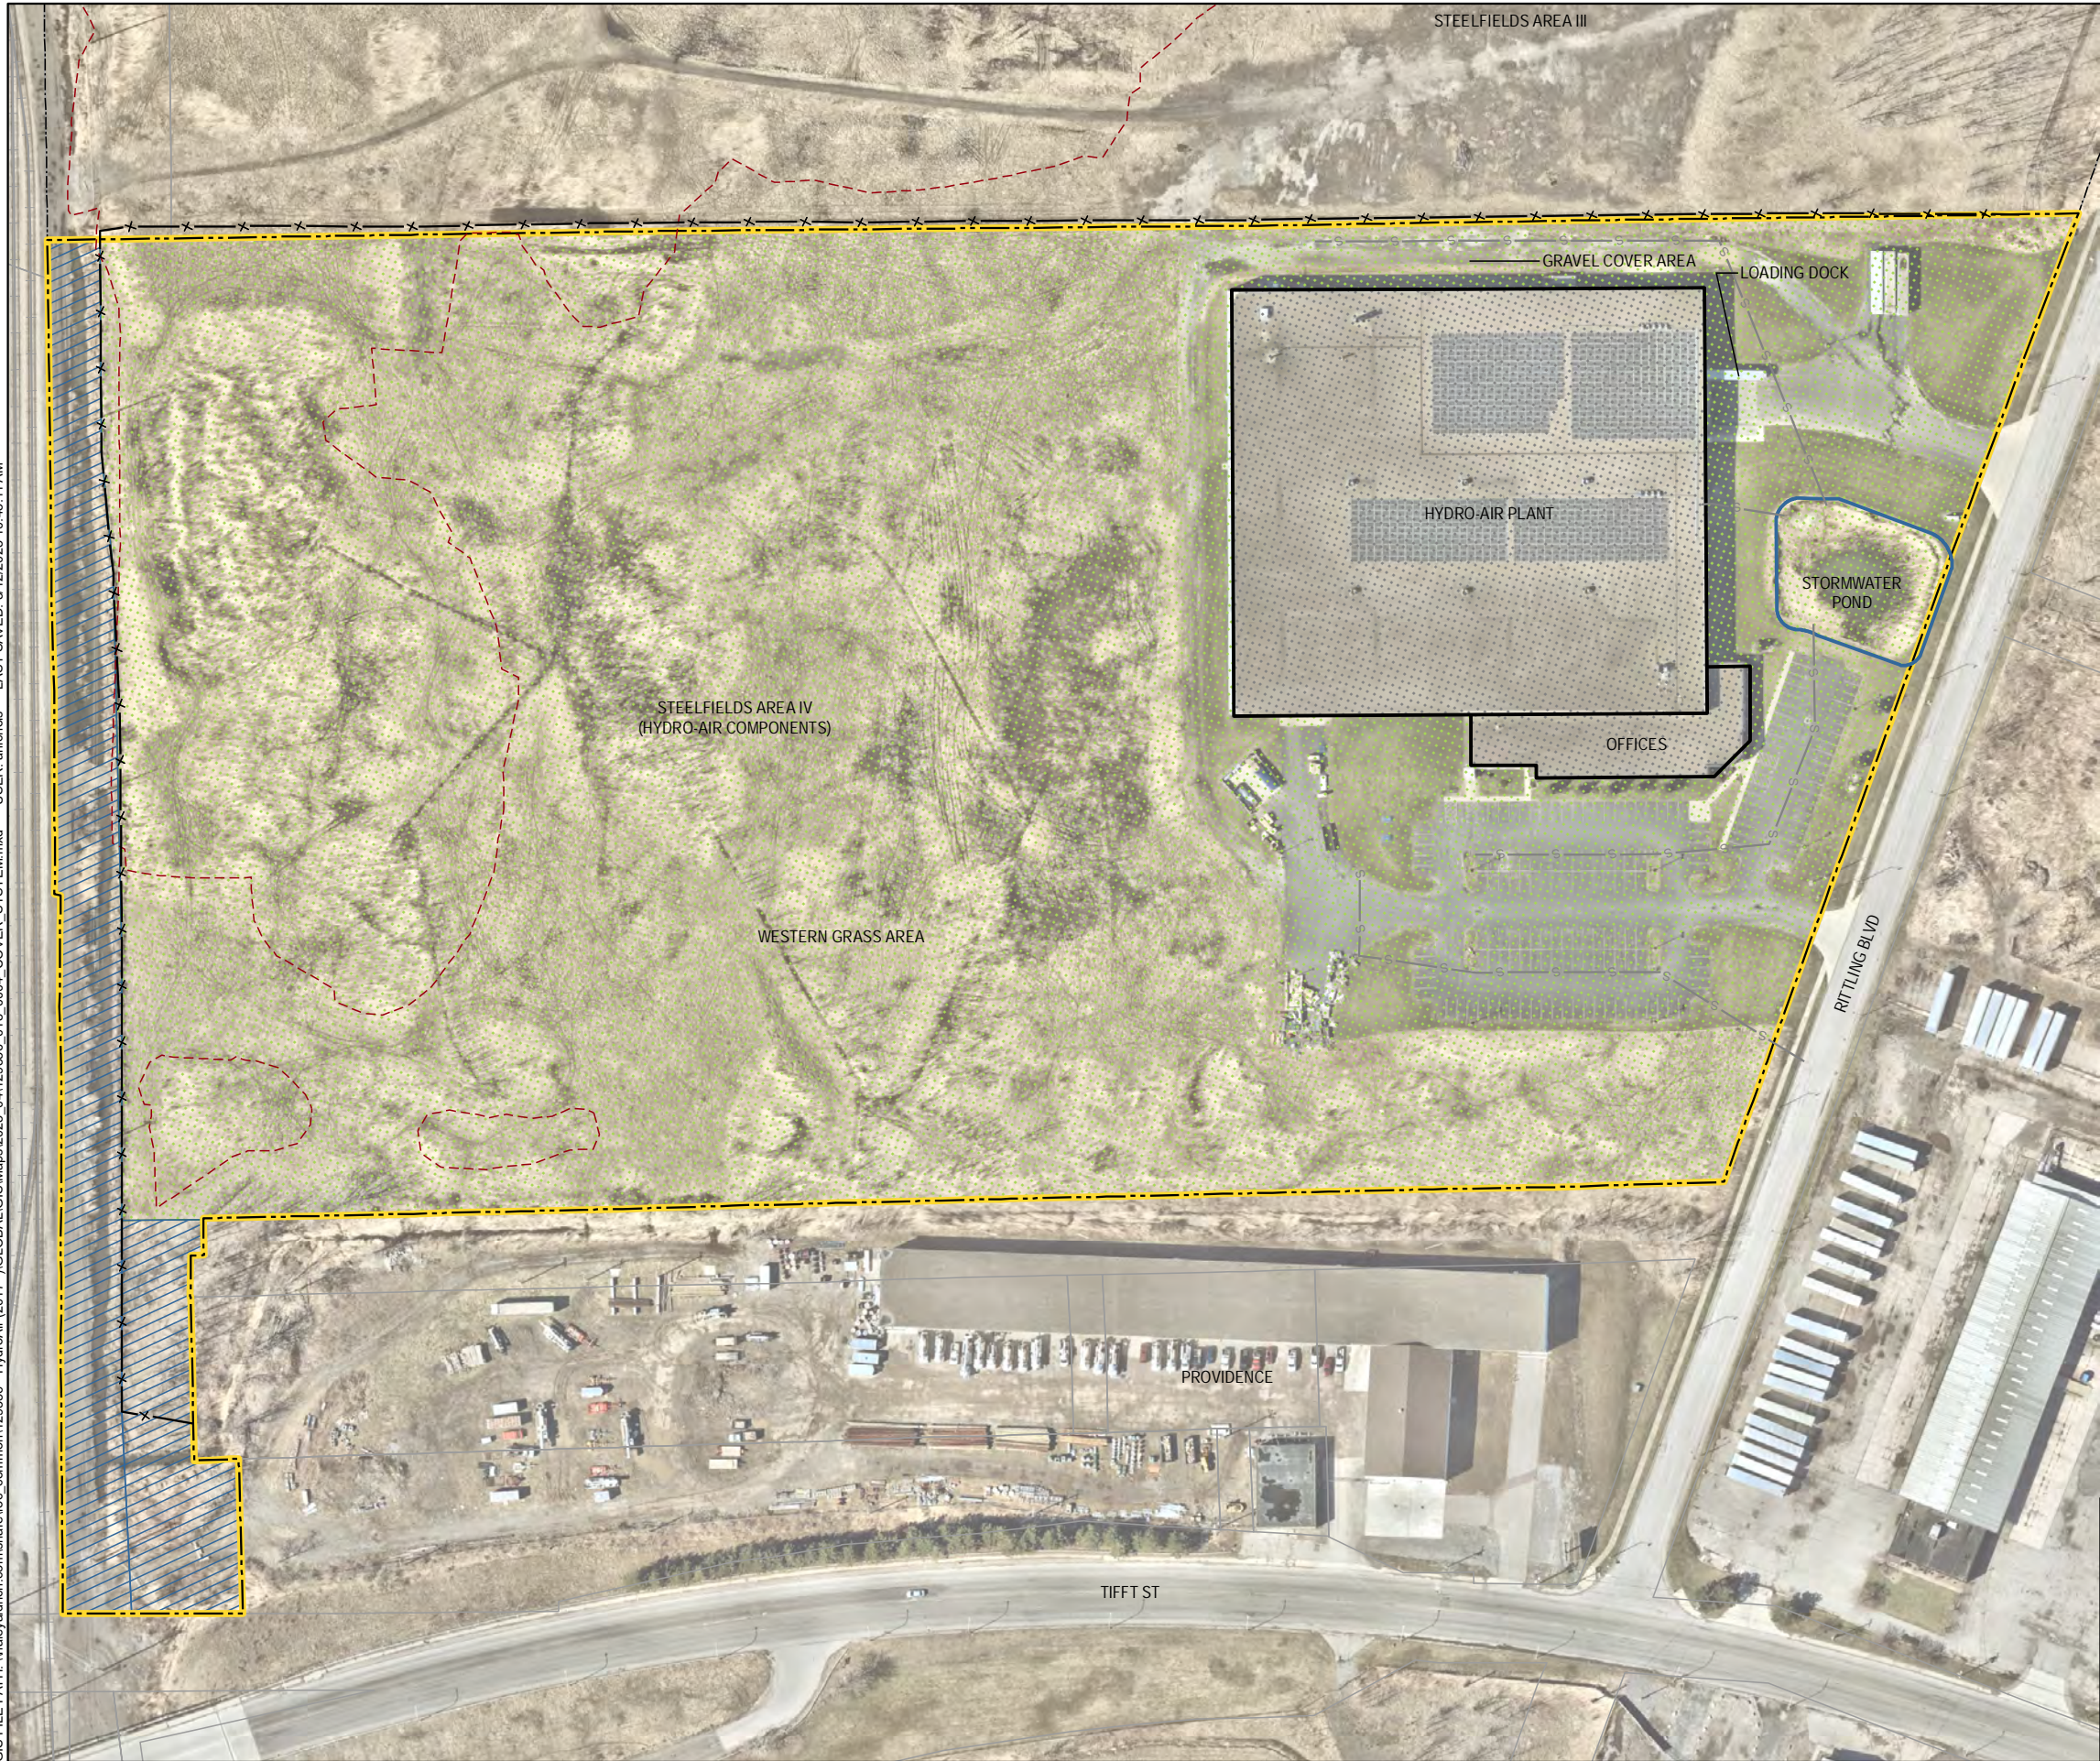
FIGURE 4

Haley & Aldrich of New York also observed piles of waste soil/fill materials, including slag, refractory brick, ash, and/or other anthropogenic fill materials, placed along and on top of the Fence Line which had destroyed lengthy sections of the fence. The piles of excavated material extended onto the Site cover system located east of the Fence Line where 12 inches of imported cover is present. BRPRR representatives indicate these piles were generated during periodic maintenance of a drainage ditch within the BRPRR/NiMo easements conducted by the Railroad. Hydro-Air was not aware of the periodic maintenance of the ditch by the BRPRR. Haley & Aldrich of New York also observed that the southwest corner of the Site (see Figures 3 and 4) was not covered with one foot of imported soil/fill as described in the FER.

The April 2025 Site engineering controls inspection observations indicated that areas of the Site continue to not have cover in accordance with the SMP such that the certification of all of the Site IC/ECs cannot be made. This PRR is being submitted while Haley & Aldrich of New York, on behalf of Hydro-Air, is working on a Corrective Measures Work Plan (CMWP) for the placement, repairs and maintenance of the Site cover system.

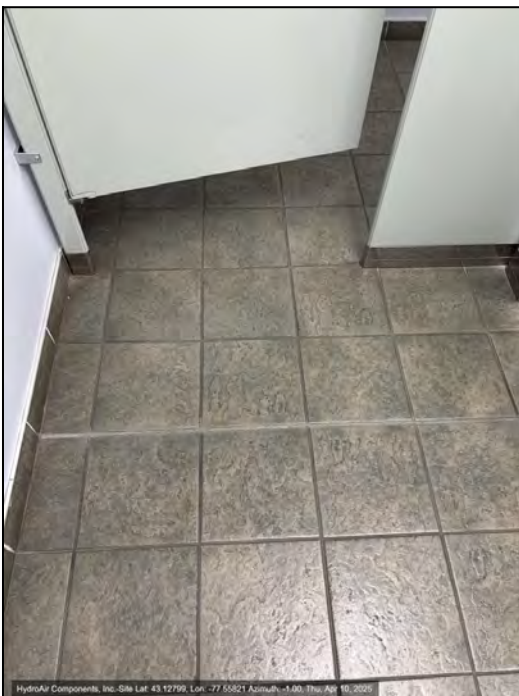
Between 2022 and 2024 Hydro-Air personnel repaired floor cracks observed in linoleum floor tiles and ceramic bathroom tiles within the western portions of the Site office areas. Observed cracks were filled with hydraulic cement and the joint surfaces were sealed with self-leveling polyurethane caulk. Damaged linoleum floor tiles were replaced, and the floors subsequently covered with carpeting in 2023. Evidence of additional floor cracking was not observed during the 2024-2025 PRR reporting period

Photo 7: Previously sealed floor crack in men's office bathroom.

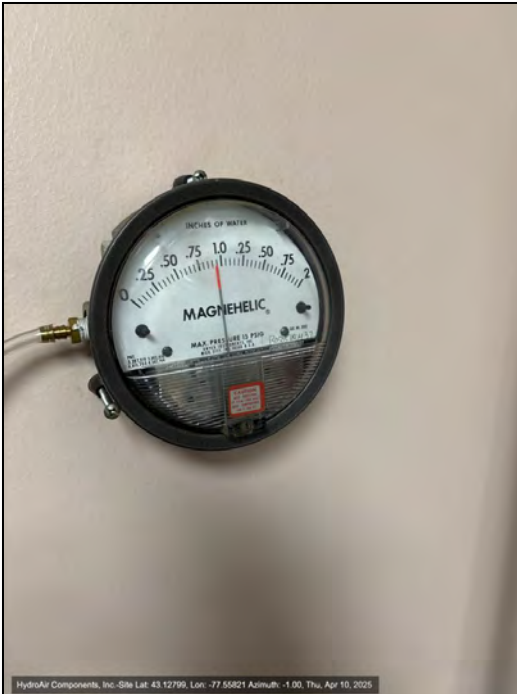
Although the server room vacuum reading is low, adjustments are not planned. The historical range of the server room gauge between 2010 and 2025 is 0.90-1.6, with an average of 1.11 for the same time period (this does not include the 0.2 reading from June 2024, which was indicative of a broken fan). Server room vacuum readings will continue to be observed in order to assess if there is a decreasing trend of vacuum readings or they continue to remain within the historical range.

Photo 9: "Server Room" Magnehelic gauge.

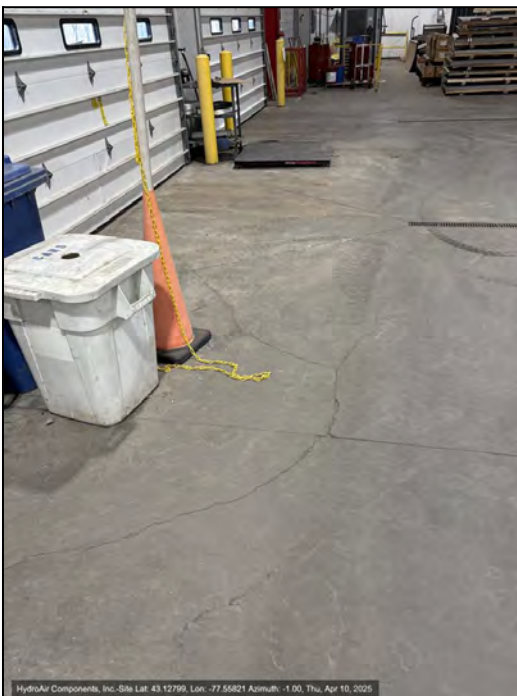
Photo 11: Small cracks in concrete floor in southwest loading area.

- The remaining engineering and institutional controls were operated and maintained during the reporting period. Hydro-Air intends to continue monitoring the concrete cracks and expansion joints in the manufacturing floor and plans to fill floor cracks greater than ¼-inch in width, and expansion joints enlarged beyond ½-inch in width.

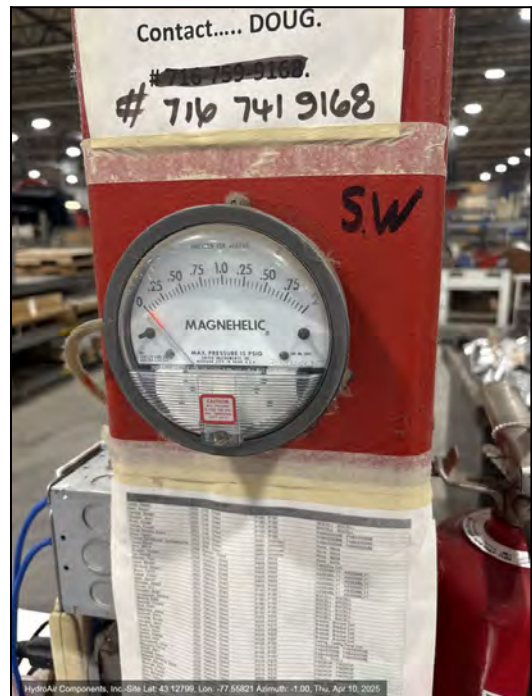
During the reporting period, two rooftop exhaust fans broke. The Server Room fan malfunctioned in late-June and early-July 2024, and the fan was replaced by Hydro-Air on July 19, 2024. During the April 10, 2025 annual Site inspection visit, a pressure reading of 0 inches of water was observed on the “SW” magnehelic gauge, and Hydro-Air confirmed the roof-top fan was not working. Hydro-Air personnel replaced the “SW” fan on April 24, 2025. Following both fan replacements, monthly magnehelic gauge pressure readings returned to within the historical operating ranges for each gauge.

Photo 12: "SW" Magnehelic gauge.

"SW" fan not operating during 4/10/25 visit replaced on 4/24/25

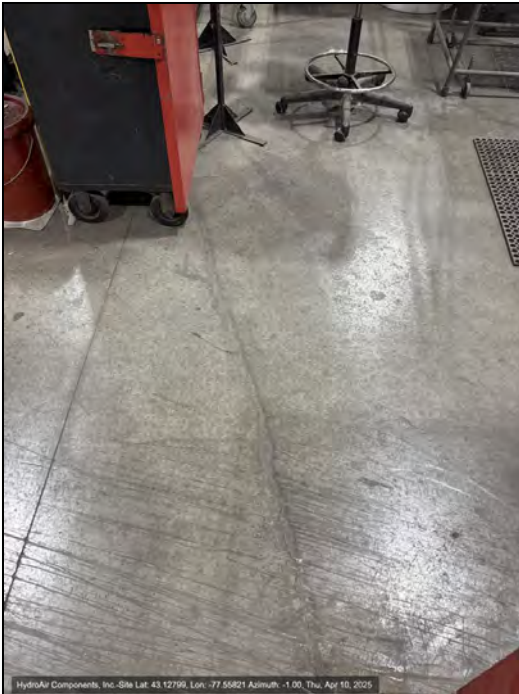
Photo 13: Previously sealed floor crack near "SW" Magnehelic gauge.

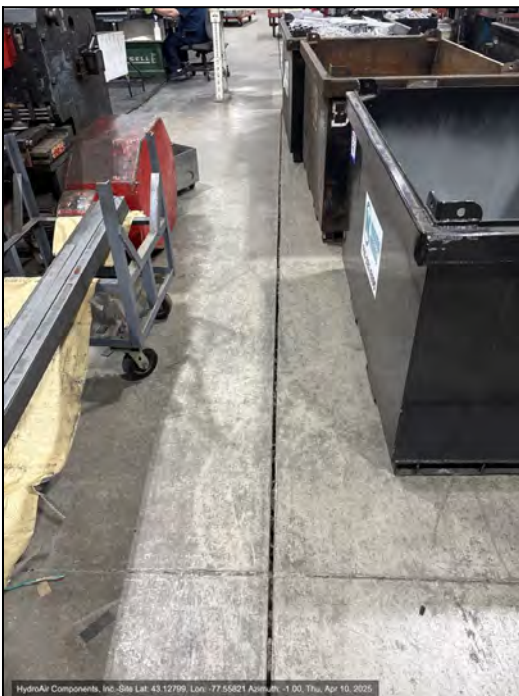
Photo 15: ~ 3/4-inch gap in manufacturing facility floor expansion joint.

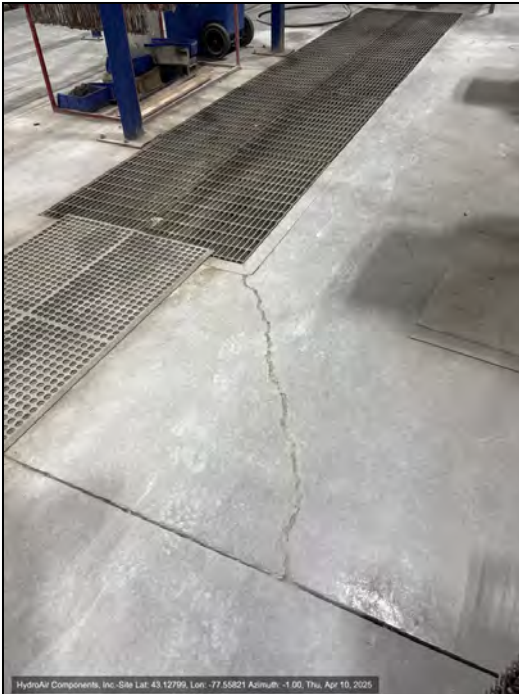
In 2023, an apparent expanding floor crack and several enlarged expansion joints were observed within the concrete floor of the Site manufacturing space. The expanding floor crack was located near the

southeast corner of the facility paint booth. The observed crack and enlarged expansion joints were filled with hydraulic cement and the joint surfaces were sealed with self-leveling polyurethane caulk. Evidence of additional cracking or floor joint expansion was not observed during the April 2025 Site visit. Although other minor surficial floor cracks continue to be observed in parts of the manufacturing space, these cracks do not appear to extend through the concrete floor slab. Evidence of manufacturing floor expansion joints enlarging beyond ½-inch was not observed during the April 2025 Site visit. Hydro-Air intends to continue to observe expansion joint thicknesses, and fill joints enlarged greater than ½-inch with hydraulic cement and seal joint surfaces with self-leveling polyurethane caulk.

Photo 17: Previously sealed floor crack near paint booth.

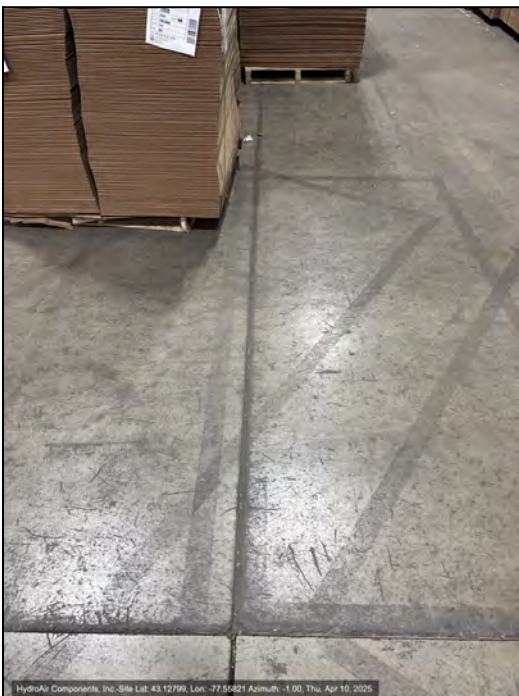
Photo 19: Previously sealed manufacturing facility floor expansion joint.

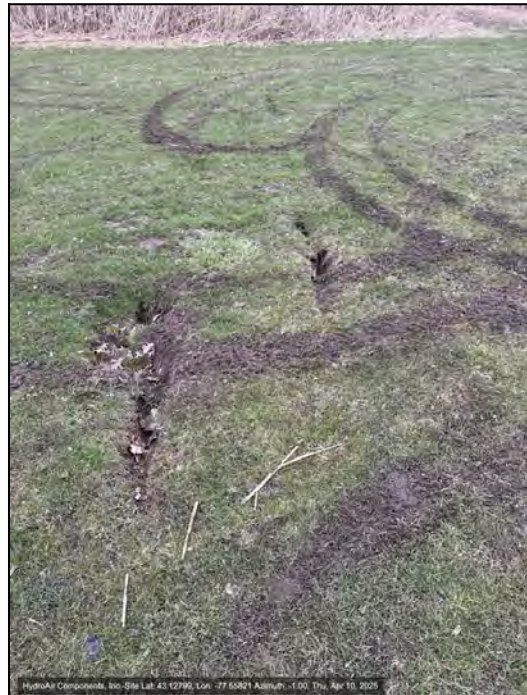
During the April 2025, Site engineering controls inspection, evidence of trespassing on the Site was observed, including tire marks and approximately 6-inch-deep divots on a lawn area in the northeast corner the Site. While the tire marks appear to have damaged the grass, they did not breach the Site cover system. However, the divots extend into the protective cover system and will be repaired with imported stone and topsoil, and the lawn vegetation will be reestablished by Hydro-Air during the 2025-2026 PRR period. Prior to importing stone or topsoil, import approval request(s) will be made to the NYSDEC.

Photo 24: Tire tracks and ~6-inch deep divots in grassy area in northeast corner of the site.

During the April 2025 site engineering controls inspection, evidence of trespassing on the Site was observed, including tire marks and two 6-inch deep divots on a lawn area in the northeast corner the site. While the tire marks appear to have damaged the grass, they did not breach the site cover system. However, the divots extend into the protective cover system and will be repaired by Hydro-Air during the 2025-2026 PRR period. Hydro-Air will continue to monitor for periodic trespassing and will continue to alert law enforcement if such trespassing is observed.

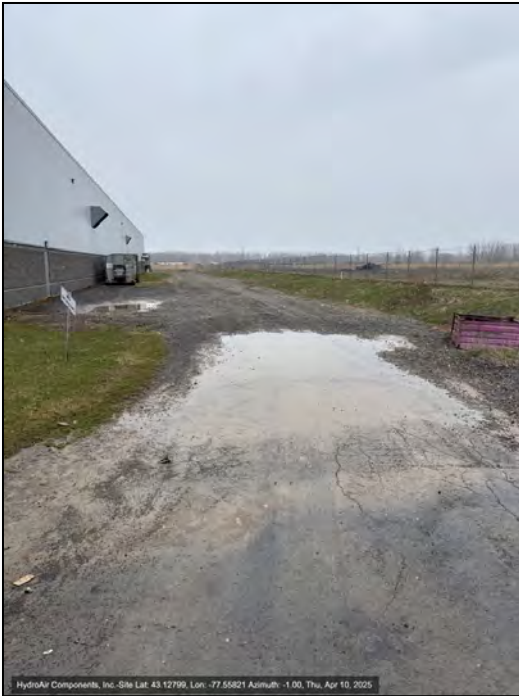
As requested by NYSDEC, french drains were installed in May 2008 to minimize ponding observed after the installation of the soil cover in 2007. Minor ponding was observed during the annual 2024-2025 PRR period. Wetland vegetation continues to grow in the western grass area.

Photo 25: Apparent stormwater ponding at eastern end of northern gravel driveway.

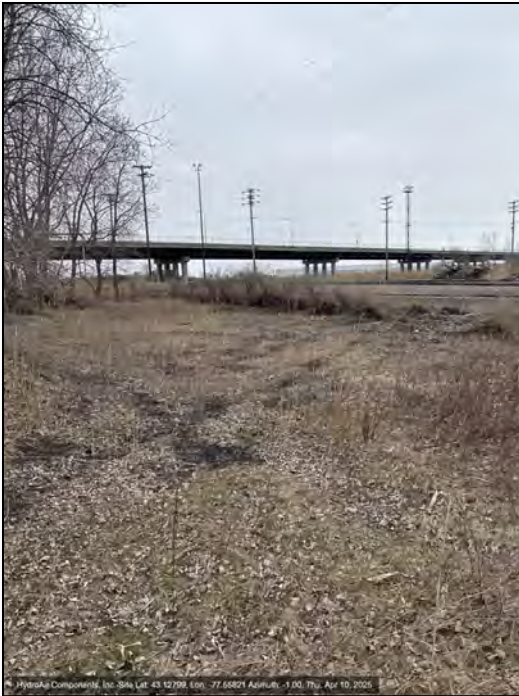
Photo 33: Southwest corner of site.

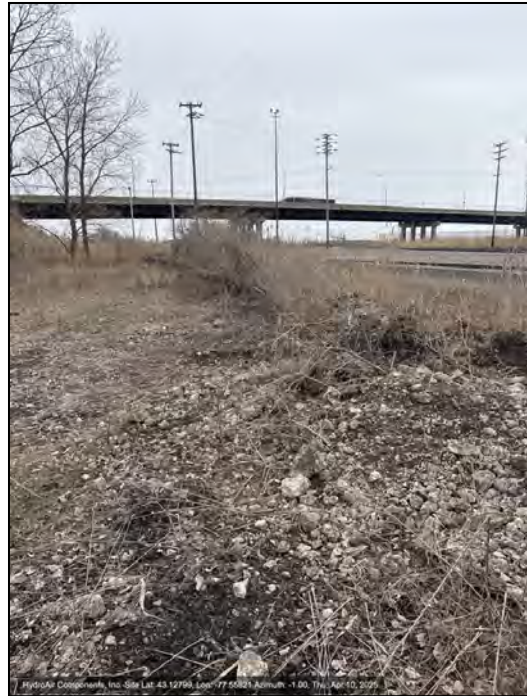
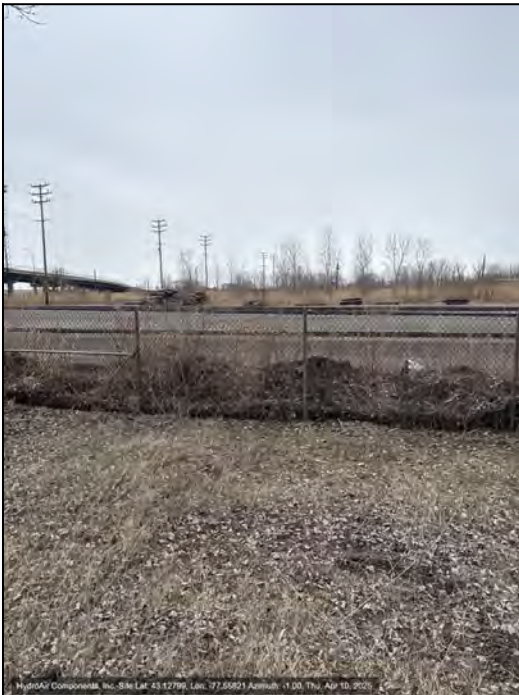
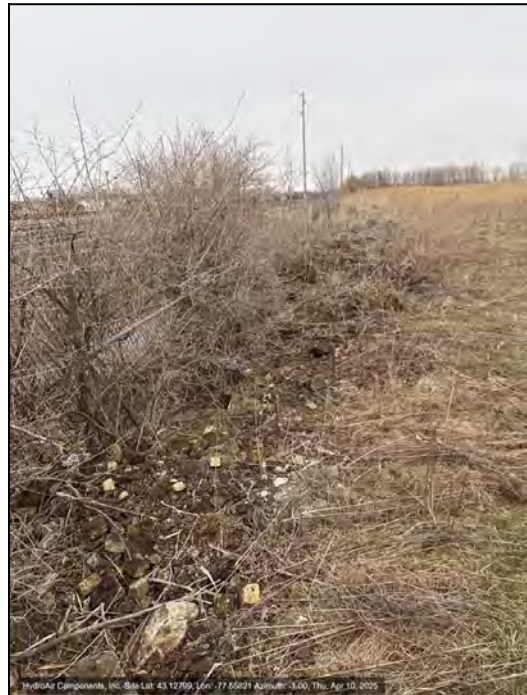
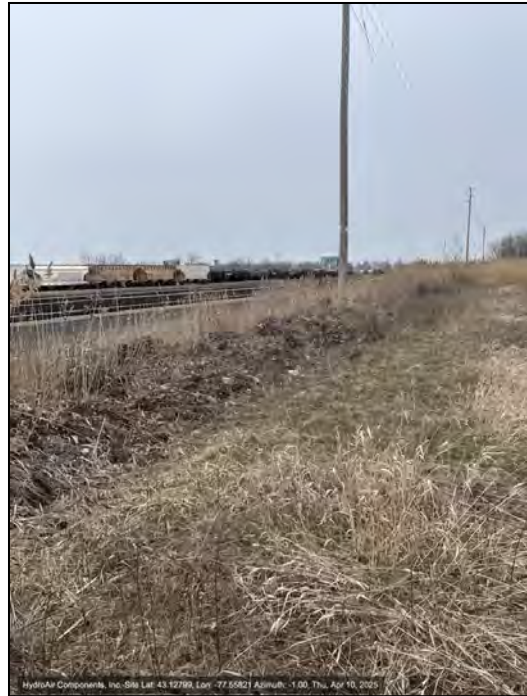
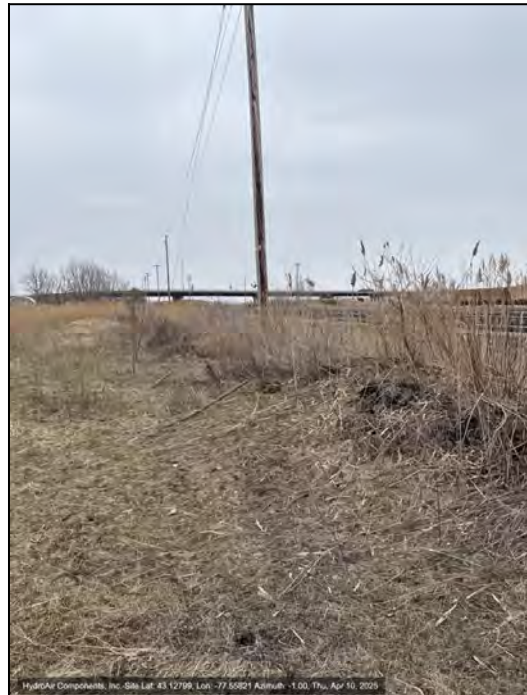
Photo 34: Fill previously excavated from drainage ditch and piled along western fence line.

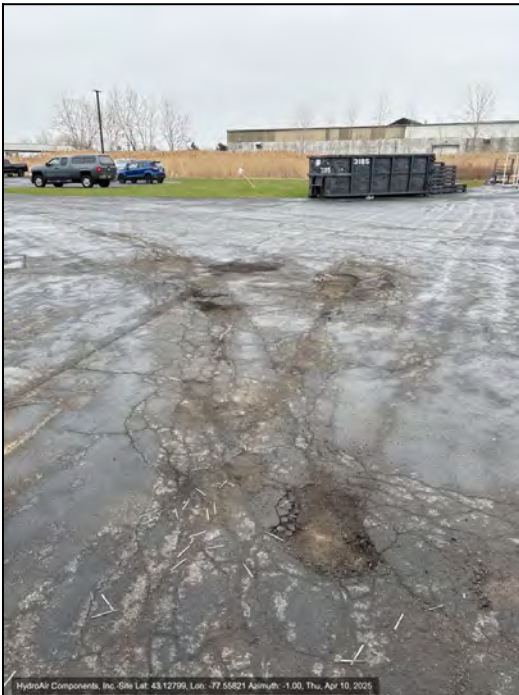
3. Cracks visible in pavement? ☒ yes ☐ no ☐ N/A

Deteriorating Asphalt Pavement in Parking Lot

Photo 43: Deteriorating asphalt in parking lot.
