PERIODIC REVIEW REPORT

Realty Income Buffalo Genesee LLC
Site No. C915211
(Former NOCO #S41)
1055 Genesee Street
Buffalo, New York

SCS File No. 02220052.00 | January 20, 2021
(revised January 27, 2021)

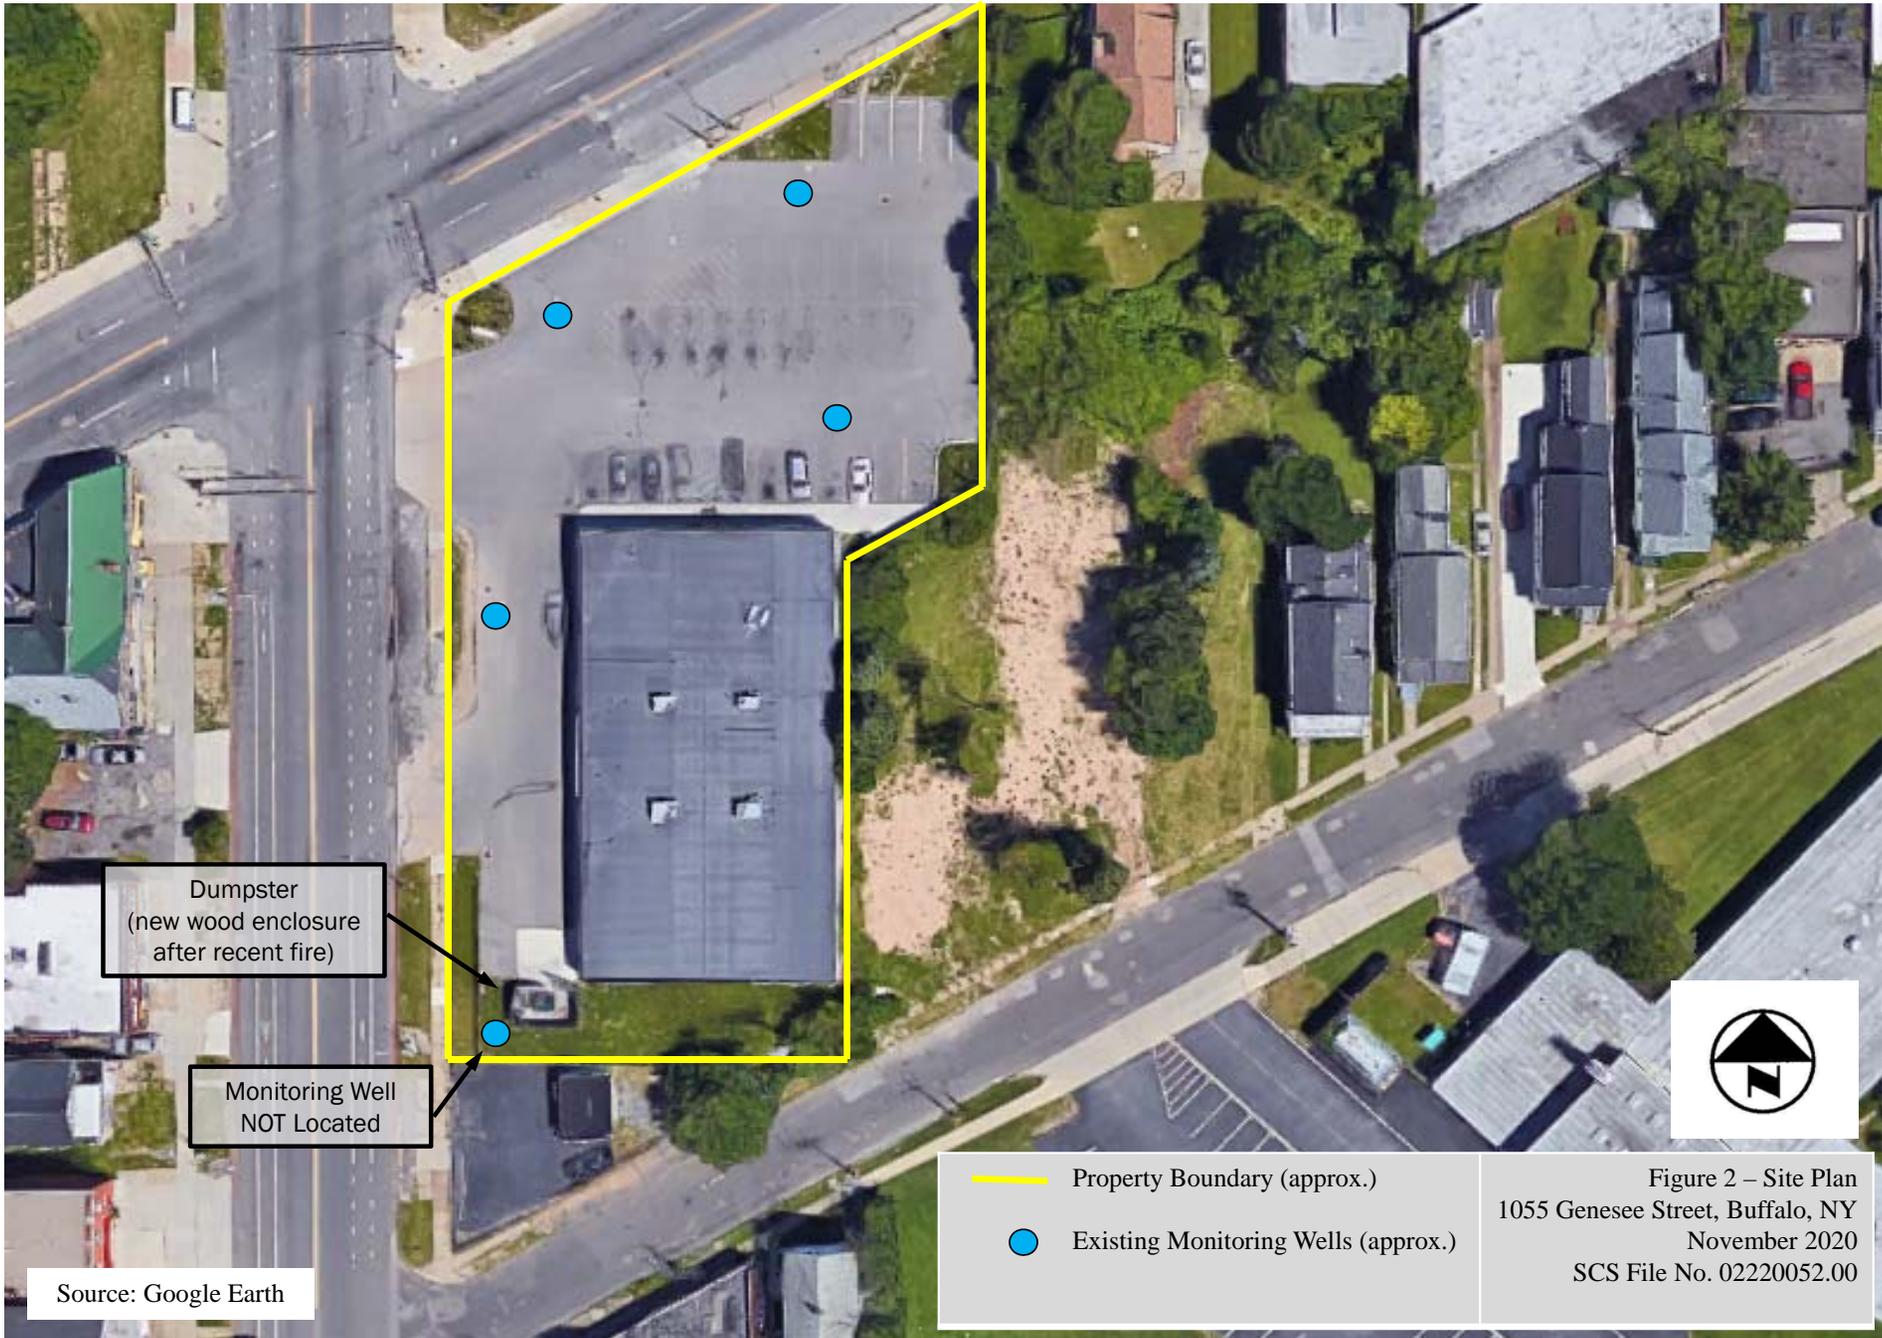
Figure 2 – Site Plan
1055 Genesee Street, Buffalo, NY
November 2020
SCS File No. 02220052.00

Dumpster
(new wood enclosure
after recent fire)

Monitoring Well
NOT Located

● Existing Monitoring Wells (approx.)

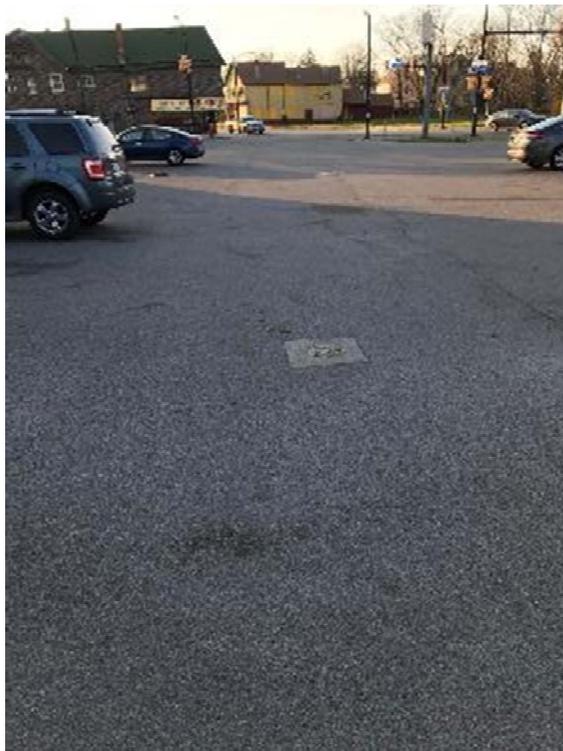
Photo 2: Existing groundwater monitoring well in parking area on north side of building.

Four groundwater monitoring wells were identified at the Site during SCS's November 20, 2020 site inspection. The wells appeared to be intact. A fifth groundwater monitoring well in the southwest corner of the property had been identified by SCS during the August 2017 site inspection. Due to overgrowth and surface debris in this area, the suspect groundwater monitoring well in the southwest corner of the property was not located during SCS's November 20, 2020 site inspection.

- Recommend notification to NYSDEC for approval to abandon the remaining groundwater monitoring wells at the Site. Six wells had been installed during previous site investigations; however, only four wells were identified during SCS's November 20, 2020 site inspection.

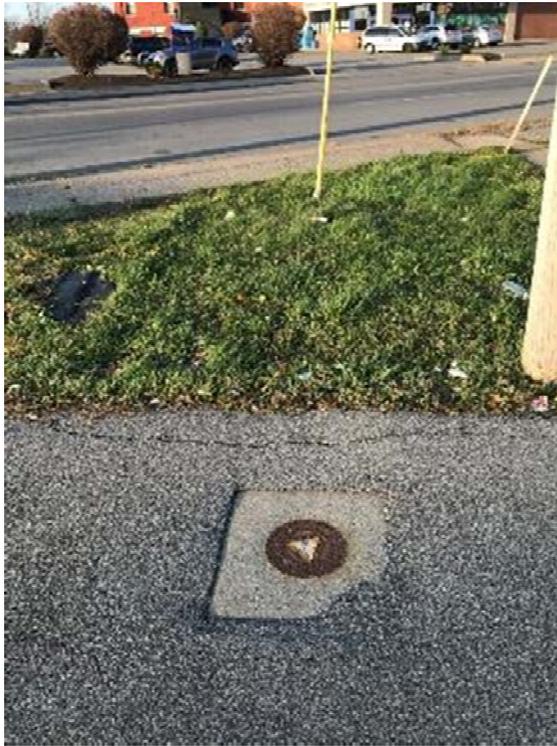
Photo 3: Existing groundwater monitoring well along northern property boundary (along Genesee Street).

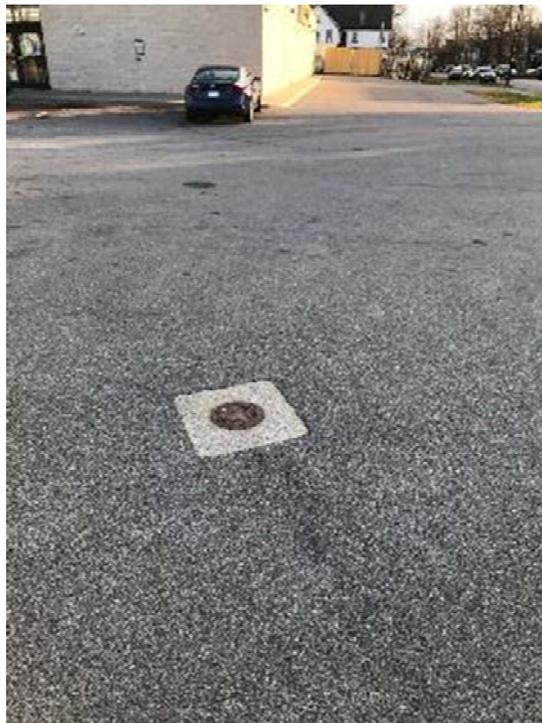
Photo 4: Existing groundwater monitoring well in northwestern portion of parking lot.

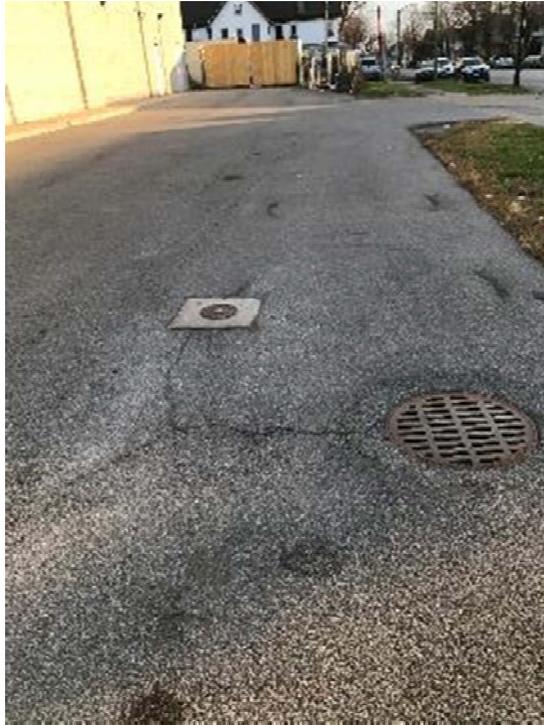
Photo 5: Existing groundwater monitoring well on western side of building.

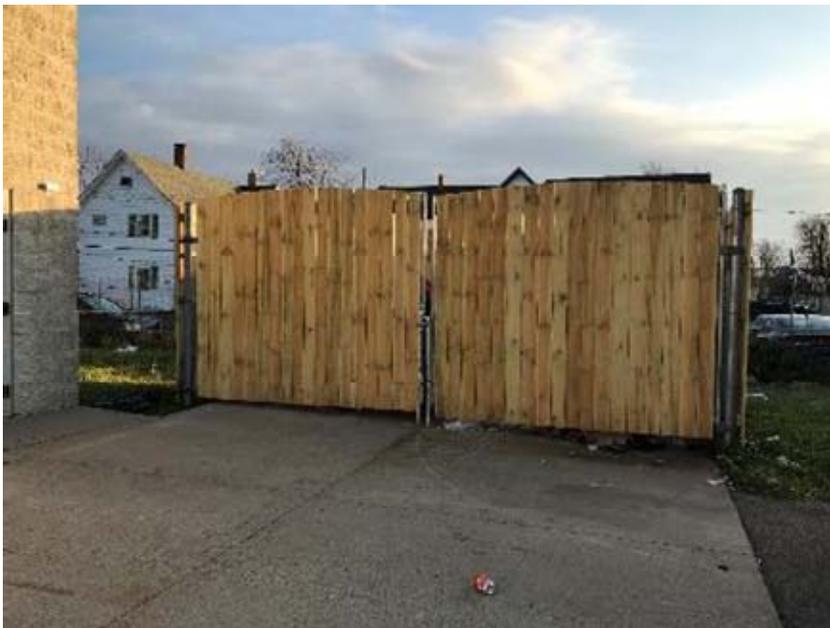
The store representative indicated to SCS that the wooden fencing around the trash dumpster recently caught fire, and a new wooden enclosure was installed in October 2020. From SCS's site inspection, remnant pieces of charred wood were noted around the dumpster. The new enclosure used the existing metal supports, which are anchored in the ground. There were no indications that the pavement or ground surface were disturbed, for example, for the installation of new fence posts.

Photo 6: New wooden enclosure around dumpster in southwest portion of site.

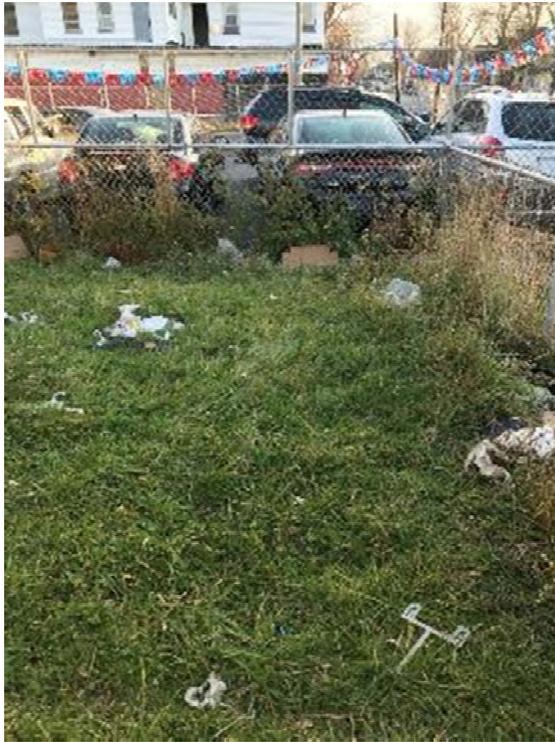
No areas of non-compliance with the SMP were identified, based on SCS's site inspection. Surficial debris was observed on the exterior portion of the Site (i.e., around the trash dumpster and generally along the southern property boundary). This is considered a housekeeping matter, rather than an issue of compliance with the SMP.

Photo 7: Surficial debris in southwestern corner of Site. Unable to locate monitoring well in this area.

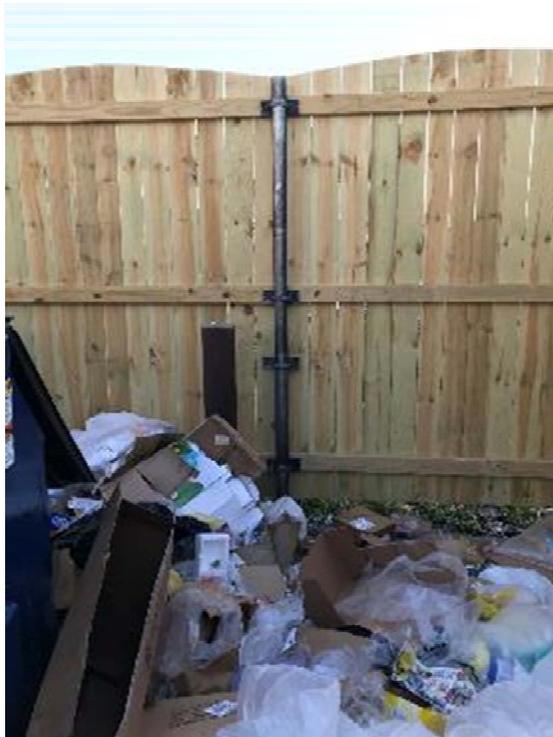
Photo 10: Surface debris in dumpster enclosure.
