**REPORT
SPRAY BOOTH DECONTAMINATION
AND SEWER EVALUATION
EASTERN ELECTRIC FACILITY
BUFFALO, NEW YORK**

AERIAL PHOTOGRAPH (1995)
1132 & 1146 SENECA STREET, BUFFALO, NEW YORK

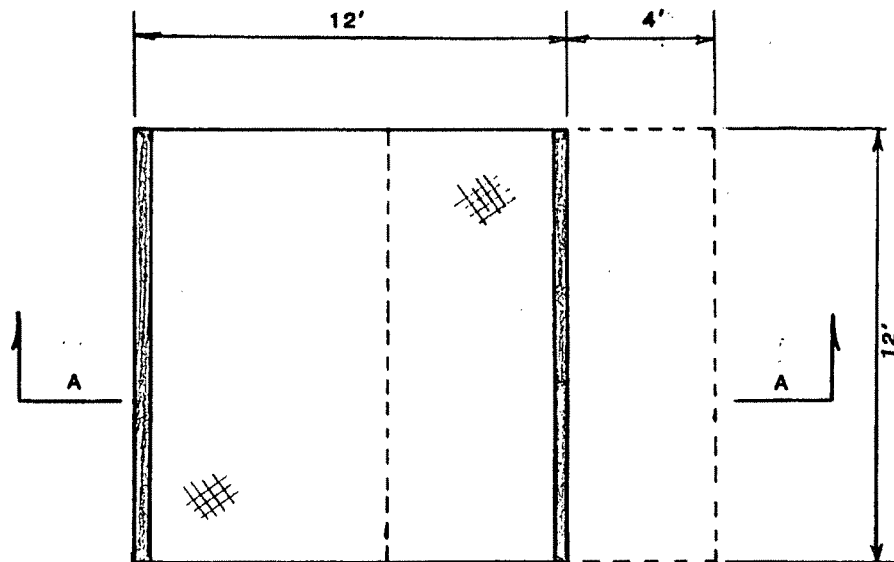
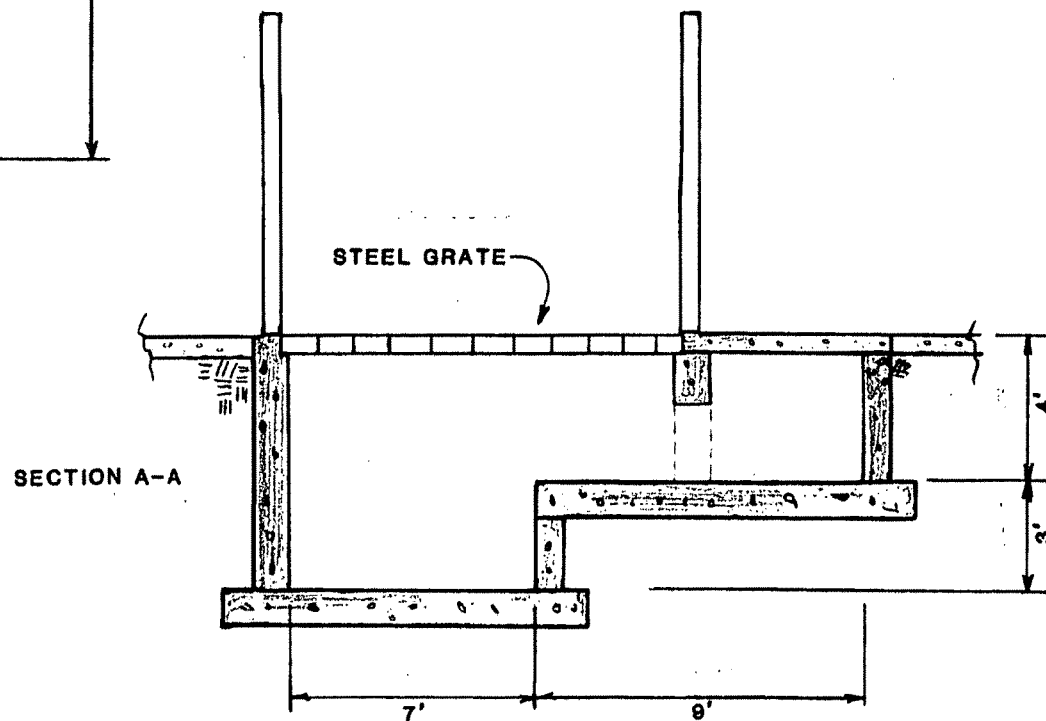
C-1
SPRAY BOOTH PIT

PLAN

SECTION A-A

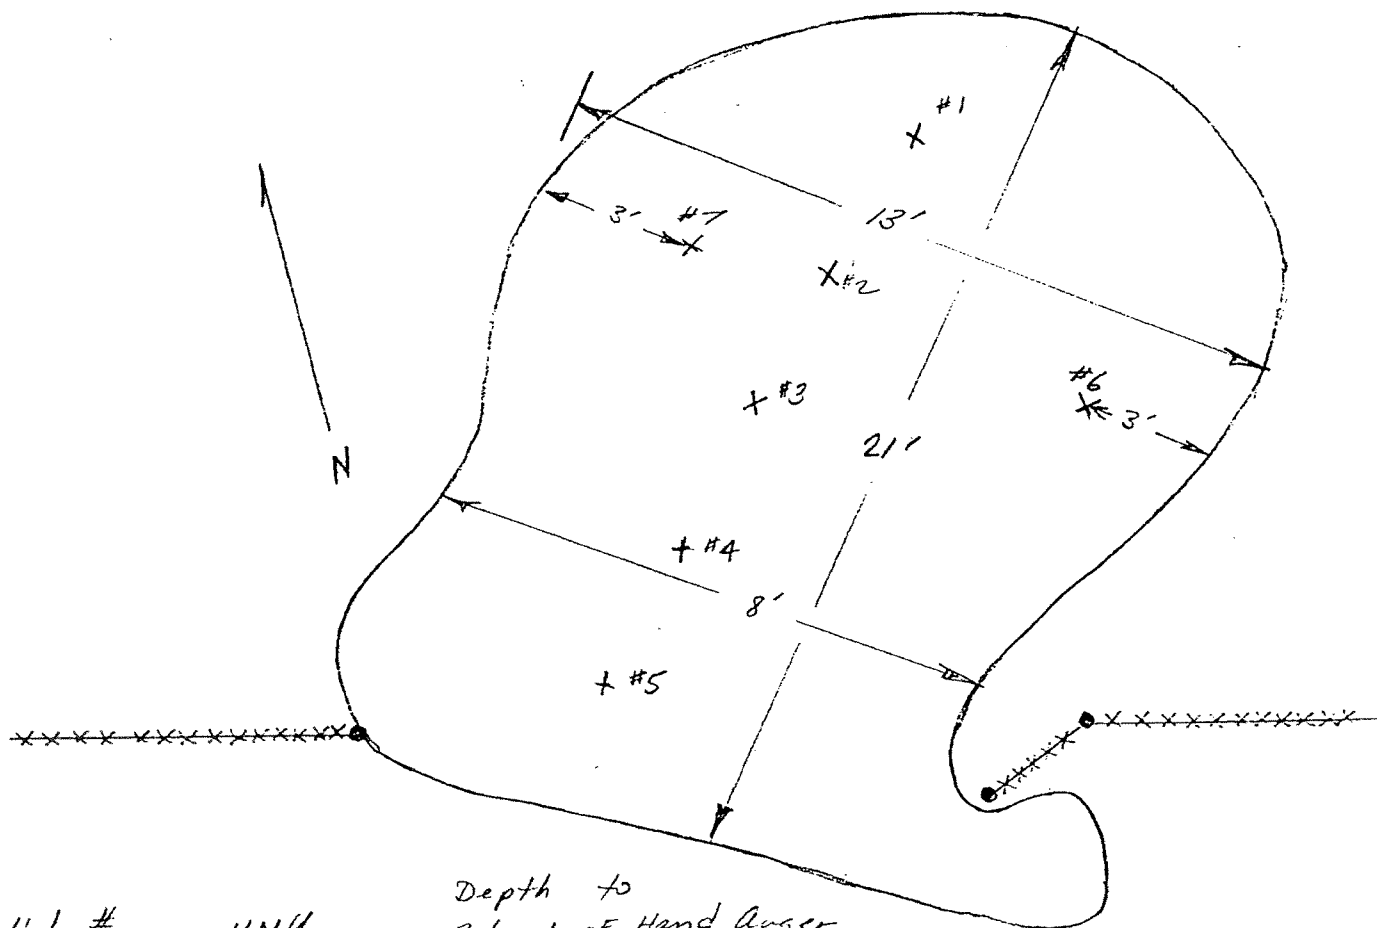
Eastern Electric
5/19/88
T. Johnson

Hole #	HNU	Depth to Refusal of Hand Auger	
1	20	7"	all sludge
2	60	13"	"
3	70	25"	"
4	100	18"	"
5	150	18"	"
6	60	6"	"
7	40	13"	"
		$\bar{x} = 14.3"$

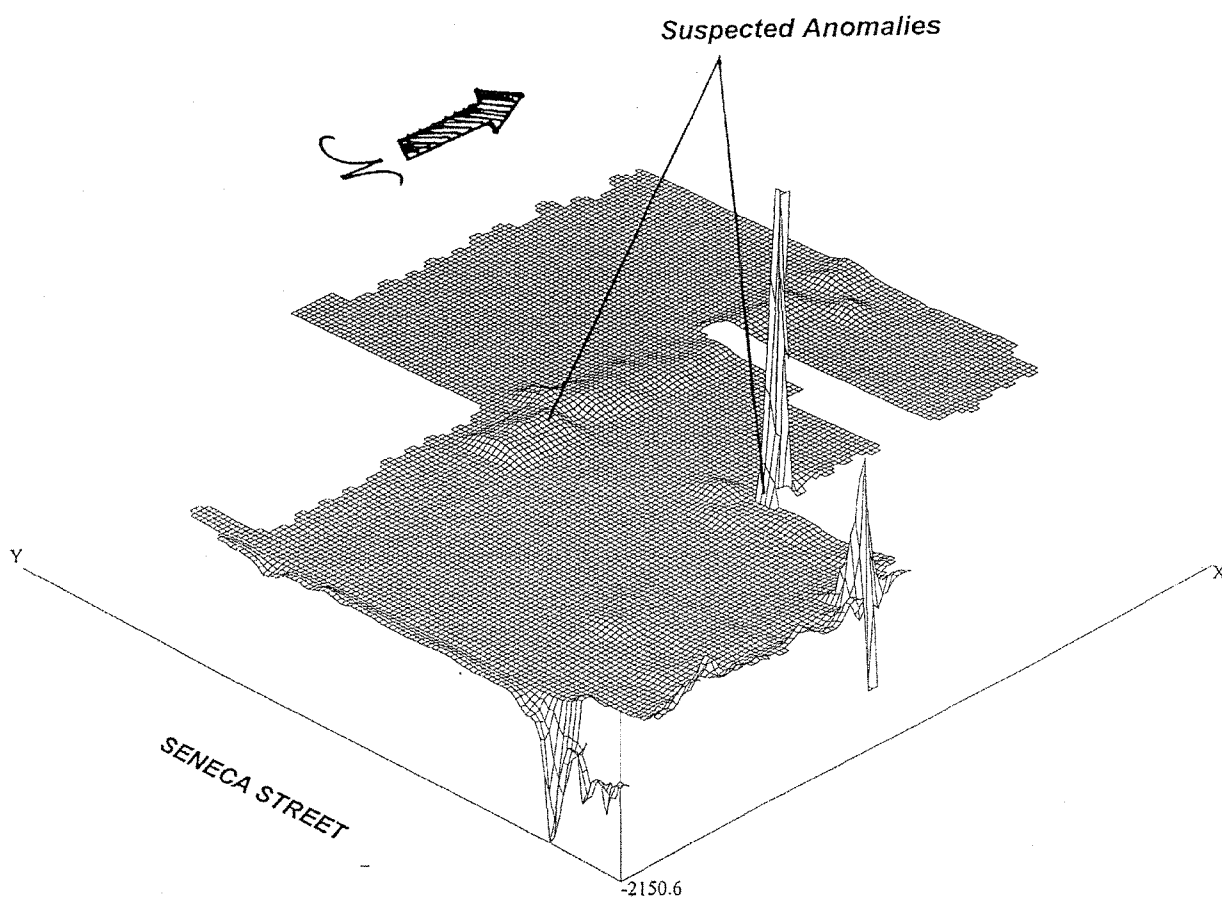
BARRON & ASSOCIATES, P.C. 10440 MAIN STREET CLARENCE, NEW YORK 14031	EM-61 Magnetometer Survey 1132 Seneca Street, Buffalo, New York	FIGURE: 4 "3-D" View (Differential Channel)
JOB NO.: 01-1302 DATE: 8/3/2001	Contour Interval: N/A	SCALE: None

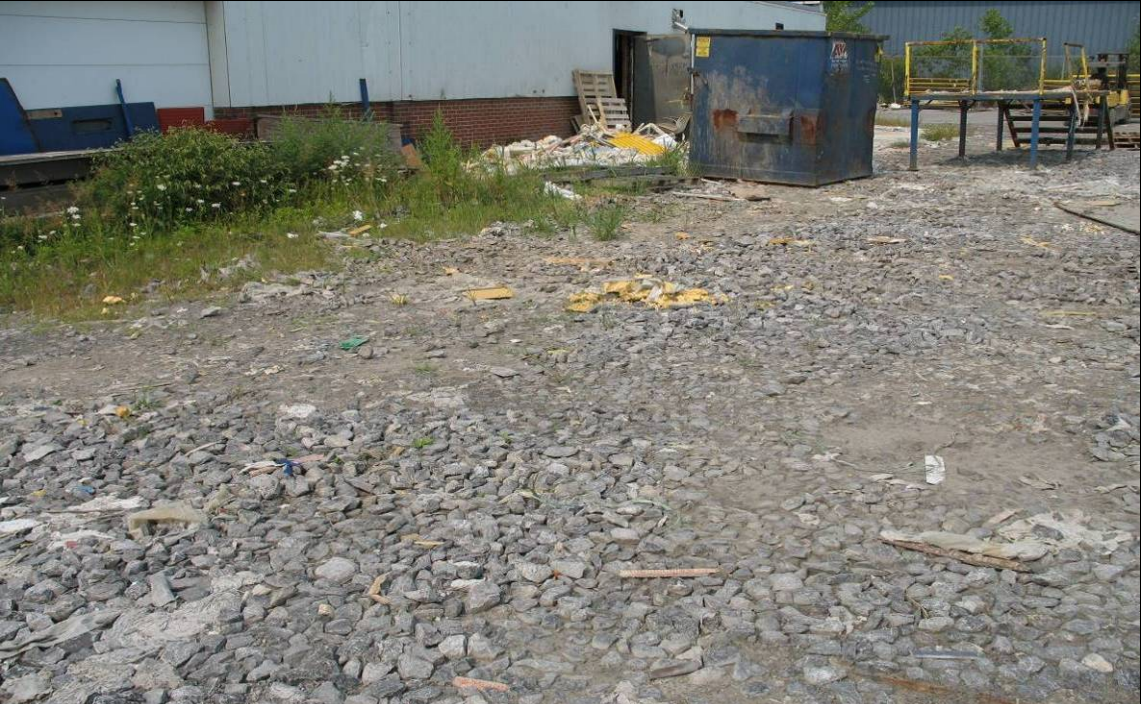
Project: 1132 Seneca Street		Location: Buffalo, NY	Project No. 6105-001
Photo No. 8	Date: 8/14/07

Direction Photo Taken: South			
Description: Unpaved area located north of the manufacturing building

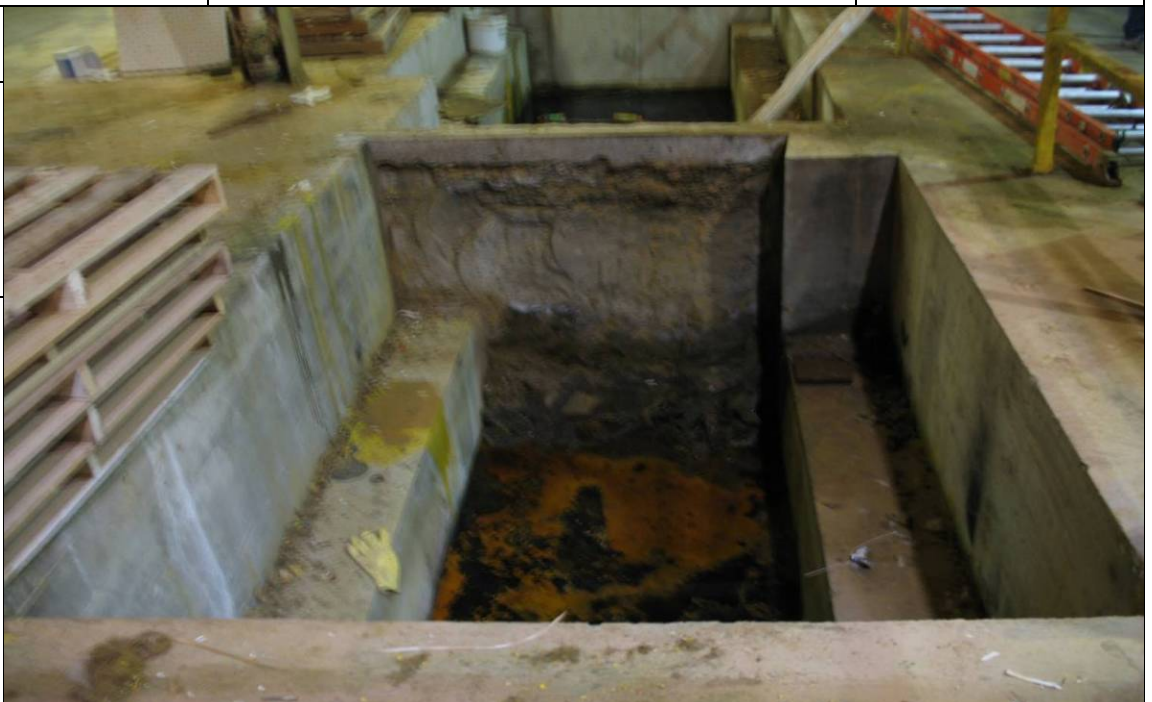
Pits
