Prepared by:
AECOM
Amherst, NY
60155991
March 2015

FINAL CONSTRUCTION COMPLETION REPORT

2014 Interim Remedial Measures

Former Scott Aviation Facility
Lancaster, NY

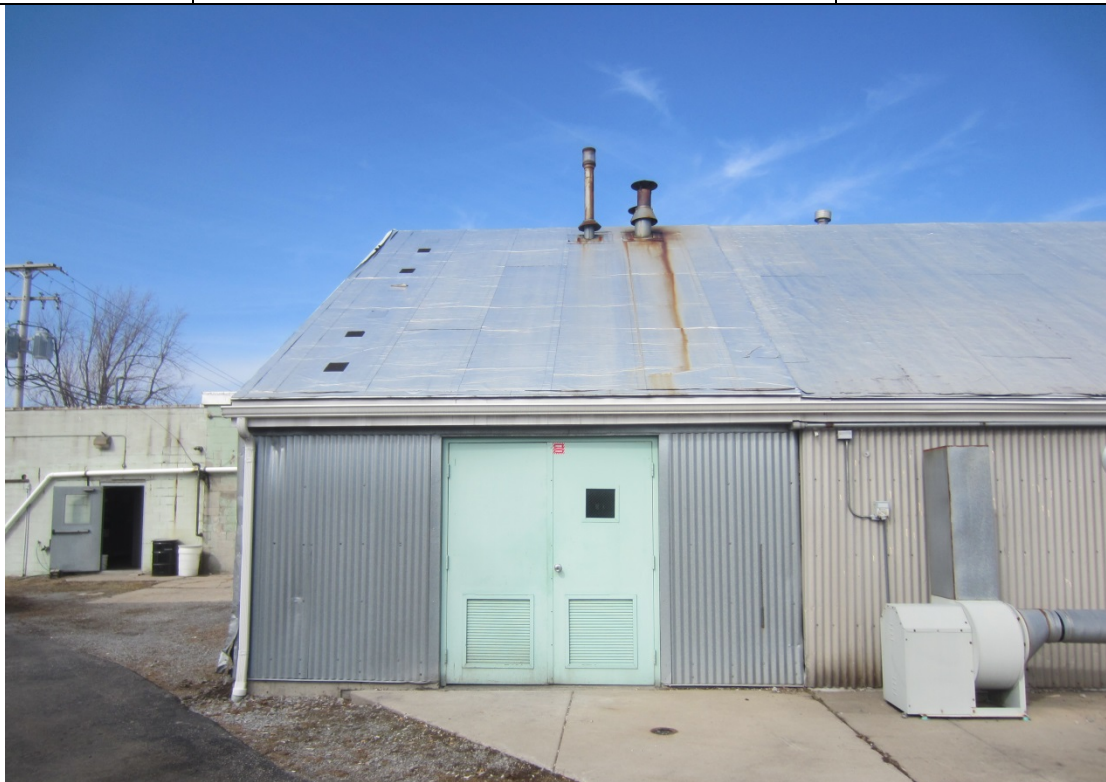
Photo No.

View of boiler room. Note boiler room (grey metal siding) is a separate building with its own foundation built next to the tan metal former Reliability Test room.

An SSD system was proposed in the June 2014 RAWP to mitigate vapor concerns identified by sub-slab indoor vapor sample data collected in 2010 in the southwestern corner of the existing Plant 1 building, specifically the boiler room (**Figure 5**).

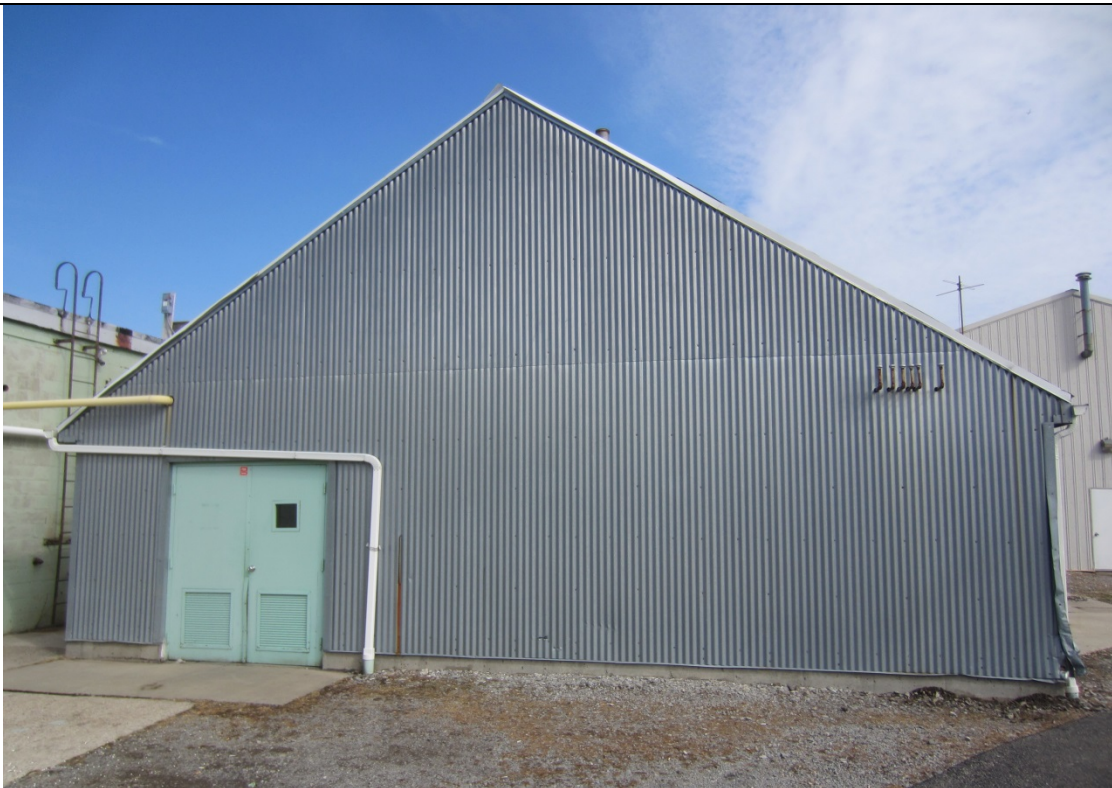
View of boiler room.

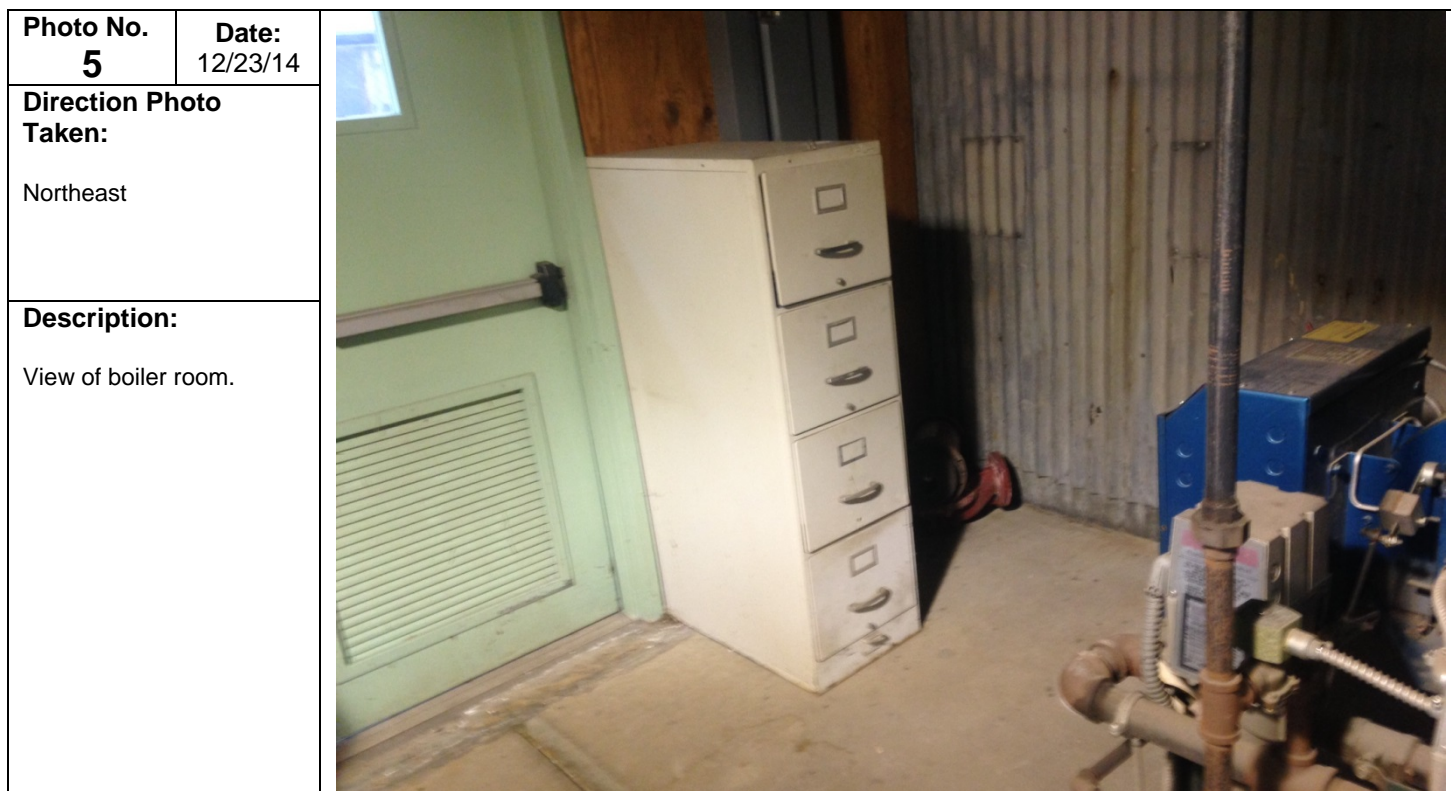
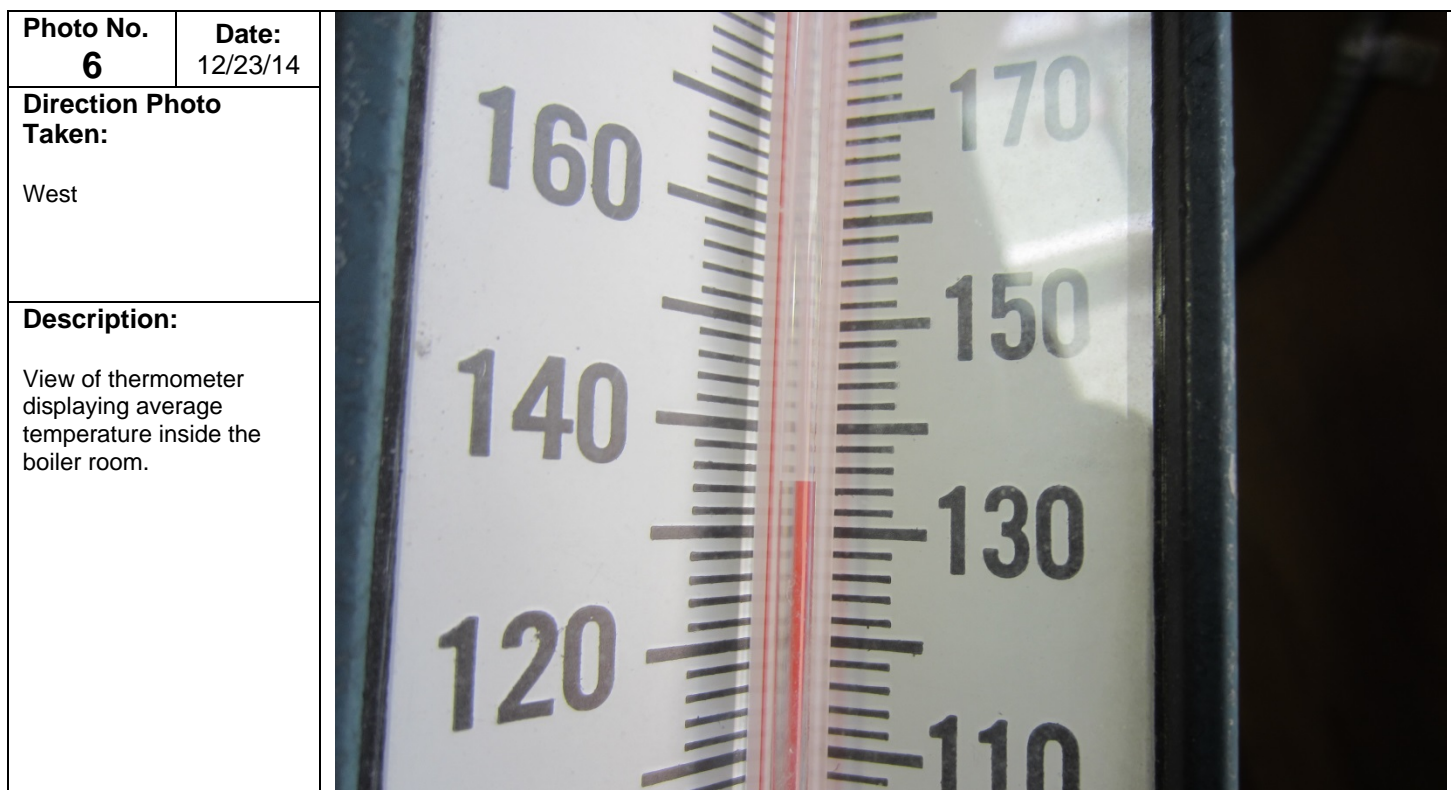
Photo No. 7	Date: 11/4/14

Photo No. 8	Date: 12/23/14	 
Direction Photo Taken: South		
Description: View of floor perforation (drain) after sealing.

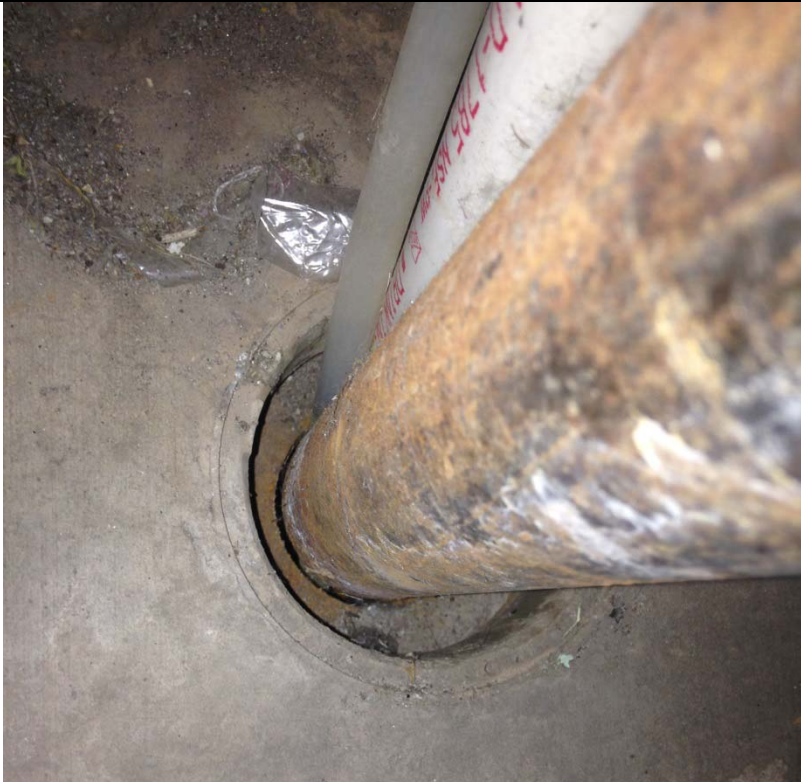
Direction Photo Taken: East		
Description: View of floor perforation (drain) prior to sealing.

On November 4, 2014, AECOM and the NYSDEC inspected the concrete floor of the boiler room and AECOM sealed visible floor cracks and saw cuts with concrete caulk. In addition, the annulus between a drain line effluent and the associated foundation perforation was sealed with expanding foam. Two other foundation perforations (drains) were observed and temporarily plugged with modelling clay. On December 23, 2014, with concurrence by NYSDEC and NYSDOH, a second round of air samples was collected from the boiler room in lieu of submitting the SSD system design. The updated vapor data and recommendations are summarized in the draft Sub-Slab Vapor Evaluation Report submitted to NYSDEC and NYSDOH on January 23, 2015; refer to **Appendix A** for a copy of this letter report.

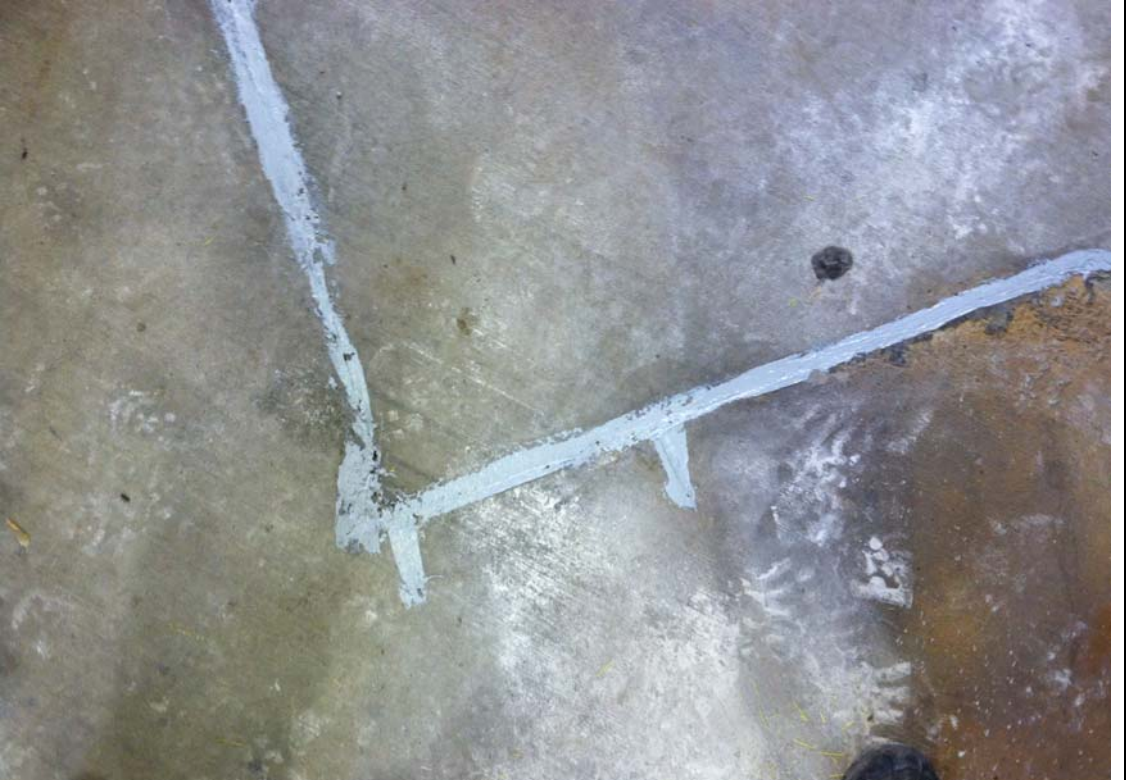
Photo No. 11	Date: 12/23/14

Direction Photo Taken: North		
Description: View of sealed floor cracks and saw cuts. Note the floor cracks/cuts were sealed on 11/4/14.

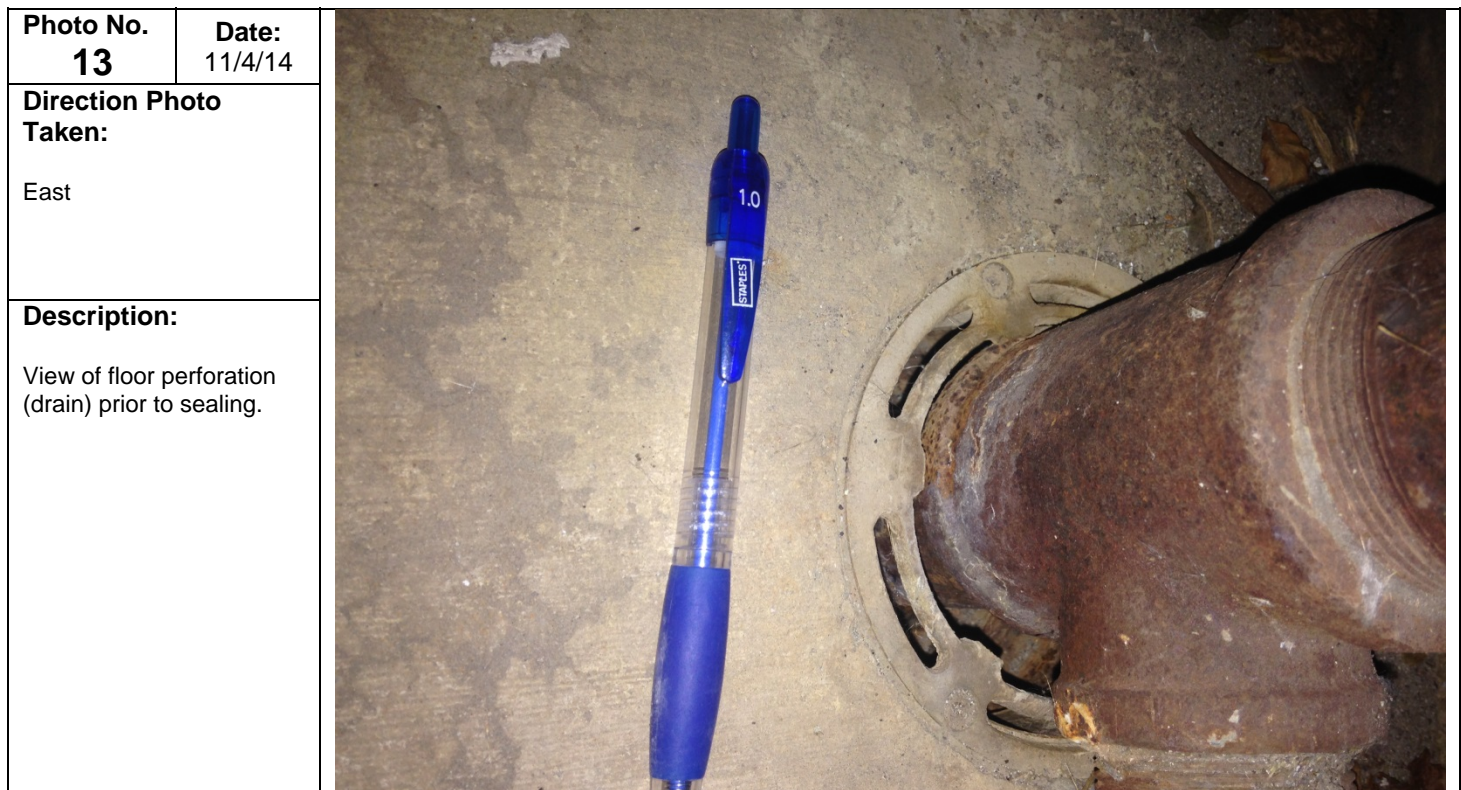
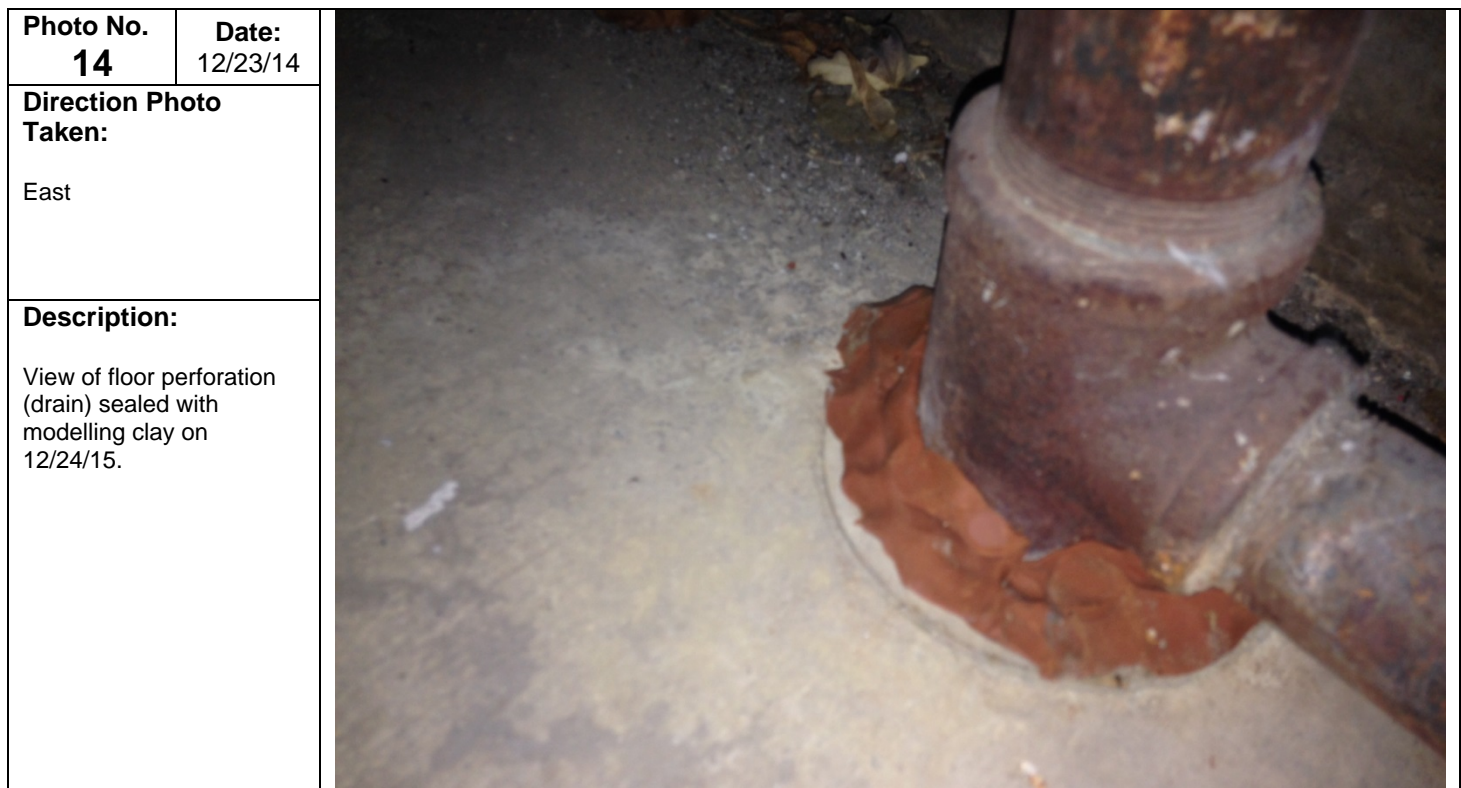
Photo No. 15	Date: 11/4/14	 
Direction Photo Taken:		
East		
Description:		
View of floor perforation (drain) prior to sealing.

Photo No. 16	Date: 12/23/14
Direction Photo Taken: West	
Description: View of floor perforation (drain) sealed with modelling clay on 12/24/15.

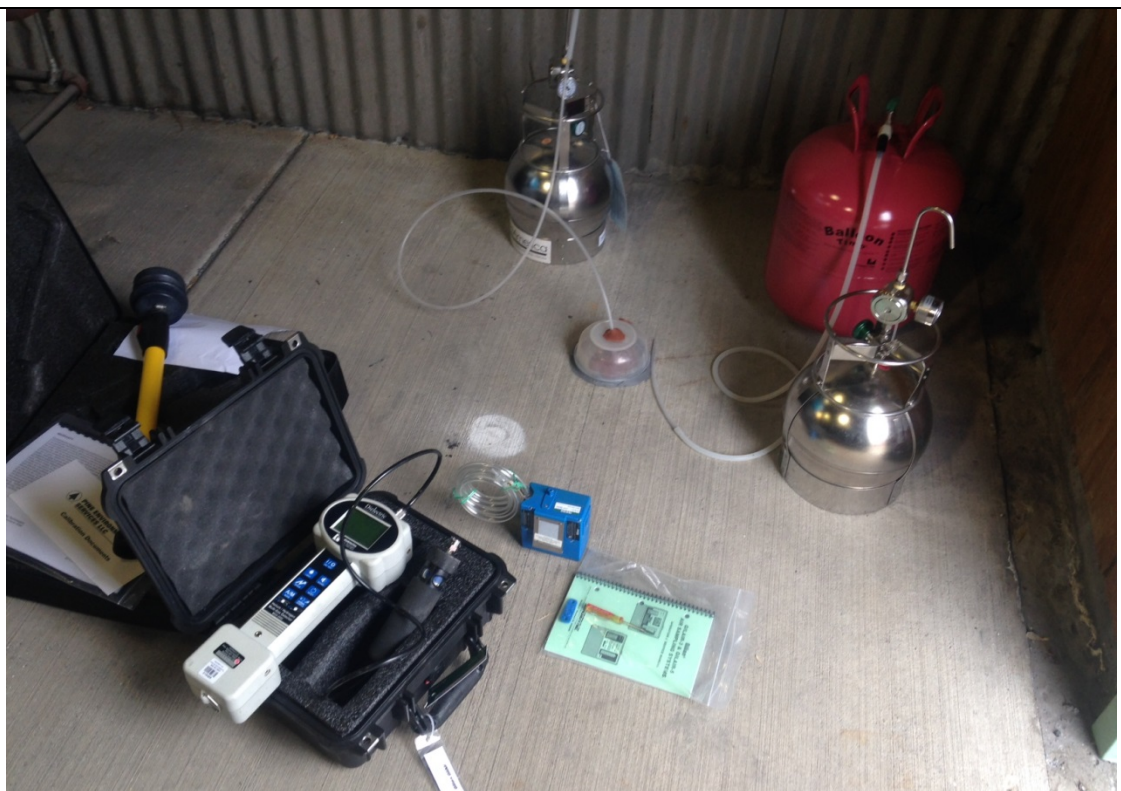
Photo No. 18	Date: 12/23/14
Direction Photo Taken: East	
Description: View of sub-slab and indoor air Summa canisters.

Sample collection was performed using a six-liter, stainless steel, Summa[®] canister, equipped with a 24-hour regulator. Sub-slab, indoor, and ambient (outdoor) air samples were collected concurrently; one field duplicate was also collected at the ambient (outdoor) air location for quality assurance purposes. The field geologist recorded the sample identification, canister and regulator

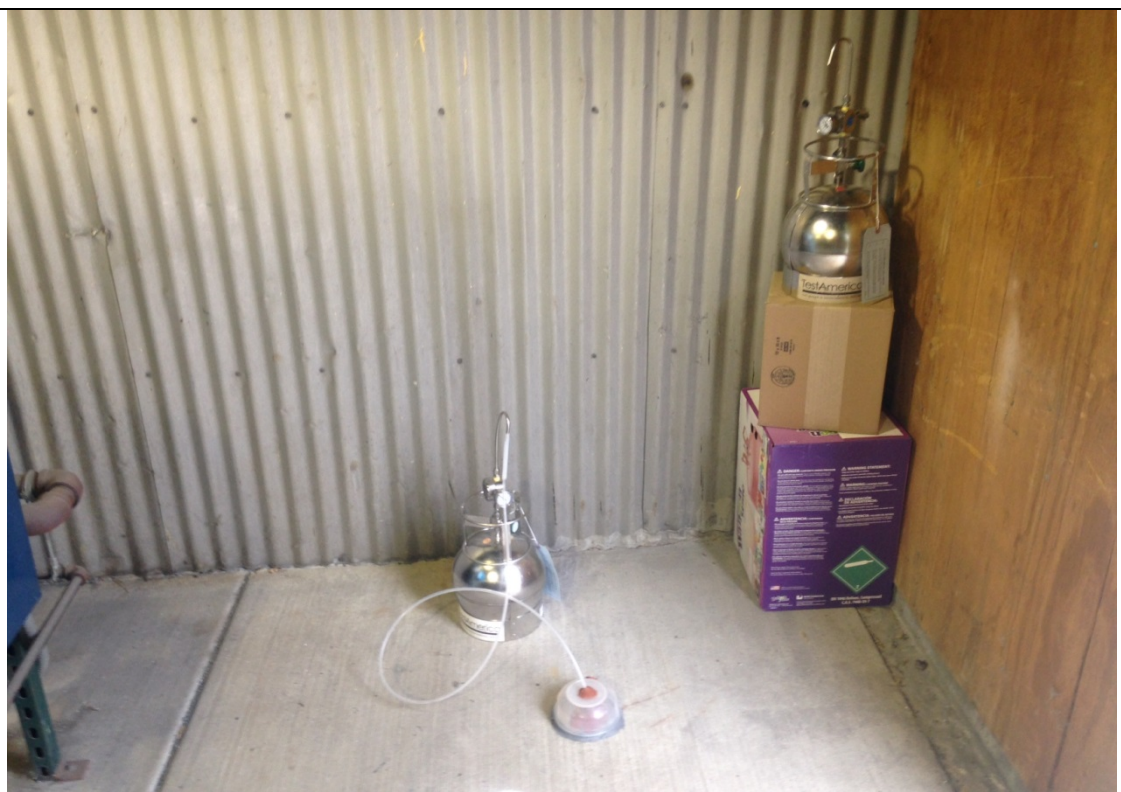
Photo No. 19	Date: 12/23/14	 
Direction Photo Taken: West		
Description: View of ambient air Summa canisters (duplicate sample being collected at this location). Note completed soil IRM restoration on west side of perimeter fence.

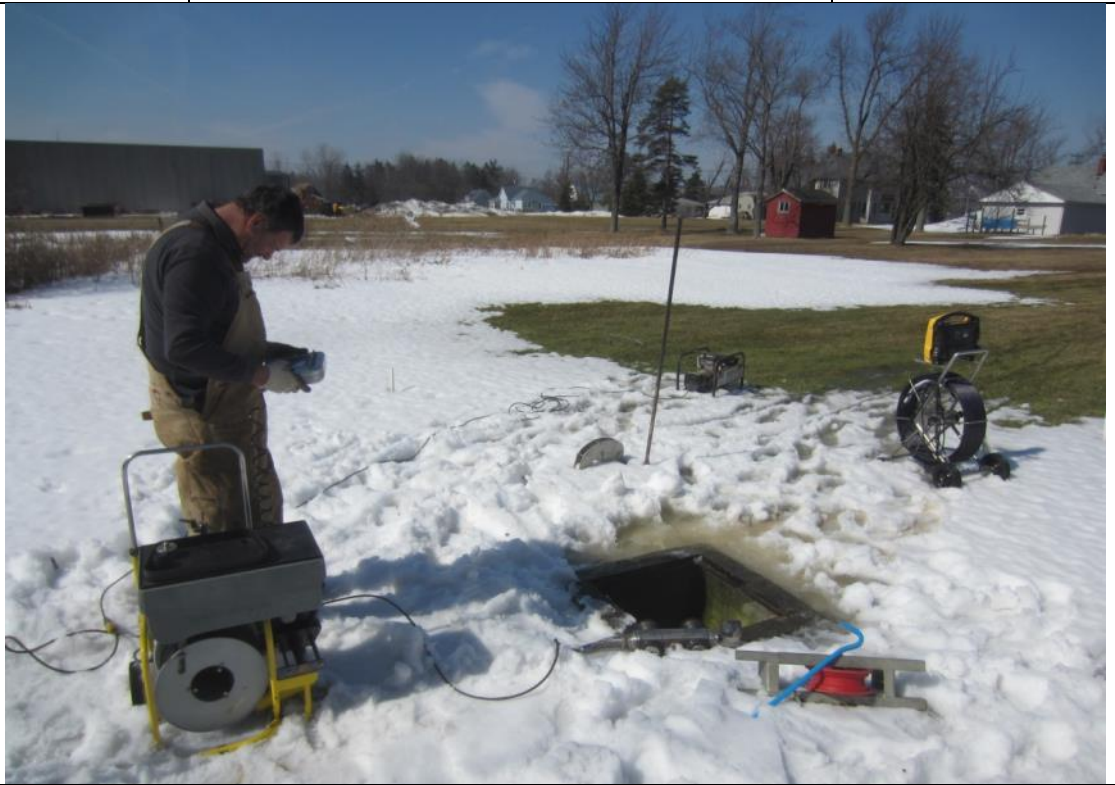
Video Survey at CB-2;
storm water flowing south
(left) to north (right).

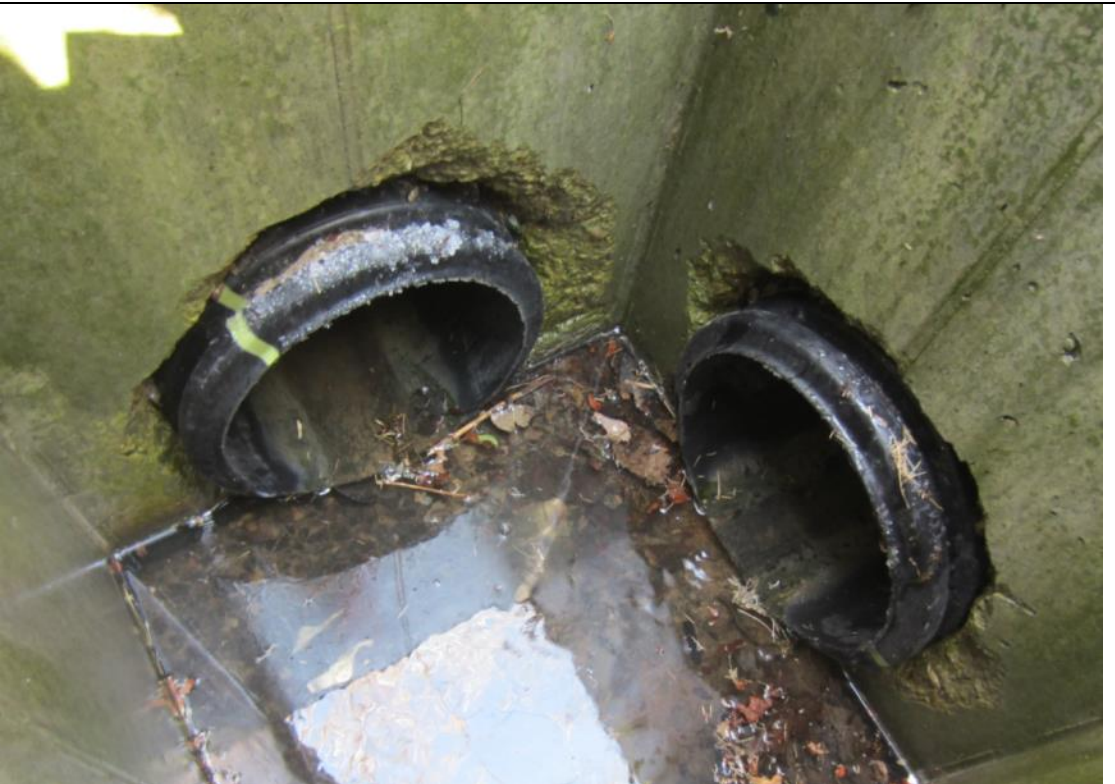
View in catch basin CB-3
prior to being sealed.

After clearance was achieved, construction began with the excavation of pipe joints and replacement of the perforated pipe between CB-W and CB-2 with a solid pipe. All pipe joints identified within the $>20 \mu\text{g/l}$ TVOC groundwater plume as shown in **Figure 7** were exposed via excavation of surrounding soil, and sealed with a bentonite / Portland cement mix (grout). Pipes entering catch basins, including CB-W, CB-E, CB-2, and CB-3, were exposed via excavating the soil around the catch basins, and each annulus was sealed. The annulus of each roof drain pipe entering a catch basin was also sealed with grout to prevent groundwater infiltration into the catch basin.

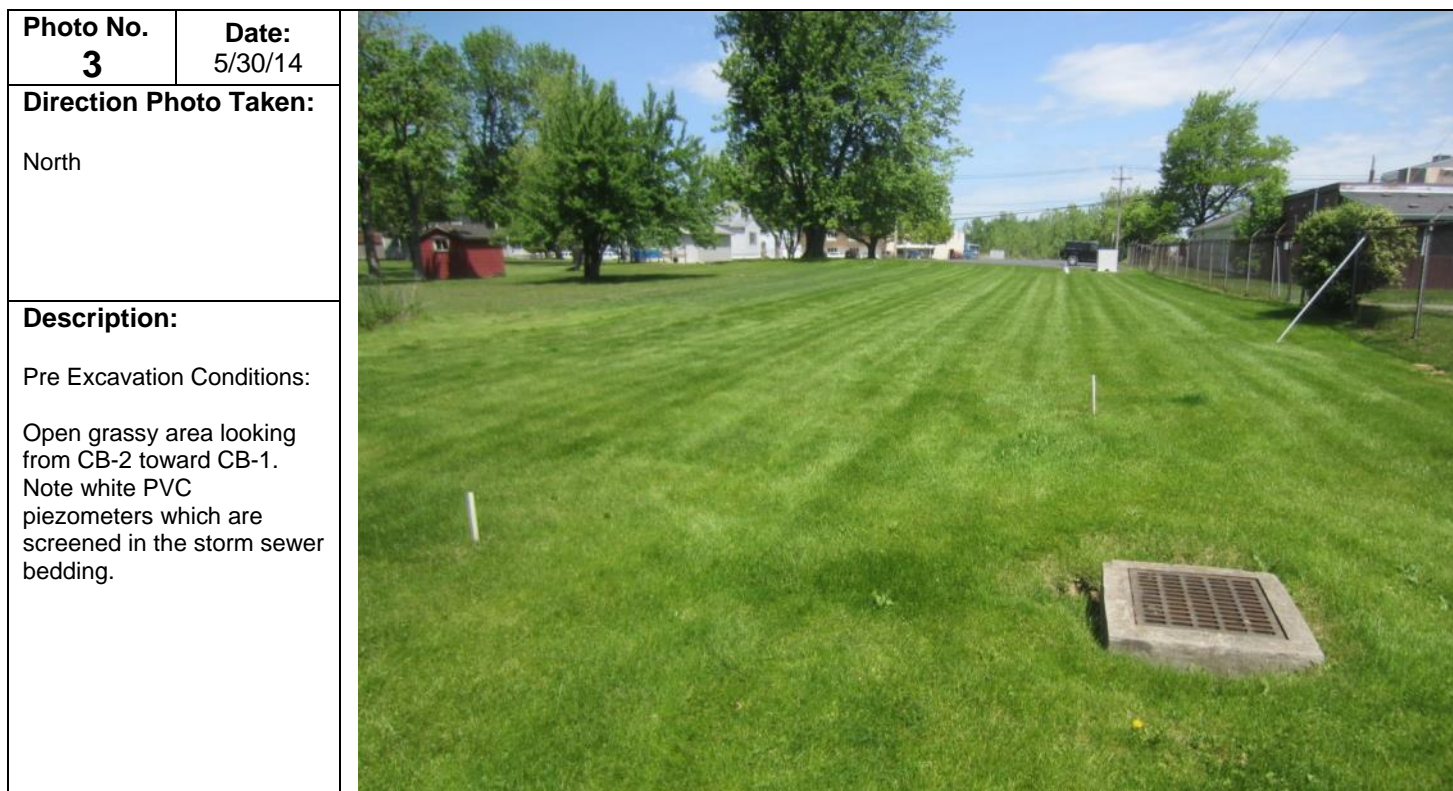
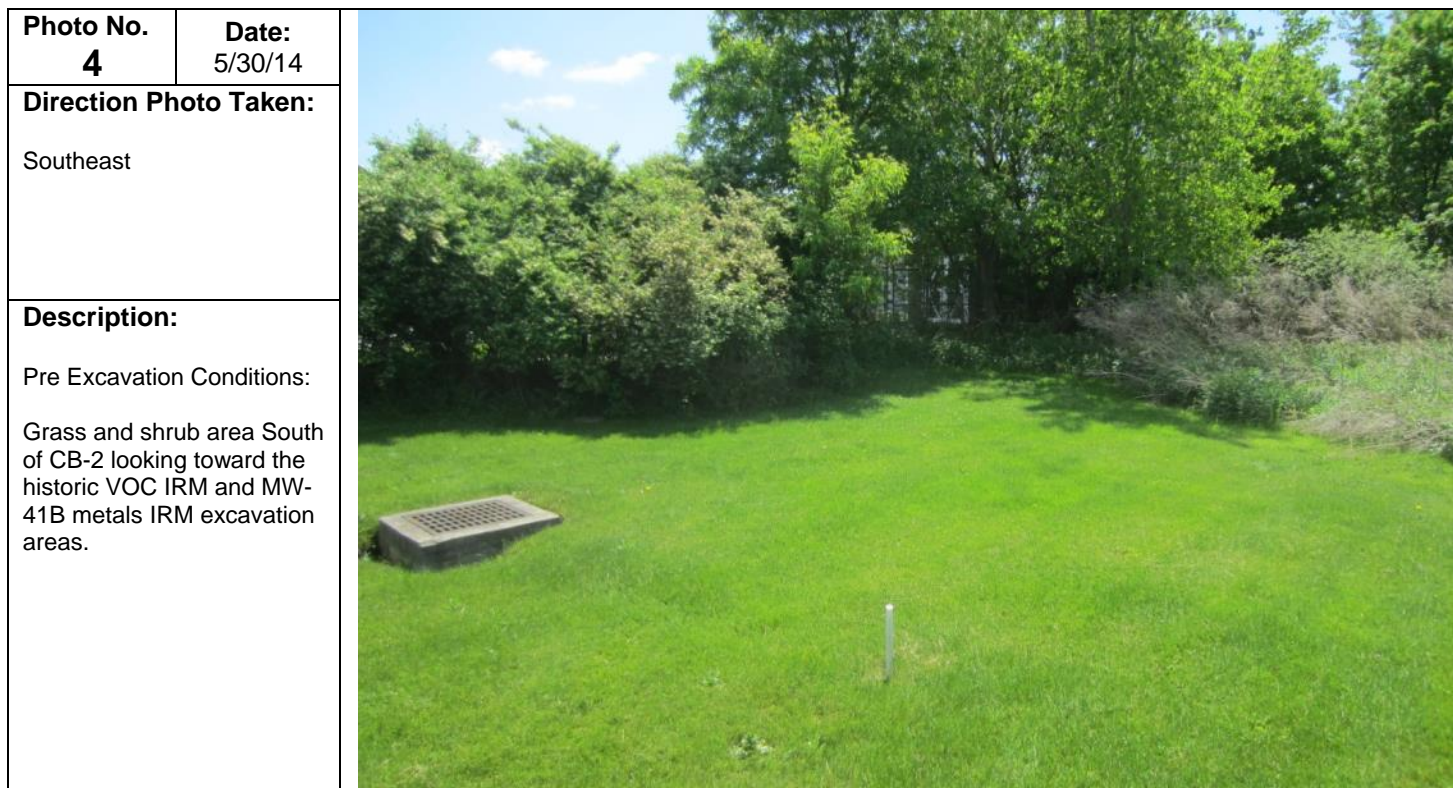
Photo No. 5	Date: 5/30/14
Direction Photo Taken: West	
Description: Pre Excavation Conditions: Note CB-E next to brown block building.

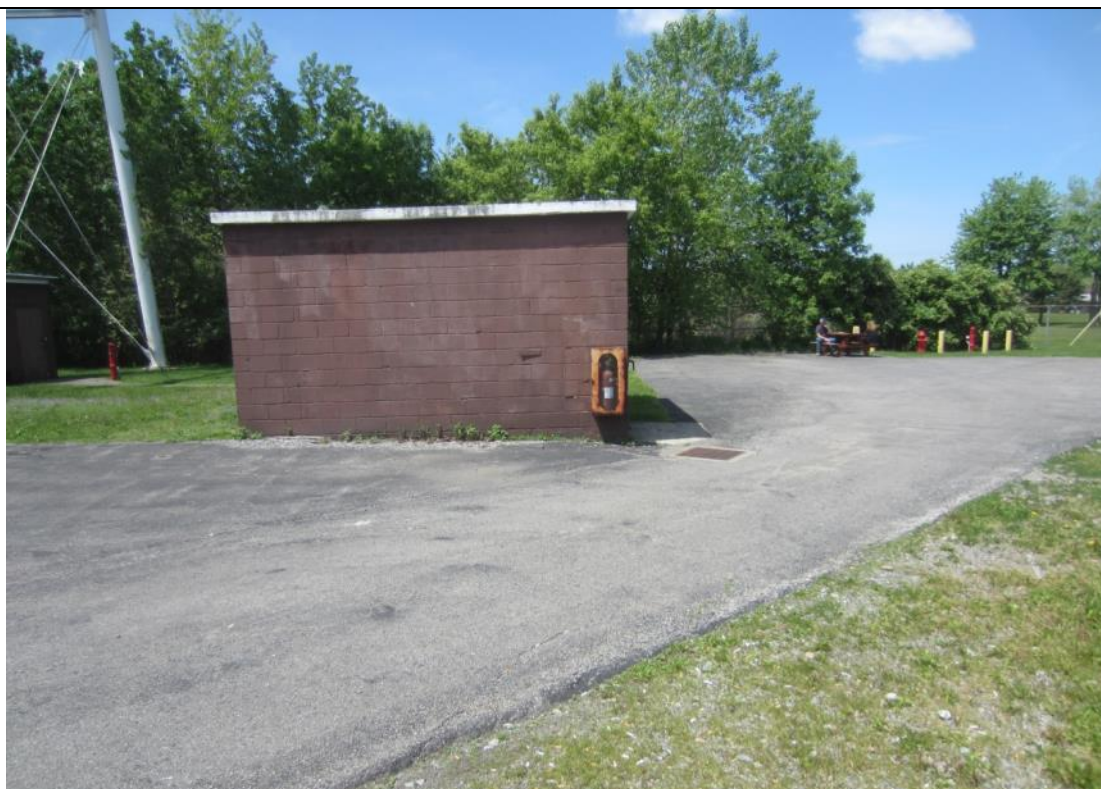
Photo No. 6	Date: 7/18/14
Direction Photo Taken: East	
Description: Pre Excavation Conditions: Excavation area demarcated for DPT8 metals IRM excavation.

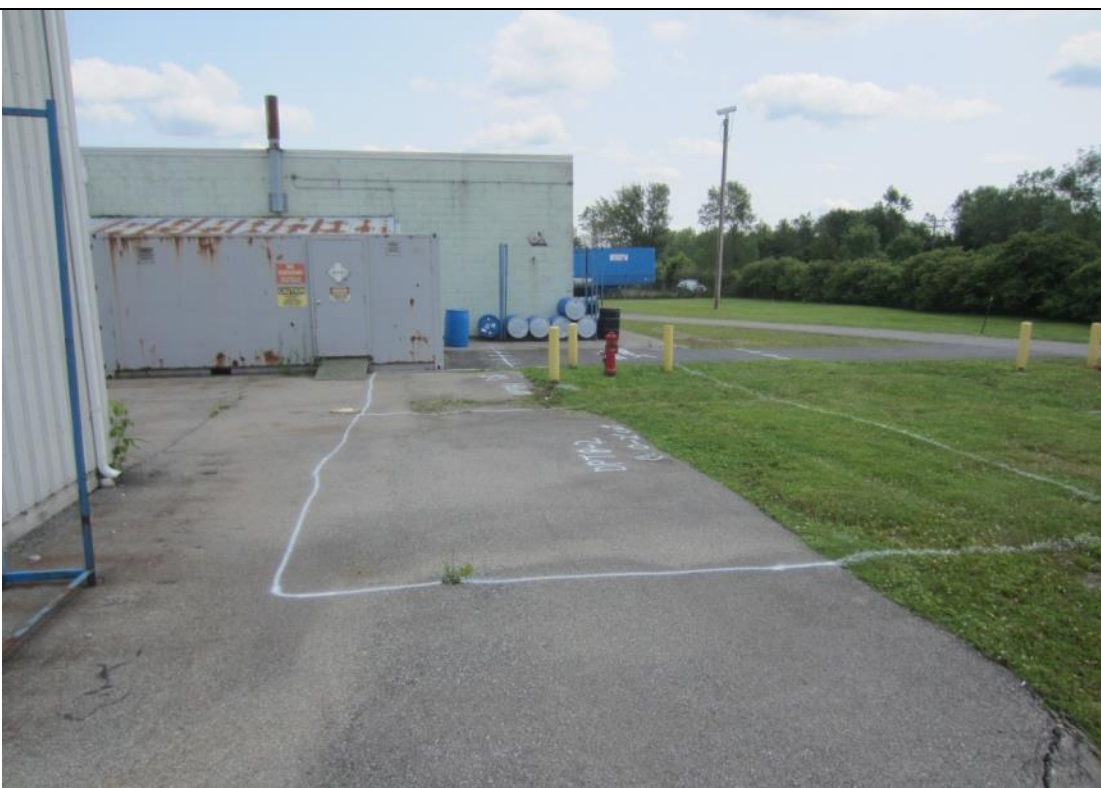
Photo No. 7	Date: 7/18/14	 
Direction Photo Taken: West		
Description: Pre Excavation Conditions: Excavation area demarcated for DPT8 metals IRM excavation.

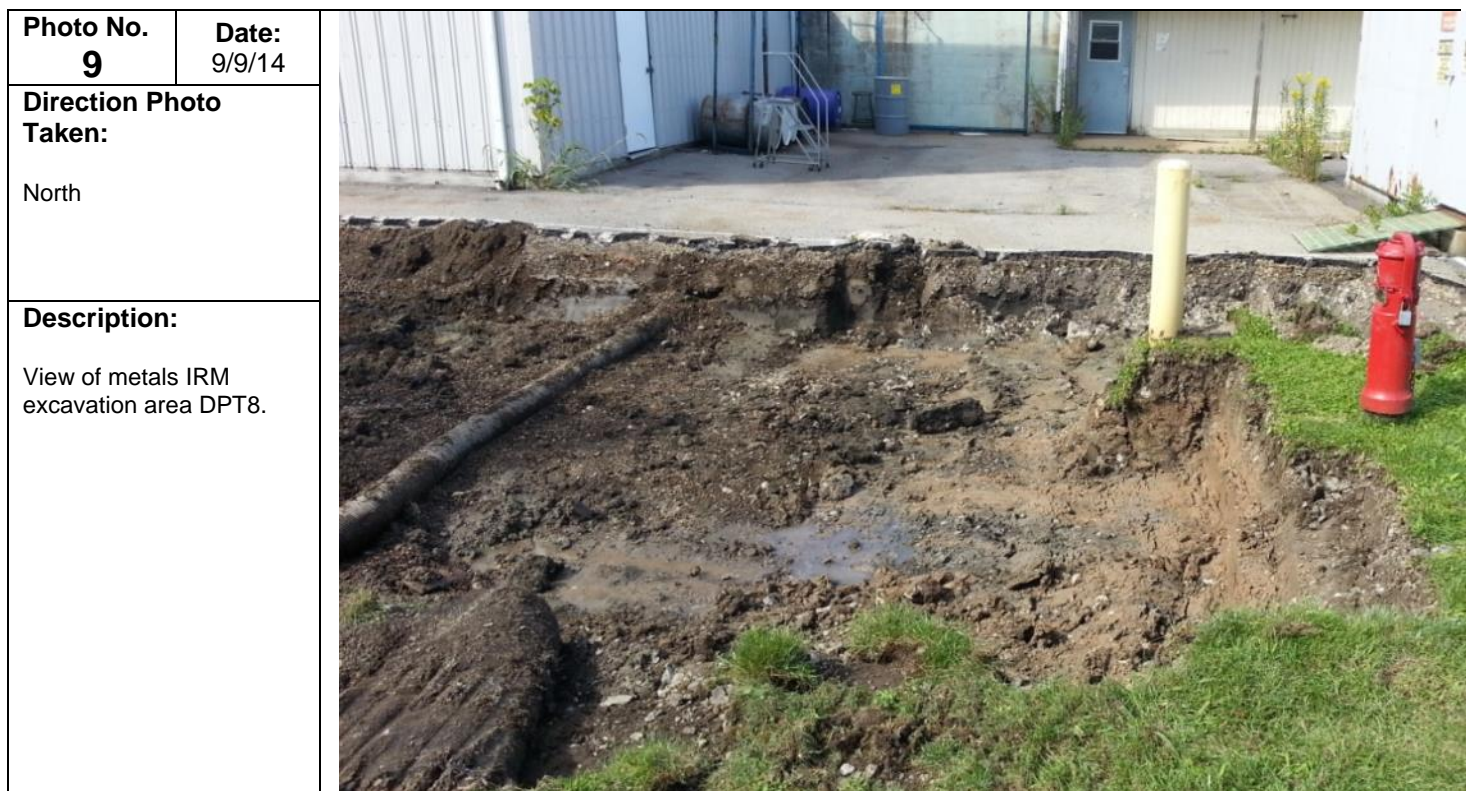
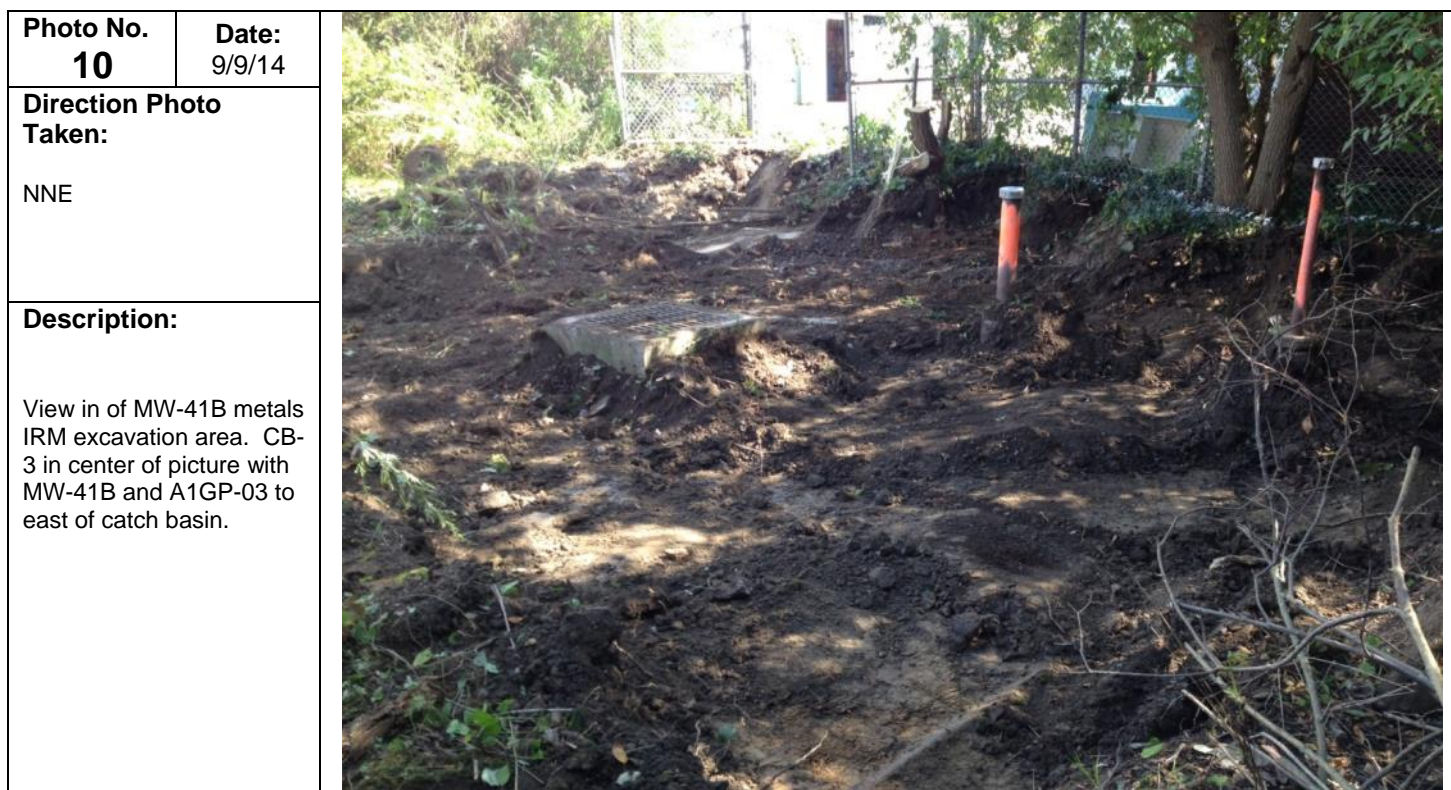
Photo No. 11	Date: 9/10/14	 
Direction Photo Taken: East		
Description: Excavation of storm sewer piping between CB-3 and CB-2. VOC IRM excavation on the right edge of photo,

Photo No. 12	Date: 9/11/14	 
Direction Photo Taken: North		
Description: VOC IRM excavation. Mixing in Klozur CR compound into groundwater accumulated in excavation.

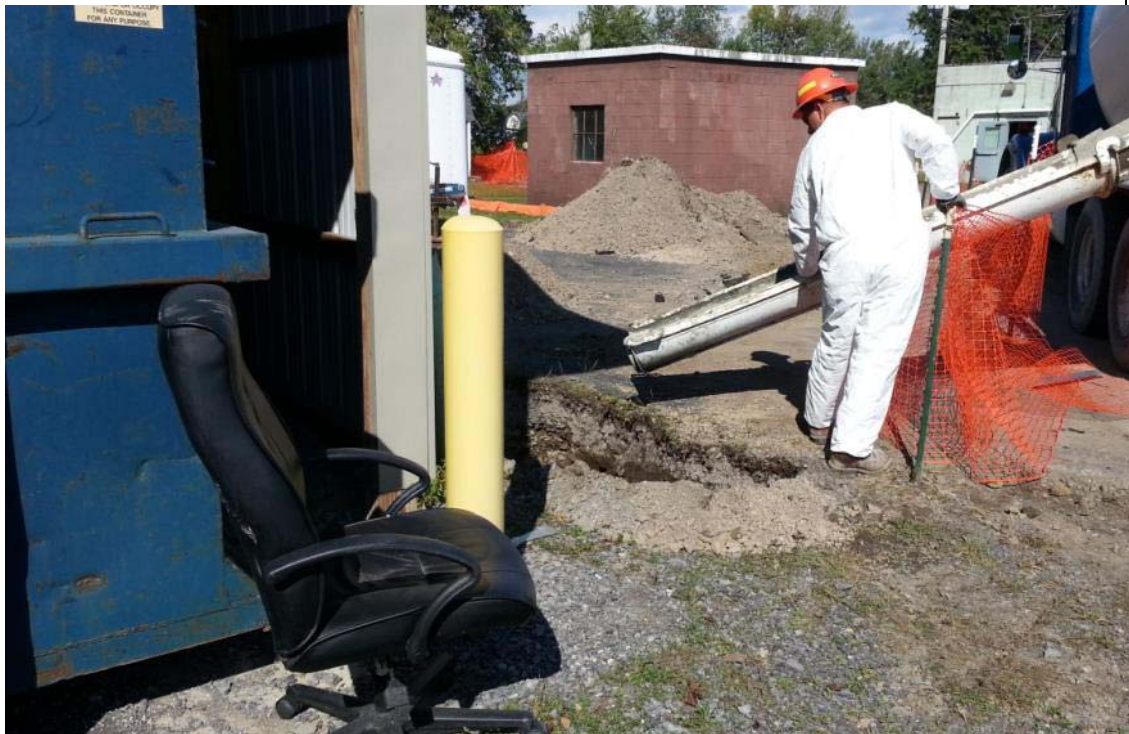
Photo No. 19	Date: 9/17/14

Photo No. 18	Date: 9/17/14
Direction Photo Taken: Northwest	
Description: Grouting storm sewer pipe joints.

A photograph showing a construction worker in a white protective suit and orange hard hat. The worker is using a long, flexible white pipe to grout a storm sewer joint. The worker is standing next to a large pile of sand. In the foreground, there is a black office chair and a yellow vertical pipe. A blue dumpster is on the left, and a red brick building is in the background. The scene is outdoors on a gravel surface.

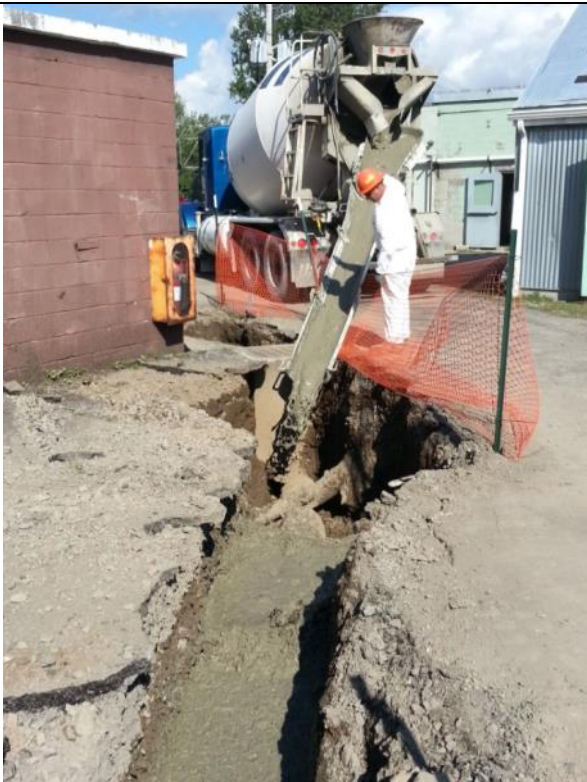
Direction Photo Taken: South		
Description: Grouting in storm sewer pipe joints between CB-E and CB-4.
