*INVENTUM ENGINEERING, PC*

# **Corrective Measures Injection Program Work Plan**

Brownfield Cleanup Program Site #C915208

275 Franklin Street

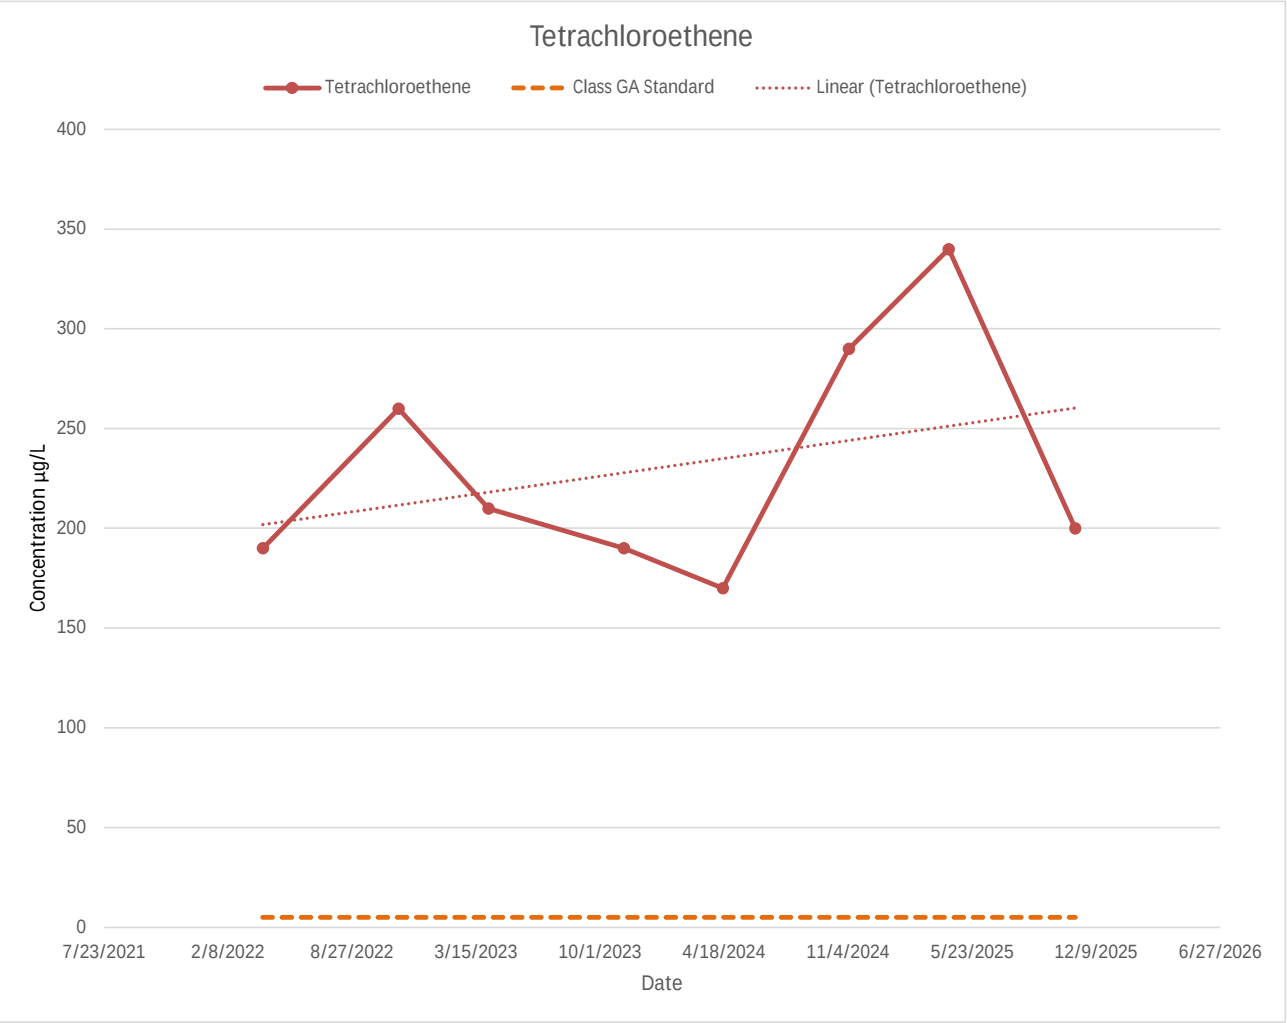
Table 6  
PZ-5 Recent cVOCs Trends  
275 Franklin Street and 432 Pearl Street BCP Site

1: Results that were not detected above the laboratory reporting limit were plotted as half of the reporting limit.

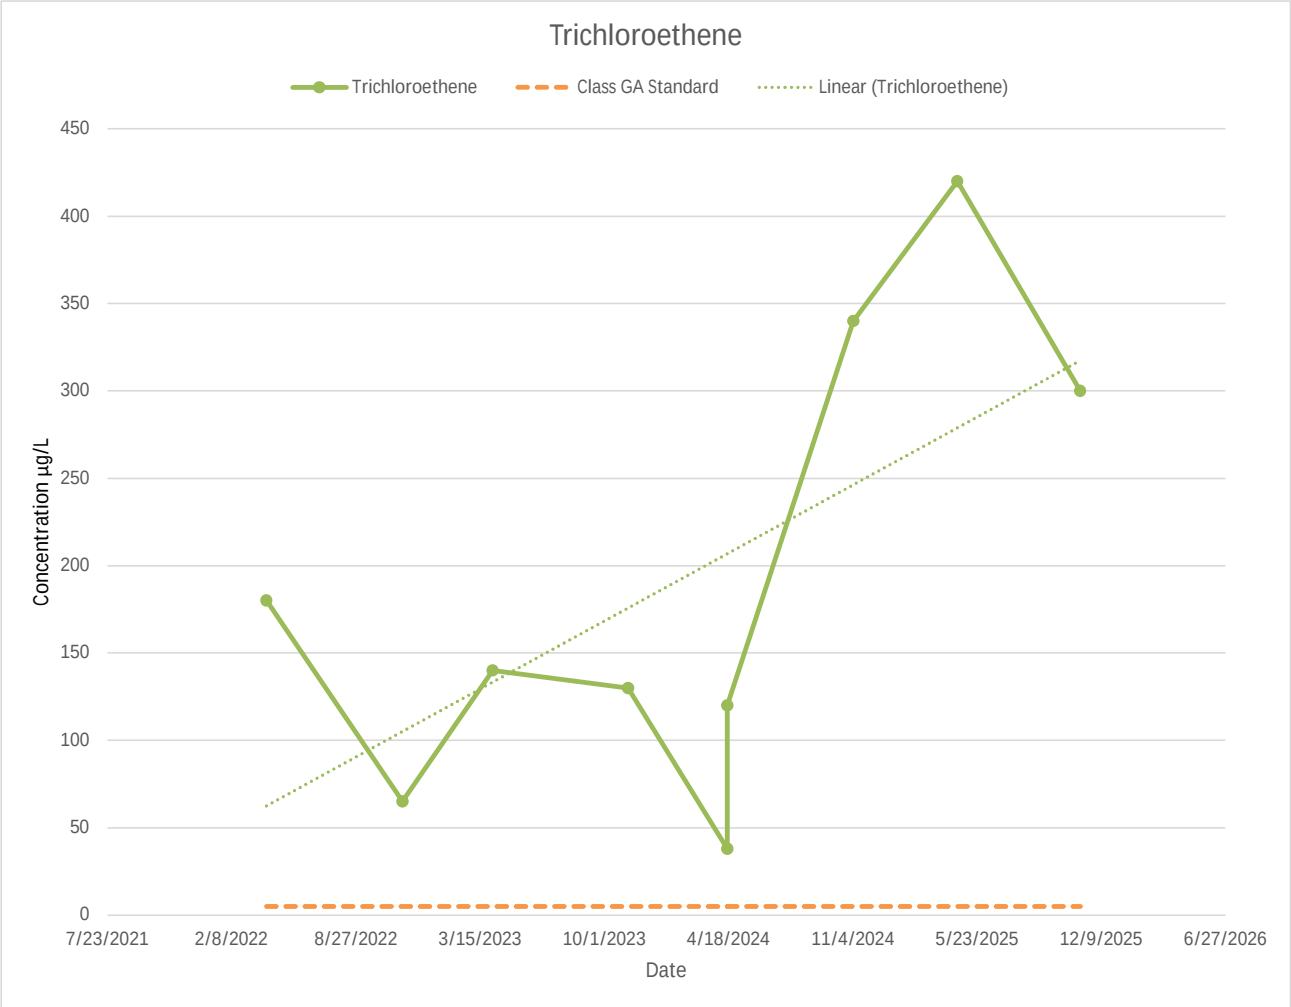
Table 12  
MW-5R Recent cVOCs Trends  
275 Franklin Street and 432 Pearl Street BCP Site

1: Results that were not detected above the laboratory reporting limit were plotted as half of the reporting limit.

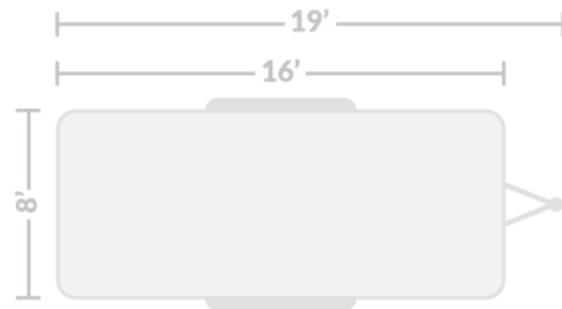
The remediation technologies will be prepared and applied via an RRS custom injection trailer(s) (see image below). Each injection trailer is fully enclosed and contains mixing tanks, pumps, and a delivery system equipped for direct connection to downhole injection tooling or injection wells. In short, each trailer has the following components:

- Flow and pressure transducers to ensure accuracy and safety
- Complete drain conical mixing tanks
- Vortex/Cyclone mixer
- Application pump
- Multiple fluid delivery lines
- Self-sufficient, dedicated power
- Slip-resistant and chemical-resistant flooring
- Backflow prevention
- Pressure bypass controls
- Emergency eyewash and First-Aid station

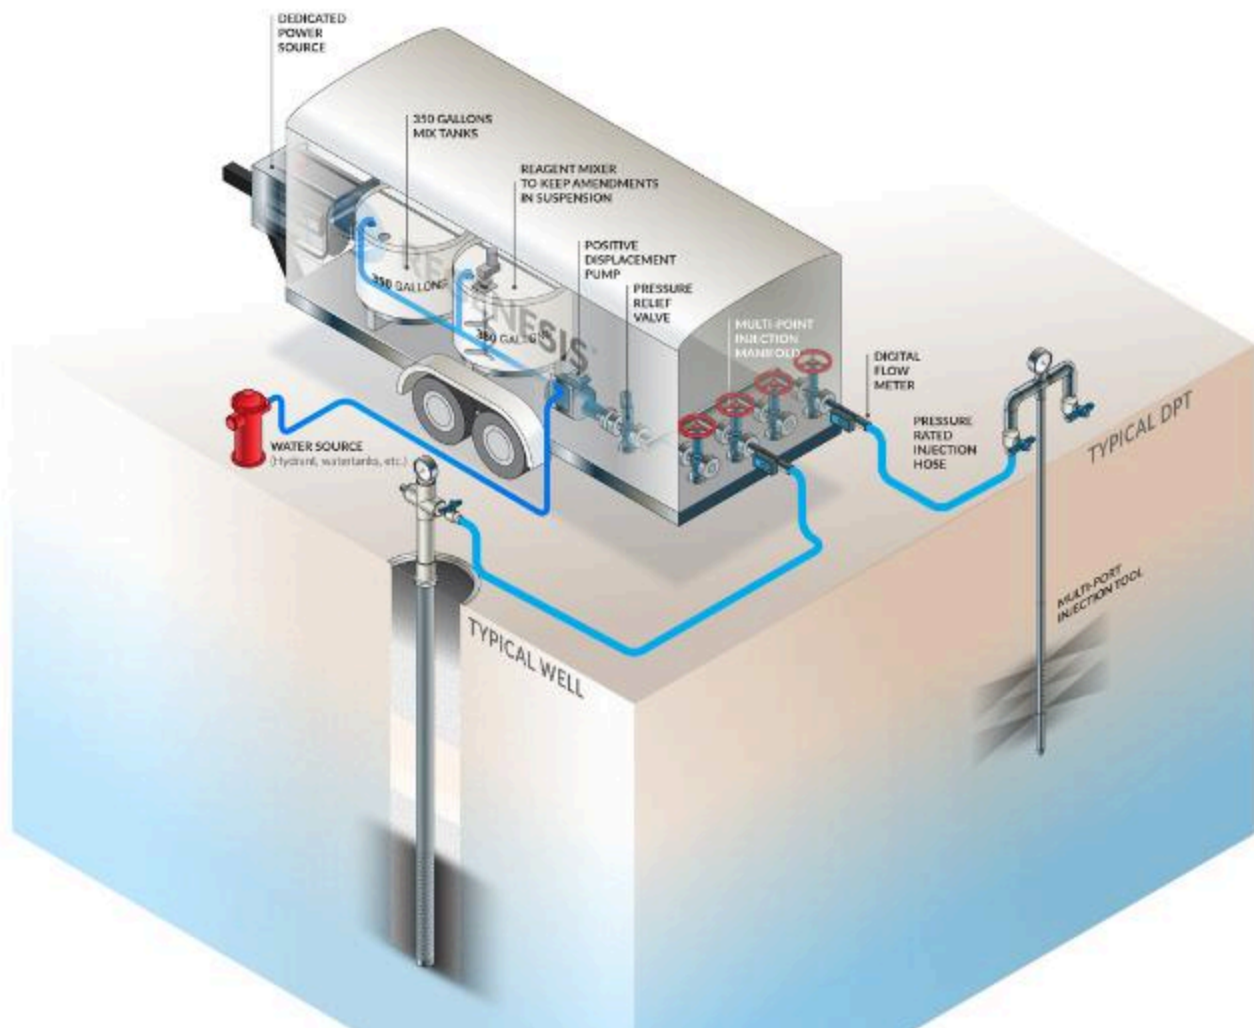
Overhead view of injection trailer dimensions
