# Periodic Review Report

*Fmr. American Linen Supply Company Site  
BCP Site No. C915241*

*822 Seneca Street  
Buffalo, New York*

Revised May 2020

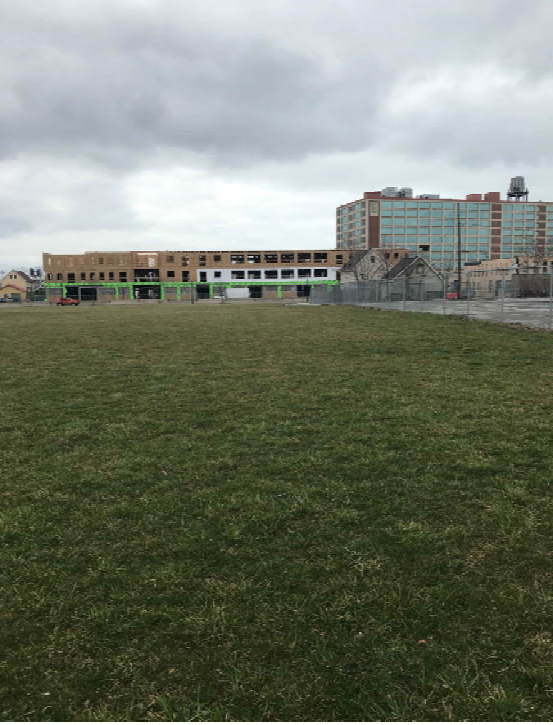
<b>Client Name:</b> Mill Race Commons, LLC		<b>Site Location:</b> 822 Seneca Street, Buffalo, NY	<b>Project No.:</b> B0126-020-002
<b>Photo No.</b> 1	<b>Date</b> 03/28/20

<b>Direction Photo Taken:</b> W-SW			
<b>Description:</b> Soil Cover (looking toward Seneca St.)

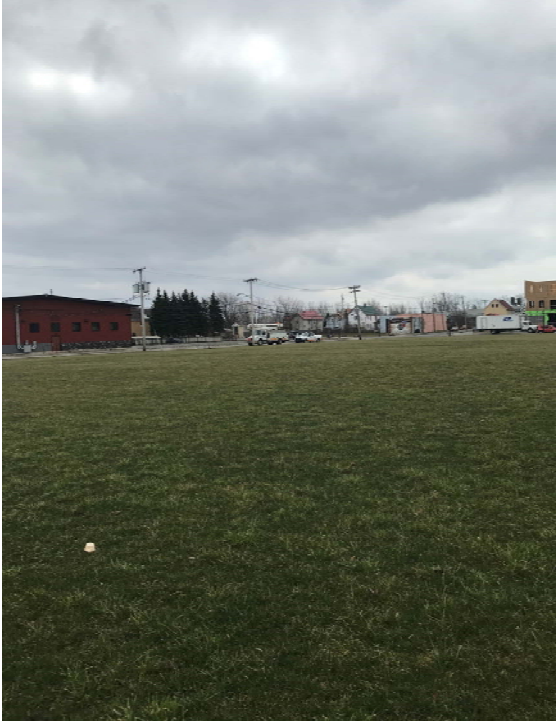
<b>Photo No.</b> 2	<b>Date</b> 03/28/20

<b>Direction Photo Taken:</b> SE			
<b>Description:</b> Soil Cover (from Northern end)

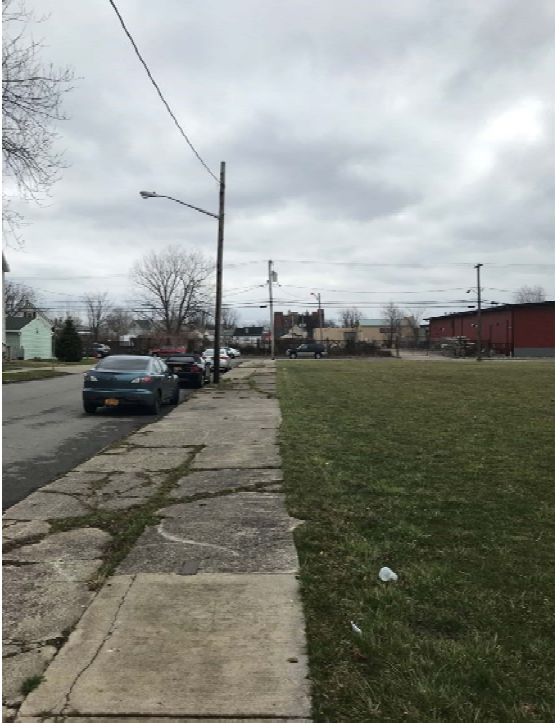
<b>Client Name:</b> Mill Race Commons, LLC		<b>Site Location:</b> 822 Seneca Street, Buffalo, NY	<b>Project No.:</b> B0126-020-002
<b>Photo No.</b> 3	<b>Date</b> 03/28/20

<b>Direction Photo Taken:</b> E-SE			
<b>Description:</b> Soil Cover (from Northern end)

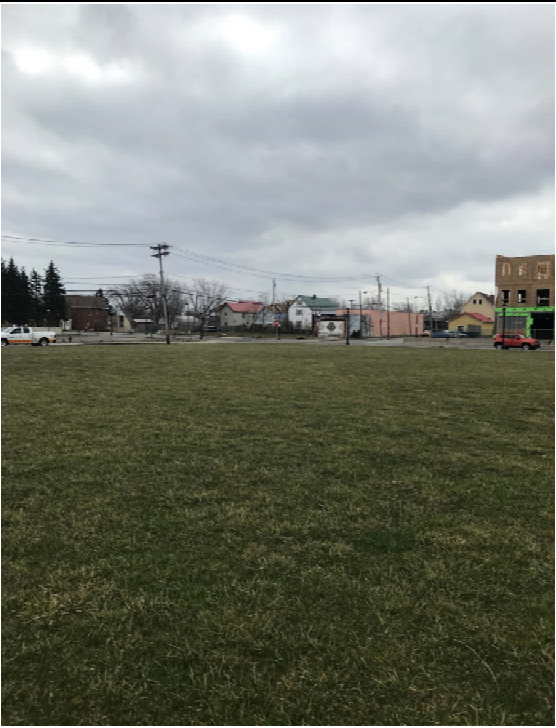
<b>Photo No.</b> 4	<b>Date</b> 03/28/20

<b>Direction Photo Taken:</b> S			
<b>Description:</b> Soil Cover (looking toward Seneca St. and Lord St.)

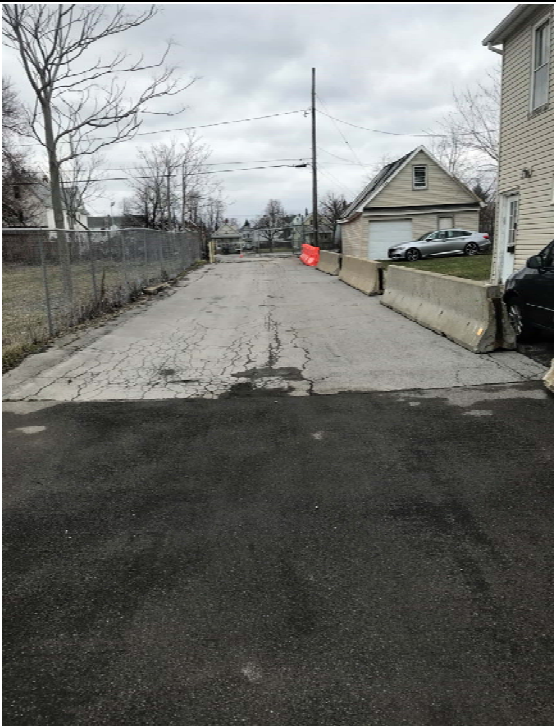
<b>Photo No.</b> 6	<b>Date</b> 03/28/20

<b>Direction Photo Taken:</b> N-NE			
<b>Description:</b> Asphalt Paved Area (Adjacent to 798 Seneca St.)

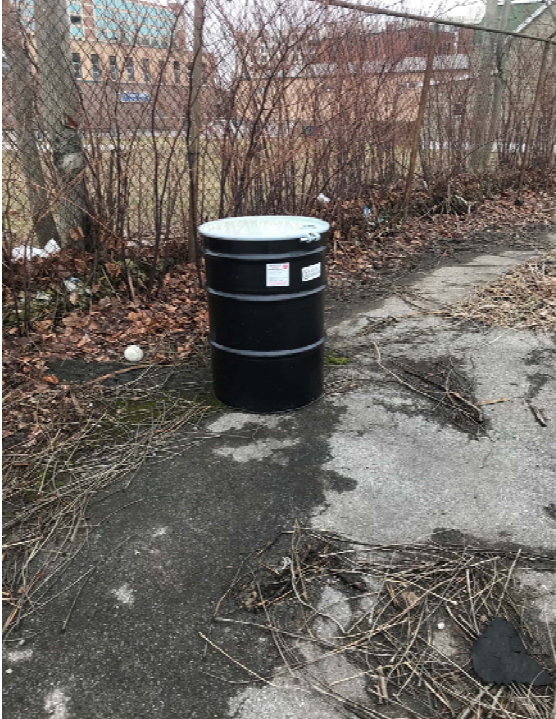
<b>Client Name:</b> Mill Race Commons, LLC		<b>Site Location:</b> 822 Seneca Street, Buffalo, NY	<b>Project No.:</b> B0126-020-002
<b>Photo No.</b> 7	<b>Date</b> 03/28/20

<b>Direction Photo Taken:</b> --			
<b>Description:</b> 55-Gallon Drum Containing Groundwater Monitoring Purge Water.

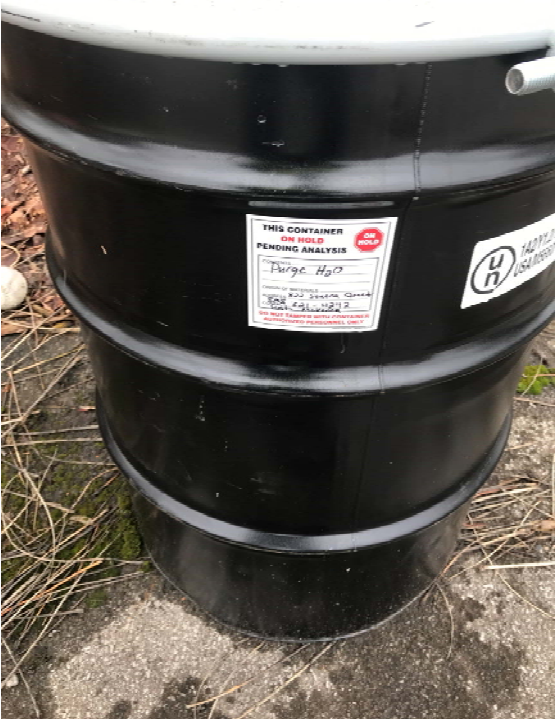
<b>Photo No.</b> 8	<b>Date</b> 03/28/20

<b>Direction Photo Taken:</b> --		
<b>Description:</b> 55-Gallon Drum Containing Groundwater Monitoring Purge Water.

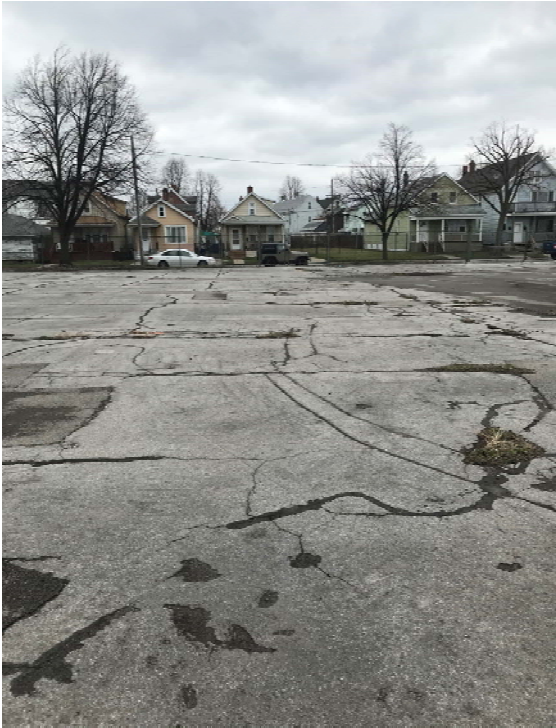
<b>Photo No.</b> 10	<b>Date</b> 03/28/20

<b>Direction Photo Taken:</b> N-NW			
<b>Description:</b> Asphalt Paved Area (from center)

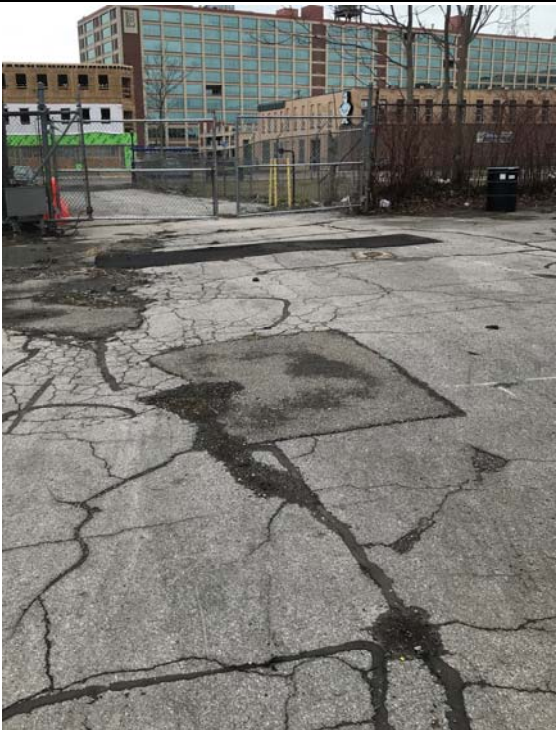
<b>Photo No.</b> 12	<b>Date</b> 03/28/20

<b>Direction Photo Taken:</b> SW			
<b>Description:</b> Asphalt Paved Area (looking toward Seneca St.)

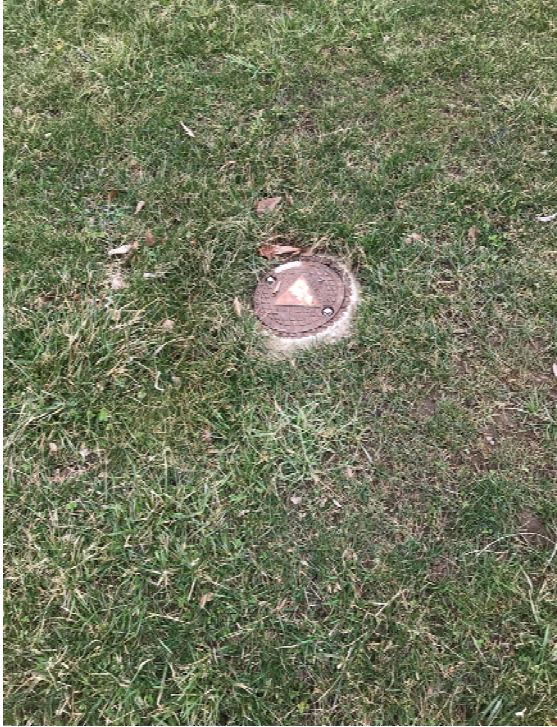
<b>Client Name:</b> Mill Race Commons, LLC		<b>Site Location:</b> 822 Seneca Street, Buffalo, NY	<b>Project No.:</b> B0126-020-002
<b>Photo No.</b> 13	<b>Date</b> 03/28/20

<b>Direction Photo Taken:</b> N-NW			
<b>Description:</b> Groundwater Monitoring Well.

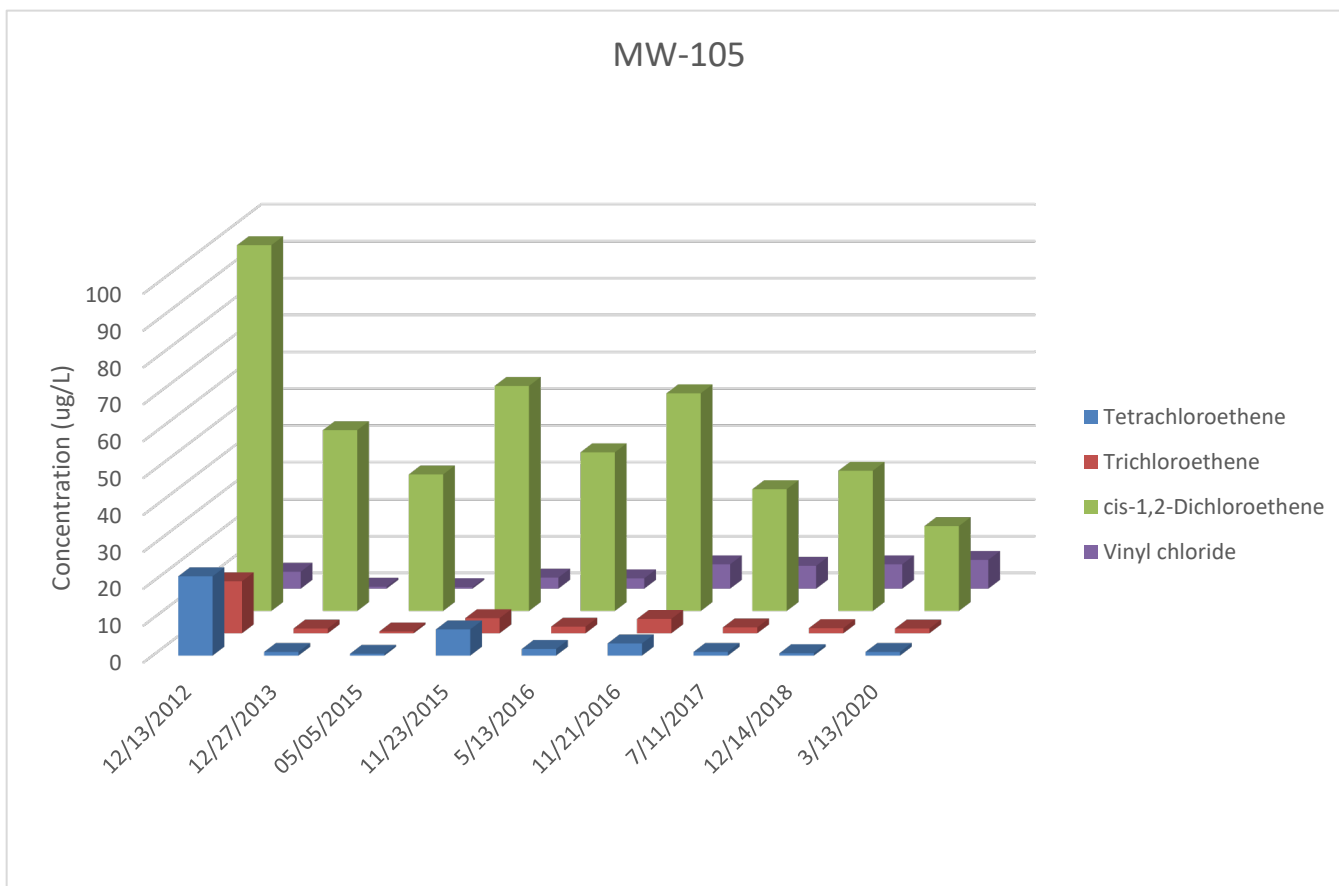
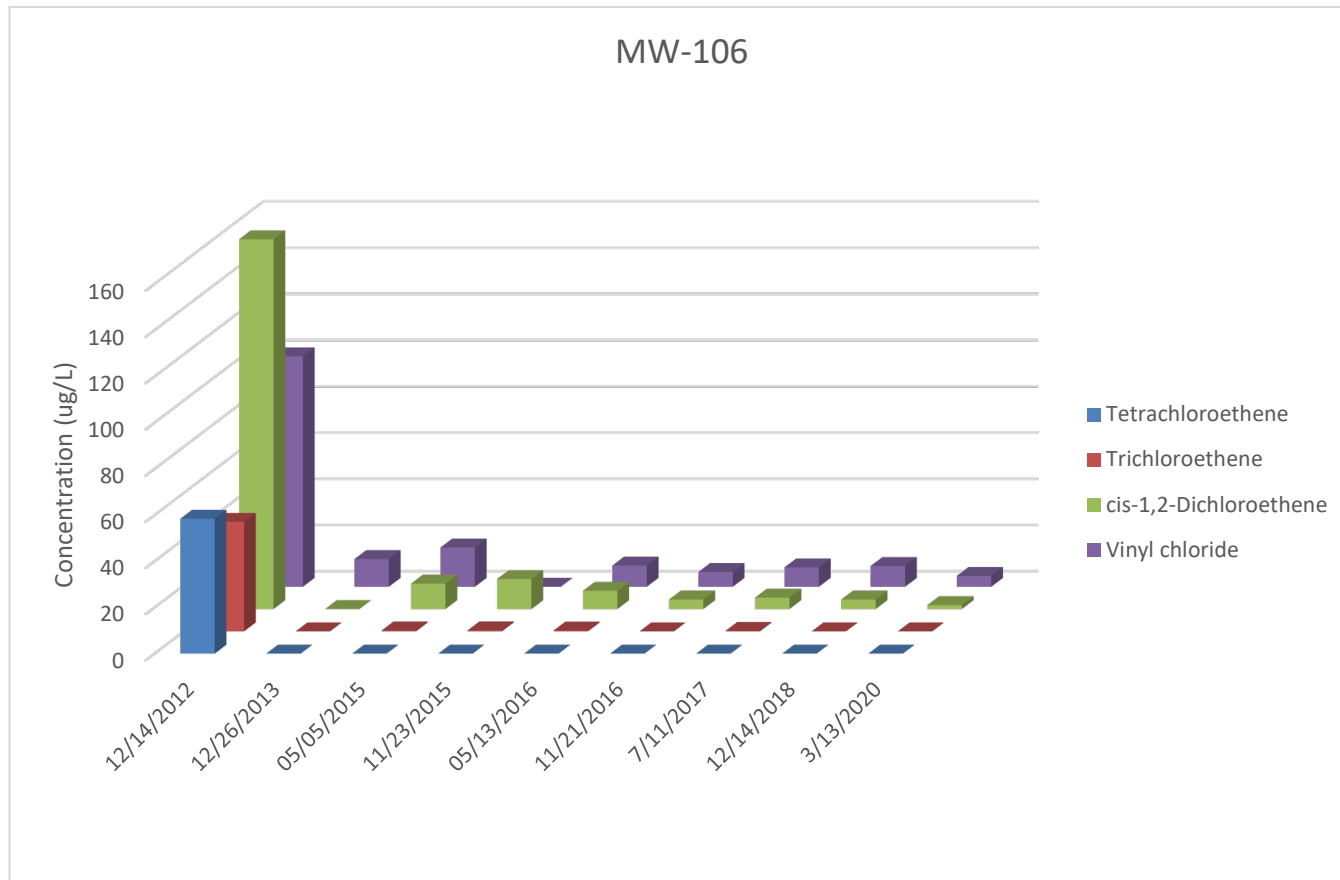
**Figure 3 - Groundwater Concentration Trends (MW-105 and MW-106)**

The 2020 results indicate that Target CVOC concentrations are stabilizing close to or below the NYSDEC groundwater standards and significantly below pre-remediation conditions. The overall concentrations of CVOCs in source area wells MW-105 and MW-106 have remained consistent or decreasing since 2013.
