Periodic Review Report

Former American Linen Supply Company Facility
822 Seneca Street, Buffalo, New York
BCP Site No. C915241

May 24, 2022, to May 24 2023 Certifying Period

June 2023
Rev. July 2023

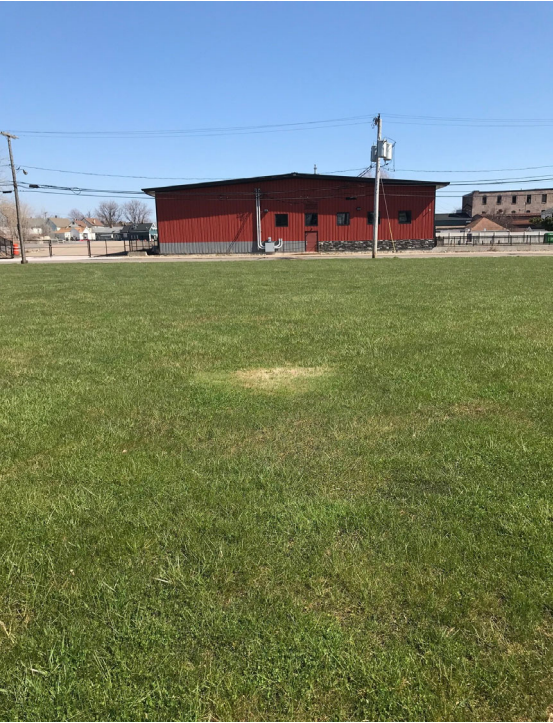
Photo No. 2	Date 04/10/23

Direction Photo Taken: SE			
Description: Soil Cover (looking toward Lord Street)

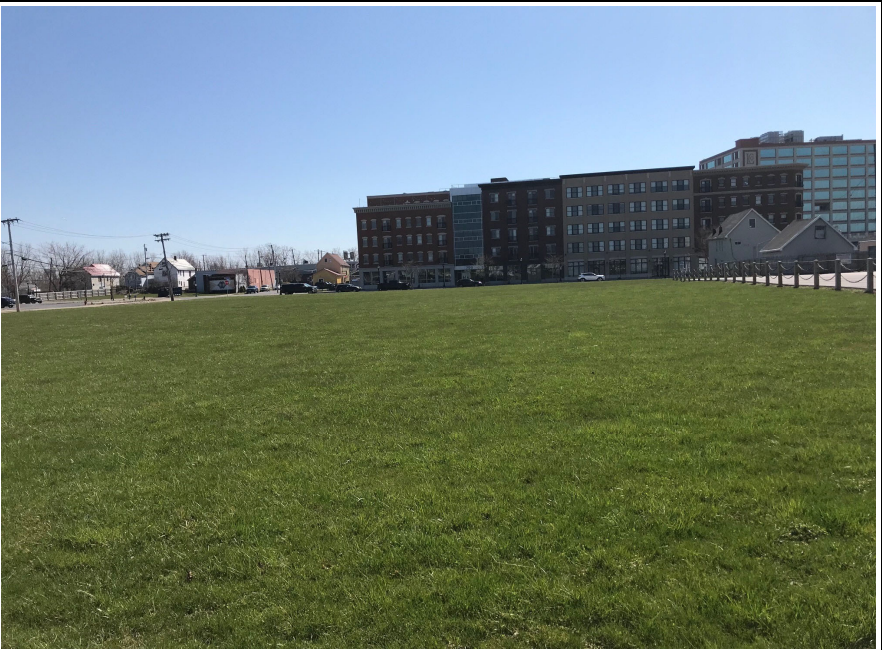
Photo No. 6	Date 04/10/23

Direction Photo Taken: S		
Description: Soil Cover (looking toward Seneca Street and Lord Street)

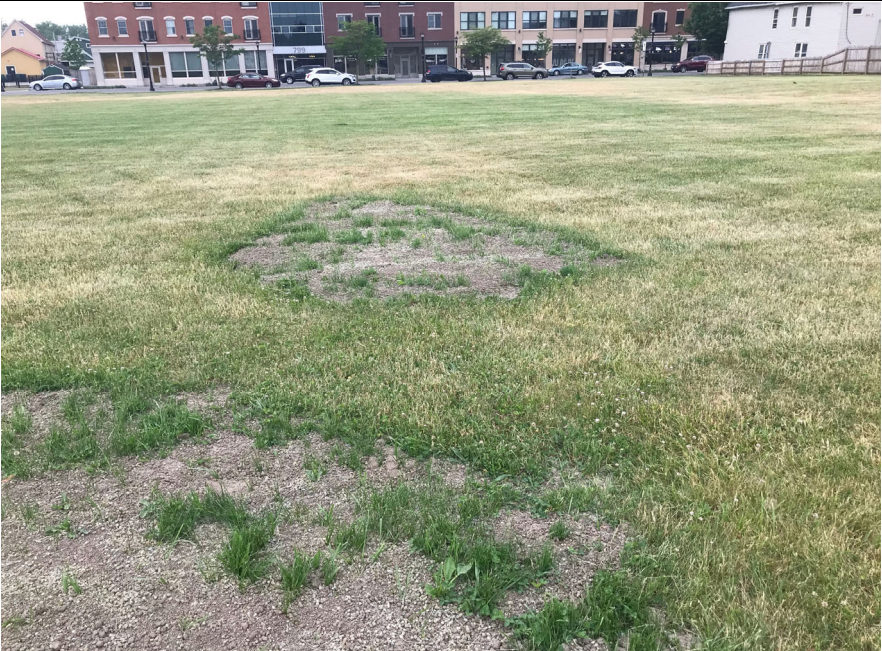
Client Name: Mill Race Commons, LLC		Site Location: 822 Seneca Street, Buffalo, NY	Project No.: B0126-023-001
Photo No. 11	Date 06/08/23

The Site was reinspected on June 8, 2023. Although seed has not yet germinated due to dry weather conditions, it was visibly present in the freshly-placed topsoil. Accordingly, the site was determined to be in compliance with the IC/EC requirements. Photo verification is provided in Appendix B.

Direction Photo Taken: S			
Description: Soil Cover System repair area.

A small patch of soil cover/grass near the center of the lawn area was noted as barren. As such, approximately 2 cubic yards of topsoil tested for previous cover system modifications and approved for import by the Department was placed in the area and reseeded on May 21, 2023.

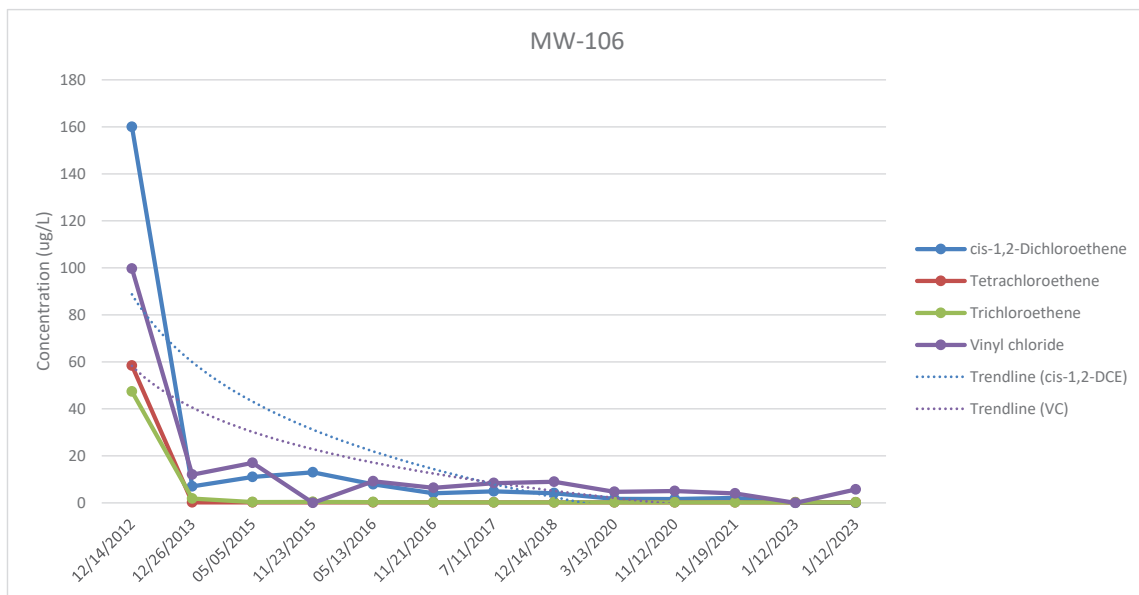
Figure 4 - Groundwater Concentration Trends (MW-105 and MW-106)
