Re: Post-Remedial Soil Vapor Intrusion (SVI) Sampling Report
December 28-29, 2017
295 Maryland Street Site (C915242), Buffalo, New York

SITE LOCATION AND VICINITY MAP
 SOIL VAPOR INTRUSION INVESTIGATION REPORT

295 MARYLAND STREET SITE
 BUFFALO, NEW YORK

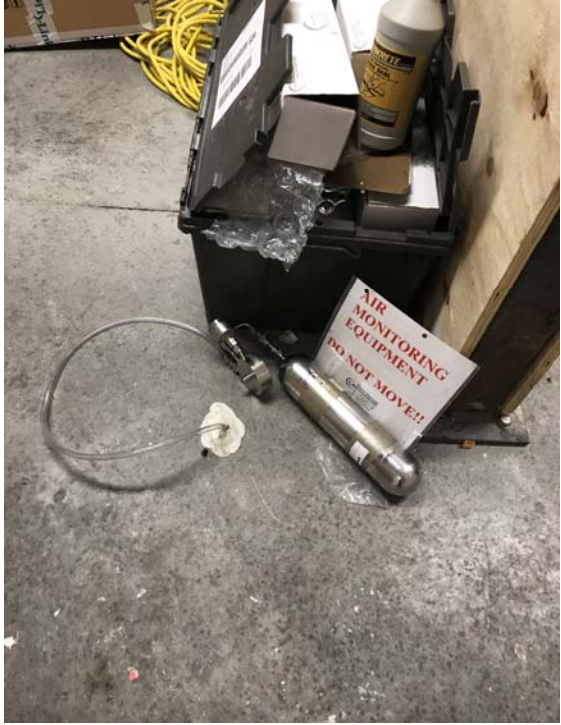
Client Name: 295 Maryland, LLC		Site Location: 295 Maryland Street Site	Project No.: 0222-017-001
Photo No. 1	Date 12/28/17

Direction Photo Taken: West			
Description: Sub-slab air sample port and air sampling canister. First floor mechanical room.

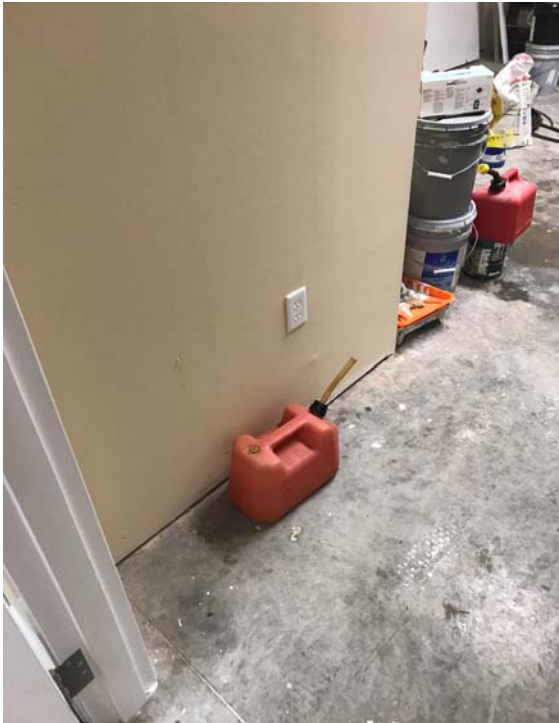
Photo No. 4	Date 12/29/17

VOC-containing products appeared to be stored in open containers within the basement and first floor of the on-Site building. While these are attributable to completion of indoor finish work within the newly constructed building, it is recommended that products containing VOCs be kept in tightly sealed, original containers and stored in a secure and well-ventilated area such as a garage or outdoor shed.

Direction Photo Taken:		
Description: Chemical Inventory - Basement

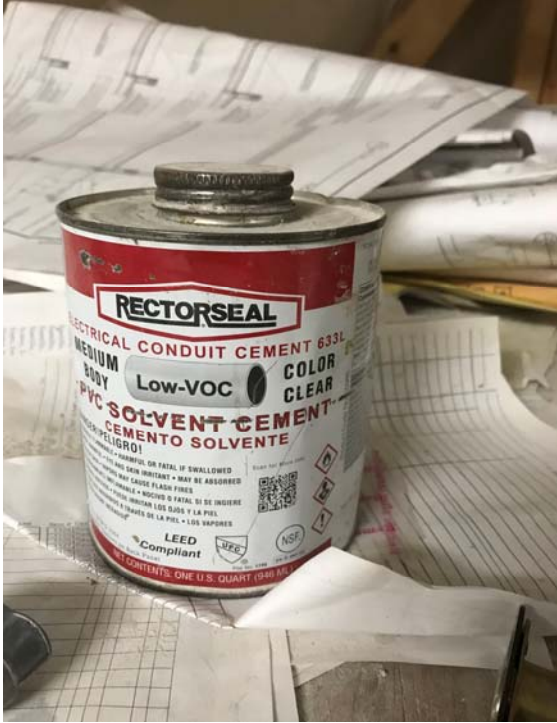
Client Name: 295 Maryland, LLC		Site Location: 295 Maryland Street Site	Project No.: 0222-017-001
Photo No. 5	Date 12/29/17

Direction Photo Taken:			
Description: Chemical Inventory - Basement

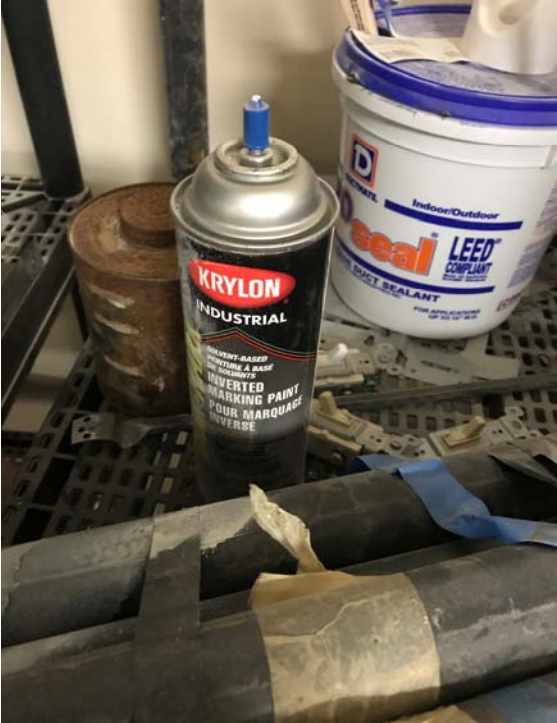
Photo No. 6	Date 12/29/17

Direction Photo Taken:			
Description: Chemical Inventory - Basement

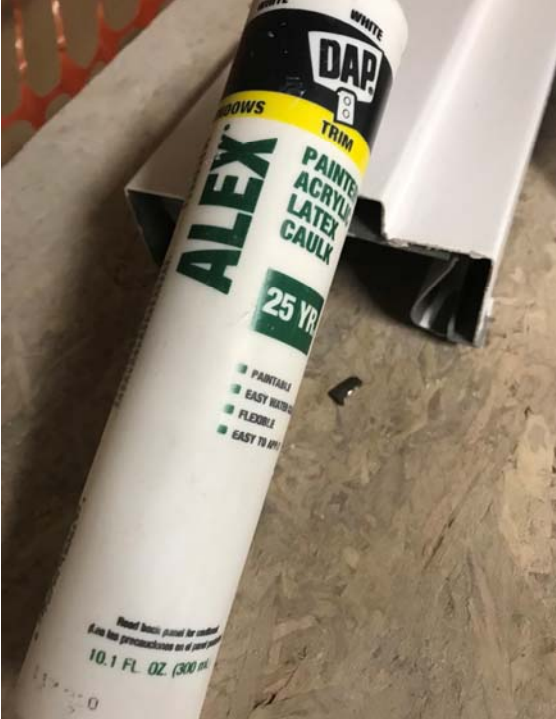
Client Name: 295 Maryland, LLC		Site Location: 295 Maryland Street Site	Project No.: 0222-017-001
Photo No. 7	Date 12/29/17

Direction Photo Taken:			
Description: Chemical Inventory - Basement

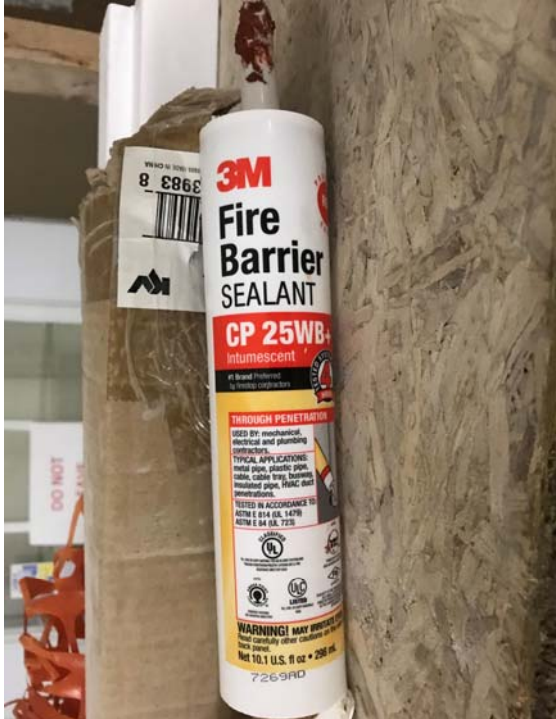
Photo No. 8	Date 12/29/17

Direction Photo Taken:			
Description: Chemical Inventory - Basement

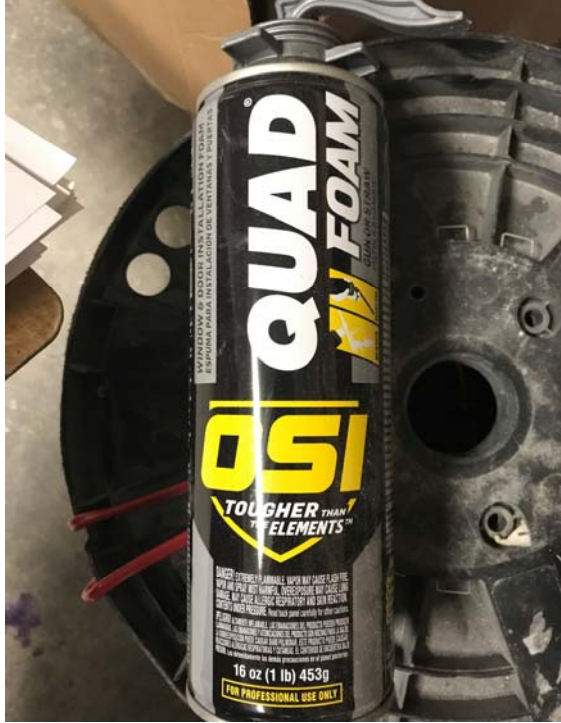
Client Name: 295 Maryland, LLC		Site Location: 295 Maryland Street Site	Project No.: 0222-017-001
Photo No. 9	Date 12/29/17

Direction Photo Taken:			
Description: Chemical Inventory - Basement

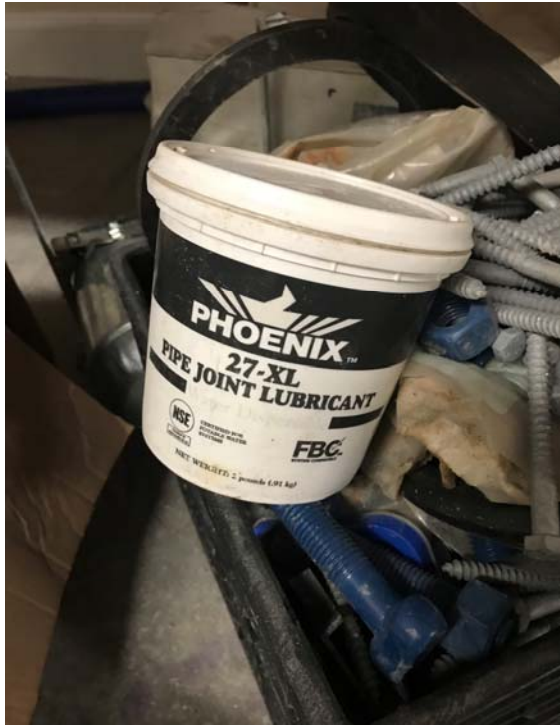
Photo No. 10	Date 12/29/17

Direction Photo Taken:			
Description: Chemical Inventory - Basement

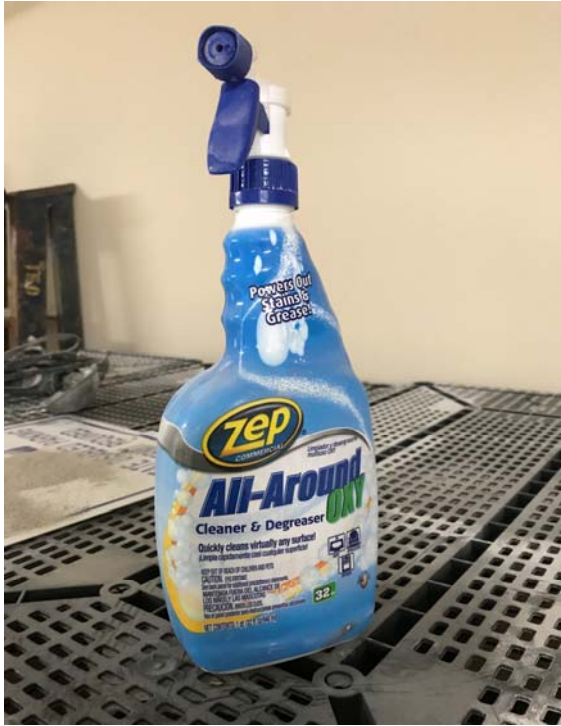
Client Name: 295 Maryland, LLC		Site Location: 295 Maryland Street Site	Project No.: 0222-017-001
Photo No. 11	Date 12/29/17

Direction Photo Taken:			
Description: Chemical Inventory - Basement

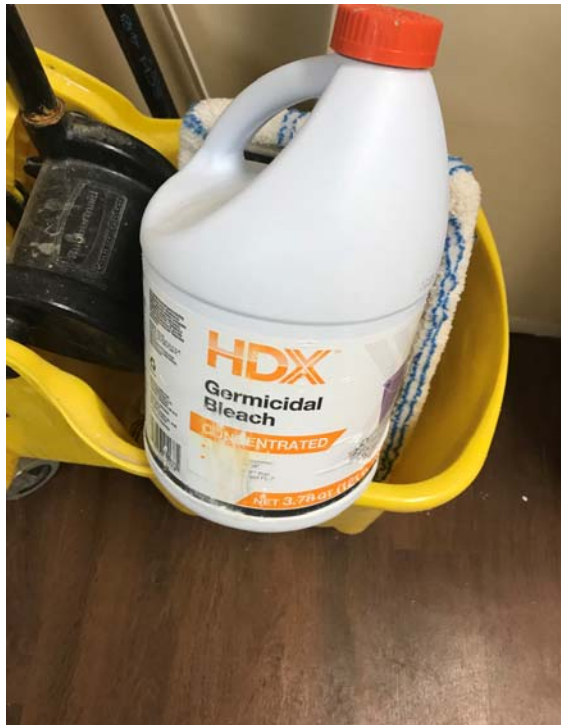
Photo No. 12	Date 12/29/17

Direction Photo Taken:			
Description: Chemical Inventory - Basement

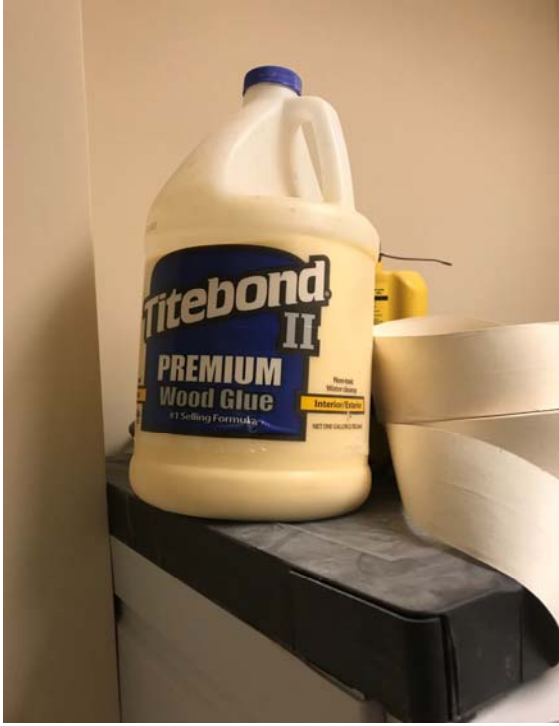
Client Name: 295 Maryland, LLC		Site Location: 295 Maryland Street Site	Project No.: 0222-017-001
Photo No. 13	Date 12/29/17

Direction Photo Taken:			
Description: Chemical Inventory - Basement

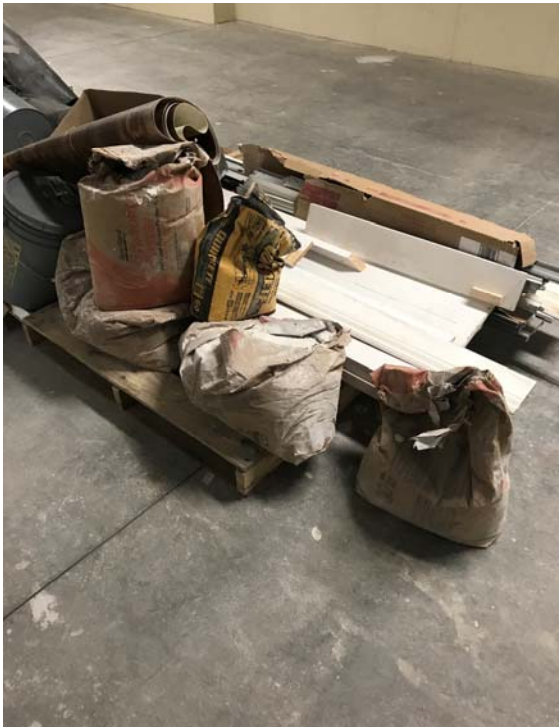
Photo No. 14	Date 12/29/17

Direction Photo Taken:		
Description: Chemical Inventory - Basement

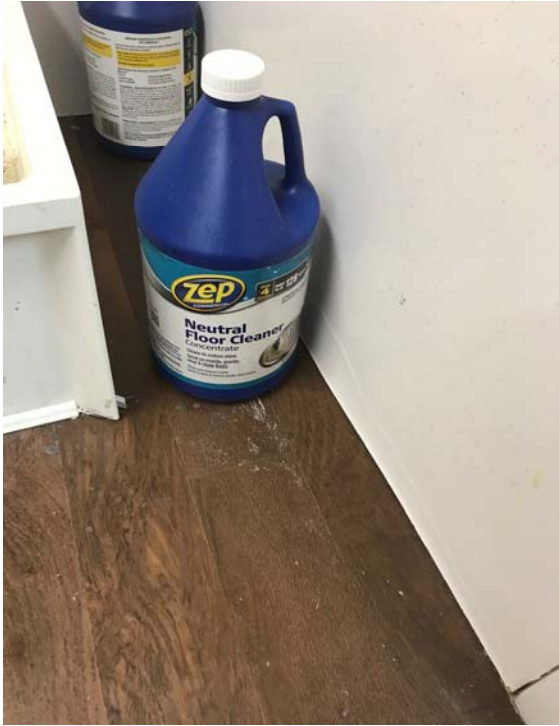
Client Name: 295 Maryland, LLC		Site Location: 295 Maryland Street Site	Project No.: 0222-017-001
Photo No. 15	Date 12/29/17

Direction Photo Taken:			
Description: Chemical Inventory - Basement

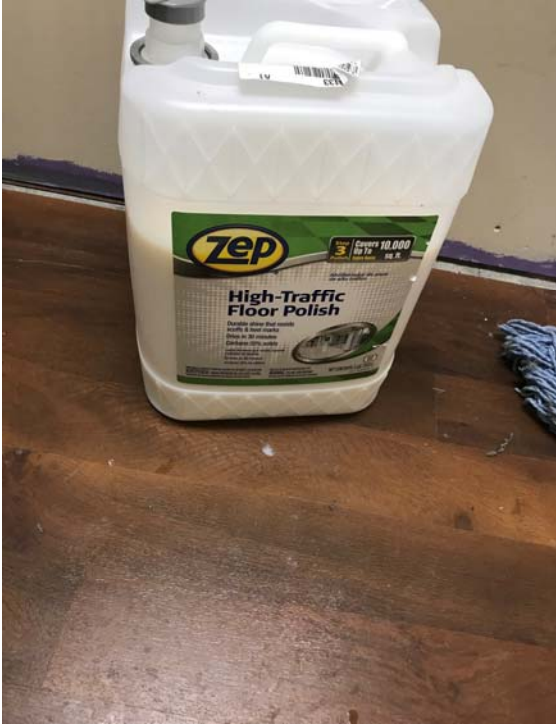
Photo No. 16	Date 12/29/17

Direction Photo Taken:		
Description: Chemical Inventory - Basement

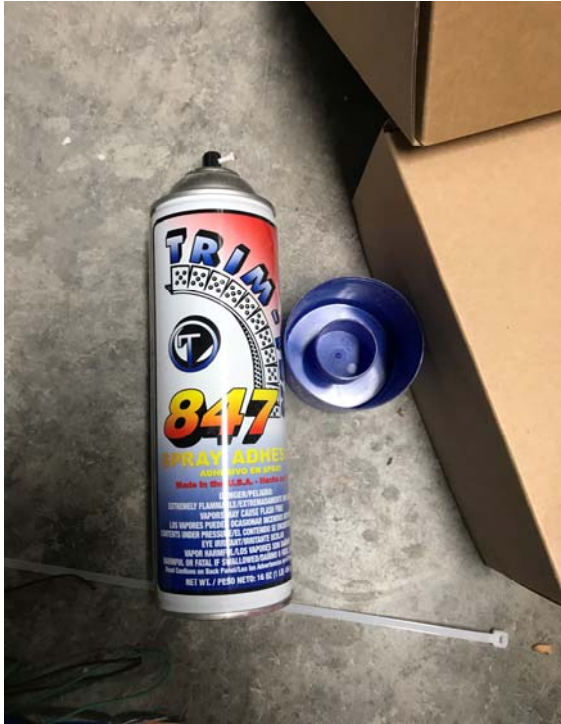
Client Name: 295 Maryland, LLC		Site Location: 295 Maryland Street Site	Project No.: 0222-017-001
Photo No. 17	Date 12/29/17

Direction Photo Taken:			
Description: Chemical Inventory - First Floor

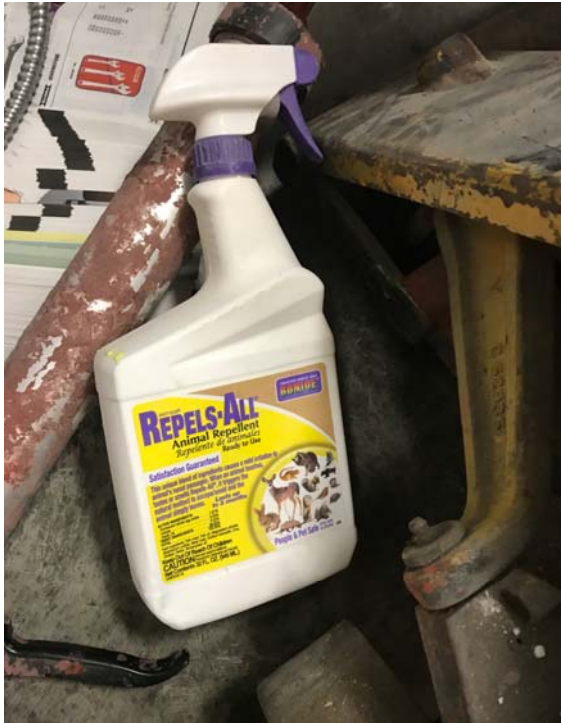
Photo No. 18	Date 12/29/17

Direction Photo Taken:			
Description: Chemical Inventory - First Floor

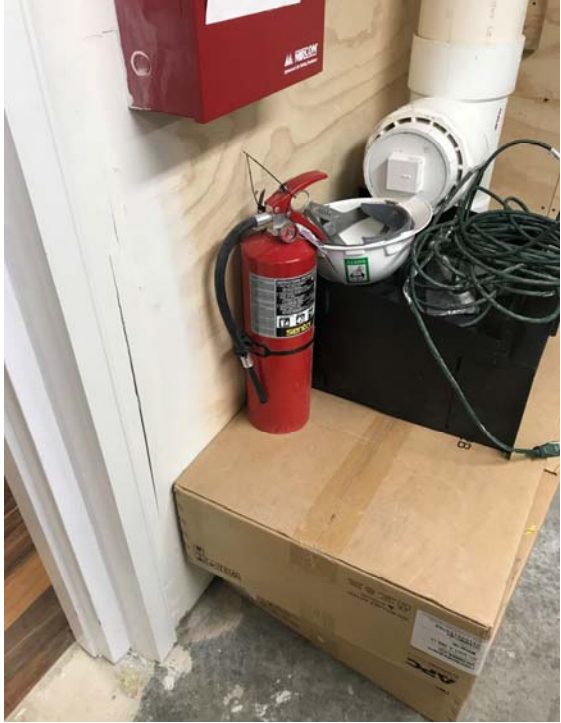
Client Name: 295 Maryland, LLC		Site Location: 295 Maryland Street Site	Project No.: 0222-017-001
Photo No. 19	Date 12/29/17

Direction Photo Taken:			
Description: Chemical Inventory - First Floor

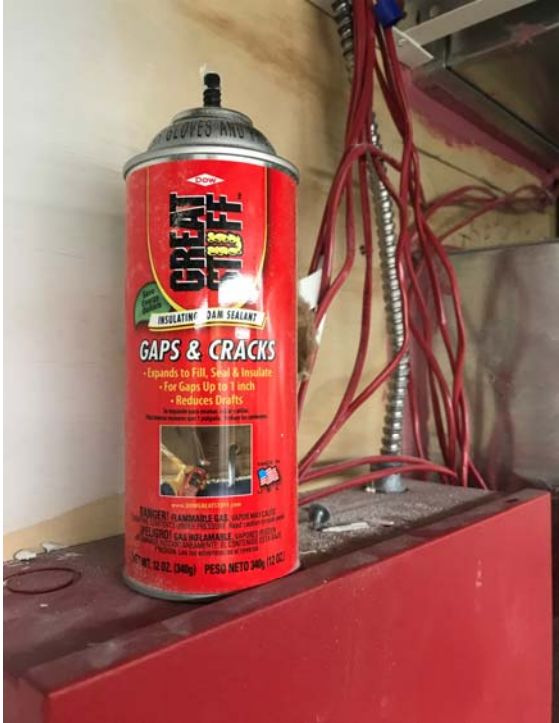
Photo No. 20	Date 12/29/17

Direction Photo Taken:		
Description: Chemical Inventory - First Floor
