# PERIODIC REVIEW REPORT (PRR)

*295 Maryland Street Site  
BCP Site No. C915242  
Buffalo, New York*

May 2019

B0222-019-001

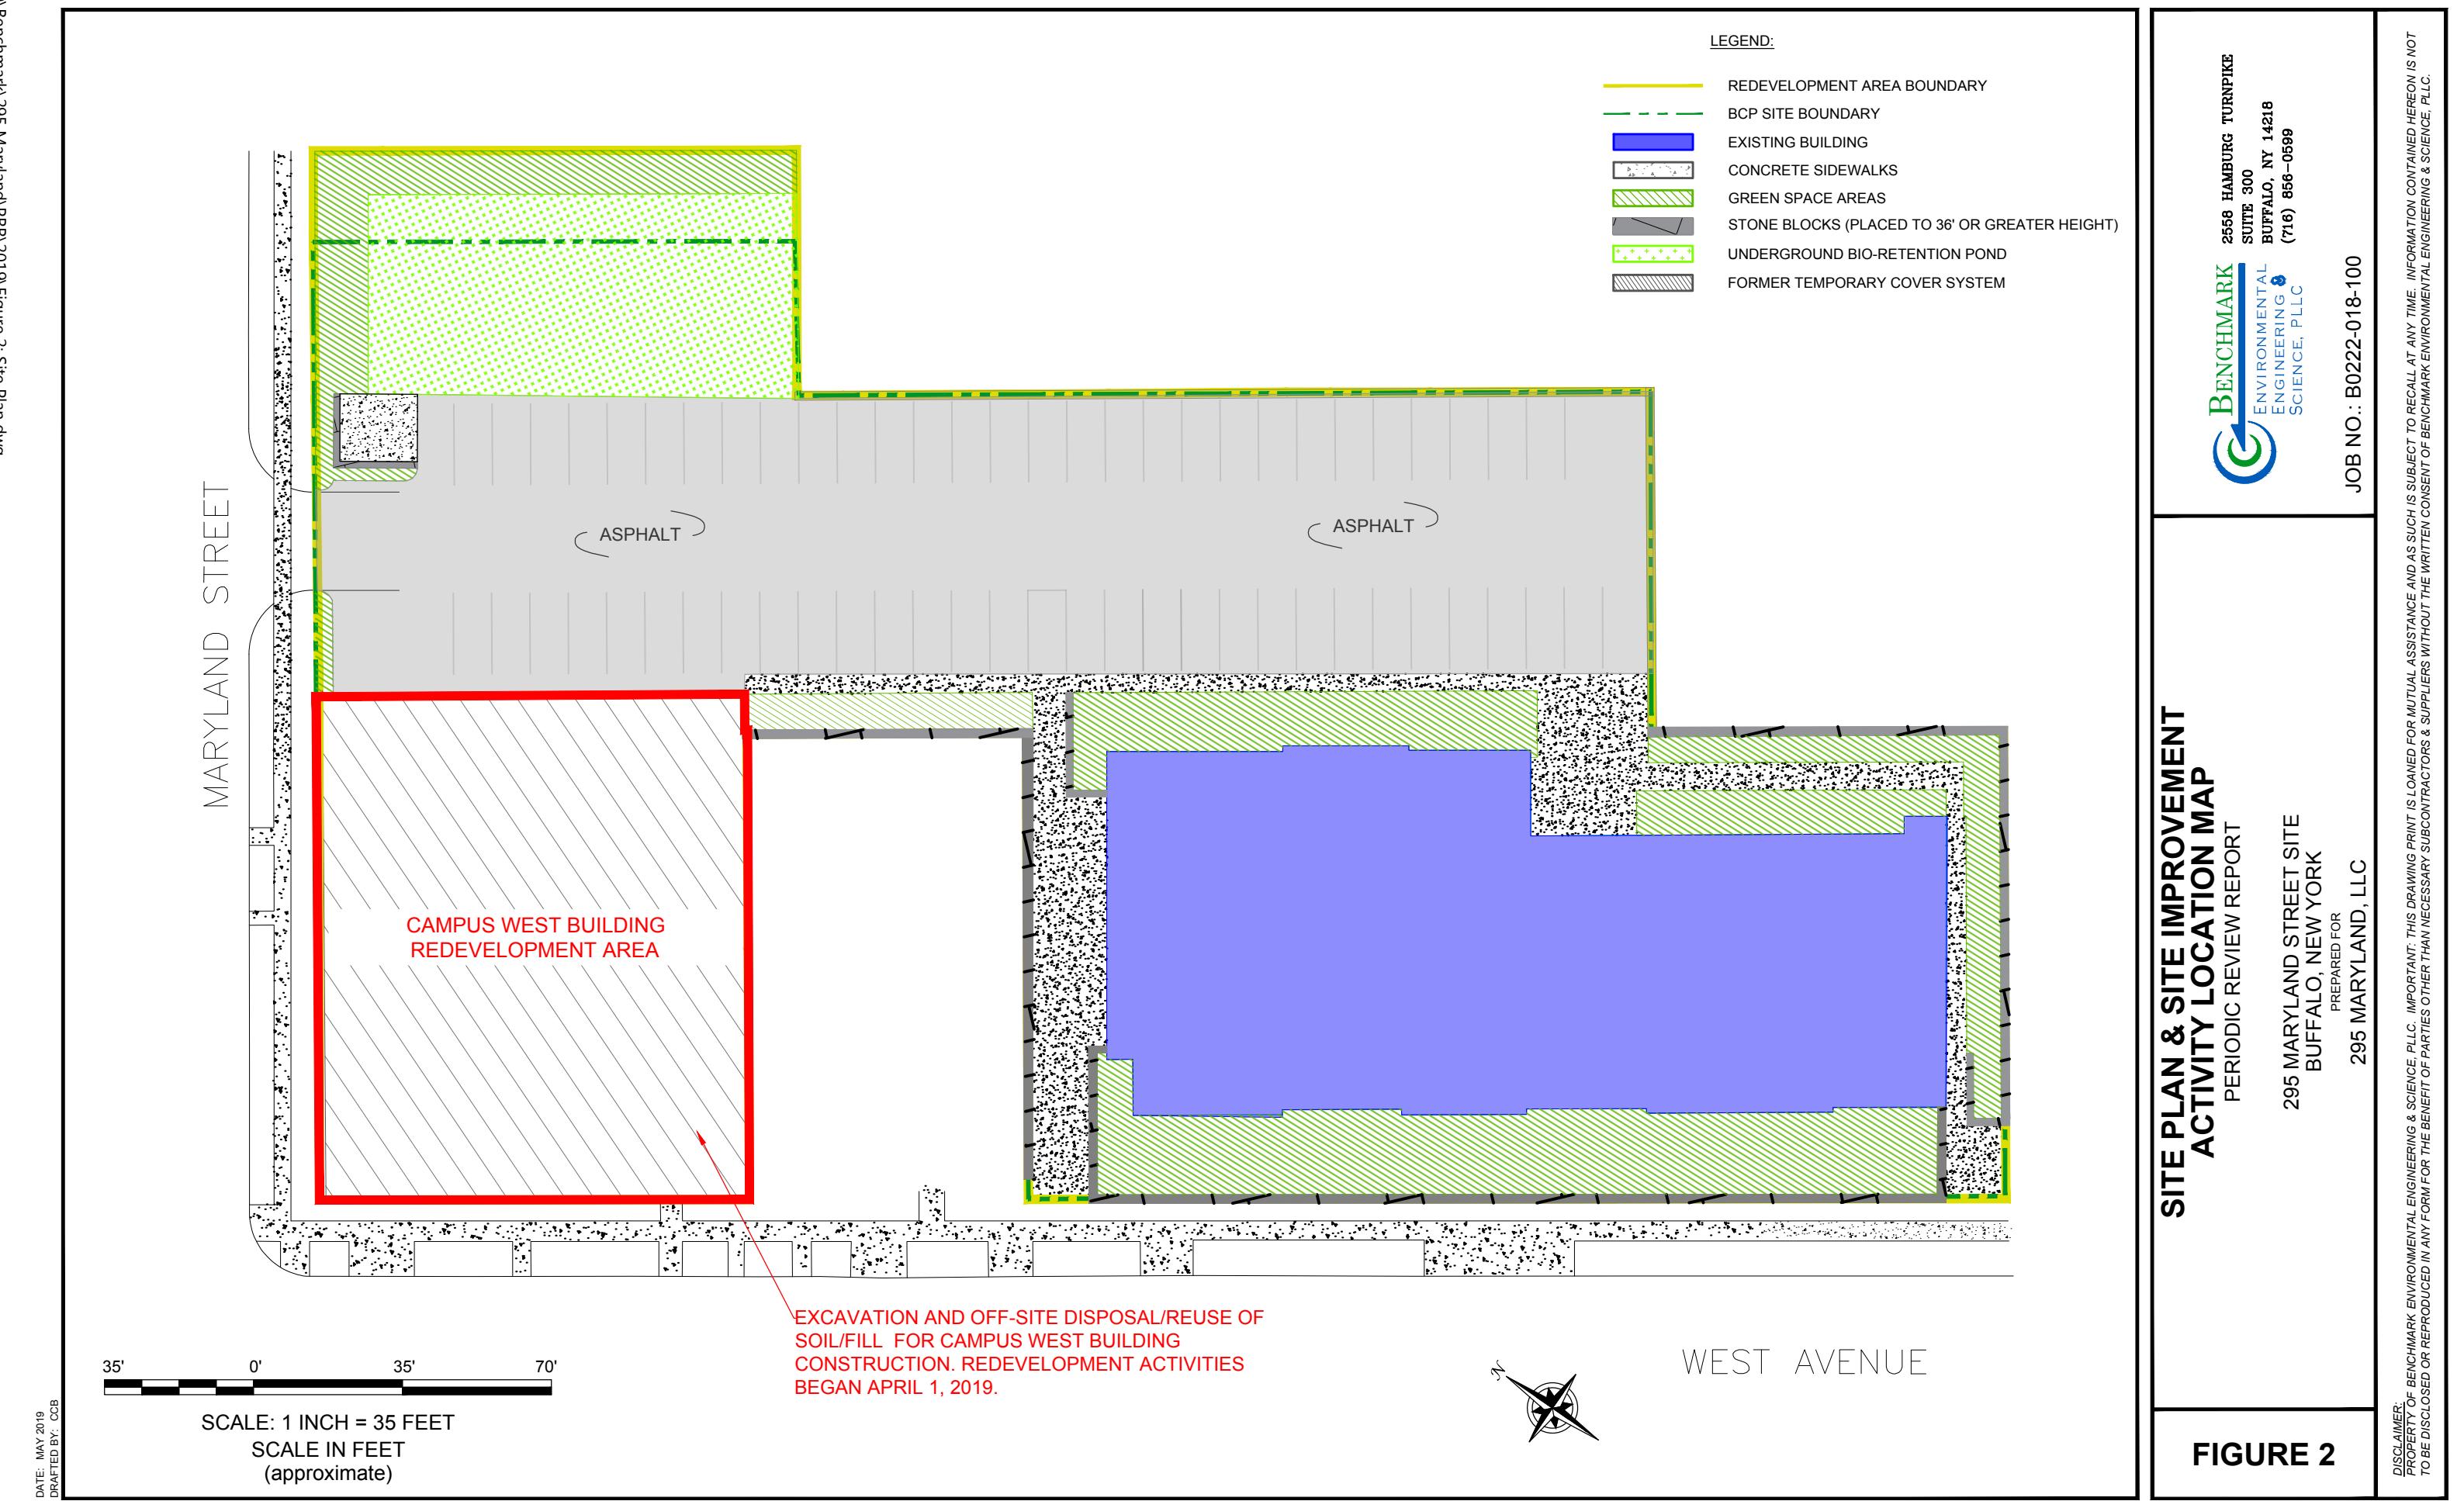
Avenue parcel portion of the Site, and import of NYSDEC approved clean backfill for construction activities (see Figure 2). Intrusive activities were observed by Benchmark personnel to verify conformance with the SMP and the EWP.

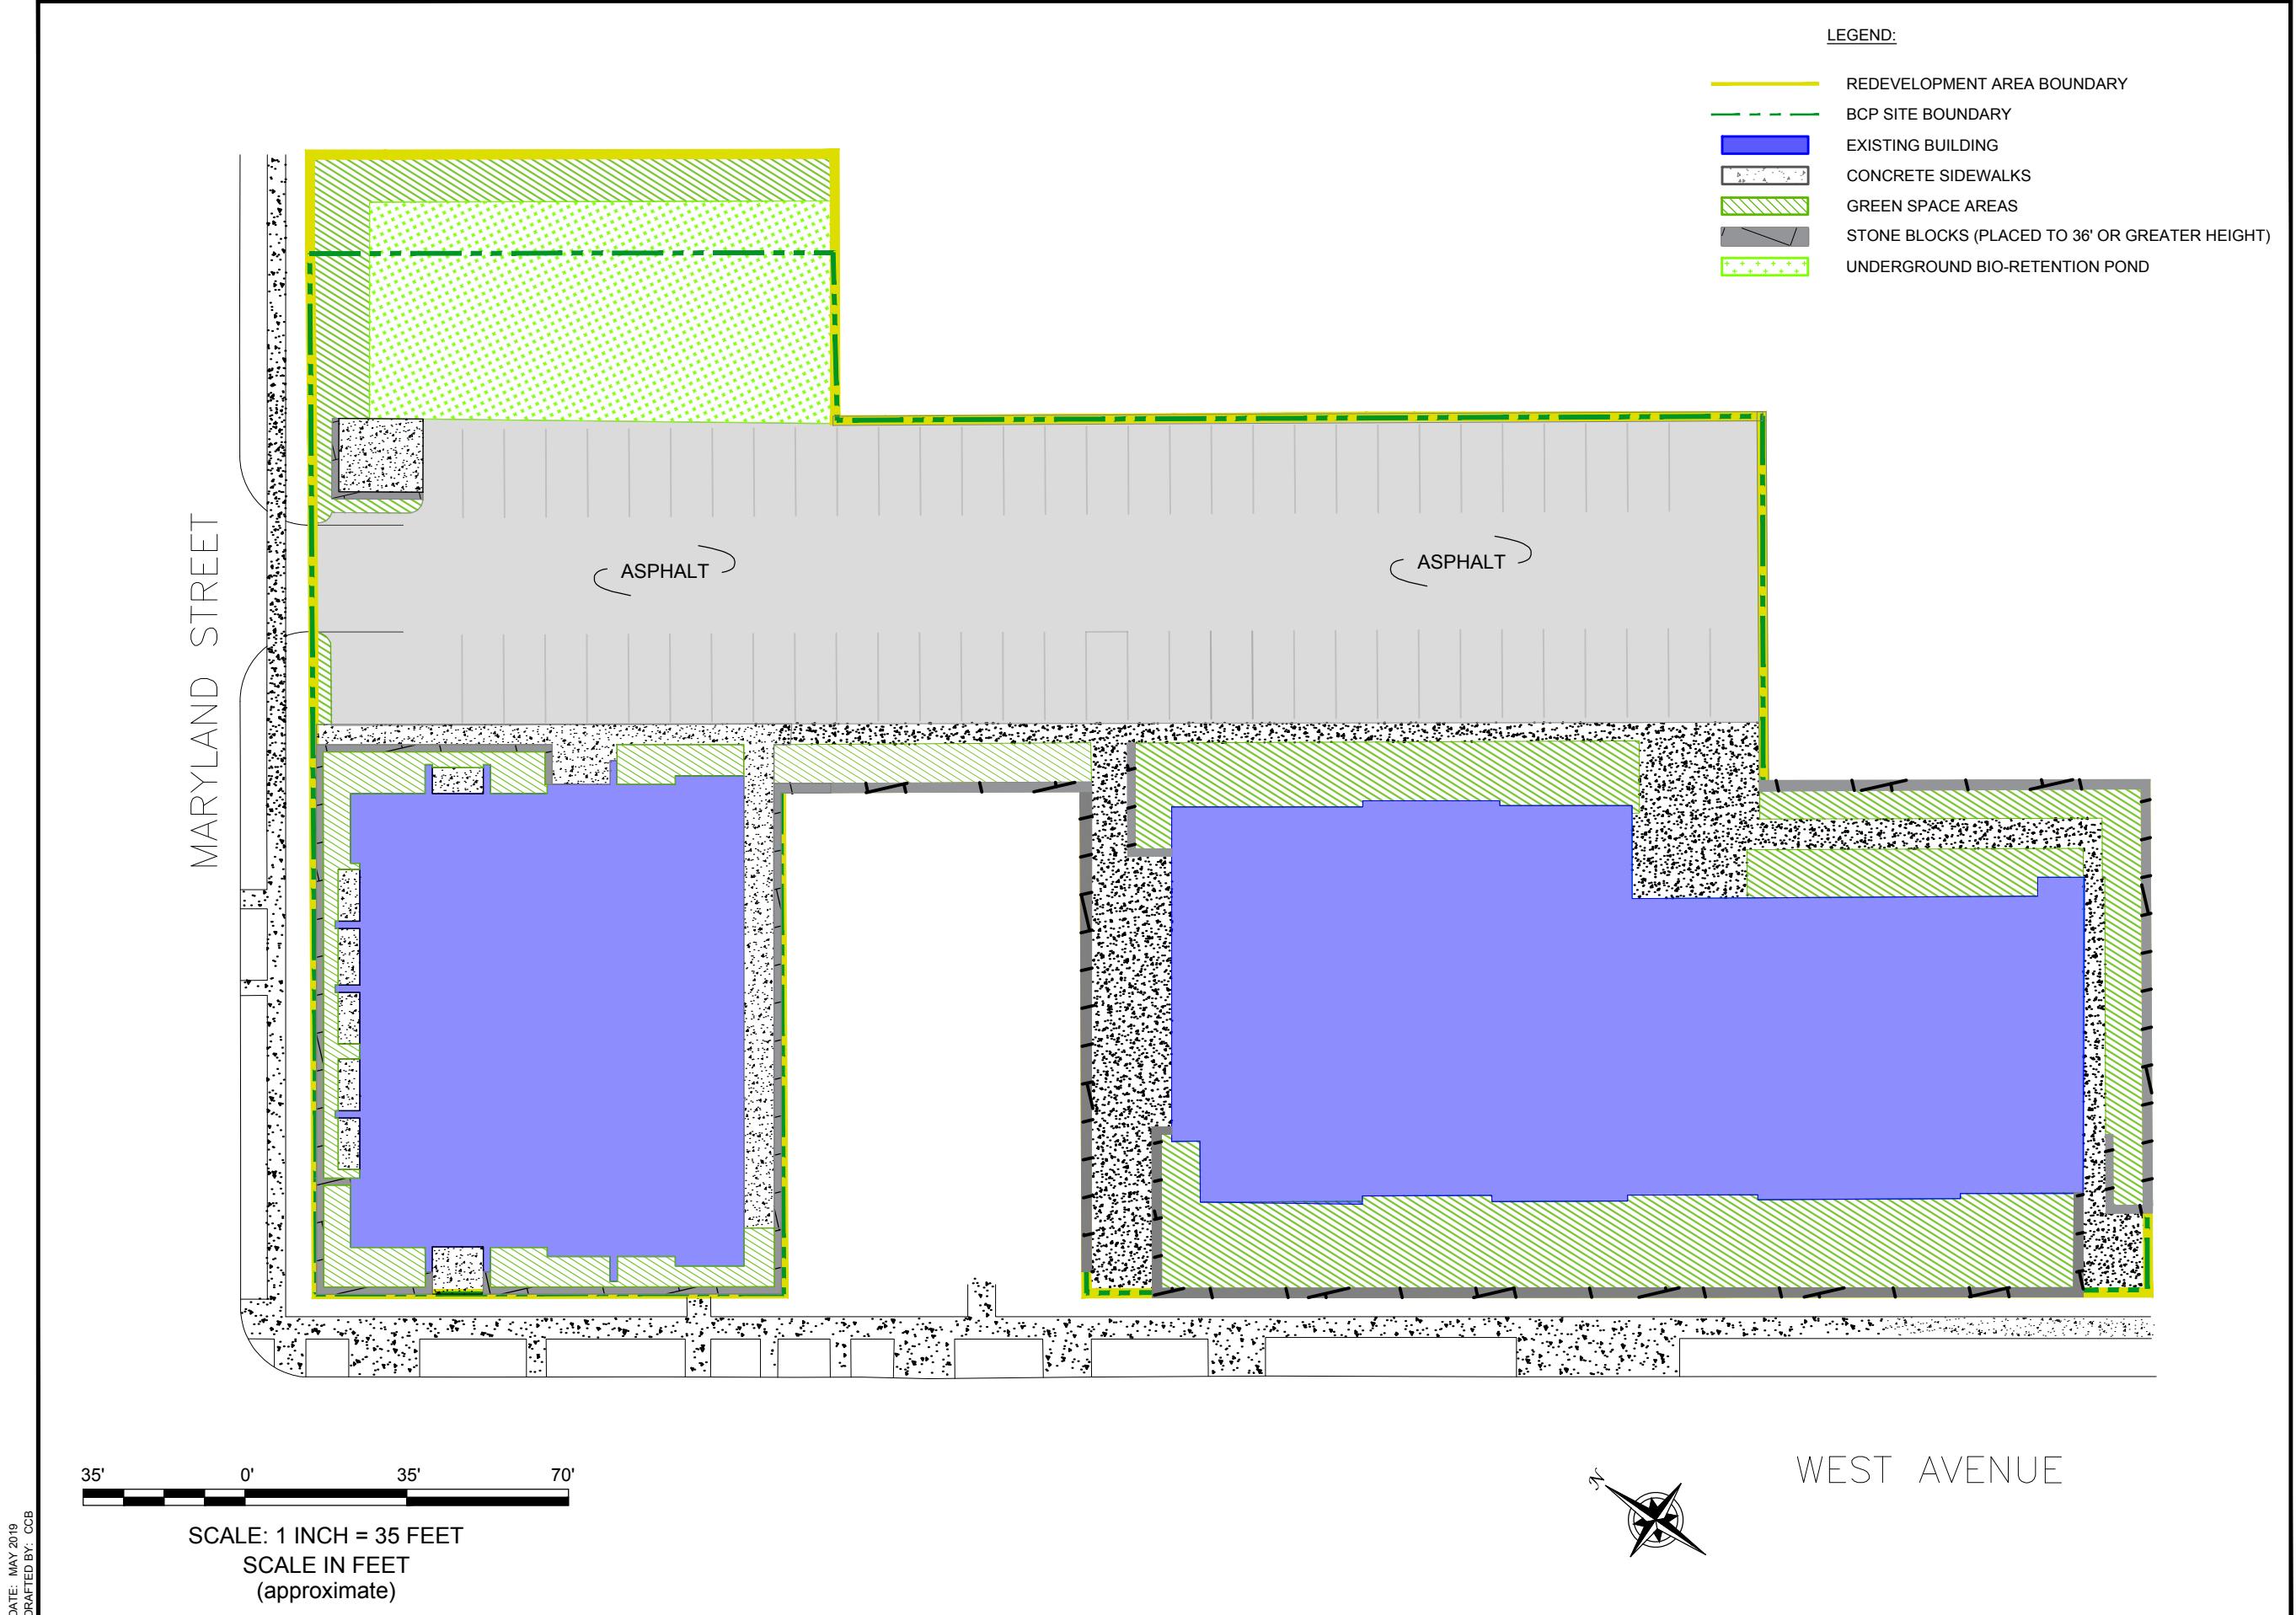
**FIGURE 3**

Benchmark personnel will be present during construction of the BCP cover elements to verify that hardscape cover elements, subbase, and cover material thicknesses are constructed in general accordance with the municipally-approved civil design and that soil cover areas are constructed in accordance with Part 375 and DER-10 requirements. The planned cover system layout for the redevelopment area is provided on Figure 3.

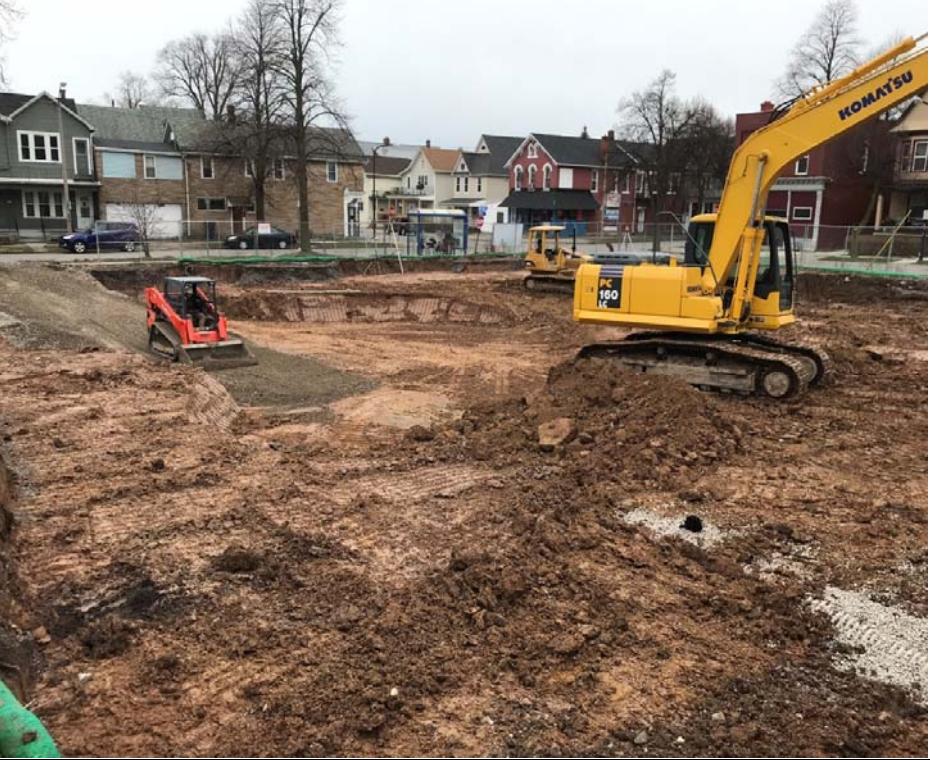
Client Name:		Site Location:	Project No.:
295 Maryland, LLC		295 Maryland Street Site (C915242)	B0222-019-001
Photo No.	Date		
3	04/16/19		
Direction Photo Taken: Northwest

A photograph of a construction site in a residential area. In the foreground, there is a large pile of brown earth and some smaller piles of gravel or aggregate. Two yellow excavators are visible: one is positioned on the right side, and another smaller one is further back on the left. In the background, there is a row of houses and some bare trees under a clear sky.	
<b>Description:</b> Site Improvement Activities: Excavation and removal activities for Campus West Building foundation.

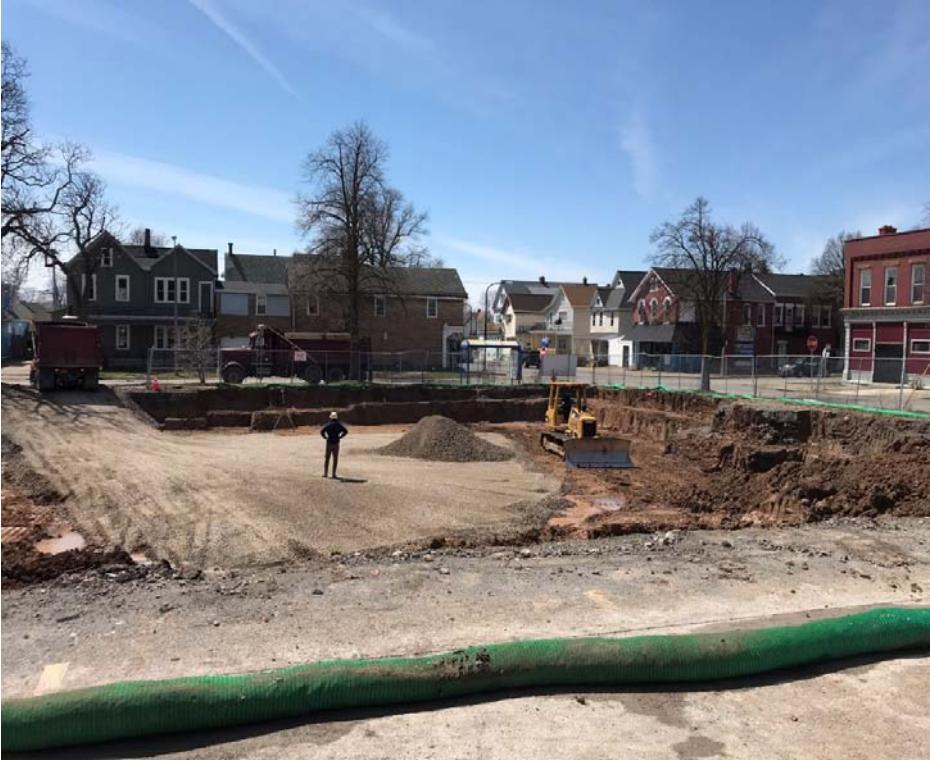
Photo No.	Date		
4	04/23/19		
Direction Photo Taken: West/Northwest

A photograph of a construction site showing the early stages of foundation work. A person stands in the center of the site, which is a mix of dirt and gravel. In the background, several vehicles are parked or working, including a red truck, a white truck, and a yellow excavator. A large green hose runs across the bottom of the frame. Residential buildings are visible behind the site under a clear blue sky.	
<b>Description:</b> Site Improvement Activities: Campus West Building foundation preparation.

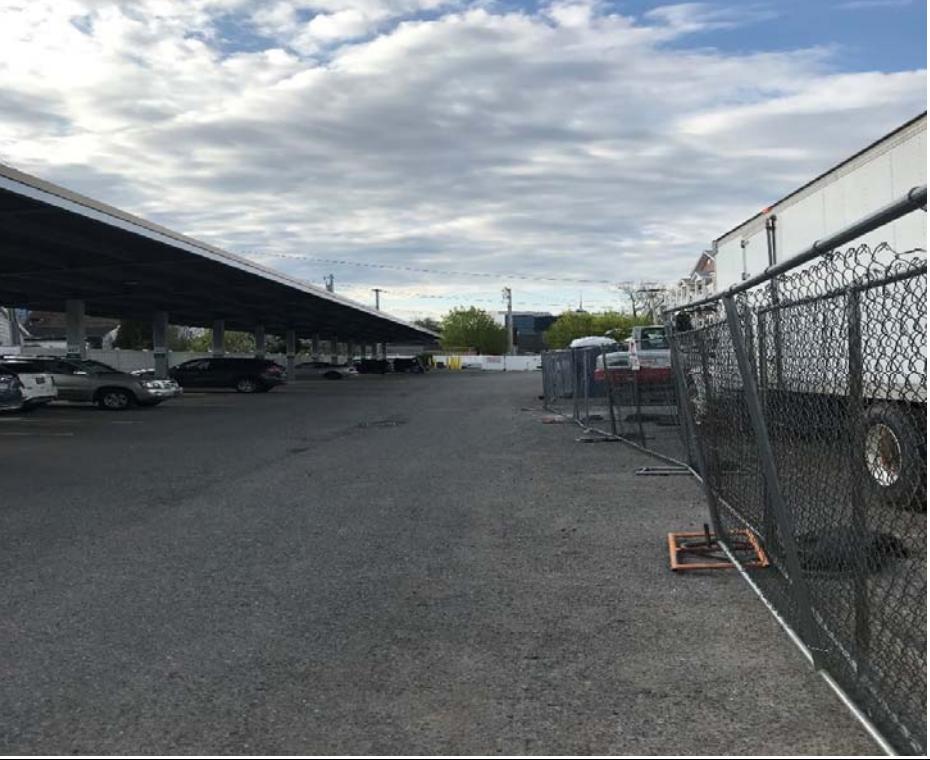
Client Name:		Site Location:	Project No.:	
295 Maryland, LLC		295 Maryland Street Site (C915242)	B0222-019-001	
Photo No.	Date			
5	05/15/19

A photograph showing a paved parking lot under a large concrete overpass. Several cars are parked in the lot. To the right, there is a chain-link fence enclosing a portion of the site. The sky is cloudy.		
Direction Photo Taken:		Southeast		
Description:		Annual Site Inspection: Asphalt paved parking lot.

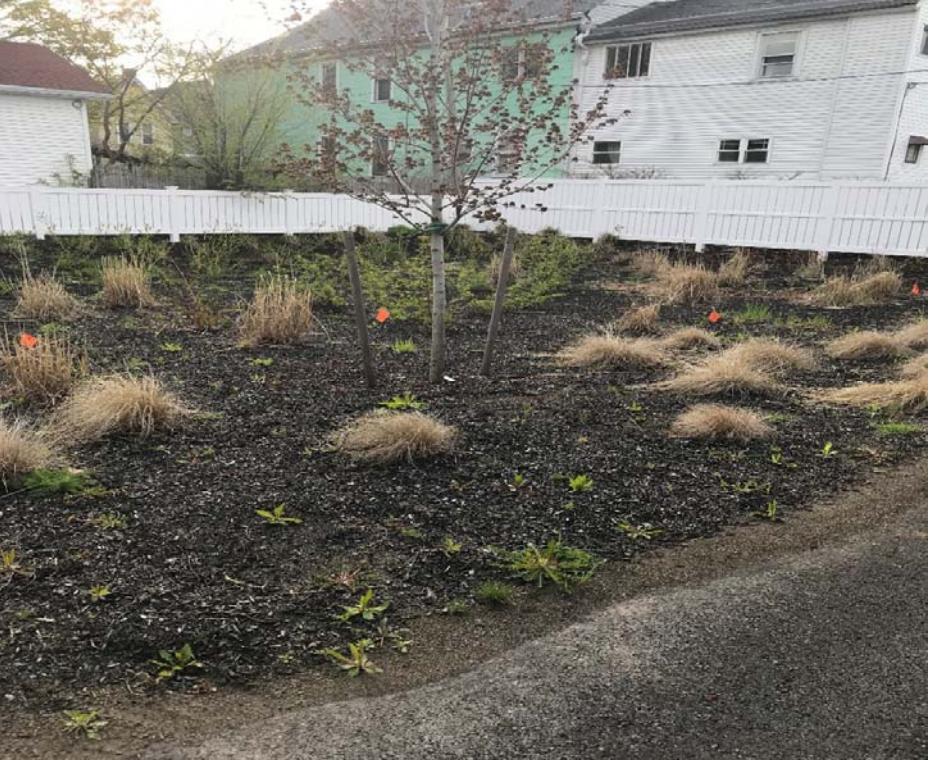
Photo No.	Date	
6	05/15/19	
Direction Photo Taken:		
East		
Description:		
Annual Site Inspection: Bioretention area.

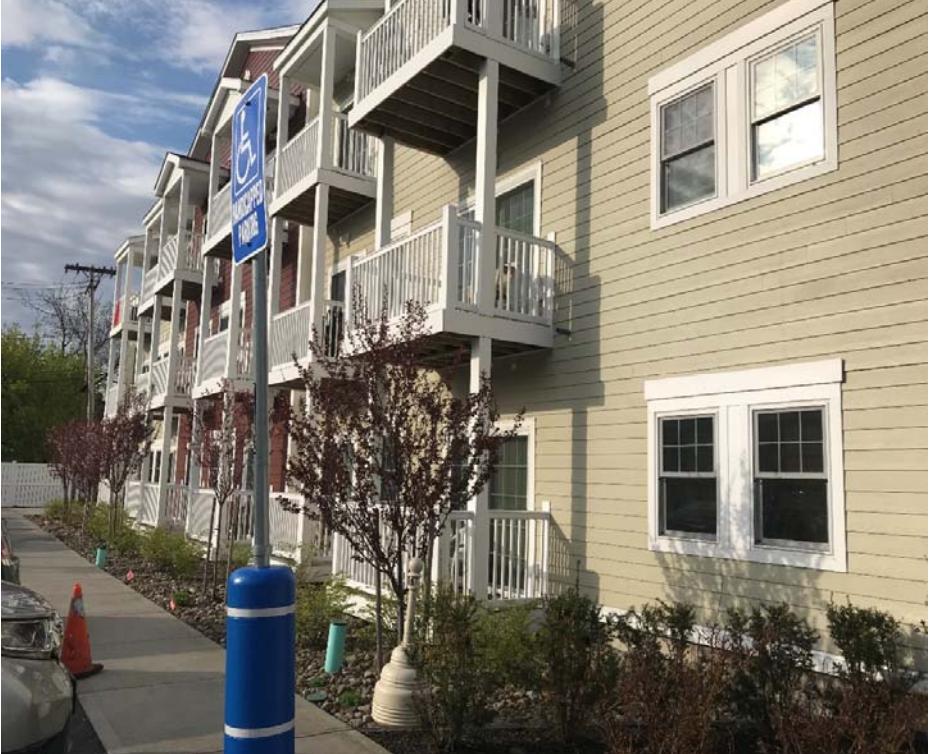
Client Name:		Site Location:	Project No.:
295 Maryland, LLC		295 Maryland Street Site (C915242)	B0222-019-001
Photo No.	Date		
7	05/15/19		
<b>Direction Photo Taken:</b> Southwest			
<b>Description:</b> Annual Site Inspection: Eastern side of the existing building.

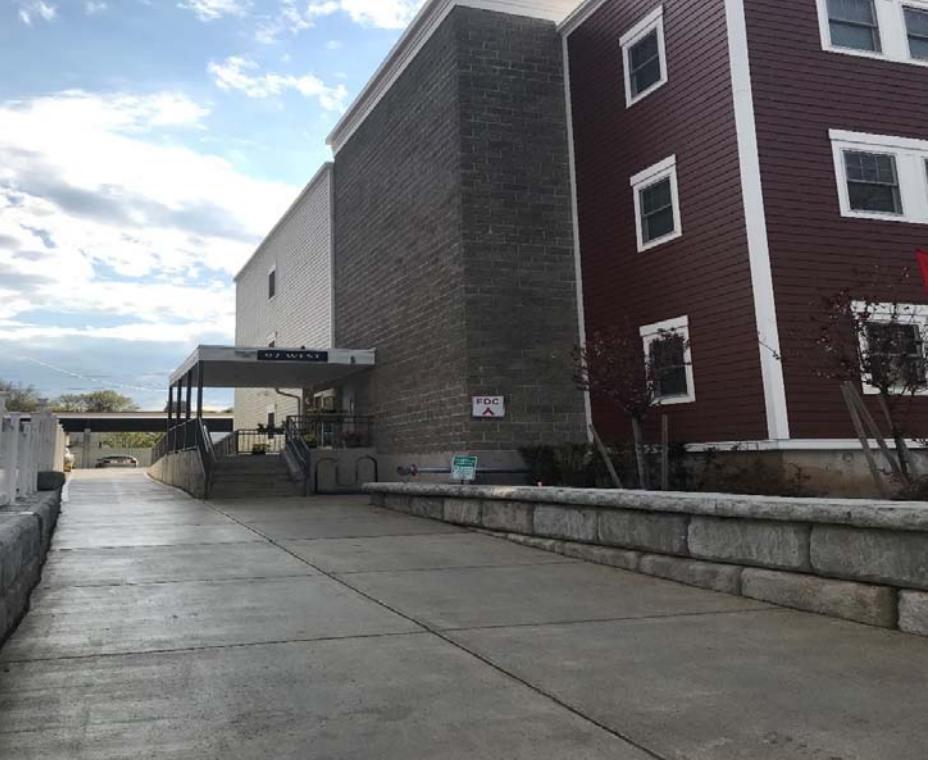
Photo No.	Date	
8	05/15/19	
<b>Direction Photo Taken:</b> East/Northeast		
<b>Description:</b> Annual Site Inspection: North side of the existing building.

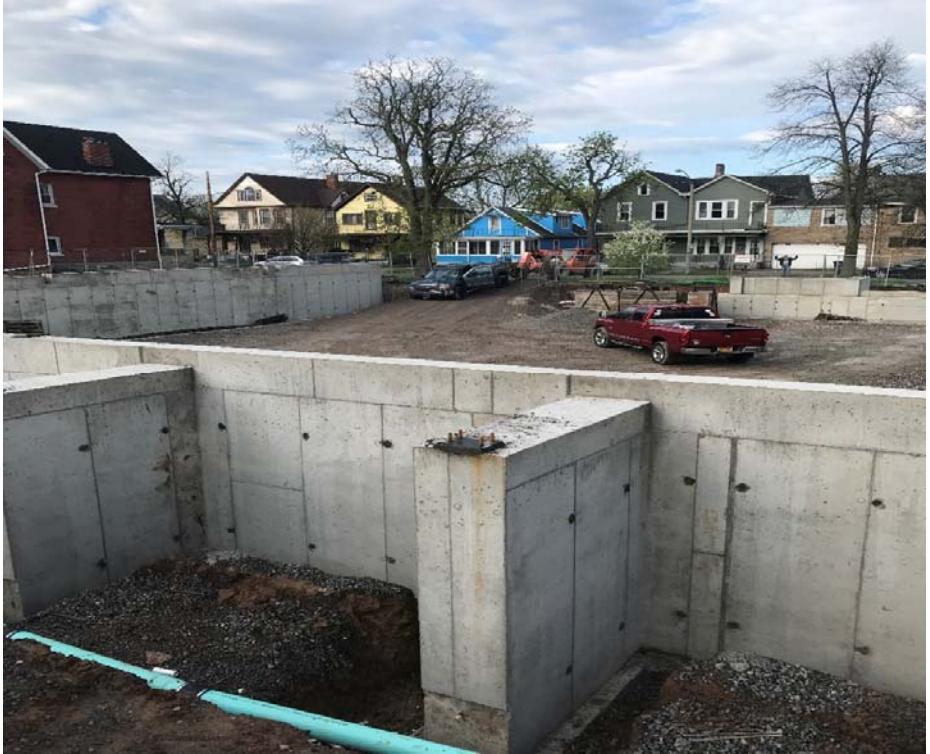
Client Name:		Site Location:	Project No.:
295 Maryland, LLC		295 Maryland Street Site (C915242)	B0222-019-001
Photo No.	Date		
11	05/15/19		
Direction Photo Taken:			
East

A photograph showing a construction site. In the foreground, there are two long, vertical concrete walls. Between them, a pile of dark gravel or aggregate sits on the ground. A bright blue plastic pipe lies across the gravel. In the background, there's a dirt area with some construction equipment, including a red pickup truck and an orange utility vehicle. Beyond the construction site, there's a row of residential houses under a cloudy sky.
Description:			
Annual Site Inspection: Campus West Building construction activities.

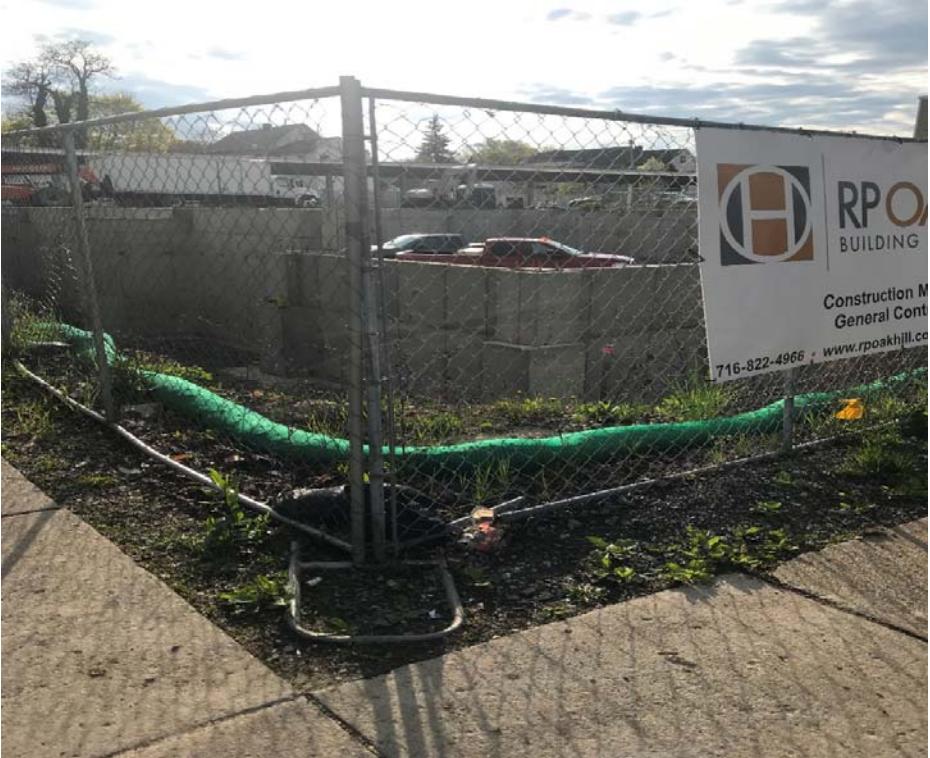
Photo No.	Date	
12	05/15/19	
Direction Photo Taken:		
Southeast

A photograph taken from a sidewalk in front of a chain-link fence. Behind the fence, a red pickup truck is parked in a dirt area. To the right of the truck, there's a white sign with a logo consisting of a stylized 'H' inside a circle, followed by the letters 'RPO' and the word 'BUILDING'. Below the logo, it says 'Construction M' and 'General Cont'. At the bottom of the sign, there's a phone number '716-822-4966' and a website 'www.rpoakhill.com'. A green garden hose lies on the ground in front of the fence. The background shows some trees and other buildings under a cloudy sky.
Description:		
Annual Site Inspection: Campus West Building construction activities.
