Periodic Review Report

295 Maryland Street Site
NYSDEC BCP #C915242
289 & 291 Maryland Street and
97 & 129 West Avenue
Buffalo, New York

Revised August 2024

(April 16, 2021 to April 16, 2024 reporting period)

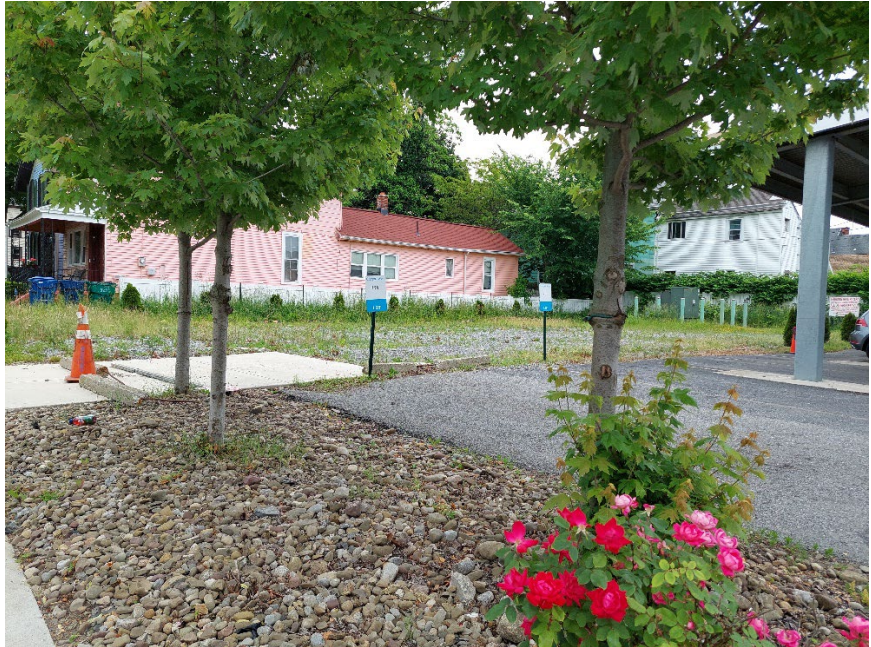
10	06/05/2024		
Direction Photo Taken:			
Description:			
View from Maryland Street looking east
