**Subject: Geophysical Survey Results, 300 Ohio Street, Buffalo, NY**

This letter report presents the results of the geophysical investigation performed for National Vacuum in support of their environmental investigation of a property located at 300 Ohio Street in Buffalo, NY. We understand that historical information compiled by others suggests that this property once operated as an automotive fuel station.

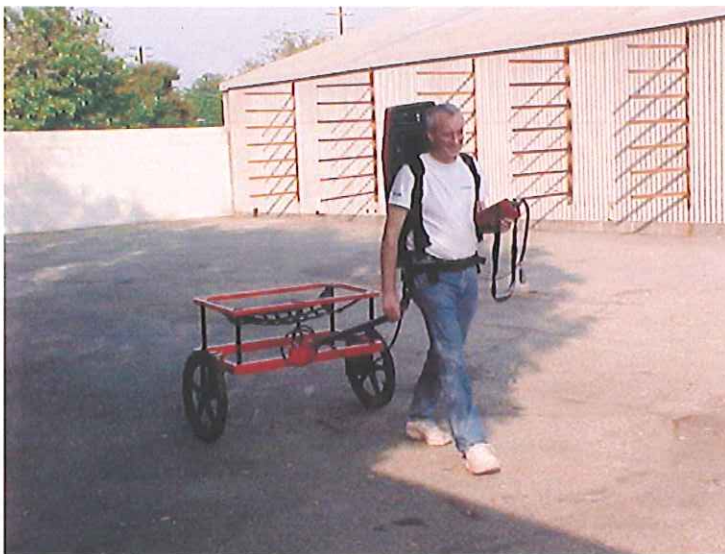
EM61 in use (photo not from this site)

The site was geophysically surveyed using the Geonics EM61. The EM61 unit is a high sensitivity, high resolution time domain electromagnetic (TDEM) metal detector that can detect both ferrous and nonferrous metallic objects. It has an approximate investigation depth of 10 feet. The processing console is contained in a backpack worn by the operator which is

interfaced to a digital data logger. The transmitter and two receiver coils are located on a two-wheeled cart that is pulled by the operator.

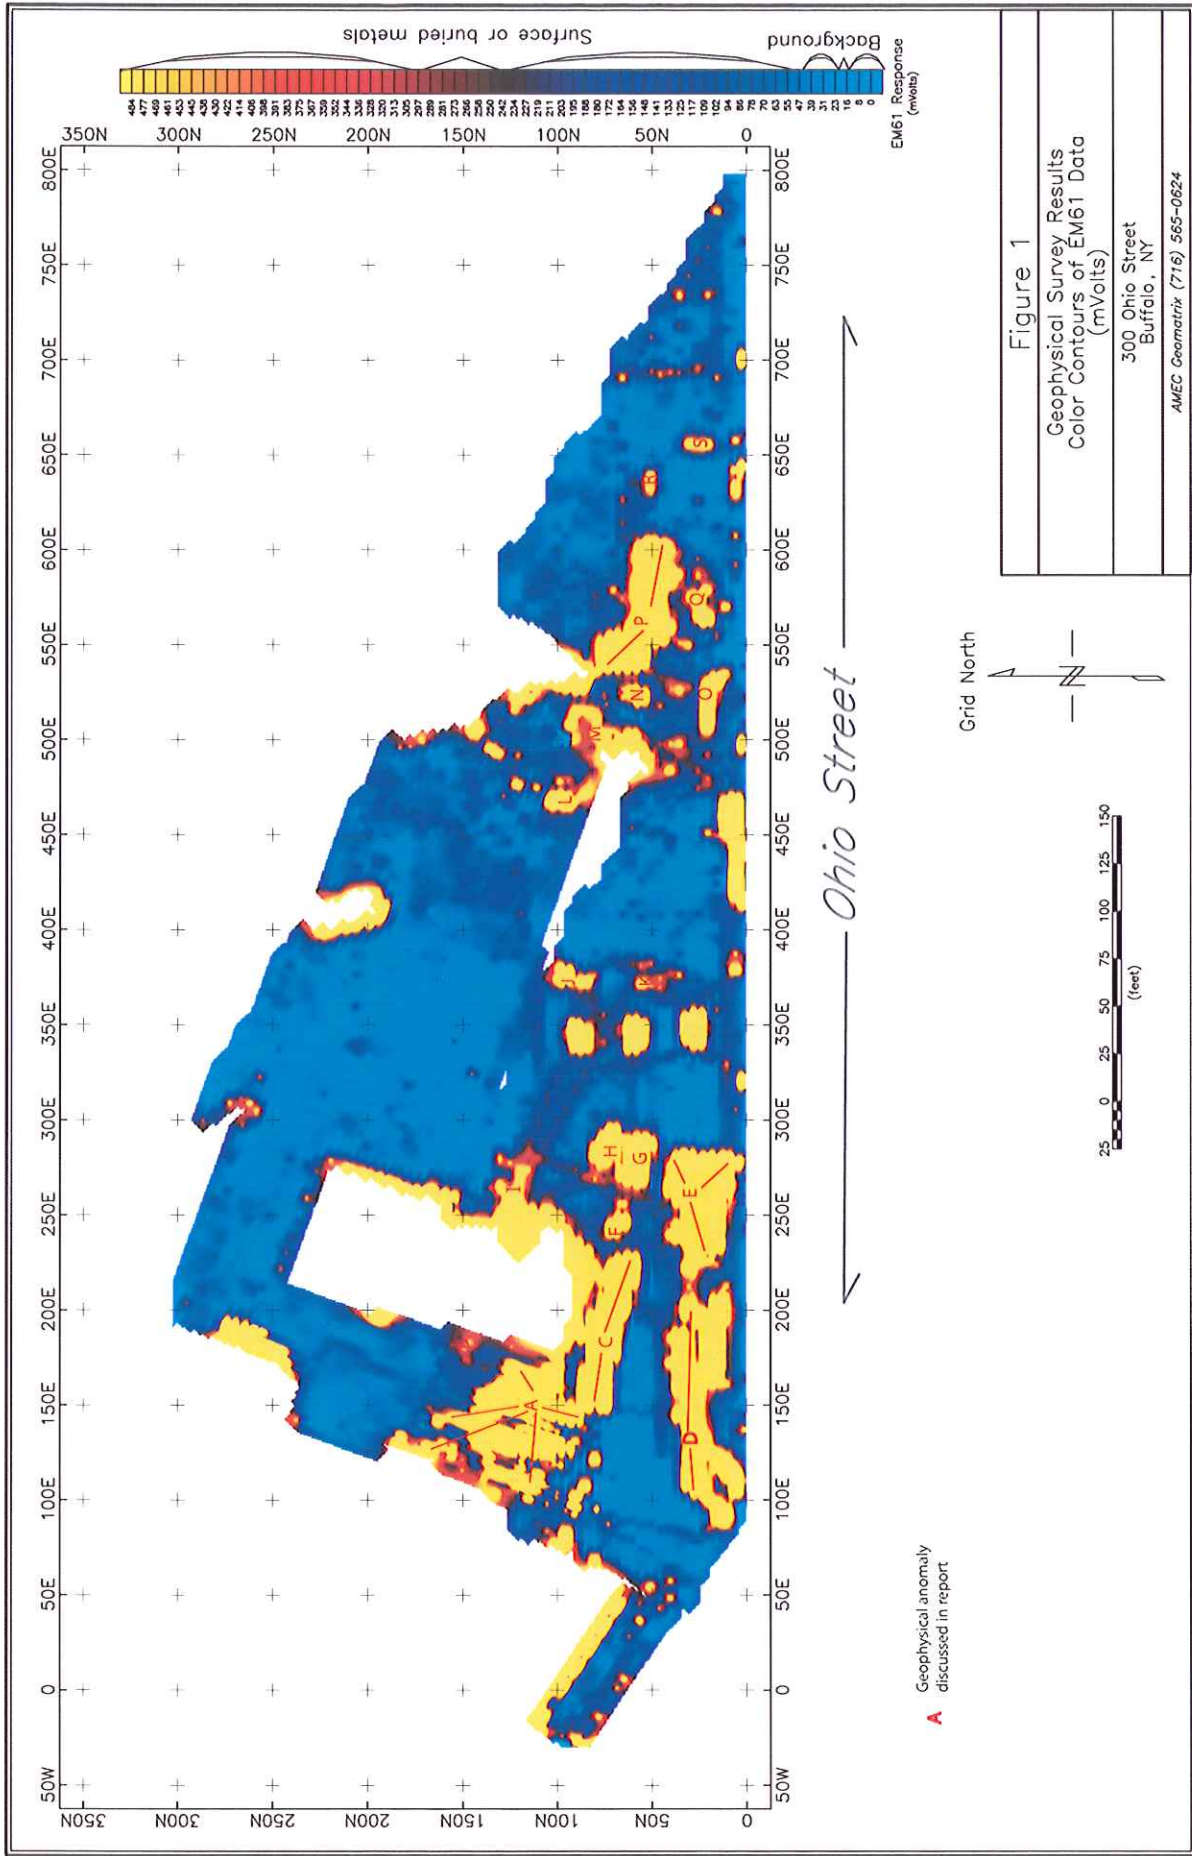
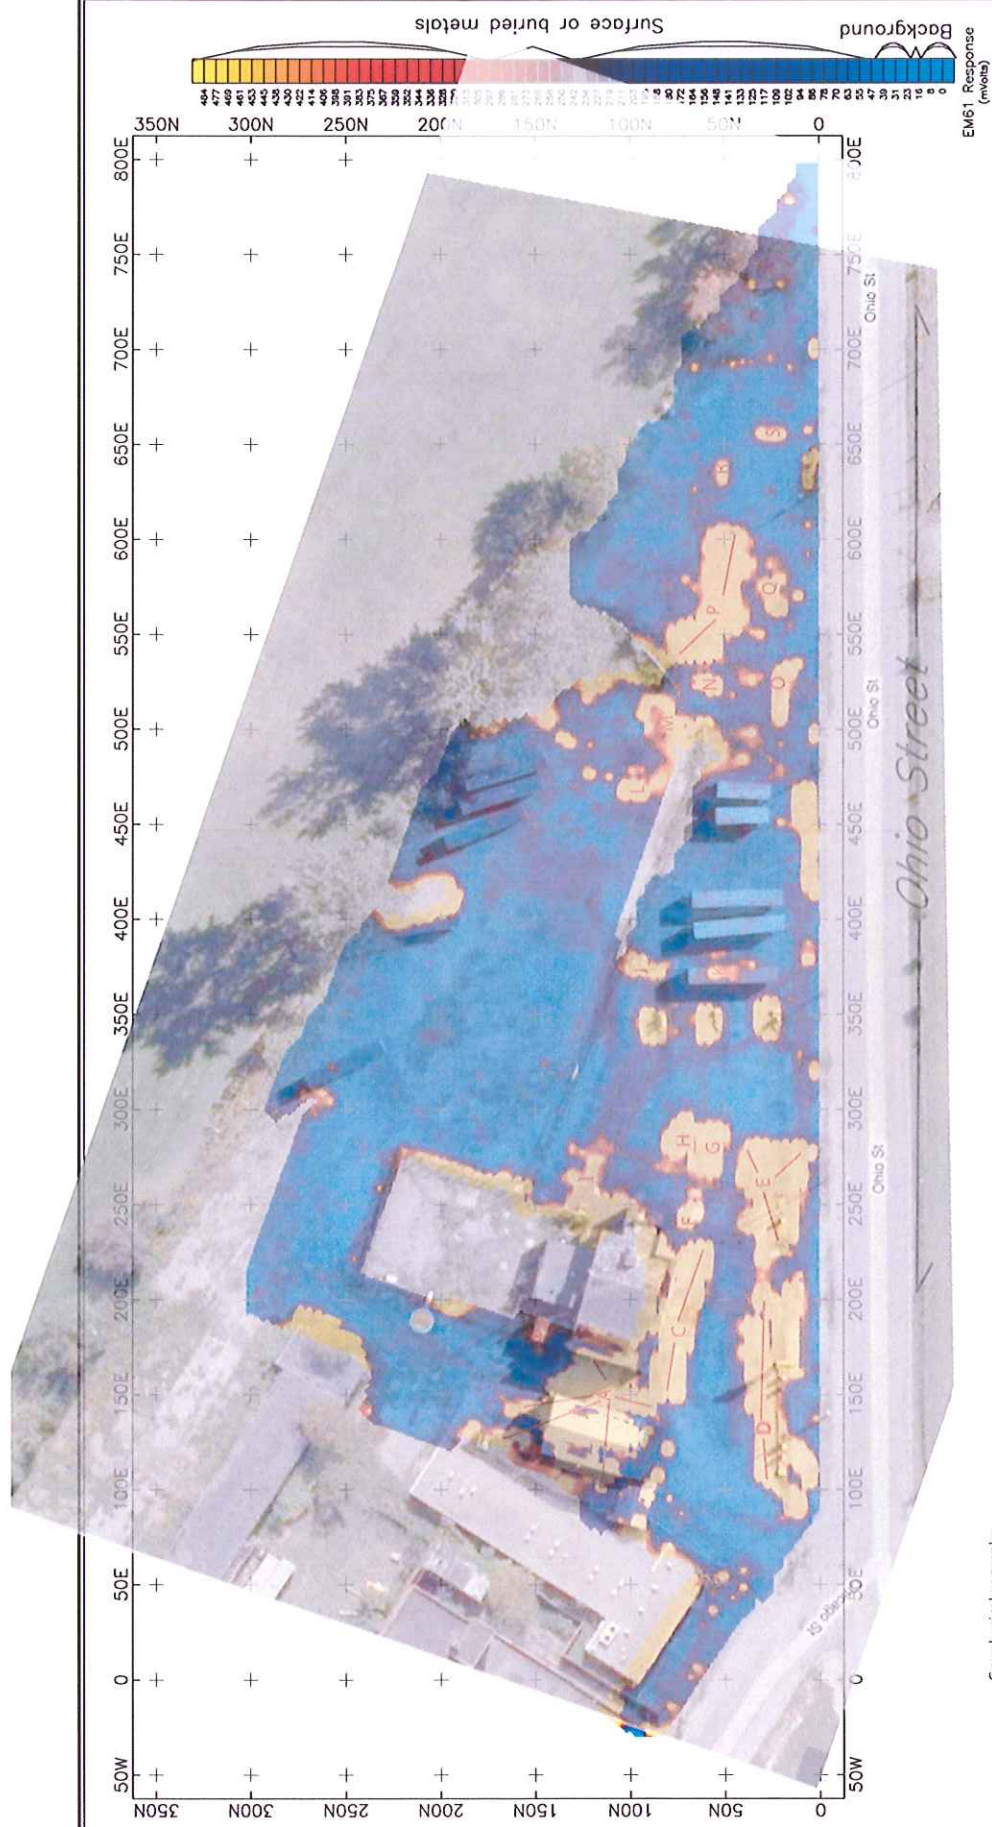
**A** Geophysical anomaly discussed in report

The EM61 data for the site are shown in Figures 1 through 3. The color bar to the right of the maps indicates the colors associated with the respective measured values. Areas suspected to be free of buried metals are shown as color shades of blue. All areas exhibiting a response greater than background (0 to 40 mVolts) likely contain buried metals. These areas are depicted in shades of dark blue through yellow on the figures.

Figure 2 shows the geophysical data overlain with an air-photo. Figure 3 shows the geophysical data overlain with a historic site map showing UST's that was provided by the DEC.

Numerous surface and buried metal anomalies are observed on the figures and are shown in shades of yellow. Several linear anomalies, likely related to buried pipes, are shown in shades of dark blue.

Anomalies interpreted to be potentially significant are labeled A through S on the figures. These anomalies likely represent buried metal objects and are potentially UST's. Other explanations for the anomalies may be that some relate to miscellaneous buried metal objects. The airphoto (Figure 2) suggests that Anomalies in the region of "A" may be related to the footprint of a former building.
