APPENDIX A

TEST TRENCH & MONITORING WELL PARAMETERS

PROJECT: 4630 River Road - Tonawanda, NY		SHEET: 1 OF 1
CLIENT: Giuseppe Holdings, LLC	JOB NUMBER: Site #C915258	
CONTRACTOR: Panamerican Environmental, Inc.	LOCATION: 4630 River Rd, Tonawanda	
DATE STARTED: January 31, 2013	GROUND ELEVATION: N/A	
DATE COMPLETED: January 31, 2013	OPERATOR: Robert Broomfield	
PIT NUMBER: RiRo-TP-01	GEOLOGIST: J. Ryszkiewicz	
	GROUND WATER: N/A

**NYSDEC Site No. C915258
4630 River Road
Tonawanda, New York**

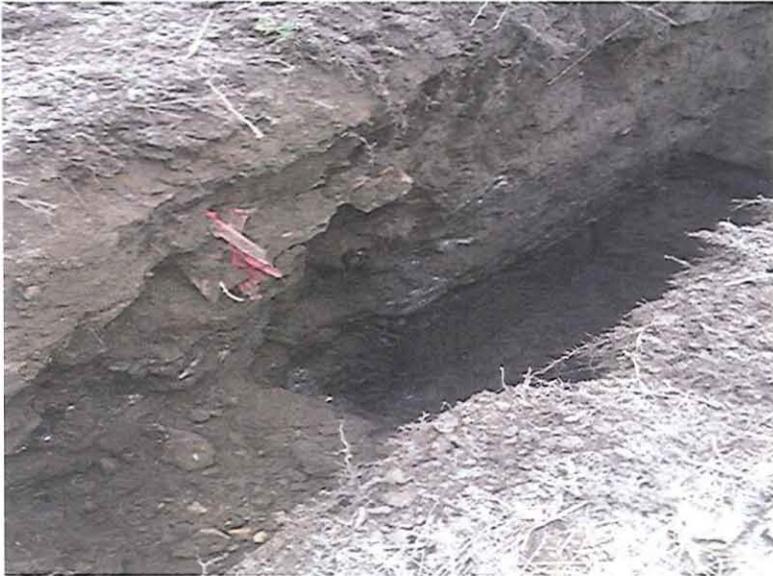
Photograph 1. View of RiRo-01 stratigraphy

DEPTH (FT)	SAMPLE		DESCRIPTION
	NO.	TYPE	
1	01A		<p>- Black and light brown, fill including pieces of asphalt, concrete, brick, wood, C-F (course to fine) gravel and M-F (medium to fine) sand. Layer had a strong odor of petroleum or cresol. Stratigraphy was wet from 6 to 8.5'bgs.</p> <hr style="width: 50%; margin-left: 0;"/> <p>- Grey and black, clay with traces of silt, M-F sand and C-F gravel. Material was damp to wet.</p> <p>Ended test trench @ 12.5 ft. bgs</p>
2			
3			
4			
5			
6			
7	01B		
8			
9			
10			
11			
12

COMMENTS: Size of Test Pit: 12.5'D x 5'W x 10'L
 Surface and Subsurface Soil samples were taken at this location (0-0.5' and 6-7.5' bgs)

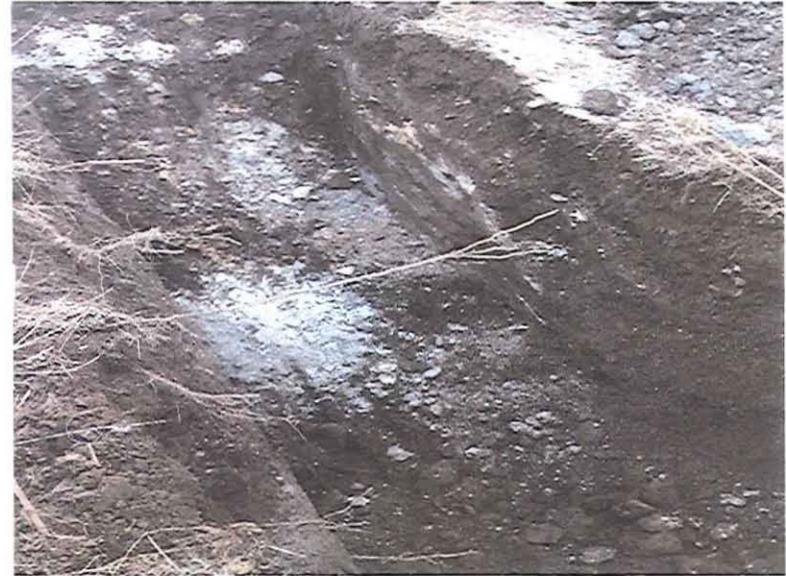
Photograph 2. View of RiRo-03 stratigraphy

DEPTH (FT)	SAMPLE		DESCRIPTION
	NO.	TYPE	
1			
2			
3			
4			- Black and light brown, fill including pieces of asphalt, concrete, brick, wood, pipes, ash, C-F (course to fine) gravel and M-F (medium to fine) sand. Stratigraphy was wet from 6 to 8' bgs.
5			
6			
7			
8			
9			- Grey, clay with traces of silt, M-F sand and C-F gravel. Material was damp to wet.
10			Ended test trench @ 10 ft. bgs
11			
12

COMMENTS: Size of Test Pit: 10'D x 5'W x 8'L

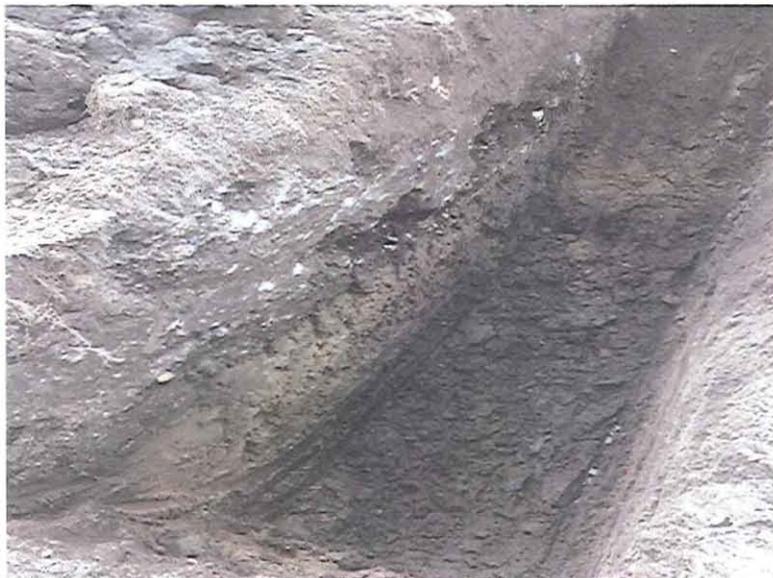
Photograph 3. View of RiRo-05 stratigraphy

DEPTH (FT)	SAMPLE		DESCRIPTION
	NO.	TYPE	
1			- Black and dark brown, fill including pieces of asphalt, concrete, brick, wood, pipes, C-F (course to fine) gravel and M-F (medium to fine) sand.
2			
3			
4			
5			
6			- Light brown, loose silty clay with traces of C-F gravel and M-F sand.
7			- Grey, clay with traces of silt, M-F sand and C-F gravel. Material was damp.
8			
9			
10			
11			
12

COMMENTS: Size of Test Pit: 12'D x 6'W x 9'L

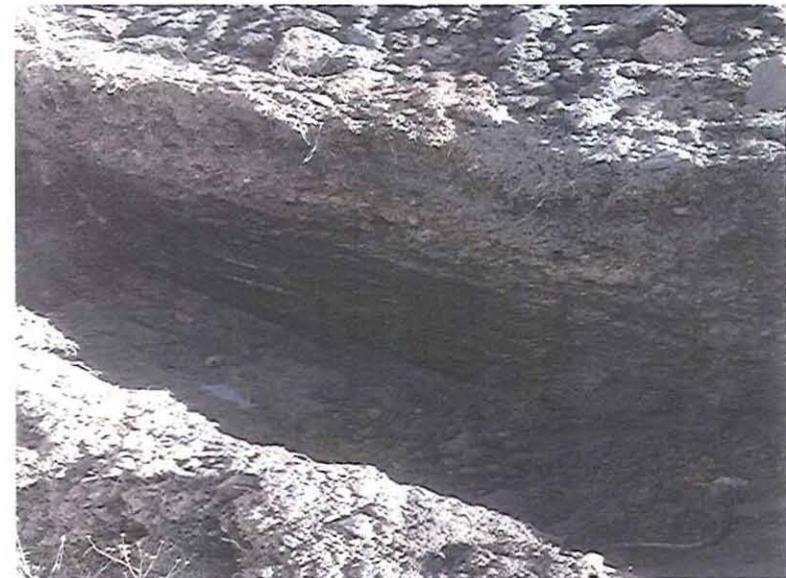
Photograph 4. View of RiRo-08 stratigraphy

DEPTH (FT)	SAMPLE		DESCRIPTION
	NO.	TYPE	
1	08A		- Black and light brown, fill including pieces of asphalt, concrete, brick, wood, C-F (course to fine) gravel and M-F (medium to fine) sand. Stratigraphy was wet from 5 to 6' bgs. - Grey and black, clay with traces of silt, M-F sand and C-F gravel. Material was damp to wet. Ended test trench @ 11 ft. bgs
2			
3			
4	08B		
5			
6			
7			
8			
9			
10			
11			
12

COMMENTS: Size of Test Pit: 11'D x 6'W x 8'L
 Surface and Subsurface Soil samples were taken at this location (0-0.5' and 4' bgs)

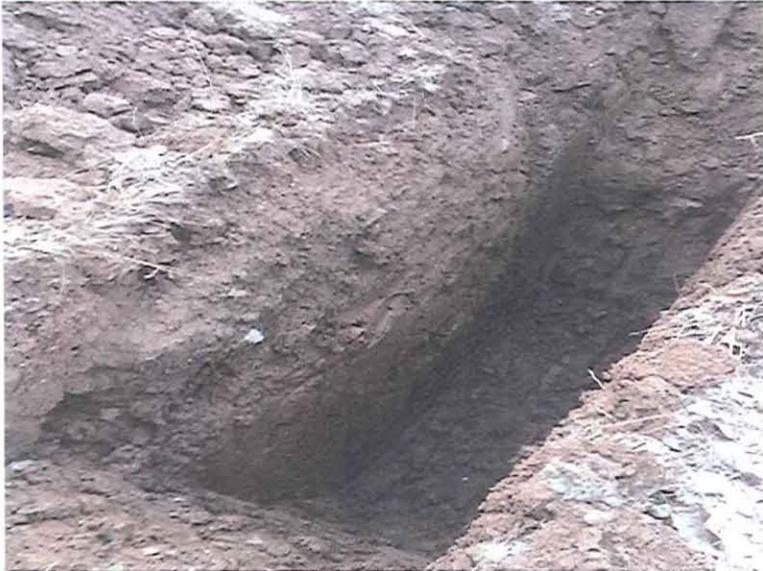
Photograph 5. View of RiRo-11 stratigraphy

DEPTH (FT)	SAMPLE		DESCRIPTION
	NO.	TYPE	
1			
2			
3			
4			- Black and light brown, fill including pieces of concrete, ash, brick, wood, C-F (course to fine) gravel and M-F (medium to fine) sand within silty clay.
5			
6			
7			
8	11		- Dark green and black, M-F sand with organics. Layer was damp.
9			
10			- Grey and black, clay with traces of silt, M-F sand and C-F gravel. Material was damp to wet.
11			Ended test trench @ 11 ft. bgs
12

COMMENTS: Size of Test Pit: 11'D x 5'W x 9'L
 Subsurface Soil sample was taken at this location (7-9' bgs)

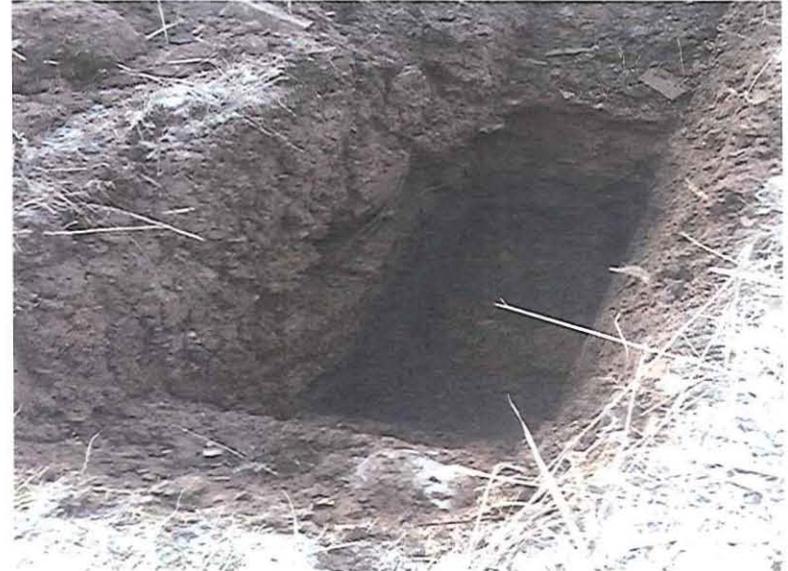
Photograph 6. View of RiRo-13 stratigraphy

DEPTH (FT)	SAMPLE		DESCRIPTION
	NO.	TYPE	
1			- Black and light brown, fill including pieces of concrete, ash, brick, wood, C-F (course to fine) gravel and M-F (medium to fine) sand within silty clay.
2			
3			
4			
5			
6			
7			
8	13		- Dark green and black, M-F sand with organics. Layer was damp.
9			- Grey and black, clay with traces of silt, M-F sand and C-F gravel. Material was damp to wet.
10			
11			
12			
			Ended test trench @ 11 ft. bgs

COMMENTS: Size of Test Pit: 11'D x 5'W x 9'L
 Subsurface Soil sample was taken at this location (7-9' bgs)

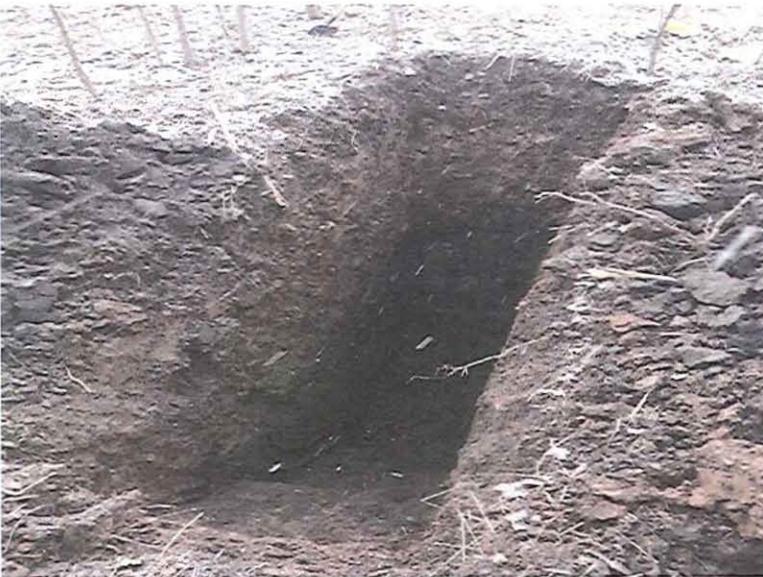
Photograph 7. View of RiRo-16 stratigraphy

DEPTH (FT)	SAMPLE		DESCRIPTION
	NO.	TYPE	
1	16A		- Black and light brown, fill including pieces of concrete, brick, wood, C-F (course to fine) gravel and M-F (medium to fine) sand. Heavy "spray paint" type odor from 4-6' bgs. Stratigraphy was wet from 5 to 6'bgs.
2			
3			
4			
5	16B		
6			- Grey and black, clay with traces of silt, M-F sand and C-F gravel. Material was damp to wet.
7			
8			
9			
10			Ended test trench @ 10 ft. bgs
11			
12

COMMENTS: Size of Test Pit: 10'D x 6'W x 9'L
 Surface, Subsurface and MS/MSD Soil samples were taken at this location (0-0.5' and 4-6' bgs)

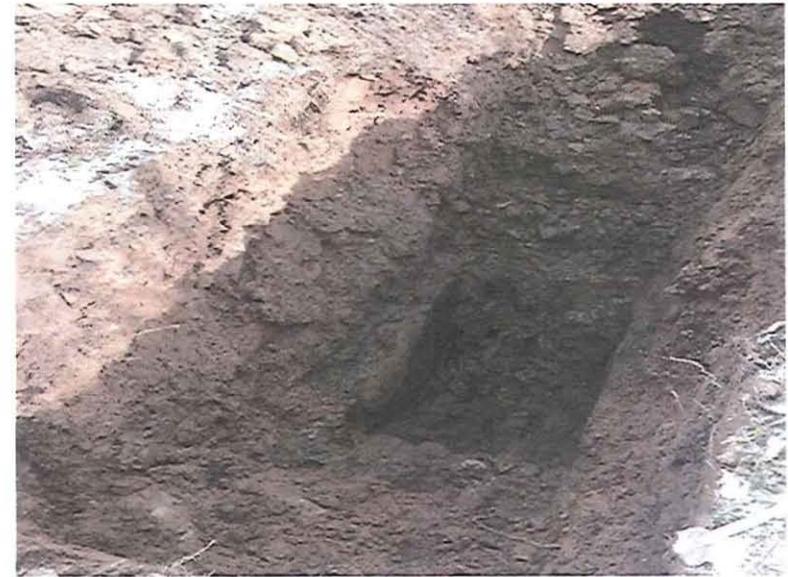
Photograph 8. View of RiRo-17 stratigraphy

DEPTH (FT)	SAMPLE		DESCRIPTION
	NO.	TYPE	
1			
2			
3			
4			- Black and light brown, fill including pieces of concrete, ash, brick, wood, C-F (course to fine) gravel and M-F (medium to fine) sand within silty clay.
5			
6			
7			
8			- Dark green and grey, M-F sandy clay. Layer was damp.
9			
10			- Grey and black, clay with traces of silt, M-F sand and C-F gravel. Material was damp to wet.
11			
12			Ended test trench @ 11 ft. bgs

COMMENTS: Size of Test Pit: 11'D x 7'W x 10'L
