2021 PERIODIC REVIEW REPORT 129 HOLDEN STREET REDEVELOPMENT BUFFALO, NEW YORK BROWNFIELD CLEANUP PROGRAM Site Number C915261

Re: 2021 Periodic Review Report
129 Holden Street Redevelopment
Buffalo, New York
Brownfield Cleanup Program Site (Number C915261)

GZA performed a Site Inspection during the reporting period on February 5, 2021. The completed Site Inspection Form is provided in **Attachment I**. A photo log is provided in **Attachment II** and a map showing the location and orientation of the Site photos is provided as **Figure 2**. The Site cover system was observed to be in place and functioning as intended. One small area of the soil cover system exhibited depressions from vehicle tires and missing grass cover. This area should be repaired during the upcoming growing season and is identified on **Figure 2**. A photo of the area in need of repair is provided in Attachment II, Photo #15. In addition, discarded vehicle tires were noted at several locations on Site along the southern Site fence, see **Figure 2** and photos 5, 6, and 7 in the photo log (**Attachment II**).

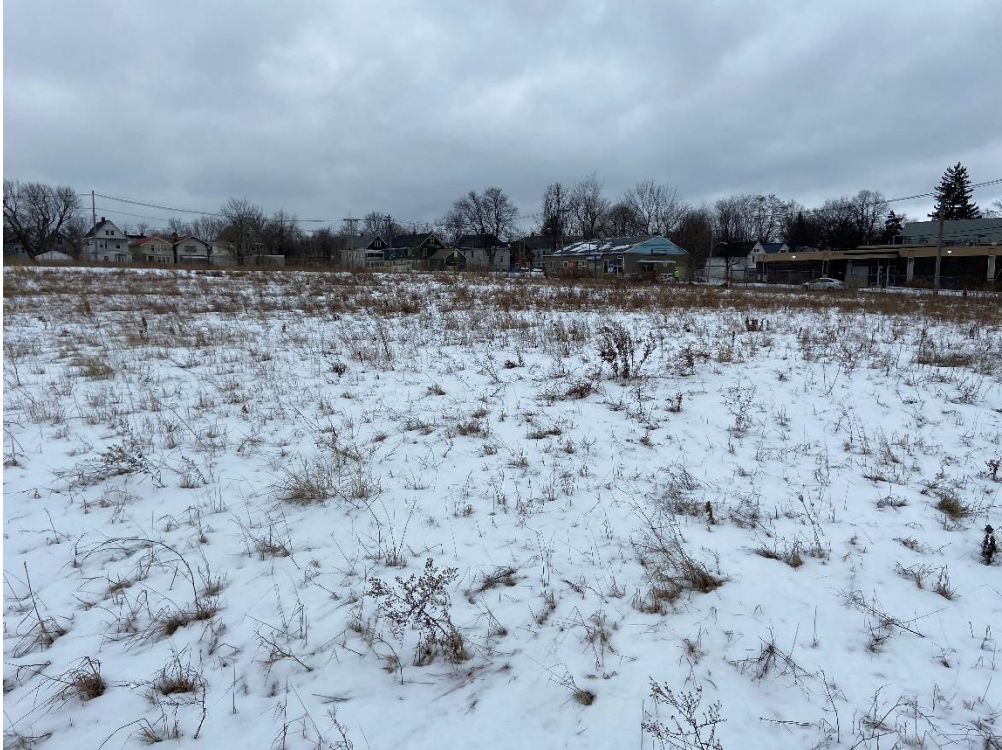
Client Name: Highland Park Village LLC		Site Location: 129 Holden Street, Buffalo, NY	Project No. 21.0056642.30
Photo No. 1	Date: 2-5-21

Direction Photo Taken: Southwest			
Description: View of SW corner of Site.

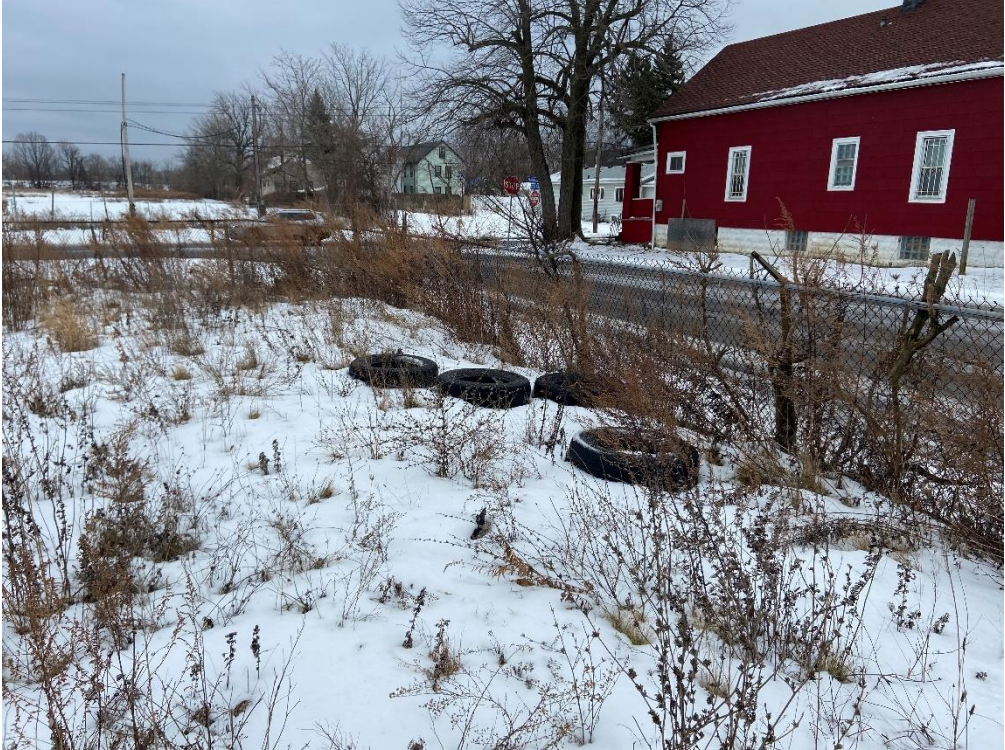
Client Name: Highland Park Village LLC		Site Location: 129 Holden Street, Buffalo, NY	Project No. 21.0056642.30
Photo No. 7	Date: 2-5-21

At four locations along the Site perimeter, solid waste debris including rubber vehicle tires and construction supplies were observed as was one small area of stressed vegetation caused by vehicle parking on the soil cover. See photos #5, #6, #7, #11, and #15 in **Attachment II**. The presence of these areas of waste dumping and minor cover damage was discussed with a representative of Highland.

Direction Photo Taken: ESE			
Description: More scrap tires located at the southeastern corner of the Site.

GZA identified no evidence of significant non-compliance with the SMP, just two minor issues (tire ruts and debris dumping) that will be address by the owner. The IC/ECs remain in place and are performing as intended and there are no active remedial systems requiring operation, monitoring, or maintenance.

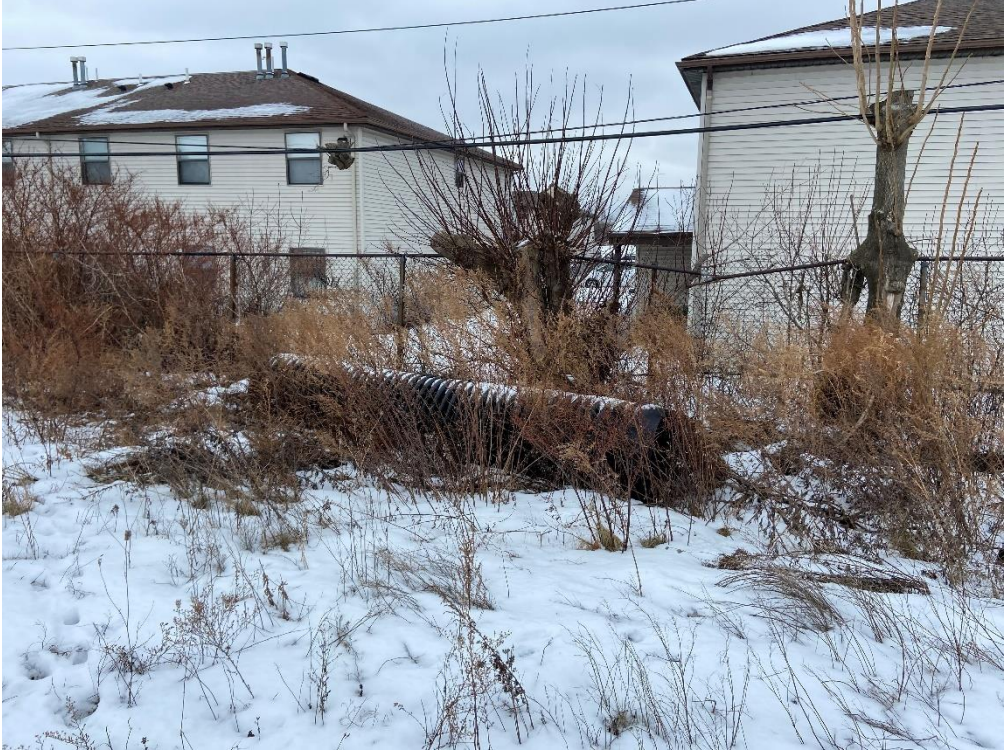
Client Name: Highland Park Village LLC		Site Location: 129 Holden Street, Buffalo, NY	Project No. 21.0056642.30
Photo No. 11	Date: 2-5-21

Direction Photo Taken: East			
Description: Large corrugated plastic drain pipe that apparently blew against the fence during the 2019 Elim development work.

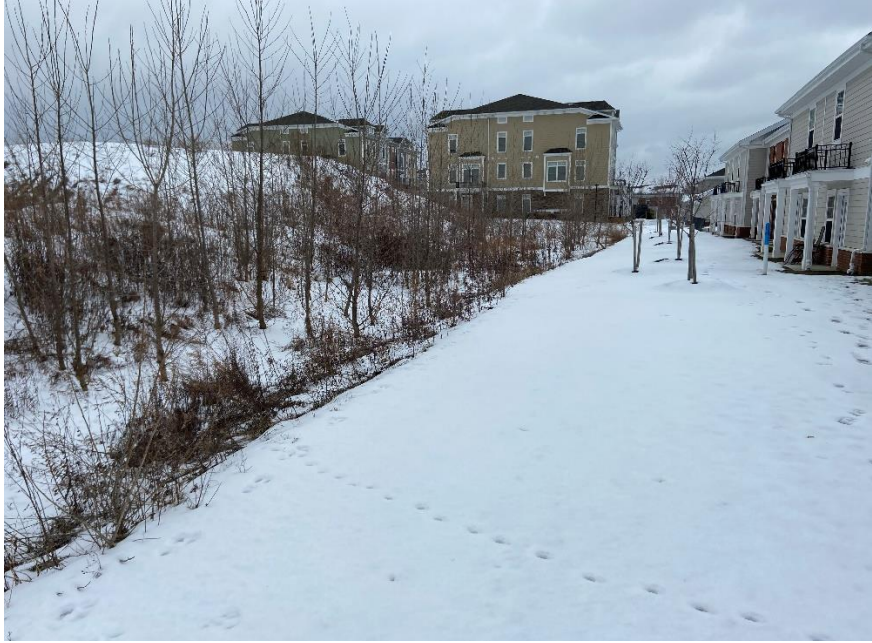
Client Name: Highland Park Village LLC		Site Location: 129 Holden Street, Buffalo, NY	Project No. 21.0056642.30
Photo No. 17	Date: 2-5-21

Direction Photo Taken: West			
Description: Rear of Elim Development.
