Revised 2022 PERIODIC REVIEW REPORT 129 HOLDEN STREET REDEVELOPMENT BUFFALO, NEW YORK BROWNFIELD CLEANUP PROGRAM Site Number C915261

April 4, 2022

Re: Revised 2022 Periodic Review Report
129 Holden Street Redevelopment
Buffalo, New York
Brownfield Cleanup Program Site (Number C915261)

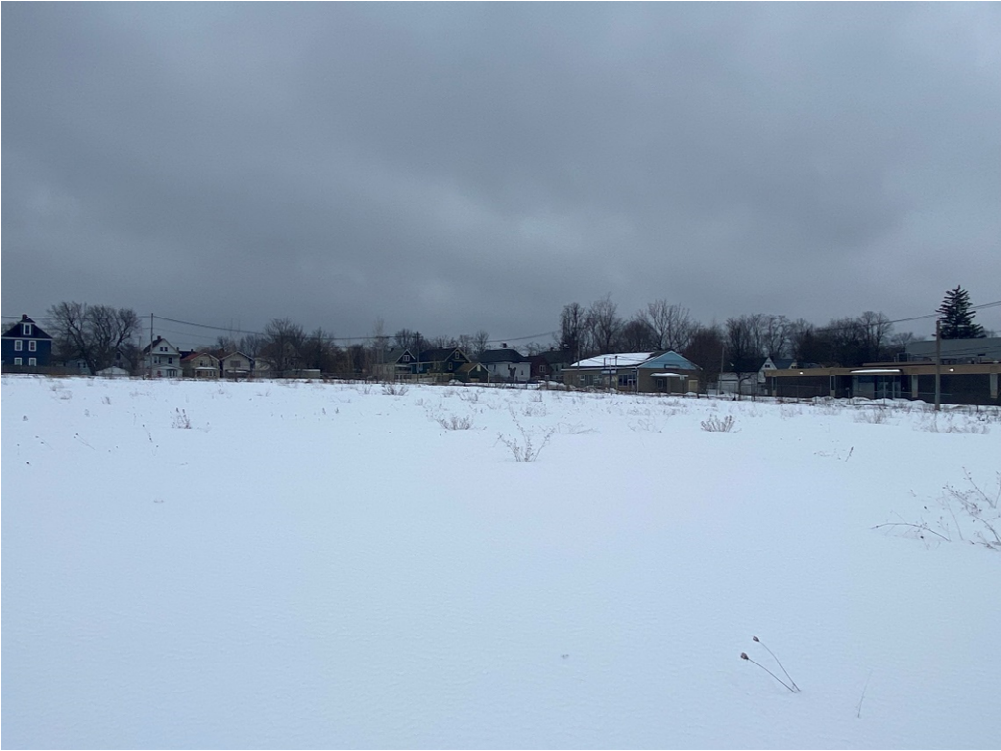
Client Name: Highland Park Village LLC		Site Location: 129 Holden Street, Buffalo, NY	Project No. 21.0056642.40
Photo No. 1	Date: 2-10-22

Direction Photo Taken: Southwest			
Description: View of SW corner of Site.

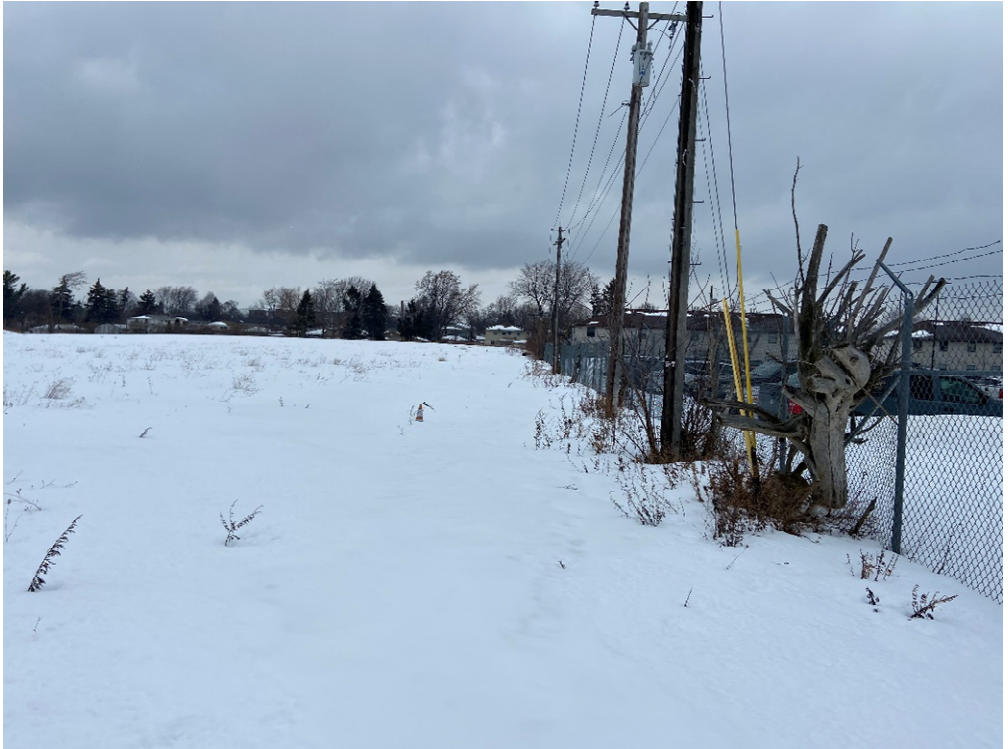
Client Name: Highland Park Village LLC		Site Location: 129 Holden Street, Buffalo, NY	Project No. 21.0056642.40
Photo No. 9	Date: 2-10-22

Direction Photo Taken: North			
Description: East edge of the Site, along the N/S fence of the post office.

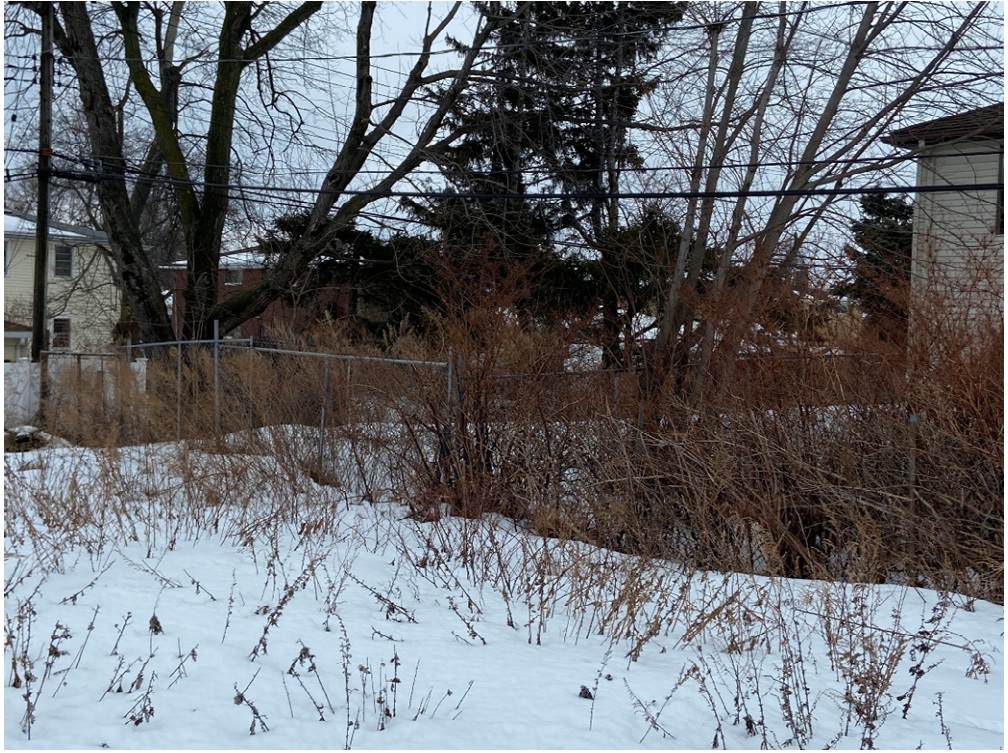
Client Name: Highland Park Village LLC		Site Location: 129 Holden Street, Buffalo, NY	Project No. 21.0056642.40
Photo No. 11	Date: 2-10-22

Direction Photo Taken: Northeast			
Description: Fence at western end of Northeastern alley way of the Site.

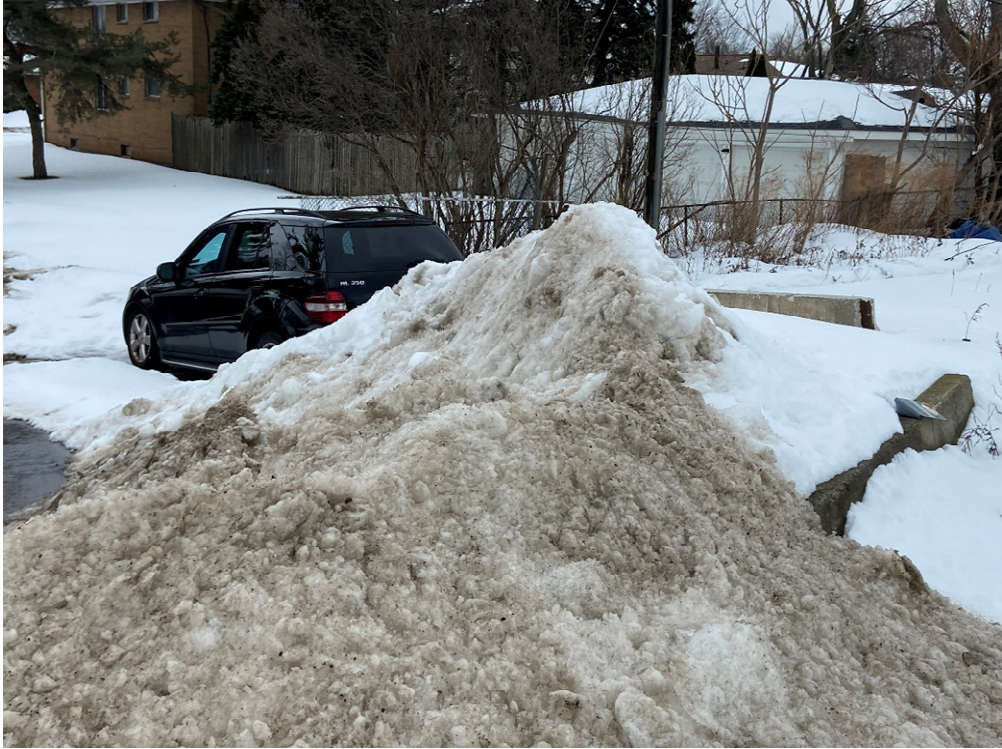
Client Name: Highland Park Village LLC		Site Location: 129 Holden Street, Buffalo, NY	Project No. 21.0056642.40
Photo No. 13	Date: 2-10-22

Direction Photo Taken: Northeast			
Description: Paved parking spot with newly placed Jersey barriers

- Regrading and re-seeding of the existing topsoil cover soil in the area of the tire ruts;
- Strategic placement of concrete barriers, and
- Addition of a “No Parking” sign

GZA performed a Site Inspection during the reporting period on February 10, 2022. The completed Site Inspection Form is provided in **Attachment I**. A photo log is provided in **Attachment II** and a map showing the location and orientation of the Site photos is provided as **Figure 2**. Although limited by snow cover, the Site cover system appeared to be in place and functioning as intended. A small area of the soil cover system that was noted in last year's PRR as exhibiting depressions from vehicle parking and missing grass cover has been repaired and the issue resolved. The Site owner reported that the existing topsoil in the area of the ruts was regraded and reseeded. Also, observed for the first time during the February 10, 2022, inspection, were concrete Jersey barriers that restrict parking from the soil cover system as well as the addition of a new road sign that reads "NO PARKING". Photos of the area with Jersey barriers and the new road sign are provided in Attachment II, Photos #13 and #14.
