**2017-2020 Periodic Review Report (PRR)  
for  
125 Main Street Site  
Buffalo, NY  
NYSDEC BCP Site No. C915262**

**EnSol, Inc.**  
661 Main Street  
Niagara Falls, New York 14301

April 2020  
Revised August 2020

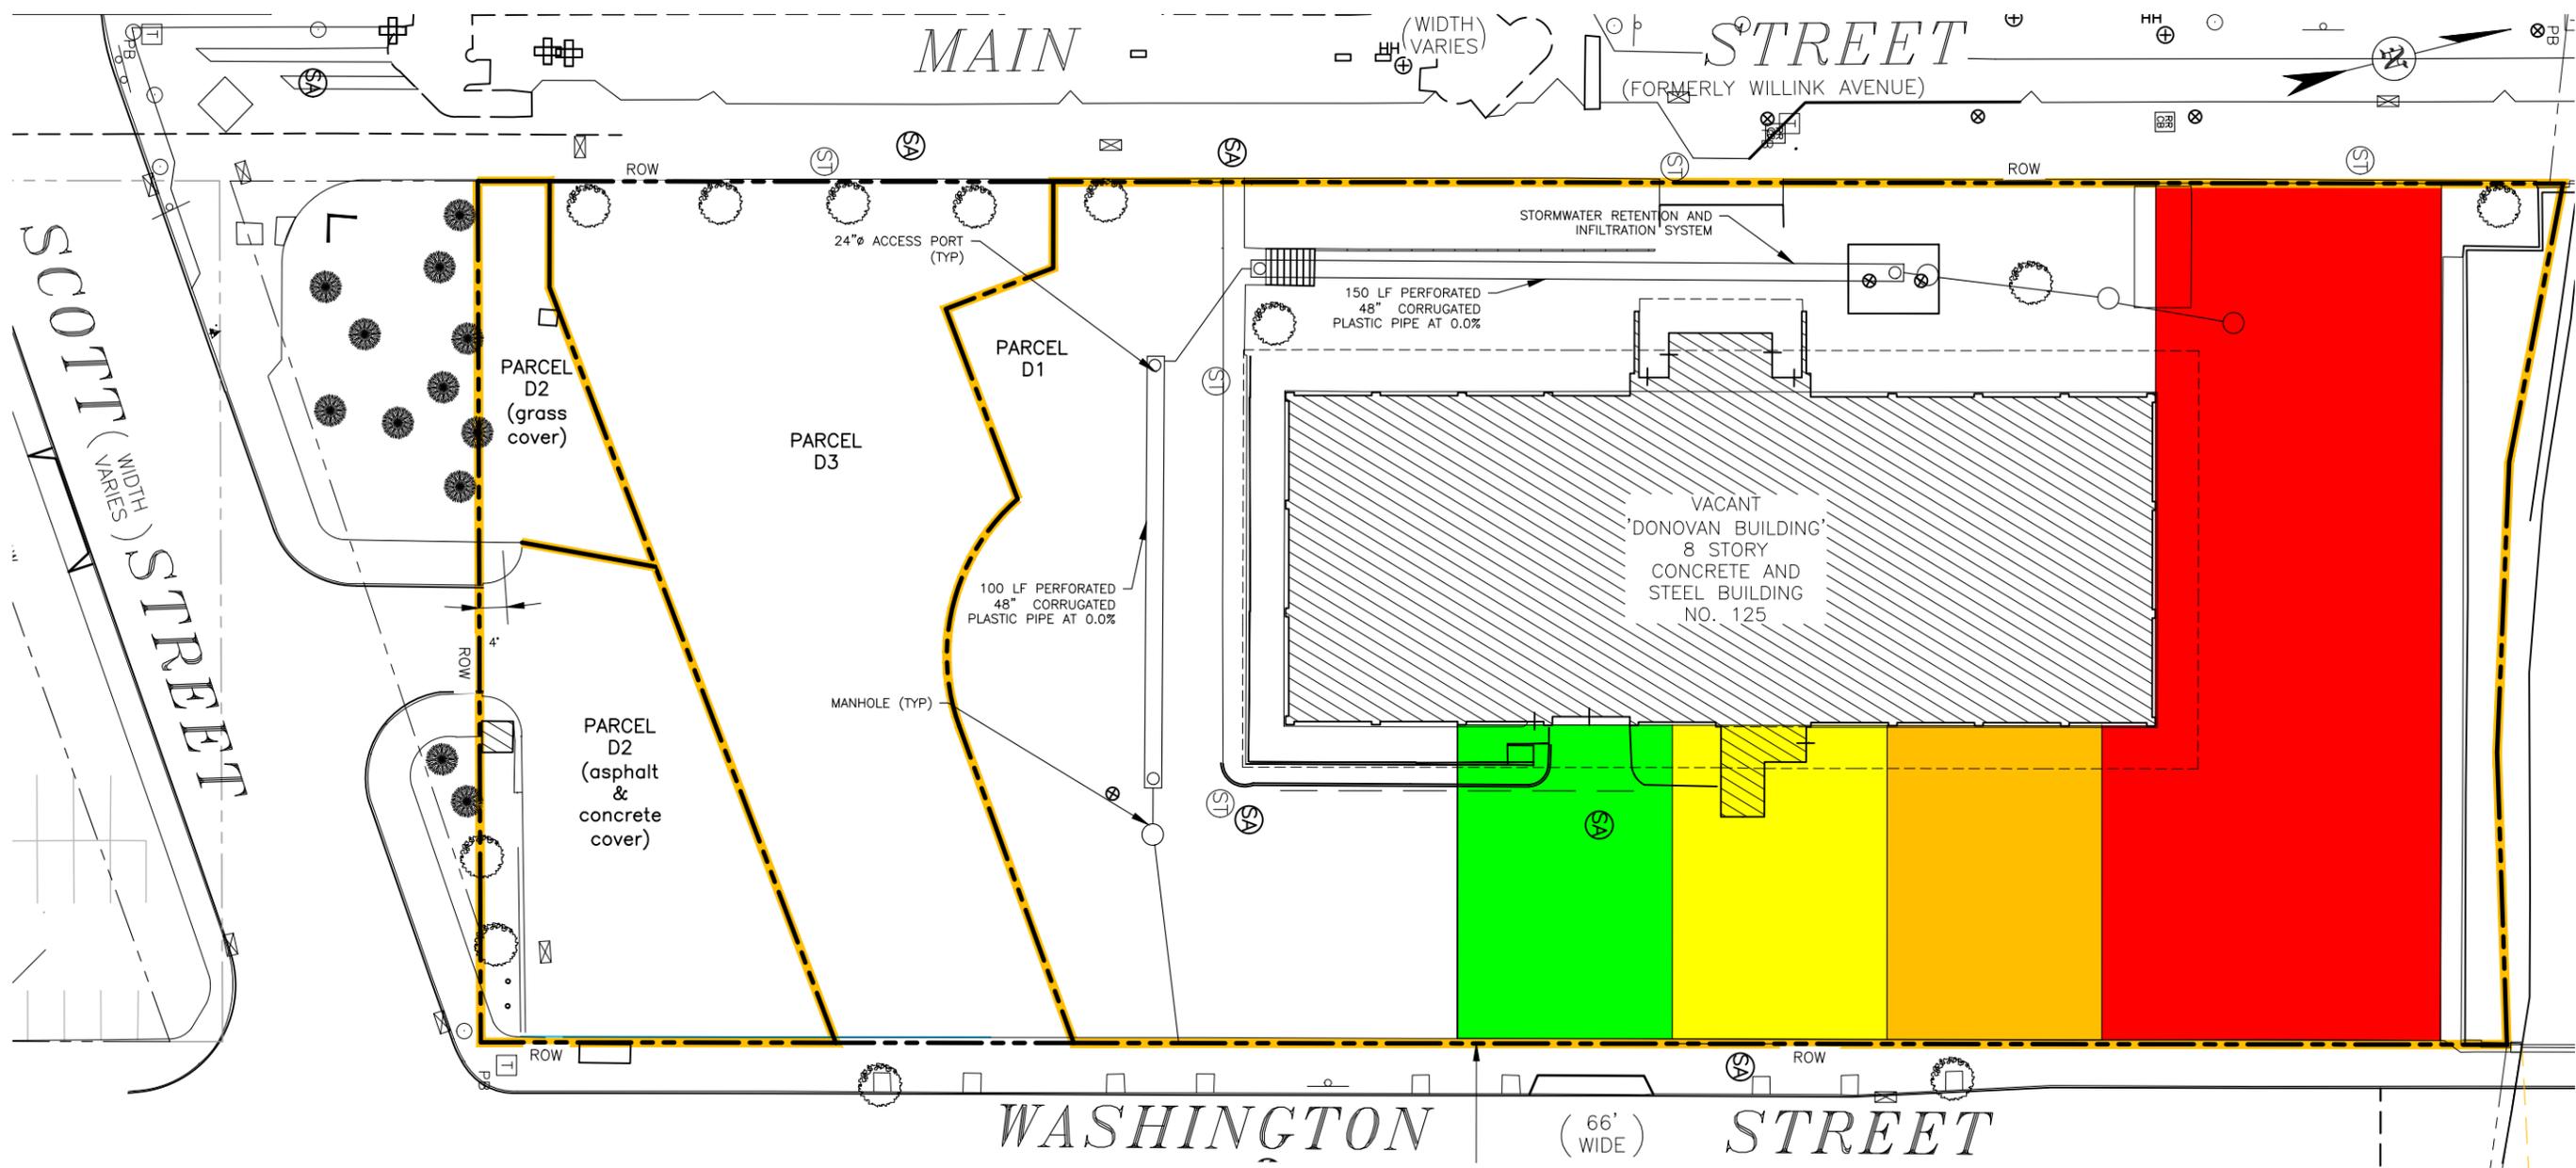
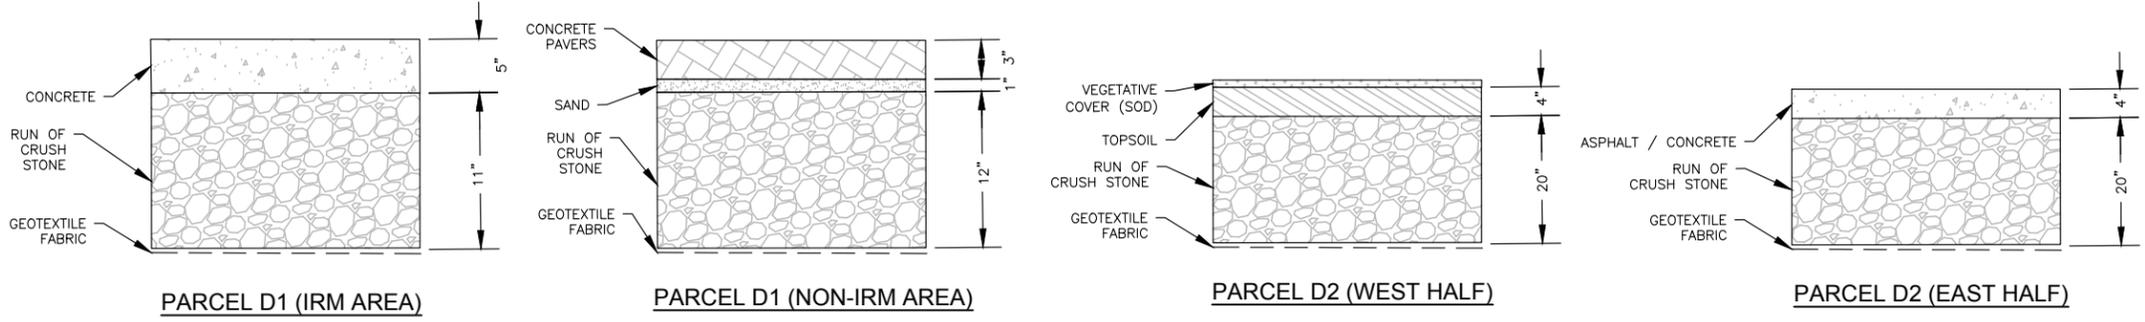
TITLE:	IRM AND COVER SYSTEM DETAILS		
PROJECT:	125 MAIN STREET SITE BUFFALO, NEW YORK		
PREPARED FOR:	HARBOR DISTRICT ASSOCIATES, LLC		
CITY OF BUFFALO	COUNTY OF ERIE	STATE OF NEW YORK

- LEGEND:**
- APPROXIMATE PARCEL BOUNDARY
  - BCP BOUNDARY
- NOTES:**
- BASE MAP PROVIDED BY FOIT ALBERT ASSOCIATES.
  - PROPERTY BOUNDARY LINES SHOWN HEREON ARE APPROXIMATE AND FOR REFERENCE ONLY.
- APPROXIMATE IRM EXCAVATION DEPTH (BELOW GROUND SURFACE)**
- 0'-3'
  - 3'-6'
  - 6'-9'
  - 9'-12'

**COVER SYSTEMS**  
NTS

It should be noted that the cover system noted on the IRM and Cover System Details drawing (Appendix A) does not include a cross-section of the asphalt and concrete cover system installed on the east half of Parcel D2 . Towards the end of the project, it was determined that since the project trailer would be not be moved until after sometime the following year, the existing asphalt in place around the project trailer could be left in place and that concrete would be placed beneath the trailer to complete the cover system. After consultation with the NYSDEC, the cover system was approved for this area of Parcel D2.

- Construction and maintenance of cover systems to prevent human exposure to remaining contaminated soil/fill remaining at the site. There are four separate cover systems that are installed and maintained at the site. Within the IRM area of Parcel D1, the cover system is comprised of a geotextile fabric demarcation layer, a minimum of 11 inches of clean stone fill, and a five-inch concrete slab. The cover system placed in the remaining areas of Parcel D1, outside of the IRM area, is comprised of a geotextile fabric demarcation layer, a minimum of 12 inches of clean stone fill, one inch of sand, and three inch concrete pavers. The cover system on the east half of Parcel D2 is comprised of a geotextile fabric demarcation layer, 20 inches of clean stone fill, and approximately four inches of asphalt. Also on the east half of Parcel D2, as approved by the NYSDEC, concrete was placed in lieu of asphalt when the project trailer was removed from the site in 2014. The cover system on the west half of Parcel D2 consists of a geotextile fabric demarcation layer, 20 inches of clean stone fill, four inches of topsoil, and a layer of sod.
