Periodic Review Report

154 South Ogden Street Site

*BCP Site No. C915268
154 South Ogden Street
Buffalo, New York*

June 2019

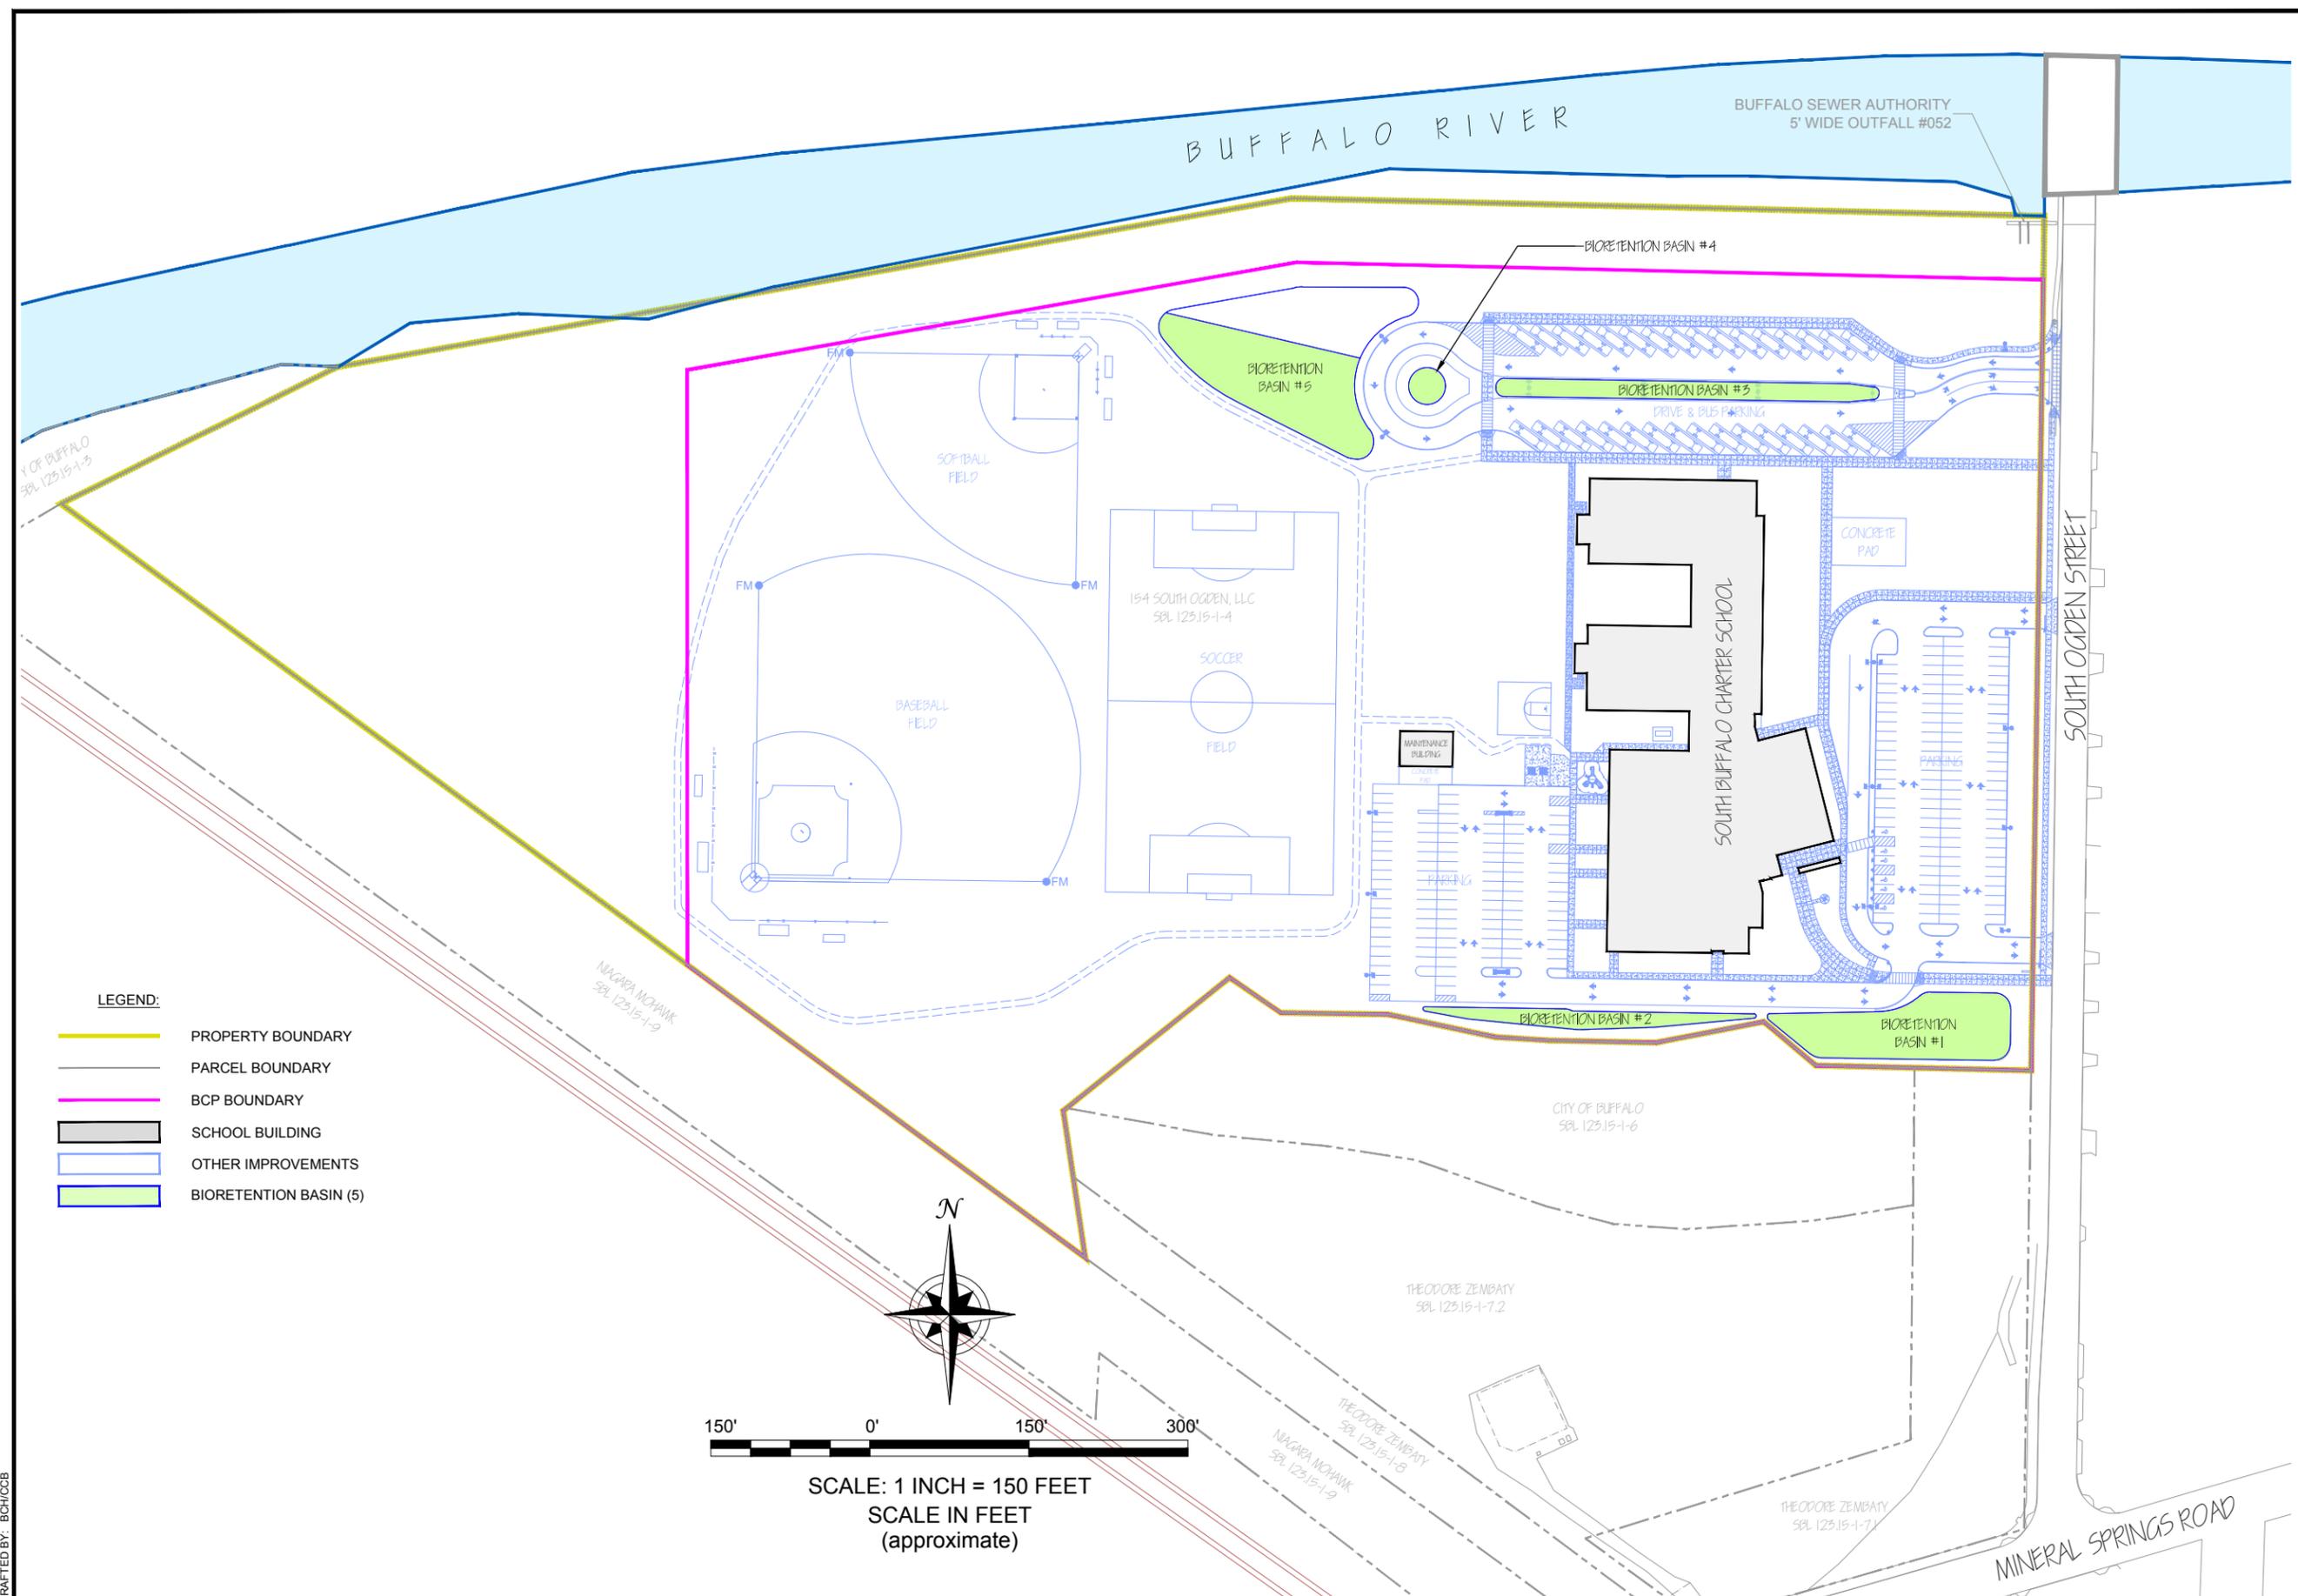
- LEGEND:**
- PROPERTY BOUNDARY
 - PARCEL BOUNDARY
 - BCP BOUNDARY
 - SCHOOL BUILDING
 - OTHER IMPROVEMENTS
 - BIORETENTION BASIN (5)

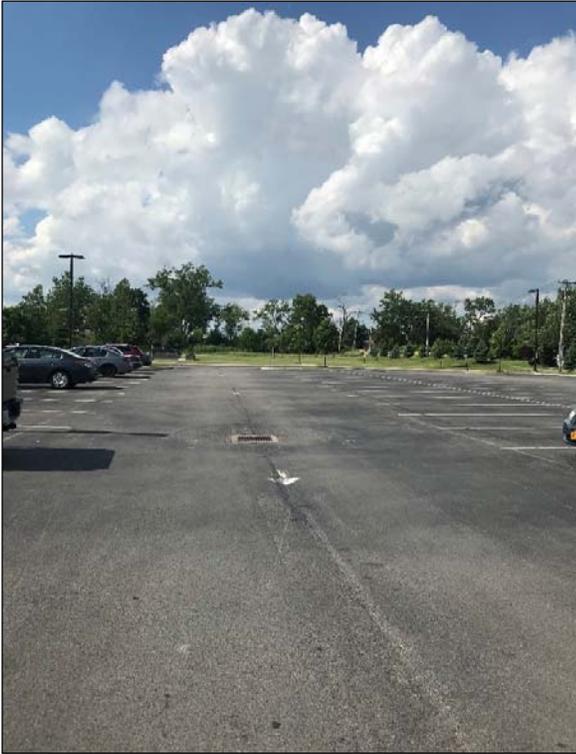
Client Name: South Buffalo Charter School		Site Location: 154 South Ogden Street Site (C915268)	Project No.: B0249-019-001
Photo No. 1	Date 06/21/19

Direction Photo Taken: north			
Description: Surface lot in front of school.

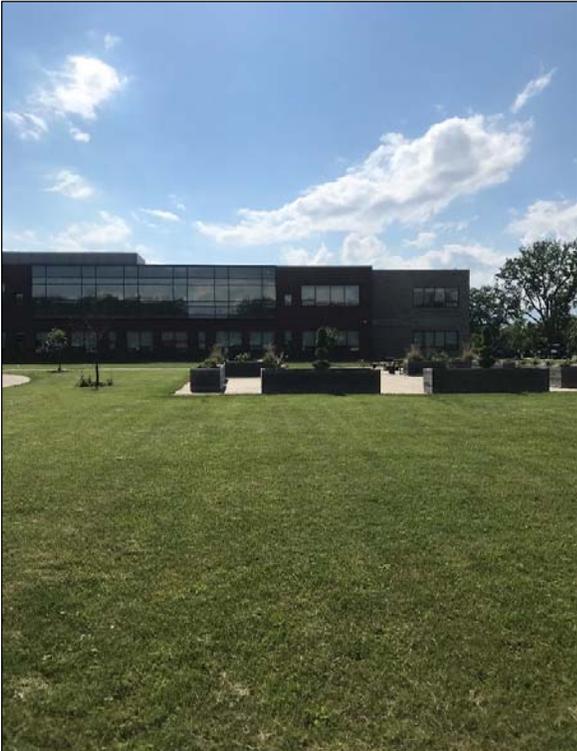
Photo No. 2	Date 06/21/19

Direction Photo Taken: west			
Description: Lawn and above grade planter boxes in front of school.

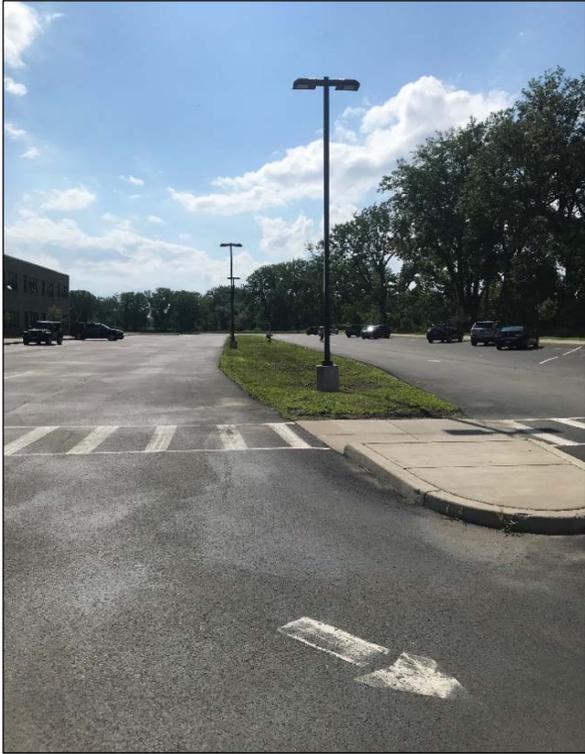
Client Name: South Buffalo Charter School		Site Location: 154 South Ogden Street Site (C915268)	Project No.: B0249-019-001
Photo No. 3	Date 06/21/19

Direction Photo Taken: west			
Description: Bus entrance drive/parking area.

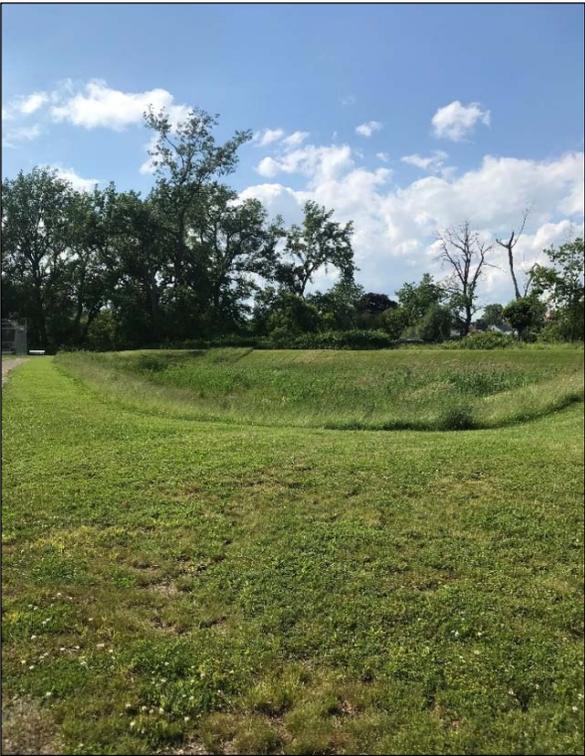
Photo No. 4	Date 06/21/19

Direction Photo Taken: northwest			
Description: Bioretention pond #5.

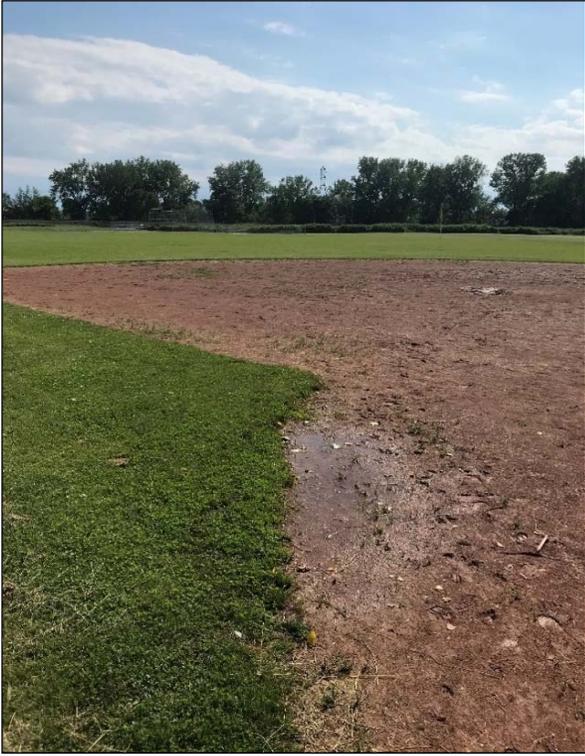
Client Name: South Buffalo Charter School		Site Location: 154 South Ogden Street Site (C915268)	Project No.: B0249-019-001
Photo No. 5	Date 06/21/19

Direction Photo Taken: southwest			
Description: Ball fields showing Marco clay and grass/topsoil cover system components.

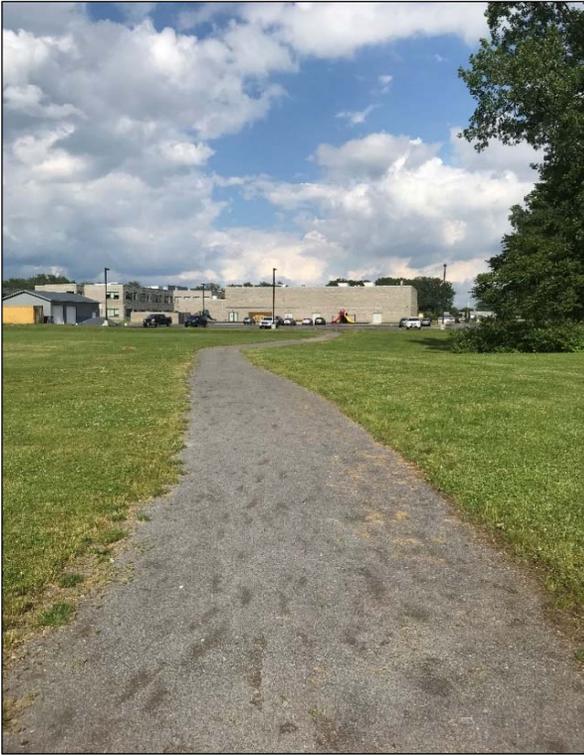
Photo No. 6	Date 06/21/19

Direction Photo Taken: east			
Description: Grass/topsoil and stone pedestrian path with school in background.

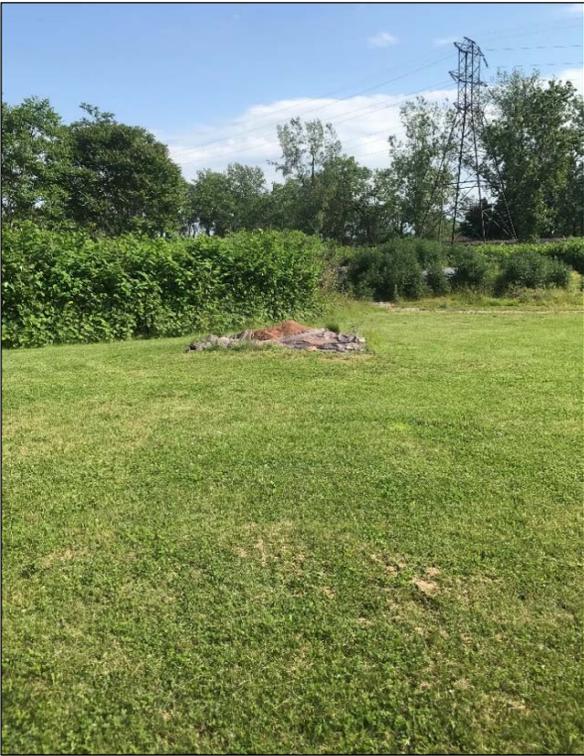
Client Name: South Buffalo Charter School		Site Location: 154 South Ogden Street Site (C915268)	Project No.: B0249-019-001
Photo No. 7	Date 06/21/19

Direction Photo Taken: south			
Description: Stockpiled cover soils partly covered with poly tarp.

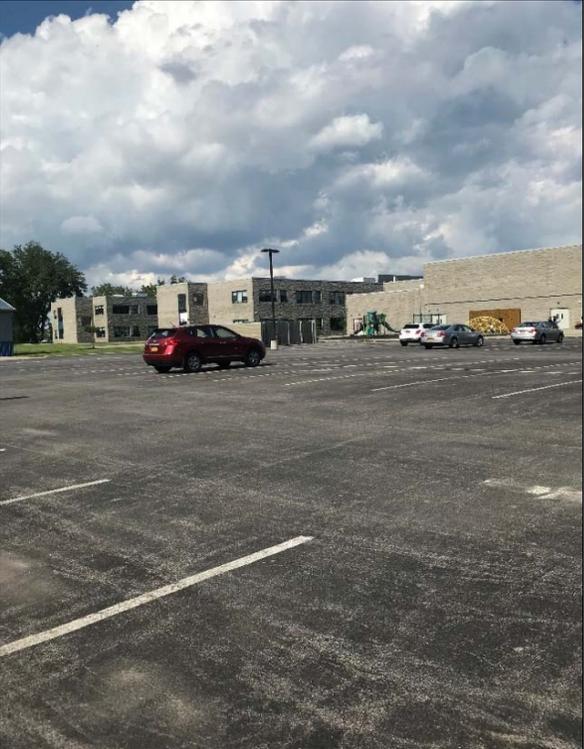
Photo No. 8	Date 06/21/19

Direction Photo Taken: northwest			
Description: Playground and rear parking area.

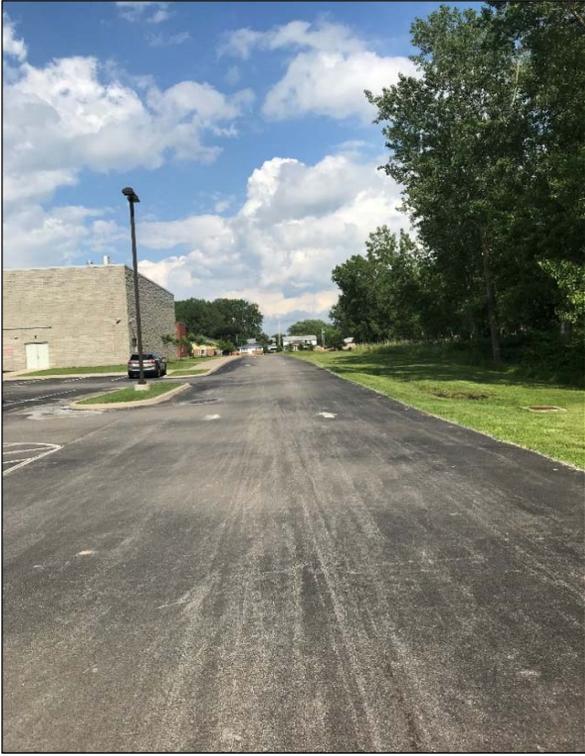
Client Name: South Buffalo Charter School		Site Location: 154 South Ogden Street Site (C915268)	Project No.: B0249-019-001
Photo No. 9	Date 06/21/19

Direction Photo Taken: east			
Description: Access drive on south side of school building. Bioretention basins #1 and #2 at right.

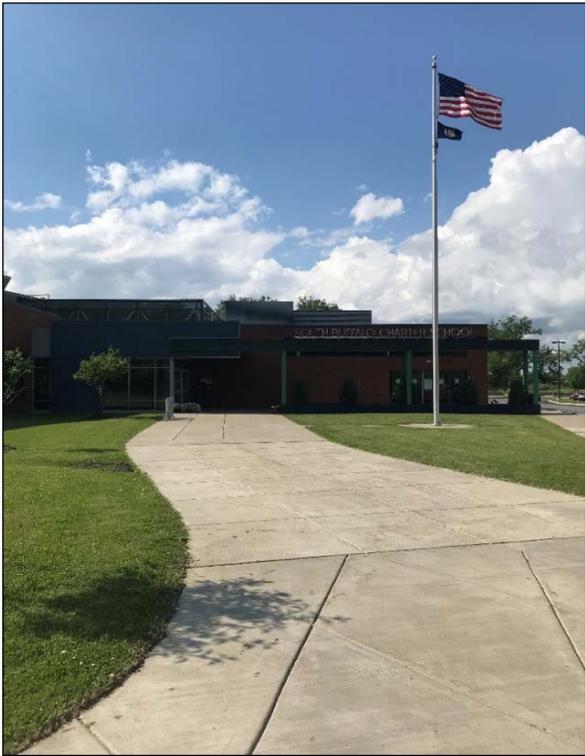
Photo No. 10	Date 06/21/19

Direction Photo Taken: north			
Description: School entrance.
