PERIODIC REVIEW REPORT

MARCH 11, 2021 TO MARCH 11, 2022

3 GATES CIRCLE SITE
(BCP SITE No. C915272)

BUFFALO, NEW YORK

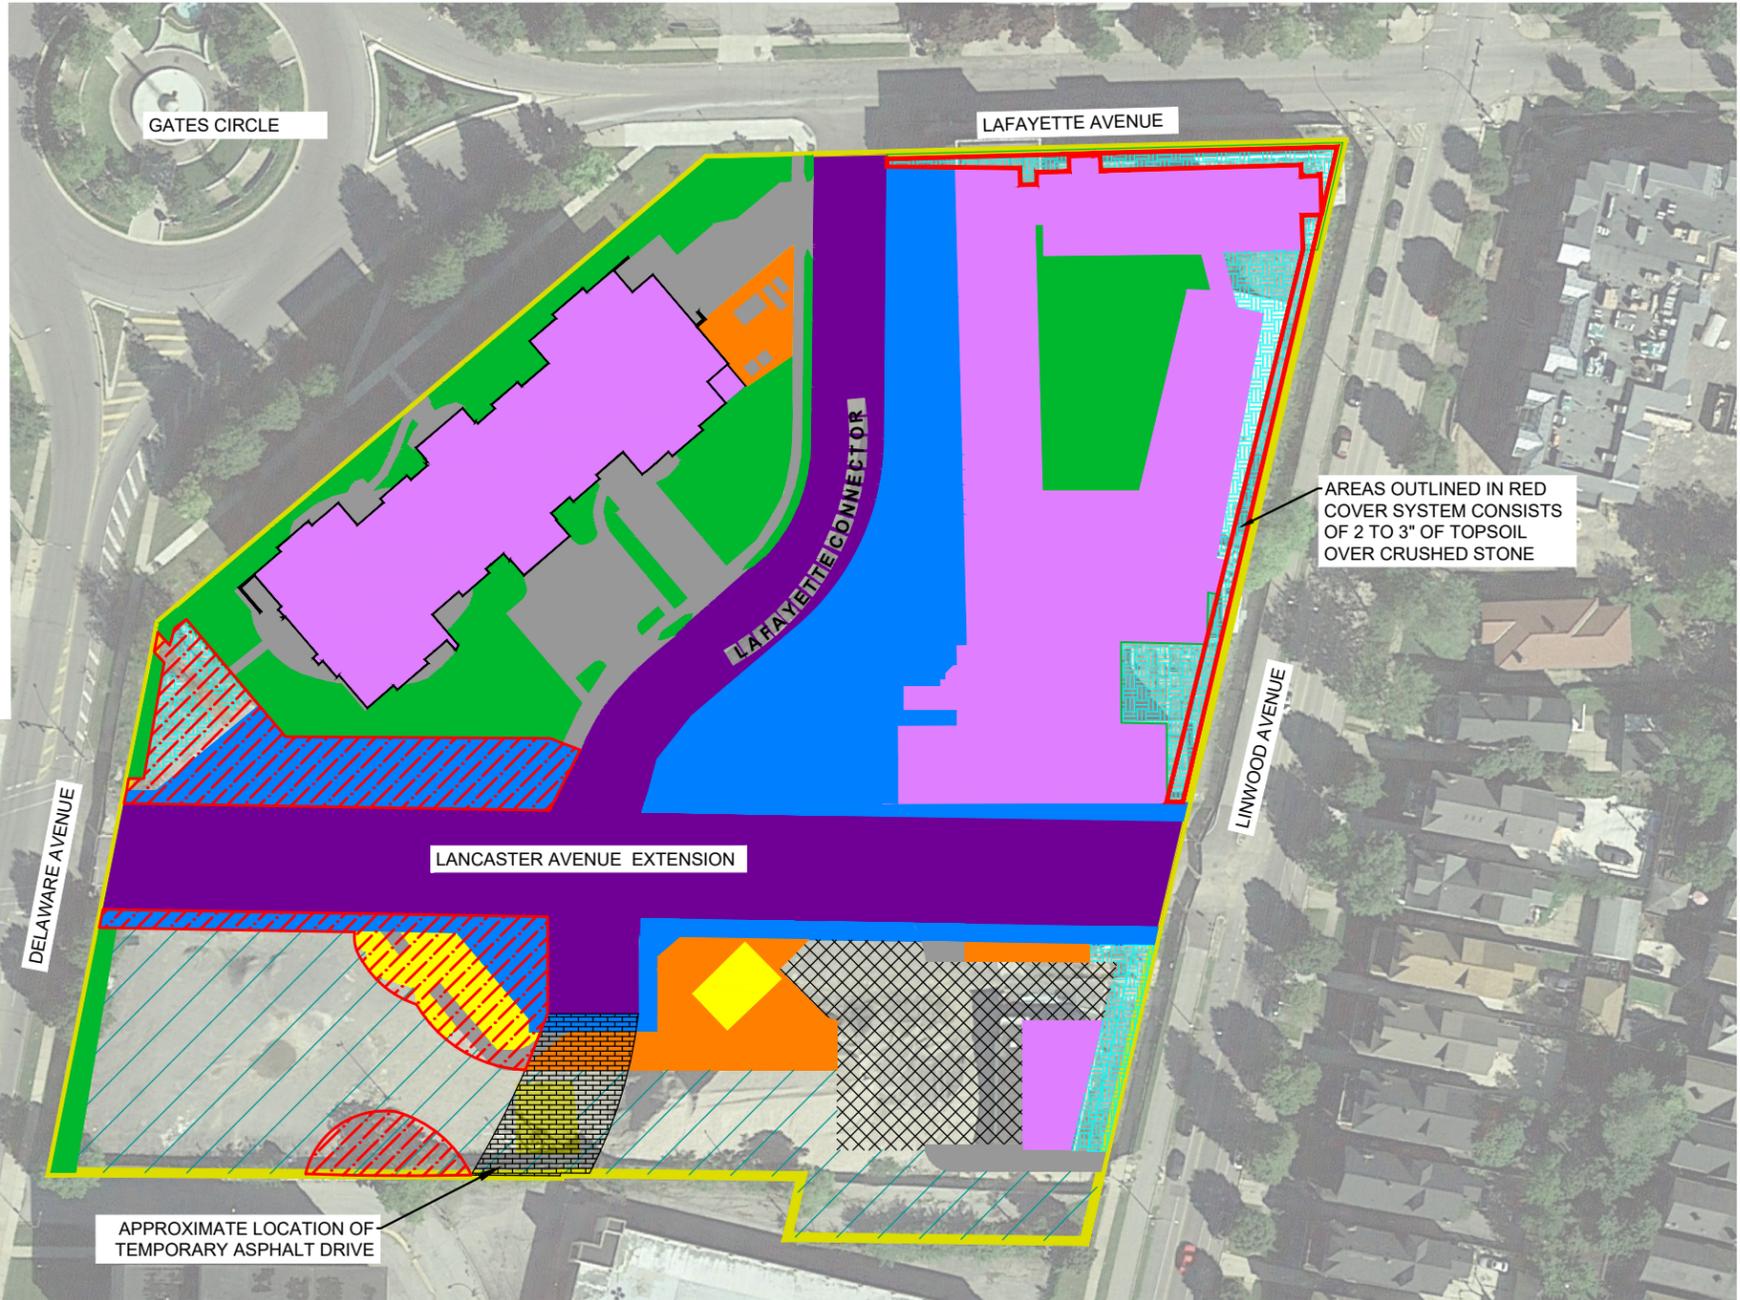
SITE COVER SYSTEM

AREAS OUTLINED IN RED COVER SYSTEM CONSISTS OF 2 TO 3" OF TOPSOIL OVER CRUSHED STONE

APPROXIMATE LOCATION OF TEMPORARY ASPHALT DRIVE

In July 2020, M/MGC replaced the top 6-inches of crushed stone of the cover system with 6-inches of NYSDEC-approved topsoil in an approximate 15-foot wide area along Delaware Avenue on the western portion of the Site, south of the Canterbury Woods property greenspace, at the City of Buffalo’s request. Topsoil (2 to 3-inches) was also placed on top of the crushed stone/existing soil cover system in an approximate 15-foot wide area along Lafayette Avenue (north end of Site) and Linwood Avenue (east end of Site) to promote vegetative growth. Additional information on the topsoil import is proved in Section 4.2.3. These activities were observed by Benchmark-TurnKey personnel to verify conformance with the SMP. Figure 3 identifies the updated cover system for the Site.

In August 2021, as shown on Figure 3, 3 to 4-inches of topsoil was placed and seeded around perimeter of the asphalt cover system for beautification purposes in western portion of the 1285 Delaware Ave parcel. The topsoil was placed on geotextile prior to placement. A portion of the asphalt surface was also resurfaced in this area. The beautification project is temporary as the redevelopment plans for the Site call for building(s) to be constructed in this area of the Site.

In October 2021, as shown on Figure 3, the 1299 Delaware Avenue parcel was also covered with 3 to 4 inches of topsoil as part of the beautification project. The concrete walkways present were removed as they were deteriorating and in poor condition. The concrete removed was staged on-Site in the western portion of the 630 Linwood Avenue parcel. The topsoil was placed on geotextile prior to placement. The beautification project is only temporary as the redevelopment plans for the Site call for building to be constructed in this area of the Site.

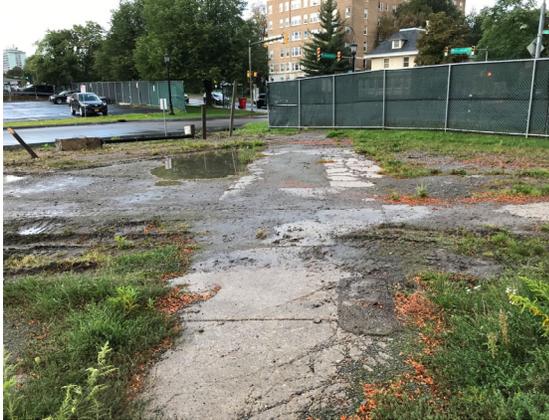
Photo 1: October 2021: Temporary Beautification work along Delaware Avenue. Spauling concrete and stone pad area north of Lancaster Avenue Extension removed and replaced, looking northeast.

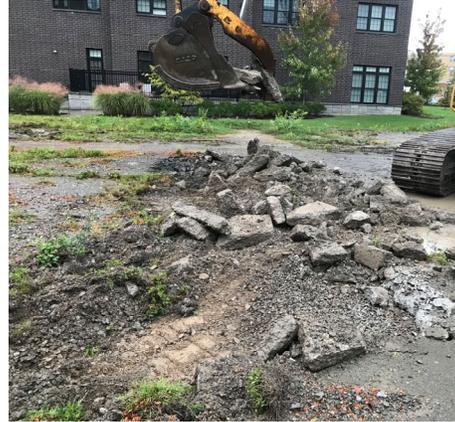
Photo 2: October 2021: Temporary Beautification work along Delaware Avenue. Spauling concrete and stone pad area north of Lancaster Avenue Extension removed and replaced, looking southwest West end of Lancaster Avenue Extension, looking east.

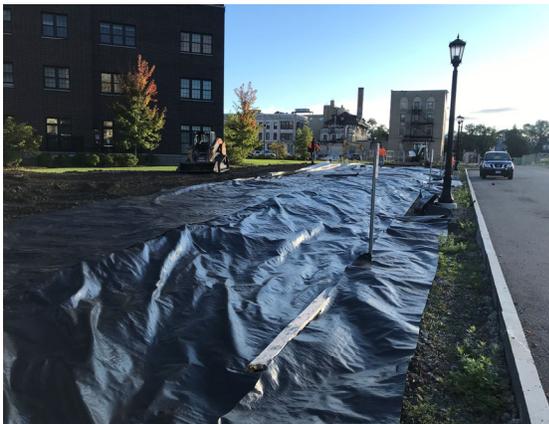
Photo 3: October 2021: Temporary Beautification work along Delaware Avenue. Geofabric placement prior to temporary topsoil cover placement, looking east. .

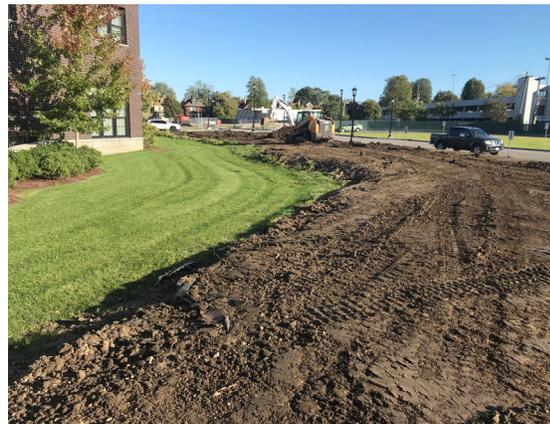
Photo 4: October 2021: Temporary Beautification work along Delaware Avenue. Topsoil placement and grading, looking southeast.

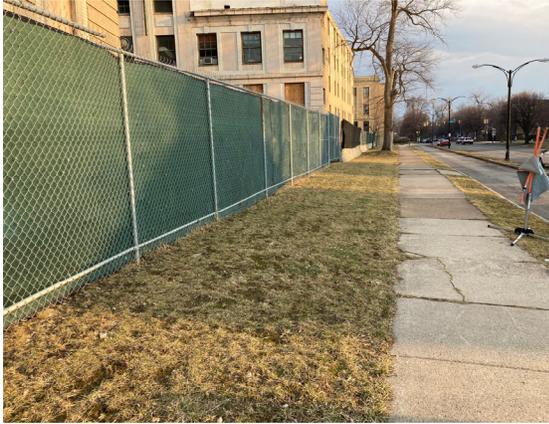
Photo 5: Cover system along eastern portion of Site along Linwood Avenue, looking north.

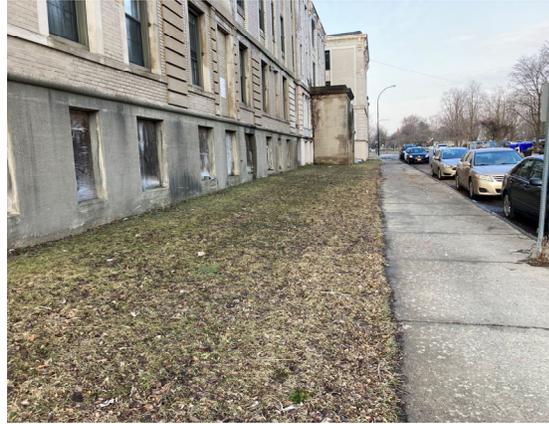
Photo 6: Cover system along northern portion of Site along Lafayette Avenue, looking west.

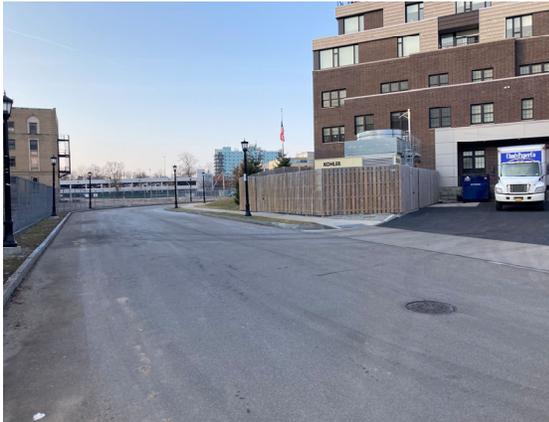
Photo 7: Lafayette Avenue and Canterbury Wood cover areas looking south.

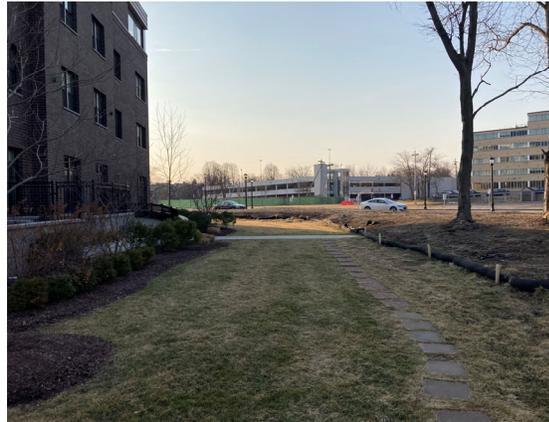
Photo 8: Canterbury Woods cover system adjacent to temporary beautification area along Delaware Avenue, looking east.

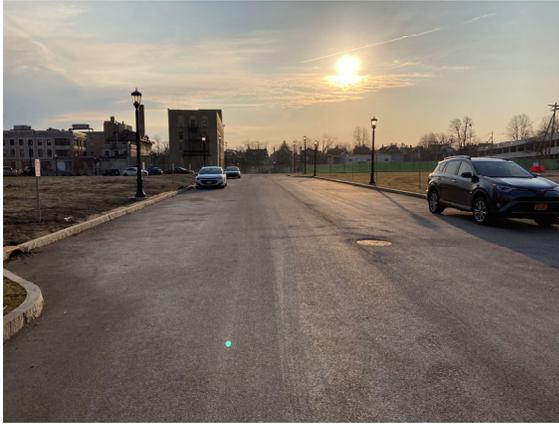
Photo 9: Lancaster Avenue Extension looking east.

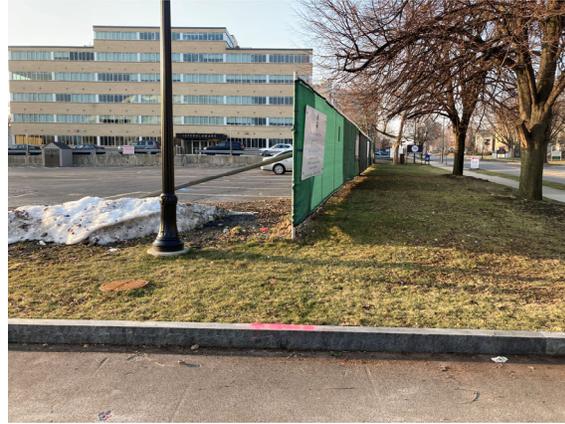
Photo 10: Cover systems along Delaware Avenue and southwestern portion of the Site, looking south.

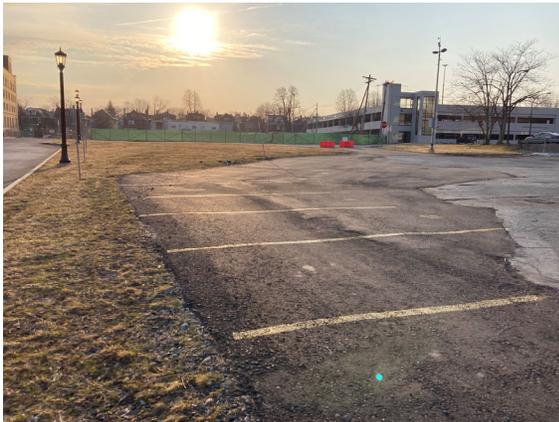
Photo 11: August 2021 Temporary Beautification work along parking lot in the southwestern portion of the Site, looking east.

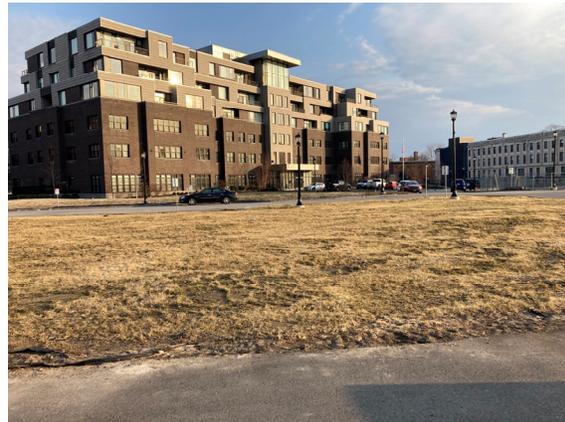
Photo 12: August 2021 Temporary Beautification work along parking lot in the southwestern portion of the Site, looking north.
