Brownfield Cleanup Program Application

1827 Fillmore Avenue Site
Buffalo, New York

July 2017

1827 Fillmore LLC

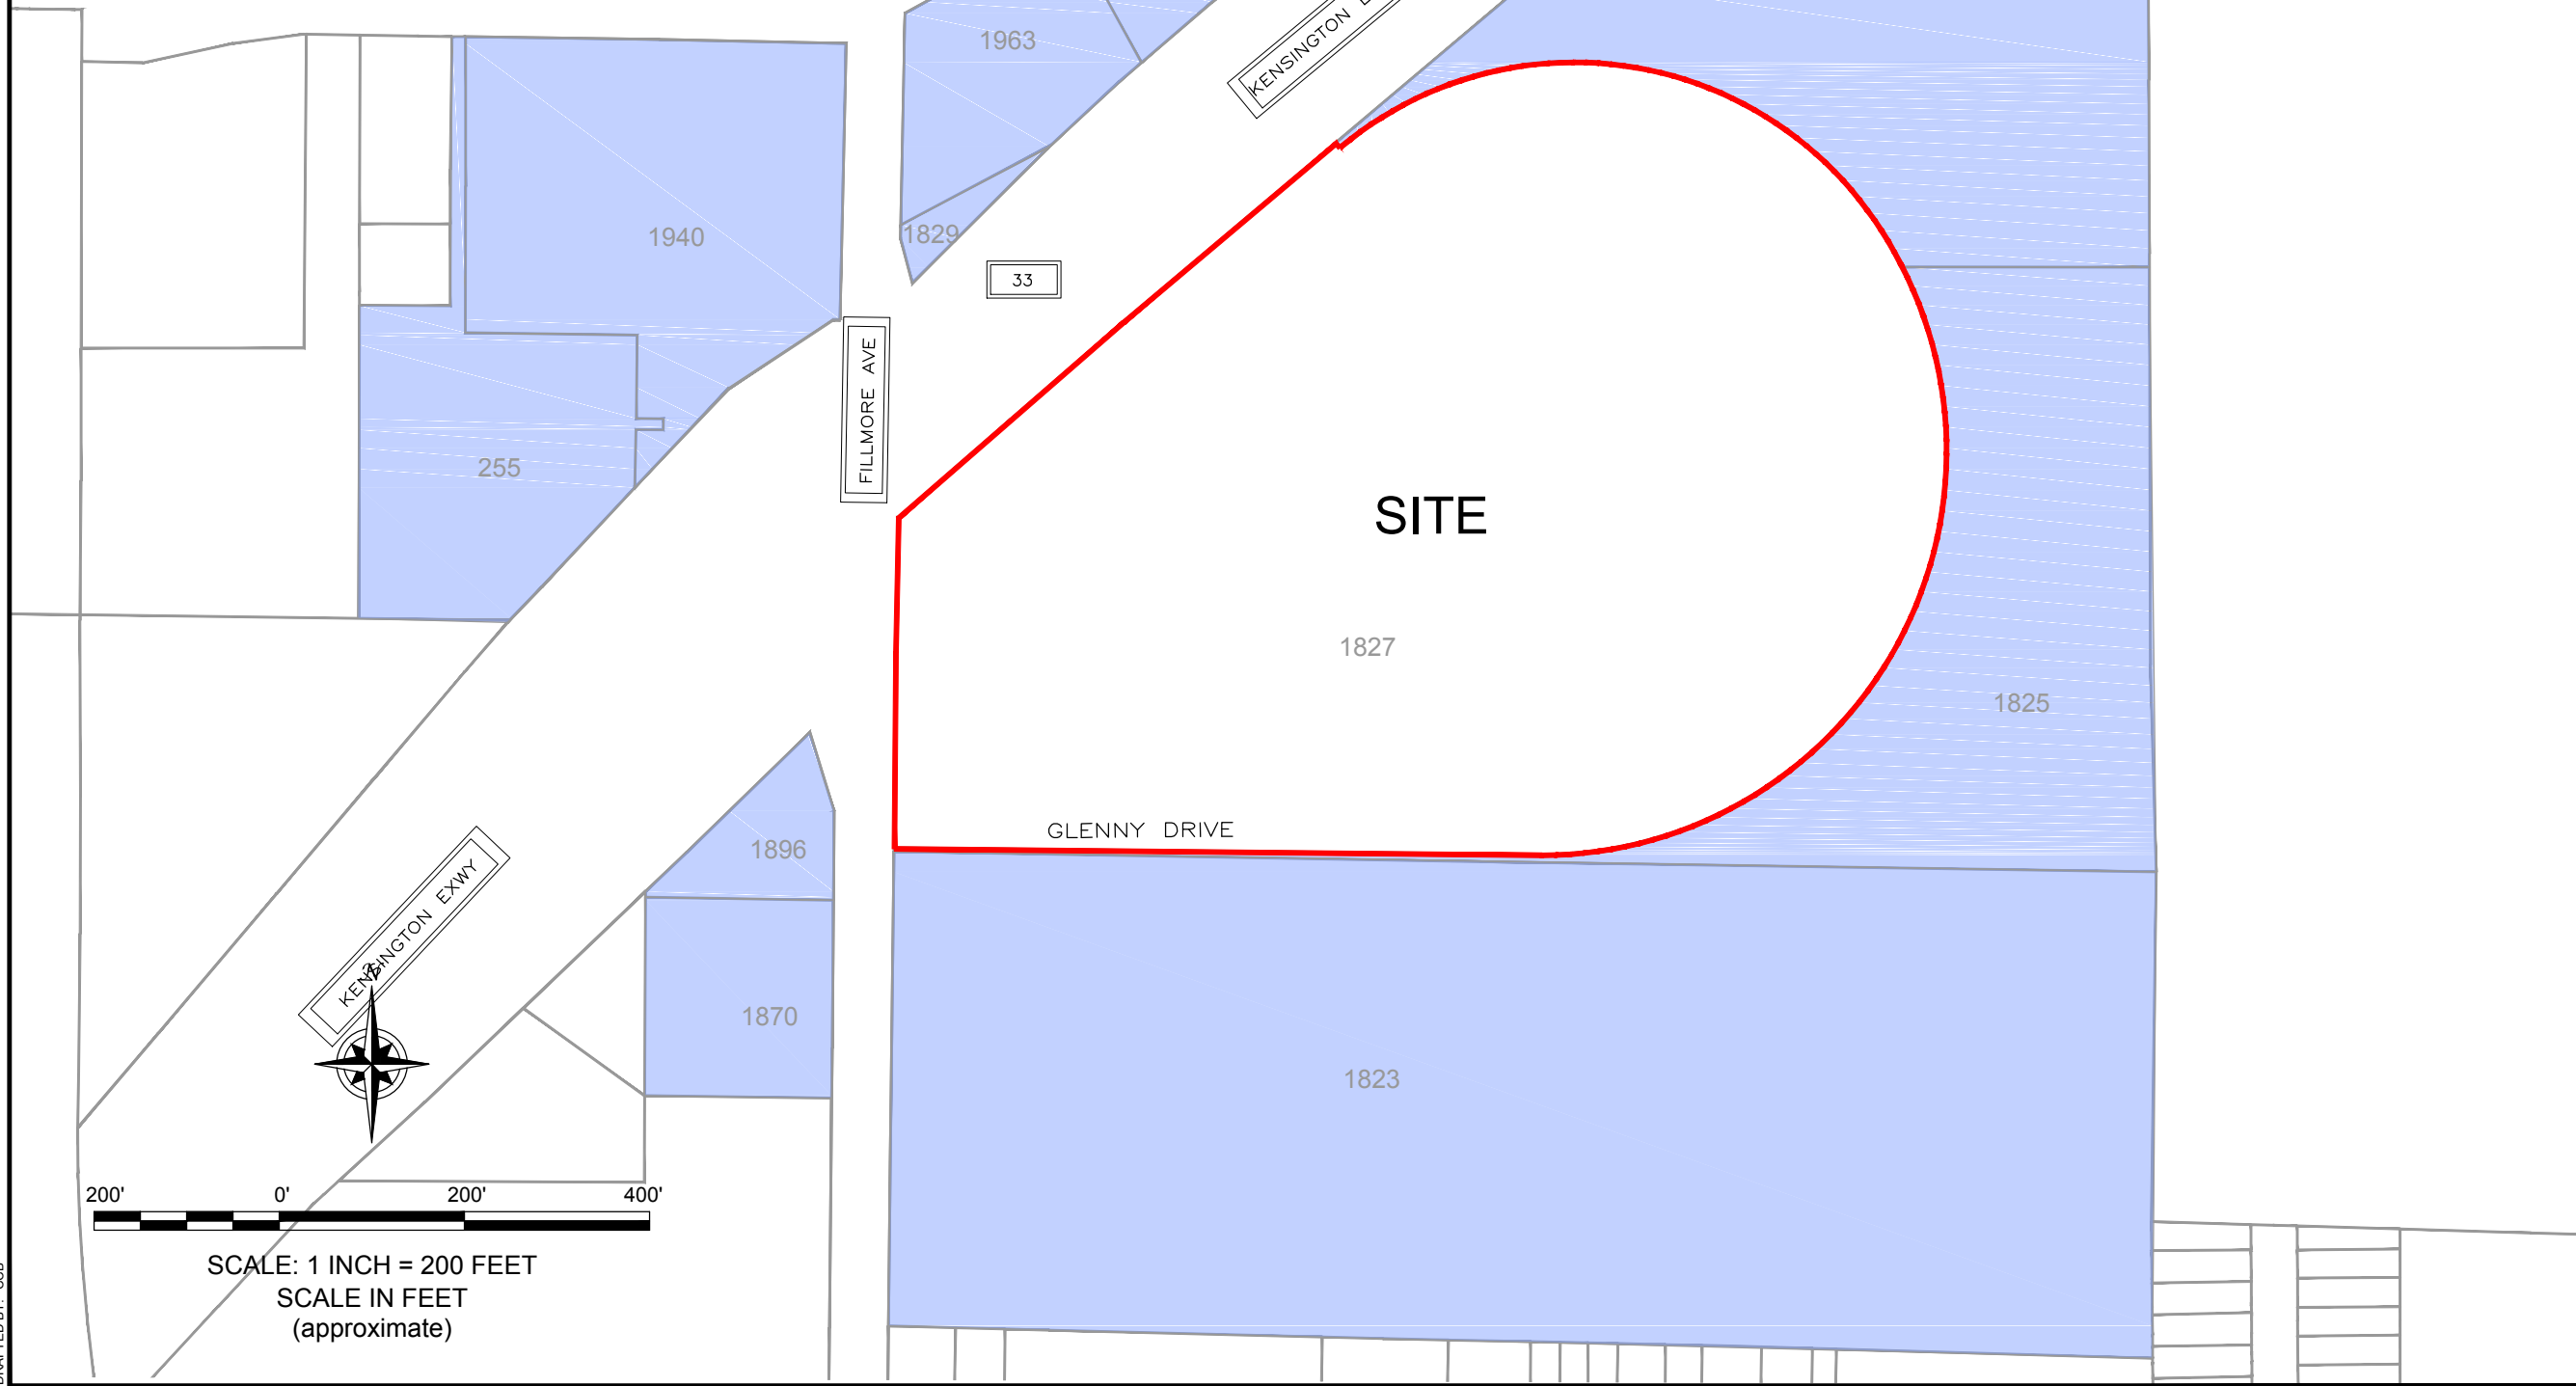
FIGURE 12

Adjacent Property Address			
SBL	ADDRESS	PROP TYPE	PROP DESC
89.16-2-7.21	255 Kensington	C	Radio
90.13-1-3	355 Kensington	B	Vacant Commercial
90.13-1-5.21	377 Kensington	C	Restaurant
90.13-1-9	659 Kensington	B	Vacant Commercial
90.17-1-1	1823 Fillmore	C	School
90.13-1-10	1825 Fillmore	B	Vacant Commercial
90.13-1-1	1829 Fillmore	B	Vacant Commercial
89.20-1-5	1870 Fillmore	C	Warehouse
89.20-1-4	1896 Fillmore	B	Vacant Commercial
89-16-2-7.11	1940 Fillmore	C	Manufacture
90.13-1-2	1963 Fillmore	C	Kennel/Vet

ADJACENT PROPERTY OWNERS
 BROWNFIELD CLEANUP PROGRAM APPLICATION
 1827 FILLMORE AVENUE SITE
 BUFFALO, NEW YORK

The Site is currently vacant and zoned residential. Based on the September 2016 City of Buffalo Land Use Plan, existing land use for the Site is general residential and existing land use surrounding the Site includes open space, neighborhood center, employment, general residential, and institutional properties (see Figure 9). Per the City of Buffalo, the proposed land use for the Site is employment and the proposed land use surrounding the Site includes open space, employment, and institutional (see Figure 10). The current zoning map indicates commercial and residential to the north, commercial and light industrial to the west, and residential to the south and east (see Figure 11). Adjacent property owners are identified on Figure 12.

School #89, Dr. Lydia T. Wright School of Excellence and athletic fields to the south with Appenheimer Avenue beyond, Erie County Medical Center (ECMC) and Buffalo Public School #84 to the east, and Fillmore Avenue to the west with commercial properties and the Kensington Expressway beyond (see Figure 12).
