Period Review Report

73 – 79 West Huron Street Site
Buffalo, New York
BCP Site No. C915282

April 28, 2023 to April 28, 2024 Certifying Period

Emerson Huron, LLC.

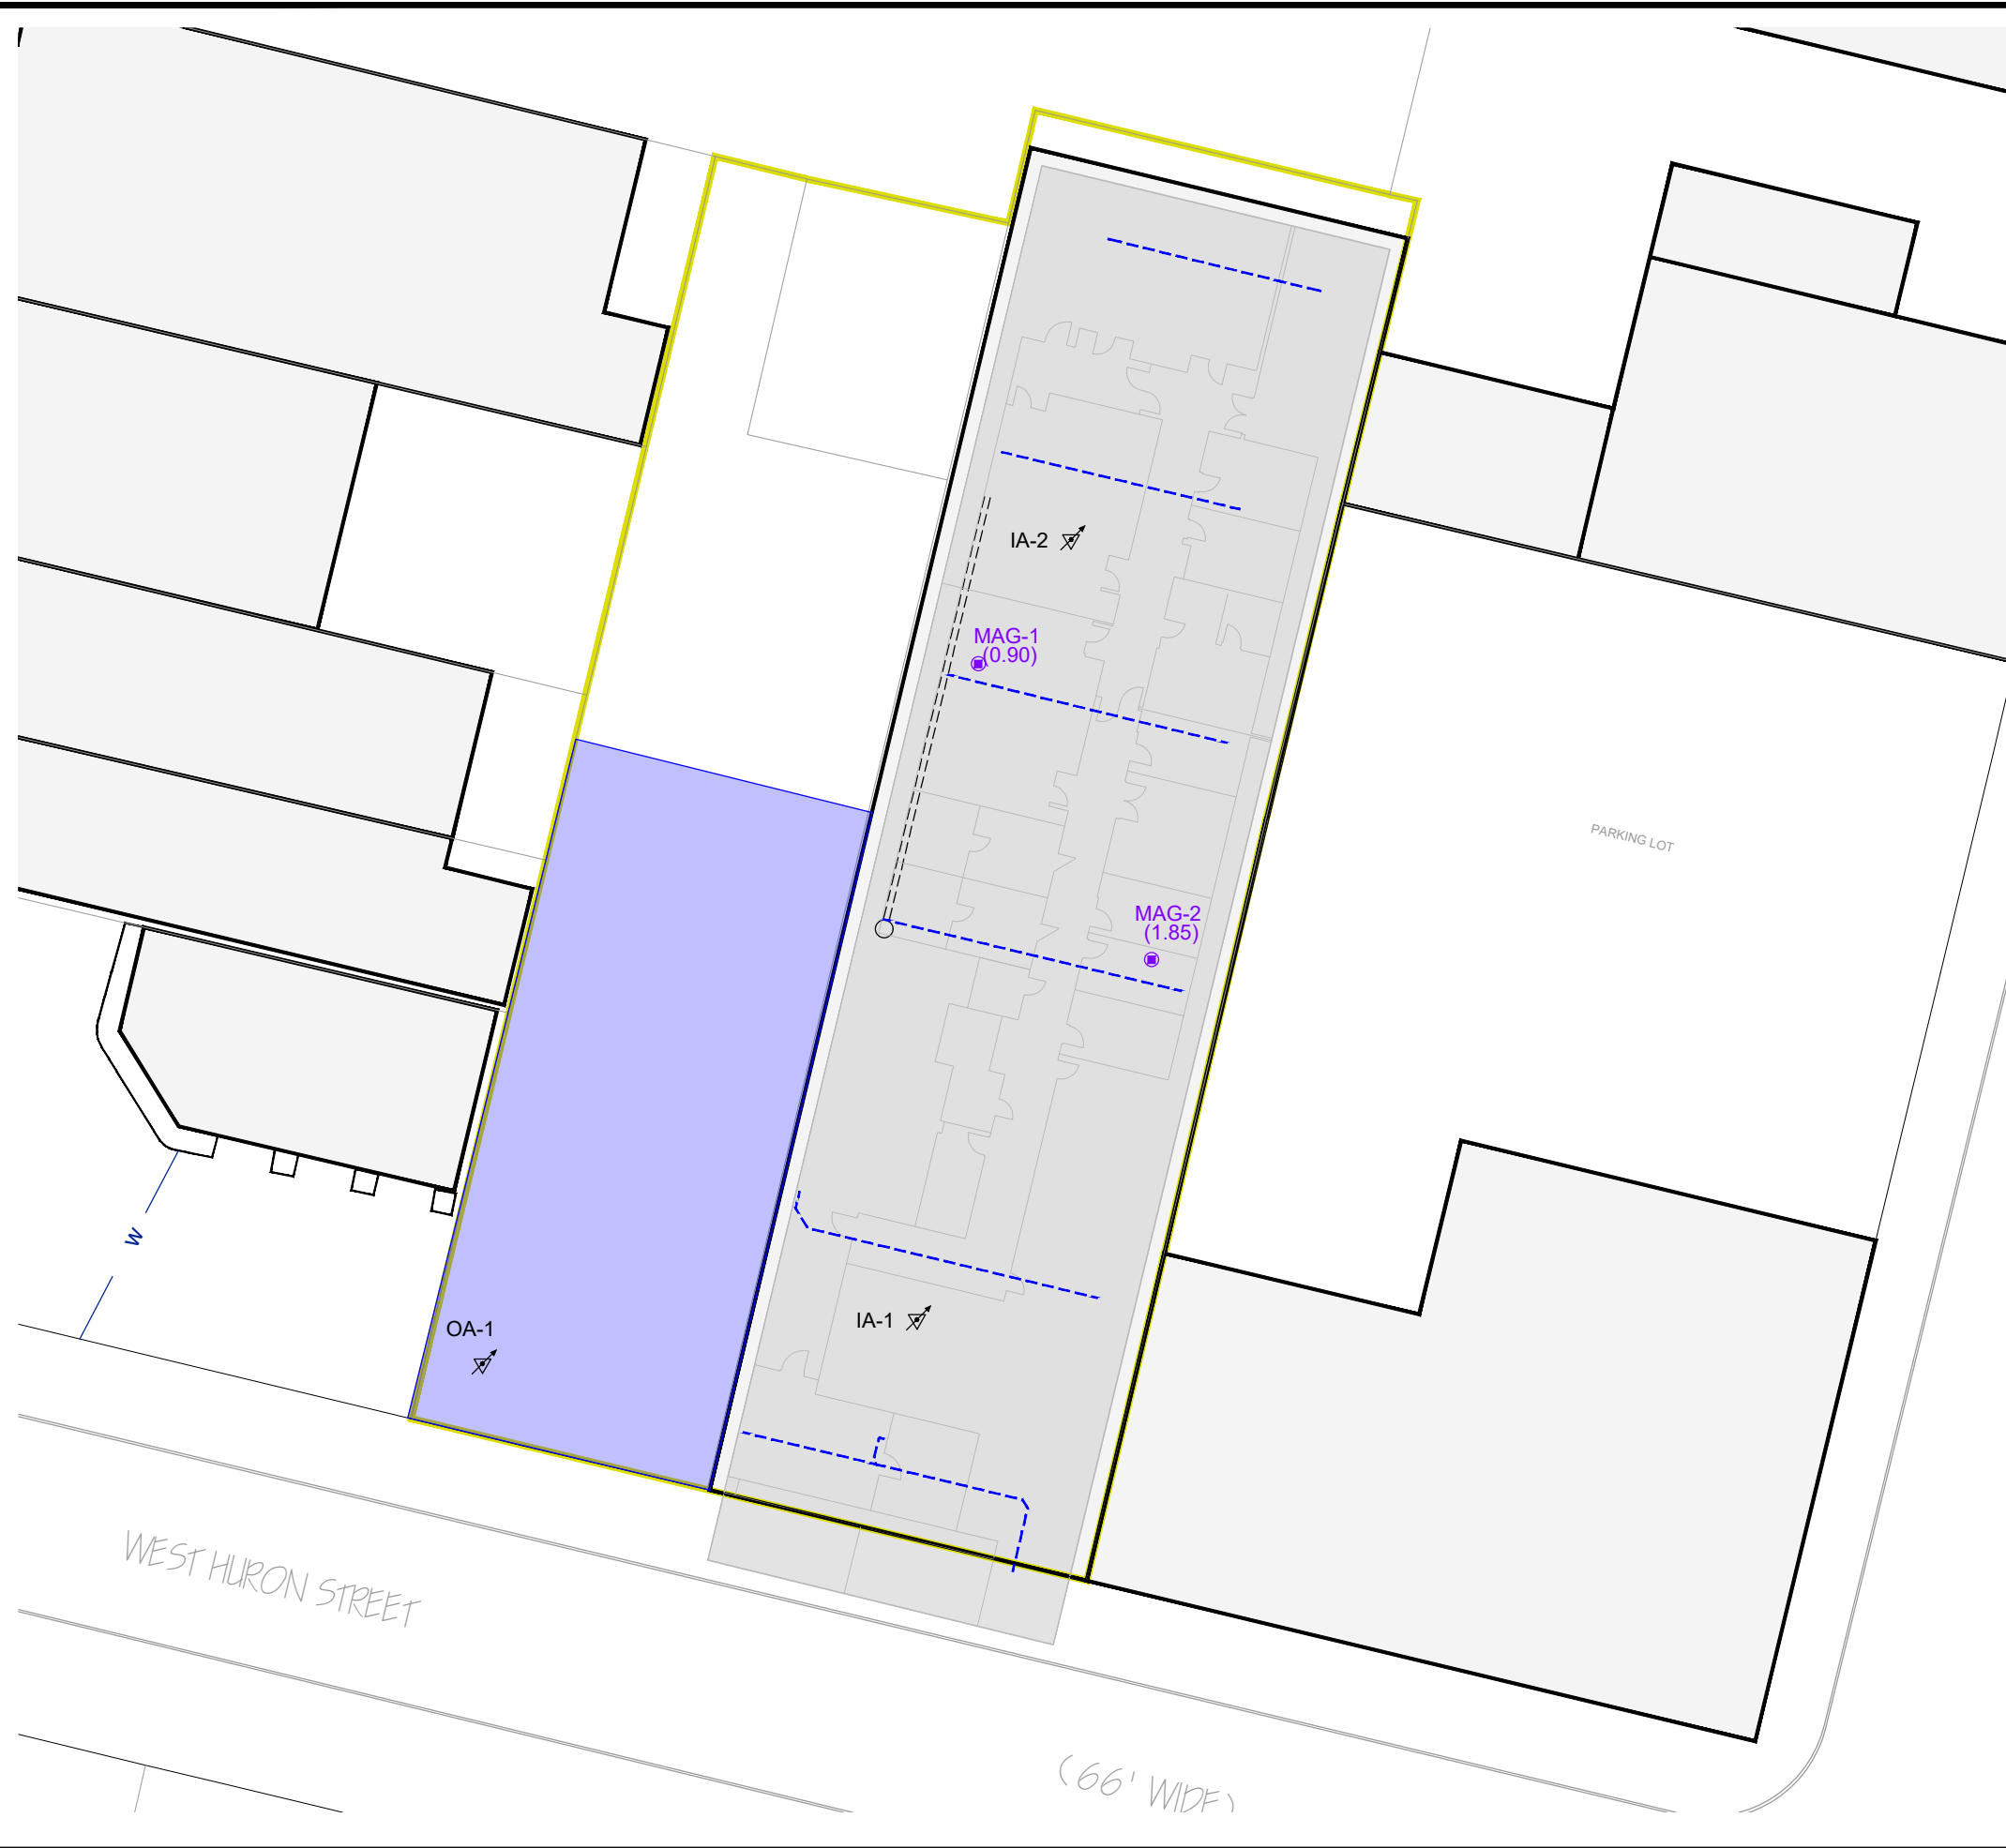
Compiled by:	Date: MAY 2024	FIGURE 3
	Prepared by: RFL-CMC	Scale: AS SHOWN	
	Project Mgr: THF	Project:	
	File: FIGURE 3: ASD AND VAPOR ASSESSMENT LOCATIONS.DWG

1. MAGNEHELIC GAUGE READINGS TAKEN ON APRIL 17, 2024
2. VAPOR ASSESSMENT SAMPLING PERFORMED ON FEBRUARY 3, 2021.

ASD SYSTEM AND VAPOR ASSESSMENT LOCATIONS			
PERIODIC REVIEW REPORT			
73-79 WEST HURON STREET SITE (BCP SITE NO. C915282) BUFFALO, NEW YORK			
Prepared for:		EMERSON HURON, LLC

There are no Engineering Controls (ECs) associated with the Site under the implemented Track 2 cleanup except for an ASD system as described in Section 4.3, below. The Site is either covered with hardscape (asphalt) or the on-site building, with no green space cover. The ASD system was observed to be in working order at the time of site inspection, readings at magnehelic gauges Mag-1 and Mag-2 (see Figure 3) were measured at -0.9 and -1.95 inches of water column, respectively.

During April 24, 2024 PRR walk through it was observed that the magnehelic gauge 1 (MAG-1) reading was similar to those recorded during previous inspections. However, magnehelic gauge 2 (MAG -2) indicated a vacuum of nearly -2 inches of water column and records maintained by building facility staff indicated readings above previous readings for a majority of the reporting period. On May 16th, 2024 Roux personnel returned to verify the MAG-2 location with a portable magnehelic gauge that reads 0 to -5 inches of water column. At that time it was observed that vacuum at MAG-2 had dropped back to -1.25 inches of water column, which is more in line with previous readings. Nevertheless, the portable gauge was temporarily connected to the riser and confirmed the permanent meter vacuum. The probable cause for the higher readings is the fluctuation of water beneath the floor slab coming into contact with the ASD piping.

Elevated readings of the MAG-2 monitoring location are believed to be caused by fluctuating groundwater levels that, upon rising, partially restrict the ASD extraction piping system. The elevated water levels are suspected to be attributable to maintenance issues associated with a submersible pump in an offsite utility vault located in the sidewalk along W. Huron St on the south side of the building.

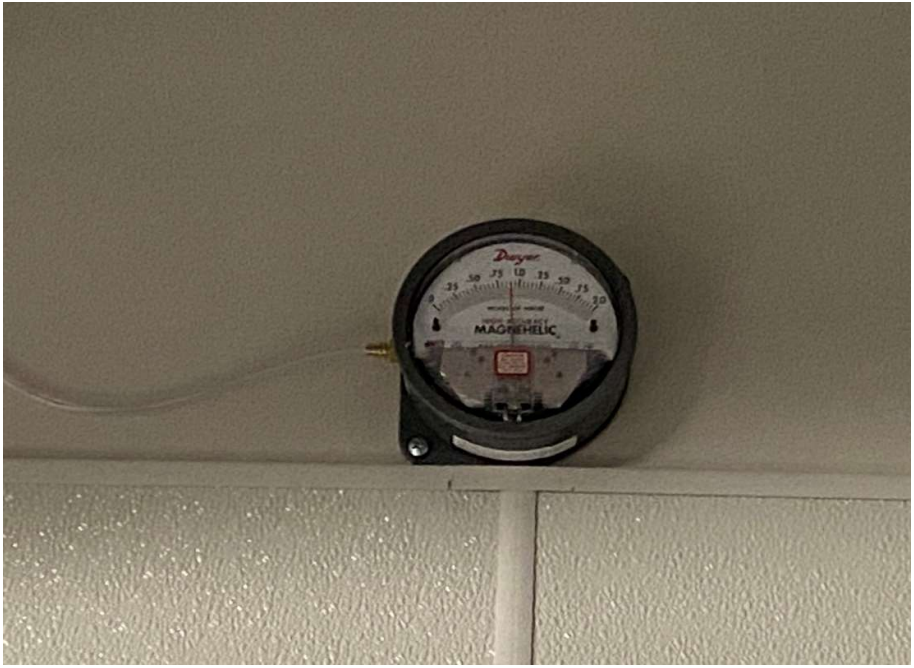
Client Name: Emerson Huron, LLC		Site Location: 73-79 W. Huron Street Site (C915282)	Project No.:
Photo No. 1	Date 04/24/24

Direction Photo Taken: Interior			
Description: Vapor Assessment ASD System Monitoring: Magnehelic Gauge Pressure Reading MAG-1 (0.90 inches of water)

During the inspection, minimal hairline cracks on the concrete slab were observed. However, the cracks appear superficial, and do not appear to affect the performance of the ASD system. Additionally, the concrete slab overlies a vapor barrier consisting of poly-sheeting. Magnehelic monitoring location 2 has been reading between -1.7 iwc and -1.90 iwc during this inspection period. At the time of the April 24th site inspection the magnehelic gauge read approximately -1.95 iwc. Recorded ASD system sheets can be found in Appendix C.

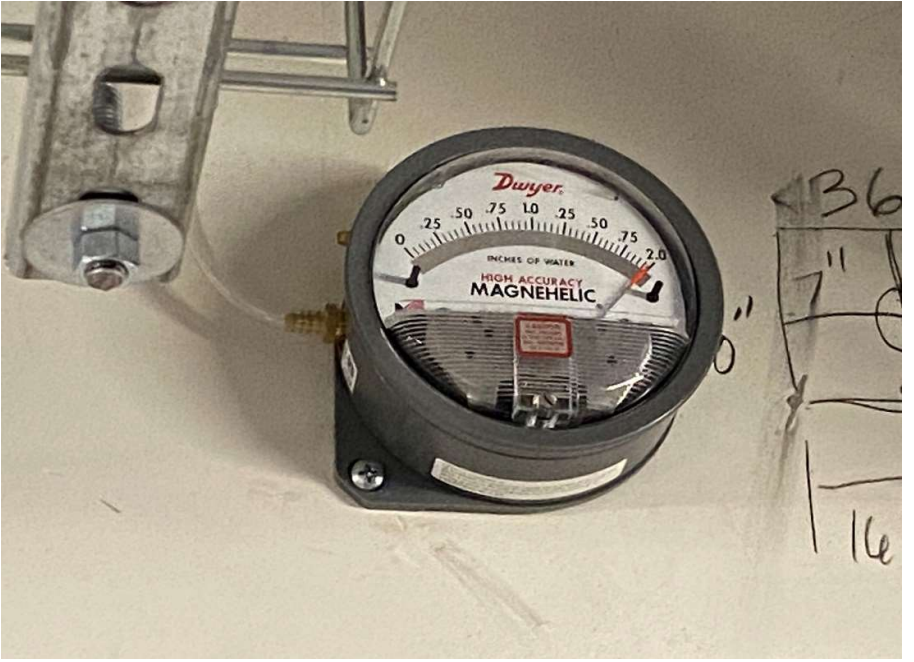
Photo No. 2	Date 04/24/24

Direction Photo Taken: Interior		
Description: Vapor Assessment ASD System Monitoring: Magnehelic Gauge Pressure Reading MAG-2 (1.95 inches of water)

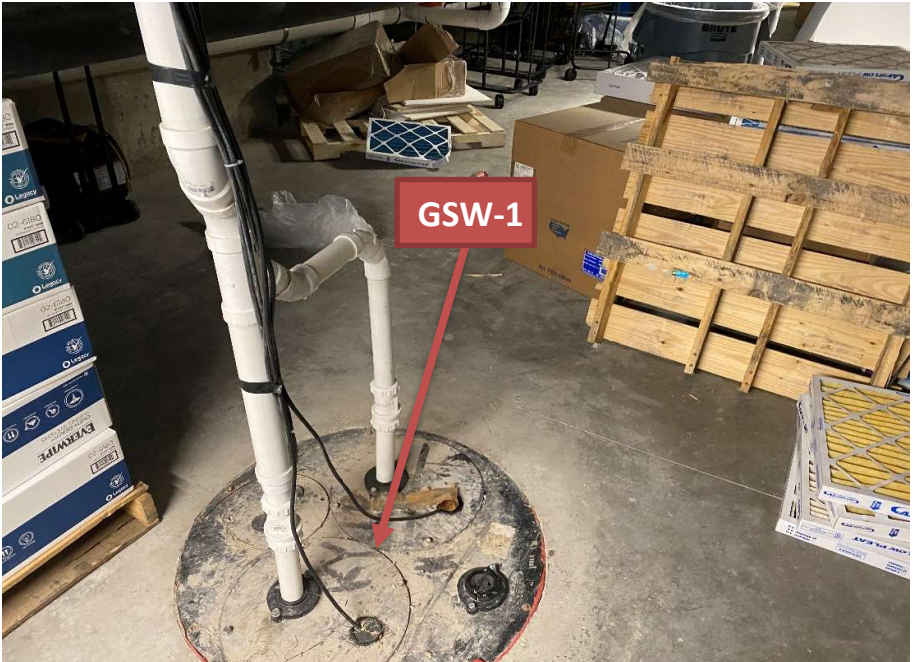
Client Name: Emerson Huron, LLC		Site Location: 73-79 W. Huron Street Site (C915282)	Project No.:
Photo No. 5	Date 04/24/24

Direction Photo Taken: Interior			
Description: Annual Site Inspection: Sealed sumps on southeast side of basement. GSW-1 sample location is noted in this picture.

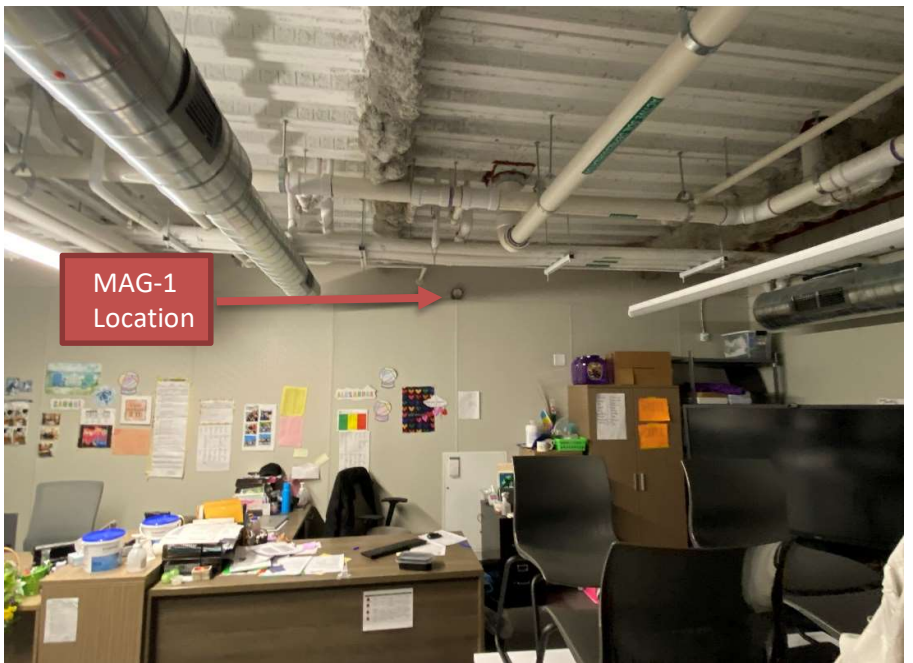
Photo No. 6	Date 04/24/23

Direction Photo Taken: Interior		
Description: Annual Site Inspection: Classroom location of MAG-1

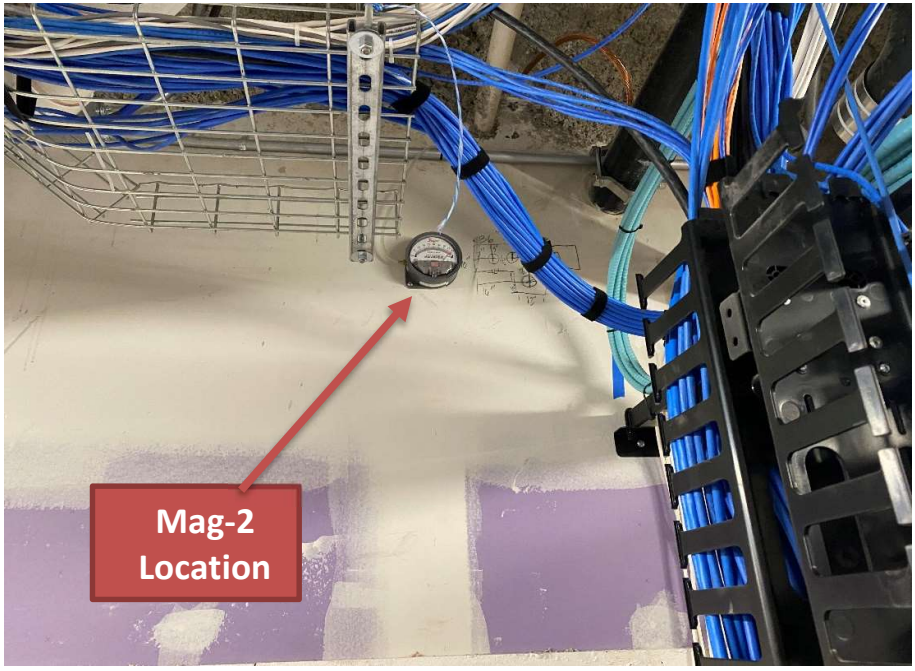
Client Name: Emerson Huron, LLC		Site Location: 73-79 W. Huron Street Site (C915282)	Project No.:
Photo No. 7	Date 04/24/24

Direction Photo Taken: Interior			
Description: Annual Site Inspection Telecommunications Room location of MAG-2

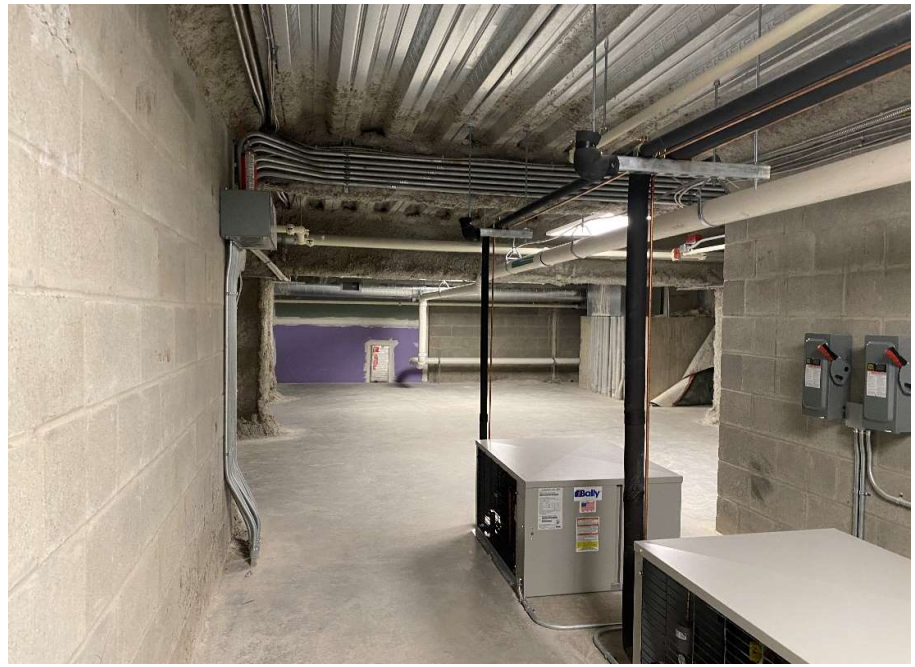
Photo No. 8	Date 04/24/24

Direction Photo Taken: Interior		
Description: Annual Site Inspection: Basement crawl space west side of the building.

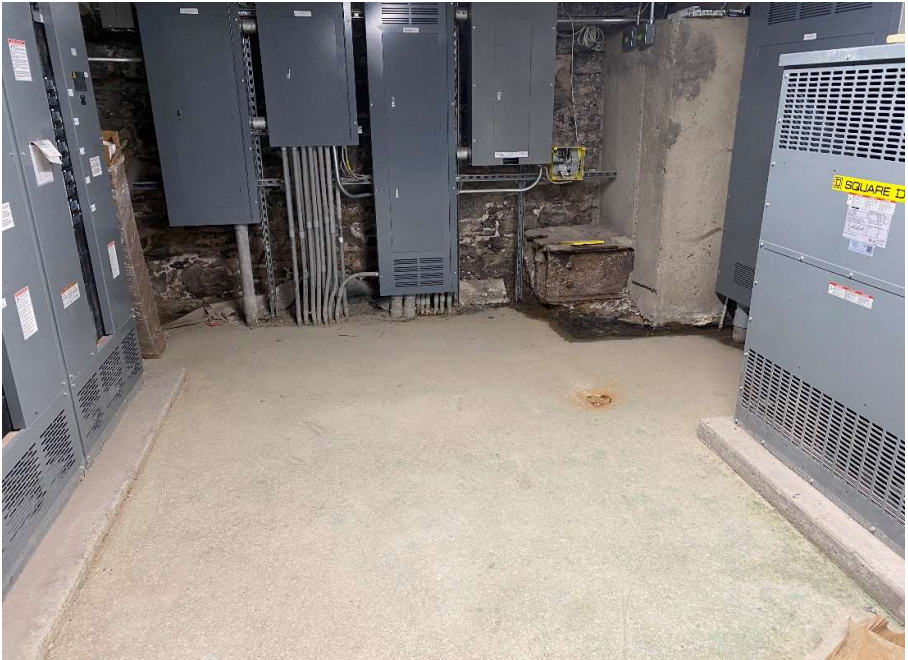
Client Name: Emerson Huron, LLC		Site Location: 73-79 W. Huron Street Site (C915282)	Project No.: B0441-022-001
Photo No. 9	Date 04/24/24

Direction Photo Taken: Interior			
Description: Annual Site Inspection: Electrical room north end of building

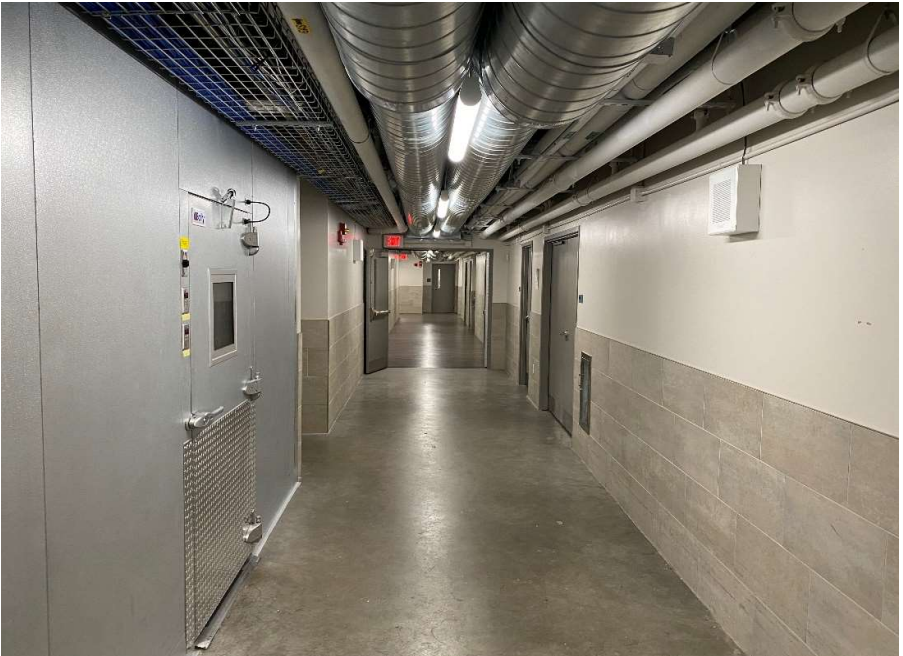
Photo No. 10	Date 04/24/24

Direction Photo Taken: Interior		
Description: Annual Site Inspection: Main hallway in basement.

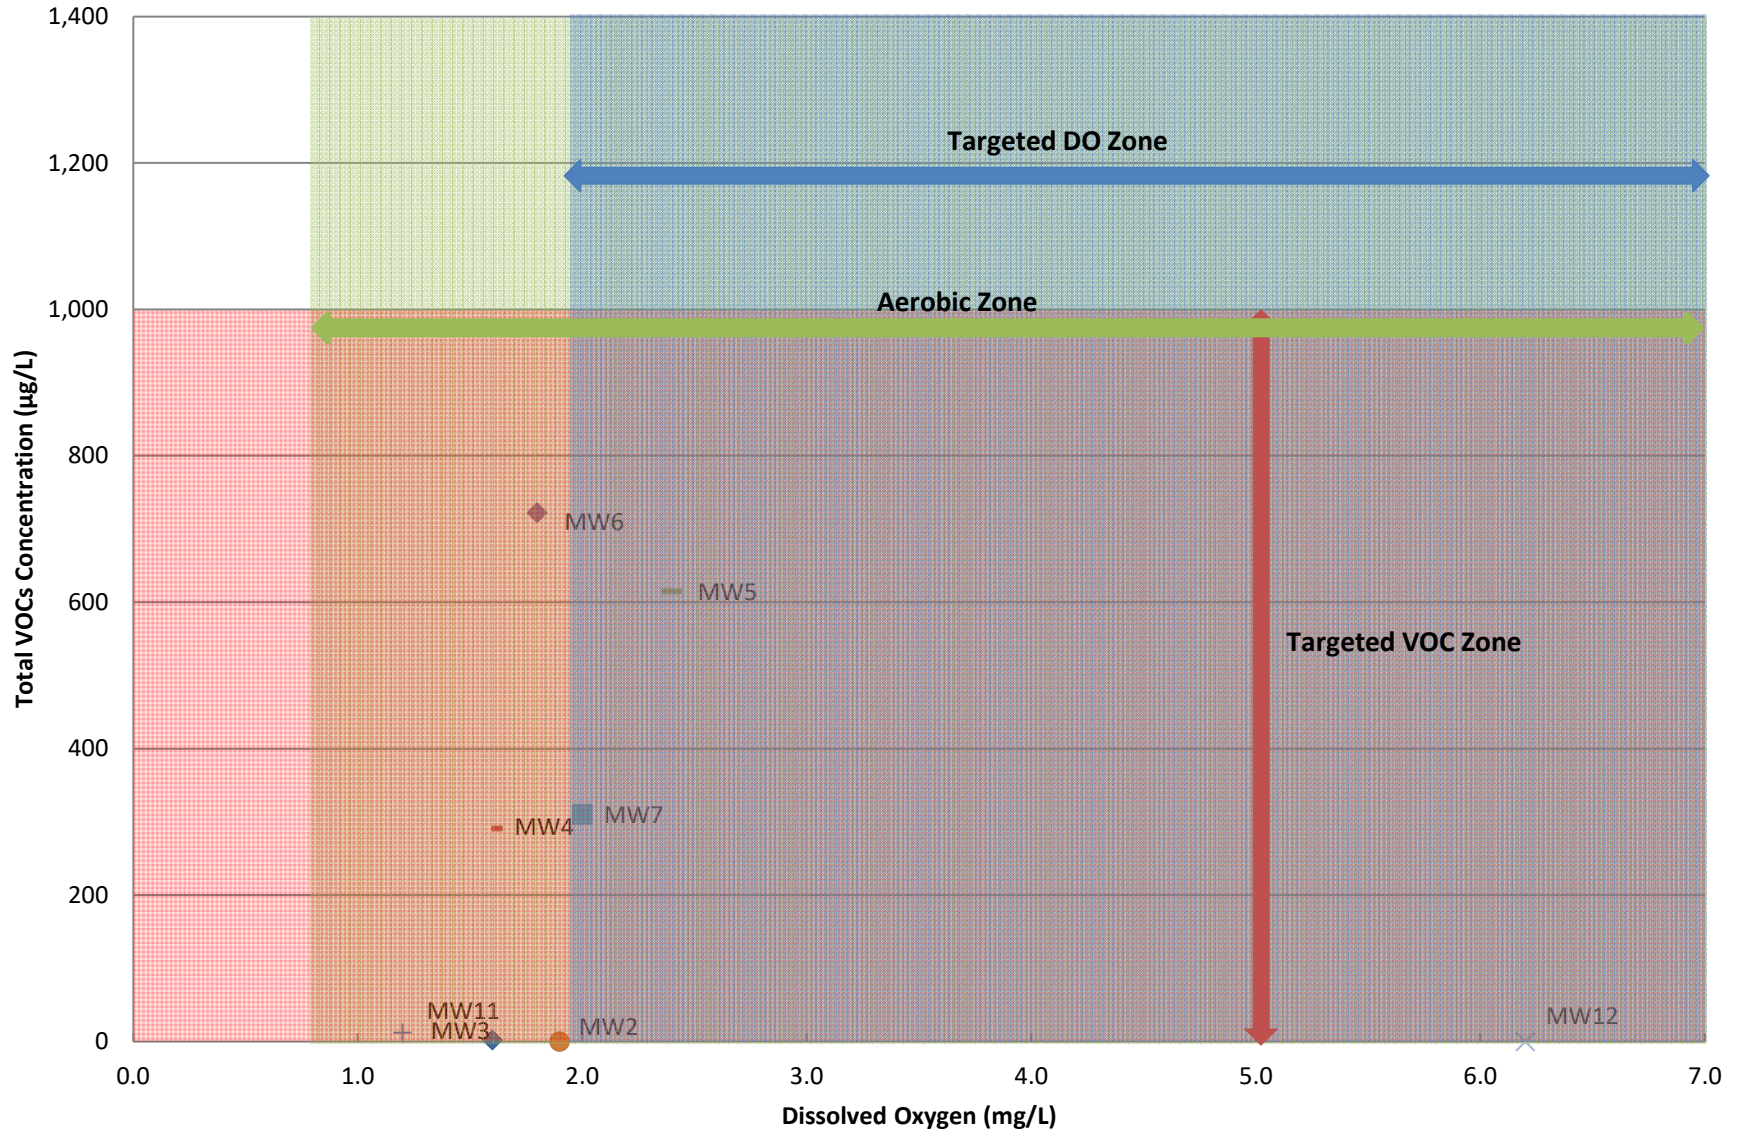
Chart 6 - Dissolved Oxygen v. Groundwater Quality (June 2020)

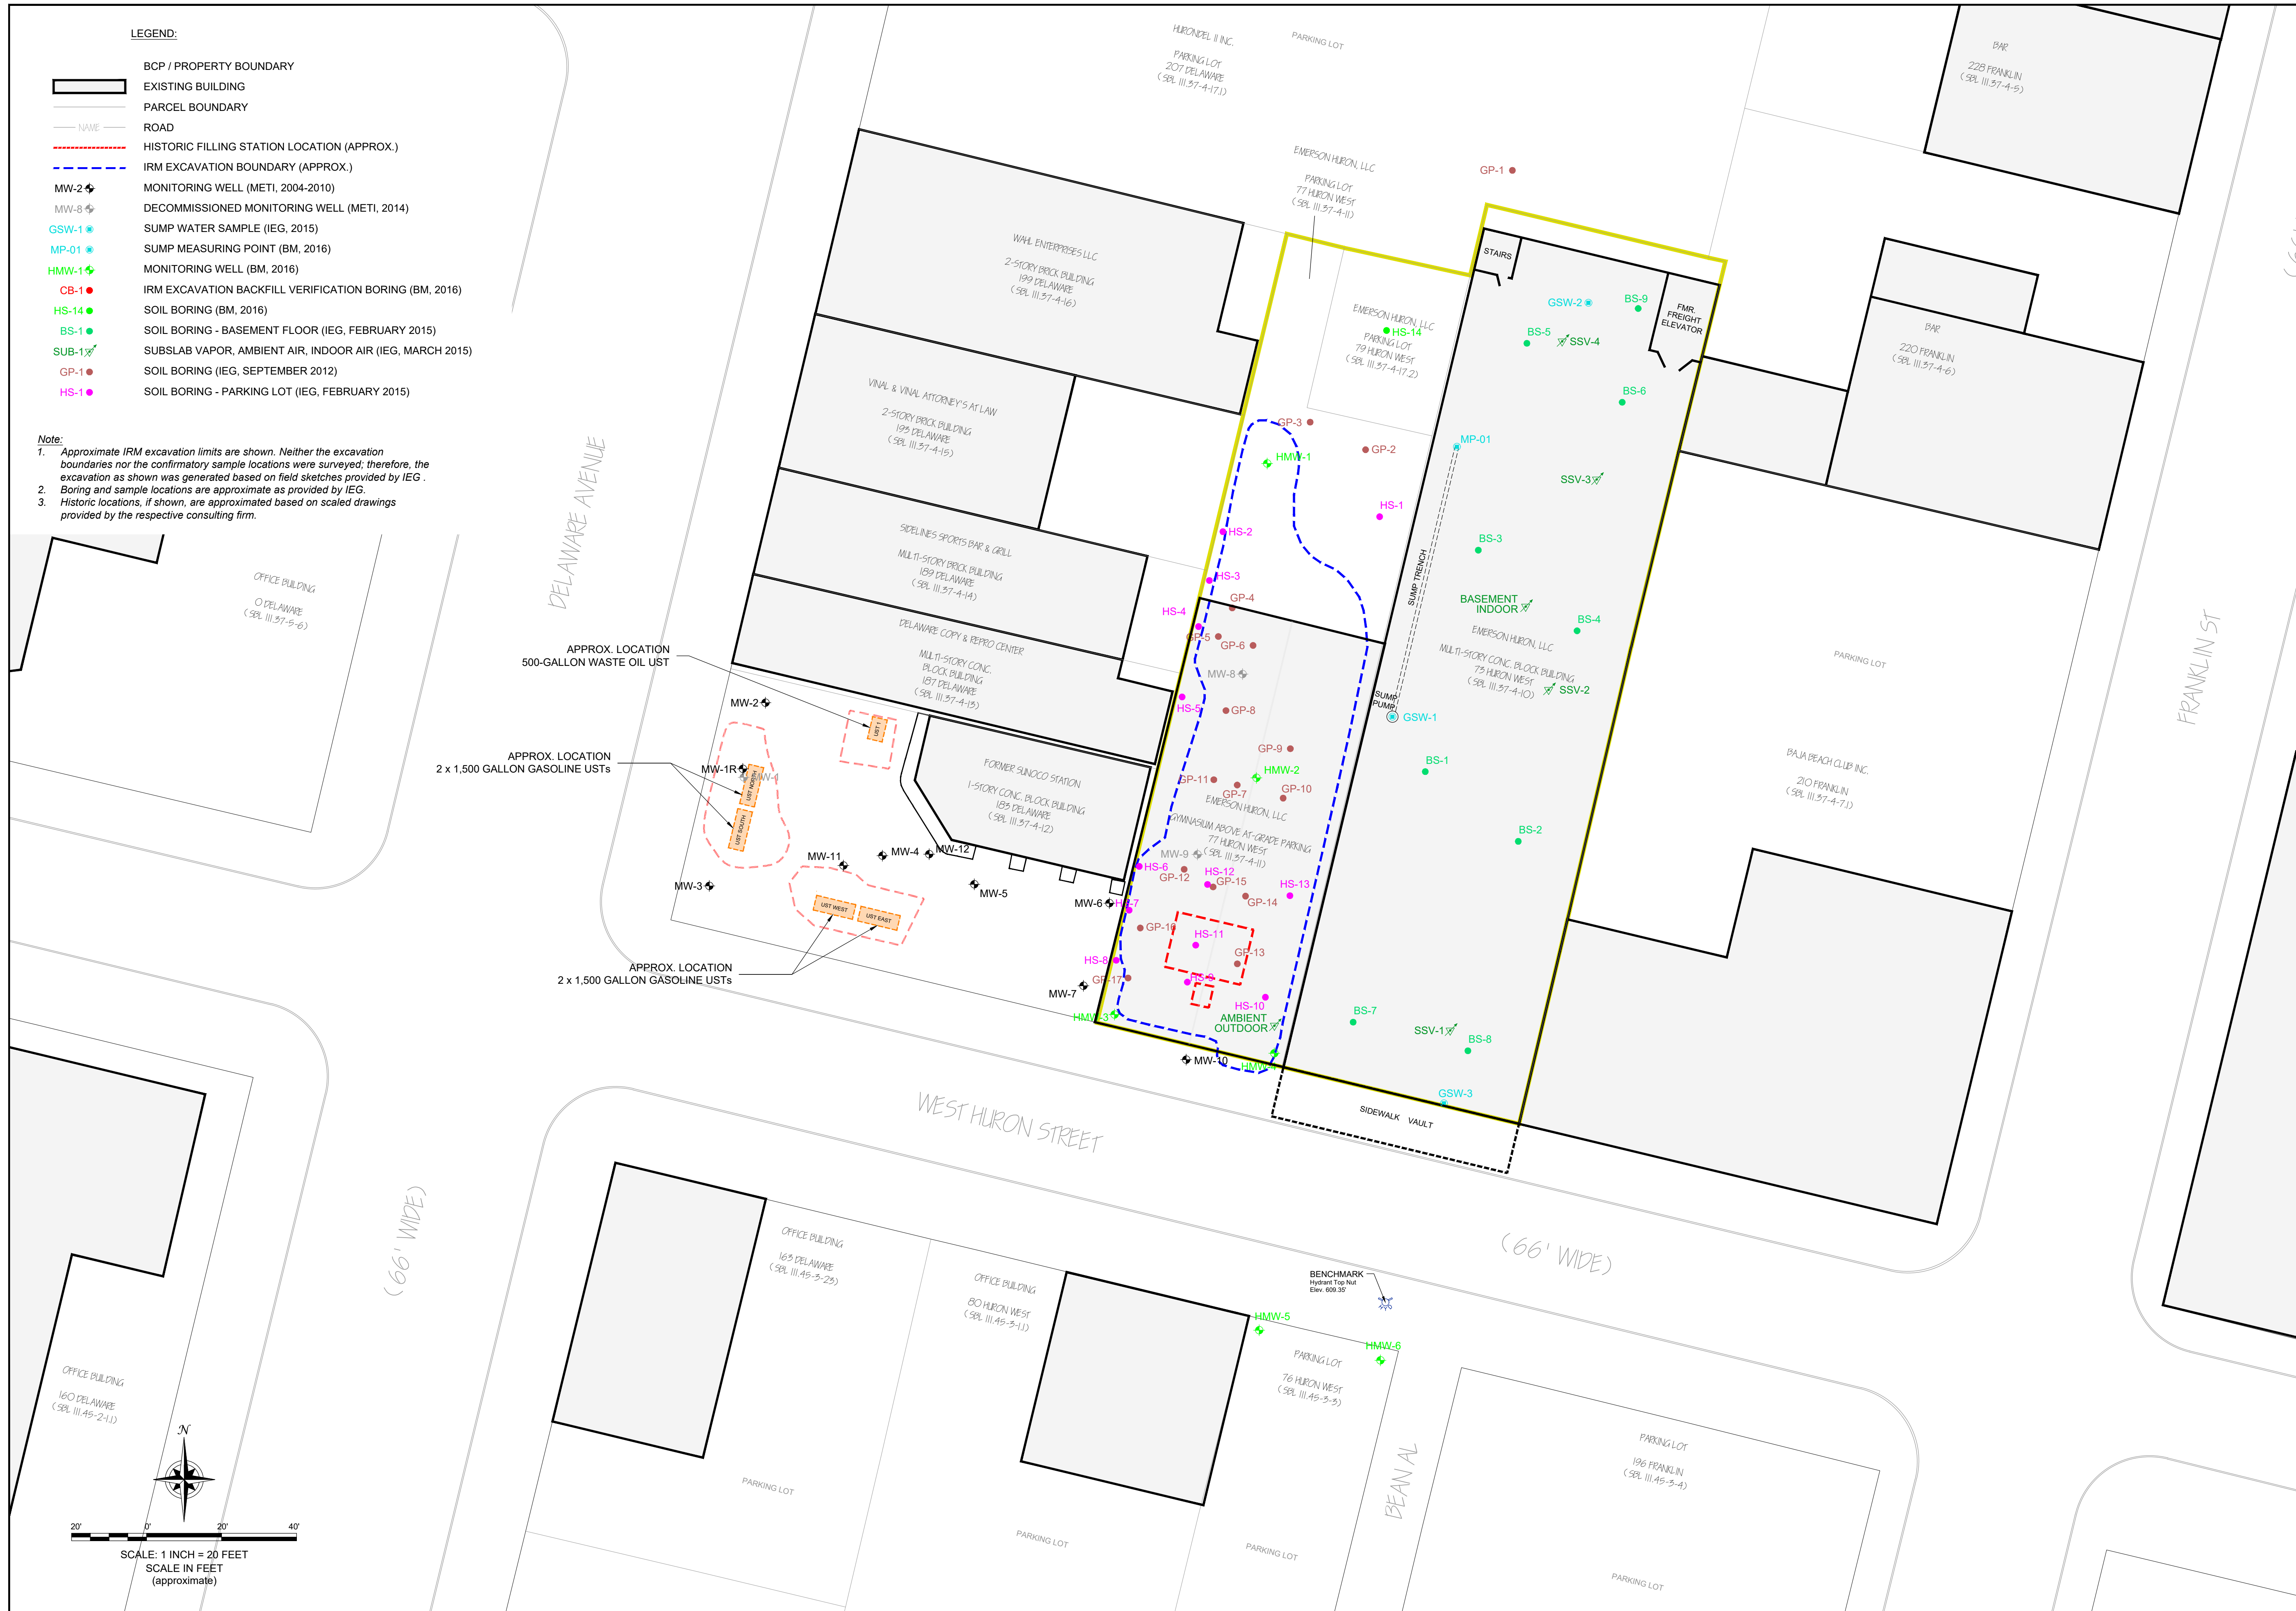
FIGURE 7

HISTORIC INVESTIGATION LOCATIONS
SITE MANAGEMENT PLAN
BCP SITE NO. C916282
75-79 WEST HURON STREET
BUFFALO, NEW YORK
PREPARED FOR:
EMERSON HURON, LLC

1. Approximate IRM excavation limits are shown. Neither the excavation boundaries nor the confirmatory sample locations were surveyed; therefore, the excavation as shown was generated based on field sketches provided by IEG.
2. Boring and sample locations are approximate as provided by IEG.
3. Historic locations, if shown, are approximated based on scaled drawings provided by the respective consulting firm.

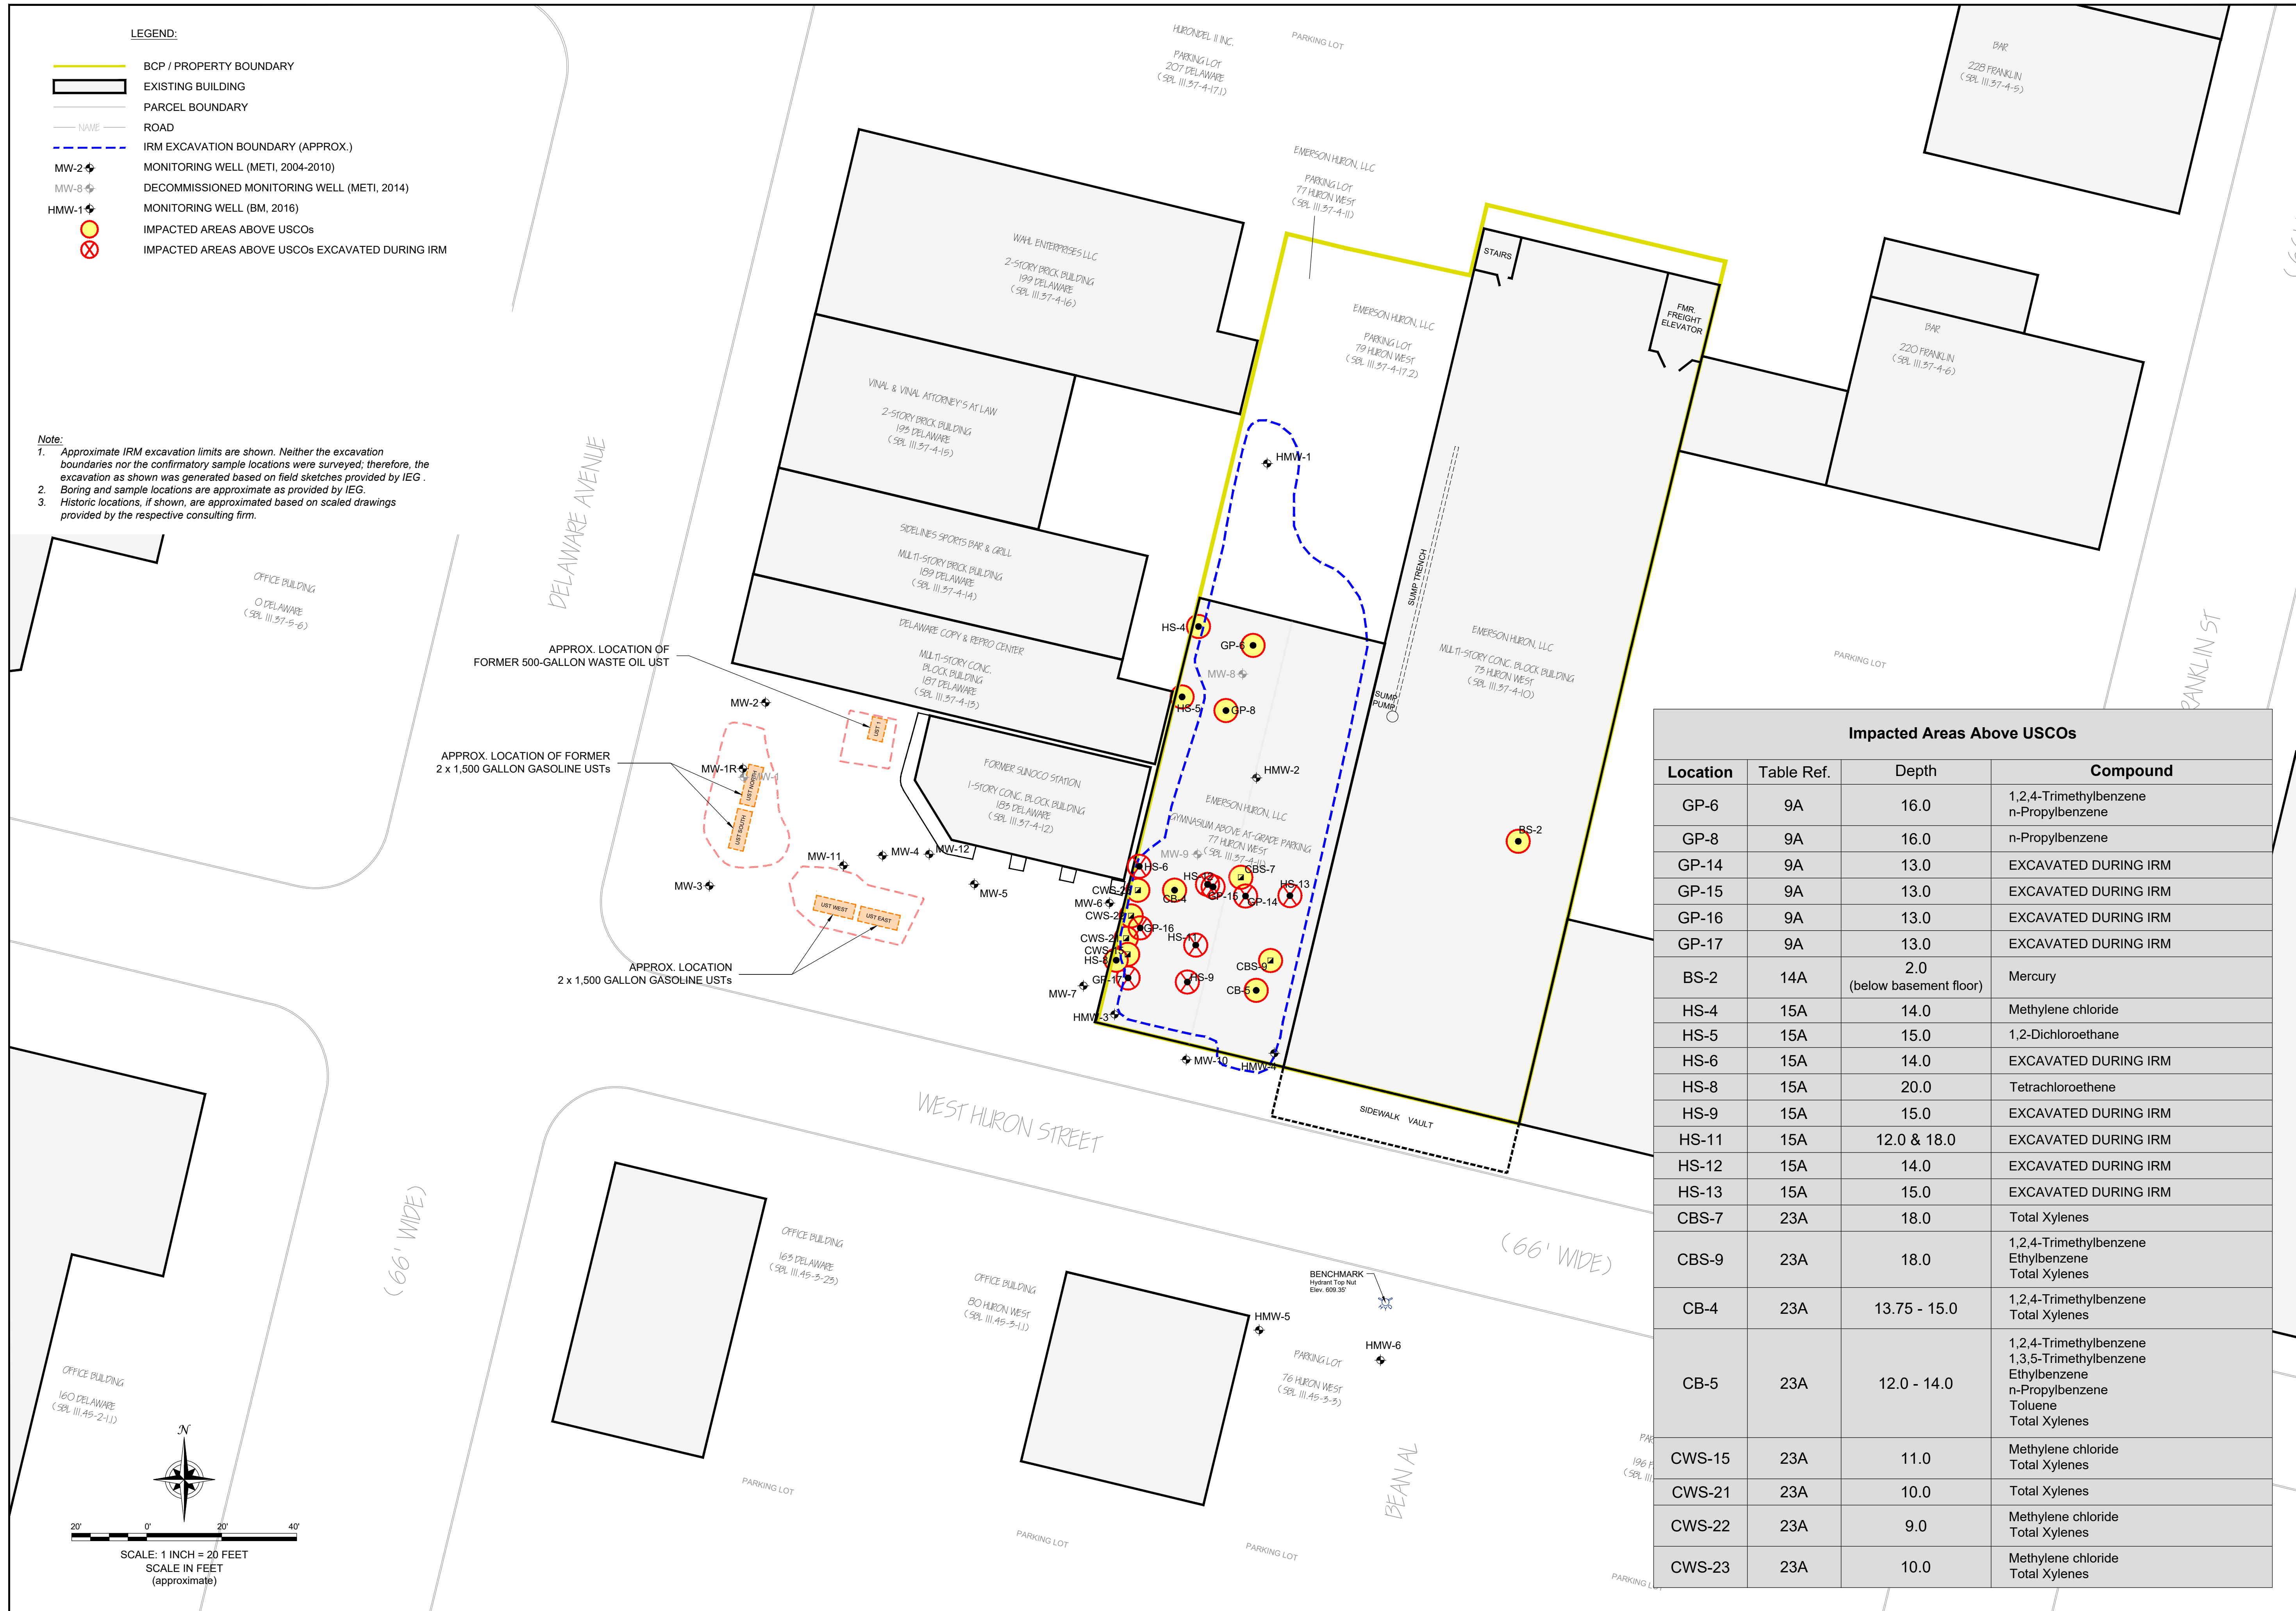
- Note:**
1. Approximate IRM excavation limits are shown. Neither the excavation boundaries nor the confirmatory sample locations were surveyed; therefore, the excavation as shown was generated based on field sketches provided by IEG.
 2. Boring and sample locations are approximate as provided by IEG.
 3. Historic locations, if shown, are approximated based on scaled drawings provided by the respective consulting firm.

Impacted Areas Above USCOS			
Location	Table Ref.	Depth	Compound
GP-6	9A	16.0	1,2,4-Trimethylbenzene n-Propylbenzene
GP-8	9A	16.0	n-Propylbenzene
GP-14	9A	13.0	EXCAVATED DURING IRM
GP-15	9A	13.0	EXCAVATED DURING IRM
GP-16	9A	13.0	EXCAVATED DURING IRM
GP-17	9A	13.0	EXCAVATED DURING IRM
BS-2	14A	2.0 (below basement floor)	Mercury
HS-4	15A	14.0	Methylene chloride
HS-5	15A	15.0	1,2-Dichloroethane
HS-6	15A	14.0	EXCAVATED DURING IRM
HS-8	15A	20.0	Tetrachloroethene
HS-9	15A	15.0	EXCAVATED DURING IRM
HS-11	15A	12.0 & 18.0	EXCAVATED DURING IRM
HS-12	15A	14.0	EXCAVATED DURING IRM
HS-13	15A	15.0	EXCAVATED DURING IRM
CBS-7	23A	18.0	Total Xylenes
CBS-9	23A	18.0	1,2,4-Trimethylbenzene Ethylbenzene Total Xylenes
CB-4	23A	13.75 - 15.0	1,2,4-Trimethylbenzene Total Xylenes
CB-5	23A	12.0 - 14.0	1,2,4-Trimethylbenzene 1,3,5-Trimethylbenzene Ethylbenzene n-Propylbenzene Toluene Total Xylenes
CWS-15	23A	11.0	Methylene chloride Total Xylenes
