# Period Review Report

73 – 79 West Huron Street Site  
Buffalo, New York  
BCP Site No. C915282

April 28, 2024 to April 28, 2025 Certifying Period

August 2025

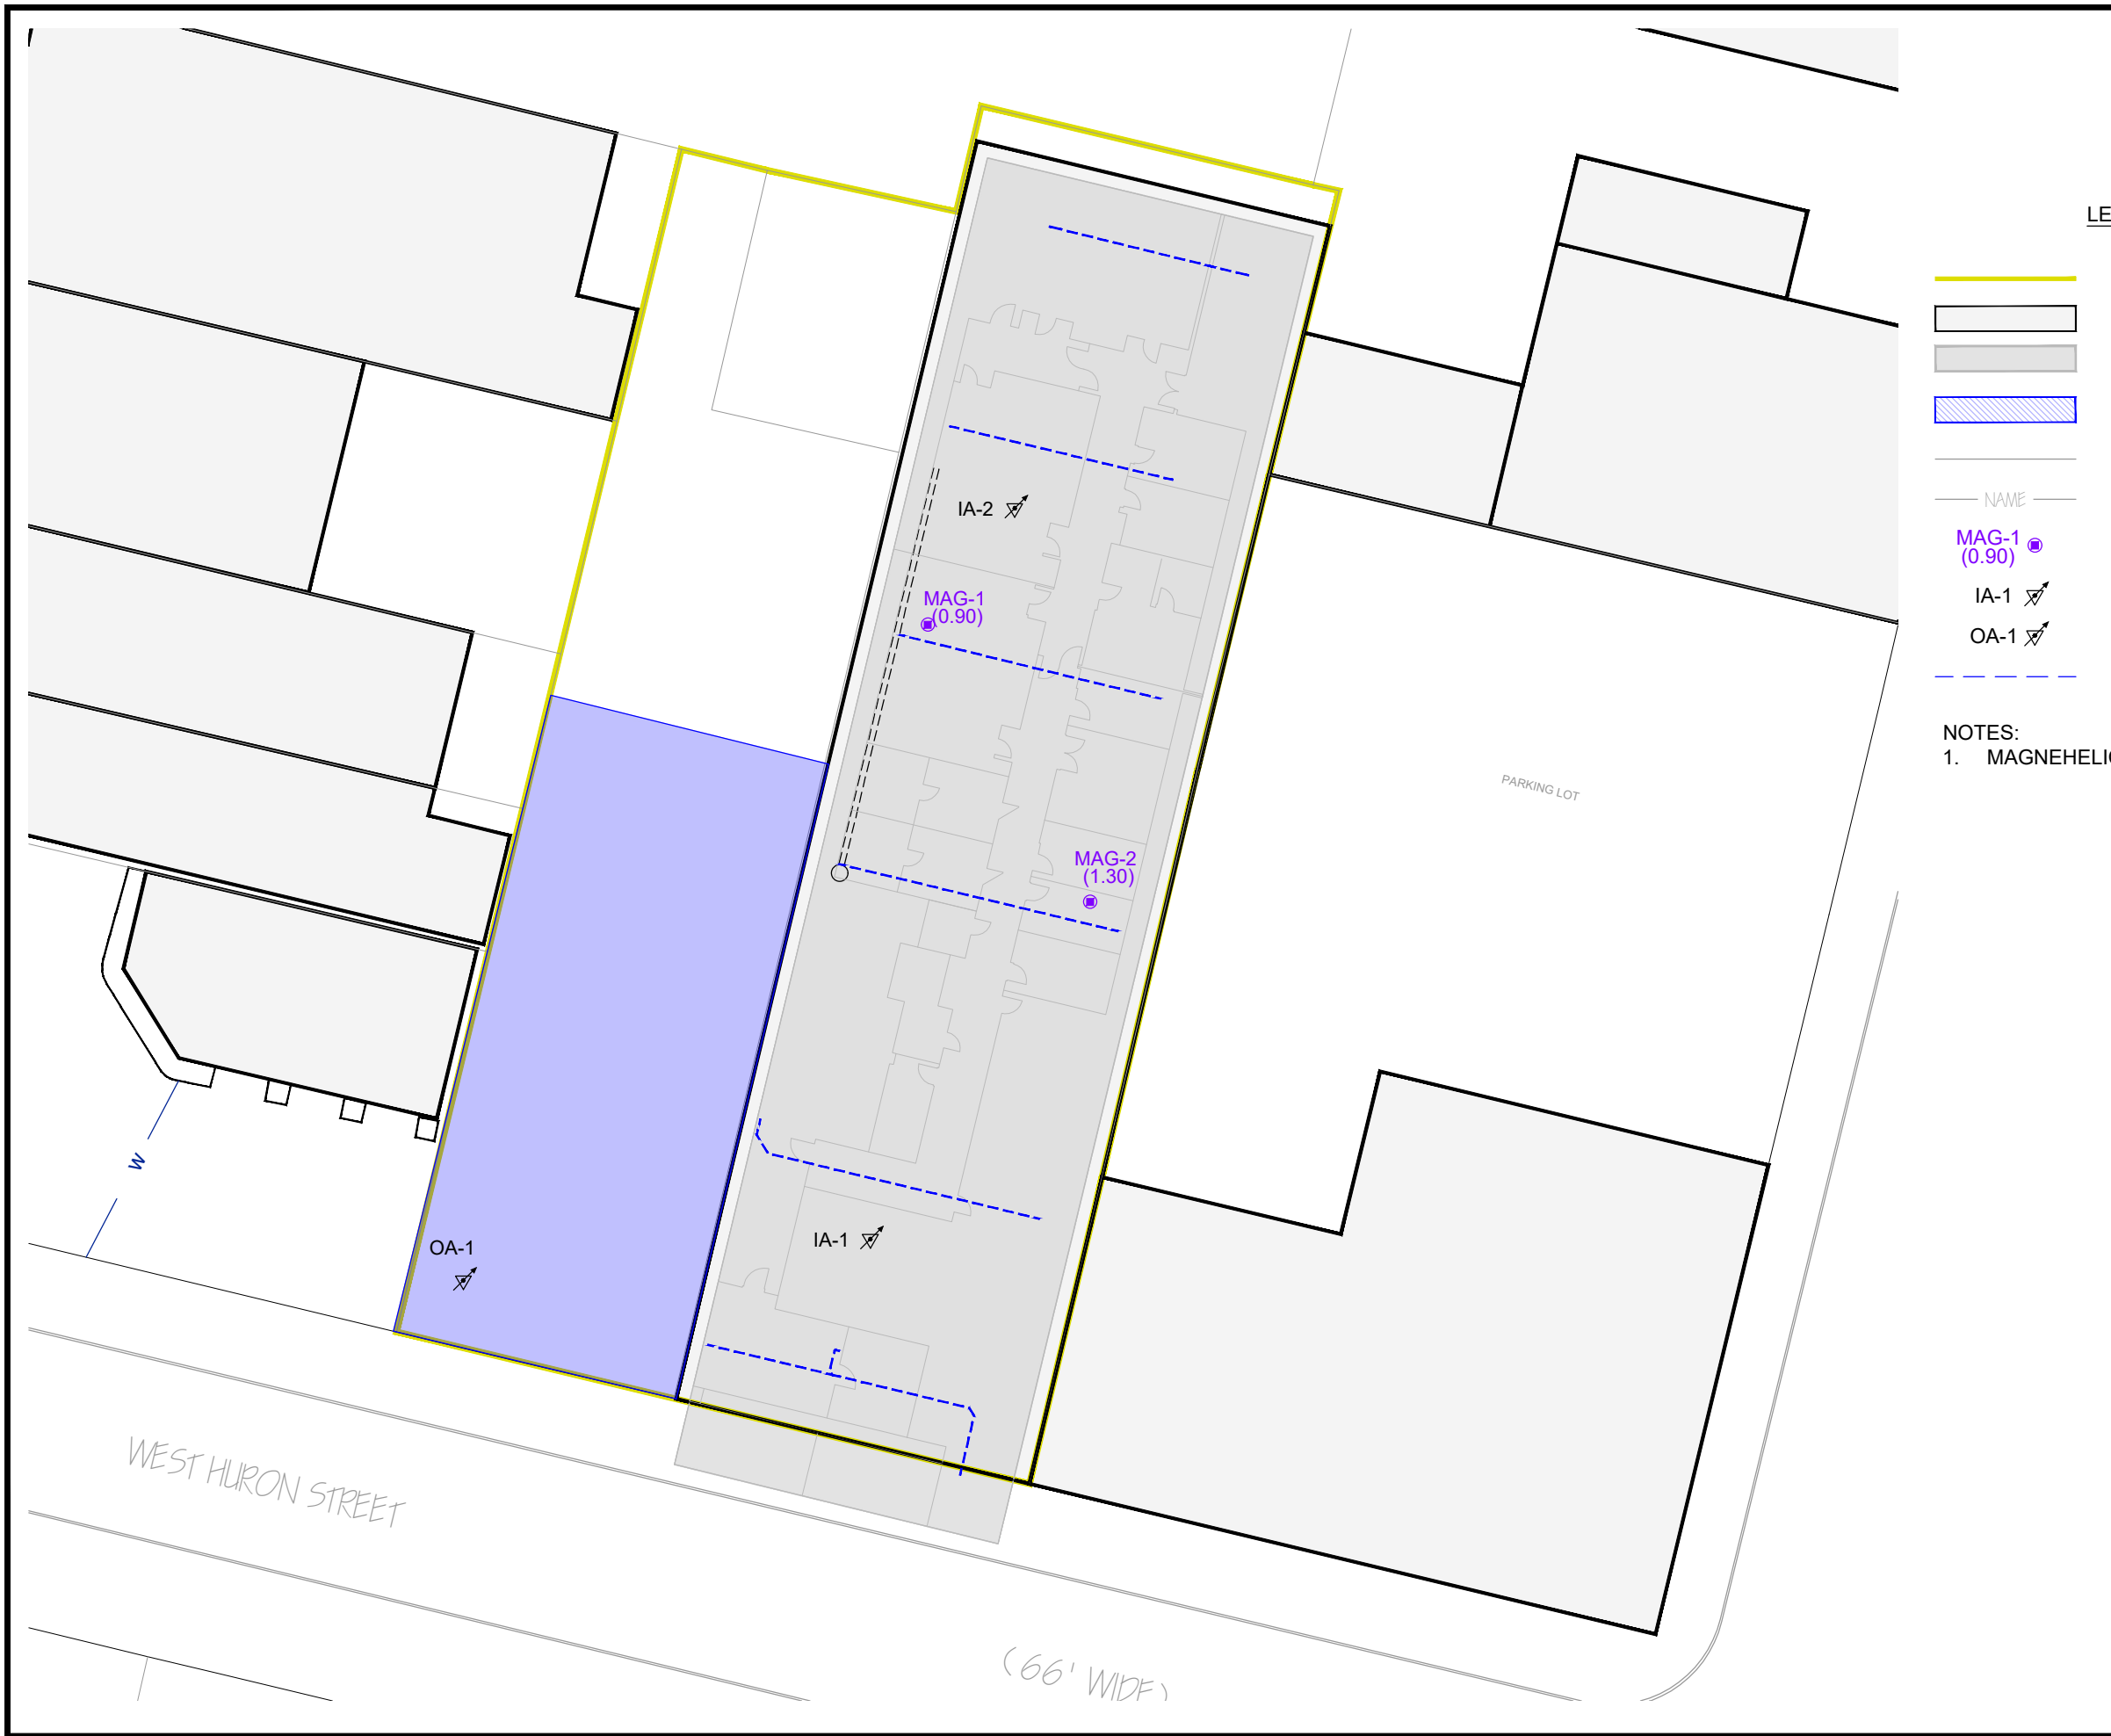
**ASD SYSTEM AND VAPOR ASSESSMENT LOCATIONS**  
PERIODIC REVIEW REPORT  
73-79 WEST HURON STREET SITE (BCP SITE NO. C915282)  
BUFFALO, NEW YORK

There are no Engineering Controls (ECs) associated with the Site under the implemented Track 2 cleanup except for an ASD system as described in Section 4.3, below. The Site is either covered with hardscape (asphalt) or the on-site building, with no green space cover. The ASD system was observed to be in working order at the time of site inspection, readings at magnehelic gauges Mag-1 and Mag-2 (see Figure 3) were measured at 0.90 and 1.30 inches of water column, respectively.

- NOTES:
- MAGNEHELIC GAUGE READINGS TAKEN ON APRIL 14, 2025

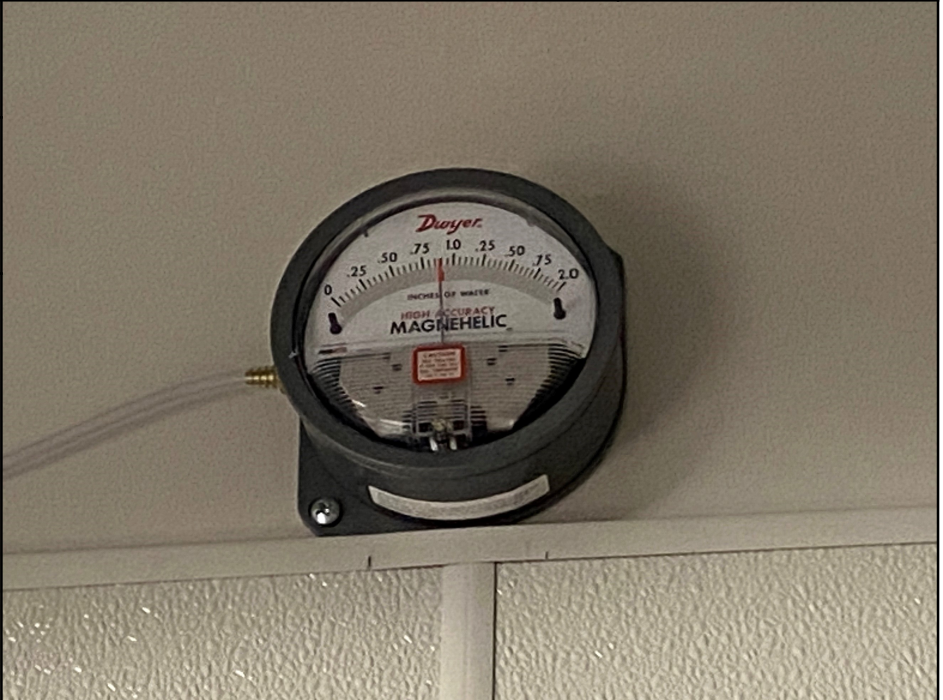
<b>Client Name:</b> Emerson Huron, LLC		<b>Site Location:</b> 73-79 W. Huron Street Site (C915282)	<b>Project No.:</b>
<b>Photo No.</b> 1	<b>Date</b> 04/14/25

<b>Direction Photo Taken:</b> Interior			
<b>Description:</b> <b>Vapor Assessment ASD System Monitoring:</b> Magnehelic Gauge Pressure Reading MAG-1 (0.90 inches of water)

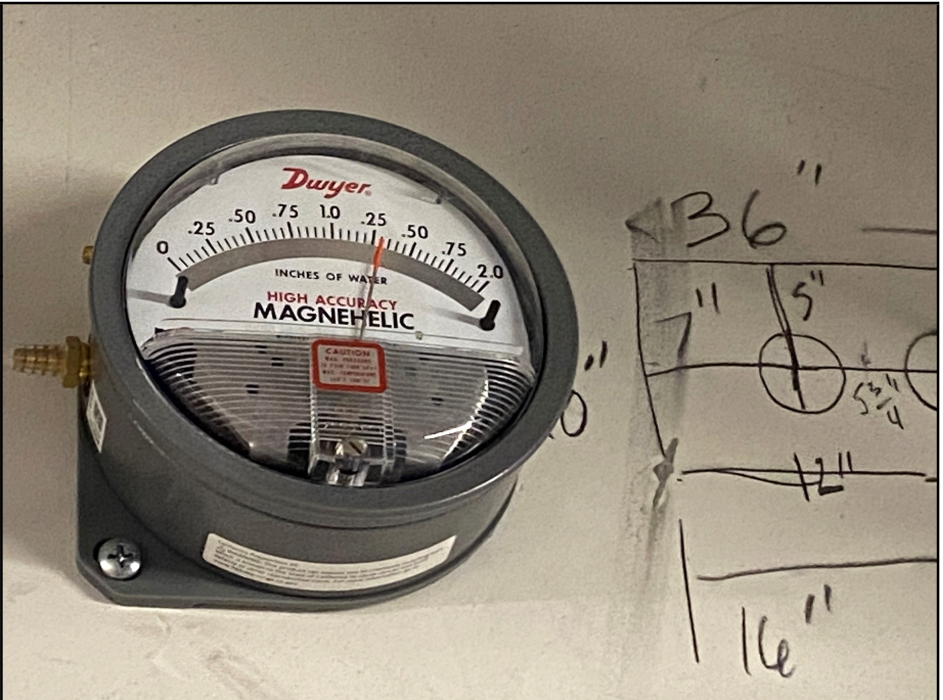
<b>Photo No.</b> 2	<b>Date</b> 04/14/25

<b>Direction Photo Taken:</b> Interior		
<b>Description:</b> <b>Vapor Assessment ASD System Monitoring:</b> Magnehelic Gauge Pressure Reading MAG-2 (1.30 inches of water)

During the April 2024 site inspection elevated vacuum readings (1.95 inches of water column as compared to typical 1.30 inches of water column) on the MAG-2 monitoring location are believed to be caused by fluctuating groundwater levels that, upon rising, partially restricted the ASD extraction piping. This caused system fans to work harder creating a higher vacuum to give elevated readings. The elevated water levels were suspected to be attributable to maintenance issues associated with a submersible pump in an offsite utility vault located in the sidewalk along W. Huron St on the south side of the building.

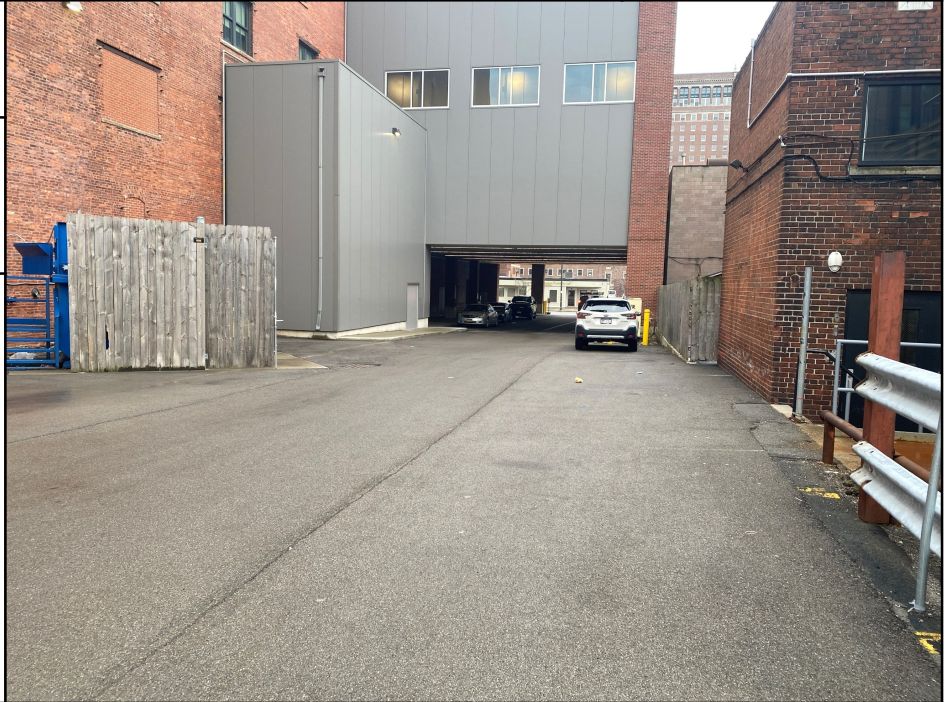
**Description:****Annual Site Inspection:**

Exterior Elevated Gymnasium Addition.

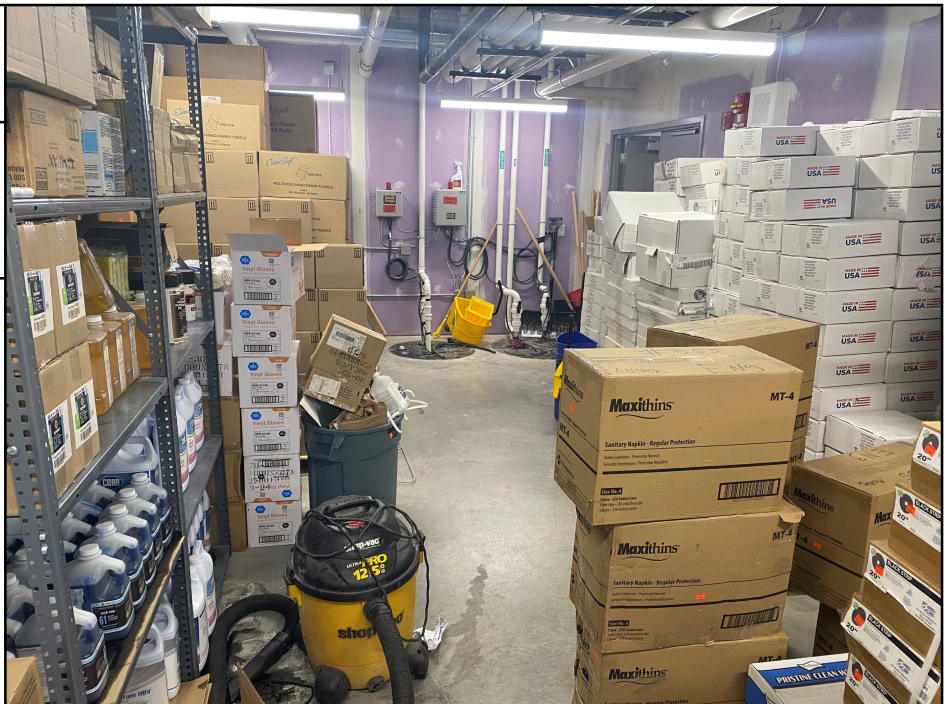
**Description:****Annual Site Inspection:**

Sealed sumps in northside of basement.

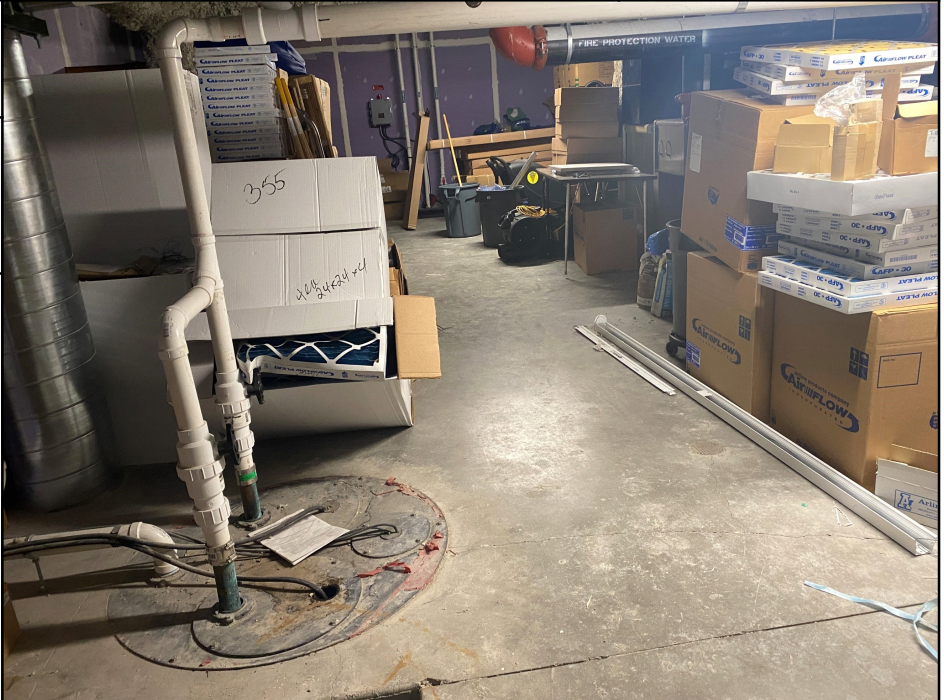
<b>Client Name:</b> Emerson Huron, LLC		<b>Site Location:</b> 73-79 W. Huron Street Site (C915282)	<b>Project No.:</b>
<b>Photo No.</b> 5	<b>Date</b> 04/14/25

<b>Direction Photo Taken:</b> Interior			
<b>Description:</b> Annual Site Inspection: Sealed sump in basement.

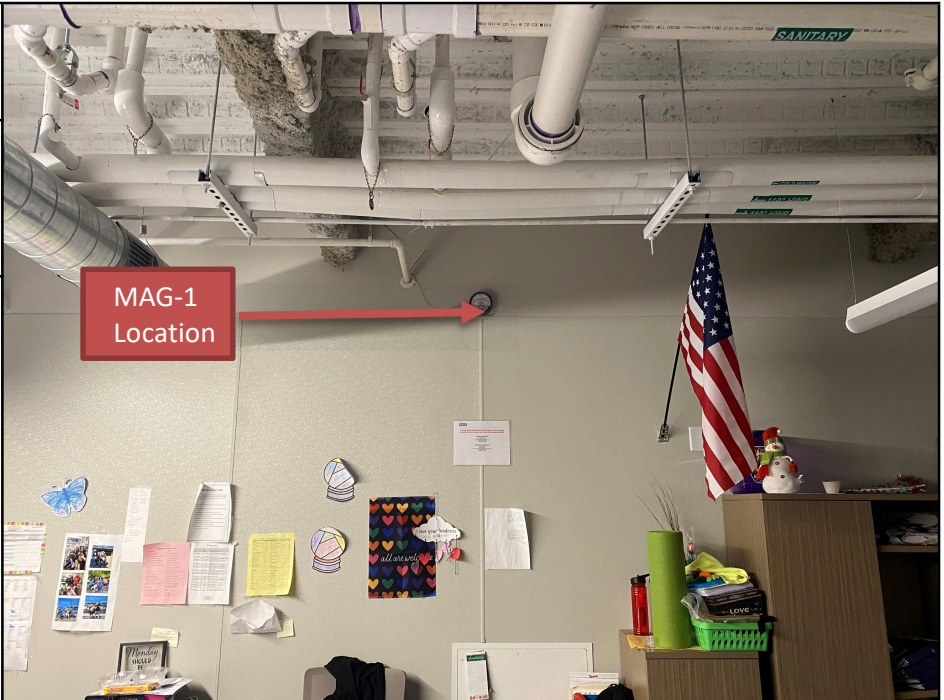
<b>Photo No.</b> 6	<b>Date</b> 04/14/25

<b>Direction Photo Taken:</b> Interior		
<b>Description:</b> Annual Site Inspection: Classroom location of MAG-1

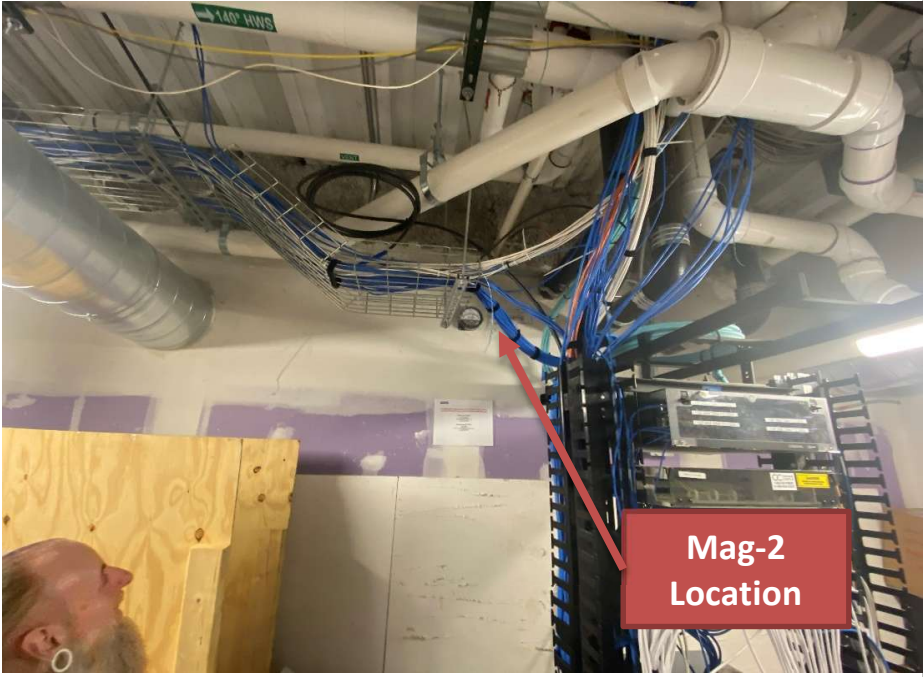
<b>Client Name:</b> Emerson Huron, LLC		<b>Site Location:</b> 73-79 W. Huron Street Site (C915282)	<b>Project No.:</b>
<b>Photo No.</b> 7	<b>Date</b> 04/14/25

<b>Direction Photo Taken:</b> Interior			
<b>Description:</b> Annual Site Inspection Telecommunications Room location of MAG-2

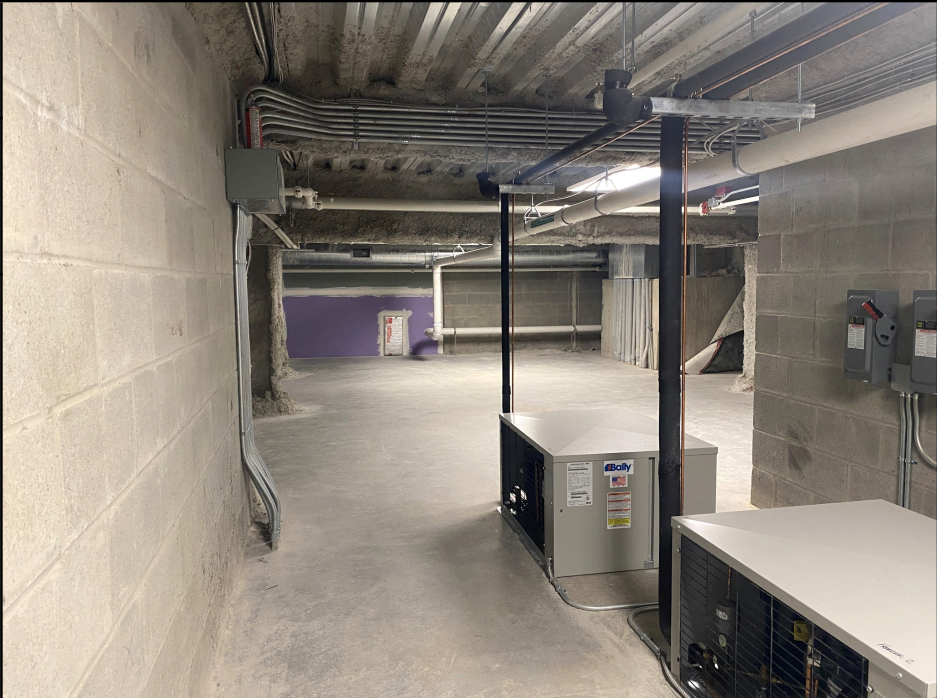
<b>Photo No.</b> 8	<b>Date</b> 04/14/25

<b>Direction Photo Taken:</b> Interior		
<b>Description:</b> Annual Site Inspection: Basement crawl space west side of the building.

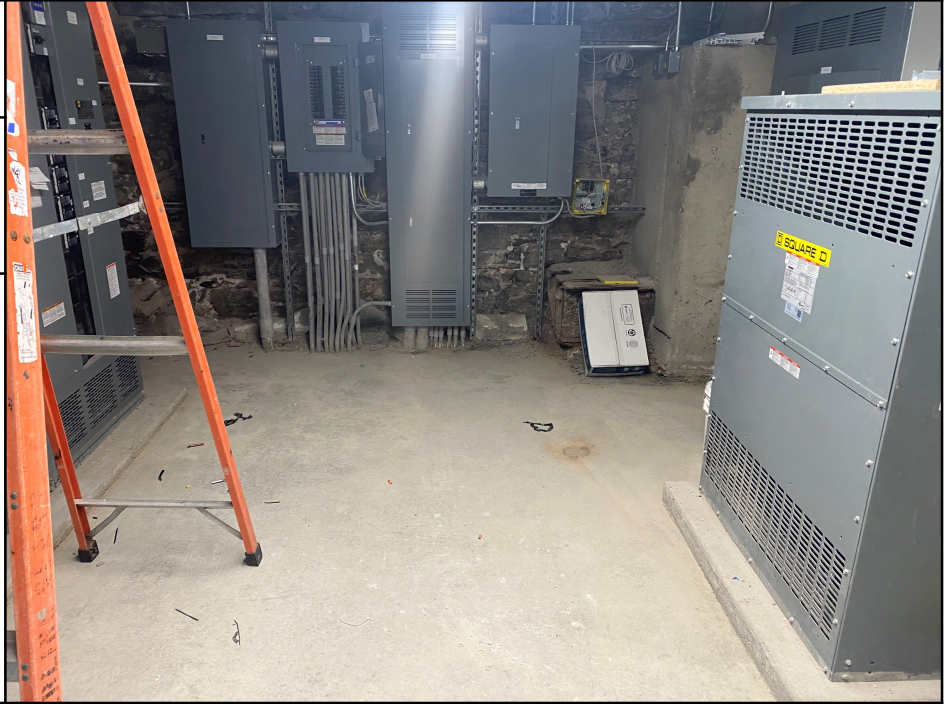
**Description:****Annual Site Inspection:**

Electrical room north end of building

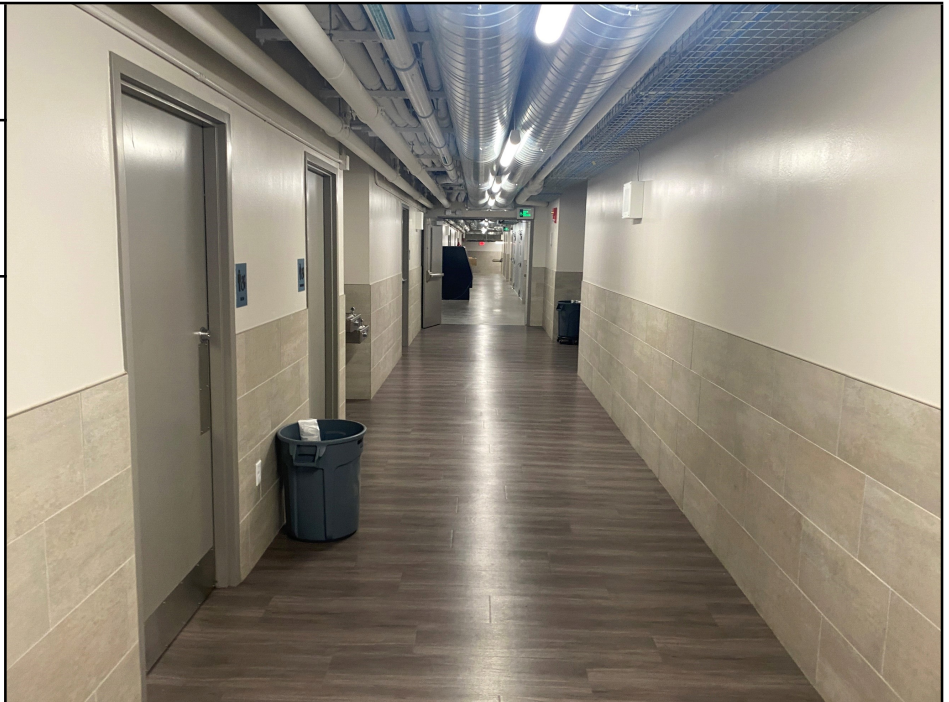
**Description:****Annual Site Inspection:**

Main hallway in basement.

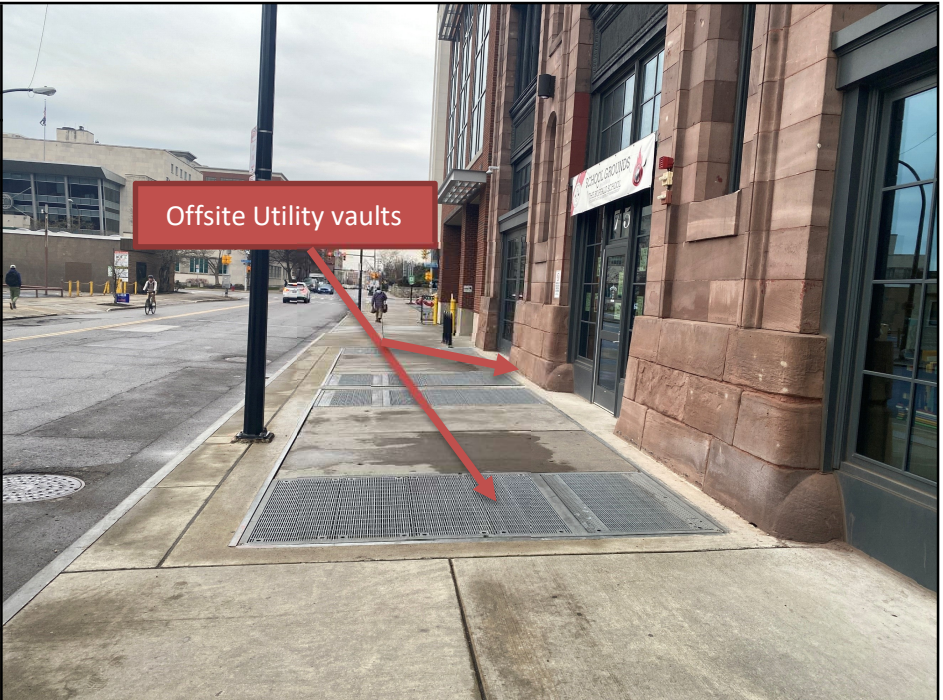
<b>Photo No.</b> 12	<b>Date</b> 04/14/25

<b>Direction Photo Taken:</b> West		
<b>Description:</b> <b>Annual Site Inspection:</b> Sidewalk along West Huron Street.

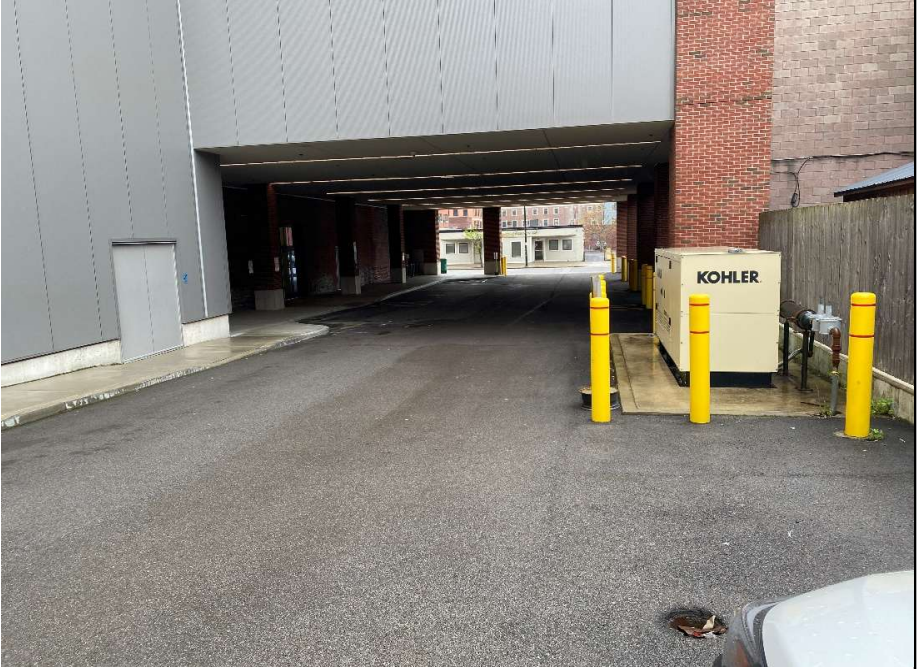
<b>Client Name:</b> Emerson Huron, LLC		<b>Site Location:</b> 73-79 W. Huron Street Site (C915282)	<b>Project No.:</b> B0441-022-001
<b>Photo No.</b> 13	<b>Date</b> 04/24/24

<b>Direction Photo Taken:</b> West/Northwest			
<b>Description:</b> <b>Annual Site Inspection:</b> Damaged monitoing well HMW-1. Repaired in October 2024.

The onsite monitoring well HMW-1 road box, which was noted has damaged in the 2024 PRR, was repaired/replaced on October 14<sup>th</sup>, 2024.

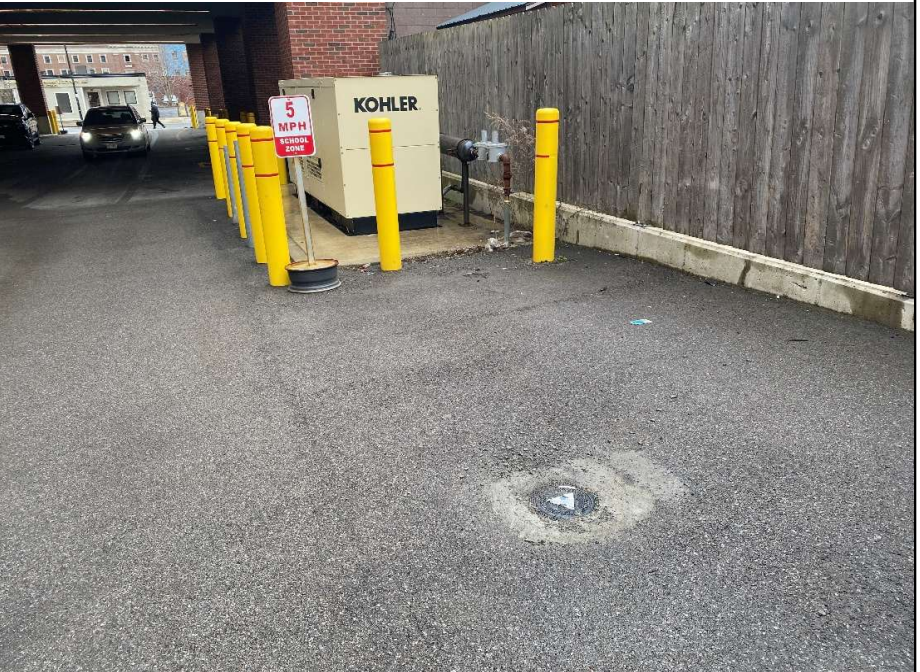
<b>Photo No.</b> 14	<b>Date</b> 04/14/25

<b>Direction Photo Taken:</b> West		
<b>Description:</b> <b>Annual Site Inspection:</b> Repaired HMW-1
