89 LaSalle Avenue Site
ERIE, NEW YORK

Periodic Review Report

NYSDEC Site Number: C915283

REVISED JUNE 2022

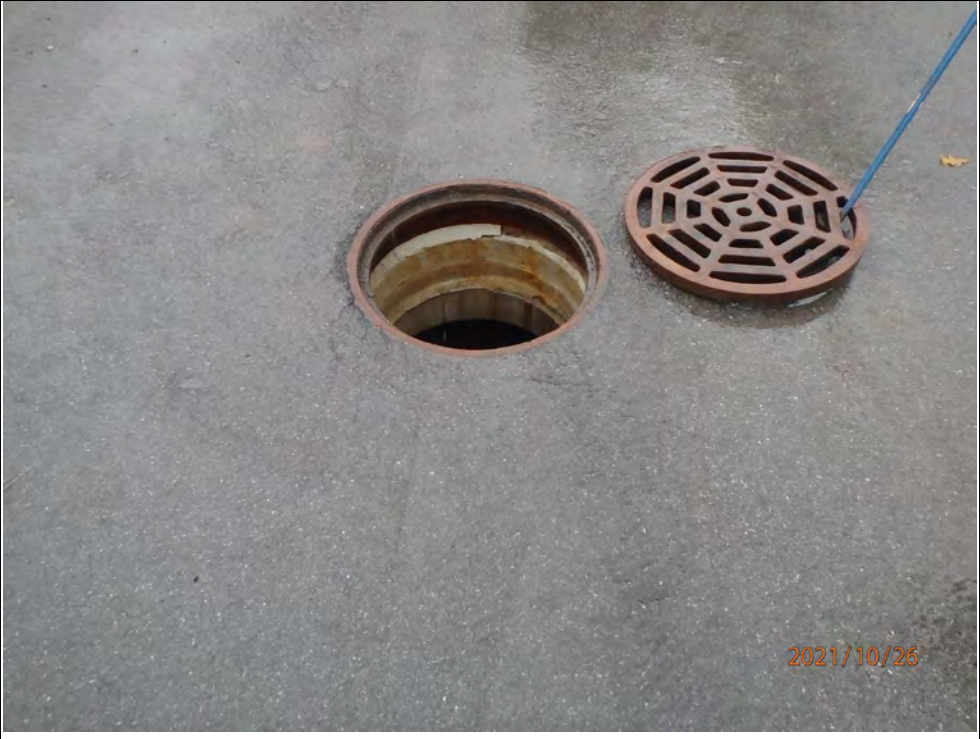
Photo No.	Date	
1	10/26/21

MH-1 Sampling location

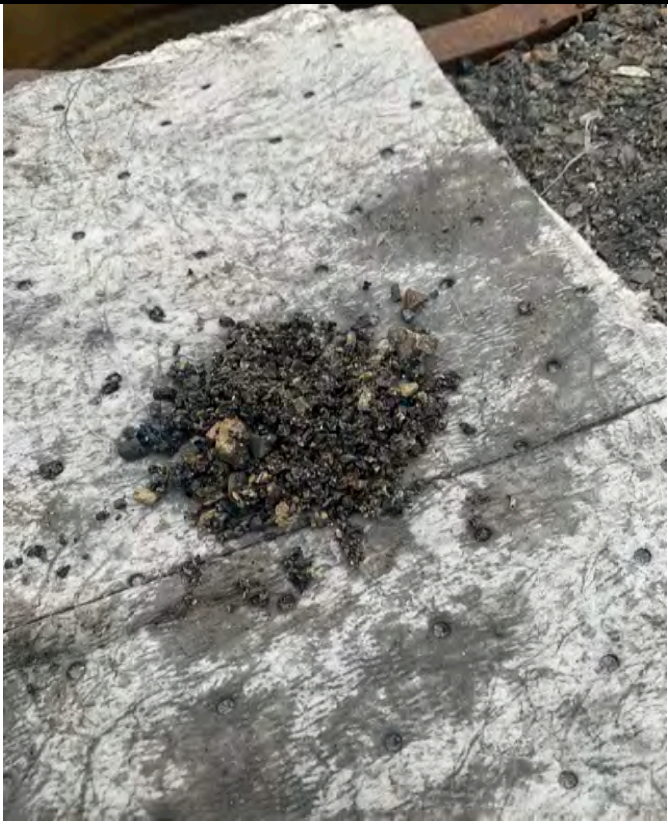
Photo No.	Date	
25	4/7/22

Solids (primarily asphalt particles and gravel) accumulated and collected from bottom of MH-1. Representative of "sediment" sample collected.
