Re: Limited Phase II Site Assessment Summary Report  
Leisure Living Property

1130 Niagara Street, Buffalo, New York

## **2.0 LIMITED PHASE II ENVIRONMENTAL SITE ASSESSMENT**

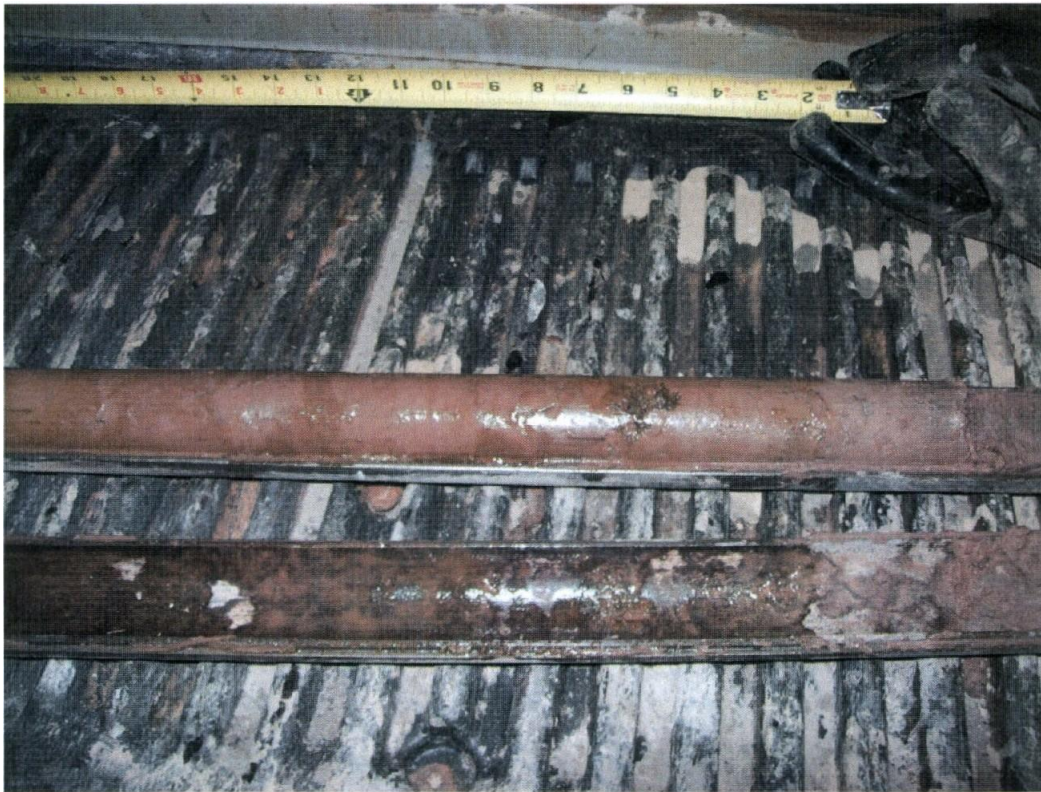
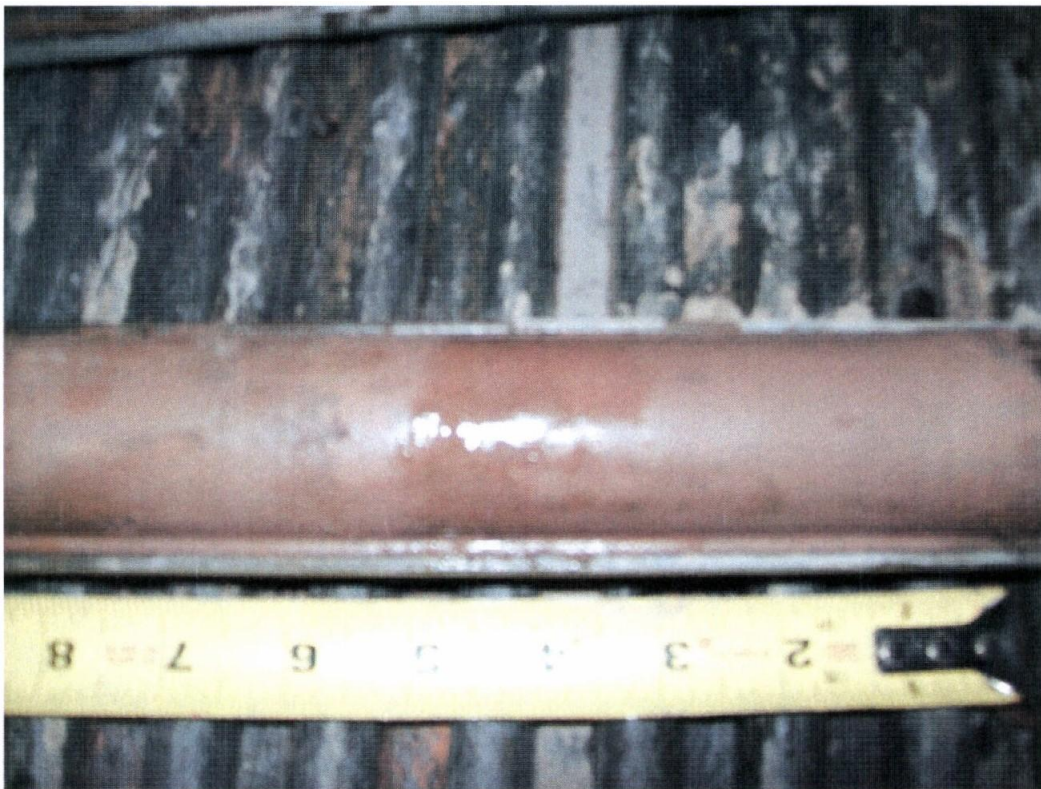
SOIL BORING SB-12 OIL PHOTOGRAPH

Field observations during the installation of SB-12 indicated the potential for environmental impacts to the Site's soil at that location. During soil boring installation, a strong odor and what appeared to be oil trapped within the soil matrix was observed. Photographs of the SB-12 soil samples showing the suspected oily substance are included as Attachment 3. No elevated PID

Soil boring SB-12 had oil observed in the soil matrix and a strong odor. These observations indicated the potential presence of impacts to the Site's soil requiring additional investigation in this area. The soil analytical data from the SB-12 sample indicates that there are VOCs, SVOCs and lead in the soil. Only lead was found in concentrations above RUSCO-Comm. Standards; however, the strong odor suggests that higher contaminant concentrations could be present in

SB-12 potential observed oil

The data from the supplemental assessment show that the soil in the SB-12 area and SB-13 area have VOCs and SVOCs in concentrations below RUSCO Comm. standards and the Site's groundwater in both areas is impacted. Based on the analytical data and field observations, it appears that the delineated area of soil contamination in the open pit area is within an approximate 20-foot radius of soil boring SB-12 and within about 5-feet below the floor, with isolated pockets of free product at depth (well MW-1). In addition, LNAPL was observed in the monitoring well MW-1. Because the native soil is clay, it is anticipated that removal of

The supplemental data collection results appear to show a delineation for contamination of no greater than 20-feet in diameter and 5-feet deep. A typical remedial technique under this situation would be to excavate and dispose of the contaminated soils. The existing concrete floor would need to be removed within the excavated area and subsequently replaced in-kind after placement and compaction of clean fill. To be conservative, it was assumed that removed material would be disposed of at a secure landfill. The estimated cost to complete this work would be approximately \$80,000 to \$110,000, including engineering, observation, soil testing and contingency.
