INTERIM REMEDIAL MEASURE WORK PLAN FOR BROWNFIELD CLEANUP PROGRAM

**945 KENMORE AVENUE
TONAWANDA, ERIE COUNTY, NEW YORK**

945 KENMORE GROUP LLC

REVISED JUNE 6, 2015

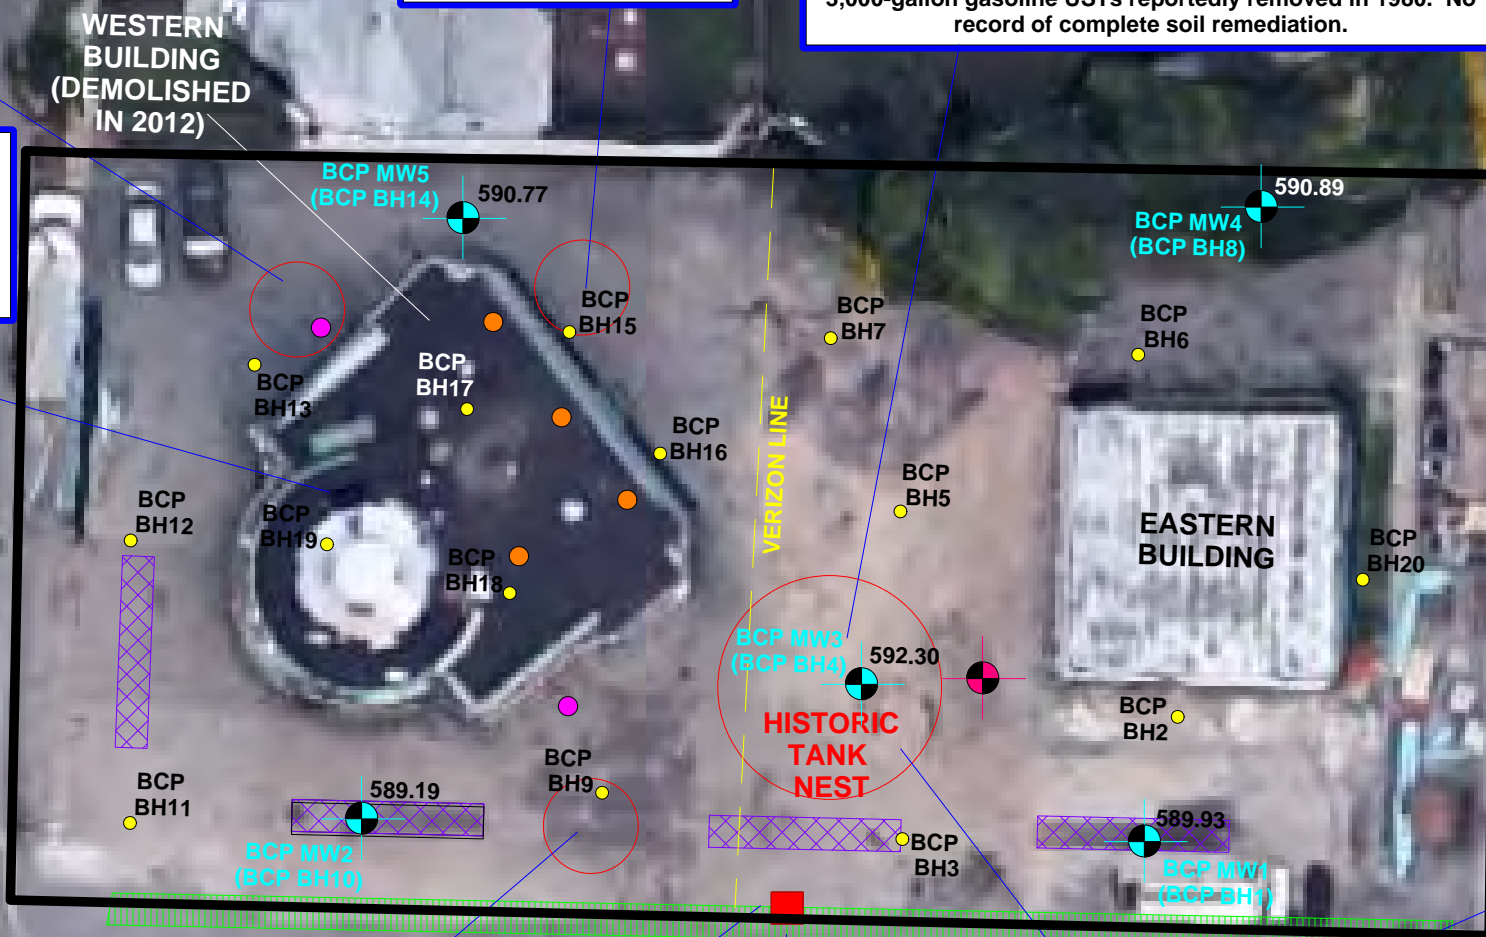
Spill 1306828 - Reported September 1, 2013. Floating oil, heavy sheen, and pooled oil reported running off of concrete slab of former building. Spill is "active." Numerous suspected hydraulic lifts and fill ports noted during spill inspection.

Spill 1104845 - Reported July 28, 2011. Petroleum-impacted soils discovered during sewer work. "Very strong gasoline odors" reported from twenty feet east of intersection almost to eastern boundary of Site. One soil sample collected from stockpile - no petroleum hydrocarbons detected. Spill inactivated on December 26, 2012. Reported zone of impact shown in green.

Area of 4,000-gallon gasoline UST reportedly "to be filled with water" in 1980

Spill 8600802 - Reported May 1, 1986. Gasoline-impacted soil and sheen discovered in six-foot excavation around fire hydrant. Attributed to leak in discharge line of 10,000-gallon UST in tank nest. Discharge line was reportedly replaced and tank tested tight. Spill inactivated on March 19, 1987. No record of soil remediation in tank nest.

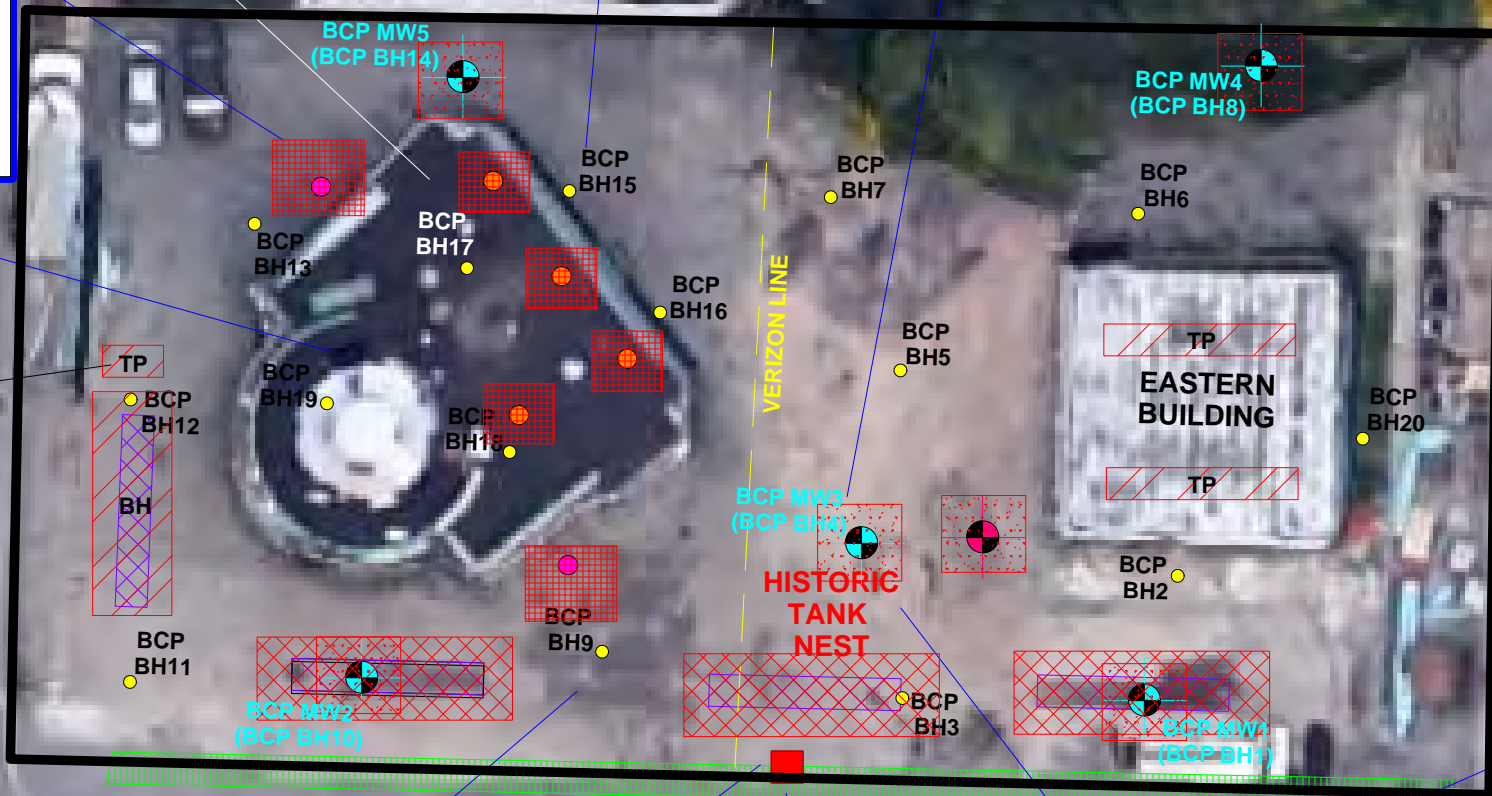
Spill 1306828 - Reported September 1, 2013. Floating oil, heavy sheen, and pooled oil reported running off of concrete slab of former building. Spill is "active." Numerous suspected hydraulic lifts and fill ports noted during spill inspection.

GEOPHYSICAL ANOMALY

Spill 1104845 - Reported July 28, 2011. Petroleum-impacted soils discovered during sewer work. "Very strong gasoline odors" reported from twenty feet east of intersection almost to eastern boundary of Site. One soil sample collected from stockpile - no petroleum hydrocarbons detected. Spill inactivated on December 26, 2012. Reported zone of impact shown in green.

Spill 8600802 - Reported May 1, 1986. Gasoline-impacted soil and sheen discovered in six-foot excavation around fire hydrant. Attributed to leak in discharge line of 10,000-gallon UST in tank nest. Discharge line was reportedly replaced and tank tested tight. Spill inactivated on March 19, 1987. No record of soil remediation in tank nest.

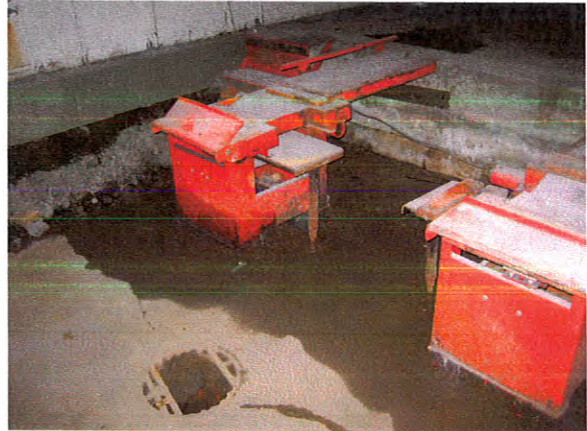
Photo 9: View of a floor drain located within an auto repair area of building #2.

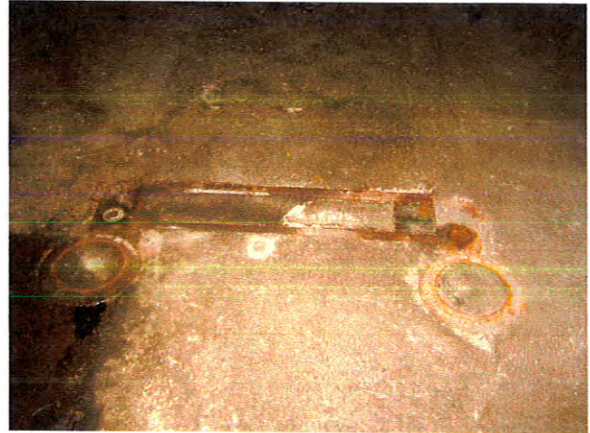
Photo 13: View of an aboveground life located within building #1.

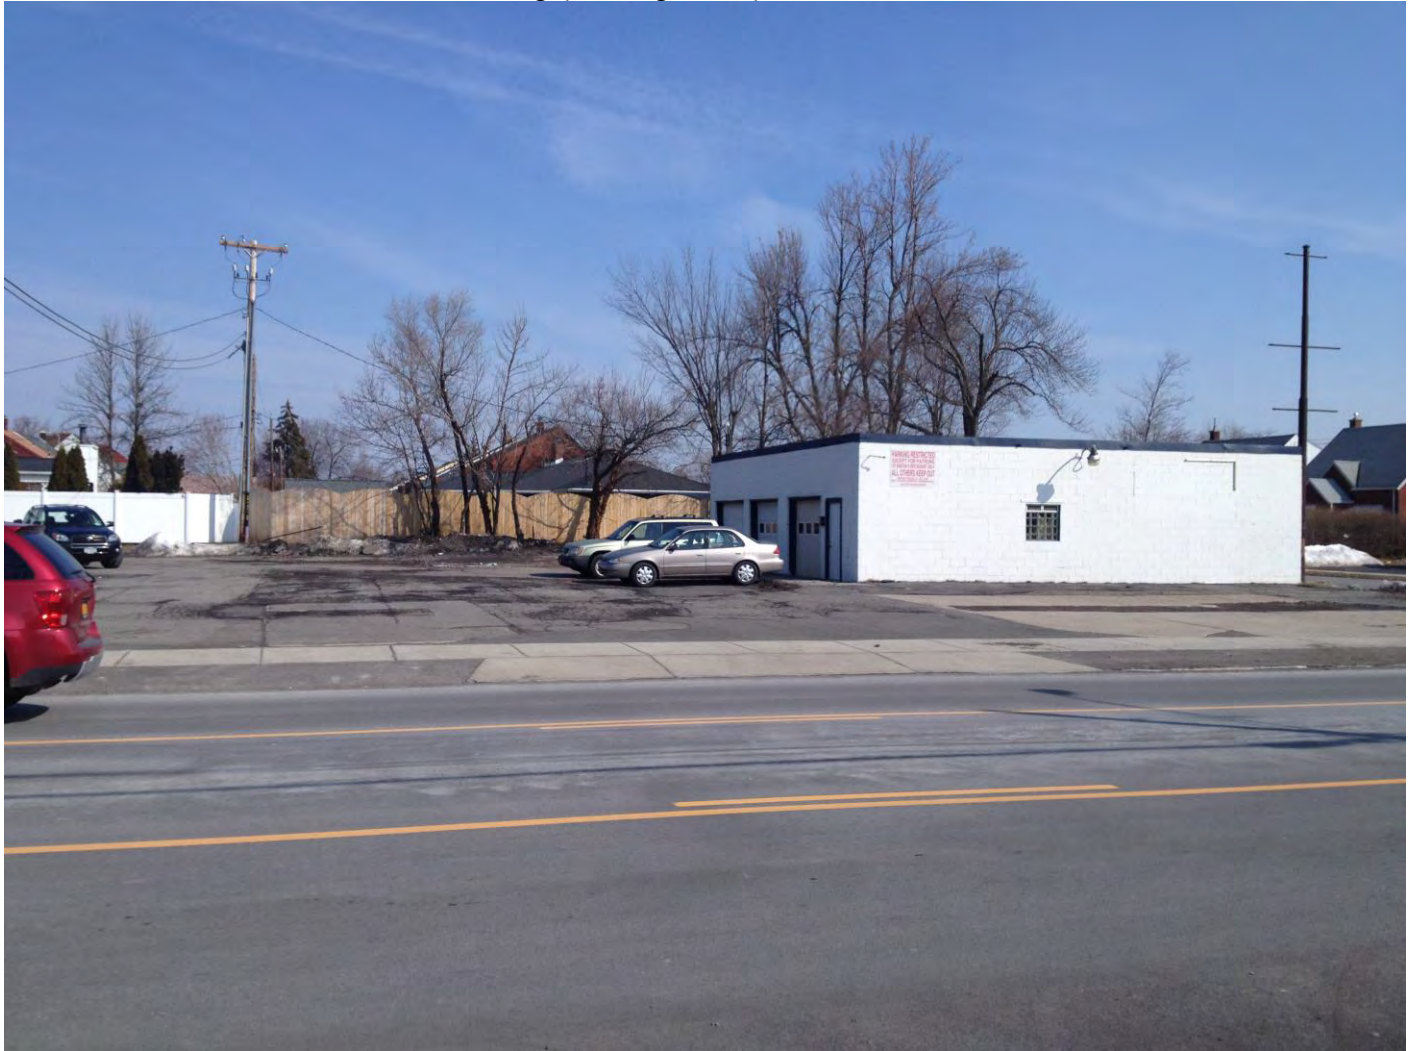
Photo 1: View of the Eastern Building (looking north)

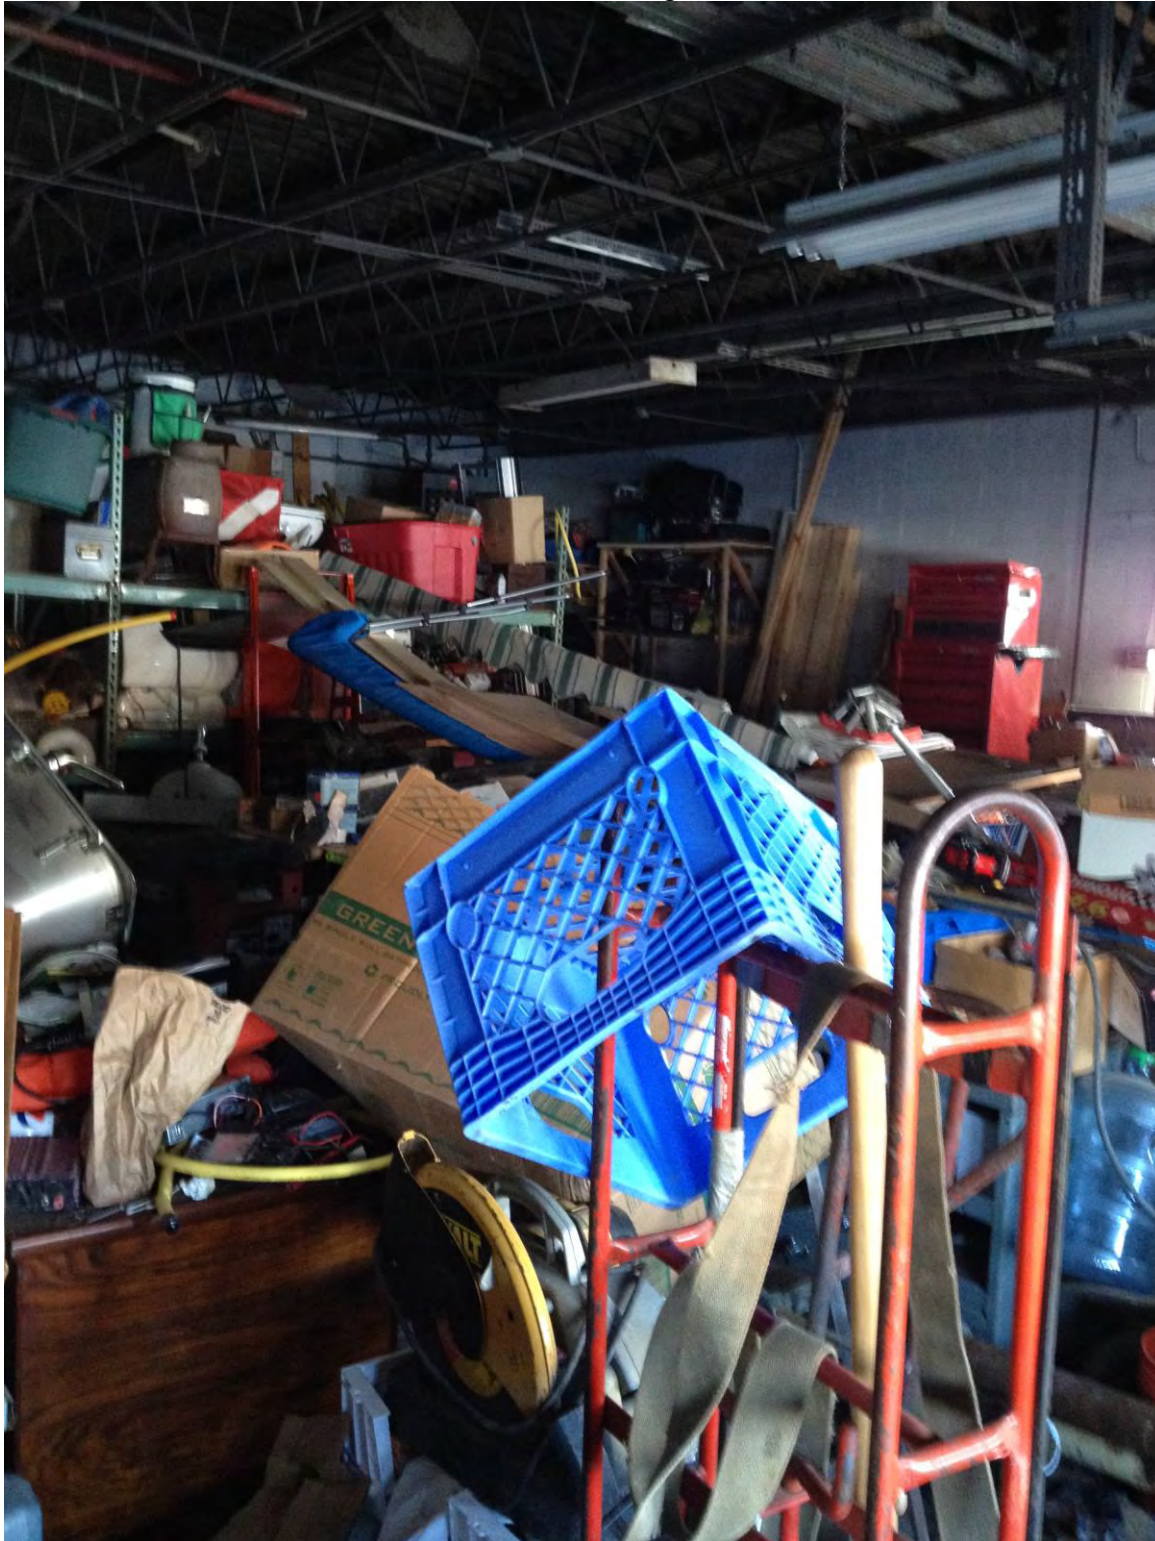
Photo 2: View of debris in the Eastern Building

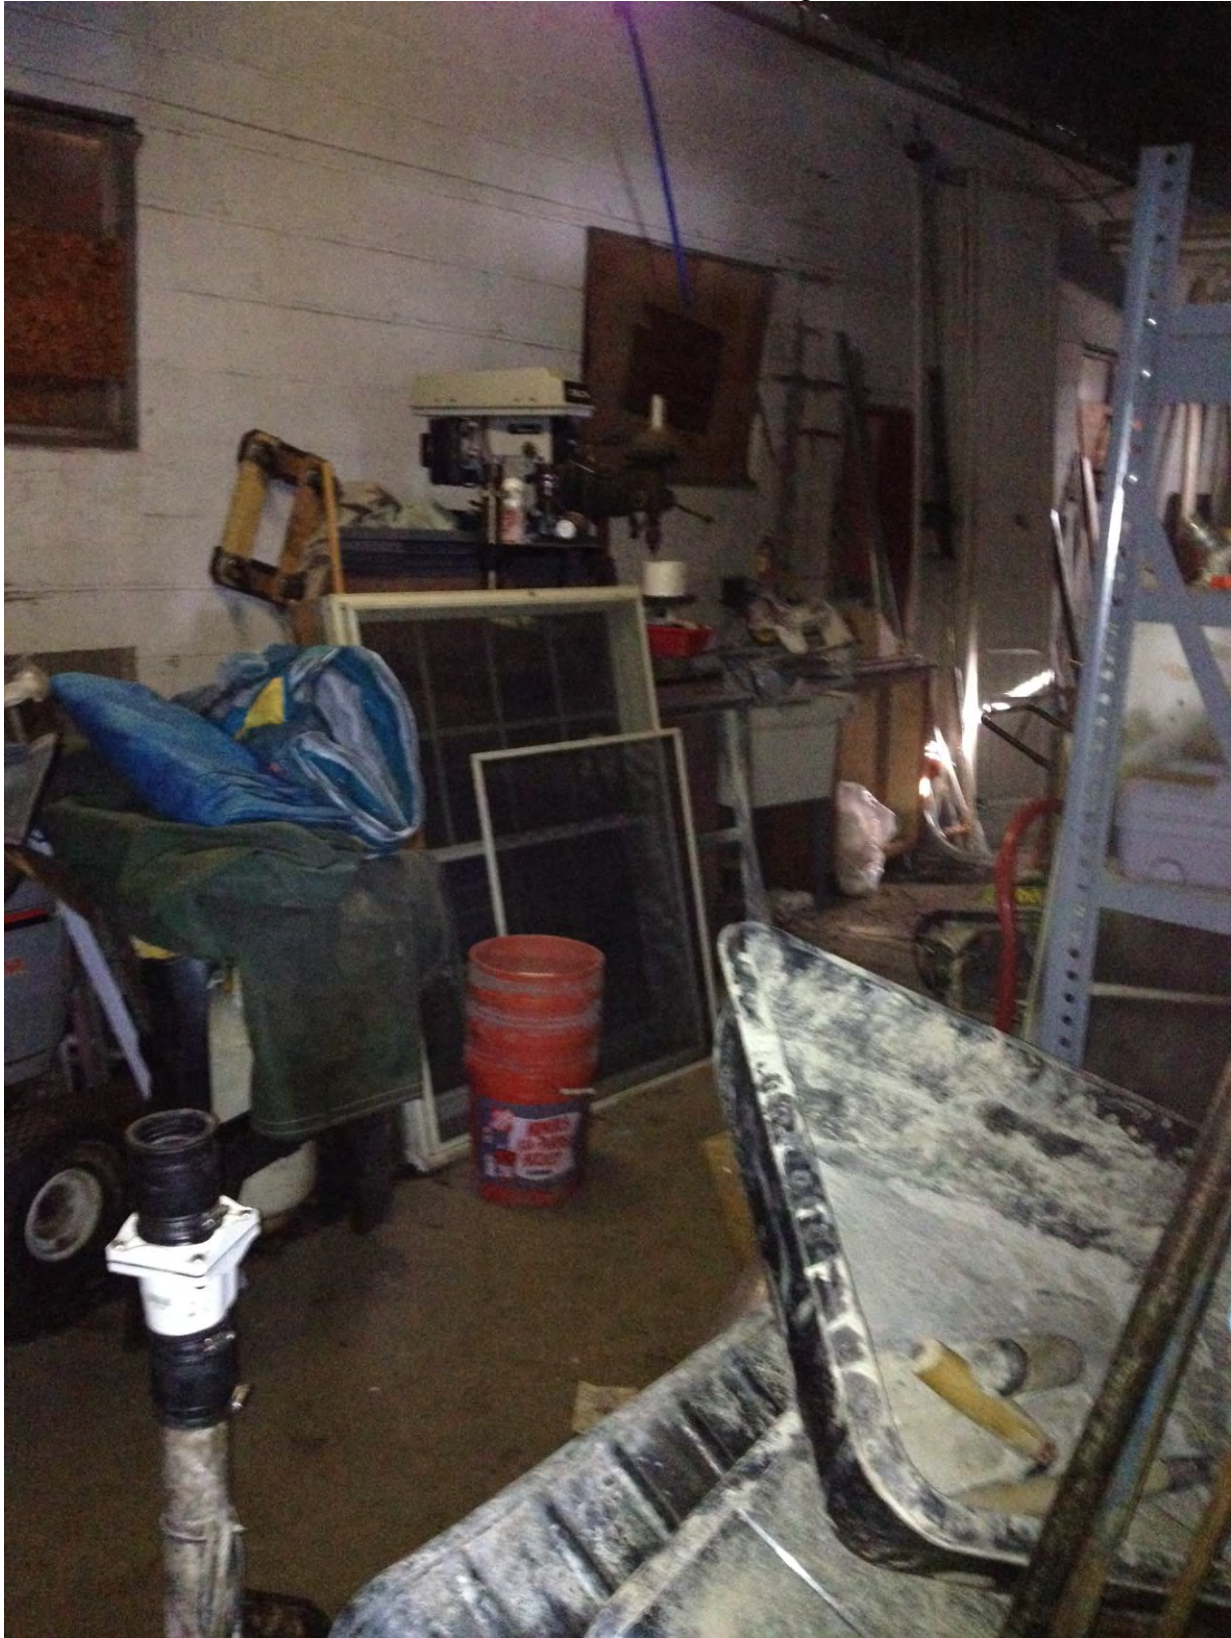
Photo 3: Additional view of debris in the Eastern Building

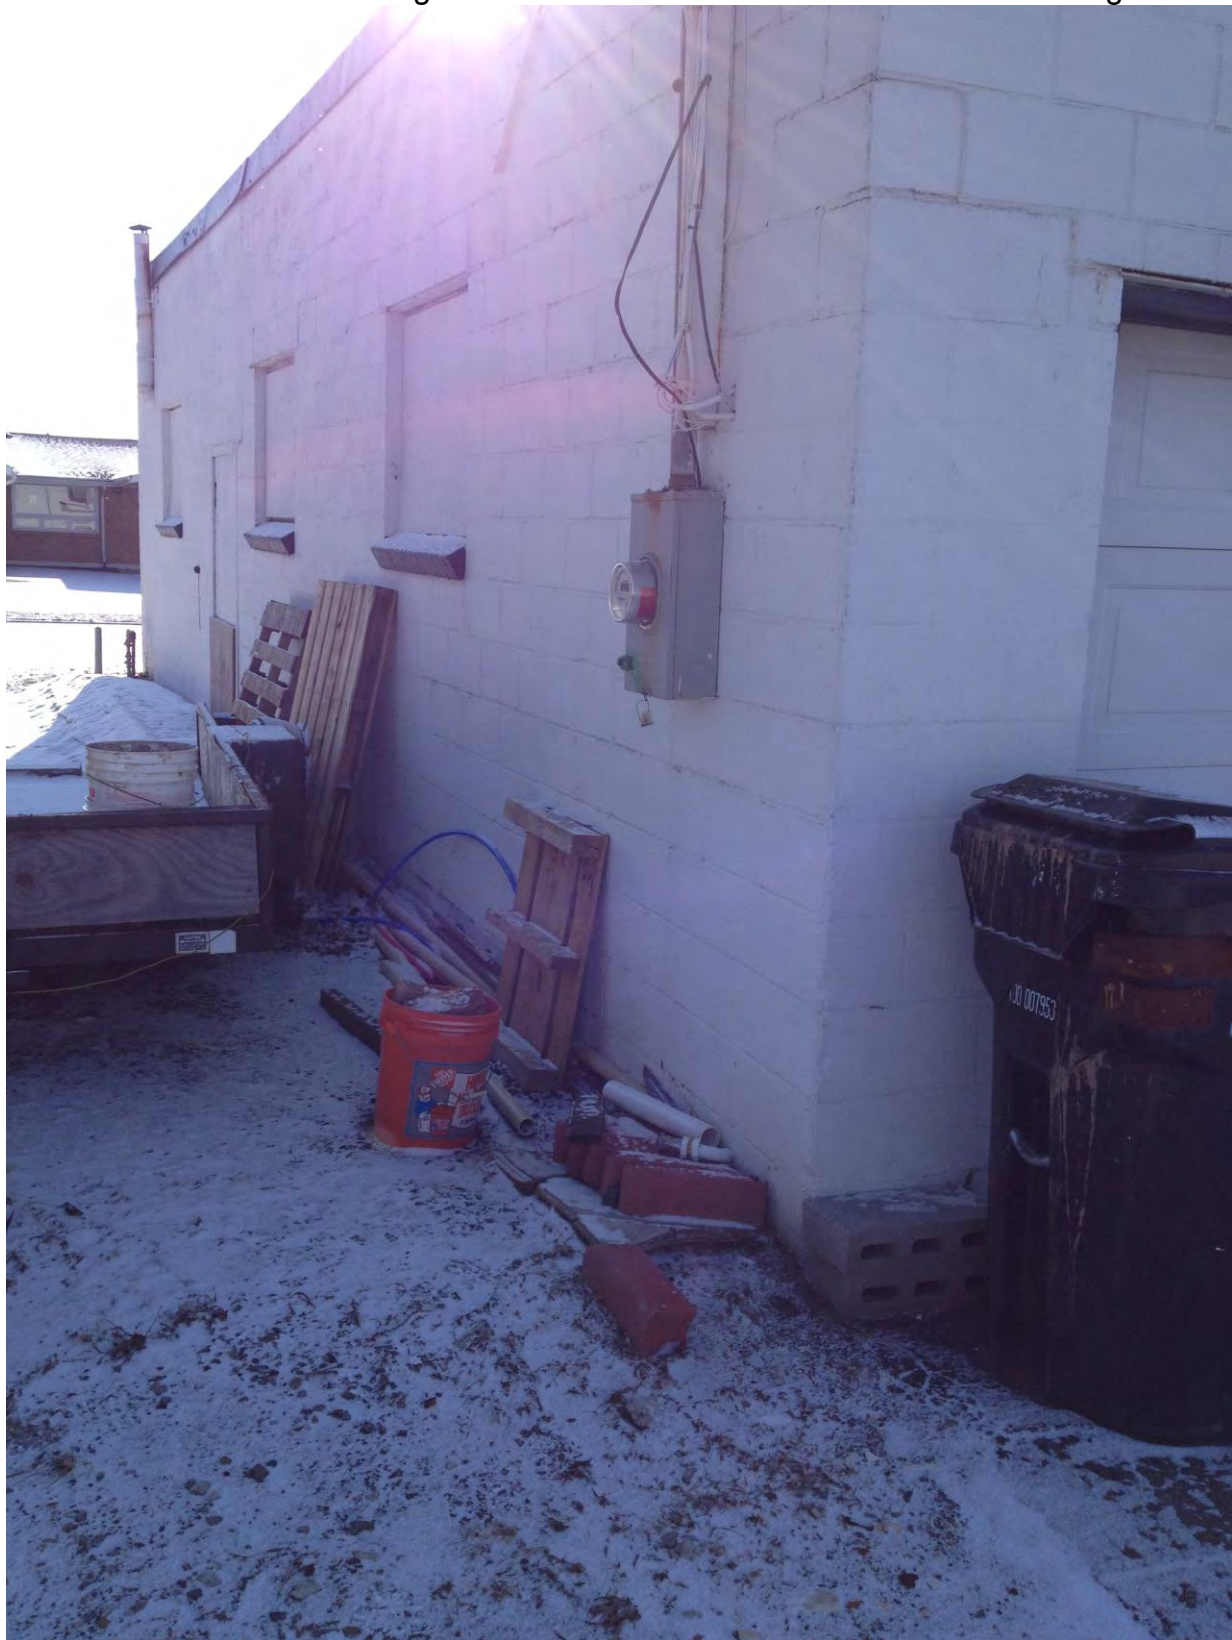
Photo 4: View of debris along the northern exterior wall of the Eastern Building

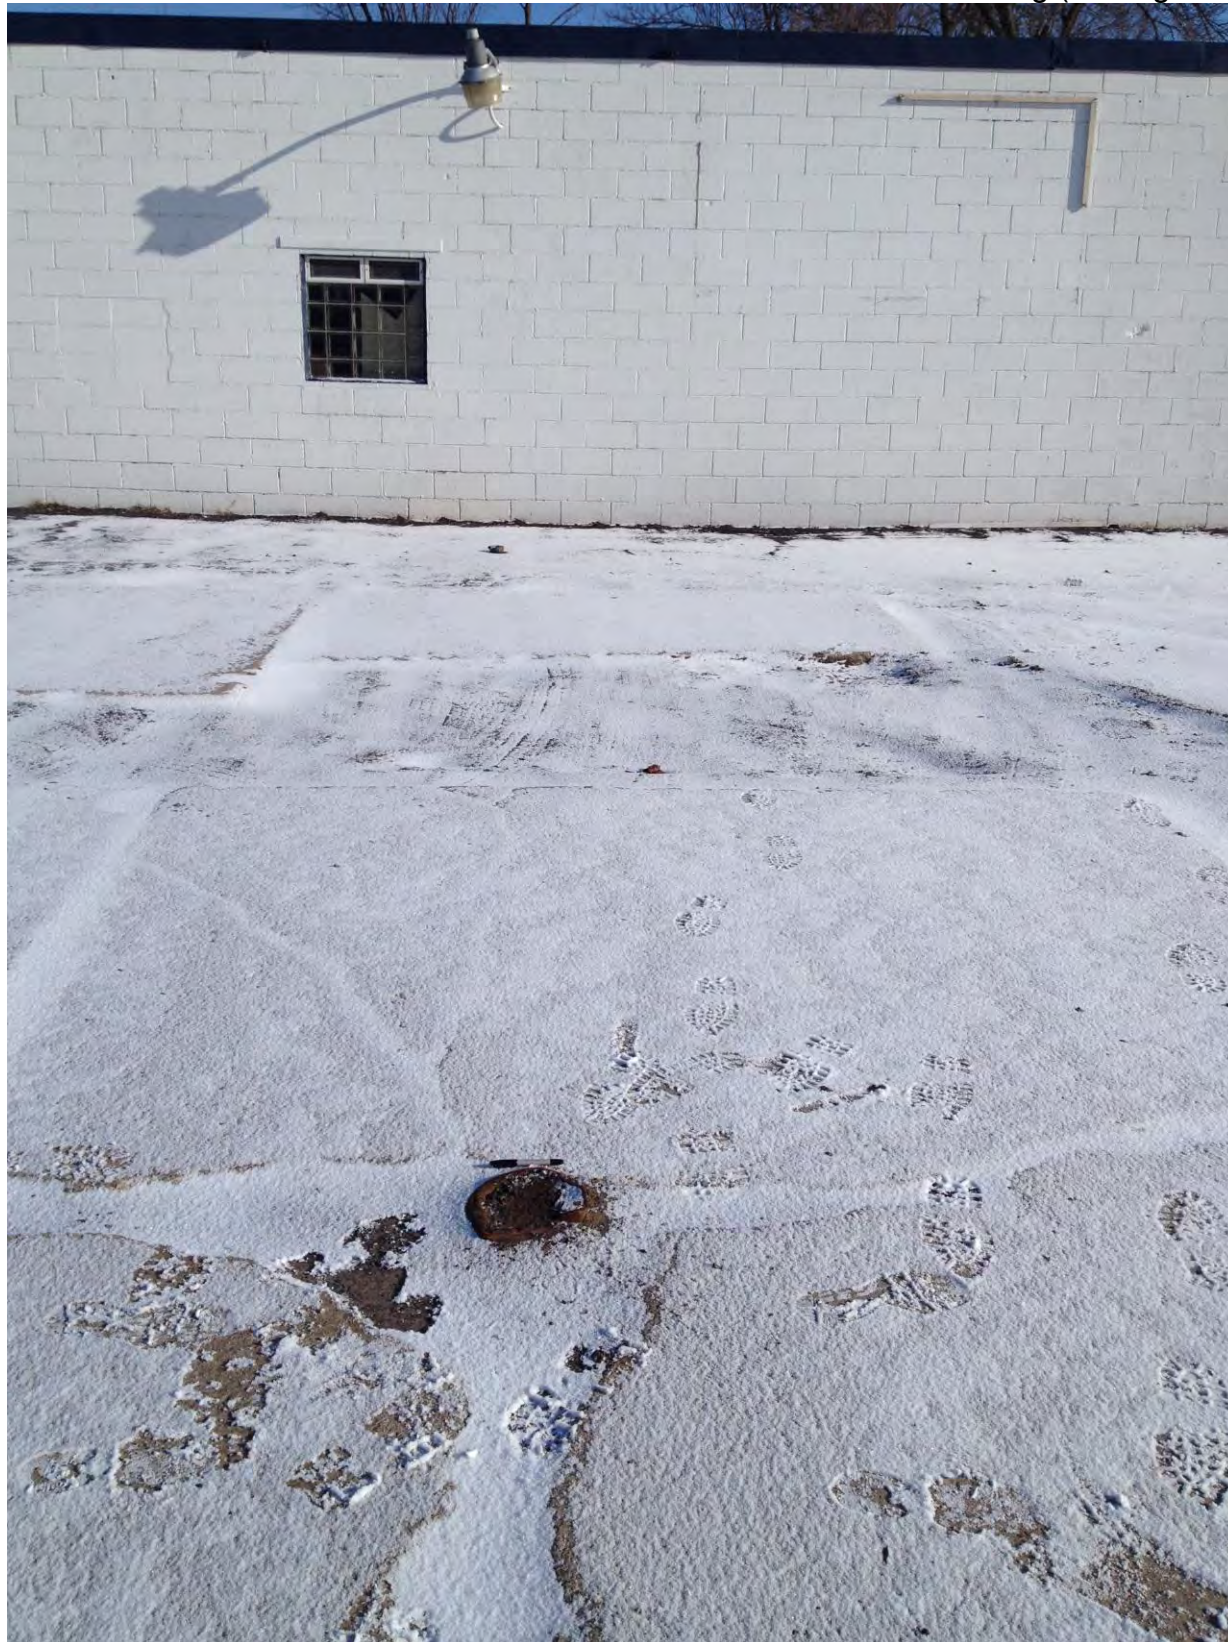
Photo 5: View of unknown circular structure south of the Eastern Building (looking north)

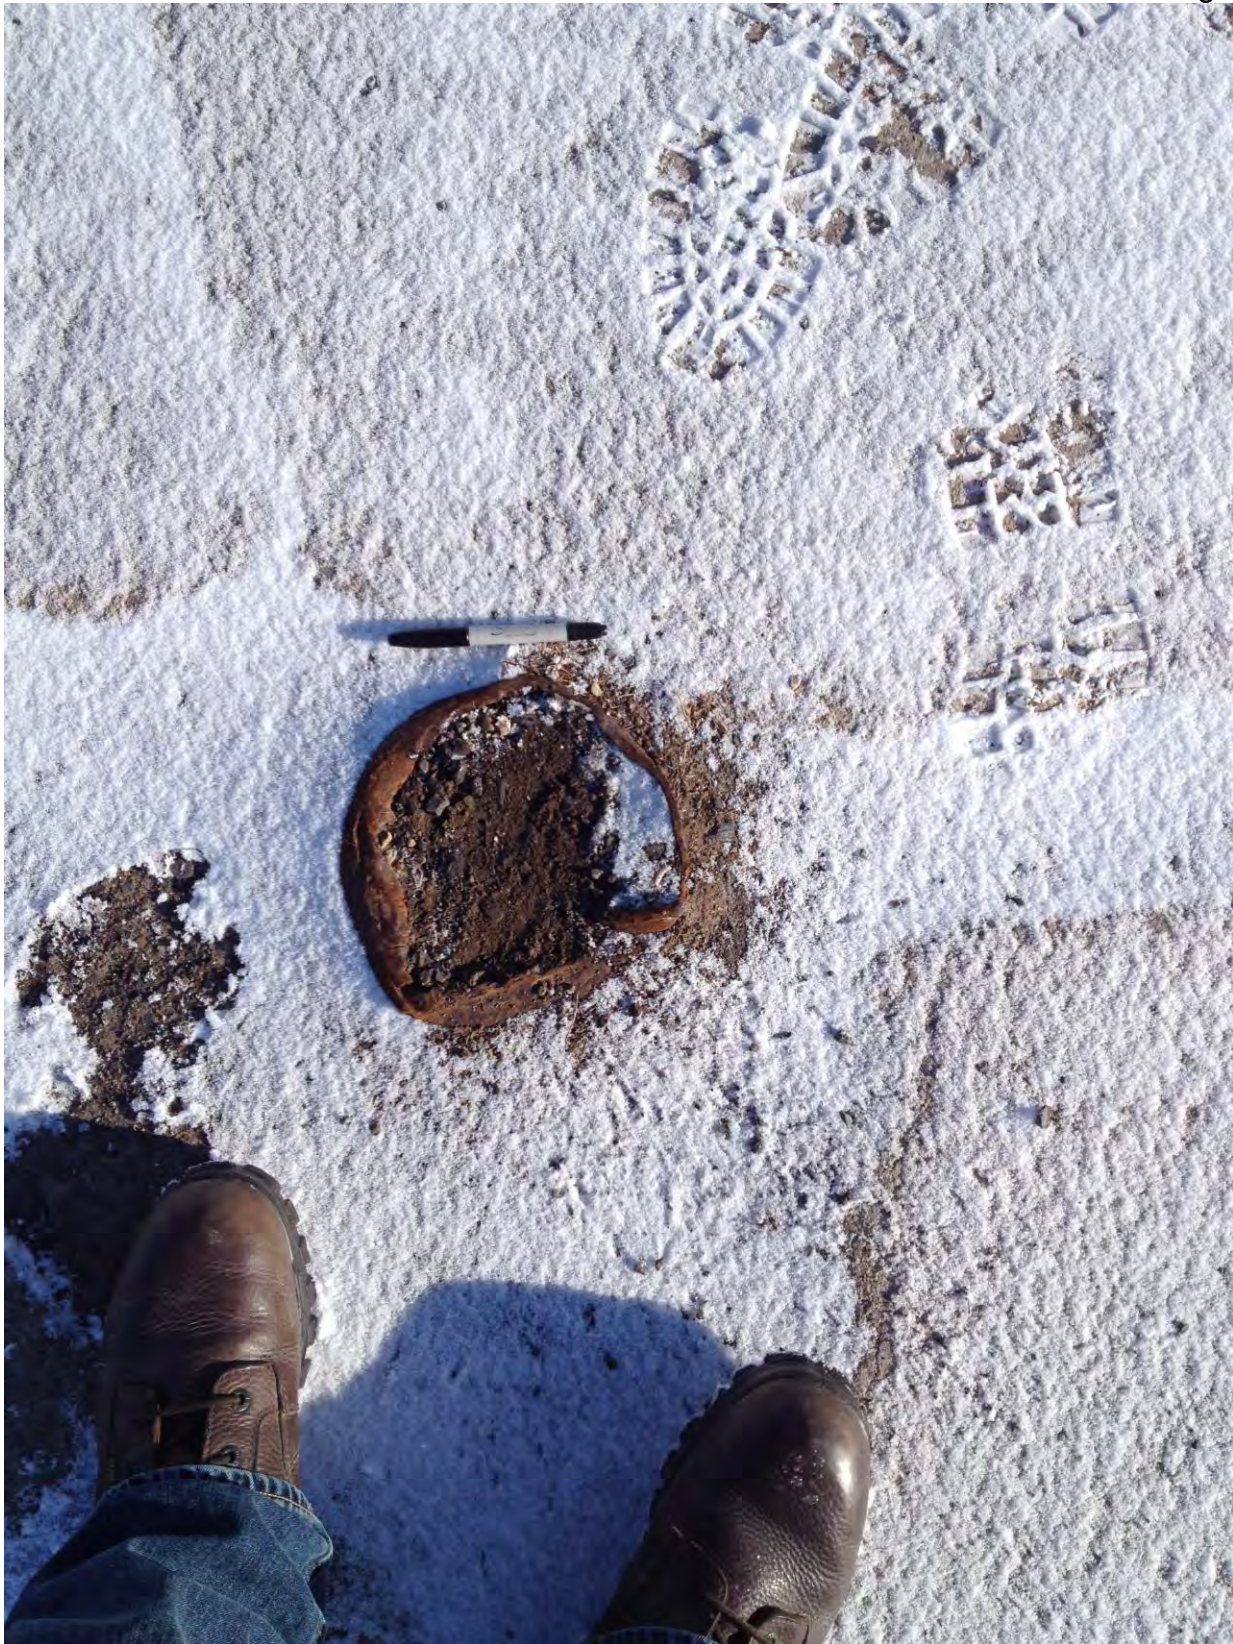
Photo 6: Another view of the unknown circular structure south of the Eastern Building

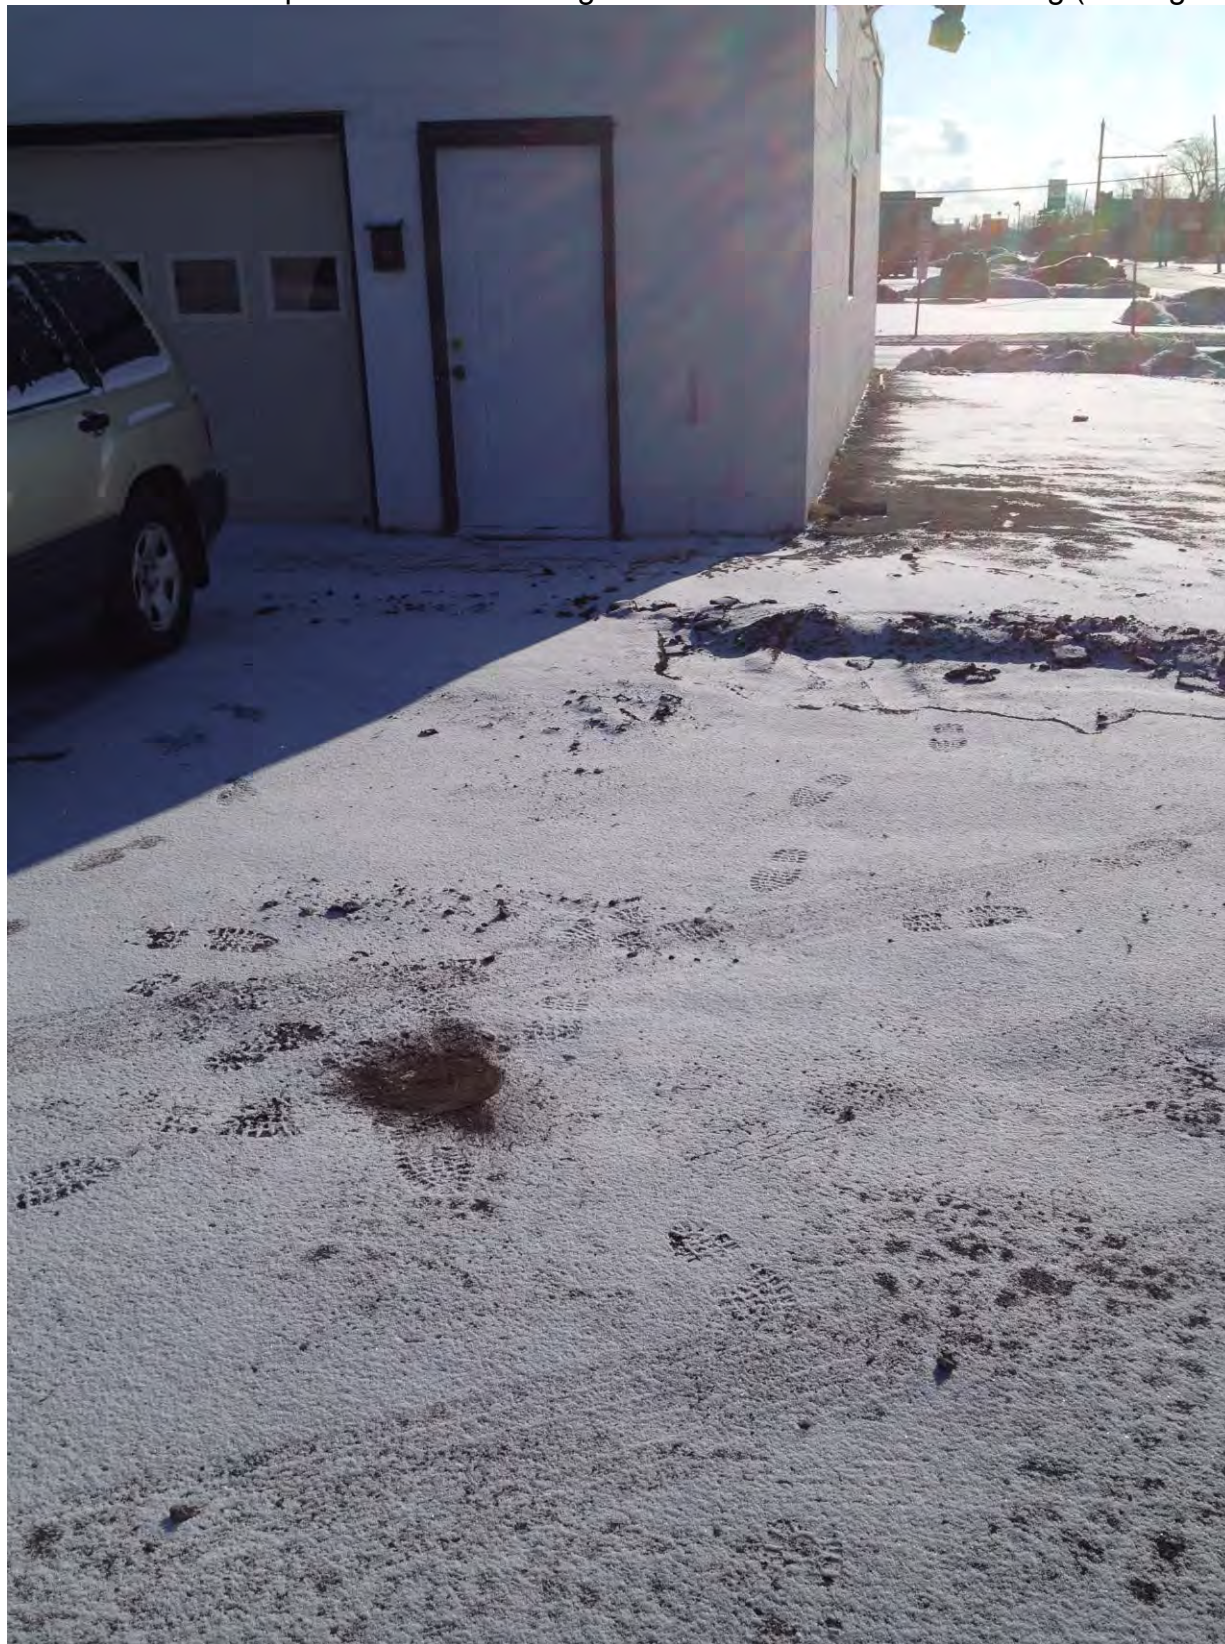
Photo 7: View of a permanent monitoring well west of the Eastern Building (looking east)

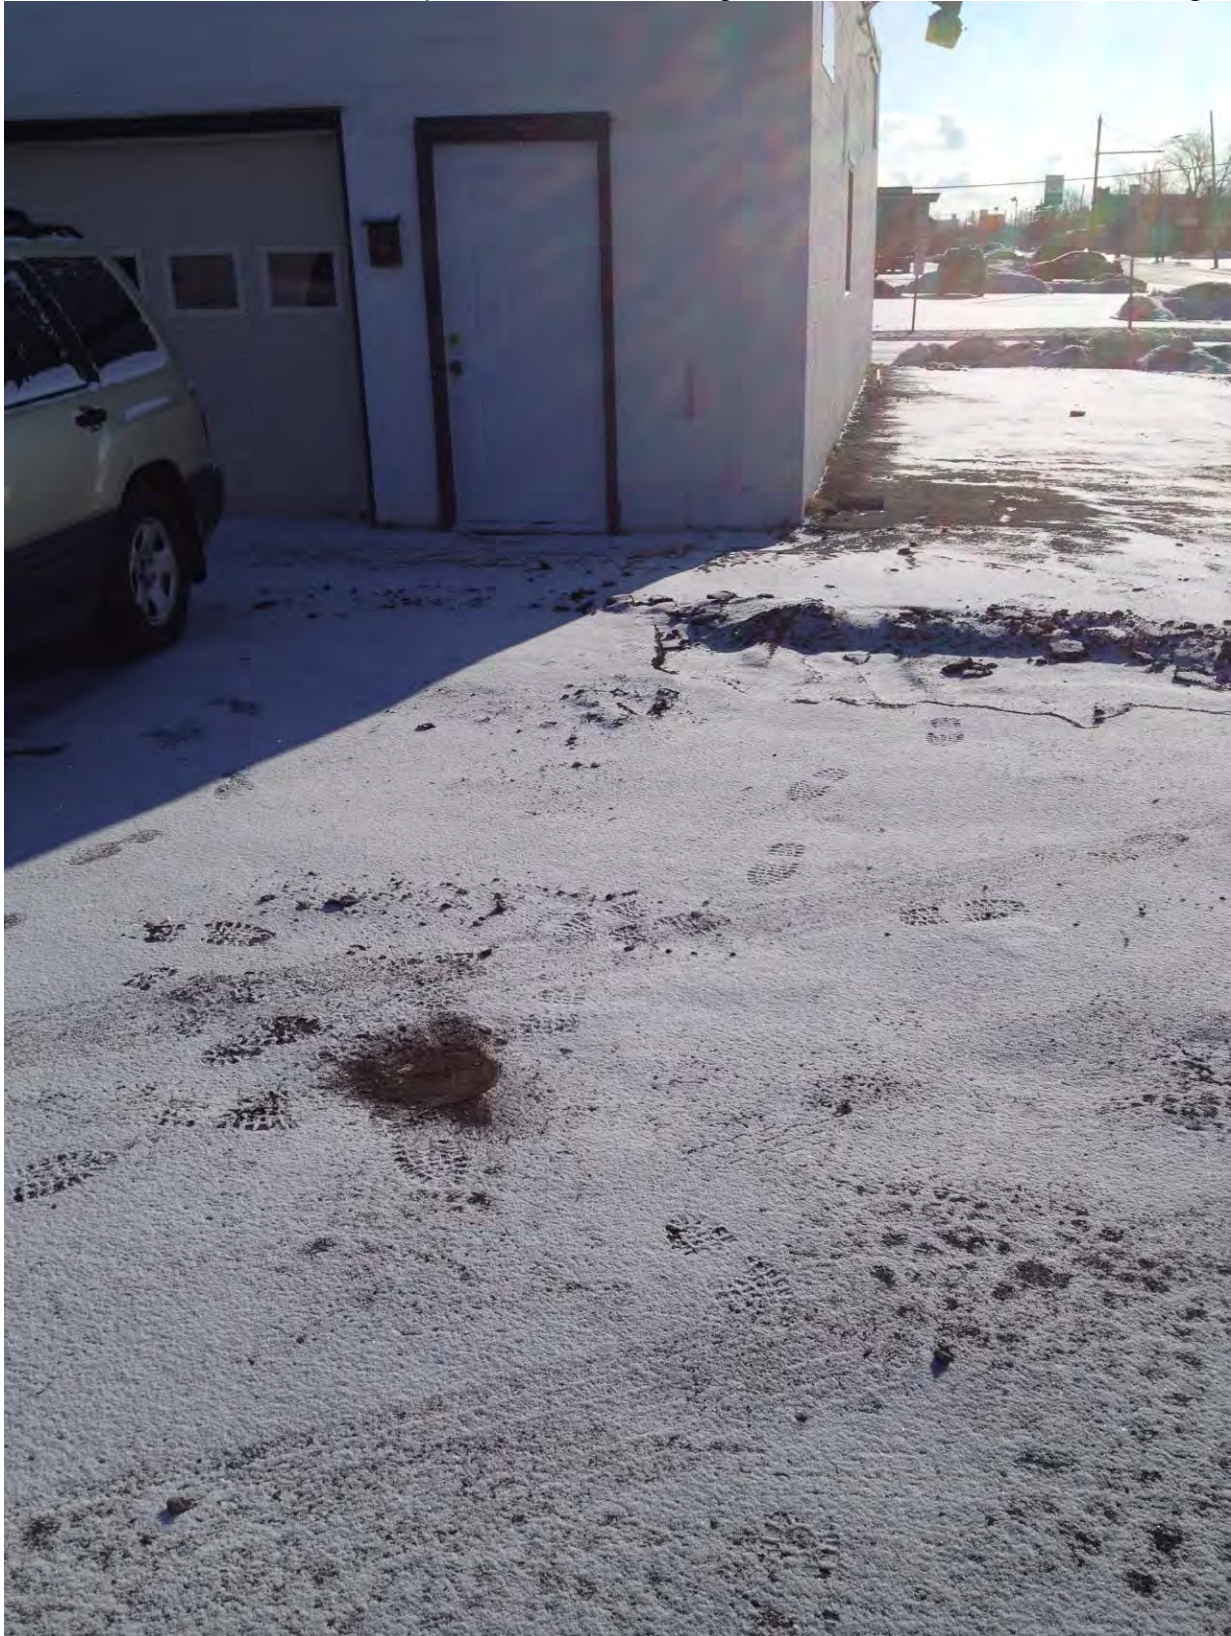
Photo 8: Another view of the permanent monitoring well west of the Eastern Building

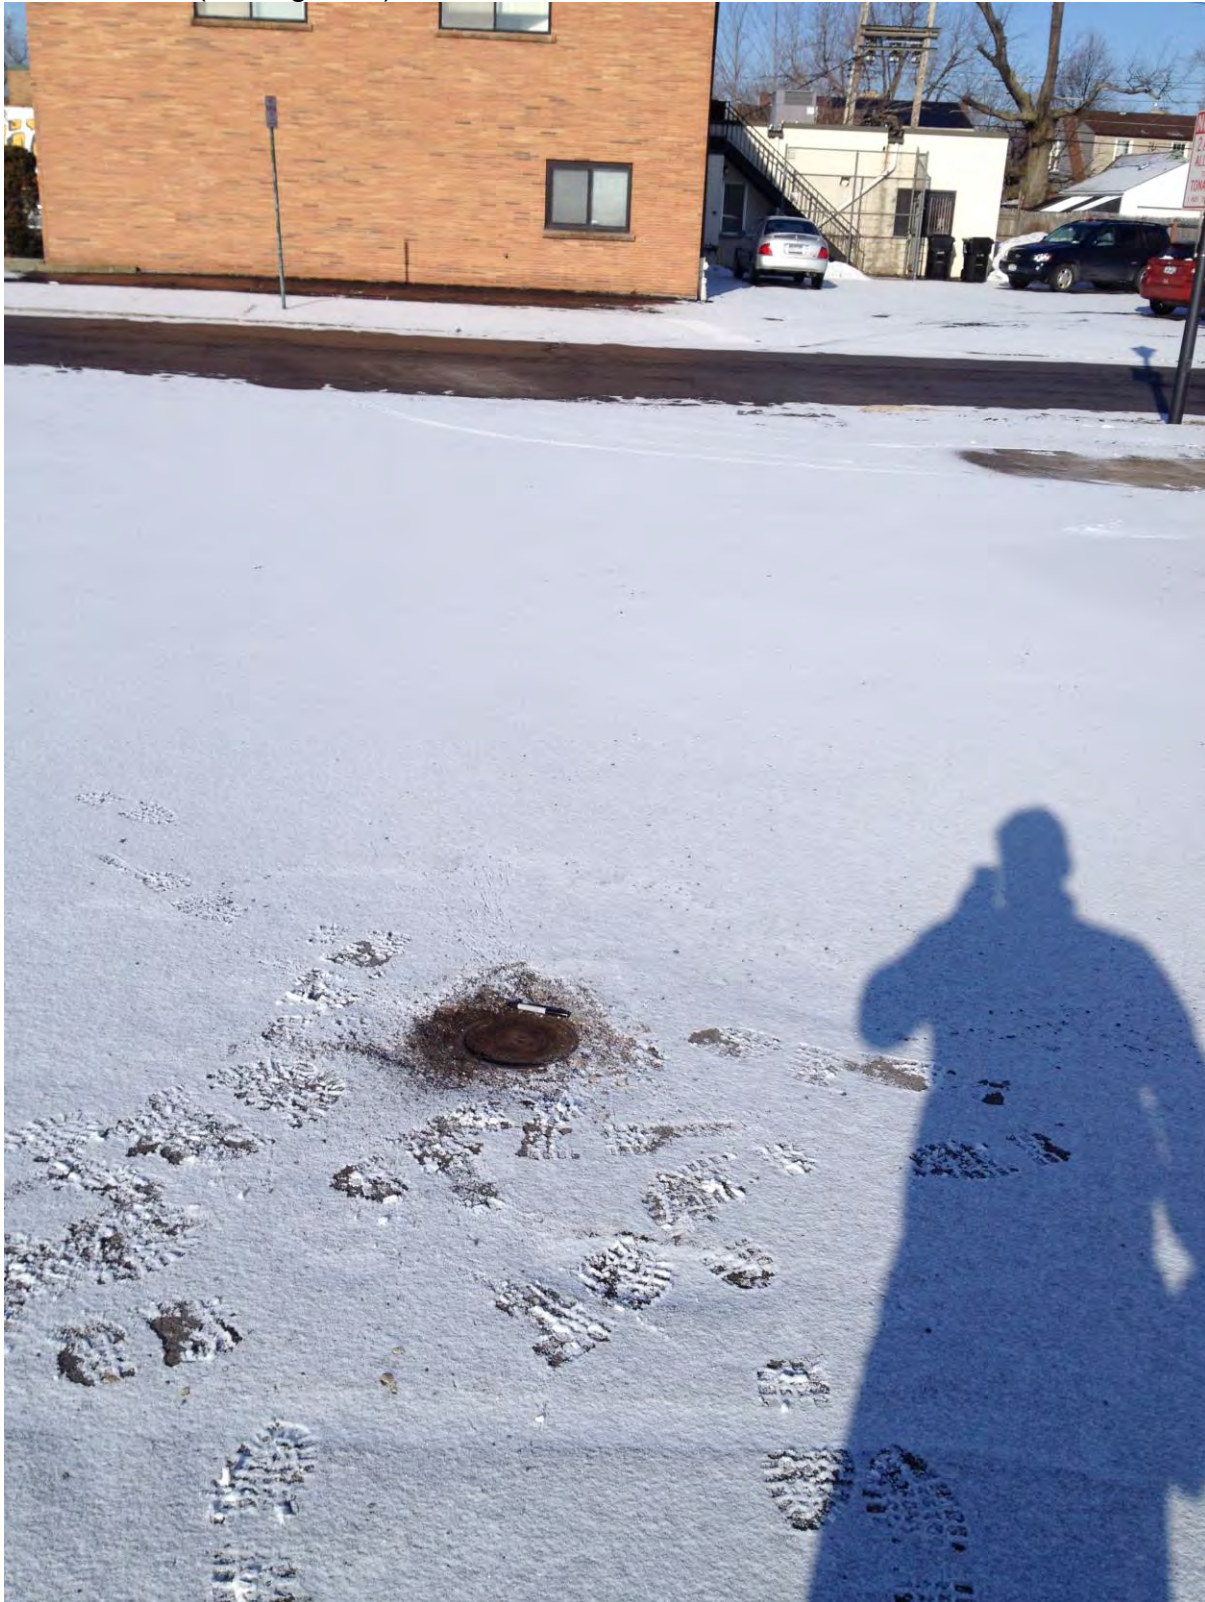
Photo 9: View of a fill port on the northwestern edge of the former Western Building (looking west)

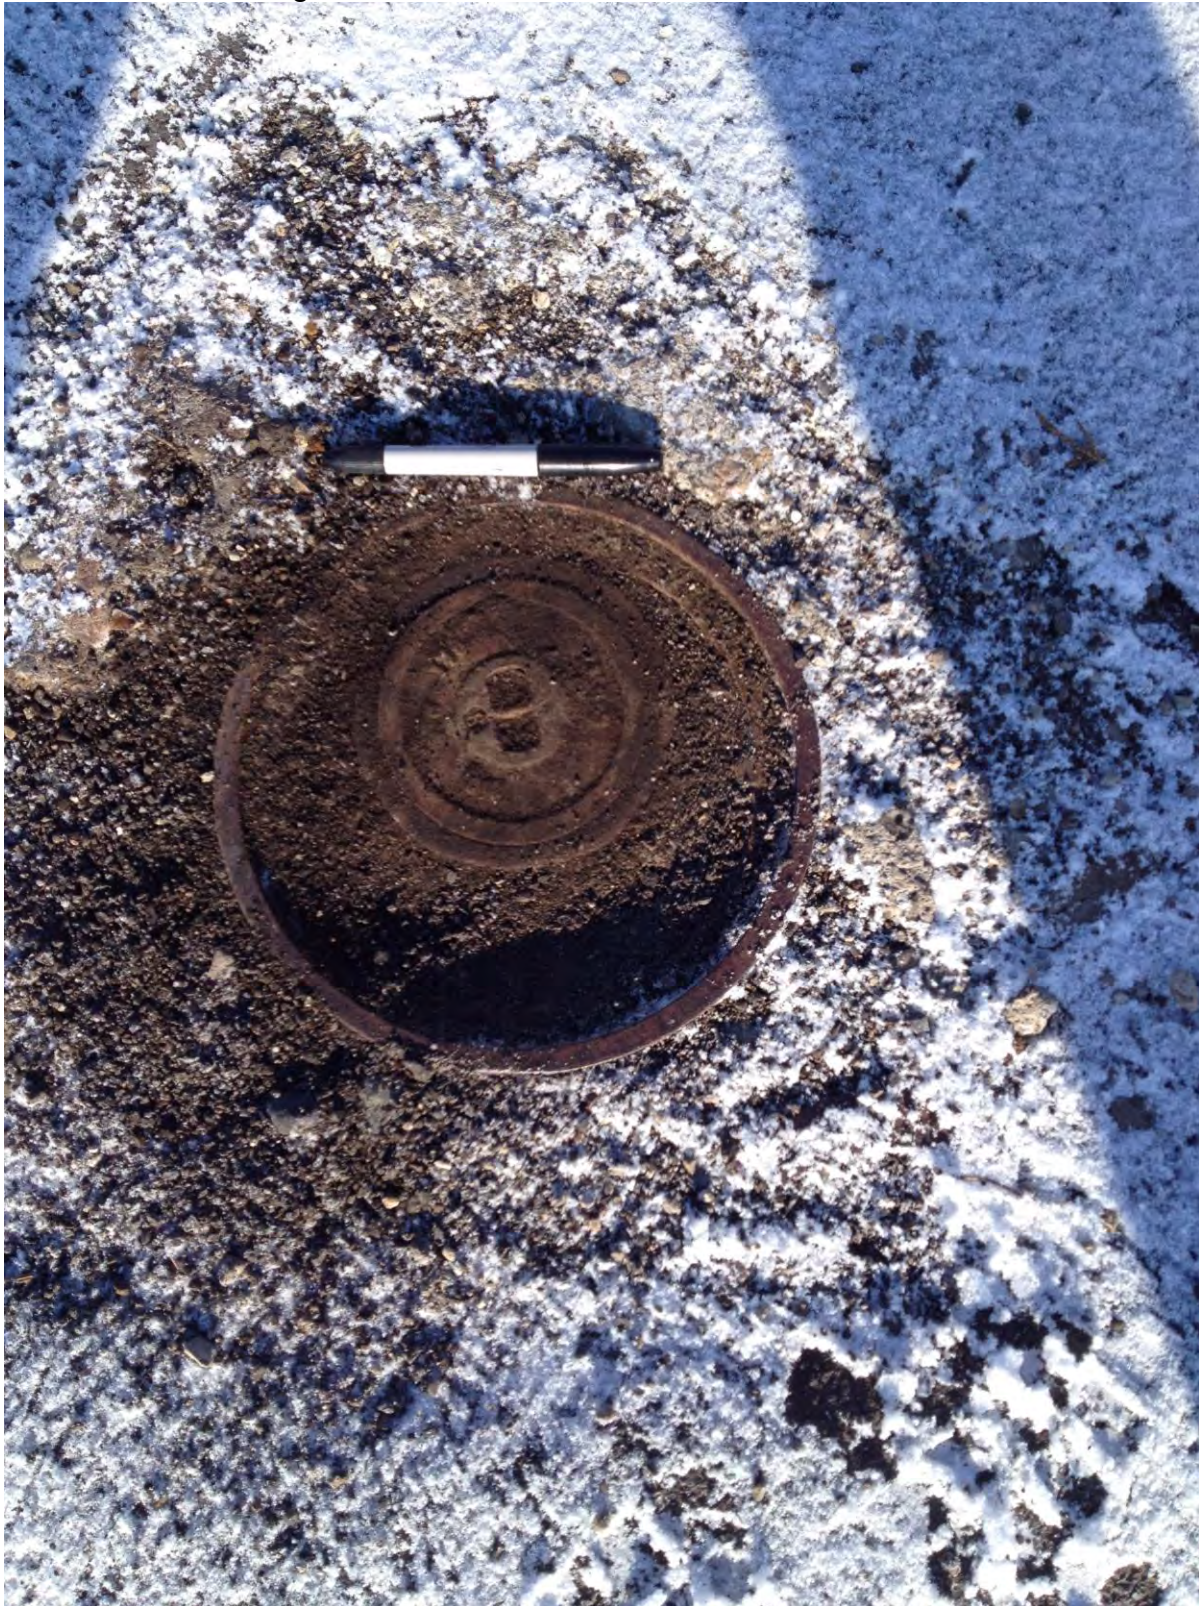
Photo 10: Another view of the fill port on the northwestern edge of the former Western Building
