INTERIM REMEDIAL MEASURE WORK PLAN FOR BROWNFIELD CLEANUP PROGRAM

**945 KENMORE AVENUE
TONAWANDA, ERIE COUNTY, NEW YORK**

945 KENMORE GROUP LLC

REVISED JUNE 6, 2015

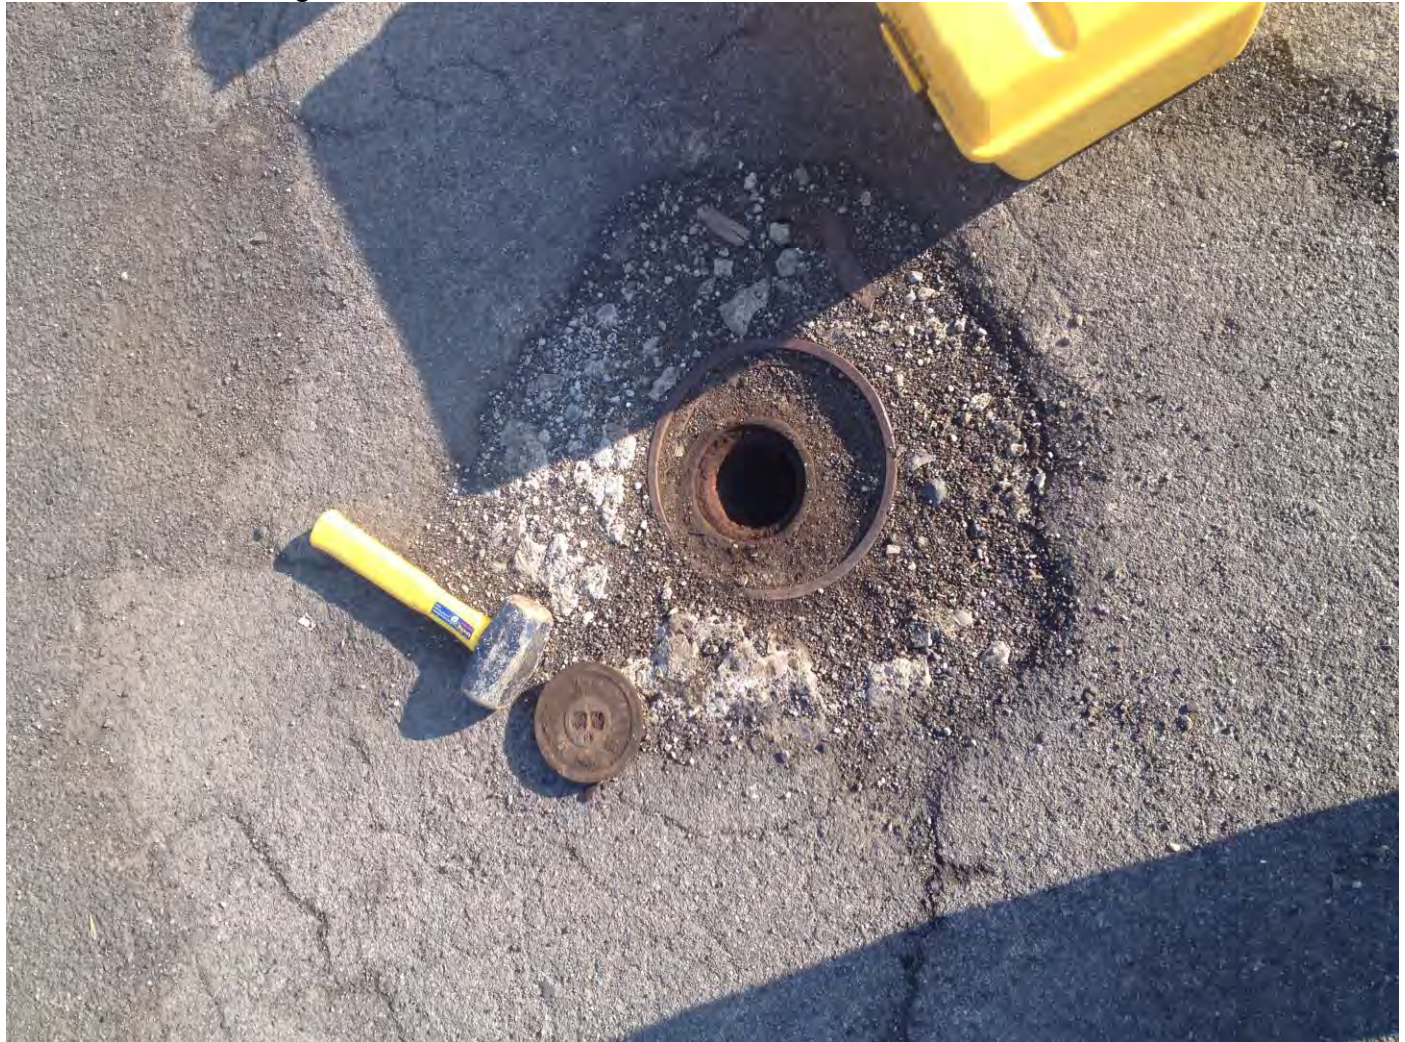
Photo 11: View of the opened fill port on the northwestern edge of the former Western Building

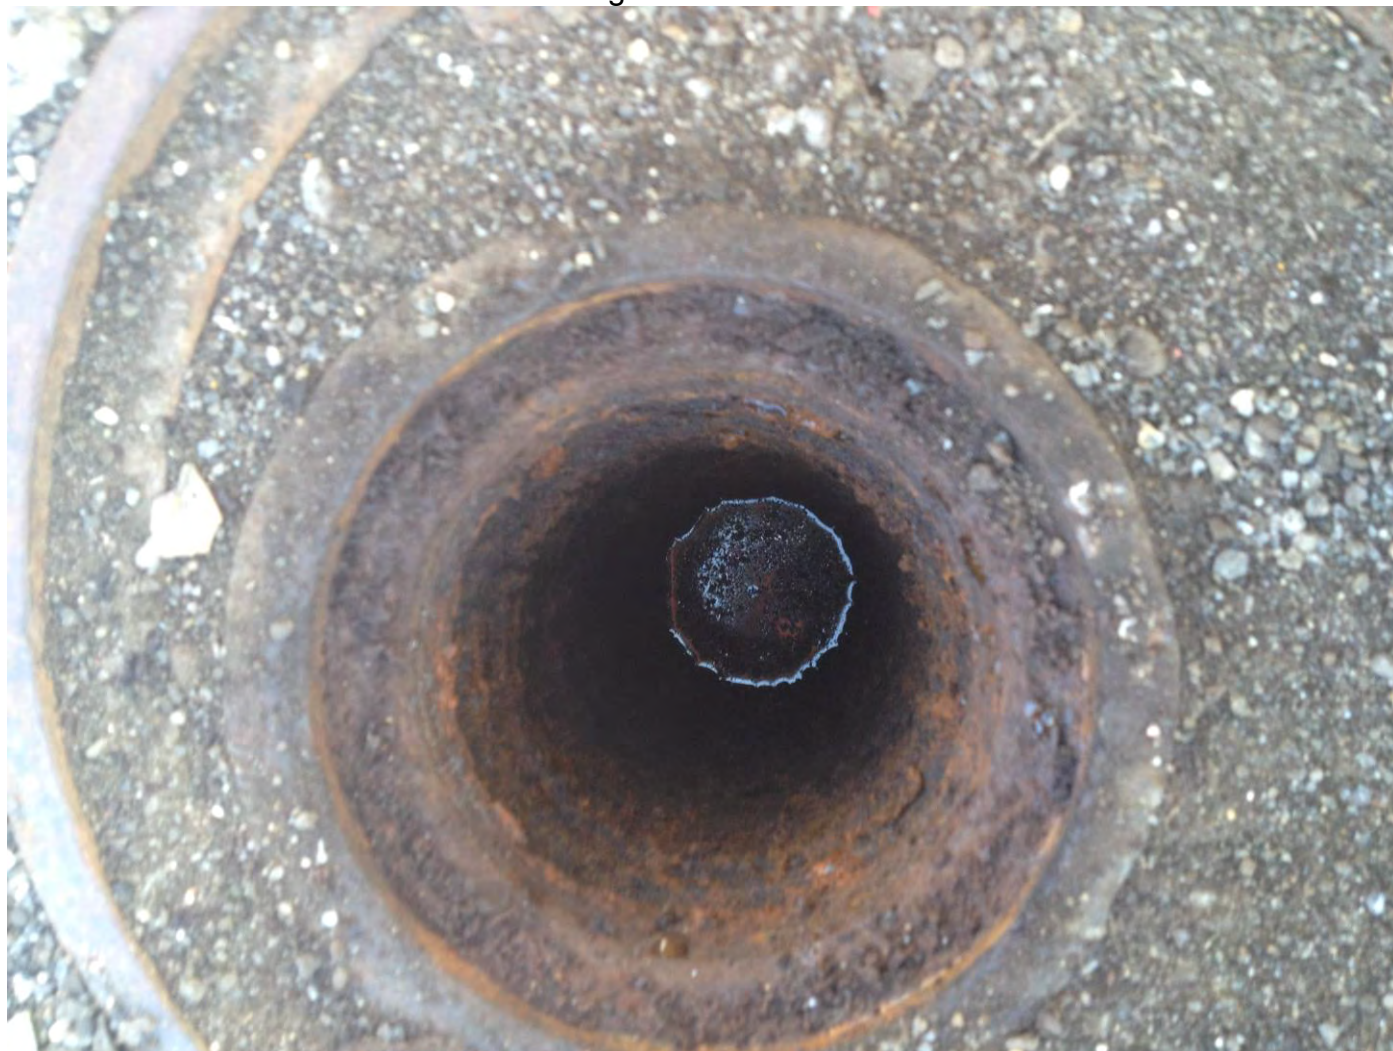
Photo 12: View of water in the UST associated with the fill port on the northwestern edge of the former Western Building

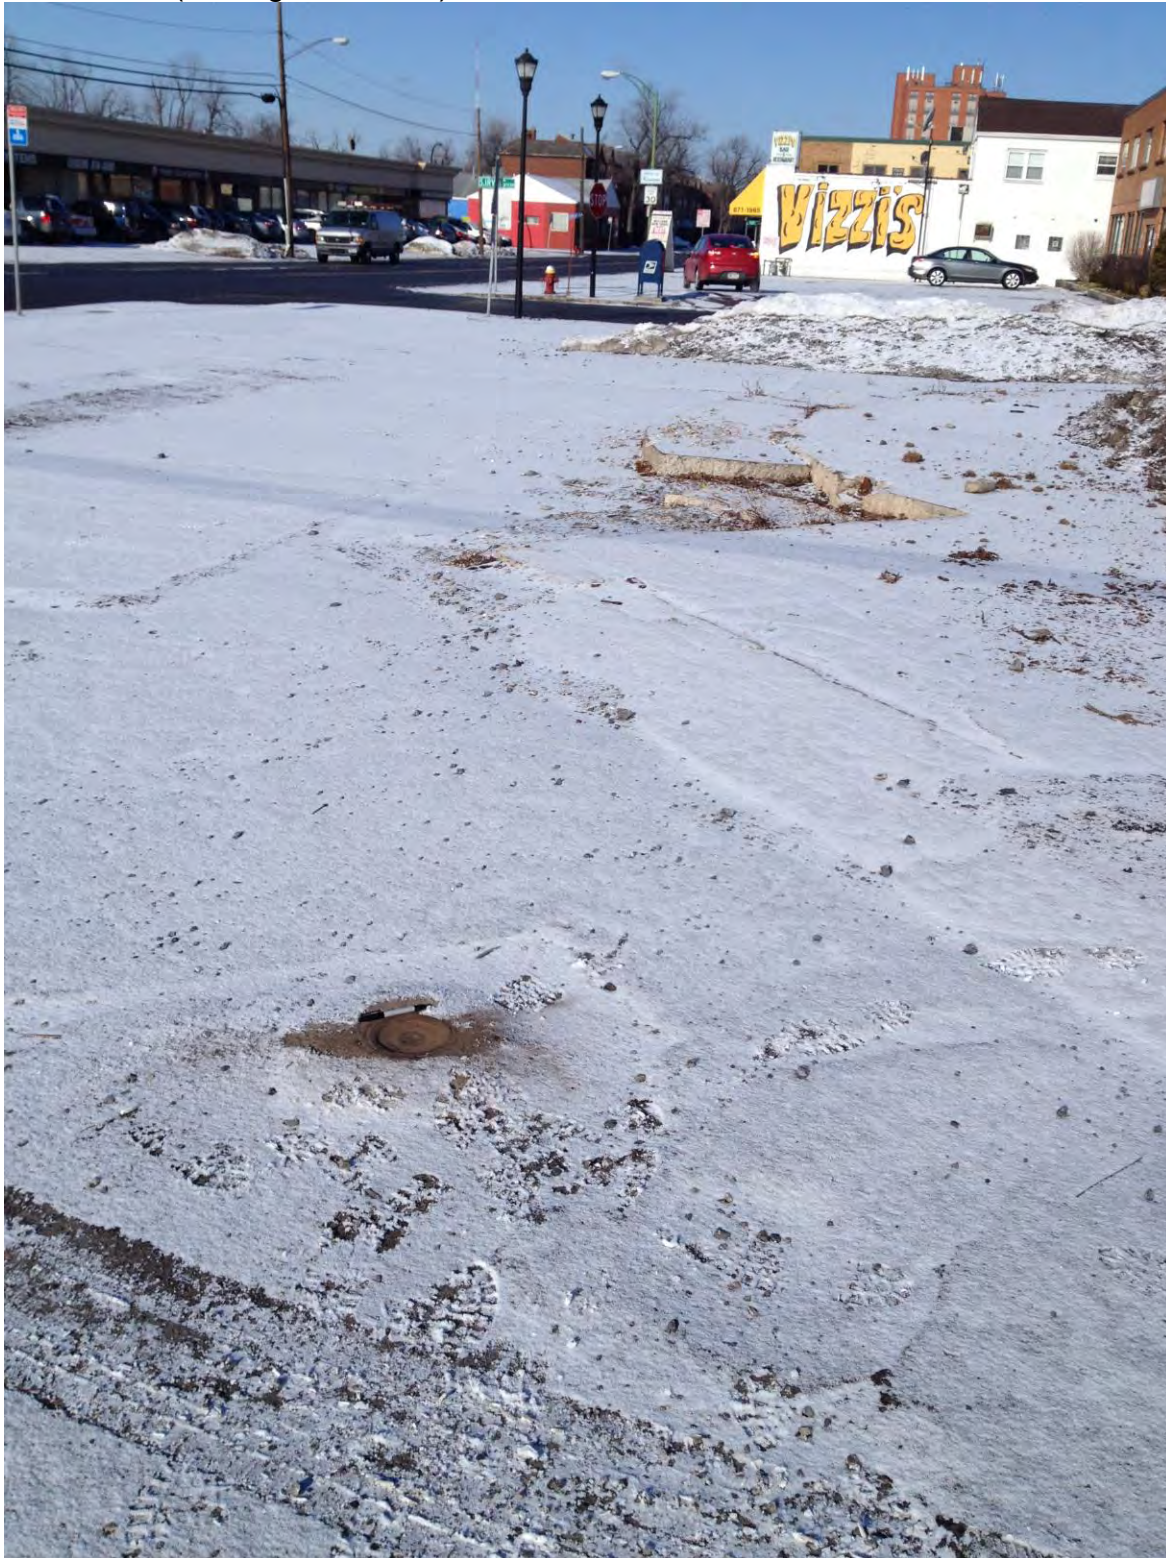
Photo 13: View of a fill port on the southeastern edge of the former Western Building (looking southwest)

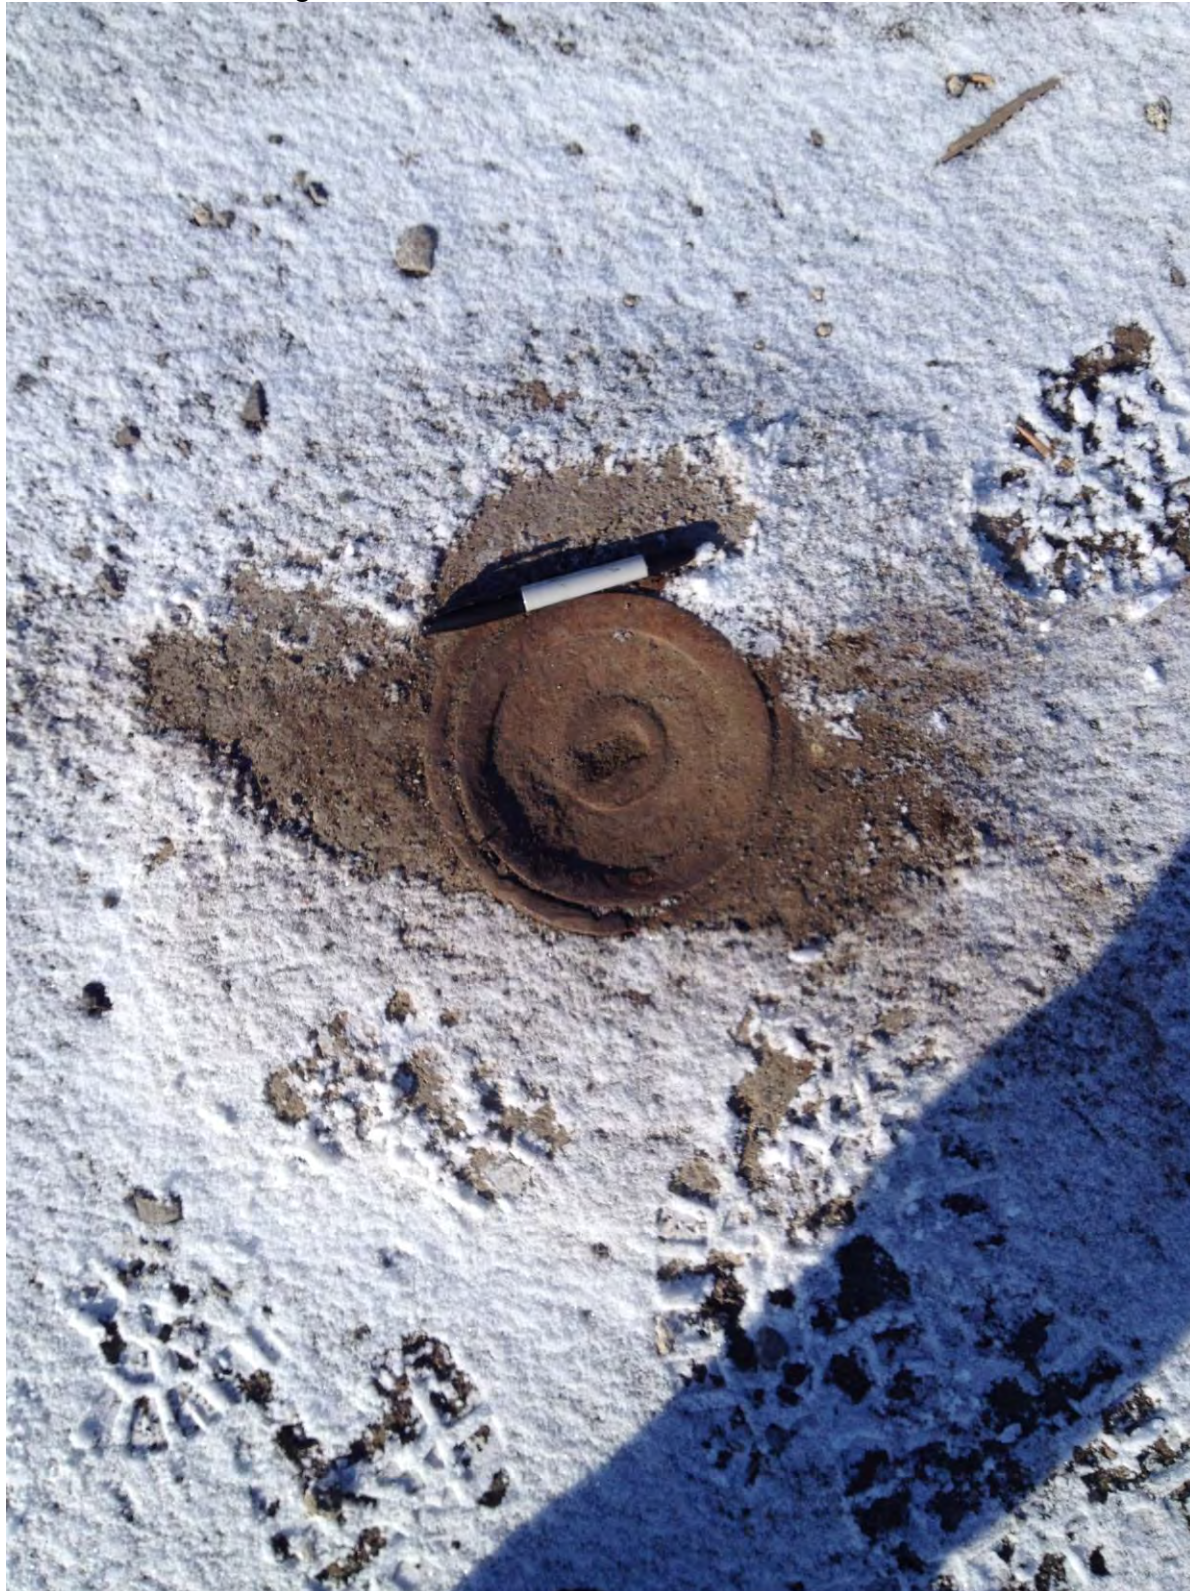
Photo 14: Another view of the fill port on the southeastern edge of the former Western Building

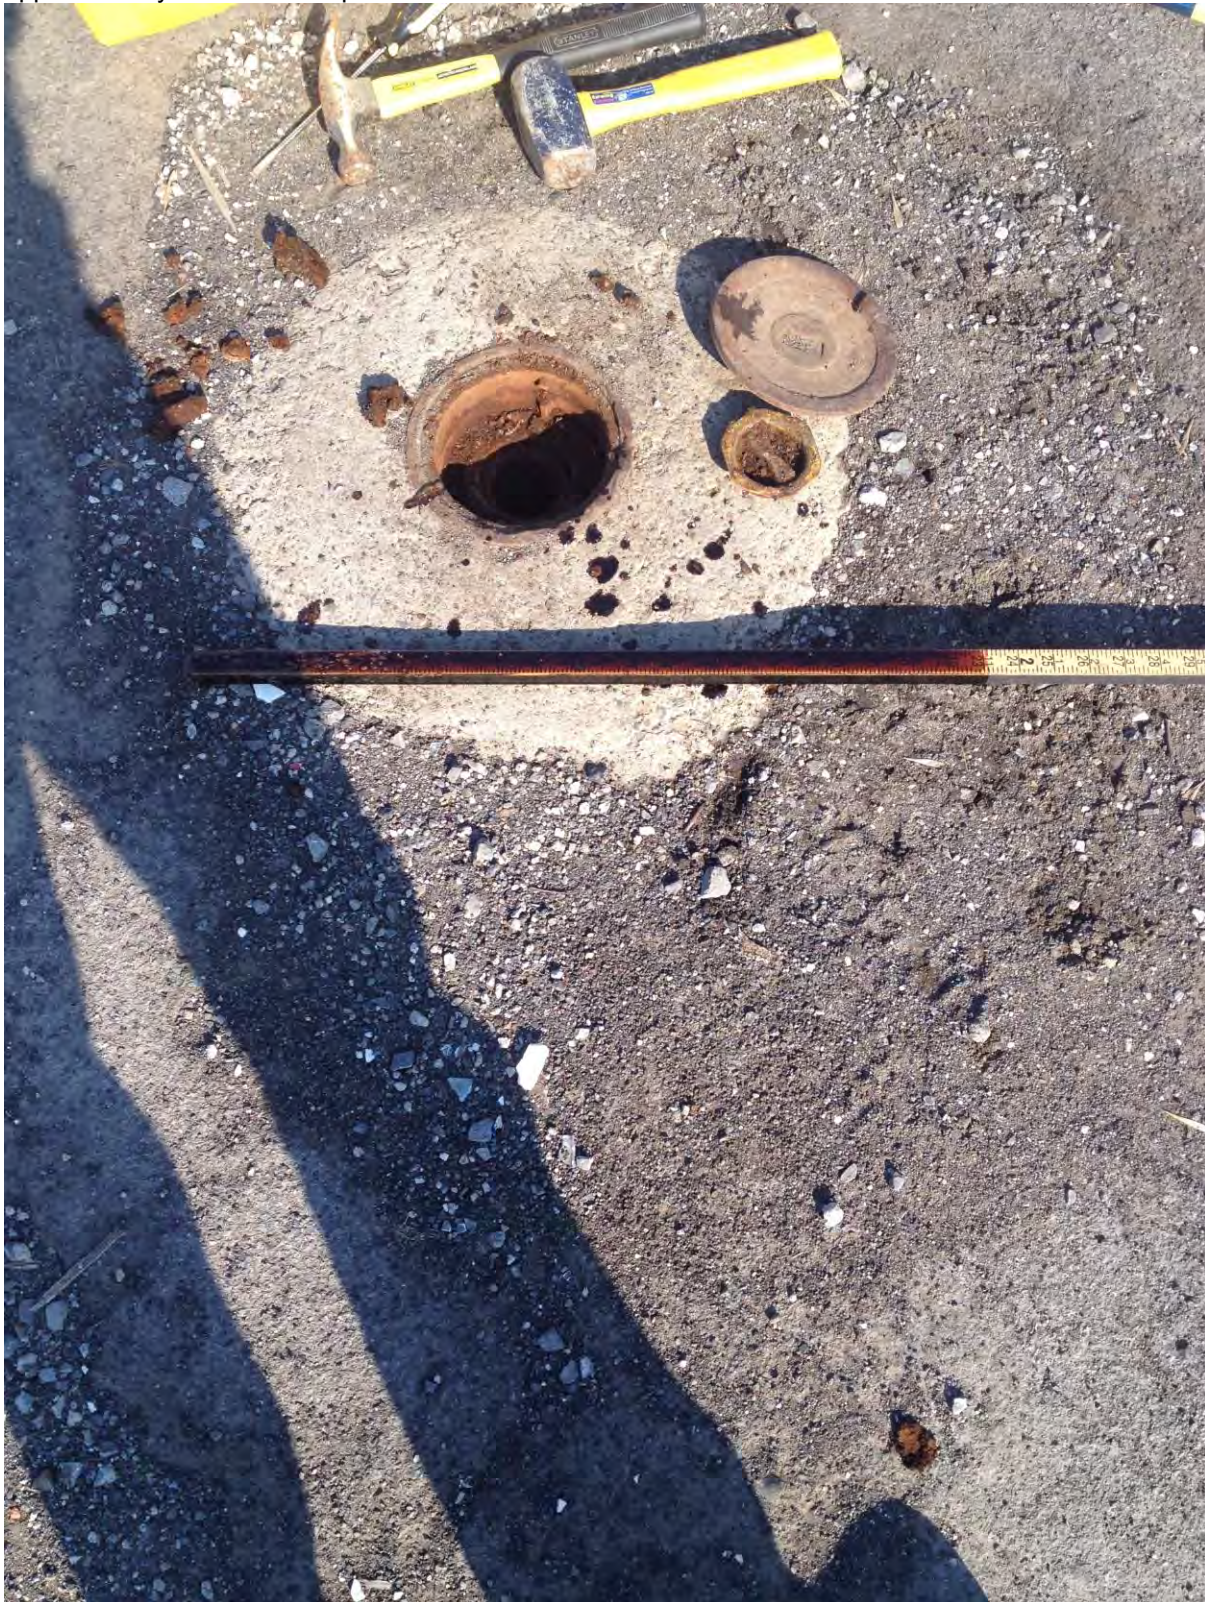
Photo 15: View of the opened fill port on the southeastern edge of the former Western Building and approximately two feet of oil product from the associated UST

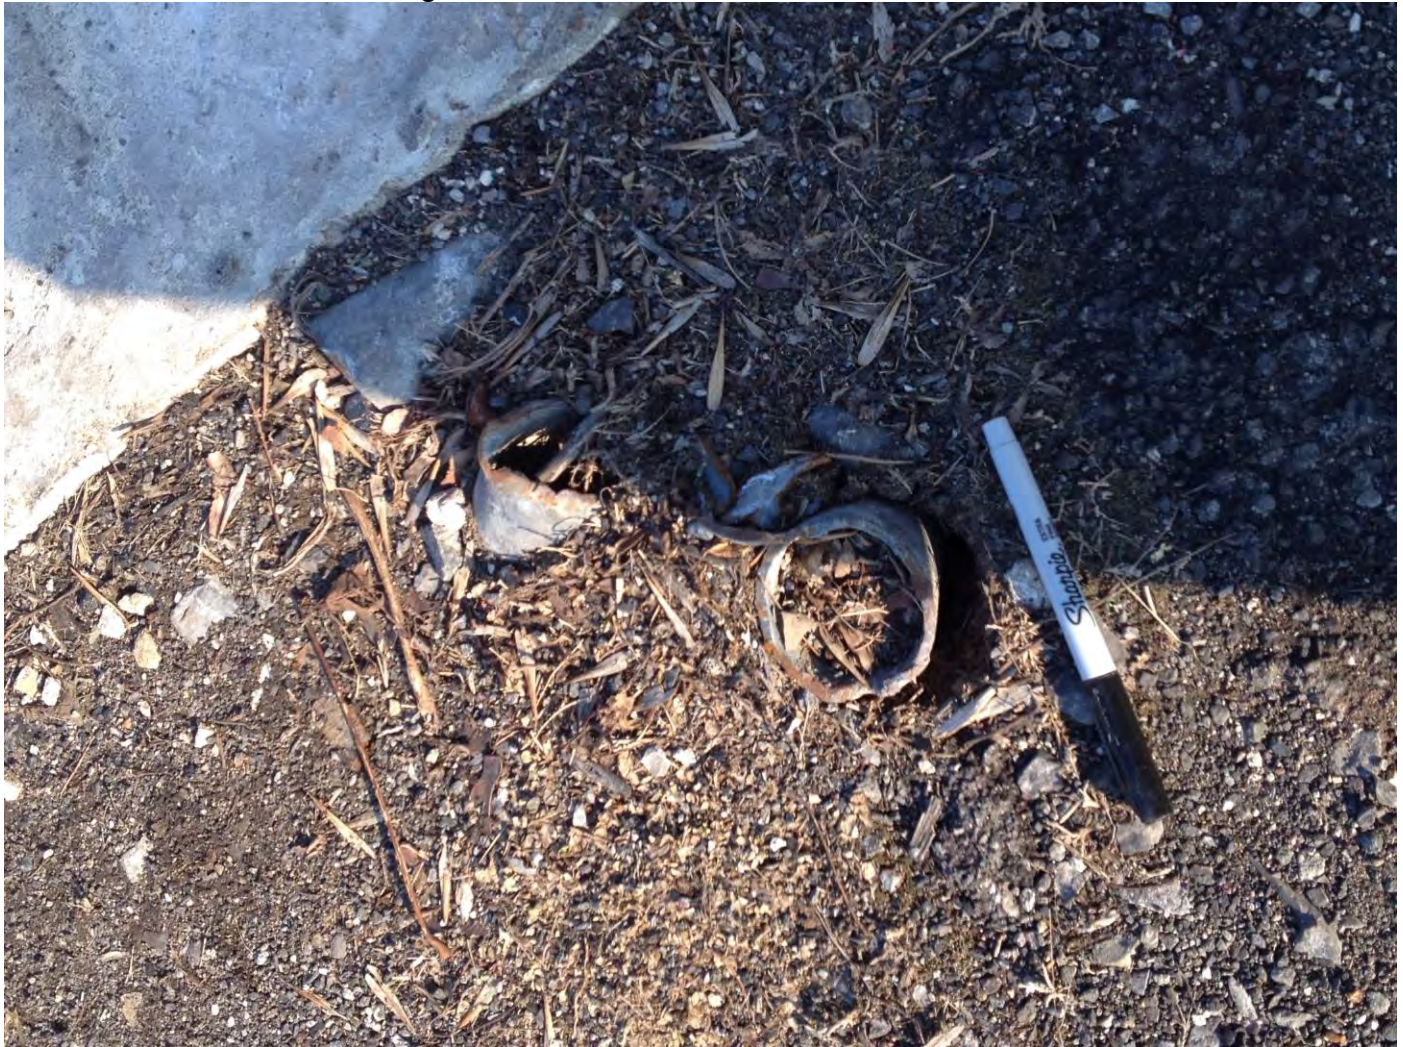
Photo 16: View of 2-3 suspected cut vent pipes on the southeastern edge of the former Western Building

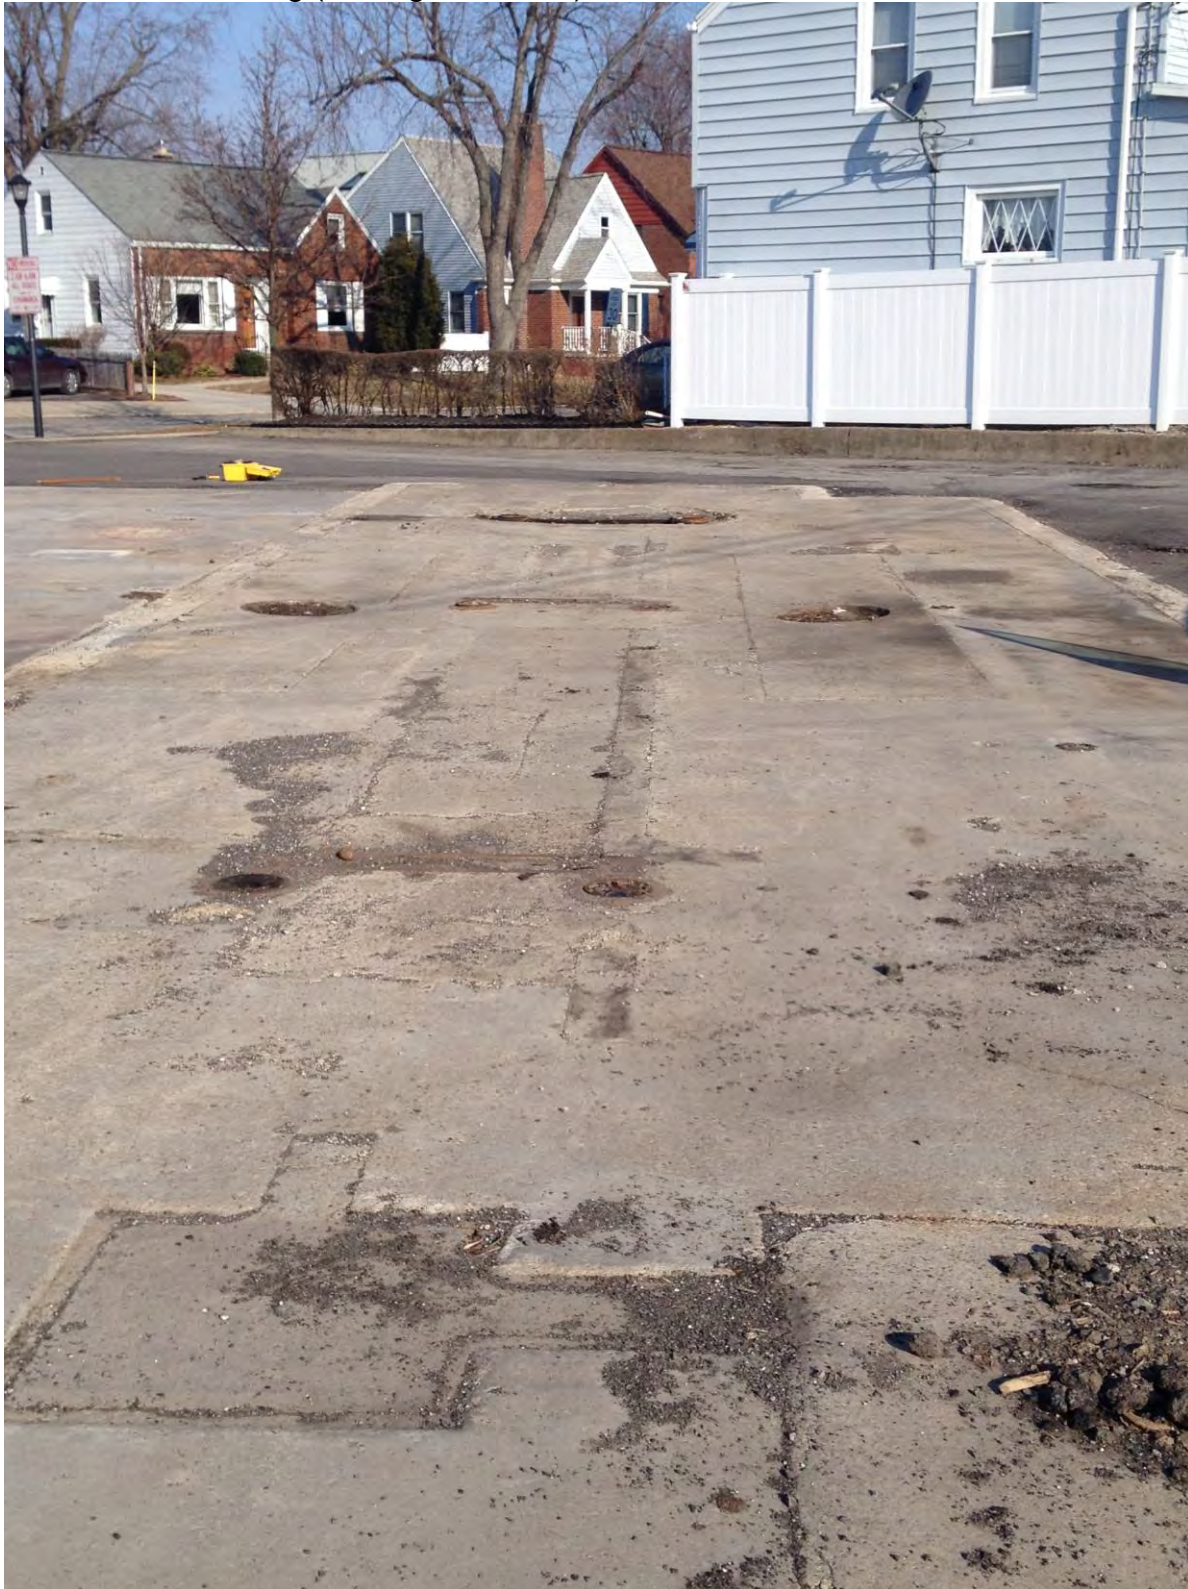
Photo 17: View of 3 historic in-ground hydraulic lifts in the footprint of the former Western Building (looking northwest)

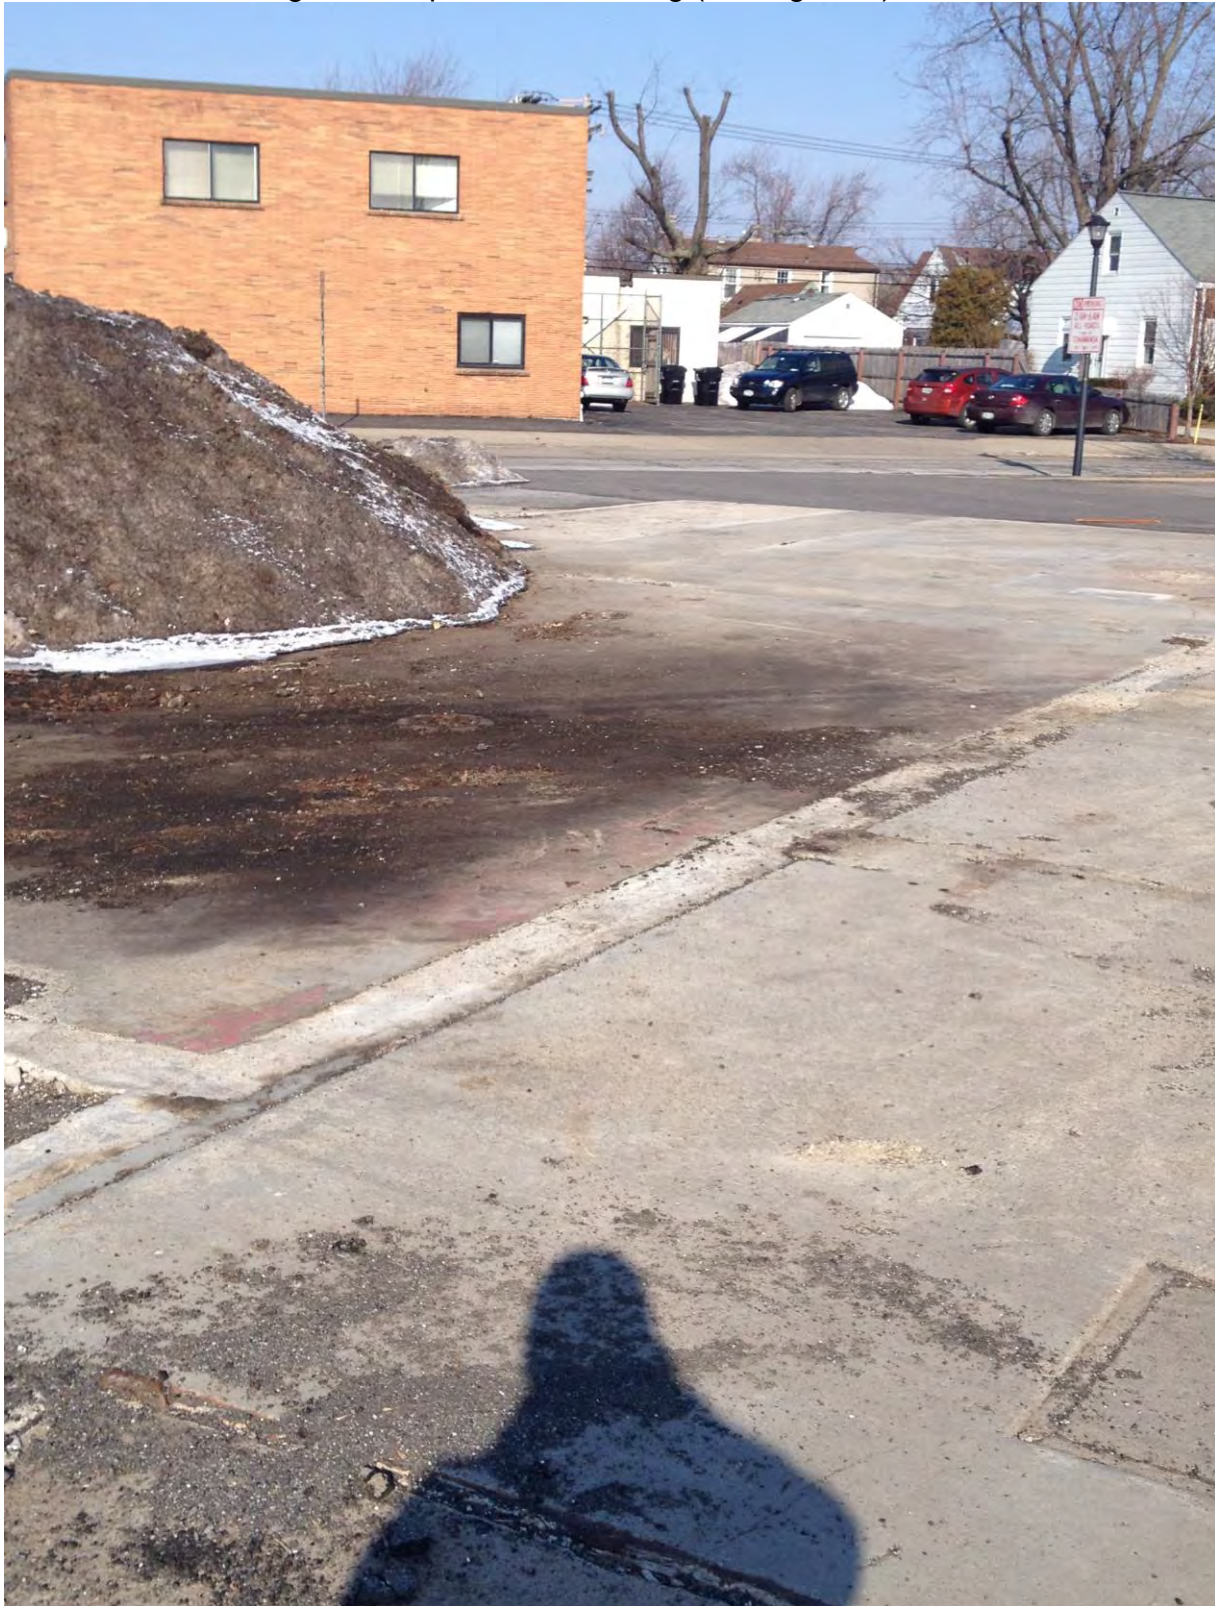
Photo 18: View of 1 historic in-ground hydraulic lift in the footprint of the former Western Building with suspected oil staining (looking west)

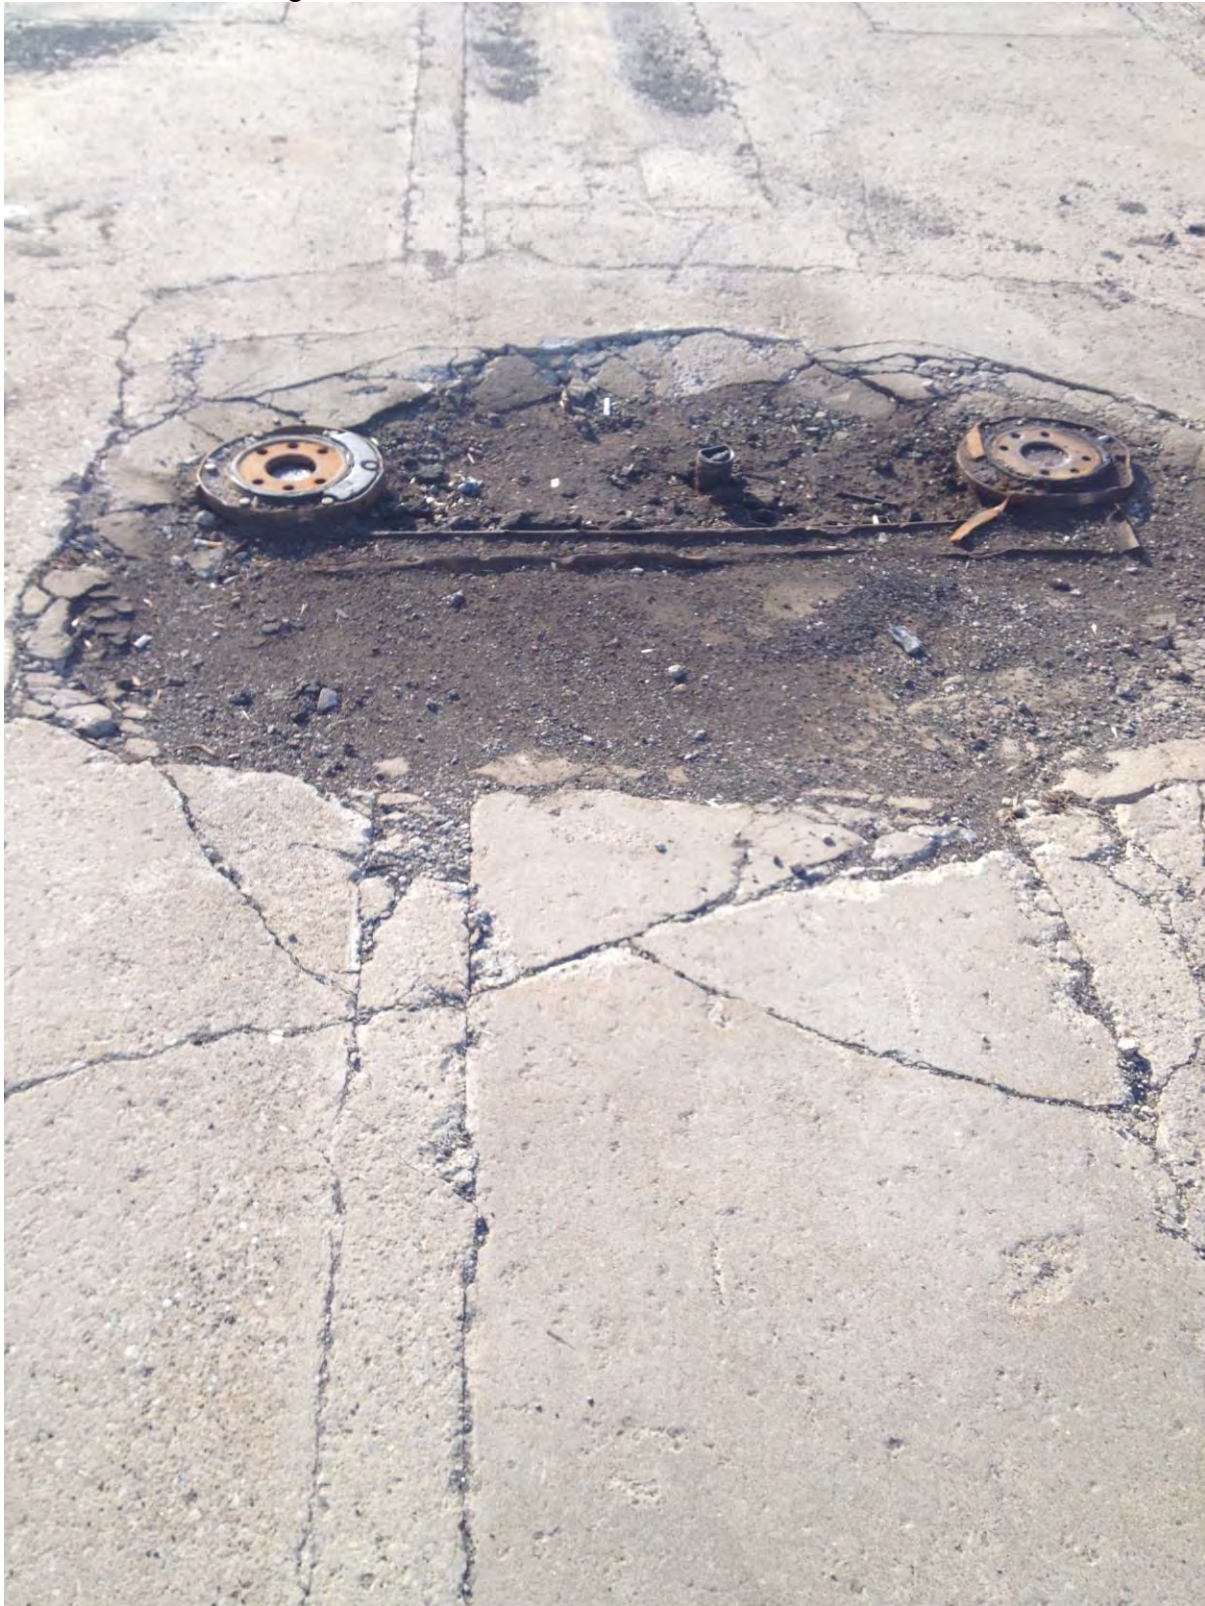
Photo 19: View of a historic in-ground hydraulic lift in the footprint of the former Western Building

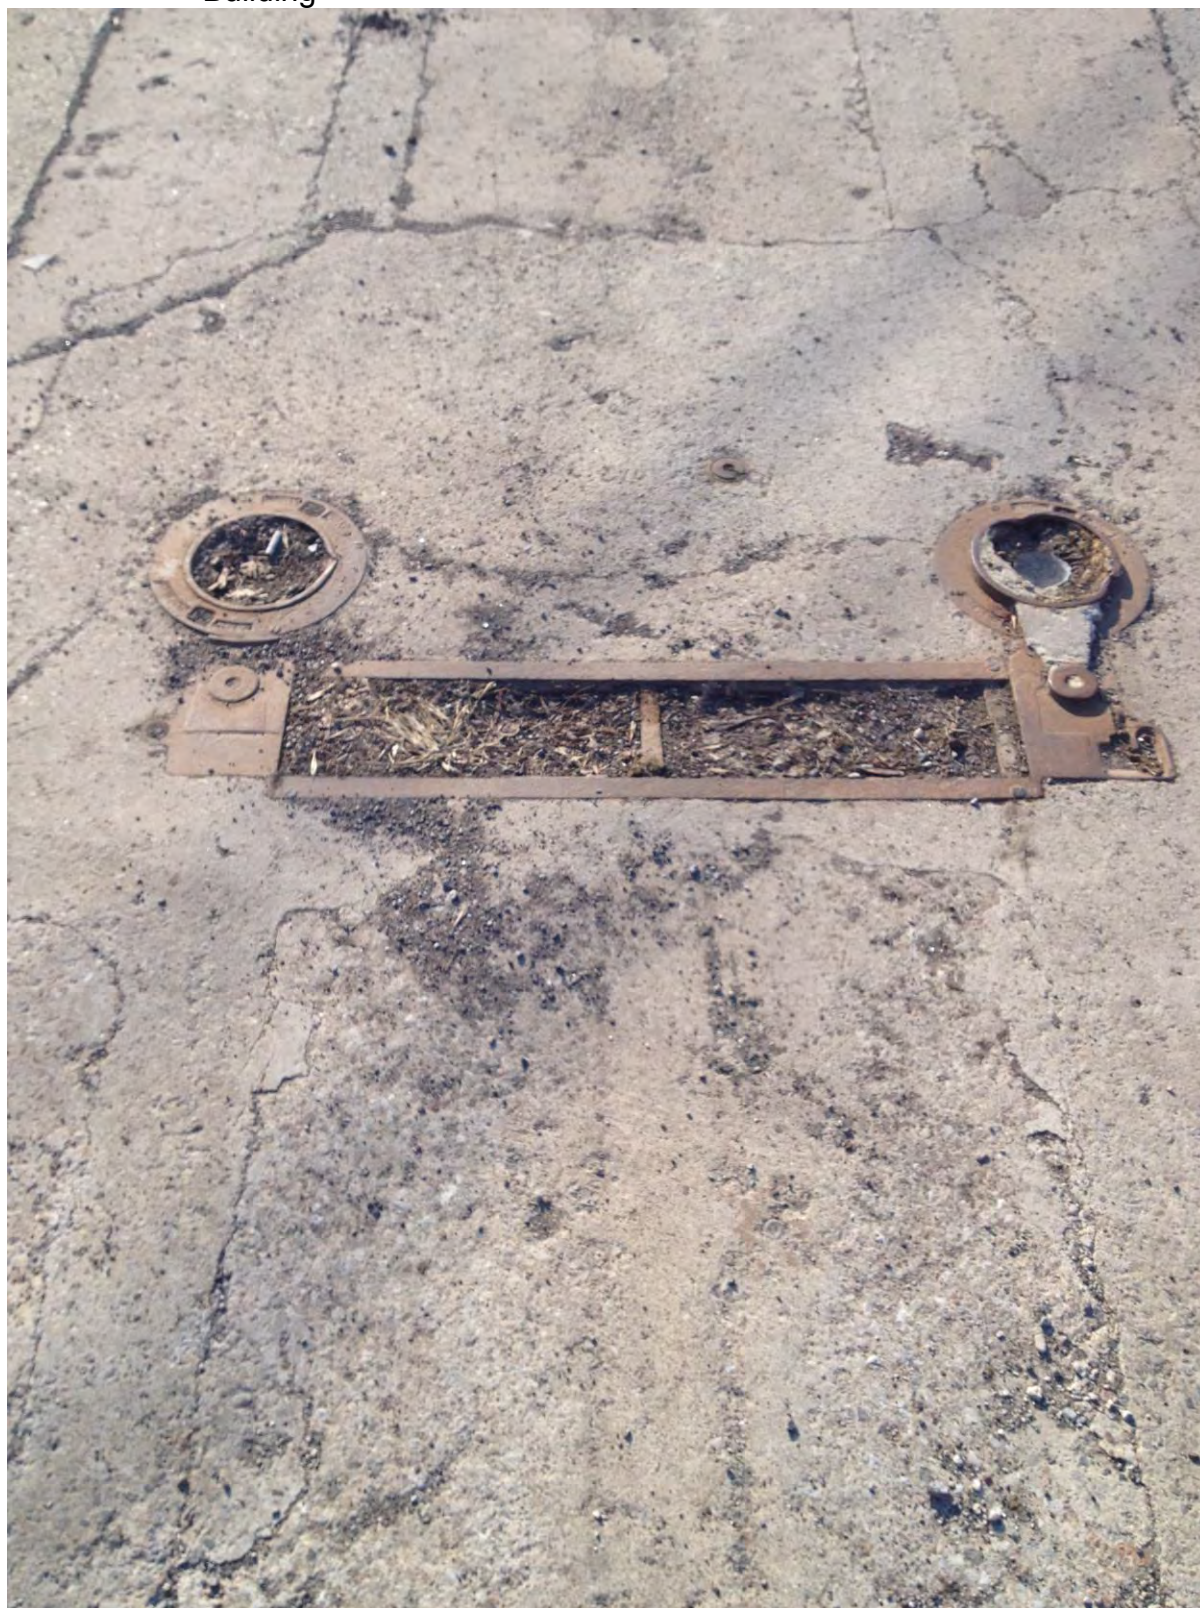
Photo 20: View of a historic in-ground hydraulic lift in the footprint of the former Western Building

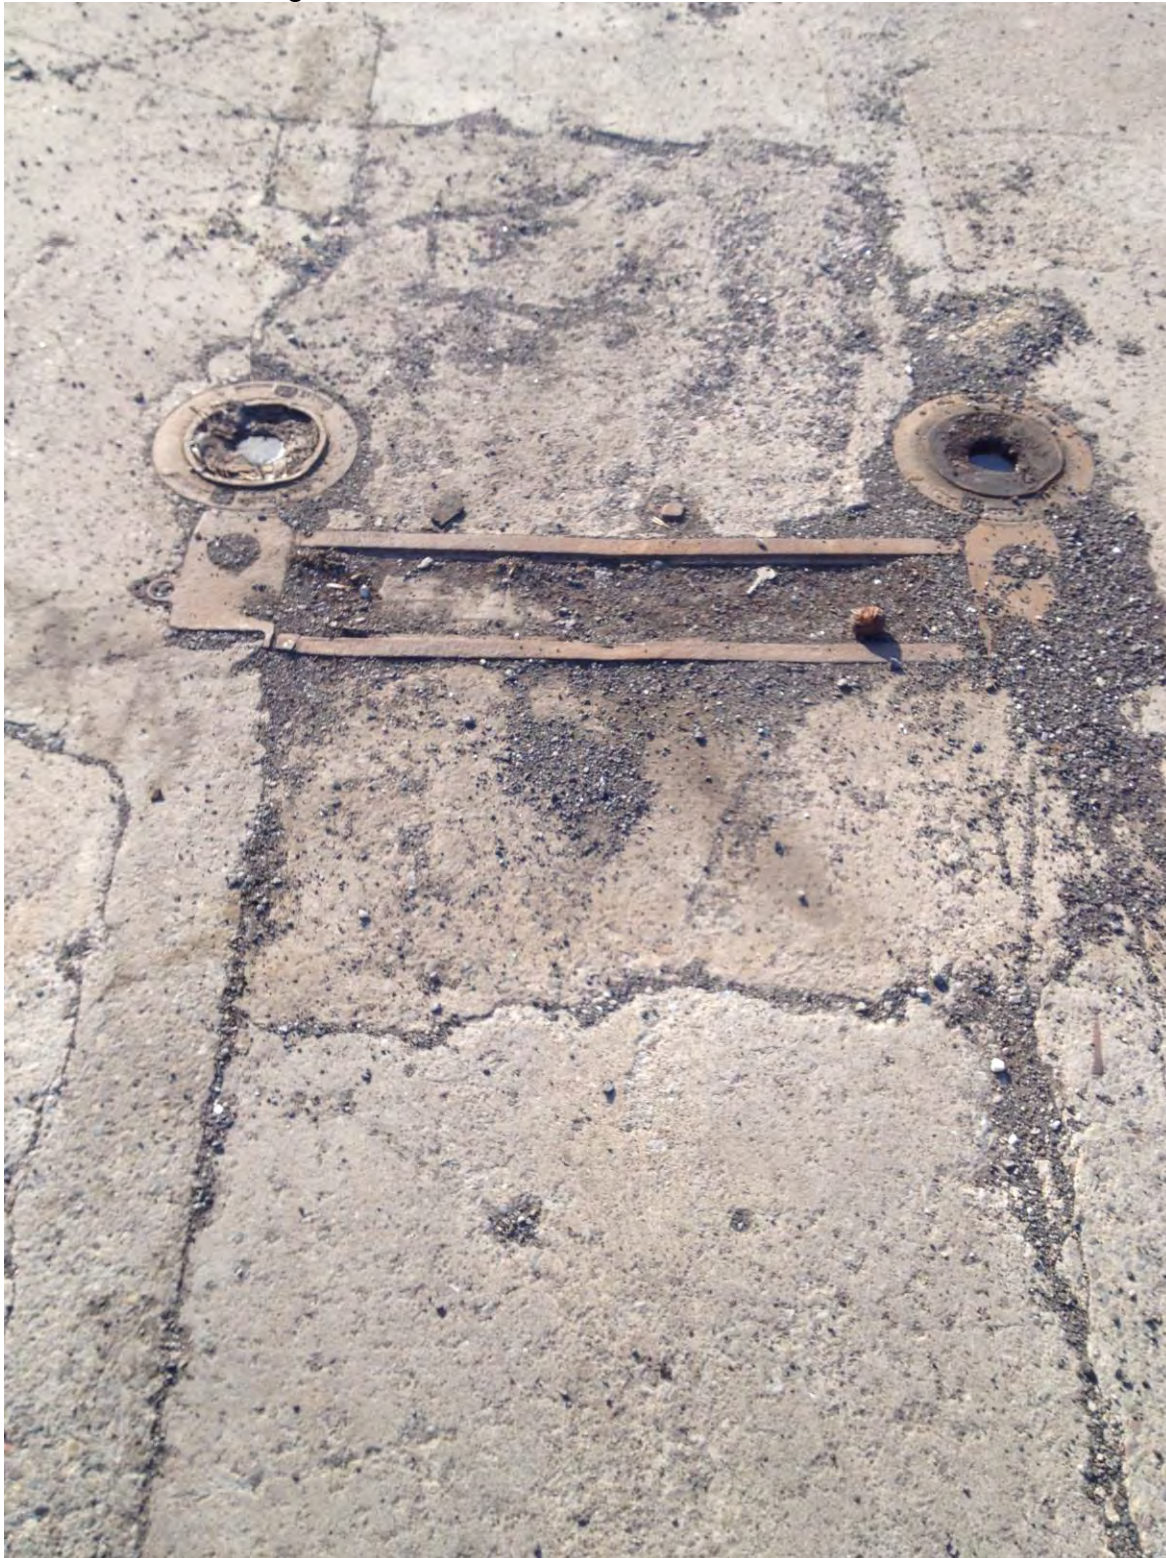
Photo 21: View of a historic in-ground hydraulic lift in the footprint of the former Western Building

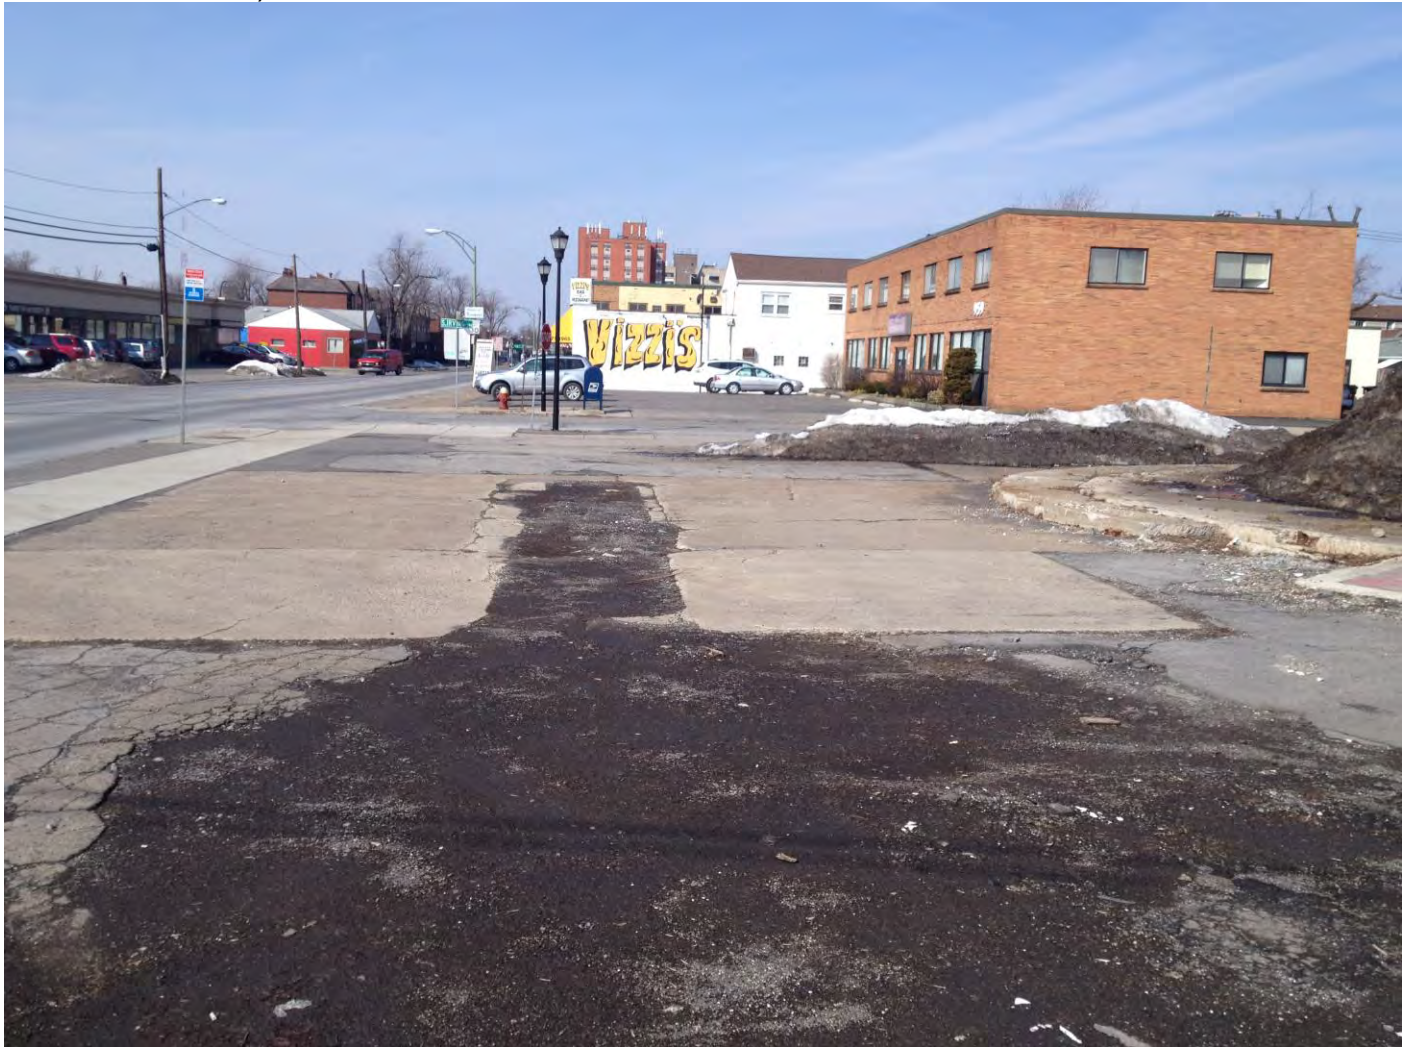
Photo 22: View of a former pump island south of the former Western Building (looking west)

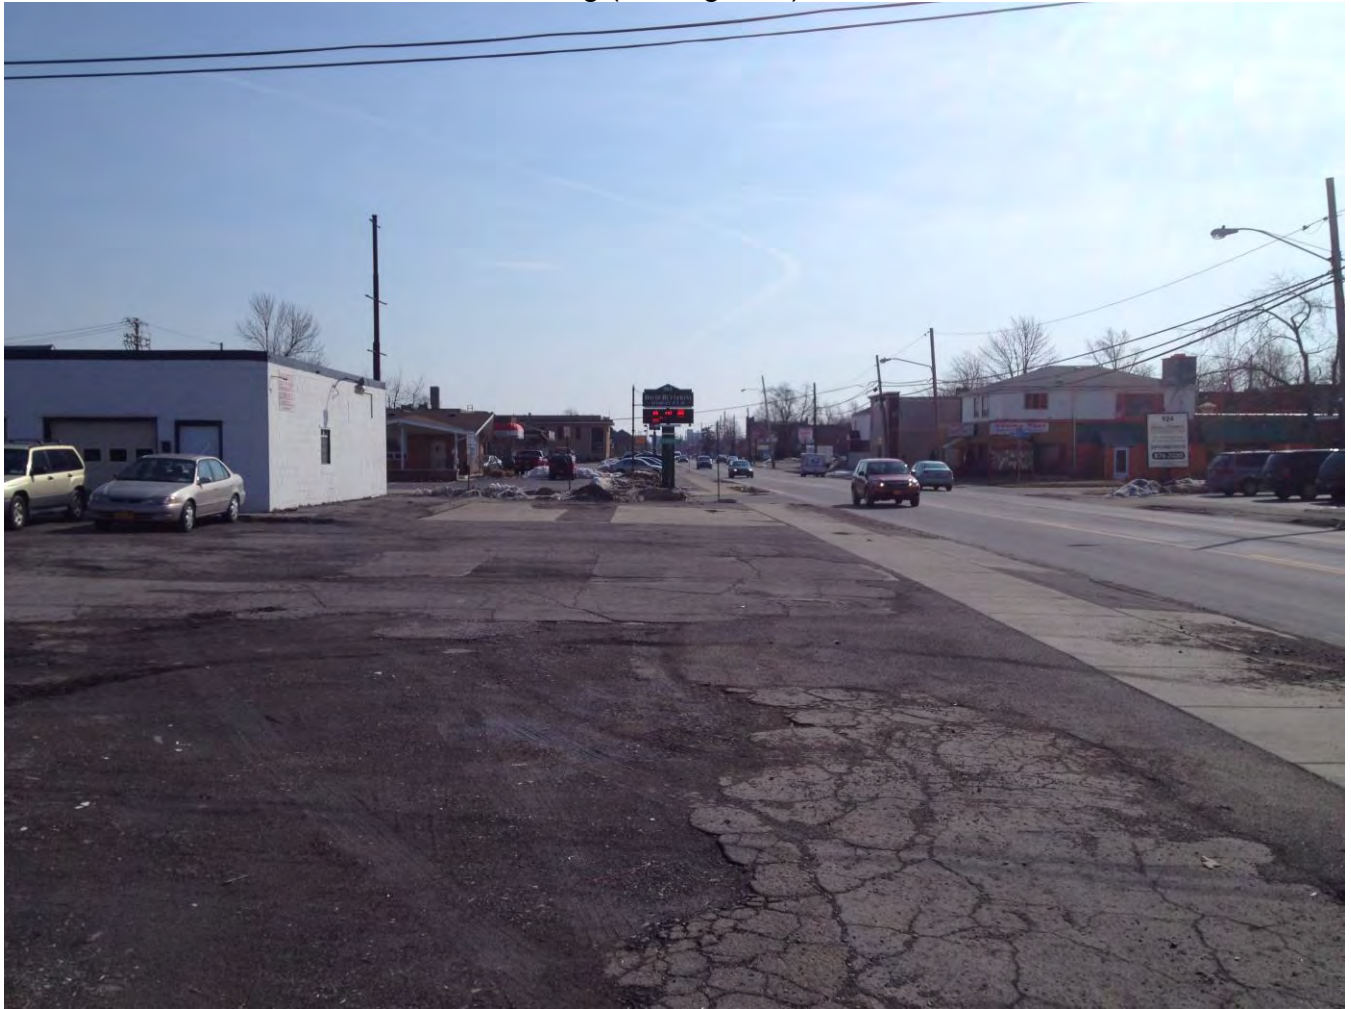
Photo 23: View of former pump islands southeast of the former Western Building and south of the Eastern Building (looking east)
