INTERIM REMEDIAL MEASURE WORK PLAN FOR BROWNFIELD CLEANUP PROGRAM

**945 KENMORE AVENUE
TONAWANDA, ERIE COUNTY, NEW YORK**

945 KENMORE GROUP LLC

REVISED JUNE 6, 2015

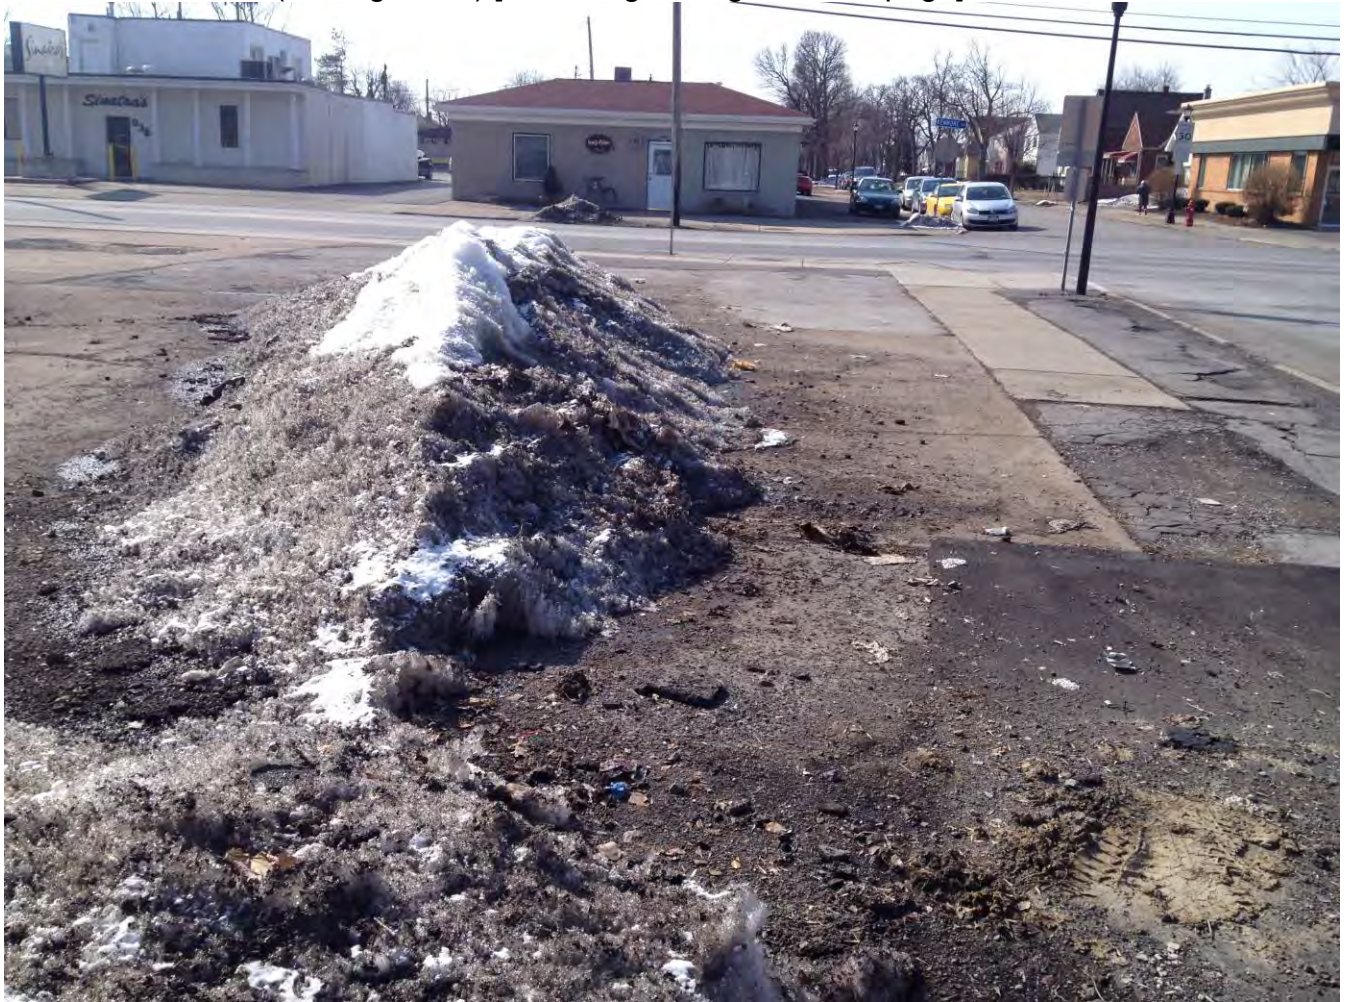
Photo 24: View of a former pump island west of the former Western Building, covered by snow (looking south) [see Google image on next page]

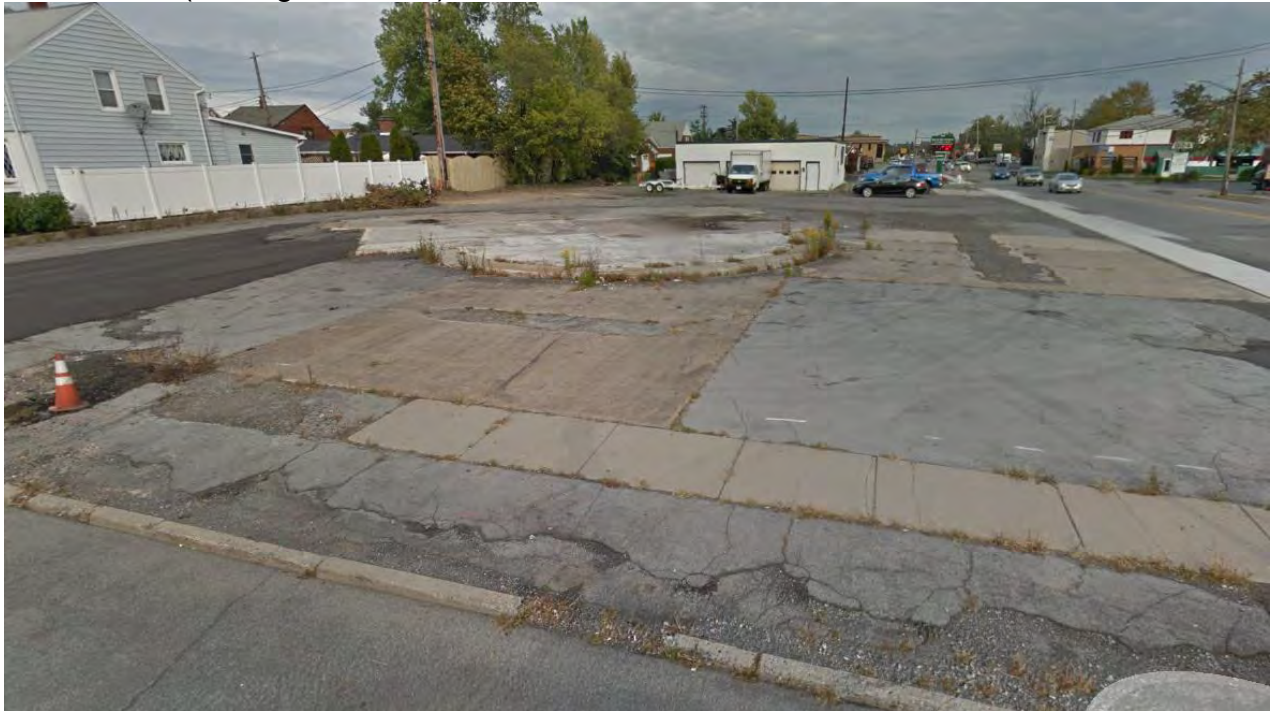
Photo 25: Google image of the former pump island west of the former Western Building (looking northeast)
