Brownfield Cleanup Program Application

399 Ohio Street Site
Buffalo, New York

April 2014

0136-013-011

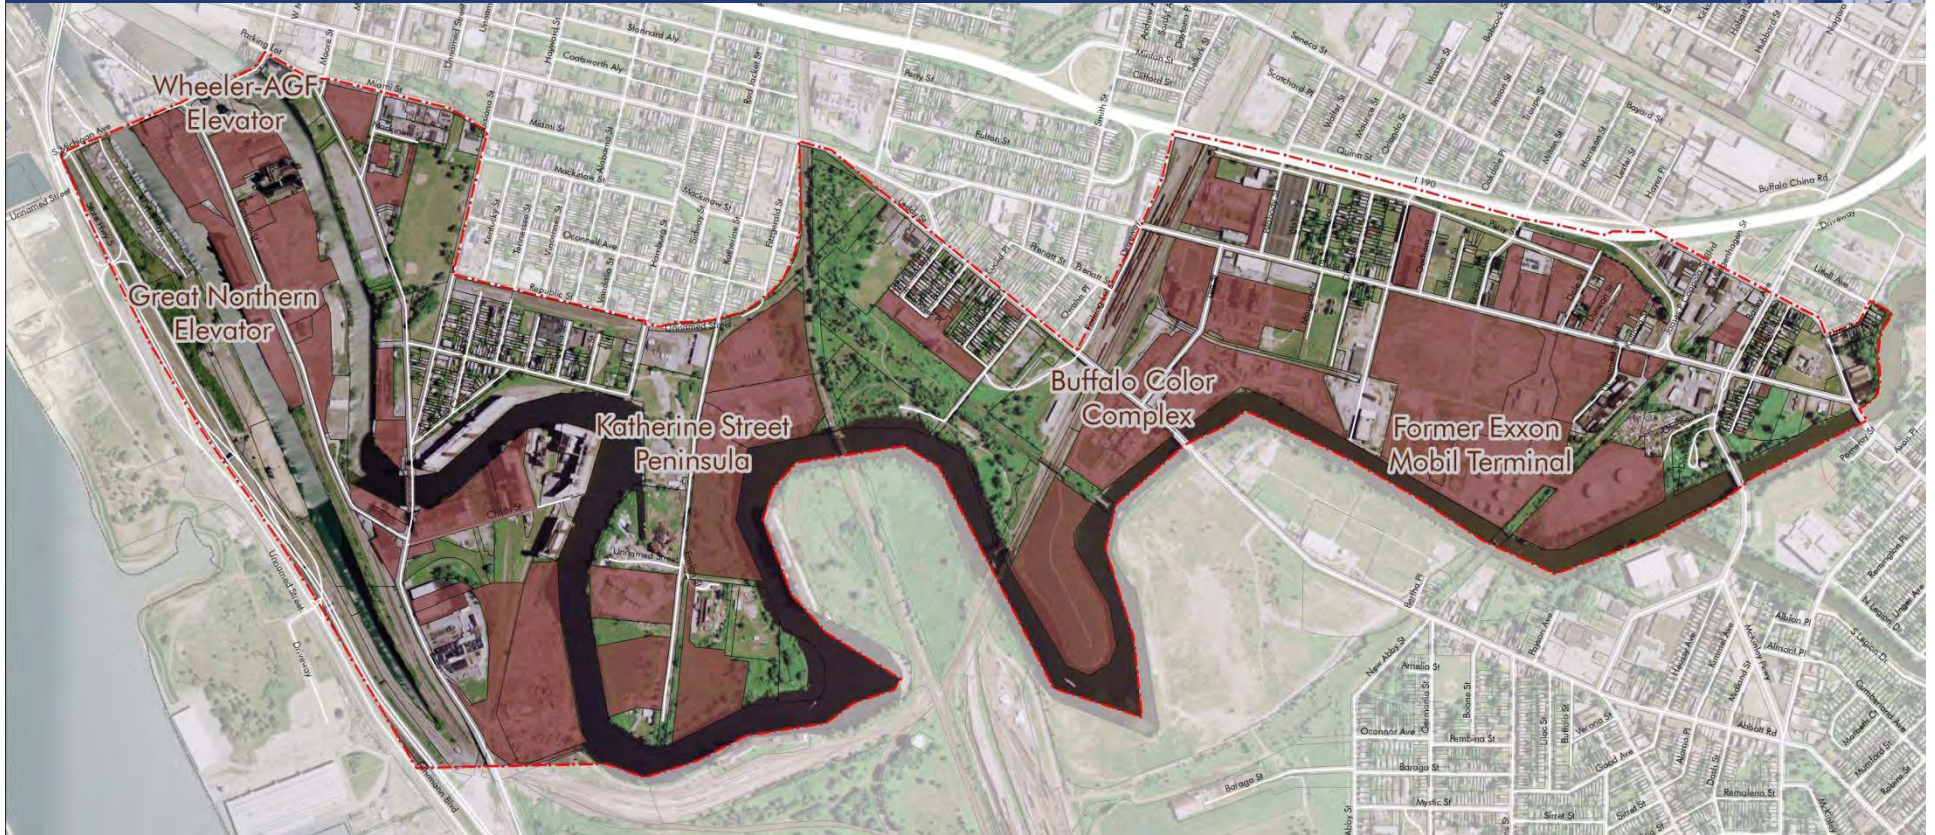
Brownfield Sites

- 60 “brownfield” parcels account for 41% of the total BOA area (325 acres)
- 90% of identified brownfields are being actively used
- As nearly all parcels along the river are potential brownfields, remediation strategies will need to be considered during redevelopment

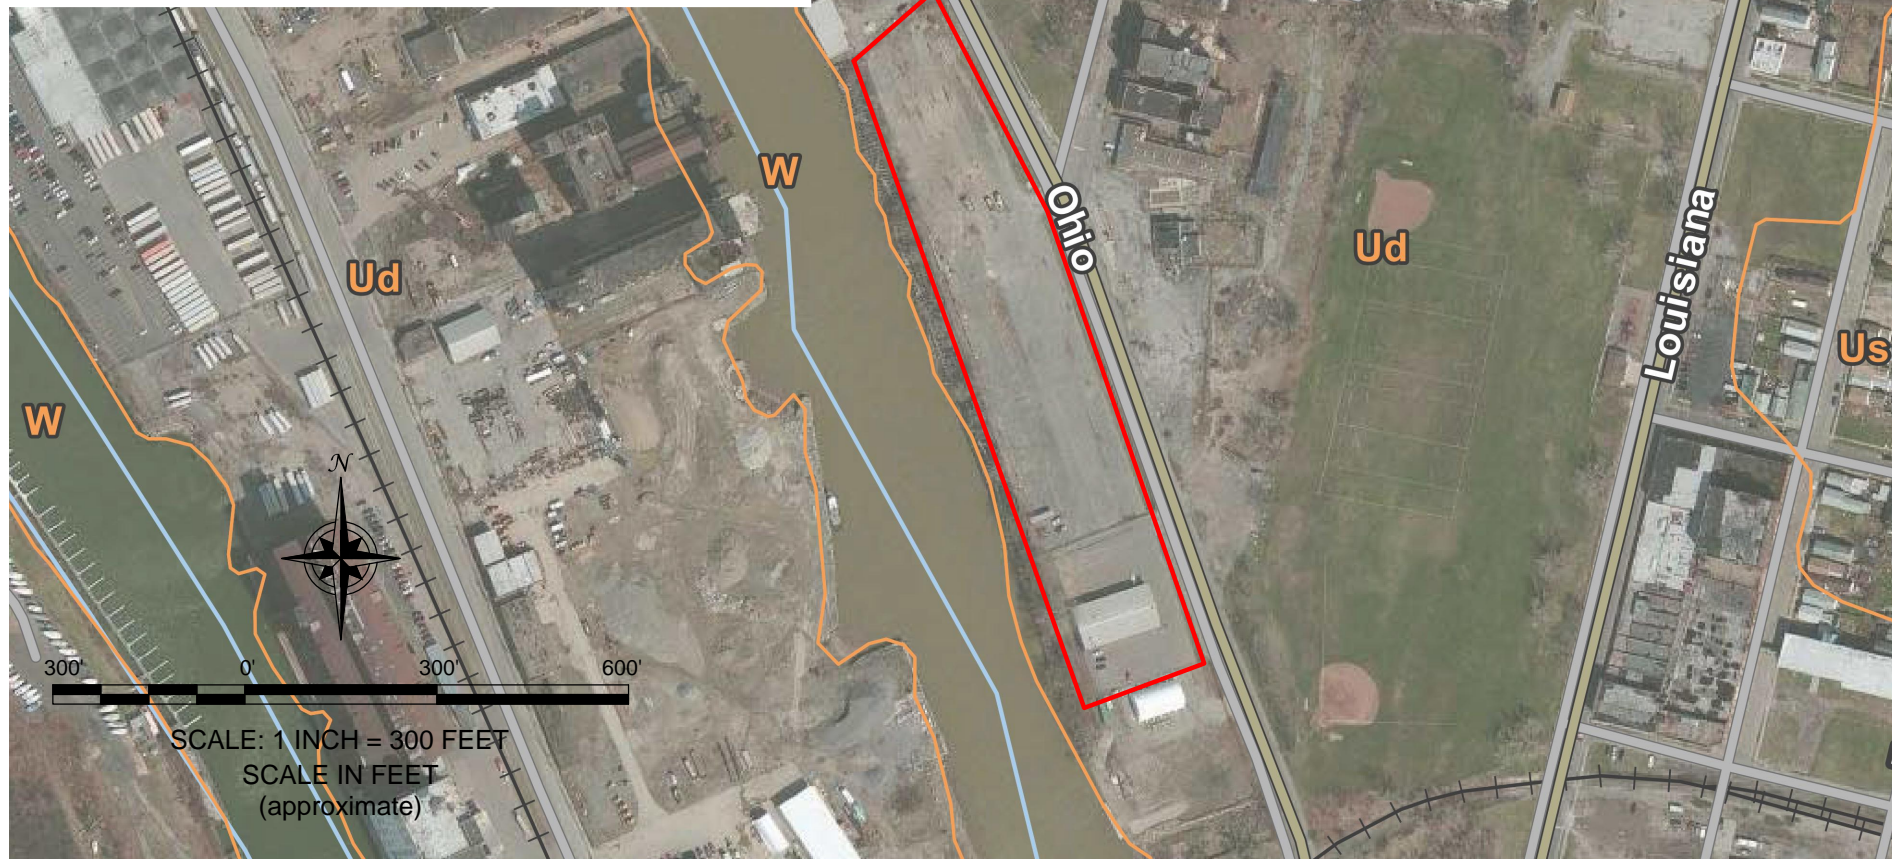
Map Unit Symbol	Map Unit Name
Ud	Urban land
Us	Urban land-Niagara complex
