**Limited and Focused Subsurface Soil and
Groundwater Investigation Report for the
Property Identified as:**

**Commercial Plaza
3021-3041 Orchard Park Road
Orchard Park, New York**

LCS PROJECT # 13B4431.22

MAY 14, 2014

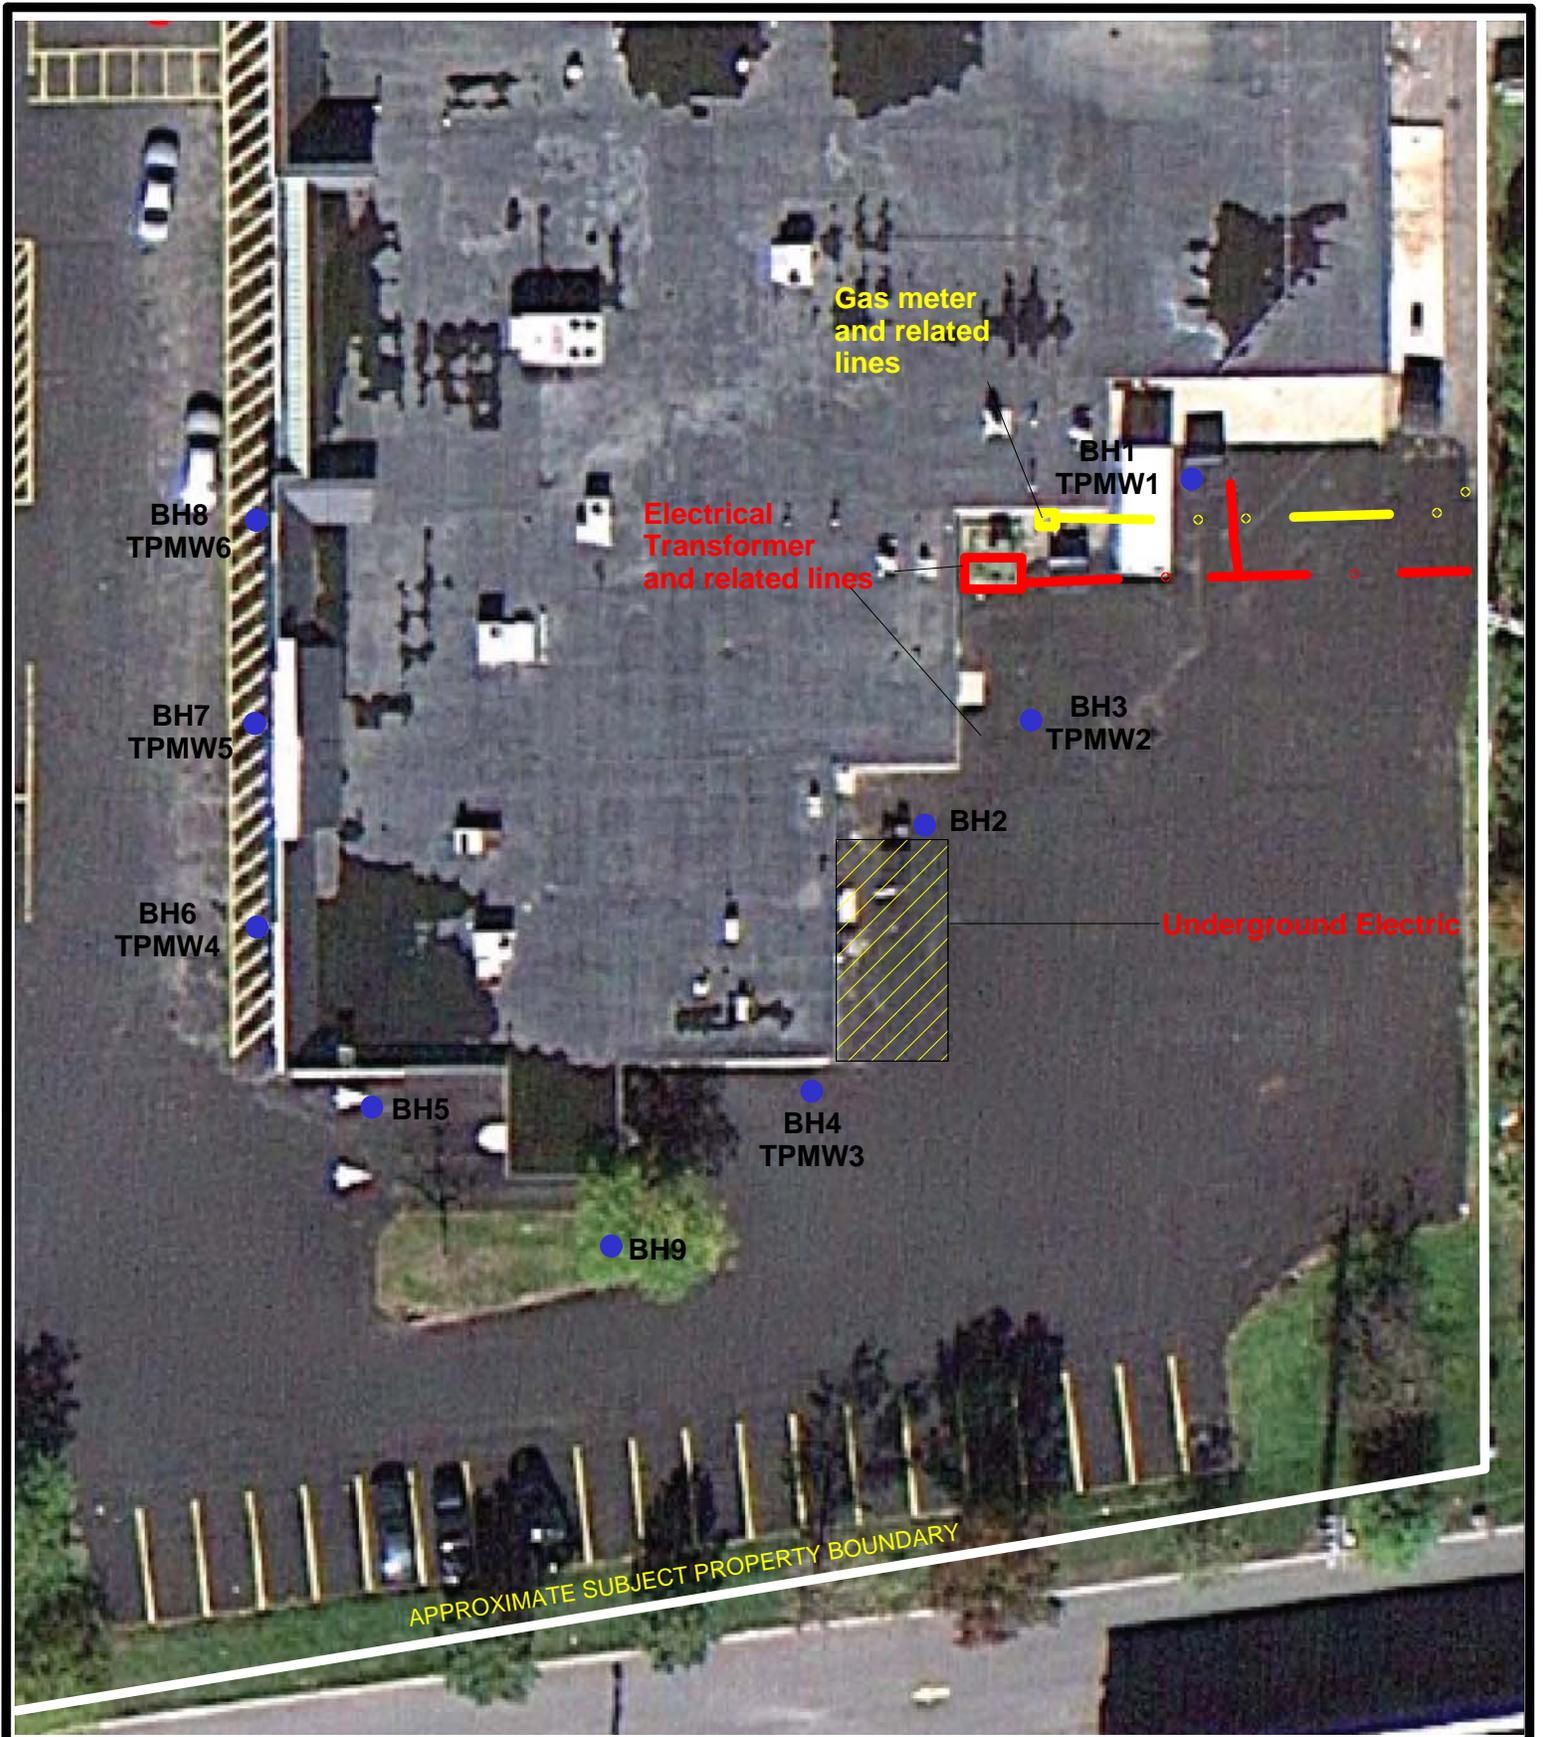
FIGURE 2 - SITE INVESTIGATION PLAN

Nine boreholes (BH1 through BH9) were completed in accessible areas of the subject property proximate to the environmental concerns. (See Figure 2.) A total of 63 soil samples were collected for geologic description. Fill material consisting of asphalt was encountered within all test borings to a depth of approximately 0.5 ft. bgs. Generally, the fill materials were underlain by native soils consisting of varying mixtures of silt, clay, sand, and gravel to the bottom of the test borings. Apparent groundwater was encountered within BH1, and BH3 through BH8 between approximately 5 and 13 ft. bgs. No apparent groundwater was encountered in BH2 and BH9.

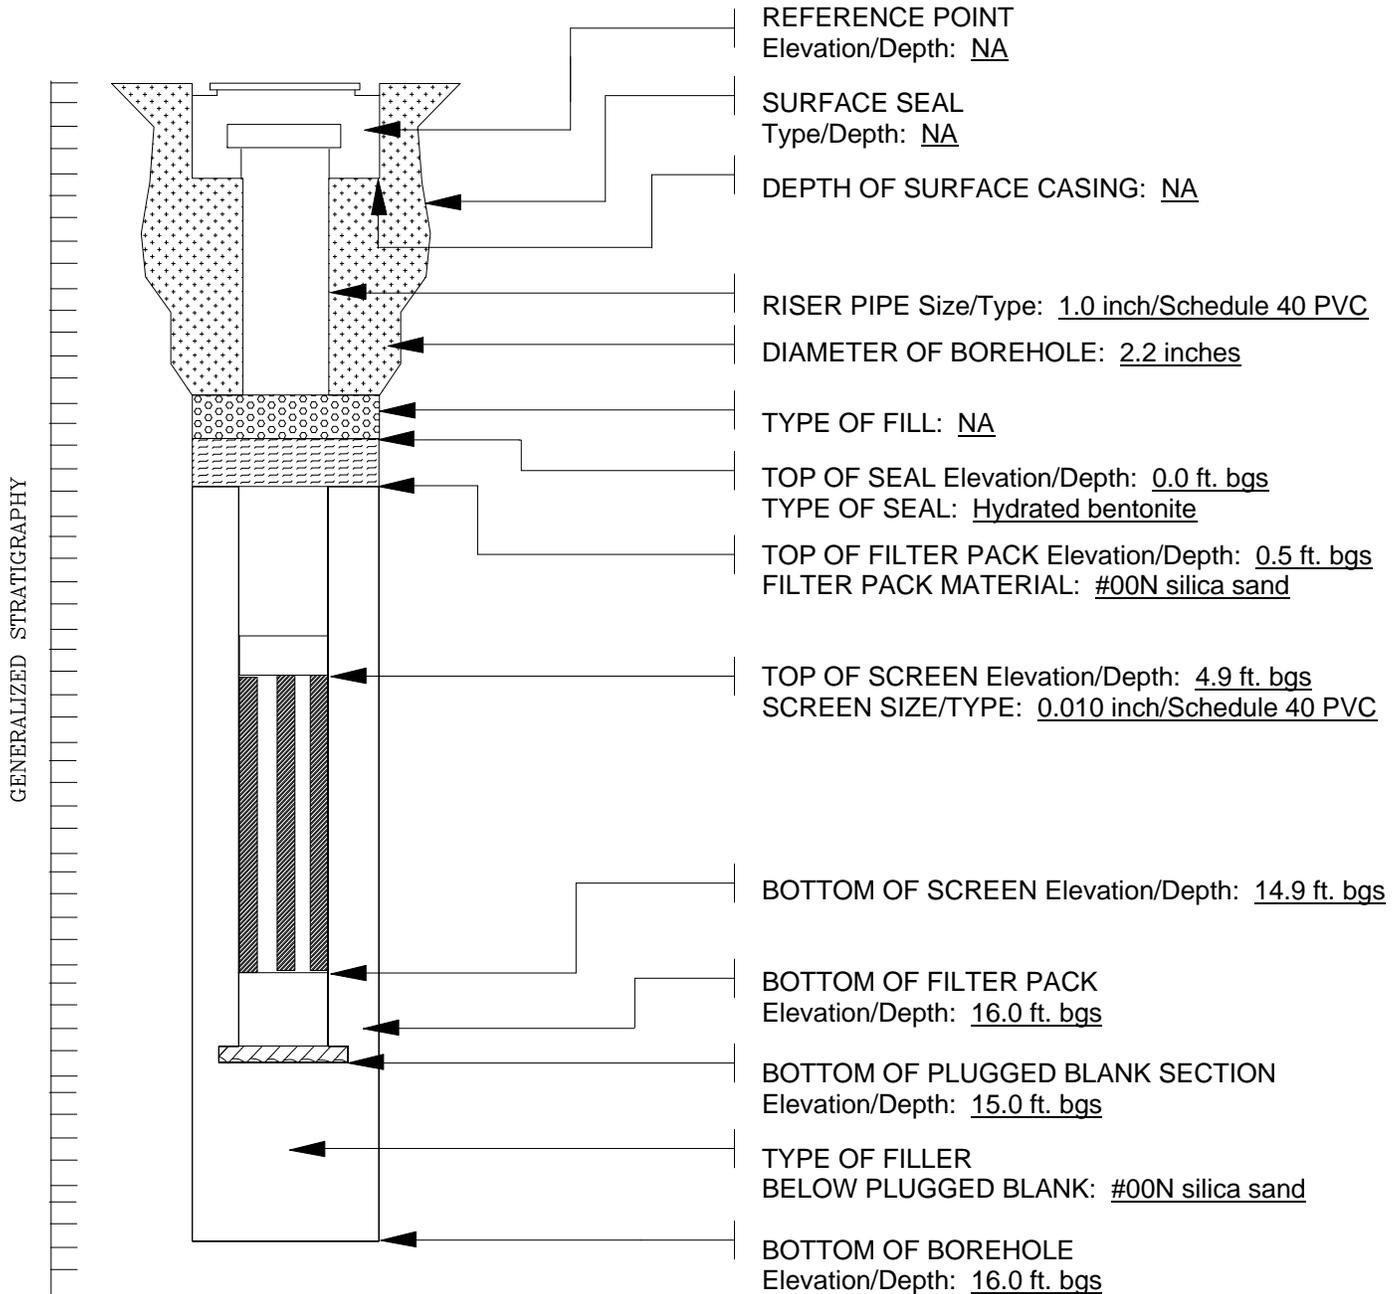
PROJECT/LOCATION:	<u>3021-3041 Orchard Park Rd, Orchard Park, NY</u>	PROJECT No.	<u>14B4431.22</u>
CLIENT:	<u>Northwest Savings Bank</u>	WELL No.	<u>TPMW1</u>
DATE COMPLETED:	<u>5/7/14</u>	SUPERVISED BY:	<u>DEC</u>

Temporary groundwater monitoring wells TPMW1 through TPMW6 were installed within boreholes BH1, BH3, BH4, BH6 through BH8. Generally, the bottoms of the wells were set to approximately 16 to 18 ft. bgs. Each of the wells was constructed with one-inch diameter PVC screen and riser with a silica filter pack placed around the well screen. A bentonite seal was placed above the sand and the wells were covered with plastic caps, to prevent surface water from entering the wells. Refer to the attached subsurface logs/well construction details for well specific well construction details.
