### **3021 Orchard Park Road Site**

BCP Site No. C915289  
3021-3041 Orchard Park Road  
Orchard Park, New York

## **Periodic Review Report**

**(December 31, 2018 to December 31, 2021)**

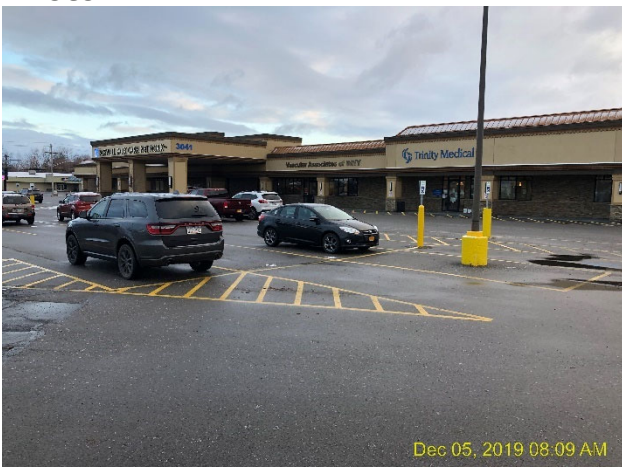
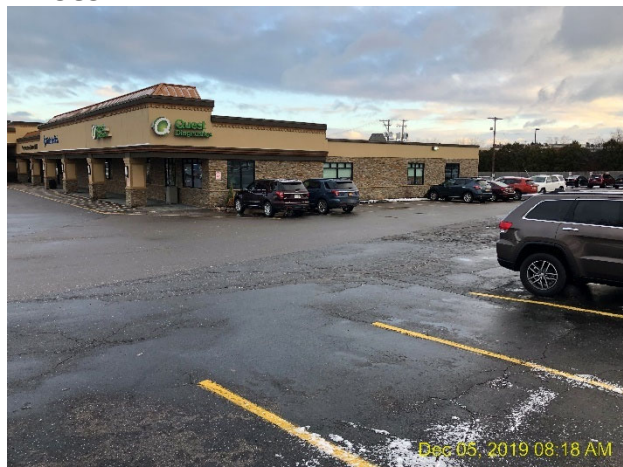
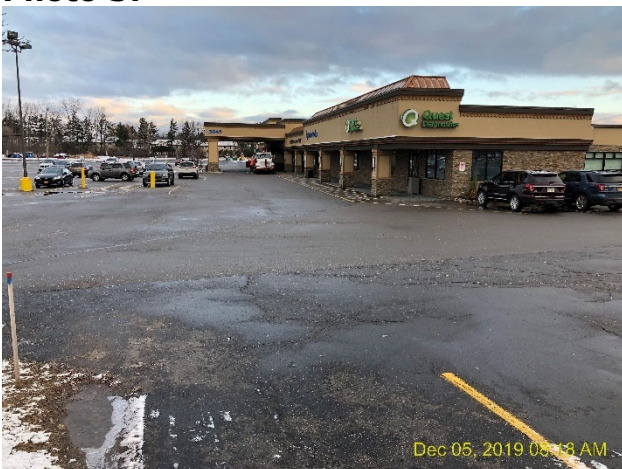
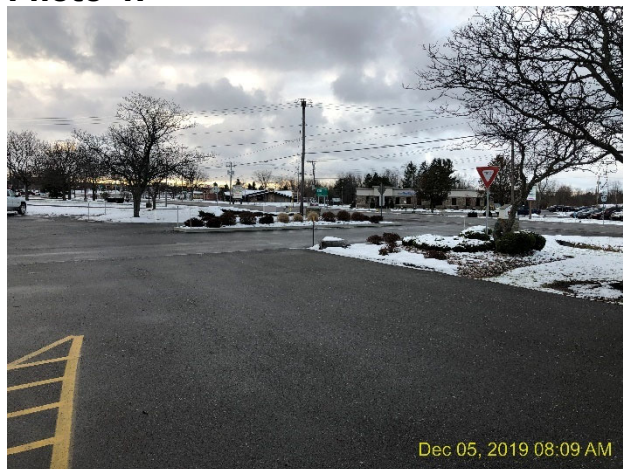
- Photo 1. Asphalt and hardscape final cover along front of Site (looking NE).
- Photo 2. Asphalt and hardscape final cover along south side of Site (looking E).
- Photo 3. Asphalt and hardscape final cover along front of Site (looking N).
- Photo 4. Asphalt final cover entrance along Orchard Park Road (looking S).

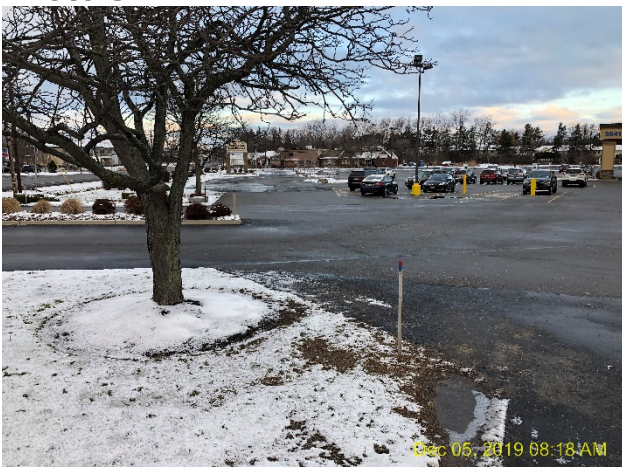
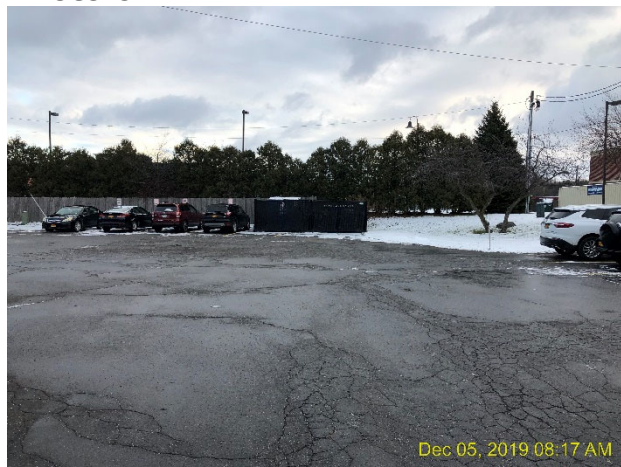
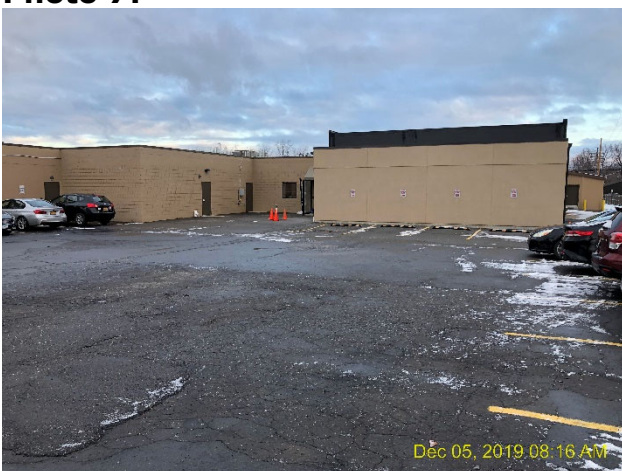
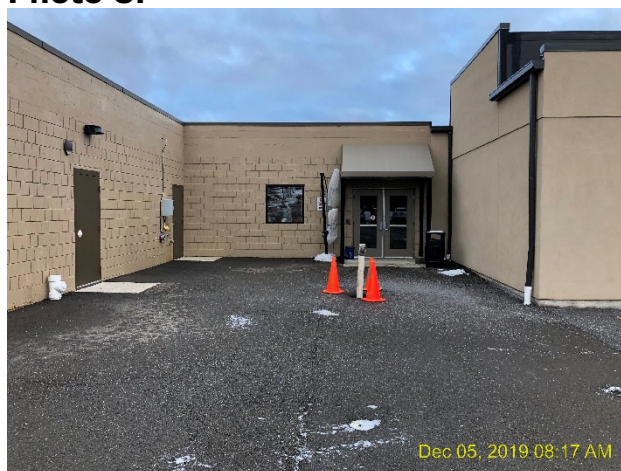
- Photo 5. Asphalt final cover along front of Site, Orchard Park Road at left (looking NW).
- Photo 6. Asphalt and hardscape final cover in SE corner of Site (looking E).
- Photo 7. Asphalt and hardscape final cover along southern portion of Site (looking N).
- Photo 8. Asphalt and hardscape final cover with decommissioned well MW-6 at center (looking N).

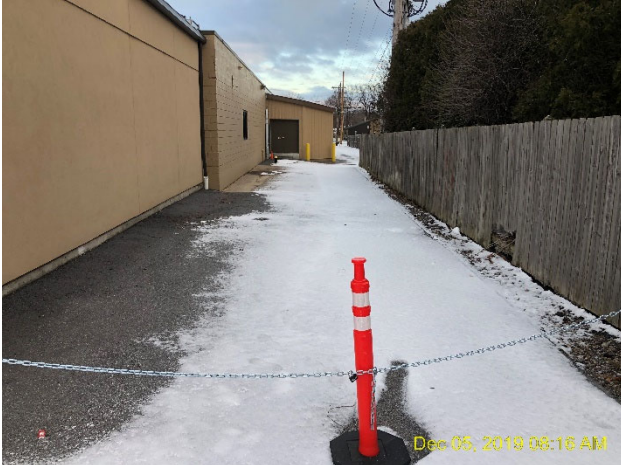
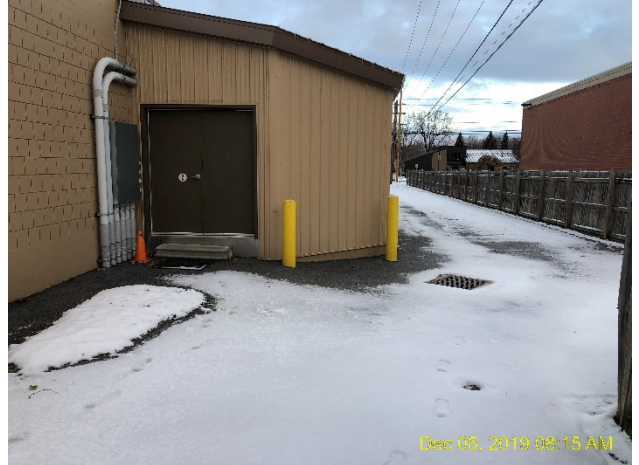
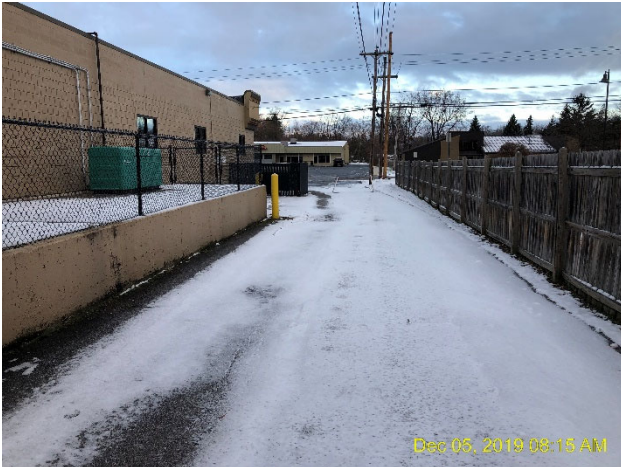
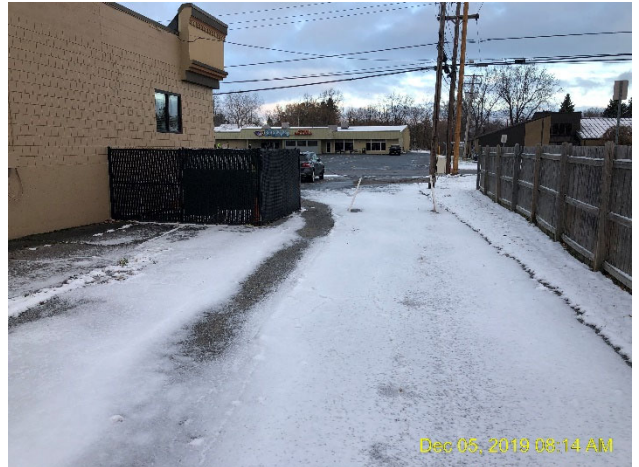
- Photo 9. Asphalt and hardscape final cover along eastern portion of Site (looking N).
- Photo 10. Asphalt and hardscape final cover along eastern portion of Site (looking N).
- Photo 11. Asphalt and hardscape final cover along eastern portion of Site (looking N).
- Photo 12. Asphalt and hardscape final cover in northeastern corner of Site (looking N).

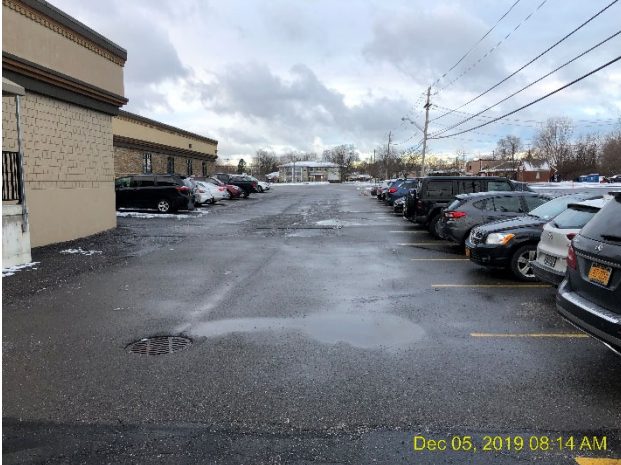
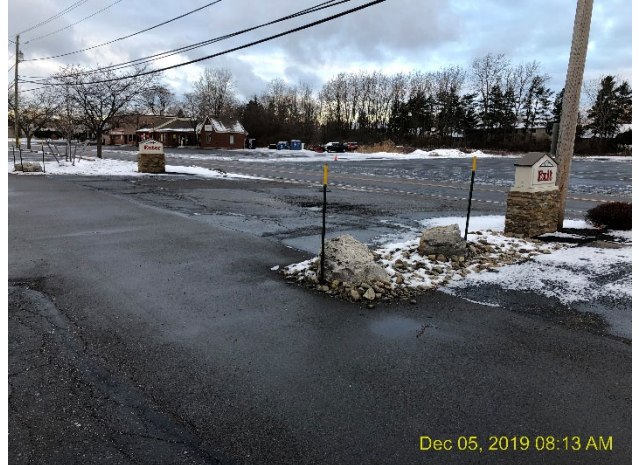
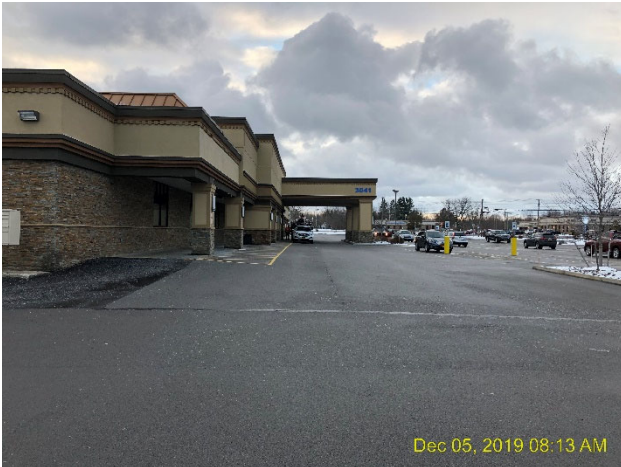
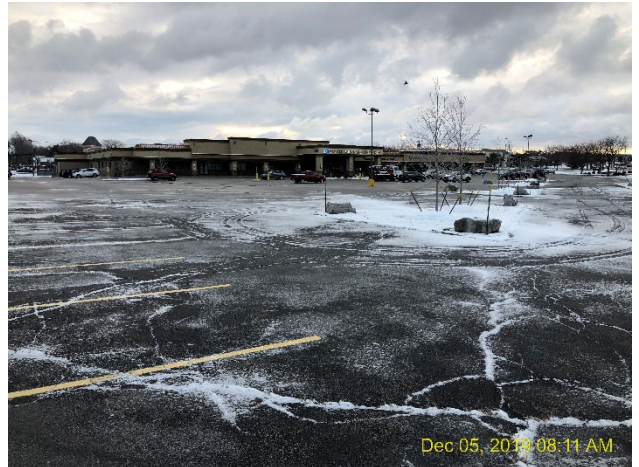
- Photo 13. Asphalt and hardscape final cover along northern portion of Site (looking W).
- Photo 14. Asphalt final cover at Michael Road entrance (looking W).
- Photo 15. Asphalt and hardscape final cover along northern portion of on-site building (looking S).
- Photo 16. Asphalt and hardscape final cover along front portion of Site, grass-covered island at right (looking E).

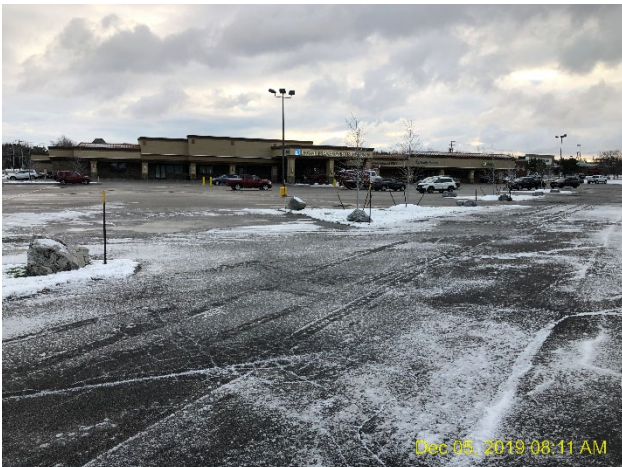
**Photo 17:**

Photo 17. Grass-covered island, typical of five (looking E).

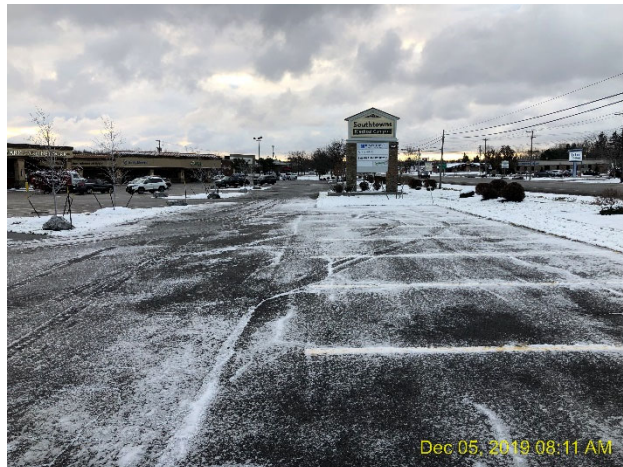
**Photo 18:**

Photo 18. Asphalt and hardscape final cover along Orchard Park Road (looking SE).

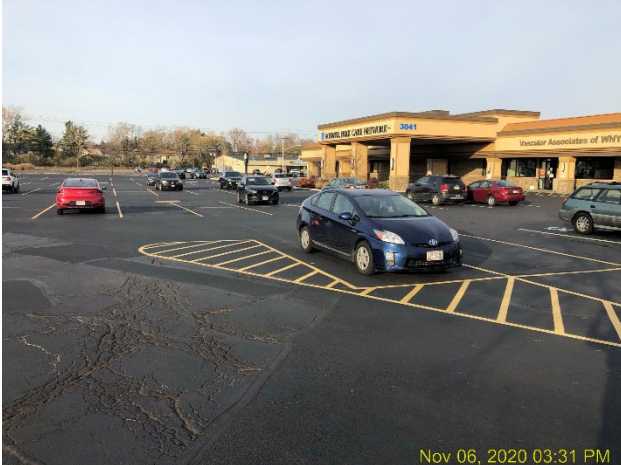
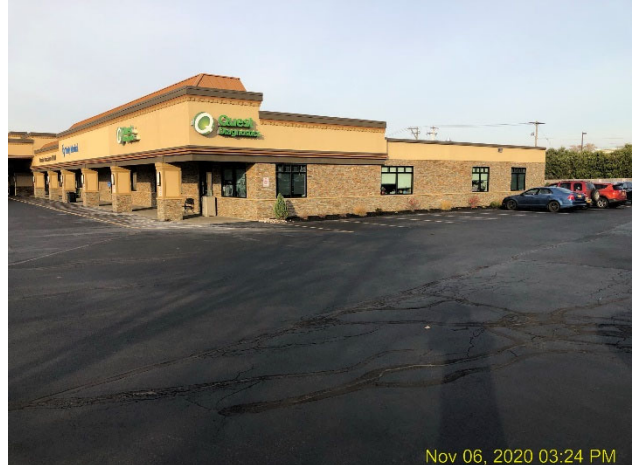
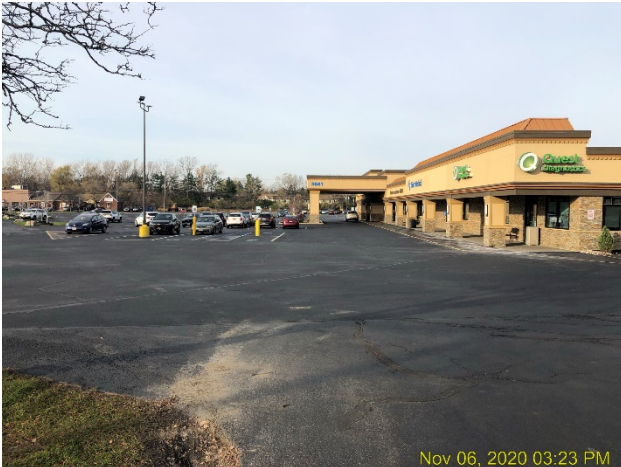
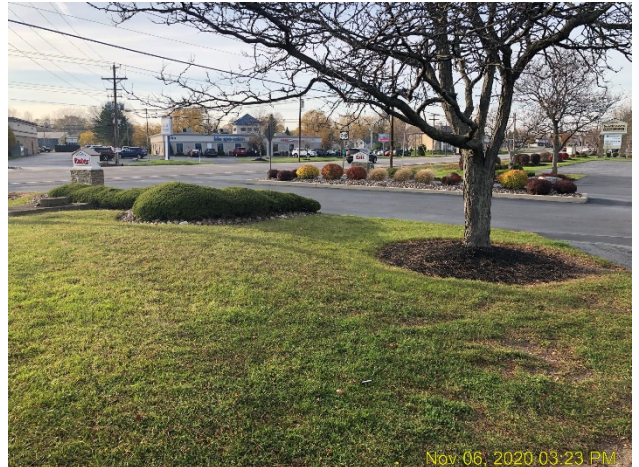
- Photo 1. Asphalt and hardscape final cover along front of Site (looking NE).
- Photo 2. Asphalt and hardscape final cover along south side of Site (looking NE).
- Photo 3. Asphalt and hardscape final cover along front of Site (looking N).
- Photo 4. Asphalt final cover entrance along Orchard Park Road (looking NW).

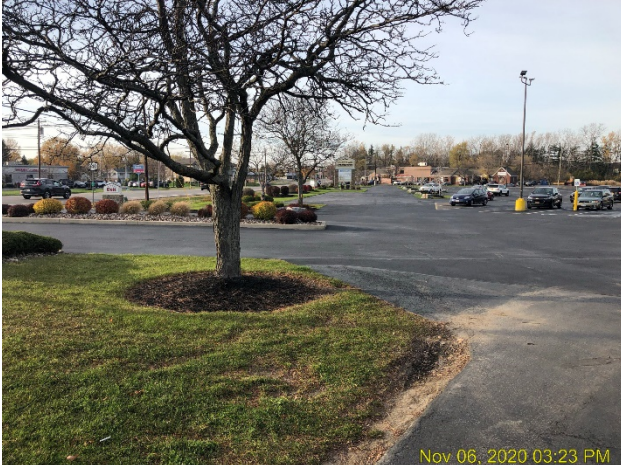
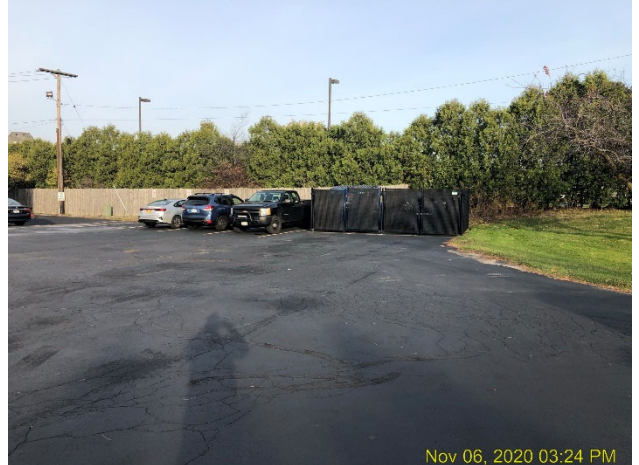
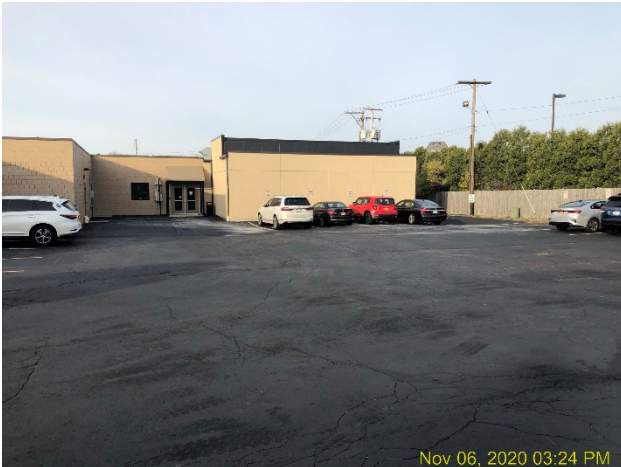
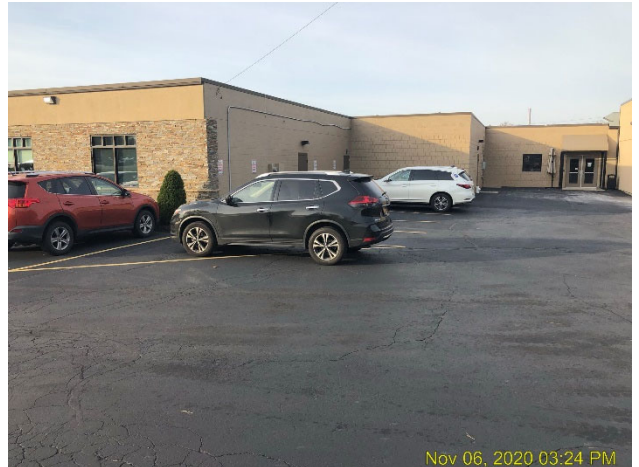
- Photo 5. Asphalt final cover along front of Site, Orchard Park Road at left (looking NW).
- Photo 6. Asphalt and hardscape final cover in SE corner of Site (looking E).
- Photo 7. Asphalt and hardscape final cover along southern portion of Site (looking N).
- Photo 8. Asphalt and hardscape final cover at decommissioned well MW-6 area (at right) (looking N).

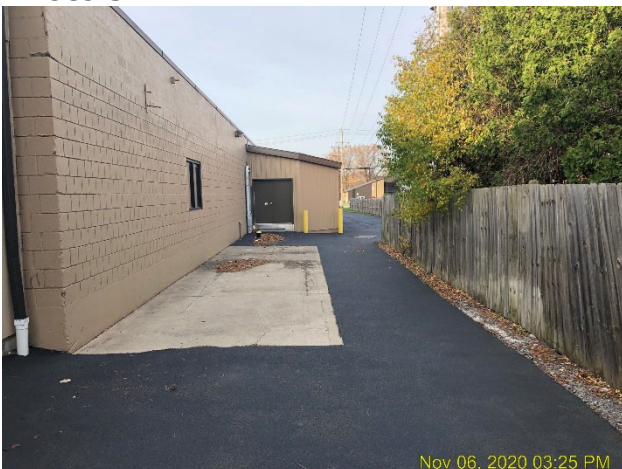
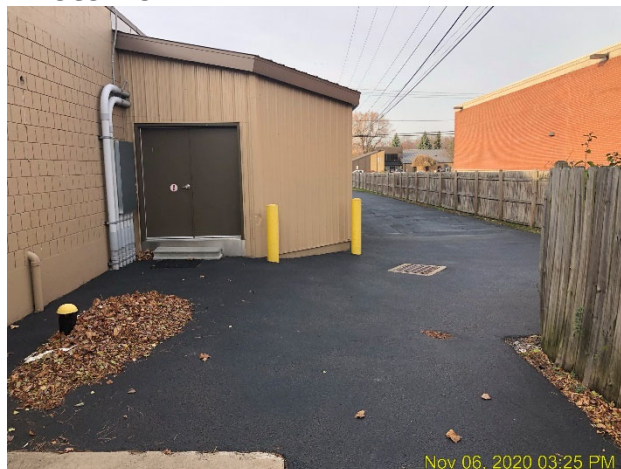
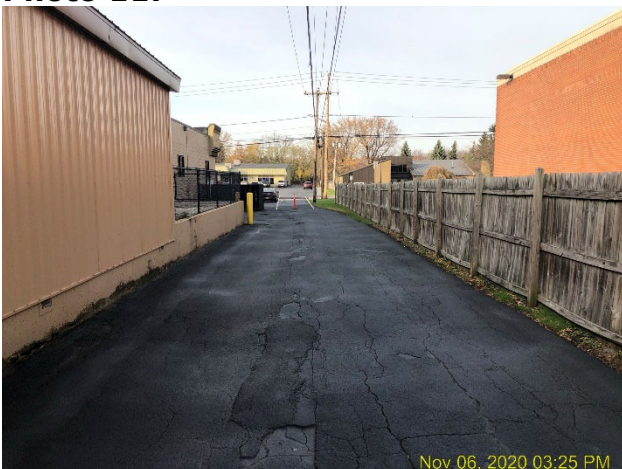
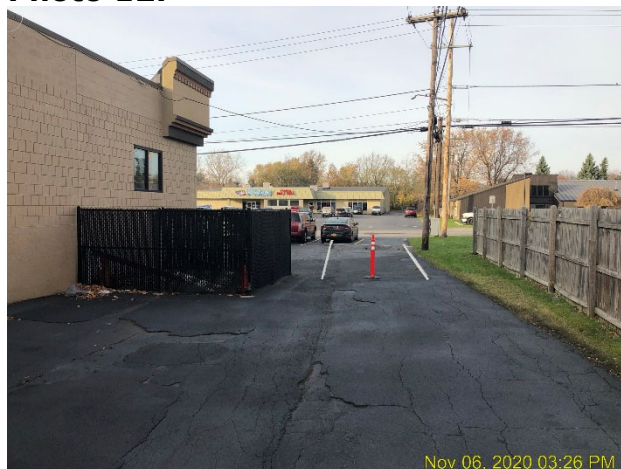
- Photo 9. Asphalt and hardscape final cover along eastern portion of Site (looking N).
- Photo 10. Asphalt and hardscape final cover along eastern portion of Site (looking N).
- Photo 11. Asphalt and hardscape final cover along eastern portion of Site (looking N).
- Photo 12. Asphalt and hardscape final cover in northeastern corner of Site (looking N).

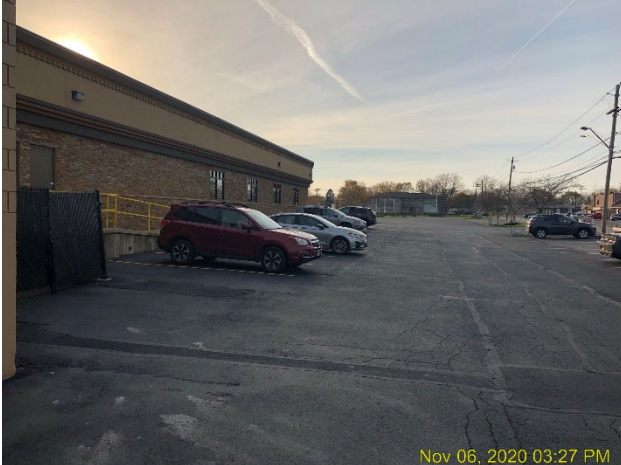
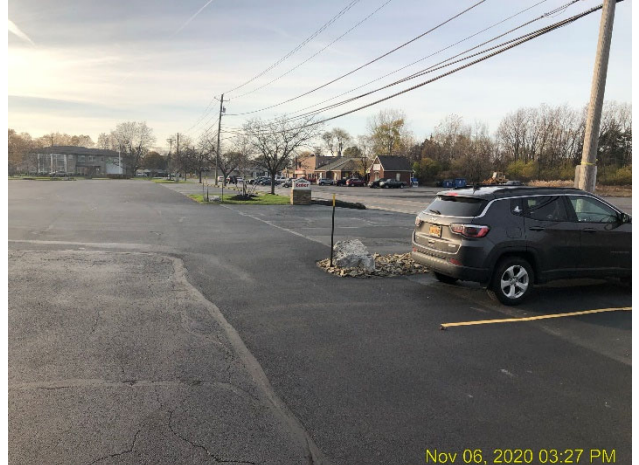
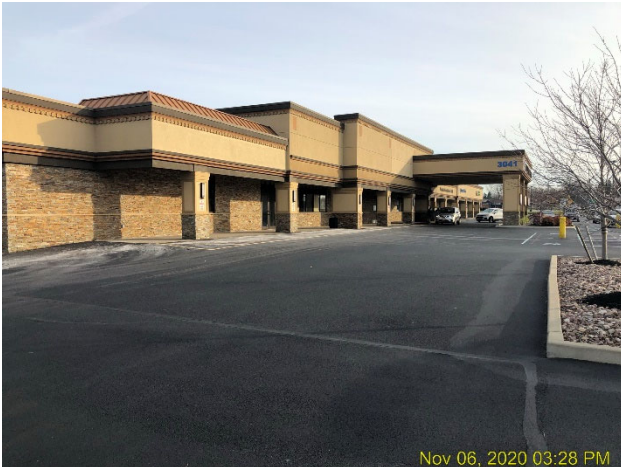
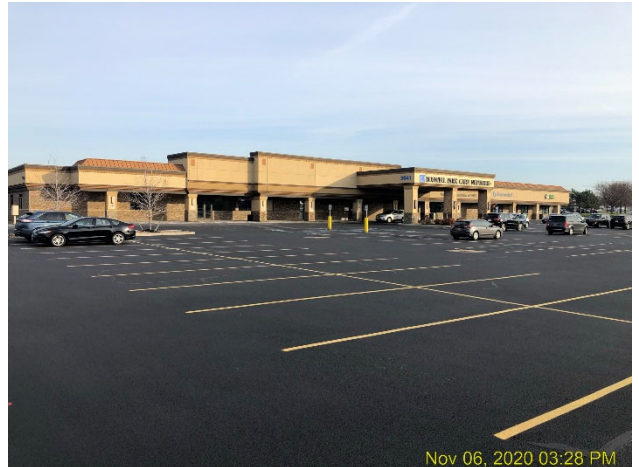
- Photo 13. Asphalt and hardscape final cover along northern portion of Site (looking W).
- Photo 14. Asphalt final cover at Michael Road entrance (looking W).
- Photo 15. Asphalt and hardscape final cover along northern portion of on-site building (looking S).
- Photo 16. Asphalt and hardscape final cover along front portion of Site (looking SE).

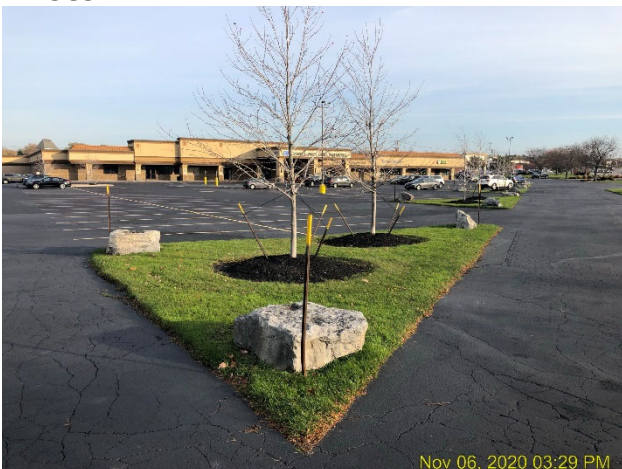
**Photo 17:**

Photo 17. Grass-covered island, typical of five (looking E).

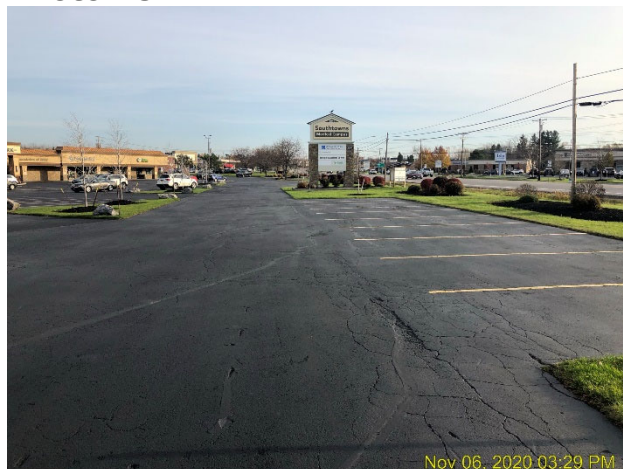
**Photo 18:**

Photo 18. Asphalt and hardscape final cover along Orchard Park Road (looking SE).

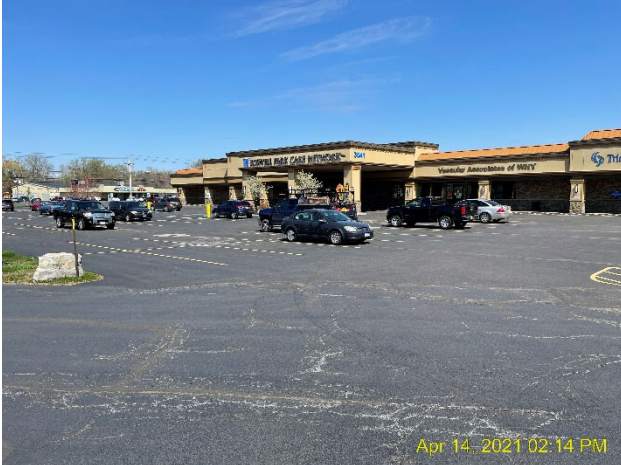
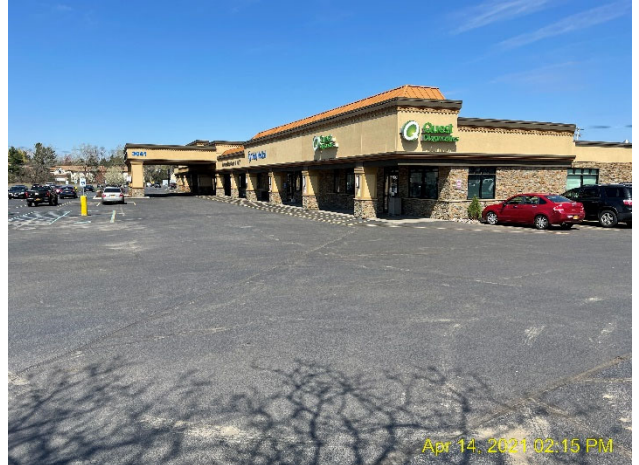
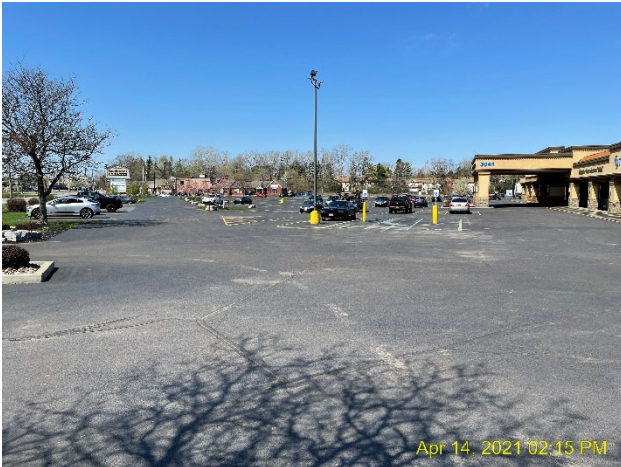
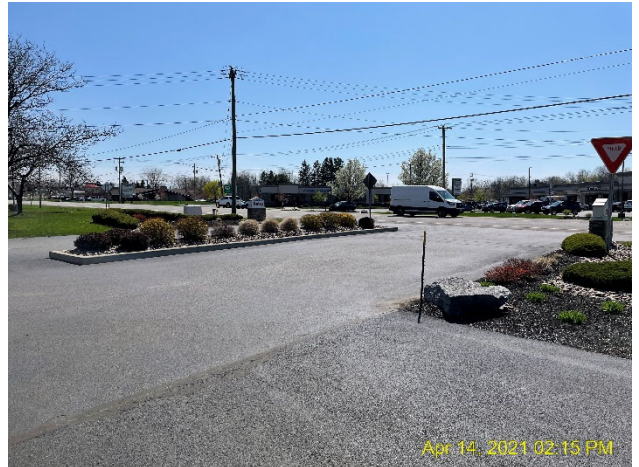
- Photo 1. Asphalt and hardscape final cover along front of Site (looking NE).
- Photo 2. Asphalt and hardscape final cover along south side of Site (looking NE).
- Photo 3. Asphalt and hardscape final cover along front of Site; Orchard Park entrance at left (looking N).
- Photo 4. Asphalt final cover entrance along Orchard Park Road (looking SW).

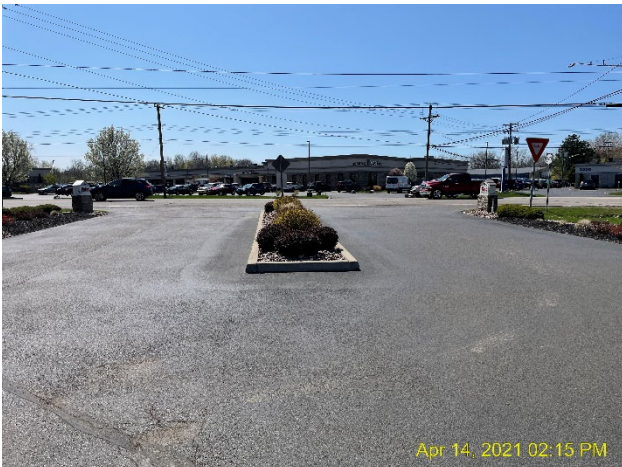
**Photo 5:**

Photo 5. Asphalt final cover at Orchard Park Road (looking W).

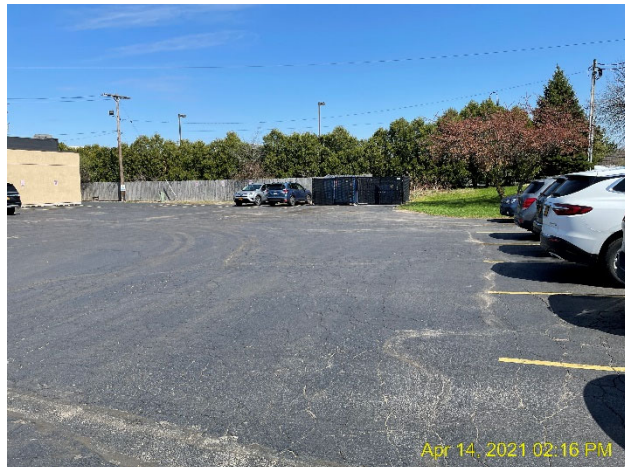
**Photo 6:**

Photo 6. Asphalt and hardscape final cover in SE corner of Site (looking E).

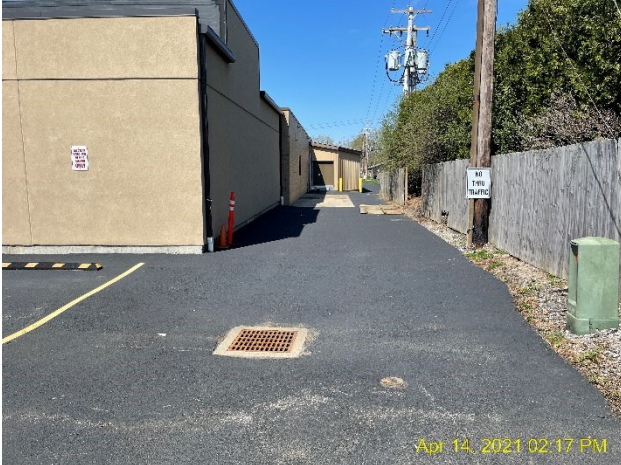
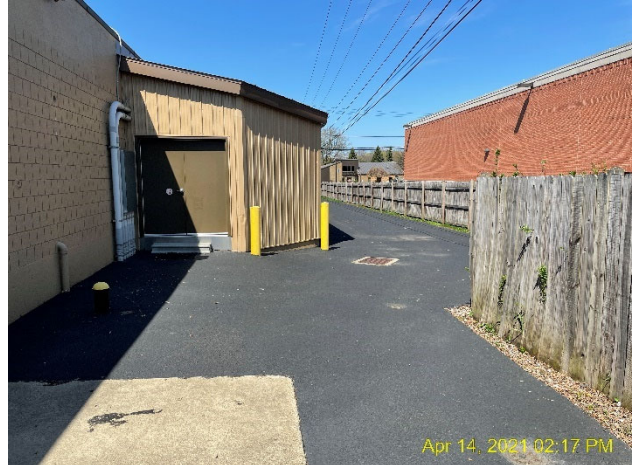
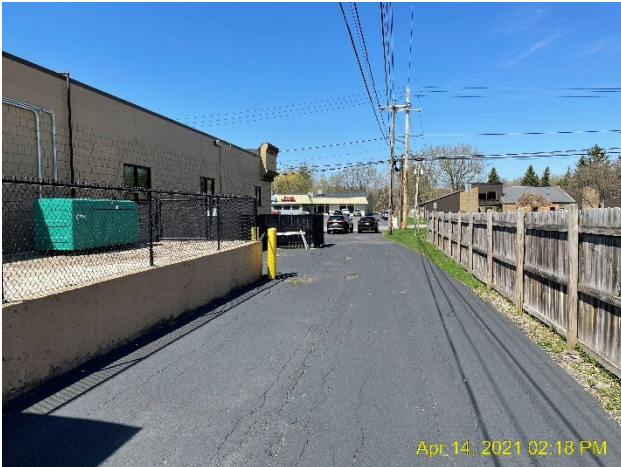
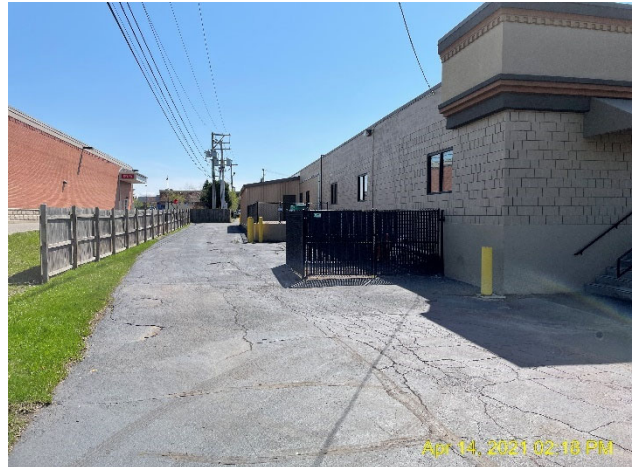
- Photo 9. Asphalt and hardscape final cover along eastern portion of Site (looking N).
- Photo 10. Asphalt and hardscape final cover along eastern portion of Site (looking N).
- Photo 11. Asphalt and hardscape final cover along eastern portion of Site (looking N).
- Photo 12. Asphalt and hardscape final cover in northeastern corner of Site (looking S).

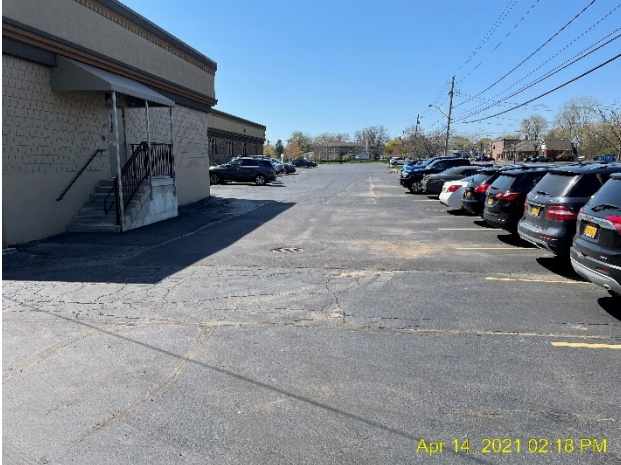
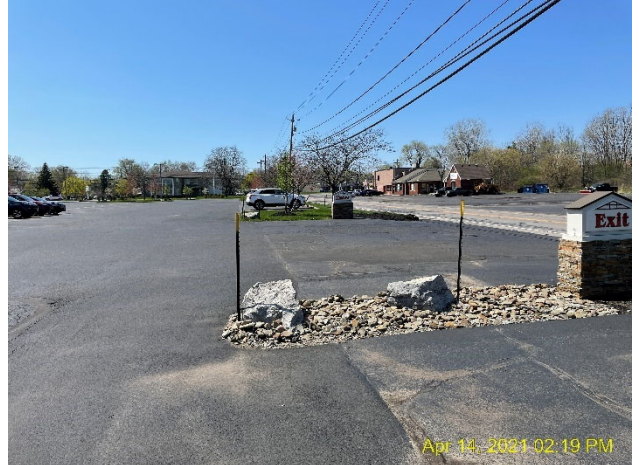
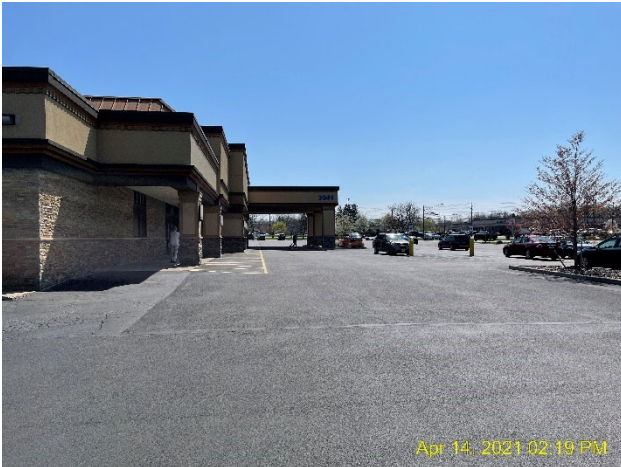
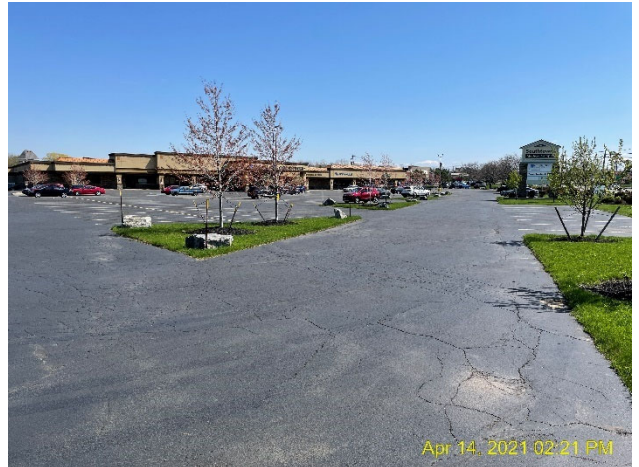
- Photo 13. Asphalt and hardscape final cover along northern portion of Site (looking W).
- Photo 14. Asphalt final cover at Michael Road entrance (looking W).
- Photo 15. Asphalt and hardscape final cover along northern portion of on-site building (looking S).
- Photo 16. Asphalt and hardscape final cover along front portion of Site, grass-covered islands, typical of five, at center (looking E).

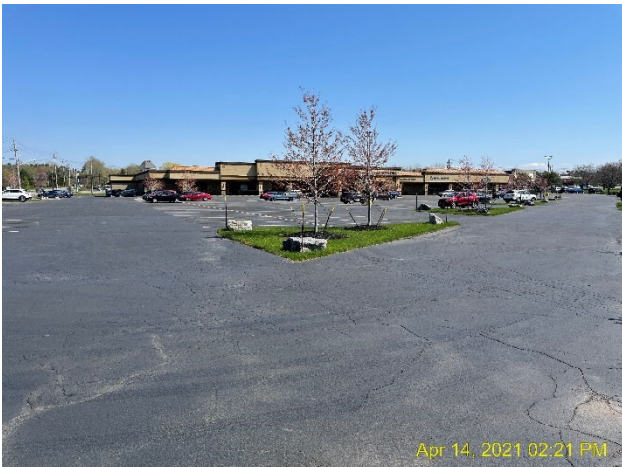
**Photo 17:**

Photo 17. Grass-covered island, typical of five (looking E).

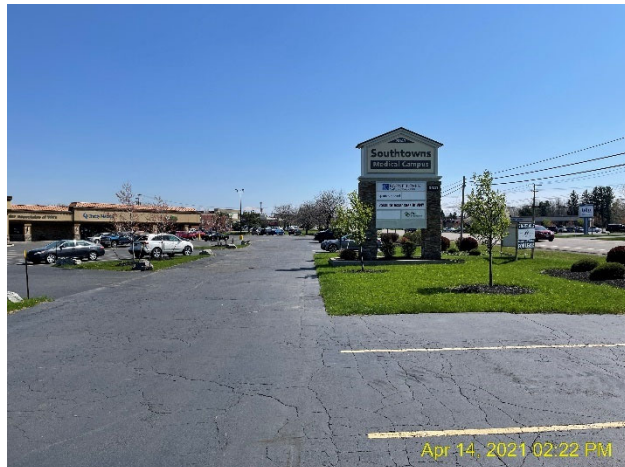
**Photo 18:**

Photo 18. Asphalt and hardscape final cover along Orchard Park Road (looking SE).
