Date: June 4, 2025 (Revised February 14, 2025, December 18, 2024)  
To: Eugene Melnyk, PE – NYSDEC DER Region 9  
From: Eric Warren, Roux Environmental Engineering and Geology, D.P.C.  
Subject: **Onsite Fill/Municipal Solid Waste Screening Work Plan for 267 Marilla Street, Buffalo, NY. NYSBCP Site No. C915290**

On behalf of American Iron & Metal Recycling Erie (AIM), Roux Environmental Engineering and Geology, D.P.C. (Roux) has prepared this Onsite Fill/Municipal Solid Waste (MSW) Screening Work Plan (MSWSWP) for 267 Marilla Street, Buffalo, NY (Site) as requested by the New York State Department of Environmental Conservation (NYSDEC).

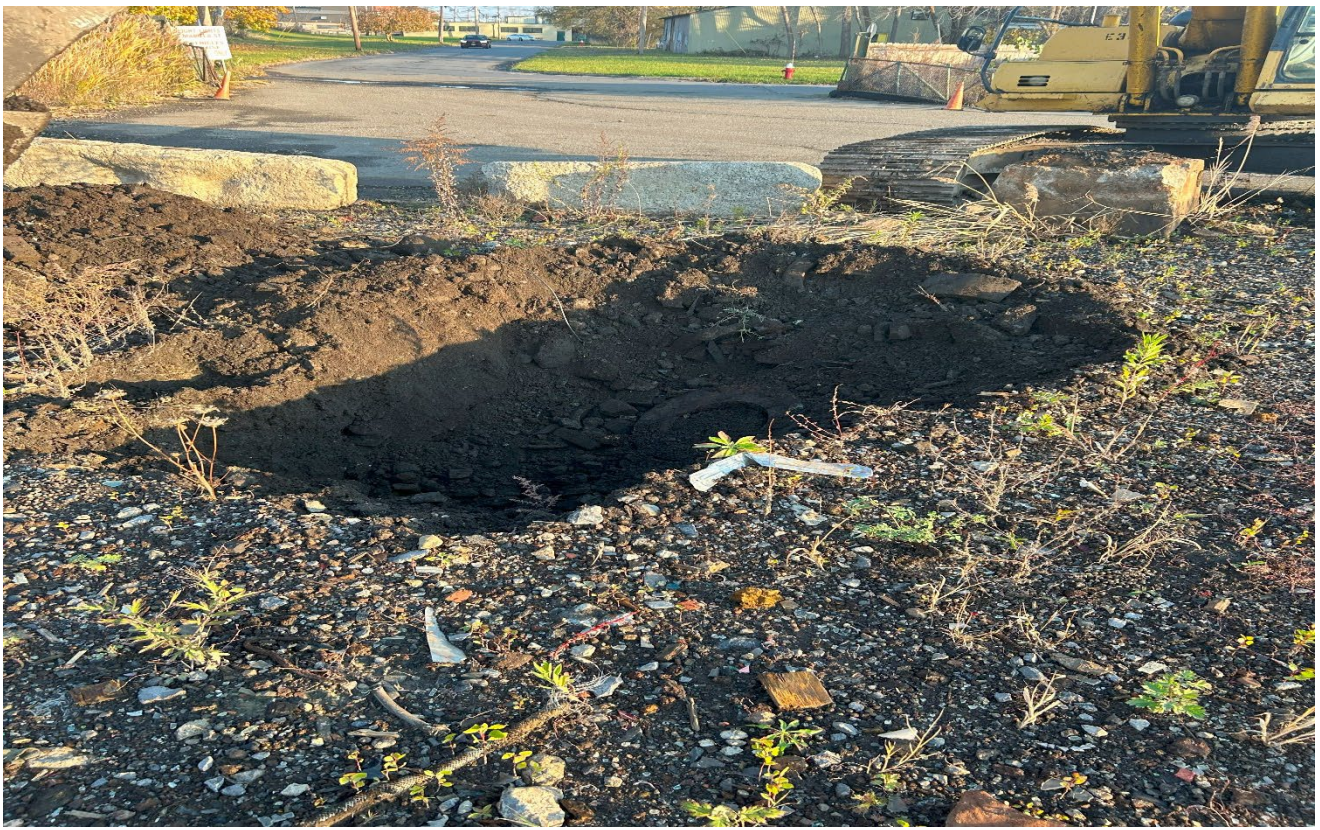
**Photograph 1: TP-1**

| Date | Project | Surface Elev. | Total Depth | | | |
|---|---|---|---|---|---|---|
| TP-1 (0-.5) | 0 - 0.5 | 100% | 0.4 | | Urban Fill: Brown Fine to coarse sand and gravel with varying amounts of glass, brick, cinders, metal, plastic, rubber etc. Dry to moist | Lab sample. |
| TP-1 (.5-2) | 0.5-2 | 100% | 0.4 | | Urban Fill: Fine to coarse sand and gravel with varying amounts of glass, brick, cinders, metal, plastic, rubber etc. Moist | |
| TP-1 (2-4) | 2-4 | 100% | 0.4 | | Urban Fill: Fine to coarse sand and gravel with varying amounts of glass, brick, cinders, metal, plastic, rubber etc. Moist to wet at 4.75 feet. | |
| TP-1 (4-6) | 4-6 | 100% | 0.7 | | Urban Fill: Fine to coarse sand and gravel with varying amounts of glass, brick, cinders, metal, plastic, rubber etc. Moist. Native found at 5.75 feet. | Lab sample. |

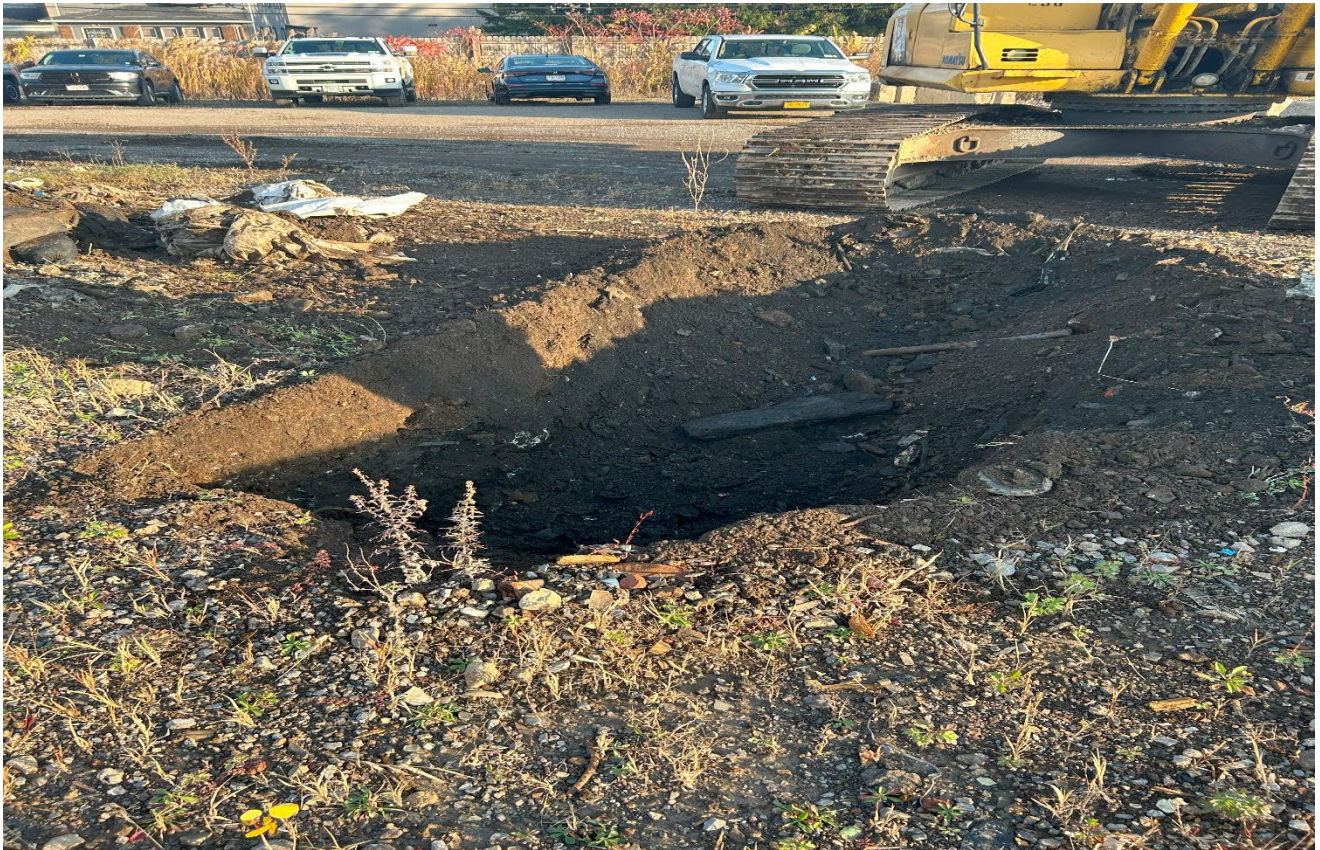
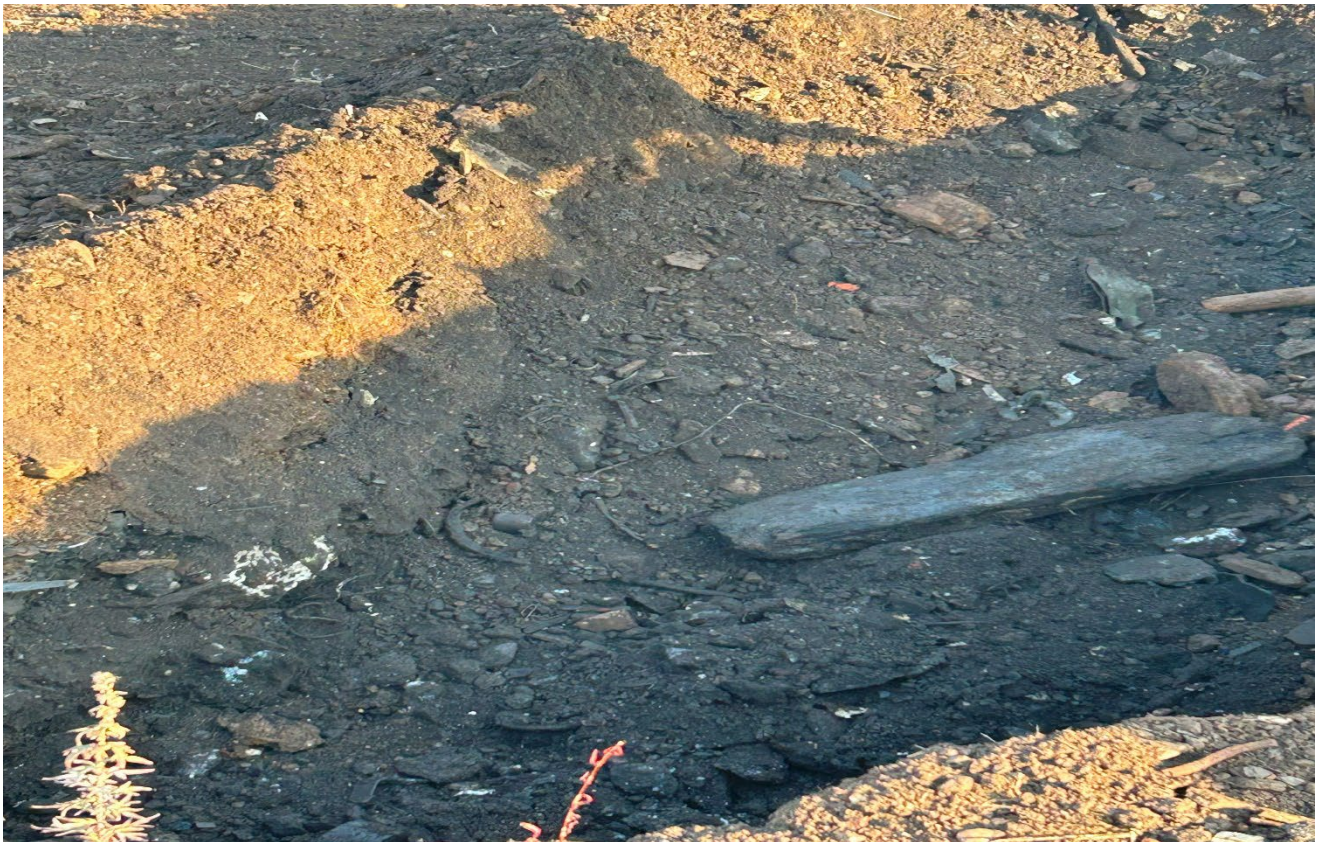
**Photograph 1: TP-2**

| Date | Project | Surface Elev. | Total Depth | | | |
|---|---|---|---|---|---|---|
| TP-2 (0-.5) | 0 - 0.5 | 100% | 0.7 | | Urban Fill: Brown Fine to coarse sand and gravel with varying amounts of glass, brick, cinders, metal, plastic, rubber etc. Dry to moist | Lab sample. |
| TP-2 (.5-2) | 0.5-2 | 100% | 0.7 | | Urban Fill: Fine to coarse sand and gravel with varying amounts of glass, brick, cinders, metal, plastic, rubber etc. Moist | |
| TP-2 (2-4) | 2-4 | 100% | 1.2 | | Urban Fill: Fine to coarse sand and gravel with varying amounts of glass, brick, cinders, metal, plastic, rubber etc. Moist to wet at 4 feet. | |
| TP-2 (6-7.25) | 6-7.25 | 100% | NA | | Urban Fill: Fine to coarse sand and gravel with varying amounts of glass, brick, cinders, metal, plastic, rubber etc. Wet. Native found at 7.25 feet. | |

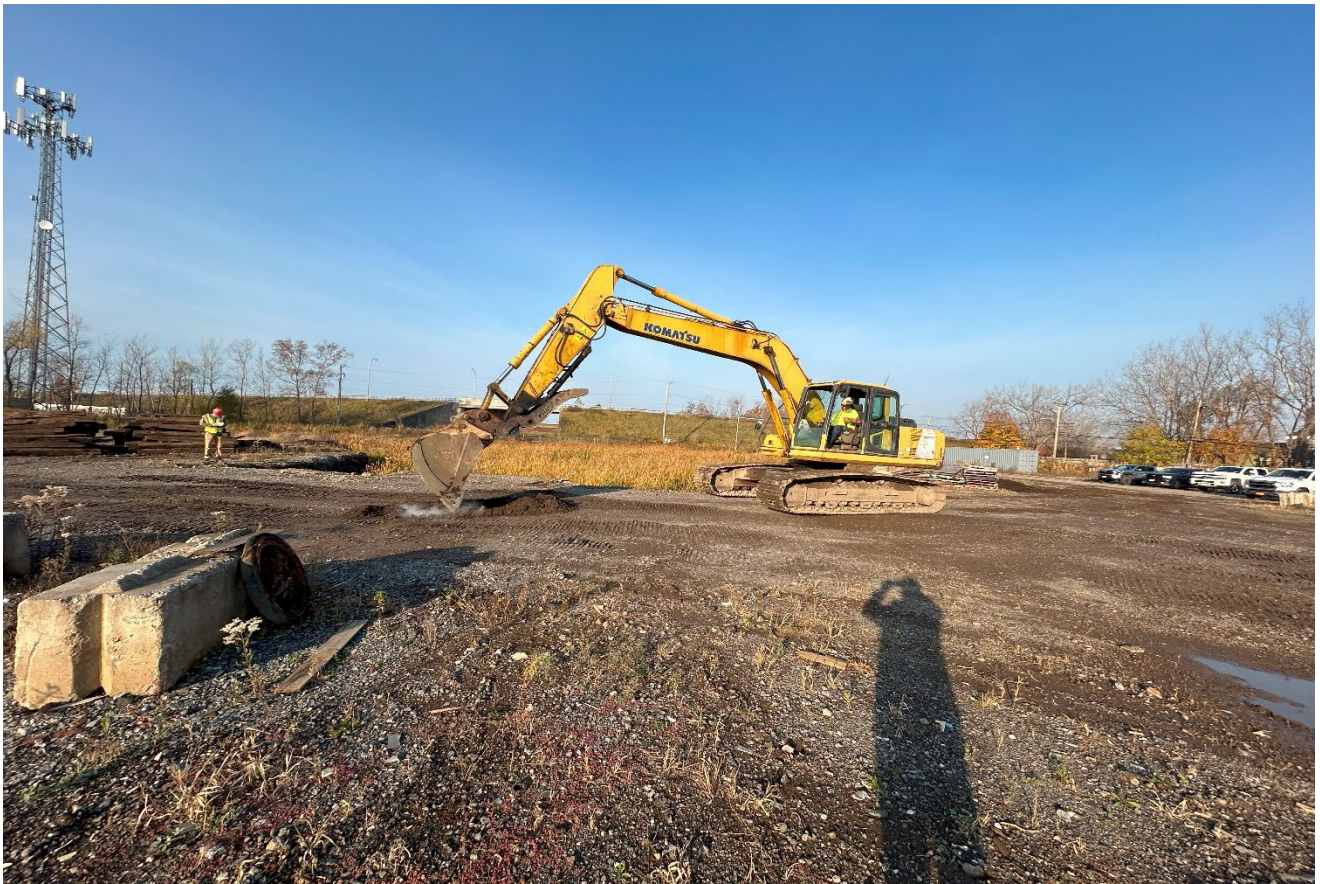
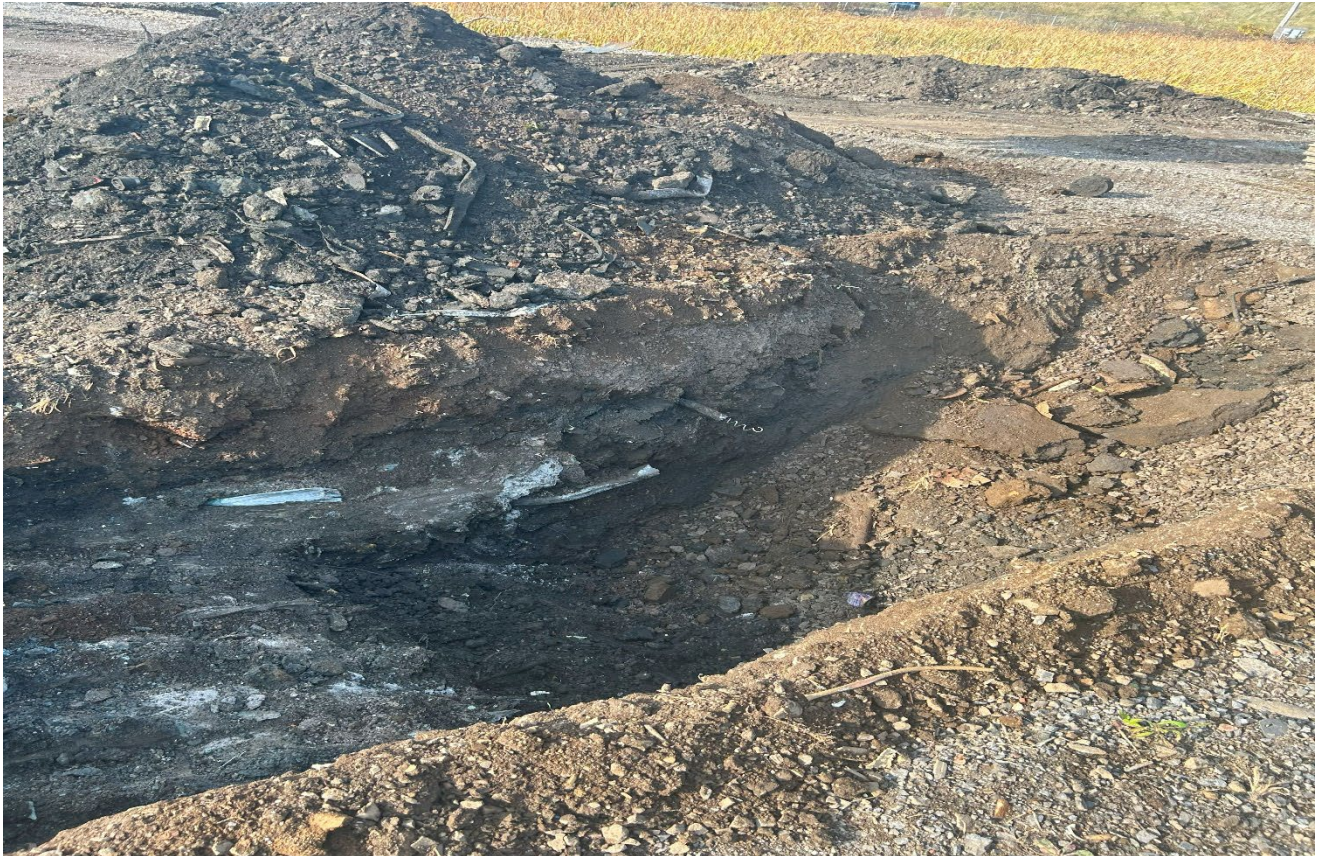
**Photograph 1: TP-4**

| Date | Project | Surface Elev. | Total Depth | | | |
|---|---|---|---|---|---|---|
| TP-4 (0-.5) | 0 - 0.5 | 100% | 0.3 | | Urban Fill: Brown Fine to coarse sand and gravel with varying amounts of glass, brick, cinders, metal, plastic, rubber etc. Dry to moist | Lab sample. Dup, MS and MSD collected also. |
| TP-4 (.5-2) | 0.5-2 | 100% | 0.4 | | Urban Fill: Fine to coarse sand and gravel with varying amounts of glass, brick, cinders, metal, plastic, rubber etc. Moist | |
| TP-4 (2-4) | 2-4 | 100% | 0.3 | | Urban Fill: Fine to coarse sand and gravel with varying amounts of glass, brick, cinders, metal, plastic, rubber etc. Moist. | |
| TP-4 (4-6) | 4-6 | 100% | 1.4 | | Urban Fill: Fine to coarse sand and gravel with varying amounts of glass, brick, cinders, metal, plastic, rubber etc. Moist to wet at 5 feet. | |
| TP-4 (6-7) | 6-7 | 100% | 10.7 | | Urban Fill: Fine to coarse sand and gravel with varying amounts of glass, brick, cinders, metal, plastic, rubber etc. Wet. Native found at 7 feet. | Slight petroleum odor. Lab sample. |

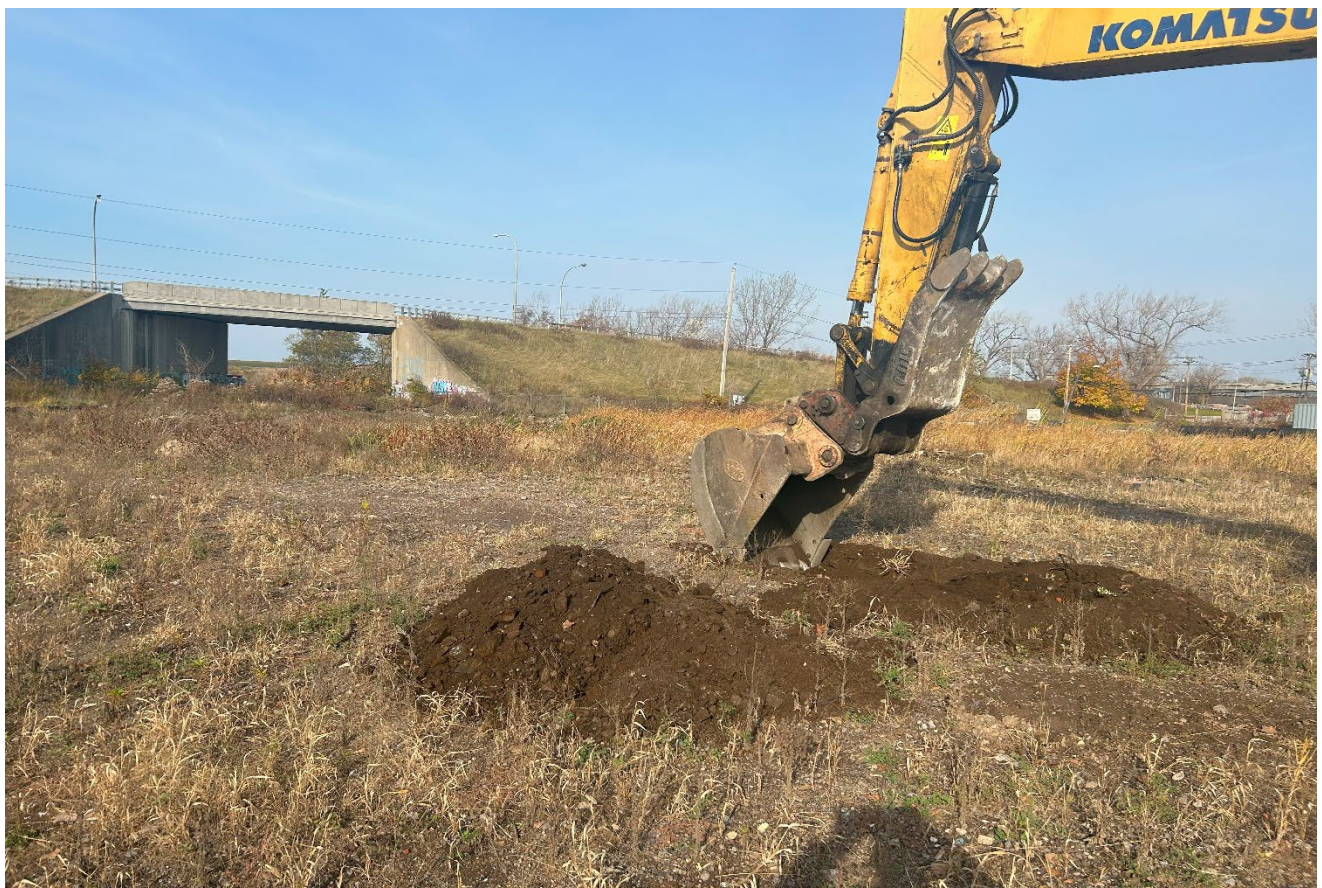
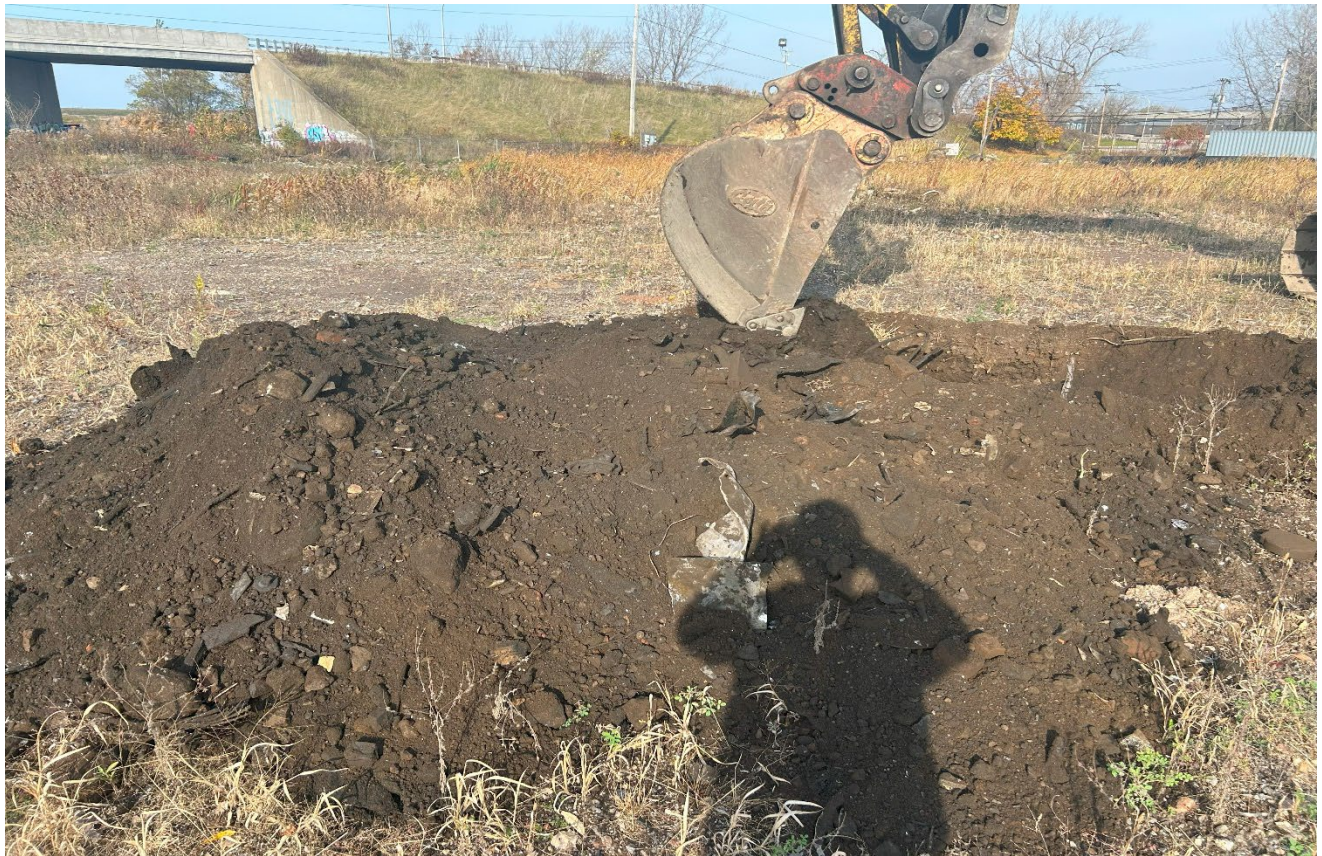
**Photograph 1: TP-5**

| Sample Number | Depth (ft) | % Rec. | PID (ppm) | SAMPLE LITHOLOGY | | COMMENTS |
|---|---|---|---|---|---|---|
| TP-5 (0-.5) | 0 - 0.5 | 100% | 0.6 | | Urban Fill: Brown Fine to coarse sand and gravel with varying amounts of glass, brick, cinders, metal, plastic, rubber etc. Dry to moist | Lab sample. |
| TP-5 (.5-2) | 0.5-2 | 100% | 0.6 | | Urban Fill: Fine to coarse sand and gravel with varying amounts of glass, brick, cinders, metal, plastic, rubber etc. Moist | |
| TP-5 (2-4.5) | 2-4.5 | 100% | 375 | | Urban Fill: Fine to coarse sand and gravel with varying amounts of glass, brick, cinders, metal, plastic, rubber etc. Moist. Native found at 4.5 feet. | Strong petroleum odor. Lab sample. |

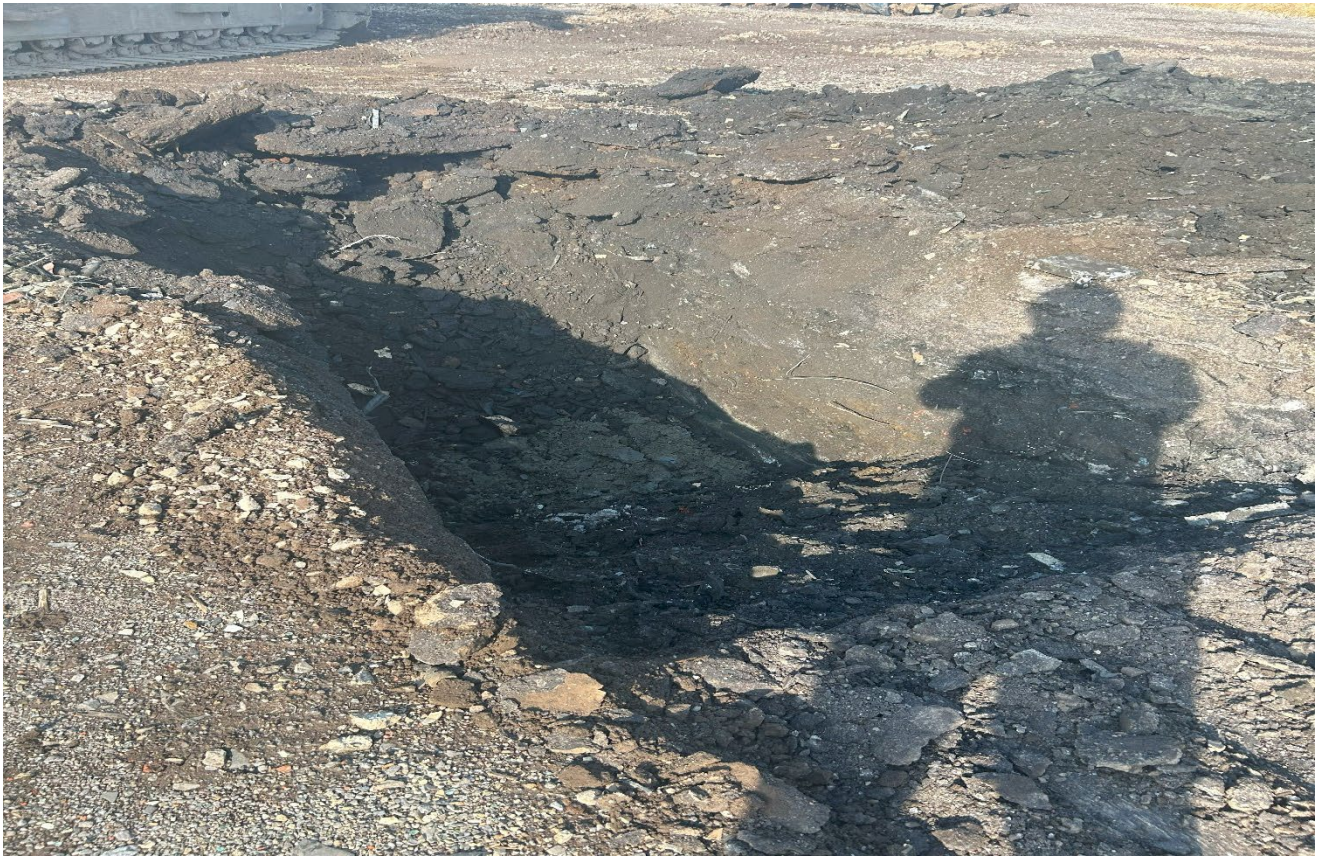
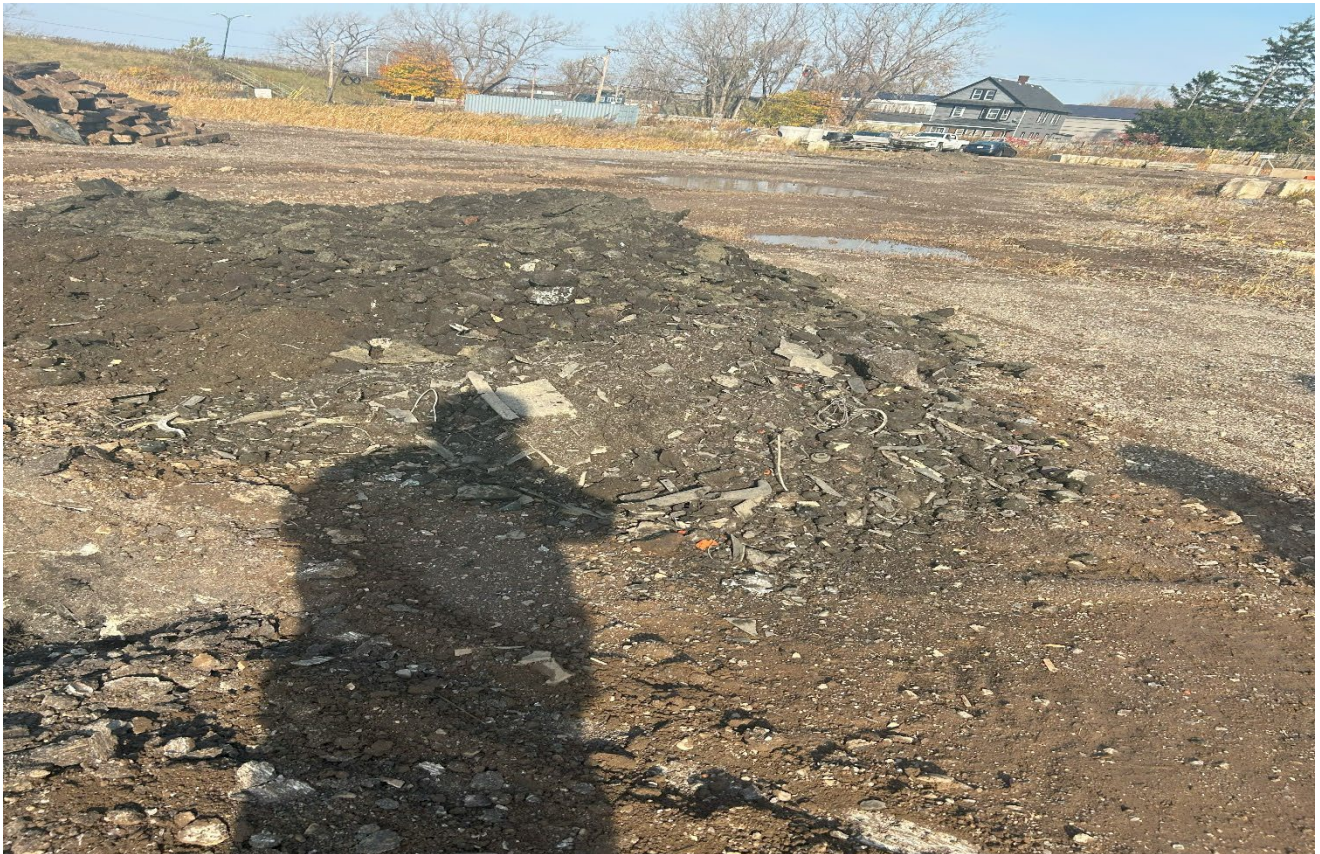
**Photograph 1: TP-6**

| Sample Number | Depth (ft) | % Rec. | PID (ppm) | SAMPLE LITHOLOGY | | COMMENTS |
|---|---|---|---|---|---|---|
| TP-6 (0-.5) | 0 - 0.5 | 100% | 0.6 | | Urban Fill: Brown Fine to coarse sand and gravel with varying amounts of glass, brick, cinders, metal, plastic, rubber etc. Dry to moist | Lab sample. |
| TP-6 (.5-2) | 0.5-2 | 100% | 0.6 | | Urban Fill: Fine to coarse sand and gravel with varying amounts of glass, brick, cinders, metal, plastic, rubber etc. Moist | |
| TP-6 (2-4.5) | 2-4.5 | 100% | 375 | | Urban Fill: Fine to coarse sand and gravel with varying amounts of glass, brick, cinders, metal, plastic, rubber etc. Moist. Native found at 4.5 feet. | Strong petroleum odor. Lab sample. |

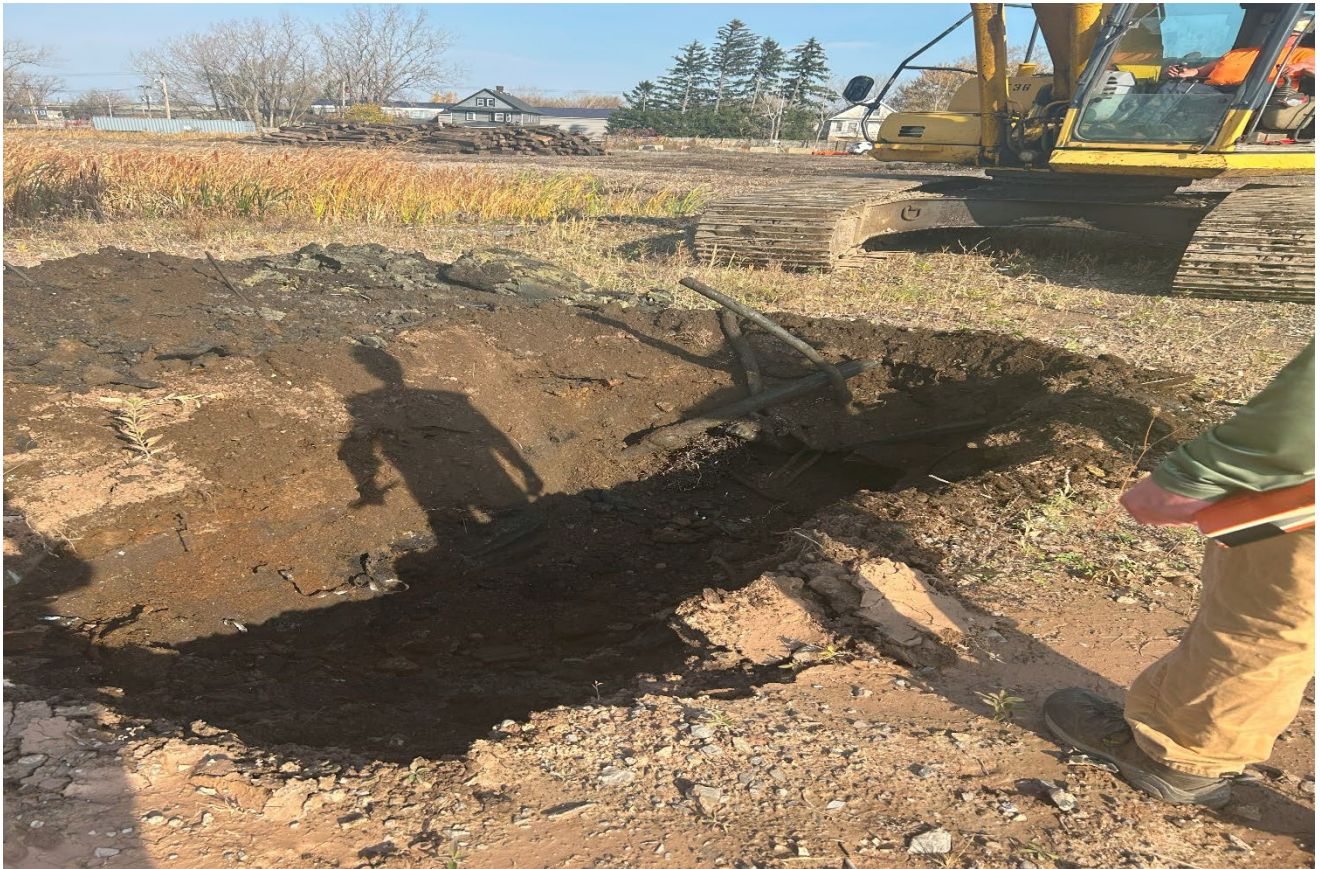
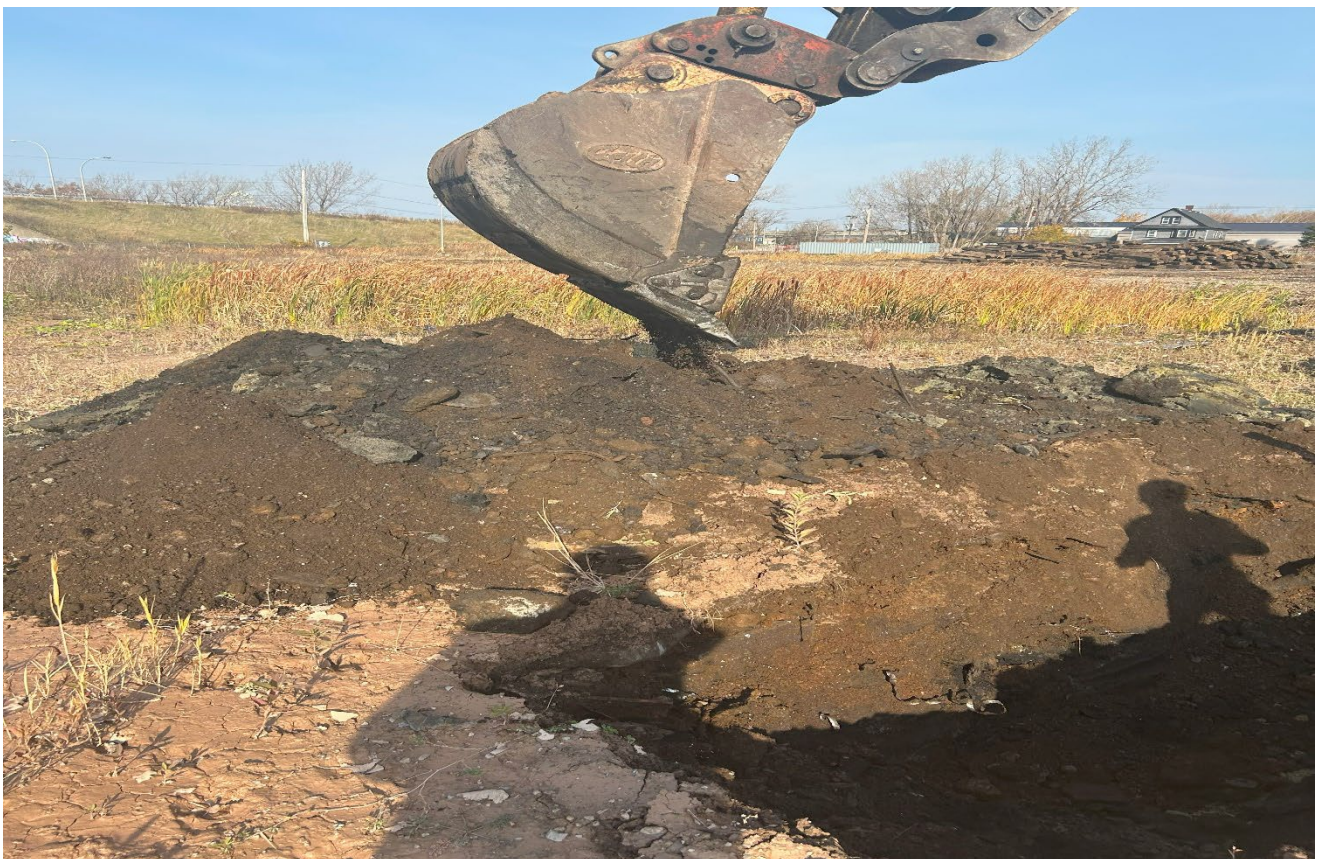
**Photograph 1: TP-7**

| Sample Number | Depth (ft) | % Rec. | PID (ppm) | SAMPLE LITHOLOGY | COMMENTS |
|---|---|---|---|---|---|
| TP-7 (0-.5) | 0 - 0.5 | 100% | 0.6 | Urban Fill: Brown Fine to coarse sand and gravel with varying amounts of glass, brick, cinders, metal, plastic, rubber etc. Dry to moist | Lab sample. |
| TP-7 (.5-2) | 0.5-2 | 100% | 0.6 | Urban Fill: Fine to coarse sand and gravel with varying amounts of glass, brick, cinders, metal, plastic, rubber etc. Moist | |
| TP-7 (2-4.5) | 2-4.5 | 100% | 2.5 | Urban Fill: Fine to coarse sand and gravel with varying amounts of glass, brick, cinders, metal, plastic, rubber etc. Moist. Native found at 4.5 feet. | Lab sample. |

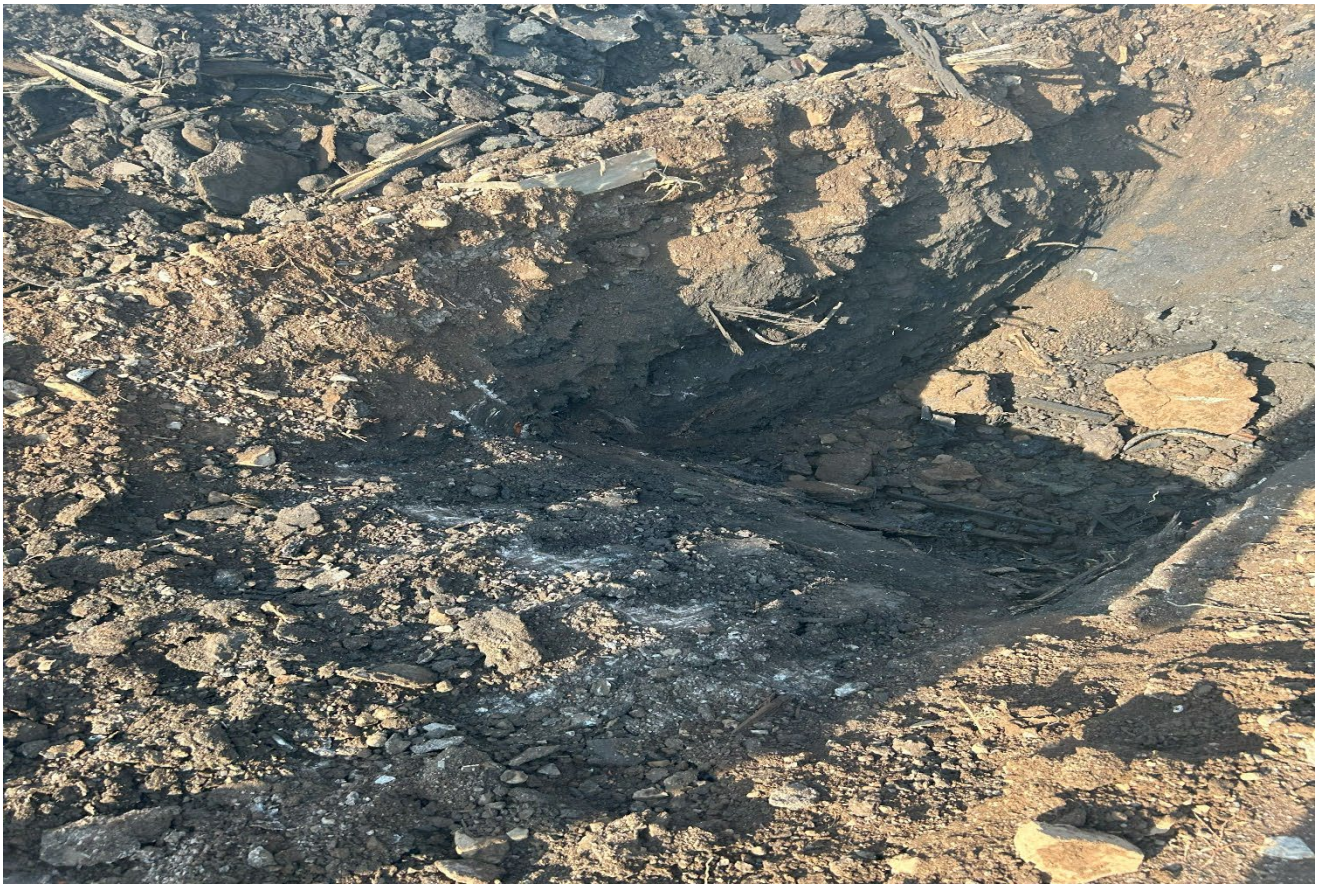
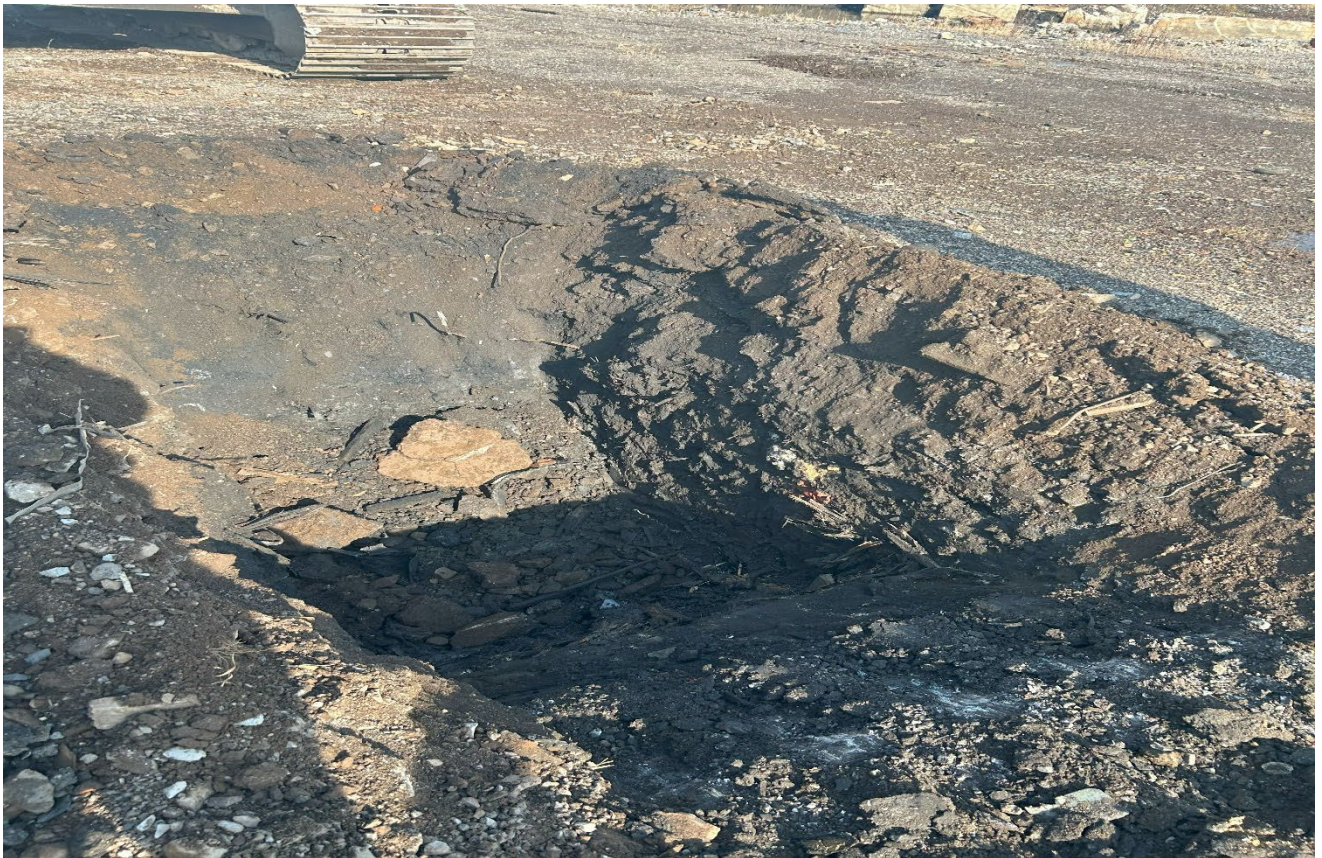
**Photograph 1: TP-8**

| Date | Project | Surface Elev. | Total Depth | | | |
|---|---|---|---|---|---|---|
| TP-8 (0-.5) | 0 - 0.5 | 5-10% | 0.3 | | Urban Fill: Brown Fine to coarse sand and gravel with varying amounts of glass, brick, cinders, metal, plastic, rubber etc. Some slag/rail ballast. Dry to moist | Lab sample. |
| TP-8 (.5-2) | 0.5-2 | 5-10% | 0.9 | | Urban Fill: Fine to coarse sand and gravel with varying amounts of glass, brick, cinders, metal, plastic, rubber etc. Moist. | |
| TP-8 (2-4) | 2-4 | 5-10% | 7.1 | | Urban Fill: Fine to coarse sand and gravel with varying amounts of glass, brick, cinders, metal, plastic, rubber etc. Moist to wet at 4 feet. | Lab sample. Dup, MS and MSD. |
| | | | | | Native found at 4 feet. | |

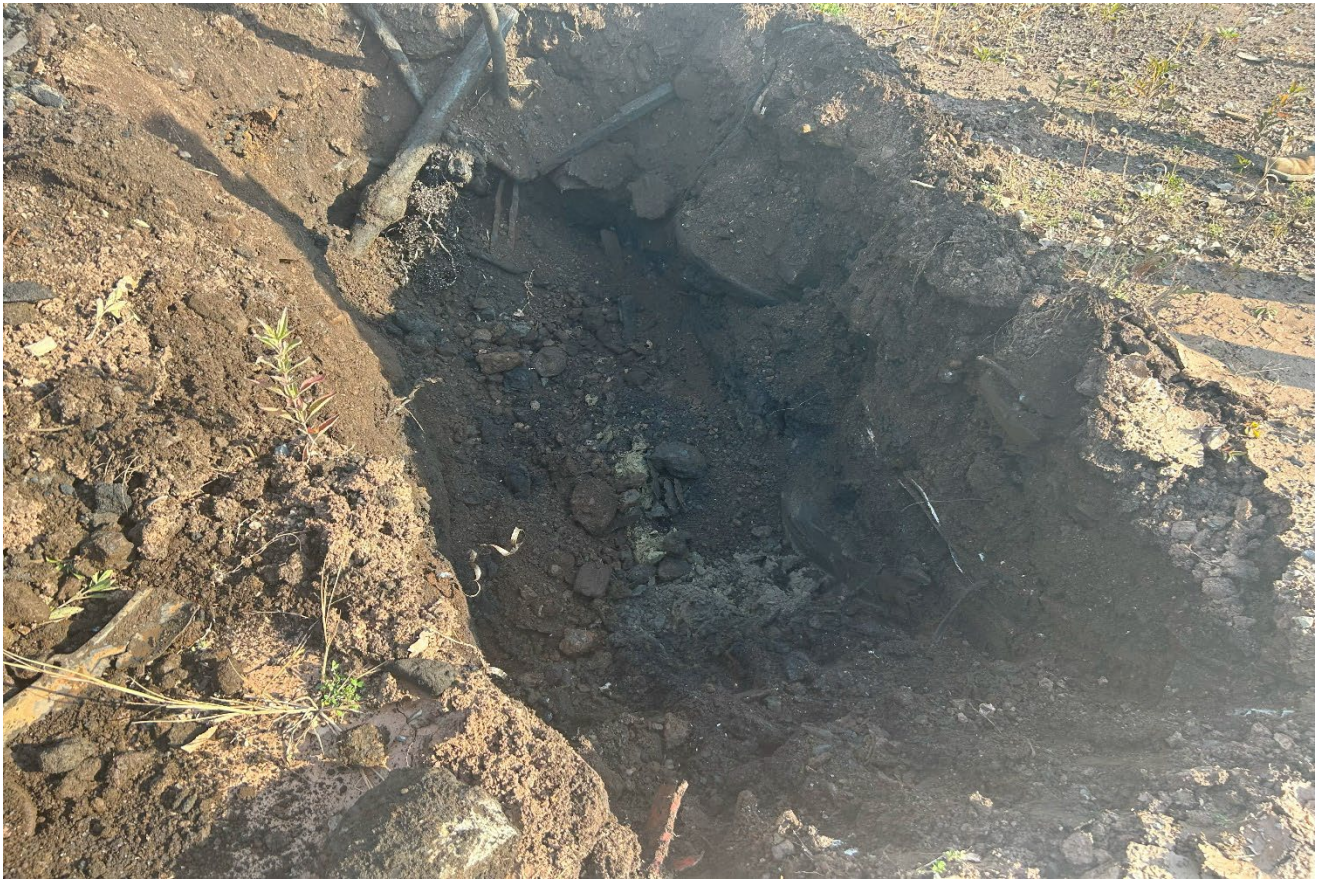
**Photograph 1: TP-9**

| Date | Project | Surface Elev. | Total Depth | | | |
|---|---|---|---|---|---|---|
| TP-9 (0-.5) | 0 - 0.5 | 5% | 0.1 | | Urban Fill: Brown Fine to coarse sand and gravel with varying amounts of glass, brick, cinders, metal, plastic, rubber etc. Dry to moist | Lab sample. |
| TP-9 (.5-2) | 0.5-2 | 5% | 0.1 | | Urban Fill: Fine to coarse sand and gravel with varying amounts of glass, brick, cinders, metal, plastic, rubber etc. Moist. | |
| TP-9 (2-4) | 2-34 | 5% | 0.1 | | Urban Fill: Fine to coarse sand and gravel with varying amounts of glass, brick, cinders, metal, plastic, rubber etc. Moist. Native found at 4 feet. | Lab sample. |

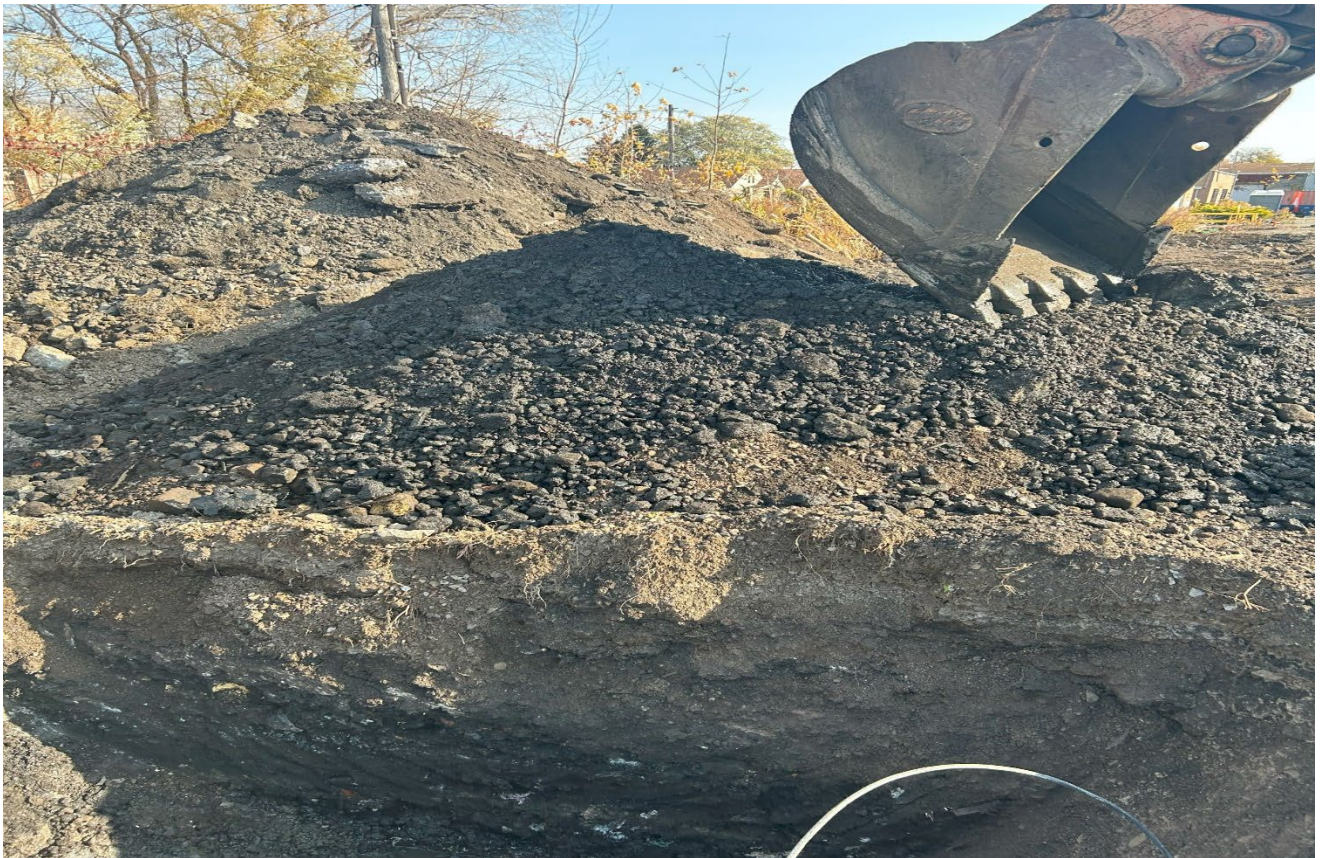
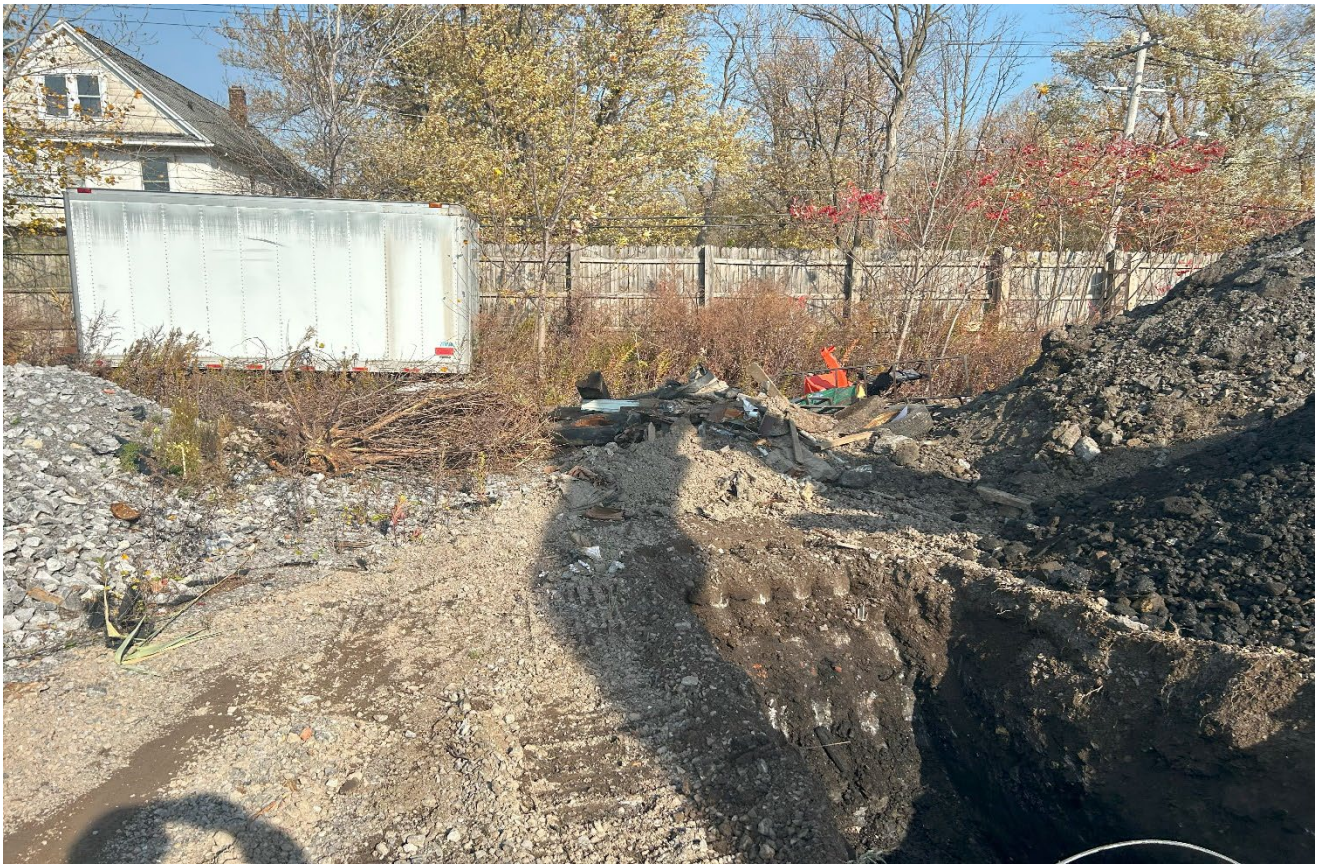
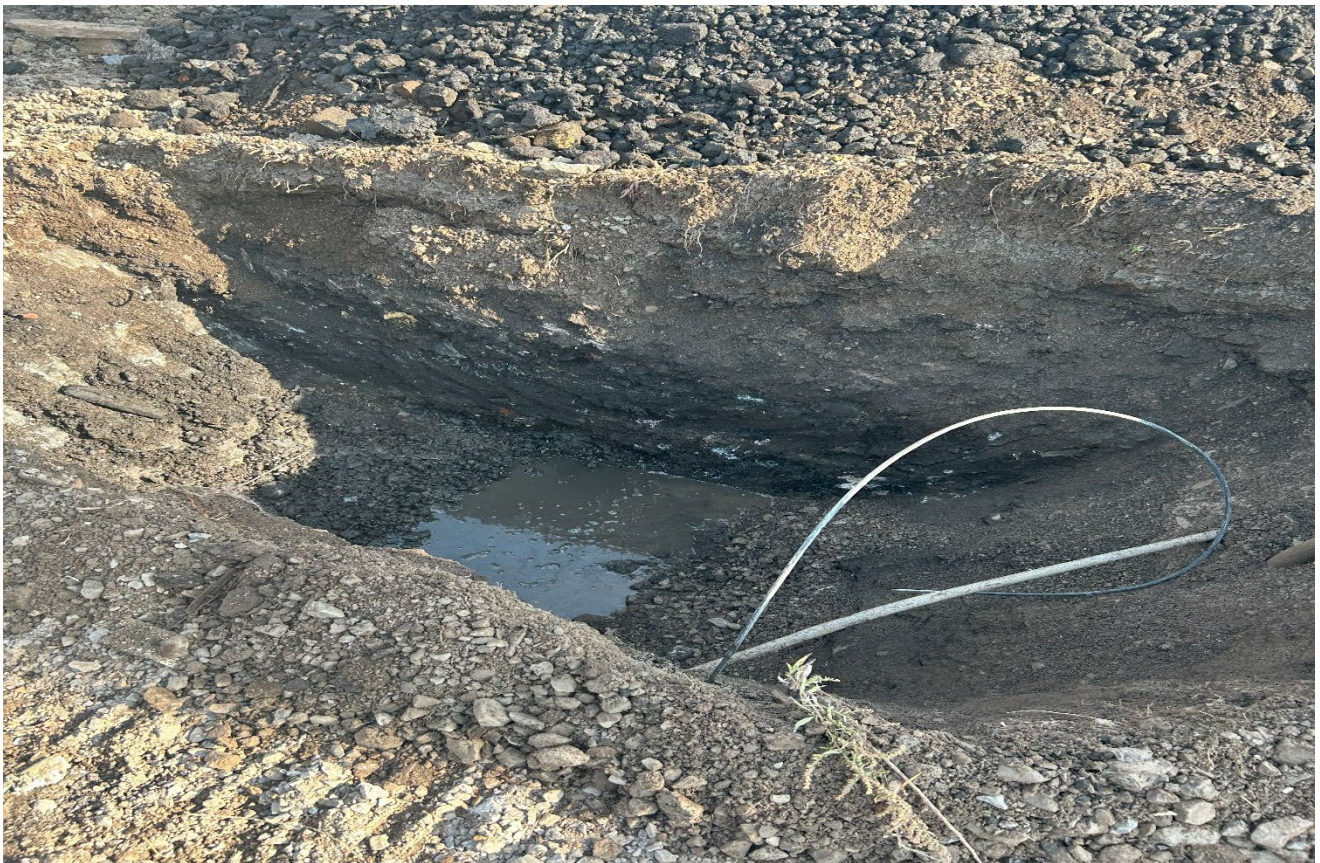
**Photograph 1: TP-10**

| Date | Project | Surface Elev. | Total Depth | | | |
|---|---|---|---|---|---|---|
| TP-10 (0-5) | 0 - 0.5 | 5-10% | 2.3 | | Urban Fill: Brown Fine to coarse sand and gravel with varying amounts of glass, brick, cinders, metal, plastic, rubber etc. Dry to moist | Lab sample. |
| TP-10 (.5-2) | 0.5-2 | 5-10% | 2.3 | | Urban Fill: Fine to coarse sand and gravel with varying amounts of glass, brick, cinders, metal, plastic, rubber etc. Moist. | |
| TP-10 (2-4) | 2-4 | 5-10% | 1.1 | | Urban Fill: Fine to coarse sand and gravel with varying amounts of glass, brick, cinders, metal, plastic, rubber etc. Moist to wet at 4 feet. | Lab sample. |
| TP-10 (4-5.5) | 4-5.5 | 5-10% | 1.1 | | Urban Fill: Fine to coarse sand and gravel with varying amounts of glass, brick, cinders, metal, plastic, rubber etc. Wet. Native found at 5.5 feet. | |
