Date: June 4, 2025 (Revised February 14, 2025, December 18, 2024)  
To: Eugene Melnyk, PE – NYSDEC DER Region 9  
From: Eric Warren, Roux Environmental Engineering and Geology, D.P.C.  
Subject: **Onsite Fill/Municipal Solid Waste Screening Work Plan for 267 Marilla Street, Buffalo, NY. NYSBCP Site No. C915290**

On behalf of American Iron & Metal Recycling Erie (AIM), Roux Environmental Engineering and Geology, D.P.C. (Roux) has prepared this Onsite Fill/Municipal Solid Waste (MSW) Screening Work Plan (MSWSWP) for 267 Marilla Street, Buffalo, NY (Site) as requested by the New York State Department of Environmental Conservation (NYSDEC).

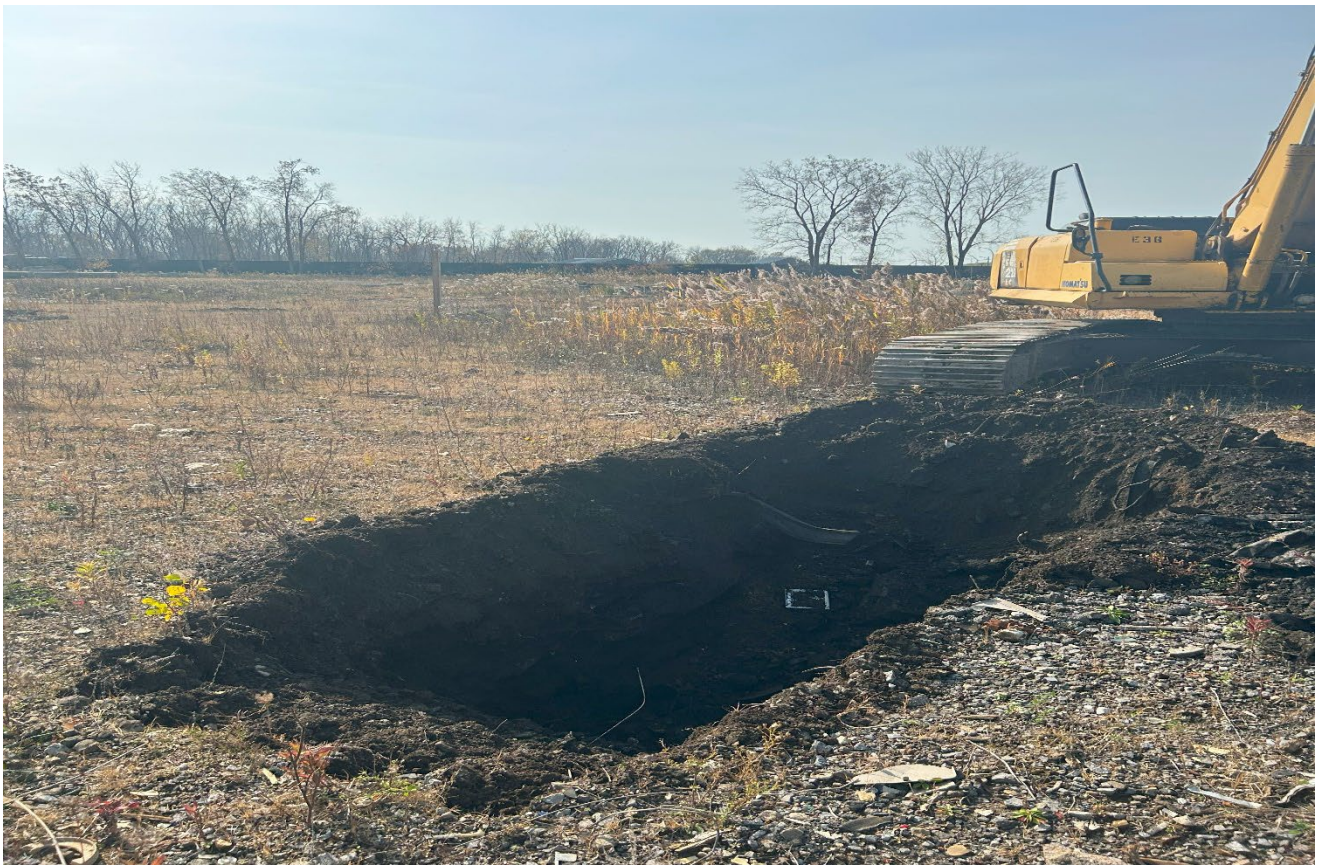
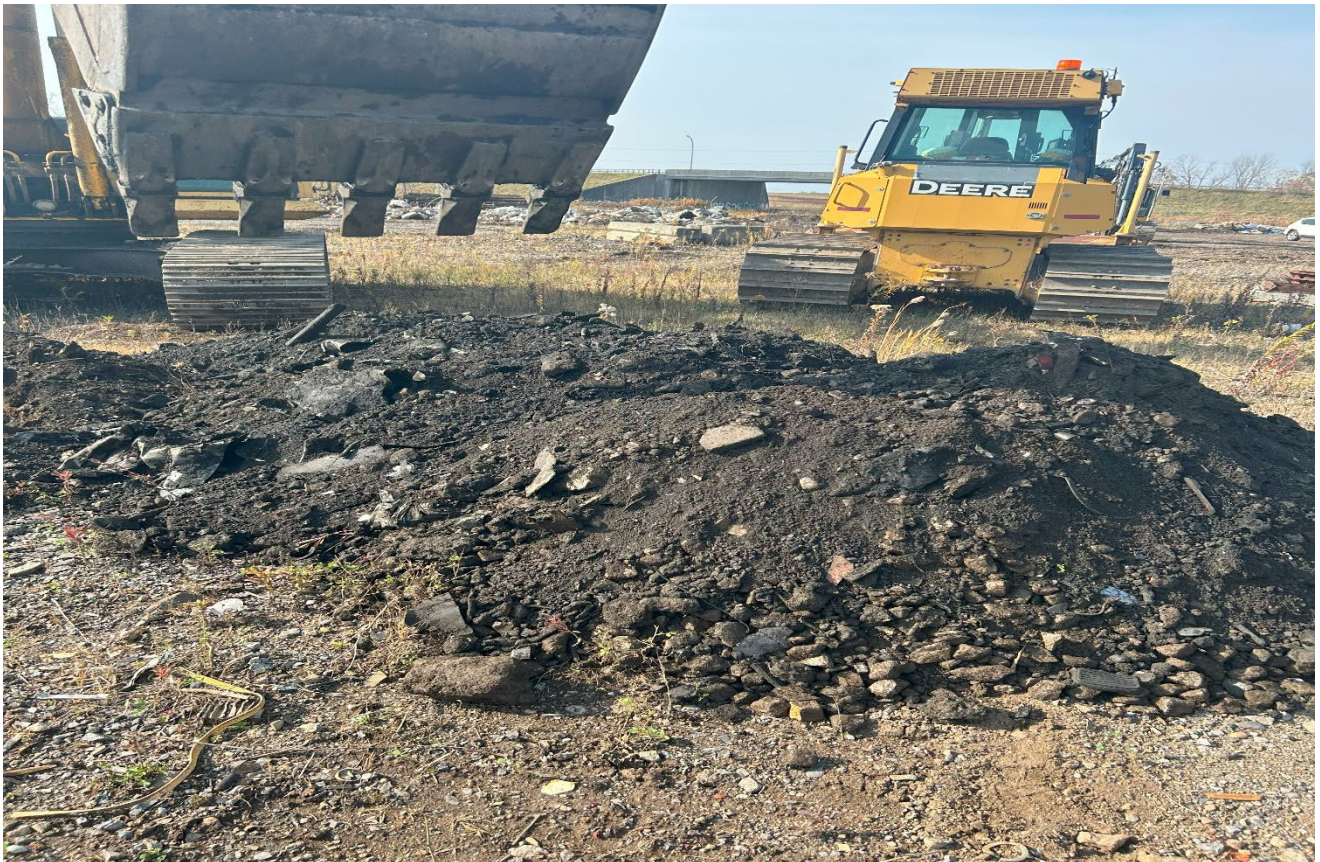
**Photograph 1: TP-11**

| Date | Project | Surface Elev. | Total Depth | | | |
|---|---|---|---|---|---|---|
| TP-11 (0-.5) | 0 - 0.5 | 5-10% | 10.1 | | Urban Fill: Brown Fine to coarse sand and gravel with varying amounts of glass, brick, cinders, metal, plastic, rubber etc. Dry to moist | Lab sample. |
| TP-11 (.5-2) | 0.5-2 | 5-10% | 12.2 | | Urban Fill: Fine to coarse sand and gravel with varying amounts of glass, brick, cinders, metal, plastic, rubber etc. Moist. | Lab sample. |
| TP-11 (2-4) | 2-4 | 5-10% | 9.9 | | Urban Fill: Fine to coarse sand and gravel with varying amounts of glass, brick, cinders, metal, plastic, rubber etc. Moist to wet at 4 feet. | |
| | | | | | Native found at 4.5 feet | |

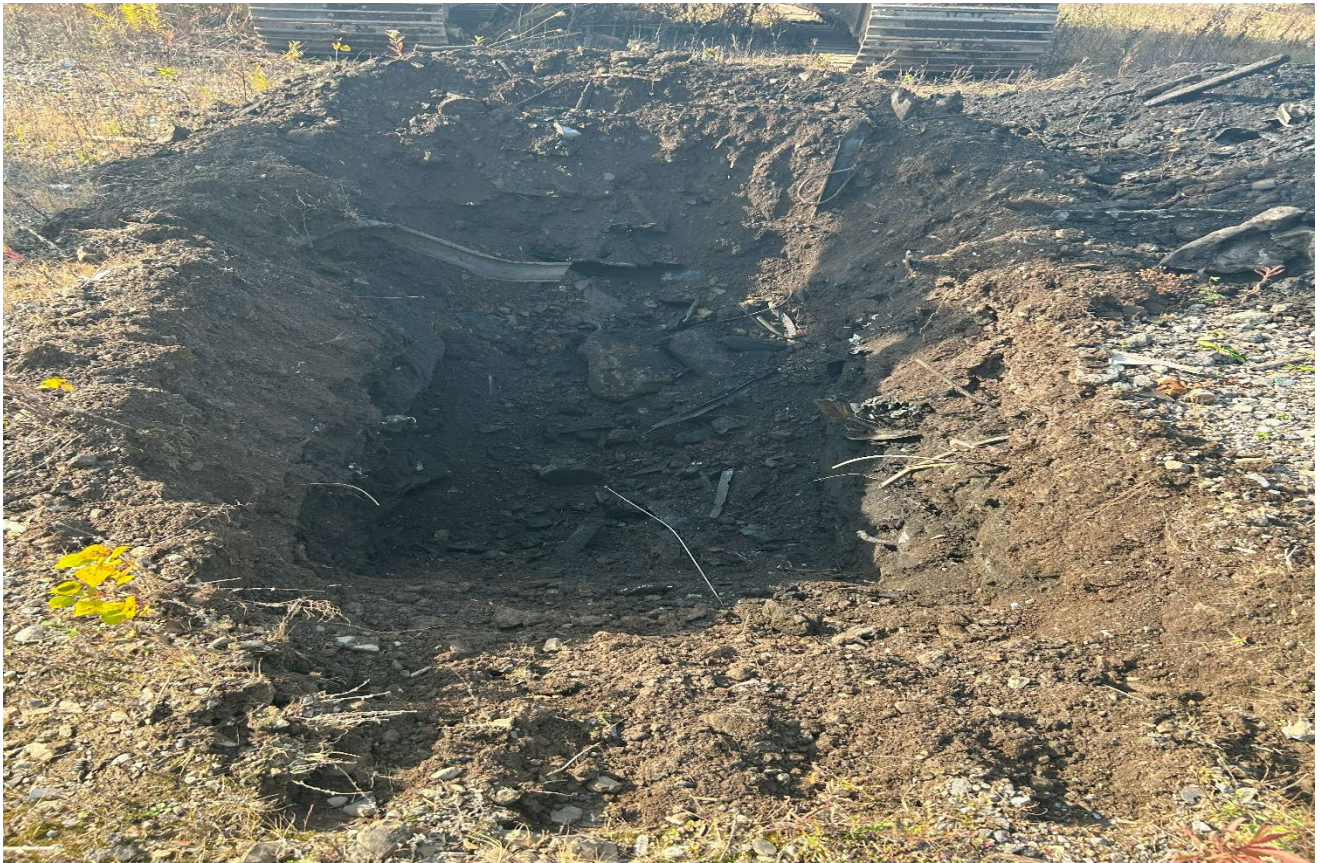
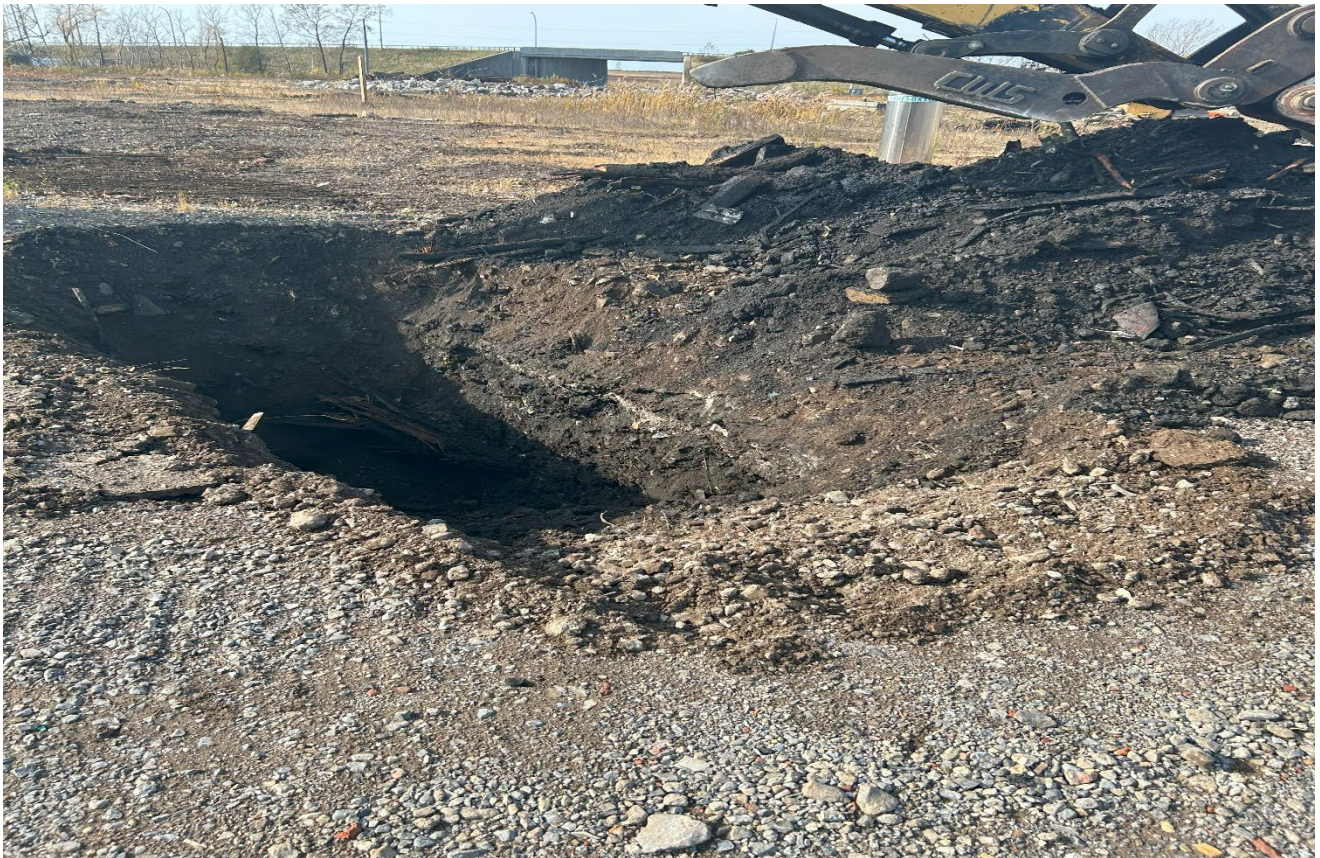
**Photograph 1: TP-12**

| Date | Project | Surface Elev. | Total Depth | | | |
|---|---|---|---|---|---|---|
| TP-12 (0-.5) | 0 - 0.5 | 5-10% | 2.3 | | Urban Fill: Brown Fine to coarse sand and gravel with varying amounts of glass, brick, cinders, metal, plastic, rubber etc. Dry to moist | Lab sample. |
| TP-12 (.5-2) | 0.5-2 | 5-10% | 42.8 | | Urban Fill: Fine to coarse sand and gravel with varying amounts of glass, brick, cinders, metal, plastic, rubber etc. Moist. | Lab sample. |
| TP-12 (2-4) | 2-4 | 5-10% | 17 | | Urban Fill: Fine to coarse sand and gravel with varying amounts of glass, brick, cinders, metal, plastic, rubber etc. Moist to wet at 4 feet. | |
| TP-12 (4-6) | 4-6 | 5-10% | 3.2 | | Urban Fill: Fine to coarse sand and gravel with varying amounts of glass, brick, cinders, metal, plastic, rubber etc. Wet. Native found at 5 feet. | |

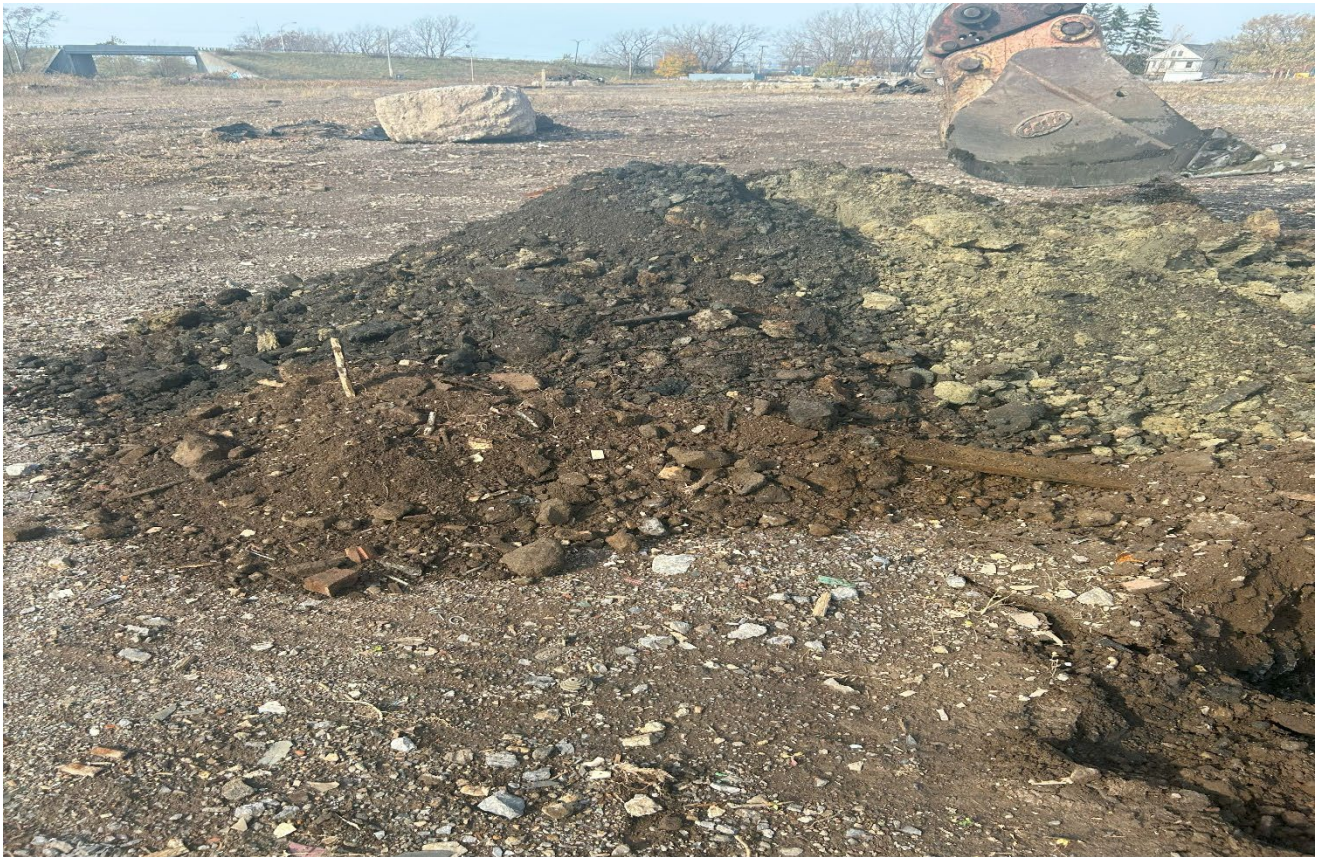
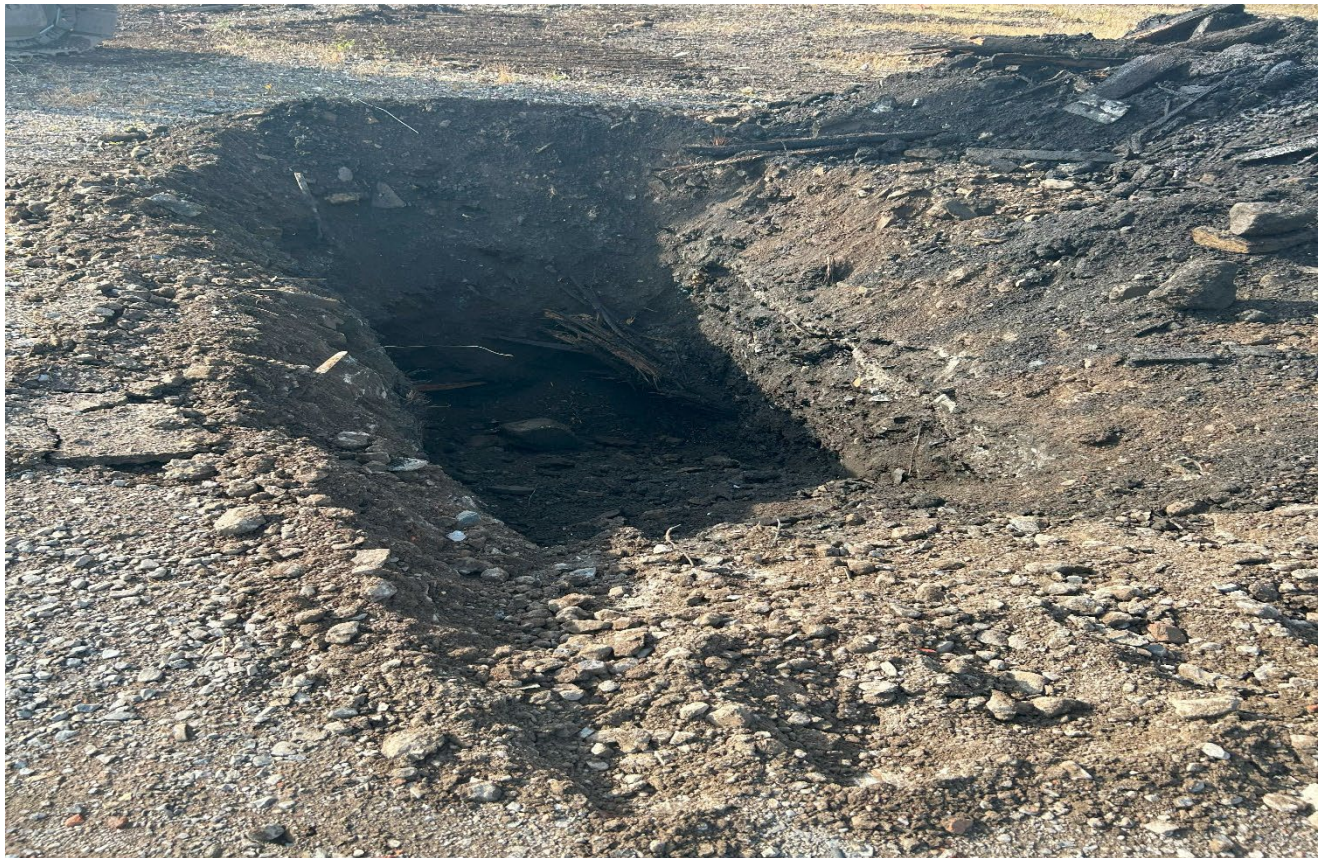
**Photograph 1: TP-13**

| Sample Number | Depth (ft) | % MSW | PID (ppm) | SAMPLE LITHOLOGY | | COMMENTS |
|---|---|---|---|---|---|---|
| TP-13 (0-.5) | 0 - 0.5 | 5-10% | 2.2 | | Urban Fill: Brown Fine to coarse sand and gravel with varying amounts of glass, brick, cinders, metal, plastic, rubber etc. Dry to moist | Lab sample. |
| TP-13 (.5-2) | 0.5-2 | 5-10% | 0.7 | | Urban Fill: Fine to coarse sand and gravel with varying amounts of glass, brick, cinders, metal, plastic, rubber etc. Moist. | |
| TP-13 (2-4) | 2-4 | 5-10% | 0.9 | | Urban Fill: Fine to coarse sand and gravel with varying amounts of glass, brick, cinders, metal, plastic, rubber etc. Moist to wet at 3 feet. Native found at 3 feet. | Lab sample. |

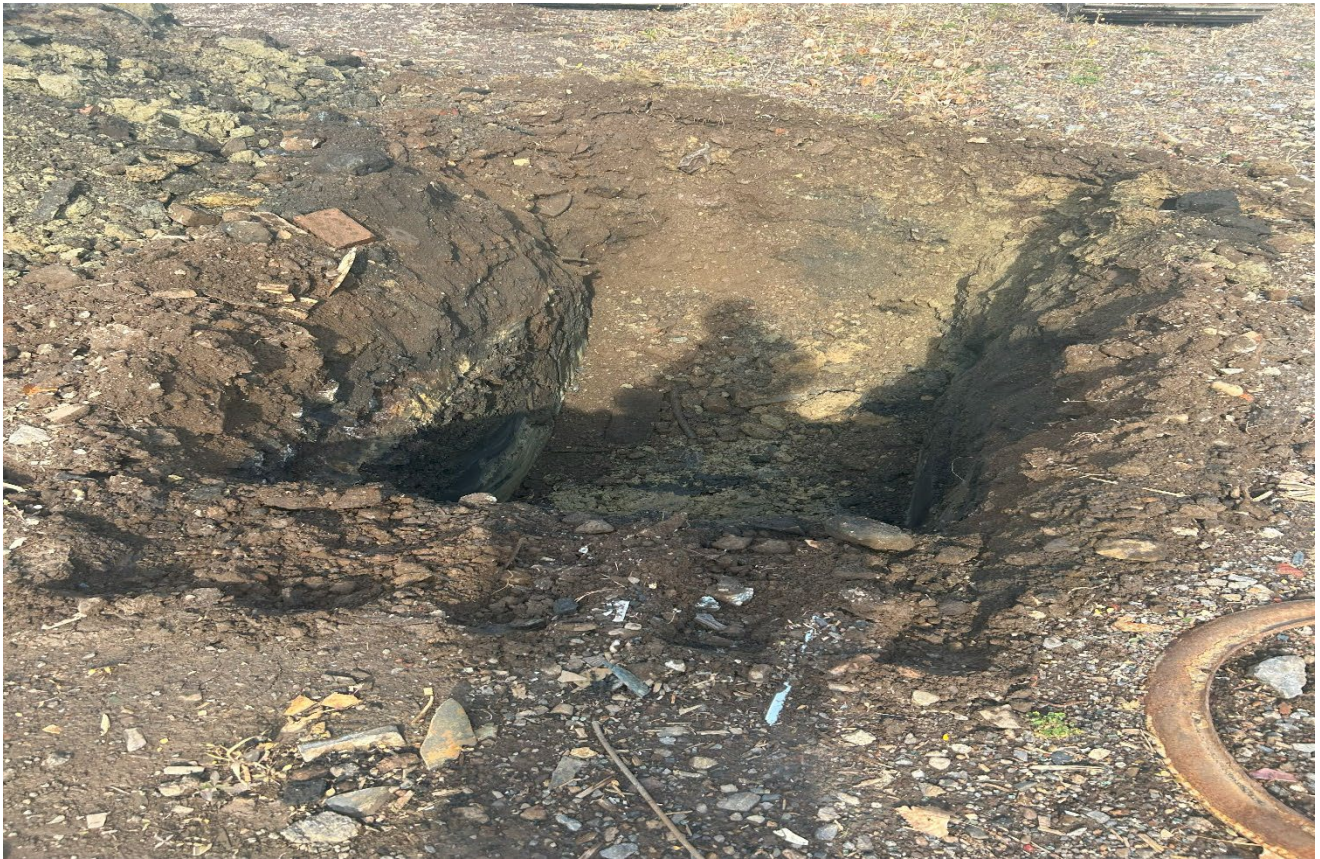
**Photograph 1: TP-14**

| Date | Project | Surface Elev. | Total Depth | | | |
|---|---|---|---|---|---|---|
| TP-14 (0-5) | 0 - 0.5 | > 5% | 3.3 | | Urban Fill: Brown Fine to coarse sand and gravel with varying amounts of glass, brick, cinders, metal, plastic, rubber etc. Dry to moist | Lab sample. |
| TP-14 (.5-2) | 0.5-2 | > 5% | 9.6 | | Urban Fill: Fine to coarse sand and gravel with varying amounts of glass, brick, cinders, metal, plastic, rubber etc. Moist. | Lab sample. |
| TP-14 (2-4) | 2-4 | > 5% | 5 | | Urban Fill: Fine to coarse sand and gravel with varying amounts of glass, brick, cinders, metal, plastic, rubber etc. Moist to wet at 4 feet. | |
| TP-14 (4-6) | 4-6 | > 5% | 6.5 | | Urban Fill: Fine to coarse sand and gravel with varying amounts of glass, brick, cinders, metal, plastic, rubber etc. Wet. Native found at 6 feet. | |

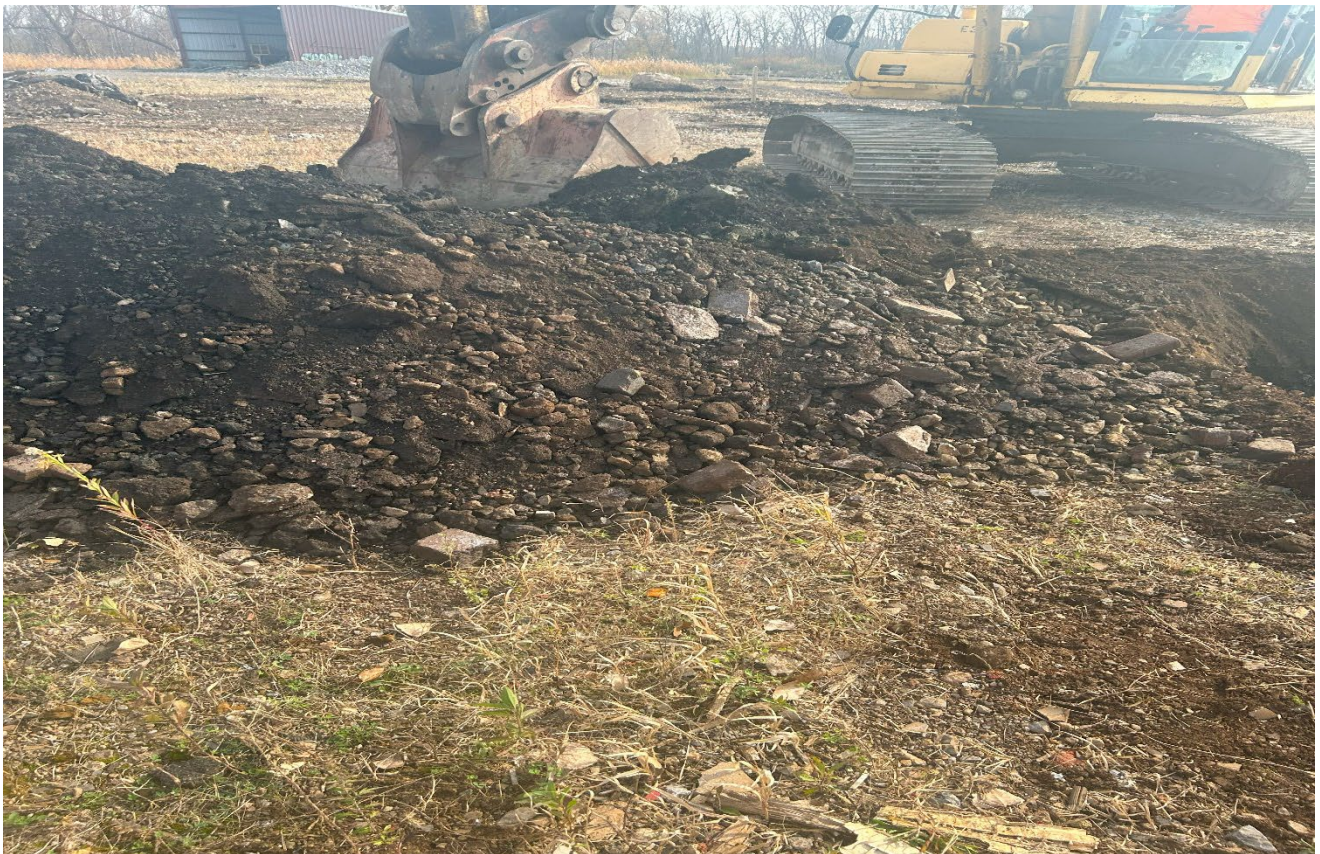
**Photograph 2: TP-15**

| Date | Project | Surface Elev. | Total Depth | | | |
|---|---|---|---|---|--|---|
| TP-15 (0-.5) | 0 - 0.5 | 5-10% | 15.8 | Urban Fill: Brown Fine to coarse sand and gravel with varying amounts of glass, brick, cinders, metal, plastic, rubber etc. Dry to moist | | Lab sample. |
| TP-15 (.5-2) | 0.5-2 | 5-10% | 30.9 | Urban Fill: Fine to coarse sand and gravel with varying amounts of glass, brick, cinders, metal, plastic, rubber etc. Moist. | | Lab sample. |
| TP-15 (2-4) | 2-4 | 5-10% | 7.3 | Urban Fill: Fine to coarse sand and gravel with varying amounts of glass, brick, cinders, metal, plastic, rubber etc. Moist to wet at 4 feet. | | |
| TP-15 (4-6) | 4-6 | 5-10% | 16.5 | Urban Fill: Fine to coarse sand and gravel with varying amounts of glass, brick, cinders, metal, plastic, rubber etc. Wet. Native found at 5.5 feet. | | |

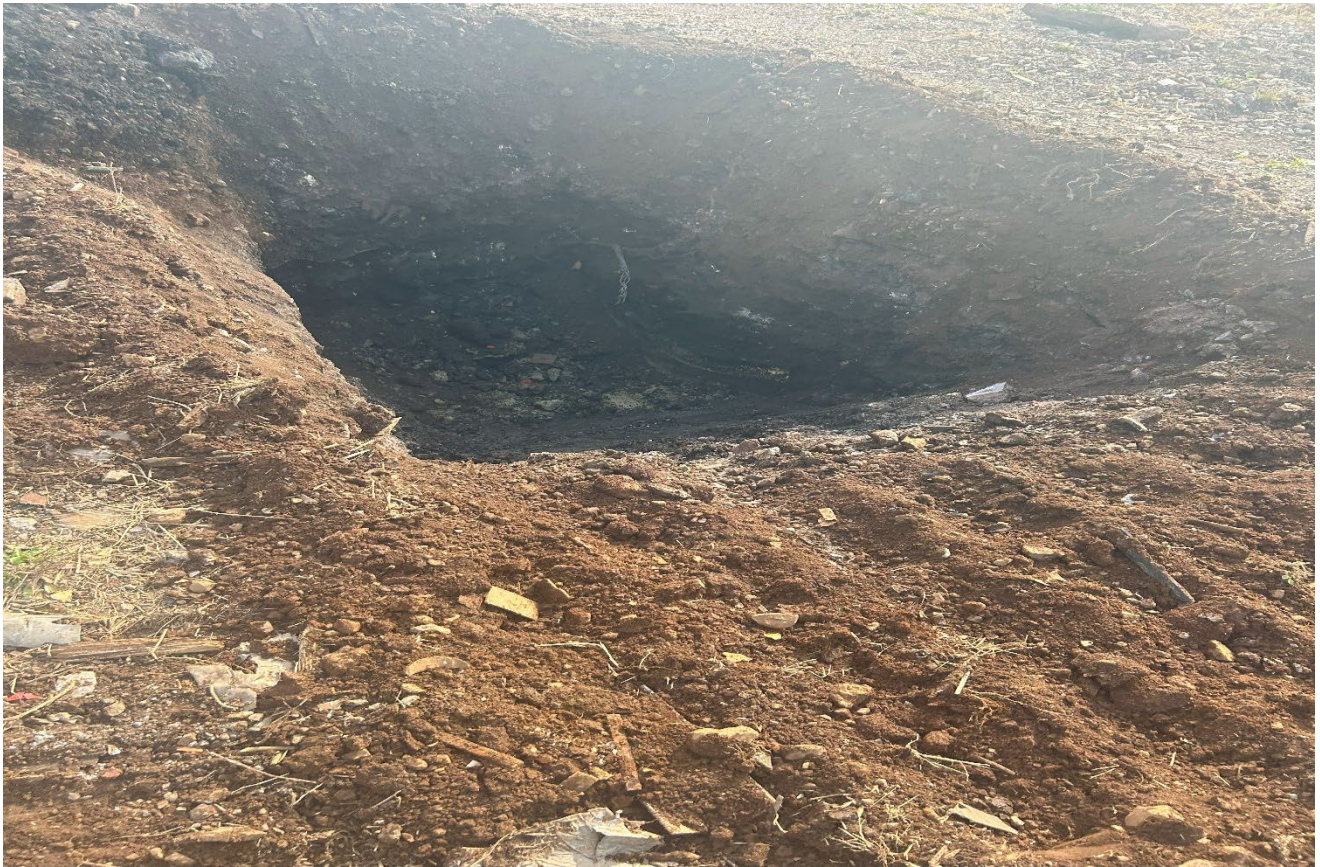
**Photograph 1: TP-16**

| Date | Project | Surface Elev. | Total Depth | | | |
|---|---|---|---|---|---|---|
| TP-16 (0-.5) | 0 - 0.5 | > 5% | 0.9 | | Urban Fill: Brown Fine to coarse sand and gravel with varying amounts of glass, brick, cinders, metal, plastic, rubber etc. Dry to moist | Lab sample. |
| TP-16 (.5-2) | 0.5-2 | > 5% | 2.3 | | Urban Fill: Fine to coarse sand and gravel with varying amounts of glass, brick, cinders, metal, plastic, rubber etc. Moist. | |
| TP-16 (2-4) | 2-4 | > 5% | 3.1 | | Urban Fill: Fine to coarse sand and gravel with varying amounts of glass, brick, cinders, metal, plastic, rubber etc. Moist to wet at 4 feet. | Lab sample. |
| TP-16 (4-6) | 4-6 | > 5% | 1.4 | | Urban Fill: Fine to coarse sand and gravel with varying amounts of glass, brick, cinders, metal, plastic, rubber etc. Wet. Native found at 5.5 feet. | |
