2021 PERIODIC REVIEW REPORT NORTHTOWN INC. SITE 3097 SHERIDAN DRIVE AMHERST, NEW YORK BCP Site Number C915292

May 14, 2021

Re: 2021 Periodic Review Report
Northtown Inc.
3097 Sheridan Drive, Amherst, New York
Brownfield Cleanup Program Site (Number C915292)

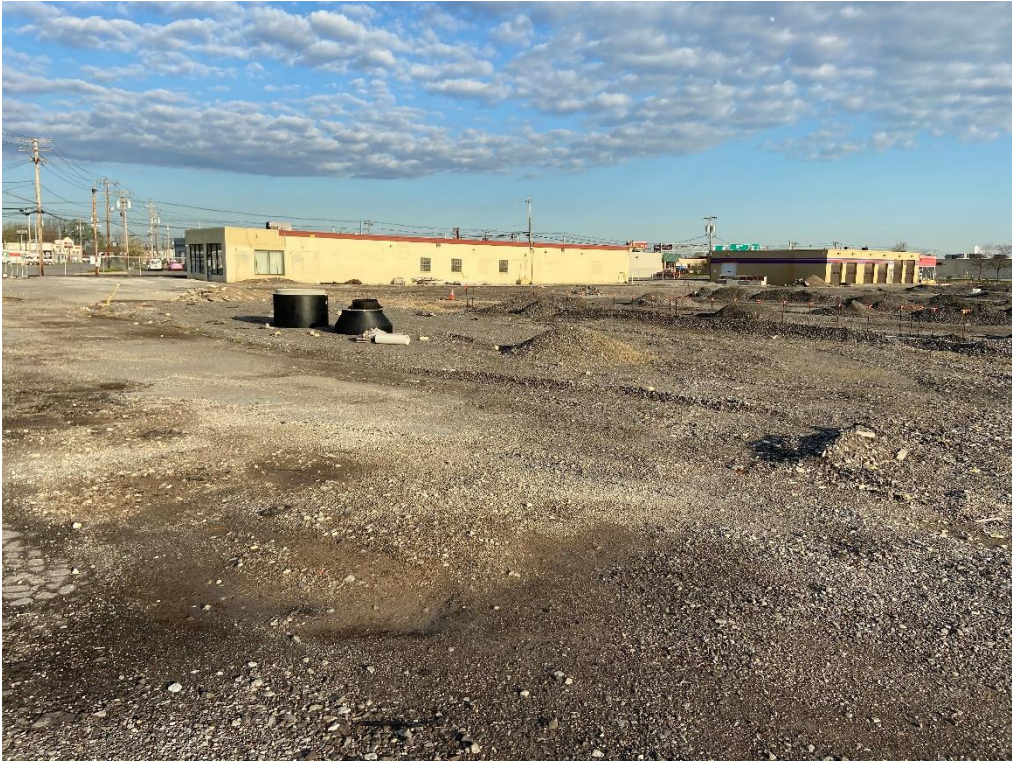
Client Name: Northtown Property Owner LLC		Site Location: 3097 Sheridan Drive, Amherst, NY	Project No. 21.0056687.33
Photo No. 1	Date: 4-14-21

Direction Photo Taken: NNW			
Description: View of AOI3 from the SE corner of the AOI.

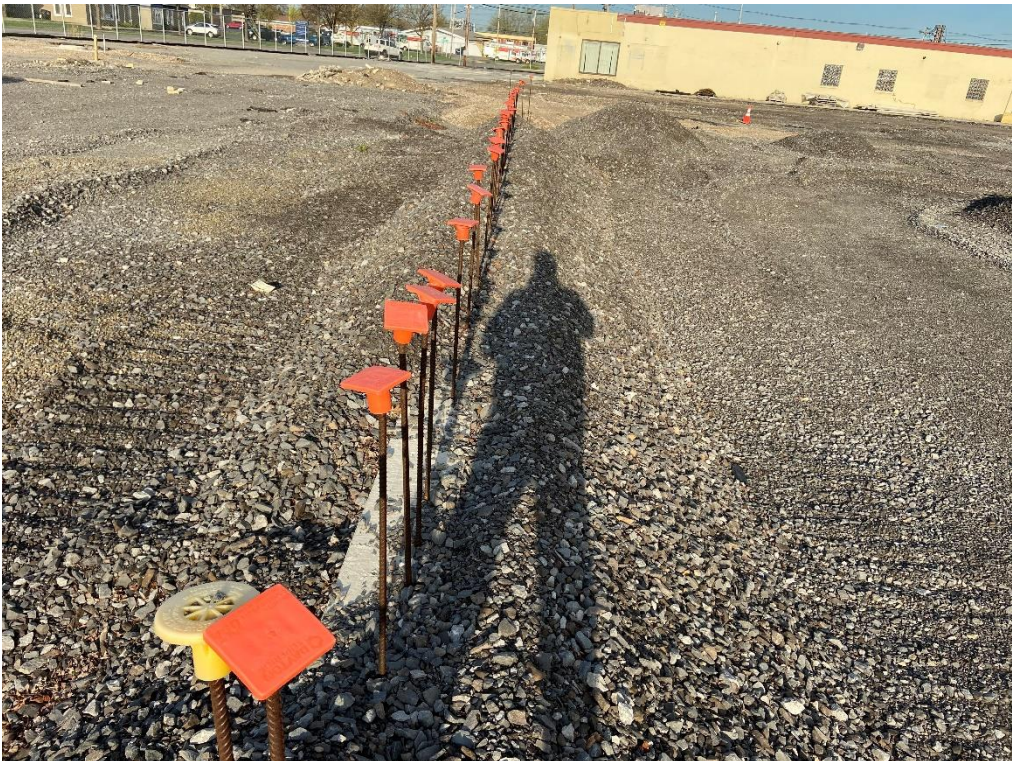
Photo No. 2	Date: 4-14-21

Direction Photo Taken: West			
Description: Footer of south wall of Building A.

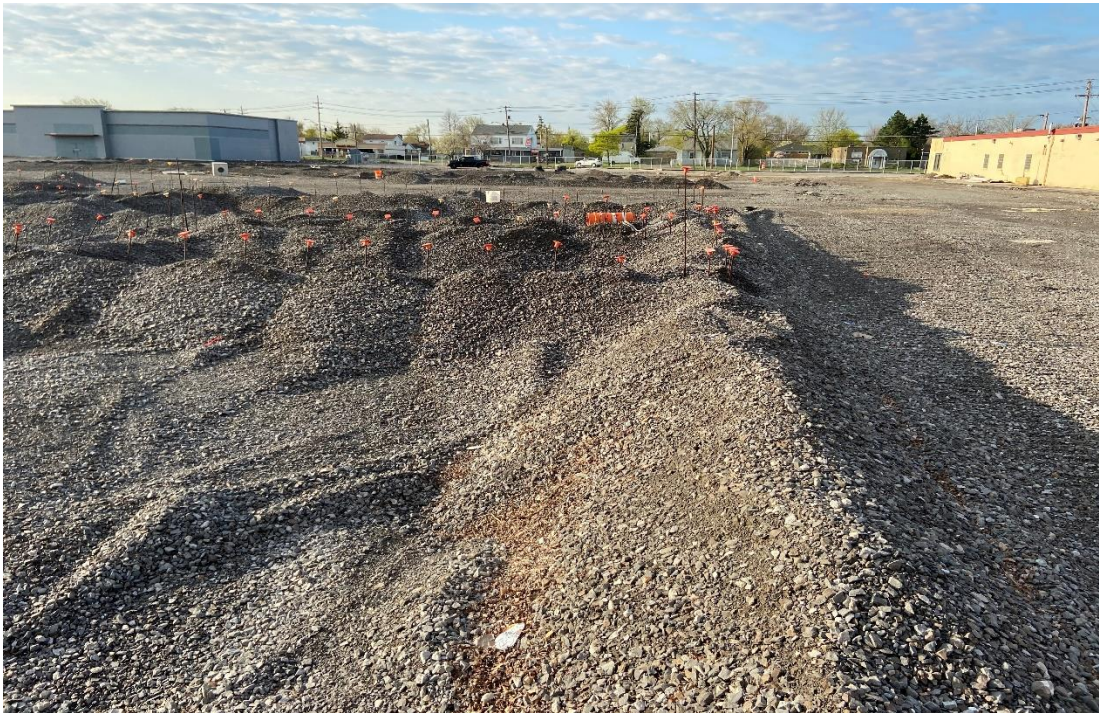
Photo No. 5	Date: 4-14-21

Direction Photo Taken: South		
Description: Stone covered footers of west walls of Building A and B.
