# **HIGHLAND PLAZA**

## **Annual Report** **2018-2019**

**NYSDEC Site Number: C 9 1 5 2 9 3**

**Environmental & Geologic Management  
Services. LLC**

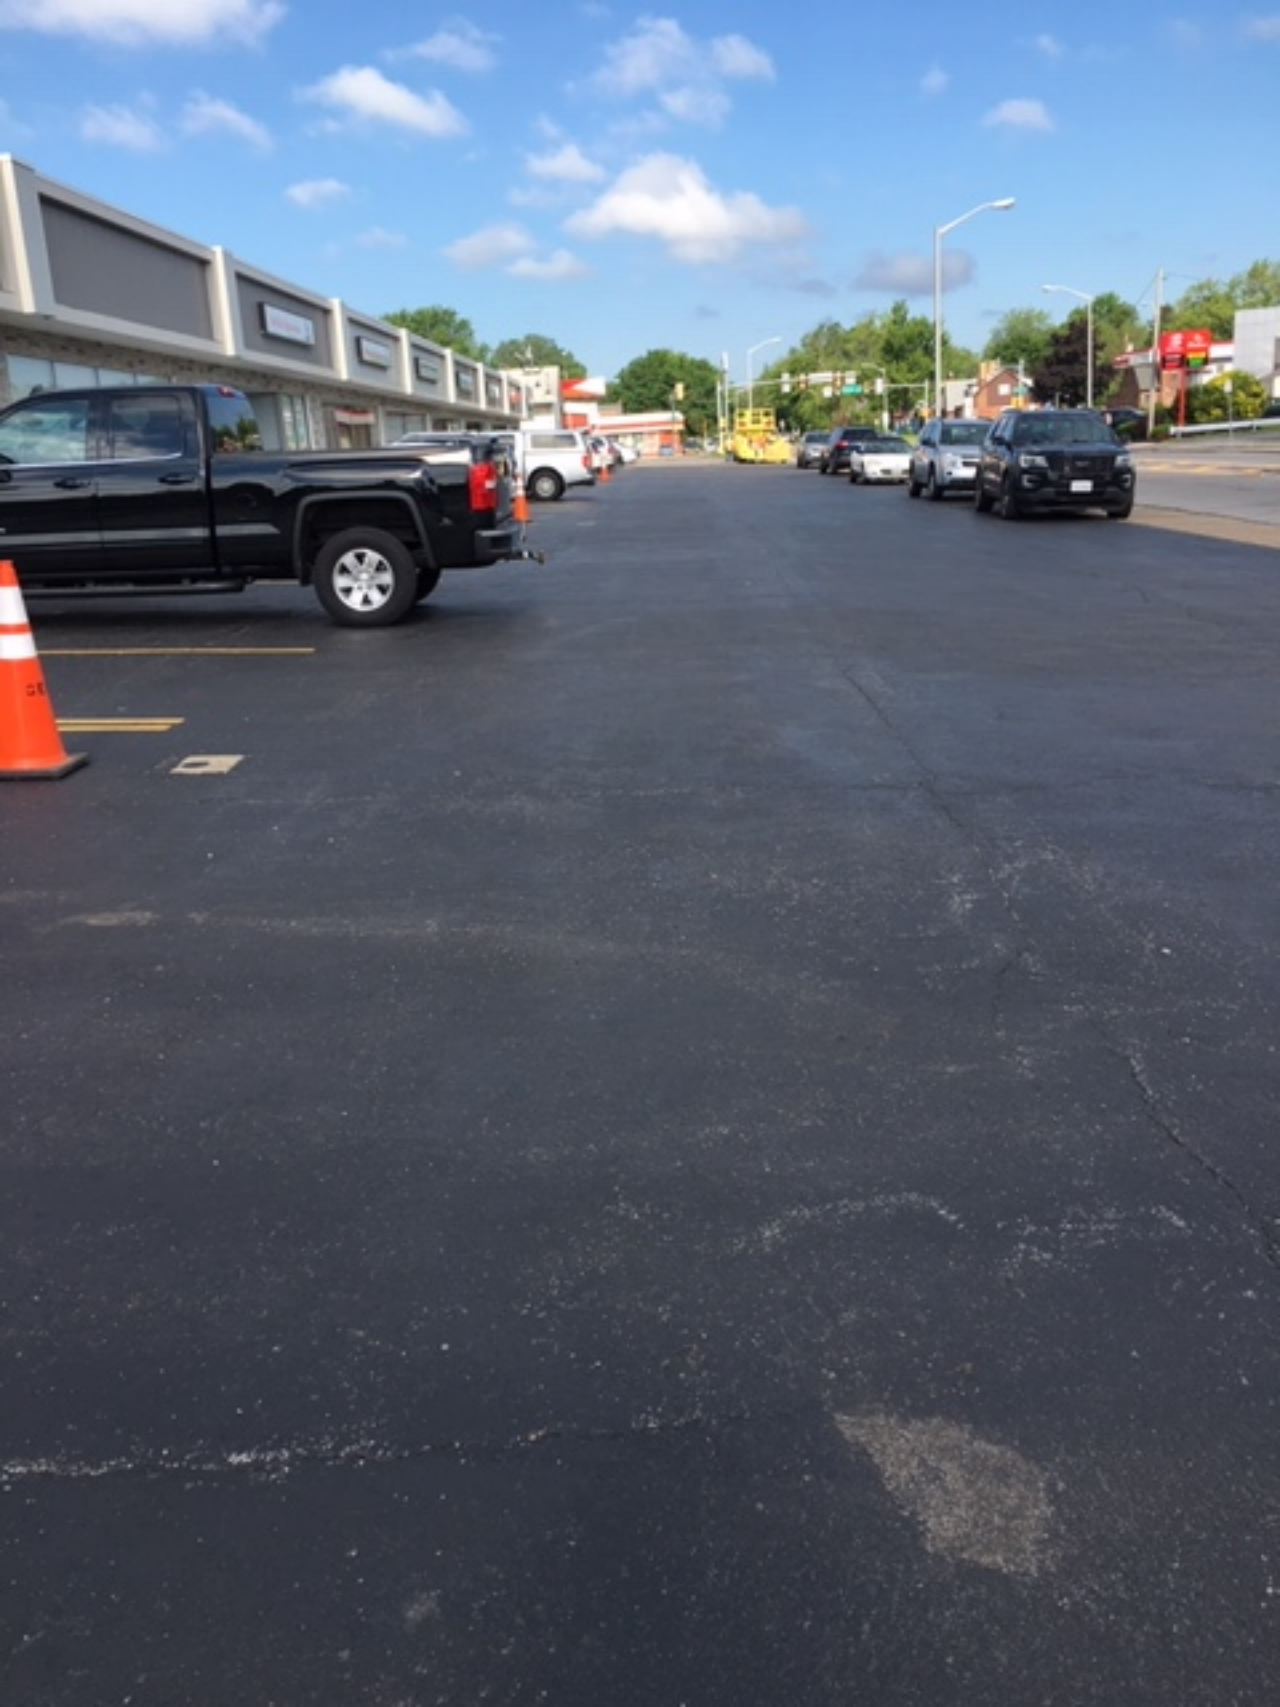
Photograph of Pavement Cap Looking West

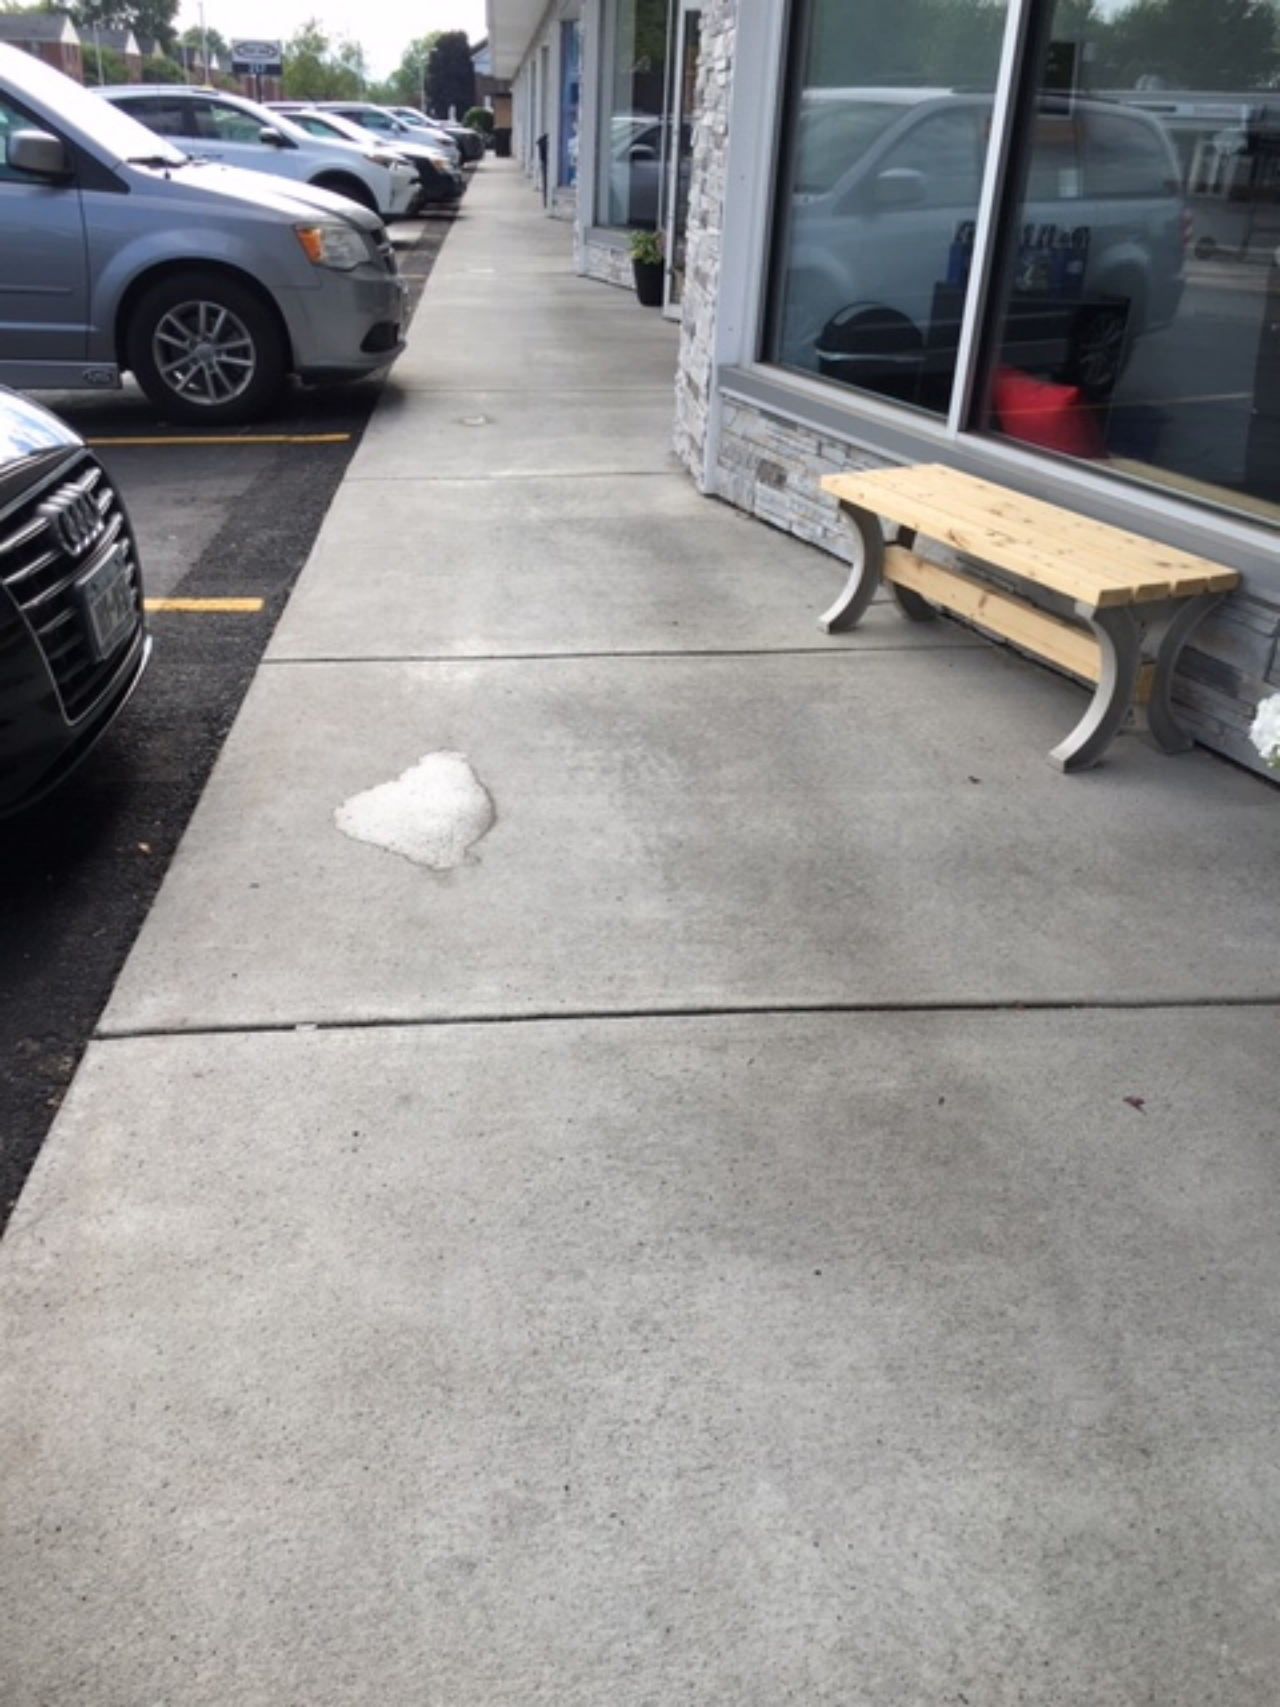
Photograph of Sidewalk Looking East

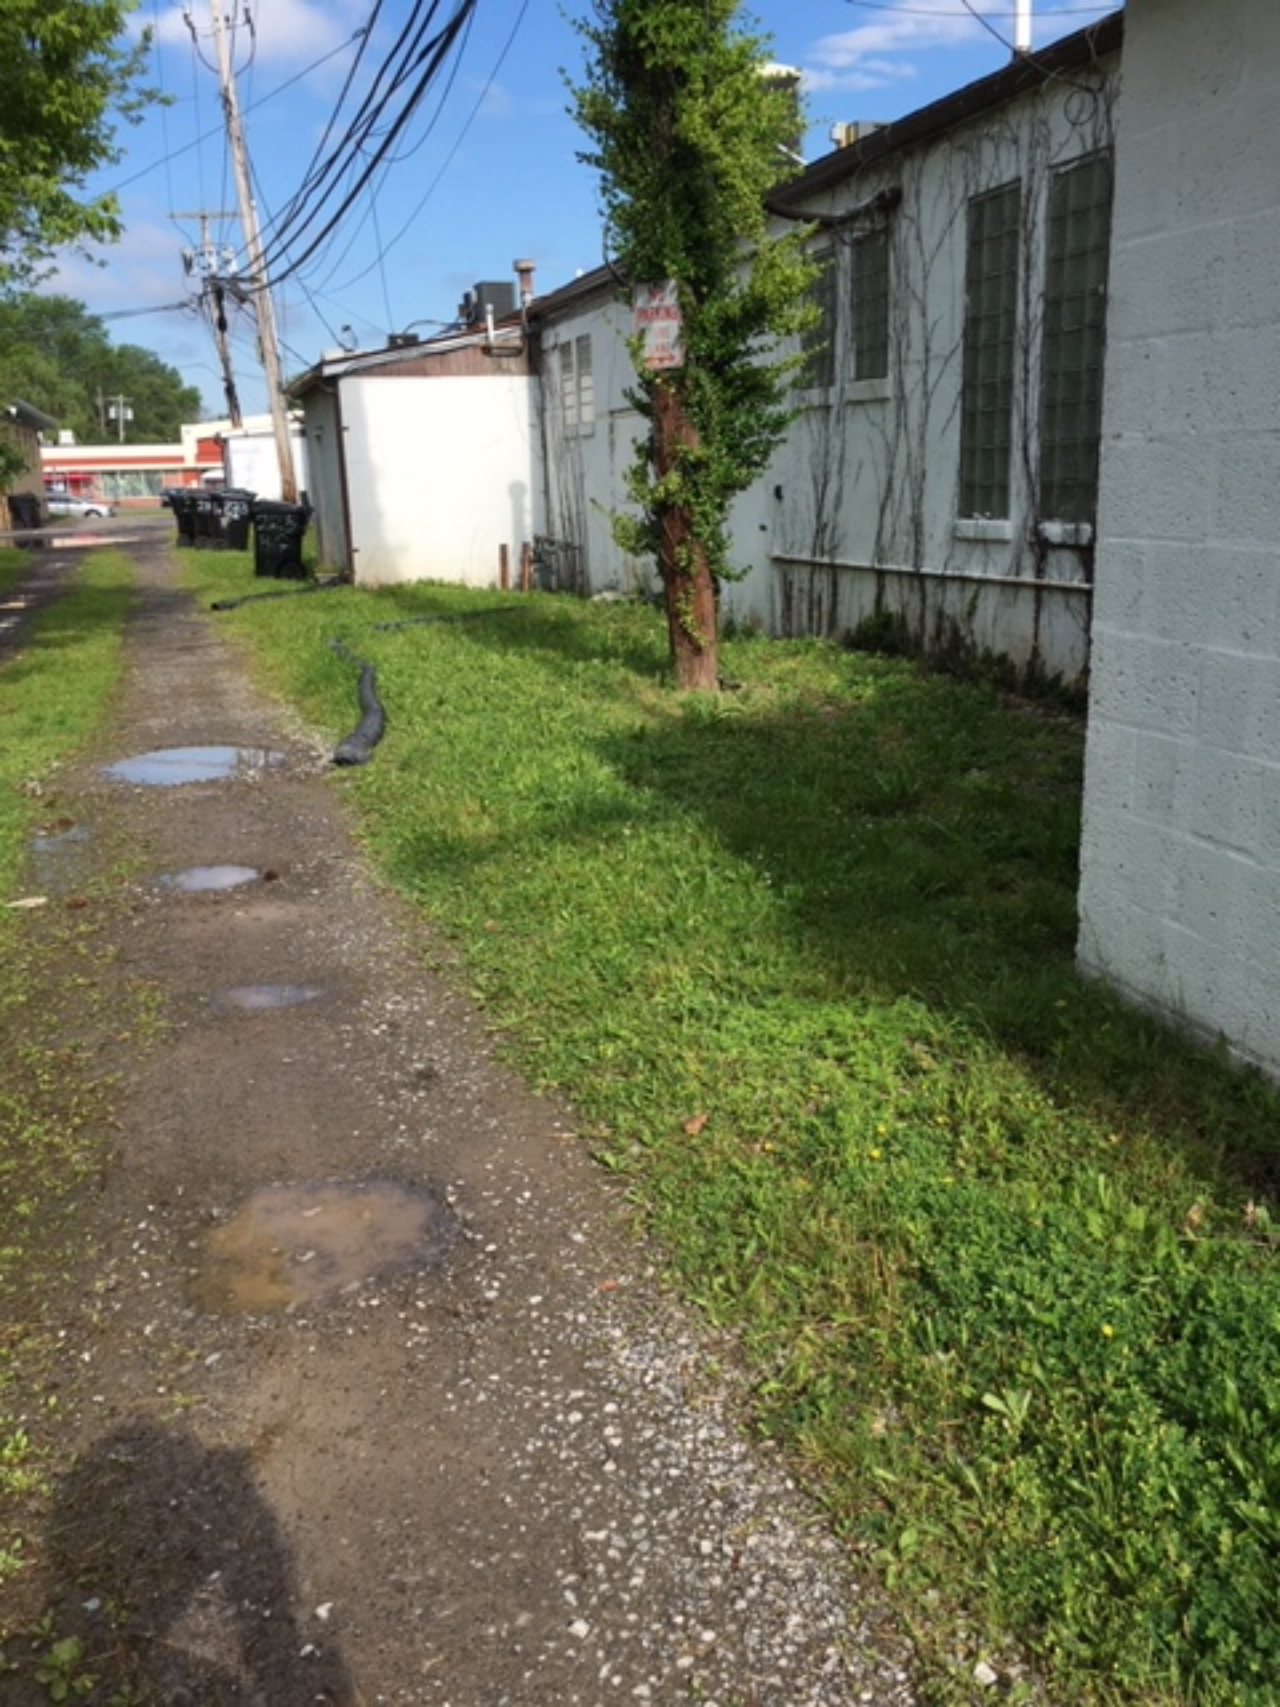
Photograph of Soil Cap Looking West
