Remedial Investigation Report

Highland Plaza Off-Site Area Tonawanda, Erie County, New York Site Number C915293A

September 2023

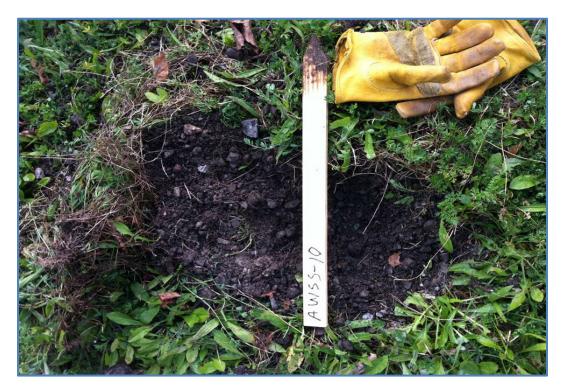
Figure 5-1. Photo showing typical shallow fill at the Highland Plaza Off-Site Area. Photo taken by Norm Wohlabaugh on October 18, 2015.

Reworked native silty clay soil mixed with sand, gravel, slag, brick fragments and/or concrete fragments was encountered in at least sixteen (16) borings completed at the Highland Plaza Off-Site Area (Site C915293A; see comment above concerning the soil boring logs). This fill was commonly found under the construction material but at several borings was encountered at ground surface or below a thin topsoil layer (Table 5-1). This fill was encountered at depths ranging from 0.0 to 1.7 feet, and ranged in thickness from 0.33 to 2.0 feet (Table 5-1).

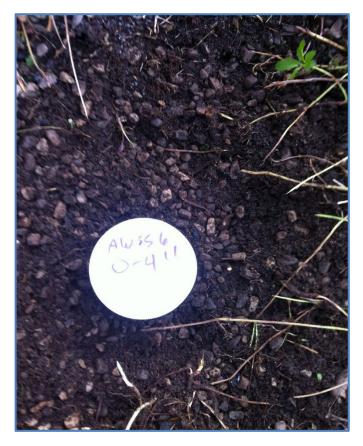
Figure 5-2. Close-up photo of the shallow fill at the Highland Plaza Off-Site Area. Photo taken by Norm Wohlabaugh on October 18, 2015.

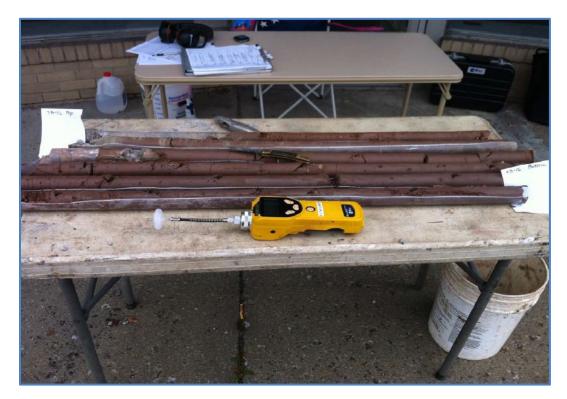
Figure 5-3. Photo of the native reddish brown silty clay from soil boring SB-16 at the Highland Plaza BCP Site. Photo taken by Norm Wohlabaugh on October 14, 2015.

The native soils underlying the Highland Plaza BCP Site and Off-Site Area consist predominantly of reddish brown, very firm to stiff, dry to moist, silty clays (Figures 5-3 thru 5-6) that were deposited in glacial lakes that covered the area during the last ice age. The upper portion of this deposit is commonly mottled (Figure 5-7). The glaciolacustrine deposit generally underlies construction materials and/or reworked native silty clay, but was also encountered at ground surface in several borings or below a thin topsoil layer (Table 5-1). This deposit was encountered at depths ranging from 0.0 to 2.3 feet (Table 5-1).

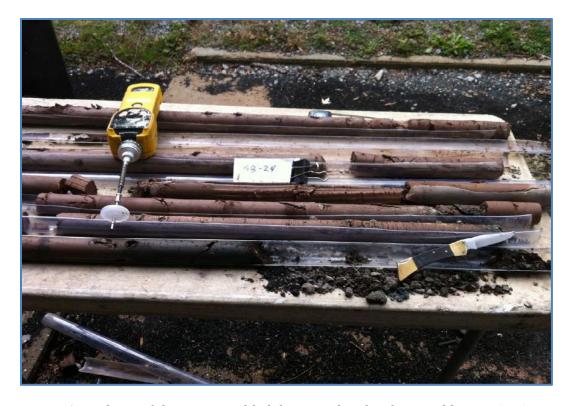
Figure 5-4. Photo of the native reddish brown silty clay from soil boring SB-24 at the Highland Plaza Off-Site Area. Photo taken by Norm Wohlabaugh on October 15, 2015.

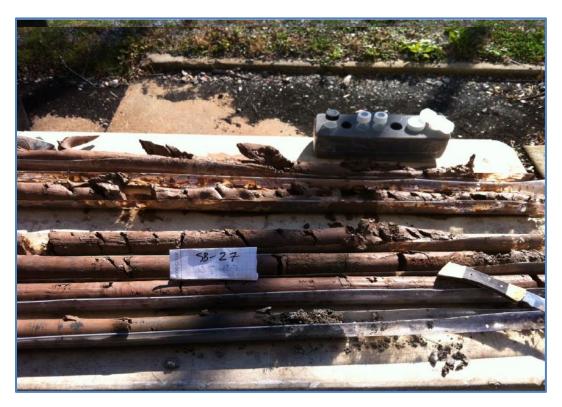
Figure 5-5. Photo of the native reddish brown silty clay from soil boring SB-27 at the Highland Plaza Off-Site Area. Photo taken by Norm Wohlabaugh on October 15, 2015.

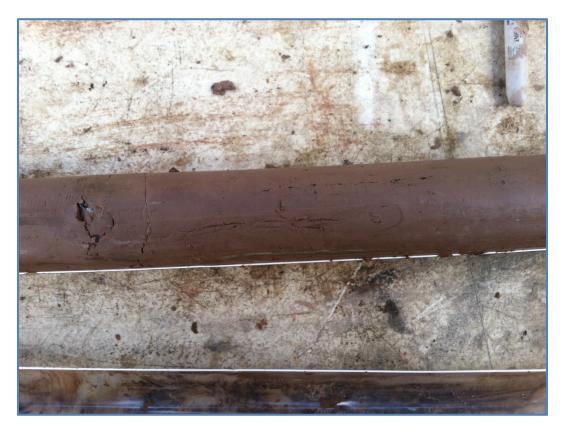
Figure 5-6. Close-up photo of the native reddish brown silty clay from soil boring SB-37 at the Highland Plaza Off-Site Area. Photo taken by Glenn M. May on May 4, 2017.

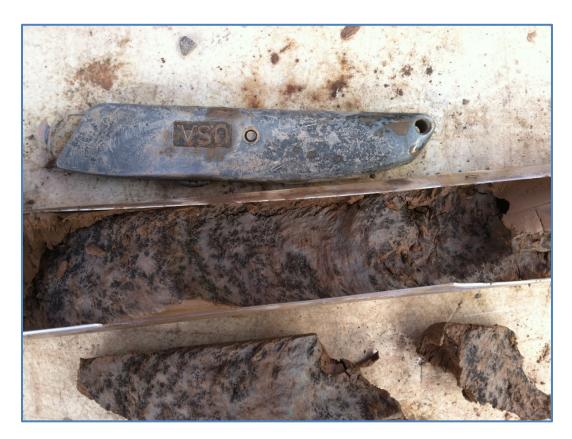
Figure 5-7. Close-up photo showing mottling of the native reddish brown silty clay in soil boring SB-52 at the Highland Plaza Off-Site Area. Photo taken by Glenn M. May on June 22, 2017.

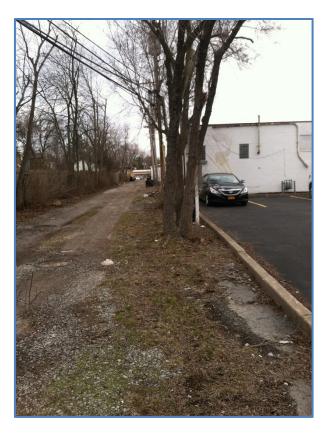
Figure 6-1. Photo showing the Highland Plaza Off-Site Area. View looking west. Photo taken by Glenn M. May March 9, 2017.

The Highland Plaza Off-Site Area is vacant, although a gravel service road runs through the center of the site (Figures 6-1 thru 6-4). Overhead and underground utilities (Figures 6-2 and 6-3) are also present in the alleyway and will need to be taken into account during the remedy selection process. In addition to the utility poles and overhead lines immediately behind Highland Plaza, utility lines cross the alleyway and connect to each residence on Grimsby Road adjacent to the site (Figure 6-5). Fences separate the alleyway from the residences on Grimsby

Road (Figures 6-4 and 6-6) and may also be an obstacle to remediation. Narrow strips of vegetation are located between the plaza building and the service road (grass and weeds), and between the service road and fences that separate the alleyway from the adjacent residential properties to the south (grass, weeds, and brush; Figures 6-1 thru 6-4; and Figures 6-6 and 6-7).

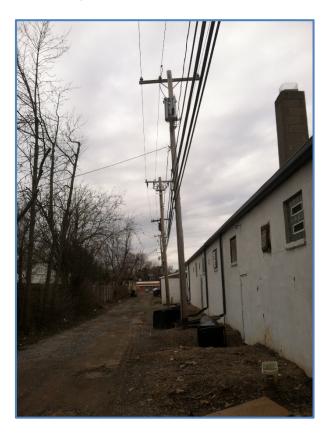
Figure 6-2. Photo showing the Highland Plaza Off-Site Area. View looking west. Note the utility poles and power lines behind Highland Plaza. Photo taken by Glenn M. May March 9, 2017.

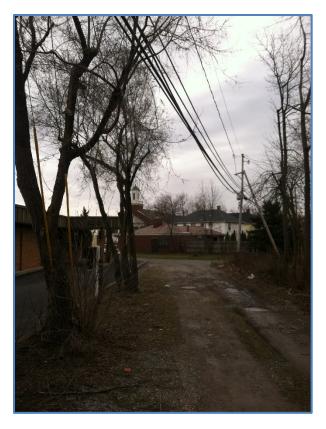
Figure 6-3. Photo showing the Highland Plaza Off-Site Area. View looking east. Photo taken by Glenn M. May March 9, 2017.

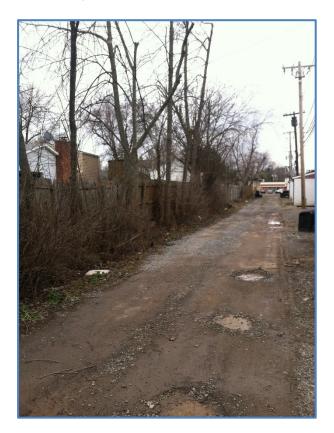
Figure 6-4. Photo showing the Highland Plaza Off-Site Area. View looking west. Note the fence that separates the site from the residential properties on Grimsby Road to the south. Photo taken by Glenn M. May March 9, 2017.

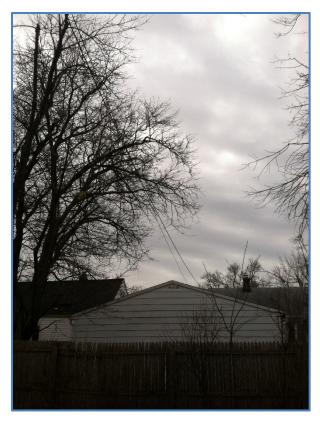
Figure 6-5. Photo showing one set of utility lines that cross the Highland Plaza Off-Site Area and connect to a residence on Grimsby Road. Photo taken by Glenn M. May March 9, 2017.

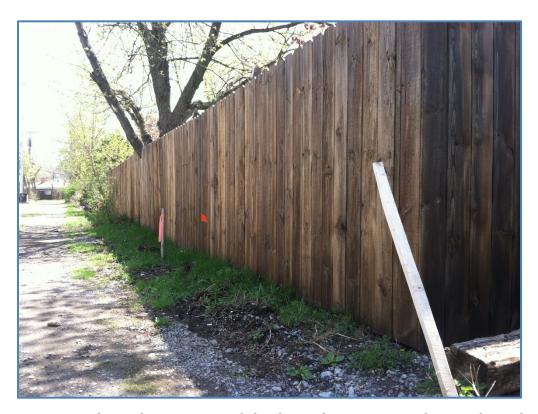
Figure 6-6. Photo showing part of the fence that separates the site from the residential properties on Grimsby Road. Photo taken by Glenn M. May April 27, 2017.

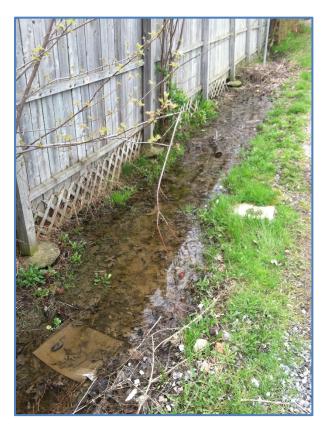
Figure 6-7. Photo showing the shallow ditch in the service alleyway. View looking west. Monitoring well MW-5 can be seen in the center right portion of the photo. Photo taken by Glenn M. May April 26, 2017.

A shallow ditch, approximately 3 inches deep, is present in the service alleyway between the gravel service road and fences that separate the site from the residential properties on Grimsby Road. This ditch was not surveyed during the NYSDEC Remedial Investigation but a photograph showing its location is provided as Figure 6-7. This ditch receives precipitation and snowmelt runoff and is dry at other times of the year. The ditch has no outlet, so it has not been observed to flow. One (1) surface water sample was collected from this ditch during the Remedial Investigation to determine if contaminated shallow fill has adversely impacted surface water at the site. The approximate location of this sample is shown on Figure 4-6. Information concerning sample collection and analysis is given in Table 4-1D, while the laboratory report is included in Appendix D.

A shallow ditch, approximately 3 inches deep, is present in the service alleyway between the gravel service road and fences that separate the site from the residential properties on Grimsby Road. This ditch was not surveyed during the NYSDEC Remedial Investigation but a photograph showing its location is provided as Figure 6-7. This ditch receives precipitation and snowmelt runoff and is dry at other times of the year. The ditch has no outlet, so it has not been observed to flow.
