# **CONTINUING ENVIRONMENTAL INVESTIGATION REPORT**

**1205 SOUTH PARK AVENUE  
BUFFALO, NEW YORK**

**PREPARED FOR:  
BUFFALO URBAN RENEWAL AGENCY  
920 CITY HALL  
BUFFALO, NEW YORK 14202-3376**

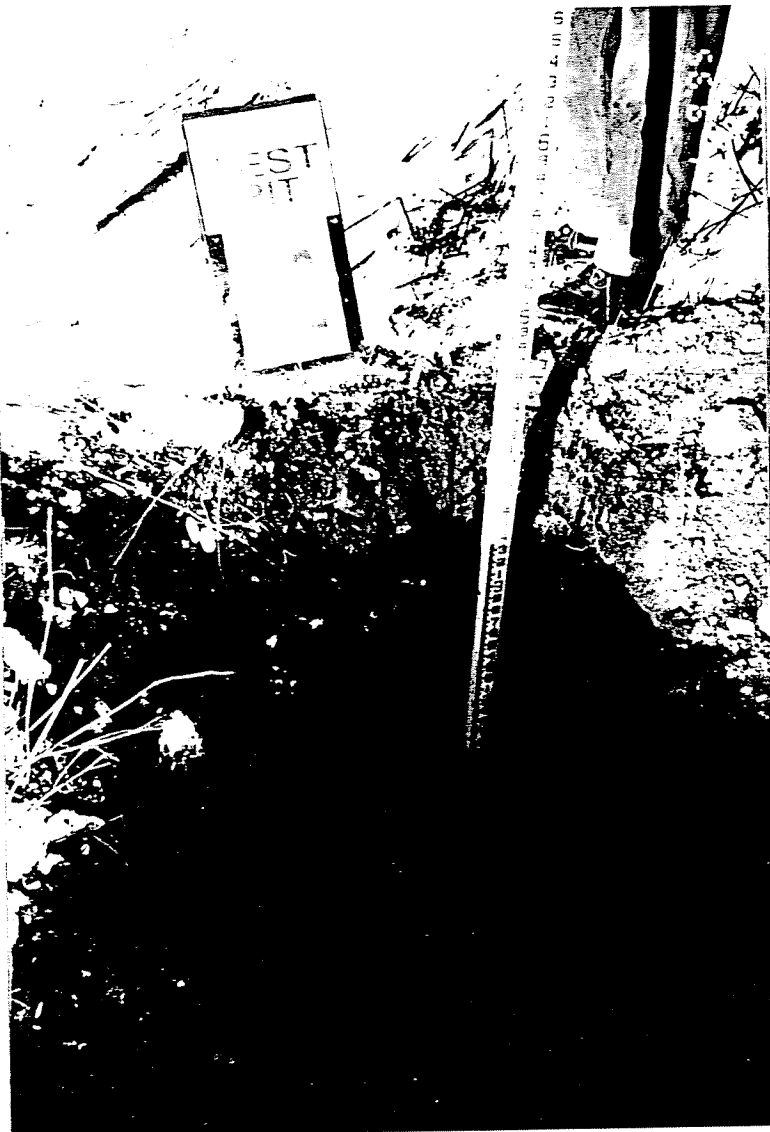
PHOTO 1 : Test Pit 12

\* Test Pit 12, is located at a distance of 125 feet northeast of Test Pit 5. The test pit was excavated to a depth of 4.5 feet. Sand and topsoil were encountered to a depth of 0.5 feet. Cinders were encountered from a depth of 0.5 feet to 2.0 feet. Sandy clay was observed from a depth of 2.0 to 3.0 feet. Clay was observed from a depth of 3.0 to 4.5 feet. No groundwater was observed infiltrating the excavation. In addition, no petroleum odors were observed. A photograph of this Test Pit can be found in Appendix B. After the excavation had been completed, a sample was obtained by compositing the soils from the entire depth of the excavation. The resultant sample was mixed, composited and placed in the appropriate, pre-cleaned and labeled sample containers. The sample containers were then placed on ice and delivered to the contract laboratory under a strict chain of custody. The samples from this test point were analyzed for the following parameters: volatile organic compounds, Method SW-846 8021; semi-volatile organic compounds, Method SW-846 8270; and TCLP lead, Method SW-846 3015/6010.

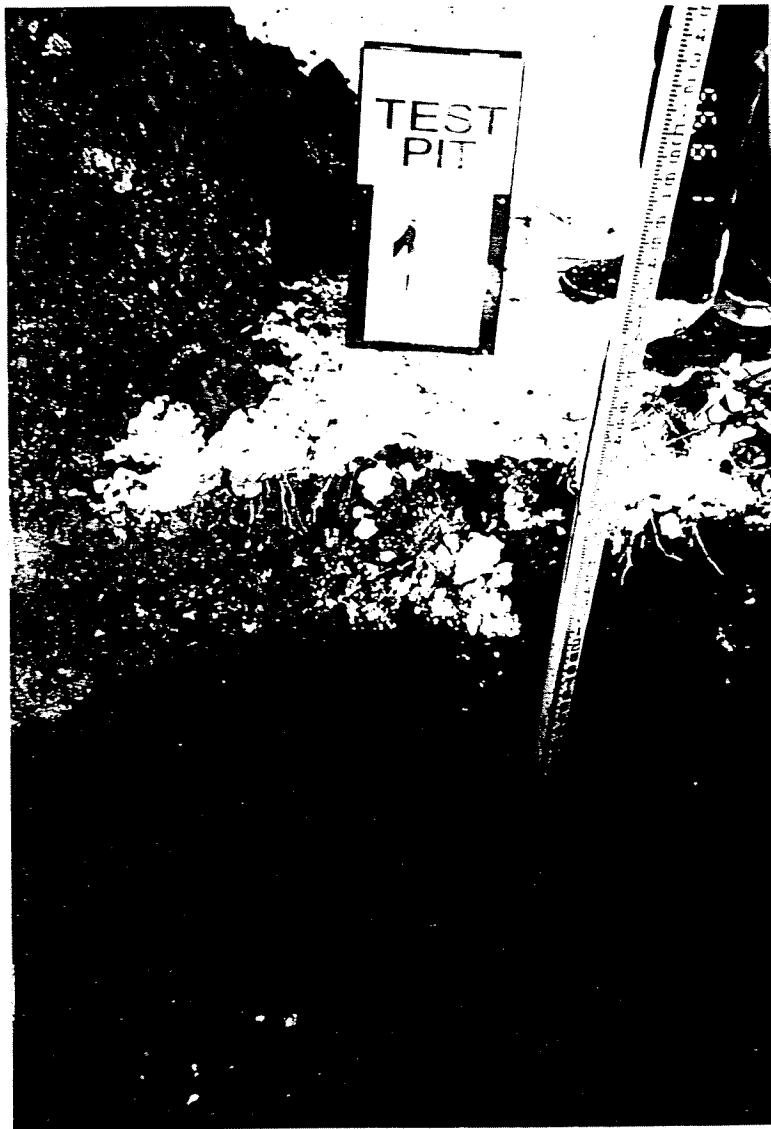
PHOTO 3 : Test Pit 14

\* Test Pit 14, is located at a distance of 150 feet southeast of Test Pit 5. The test pit was excavated to a depth of 3.0 feet. Soil and slag were encountered to a depth of 1.1 feet. Cinders were encountered from a depth of 1.1 to 1.9 feet. Clay was encountered

from 1.9 to 3.0 feet. A strong petroleum odor was noted during the excavation. Groundwater began infiltrating the excavation at a depth of 1.5 feet. Gross petroleum contamination was noted floating on top of the groundwater in the excavation. A photograph of this Test Pit can be found in Appendix B.

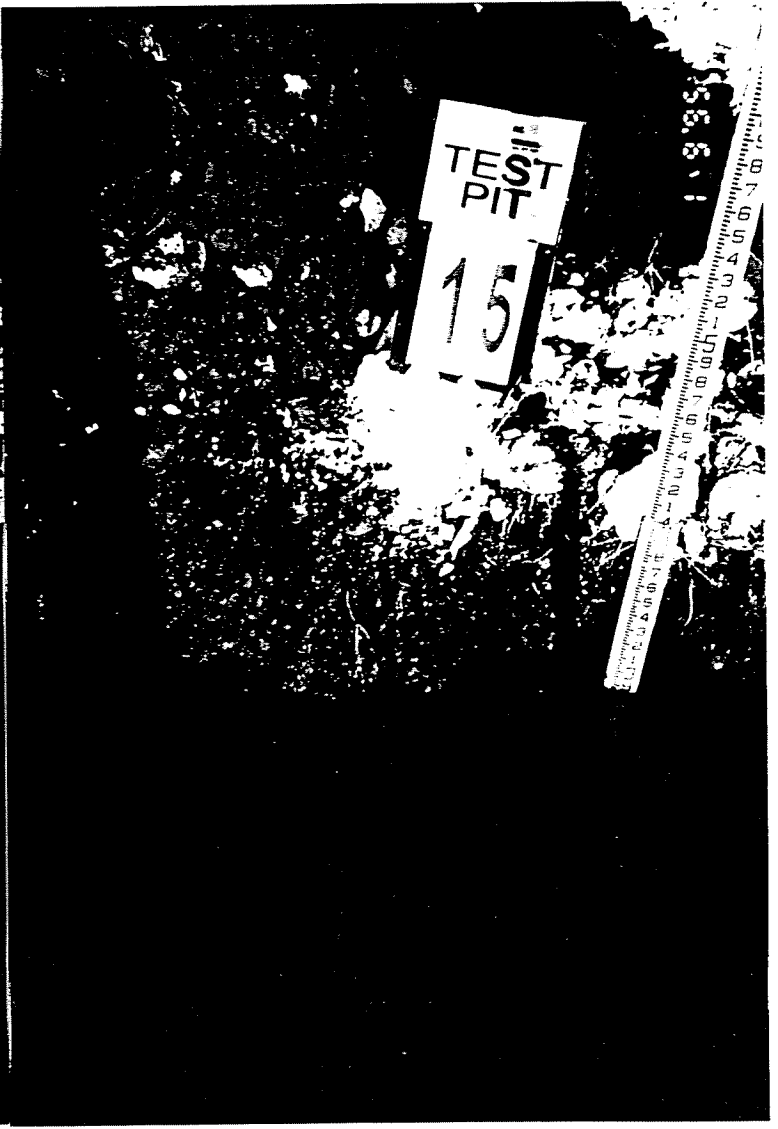
PHOTO 4 : Test Pit 15

\* Test Pit 15, is located at a distance of 200 feet southeast of Test Pit 5. The test pit was excavated to a depth of 3.5 feet. Cinders and slag were encountered to a depth of 1.5 feet. Sand was encountered from a depth of 1.5 to 2.0 feet. Clay was encountered from 2.0 to 3.5 feet. A slight petroleum odor was noted during the excavation. In addition, no groundwater was observed. A photograph of this Test Pit can be found in Appendix B.

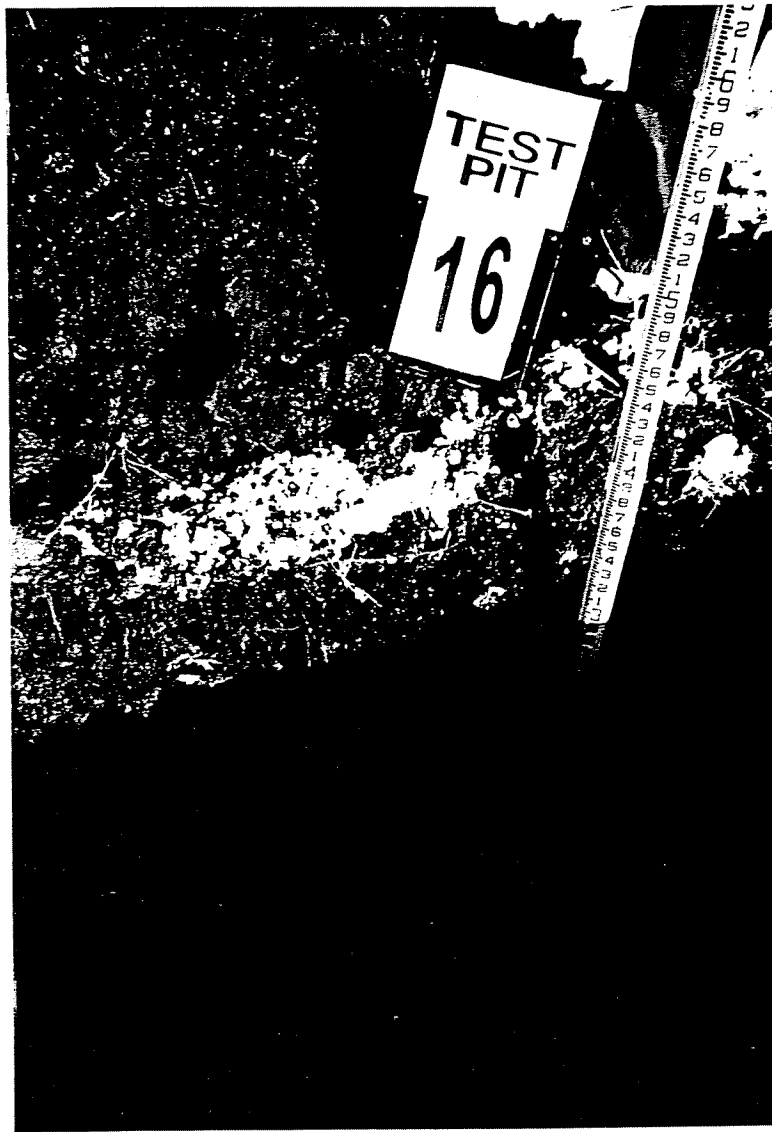
PHOTO 5 : Test Pit 16

\* Test Pit 16, is located at a distance of 250 feet southeast of Test Pit 5. The test pit was excavated to a depth of 3.7 feet. Cinders were encountered to a depth of 1.7 feet. Clay was encountered from 1.7 to 3.7 feet. A slight petroleum odor was noted during the excavation. Groundwater began infiltrating the excavation at a depth of 1.7 feet. An oil sheen was noted floating on top of the groundwater in the excavation. A photograph of this Test Pit can be found in Appendix B.

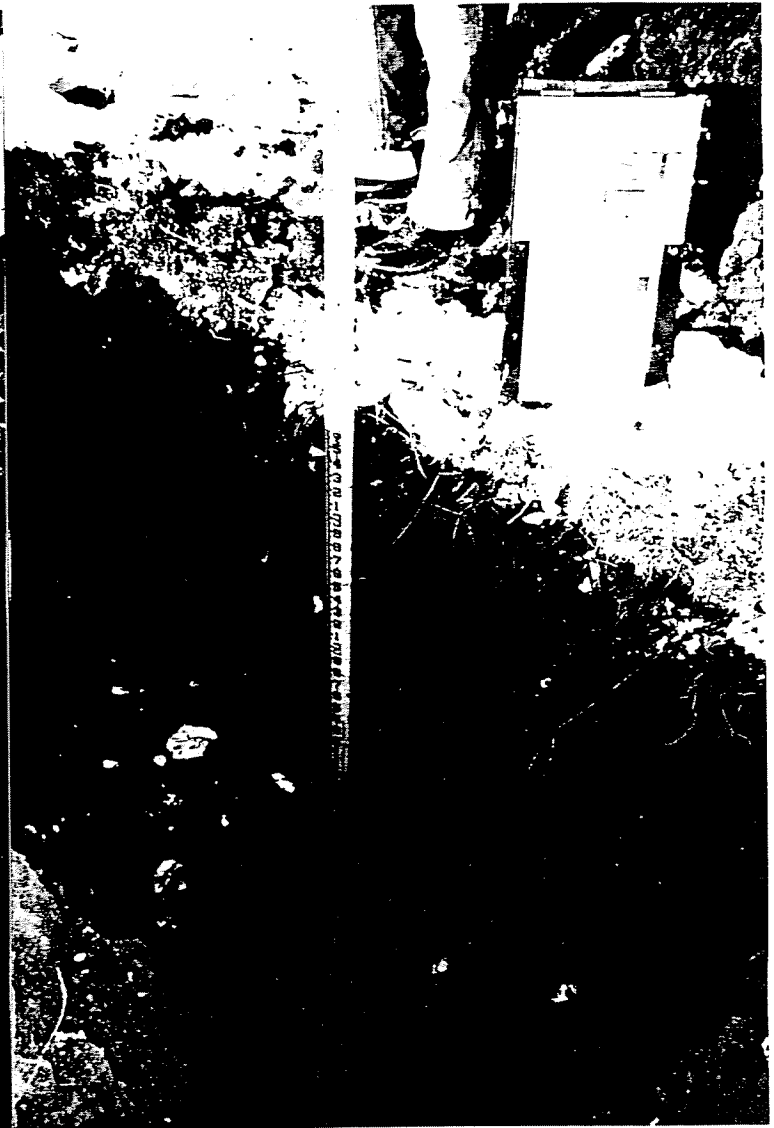
PHOTO 6 : Test Pit 17

\* Test Pit 17, is located at a distance of 275 feet southeast of Test Pit 5. The test pit was excavated to a depth of 3.7 feet. Topsoil was encountered to a depth of 1.3 feet. Sandy clay was observed from a depth of 1.3 to 3.7 feet. No groundwater was observed in the excavation. In addition, no petroleum odors were observed. A photograph of this Test Pit can be found in Appendix B. After the excavation had been completed, a sample was obtained by compositing the soils from the entire depth of the excavation. The resultant sample was mixed, composited and placed in the appropriate, pre-cleaned and labeled sample containers. The sample containers were then placed

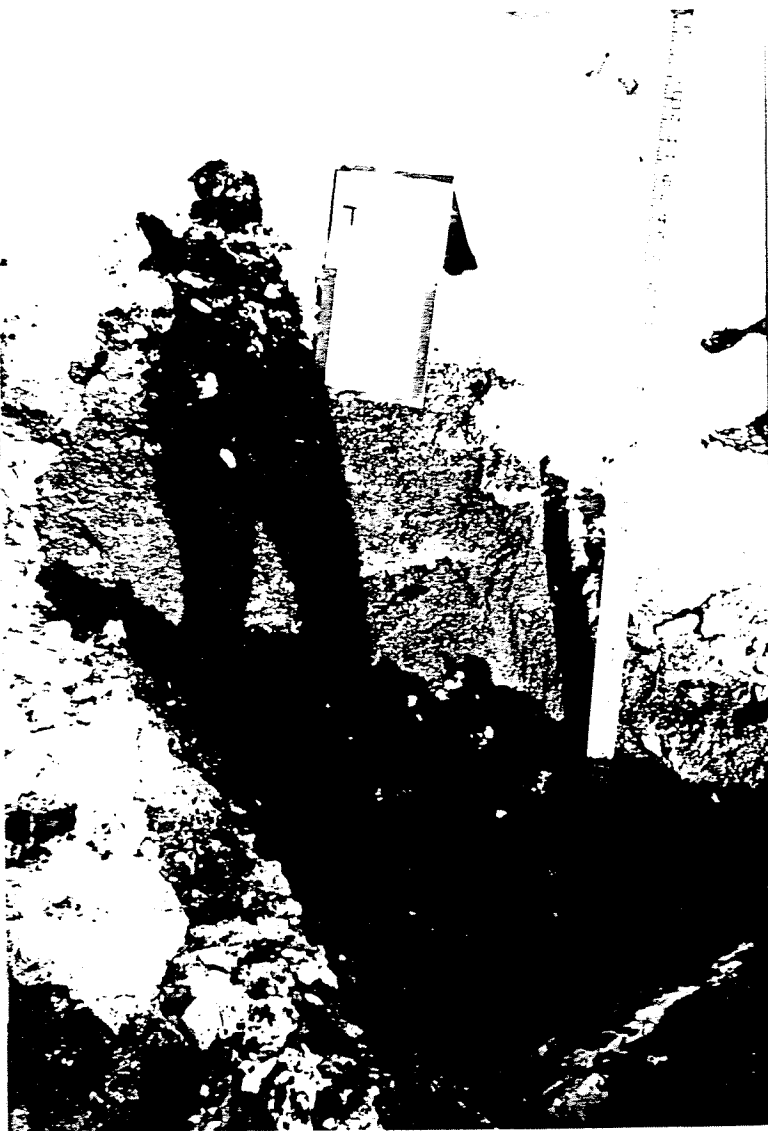
PHOTO 7 : Test Pit 18

\* Test Pit 18, is located at a distance of 100 feet south of Test Pit 5. The test pit was excavated to a depth of 3.0 feet. Slag was encountered to a depth of 0.5 feet. Topsoil was encountered from a depth of 0.5 to 1.0 feet. Cinders were encountered from a depth of 1.0 to 2.0 feet. Clay was encountered from 2.0 to 3.0 feet. A slight petroleum odor was noted during the excavation. No groundwater was observed. A photograph of this Test Pit can be found in Appendix B.

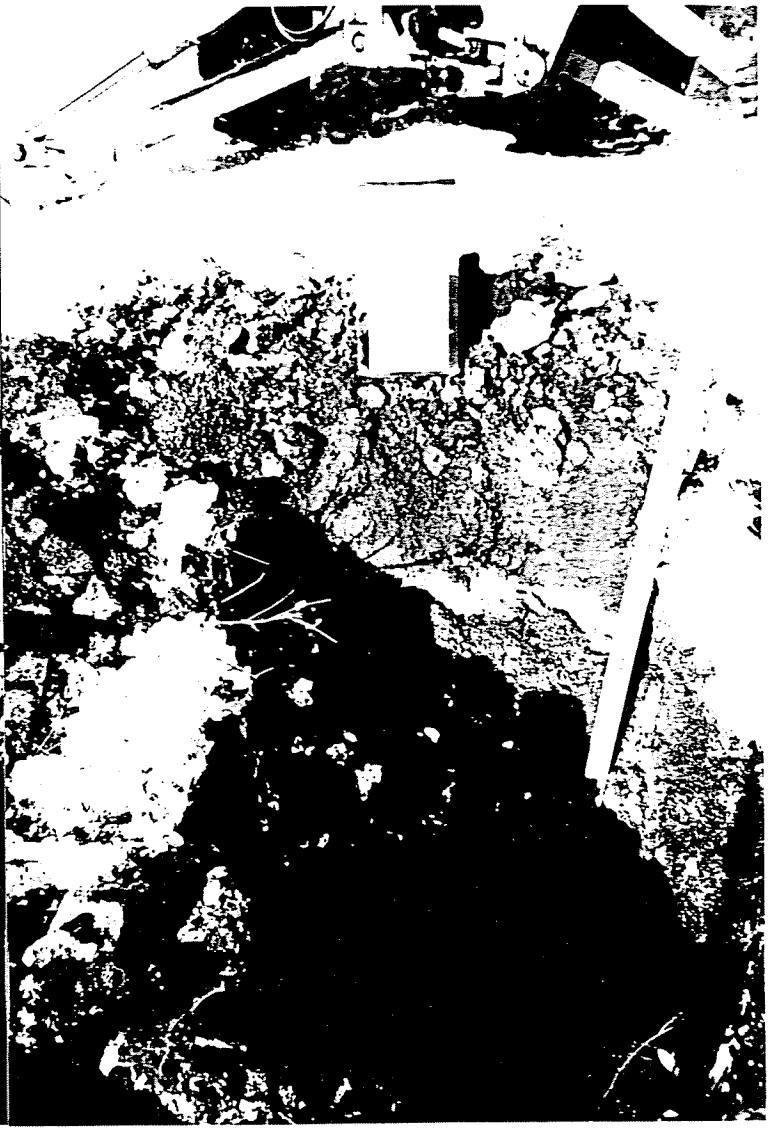
PHOTO 8 : Test Pit 19

\* Test Pit 19, is located at a distance of 175 feet south of Test Pit 5. The test pit was excavated to a depth of 3.0 feet. Slag was encountered to a depth of 0.5 feet. Topsoil was encountered from a depth of 0.5 to 1.0 feet. Sandy clay was encountered from 1.0 to 3.0 feet. No groundwater was observed. In addition, no petroleum odors were observed. A photograph of this Test Pit can be found in Appendix B.

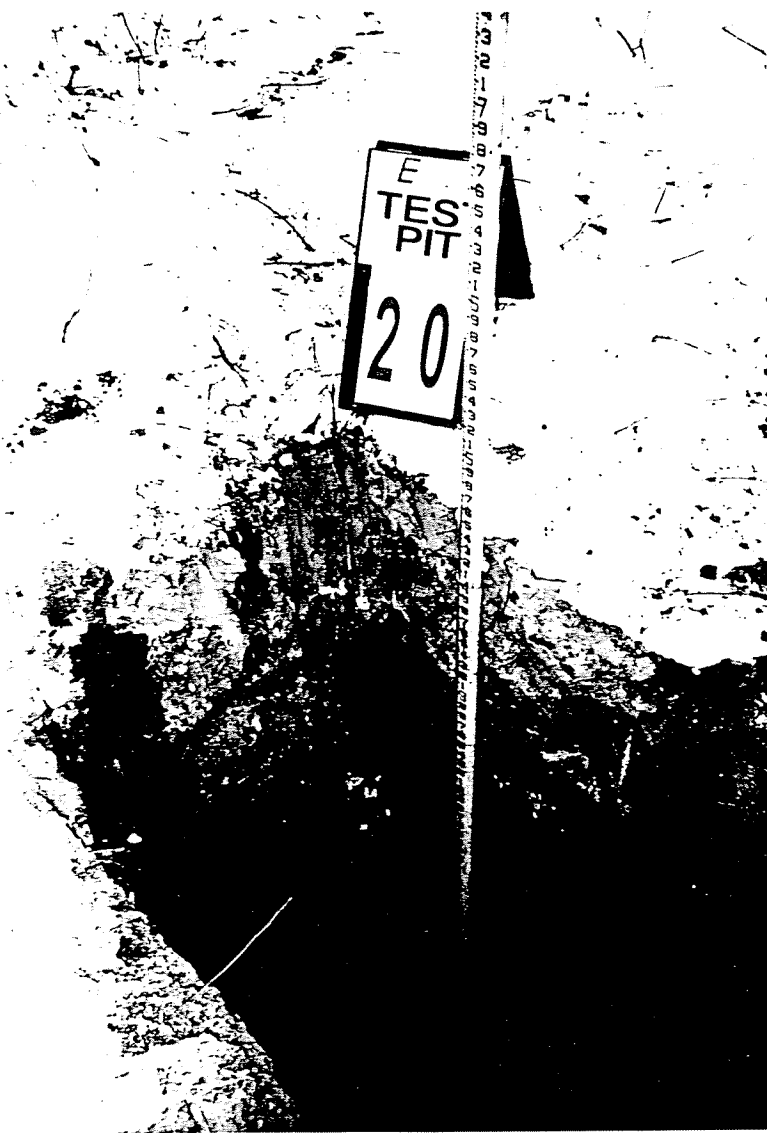
PHOTO 9 : Test Pit 20

\* Test Pit 20, is located at a distance of 125 feet southwest of Test Pit 5. The test pit was excavated to a depth of 4.3 feet. Sand and topsoil were encountered to a depth of 1.1 feet. Rubble was encountered from a depth of 1.1 feet to 2.2 feet. Beyond that point, sandy clay was observed. Petroleum contamination was first encountered at a depth of 2.2 feet. A strong petroleum odor was noted during the excavation. Groundwater began infiltrating the excavation at a depth of 2.2 feet. Gross petroleum contamination was noted floating on top of the groundwater in the excavation. A photograph of this Test Pit can be found in Appendix B.

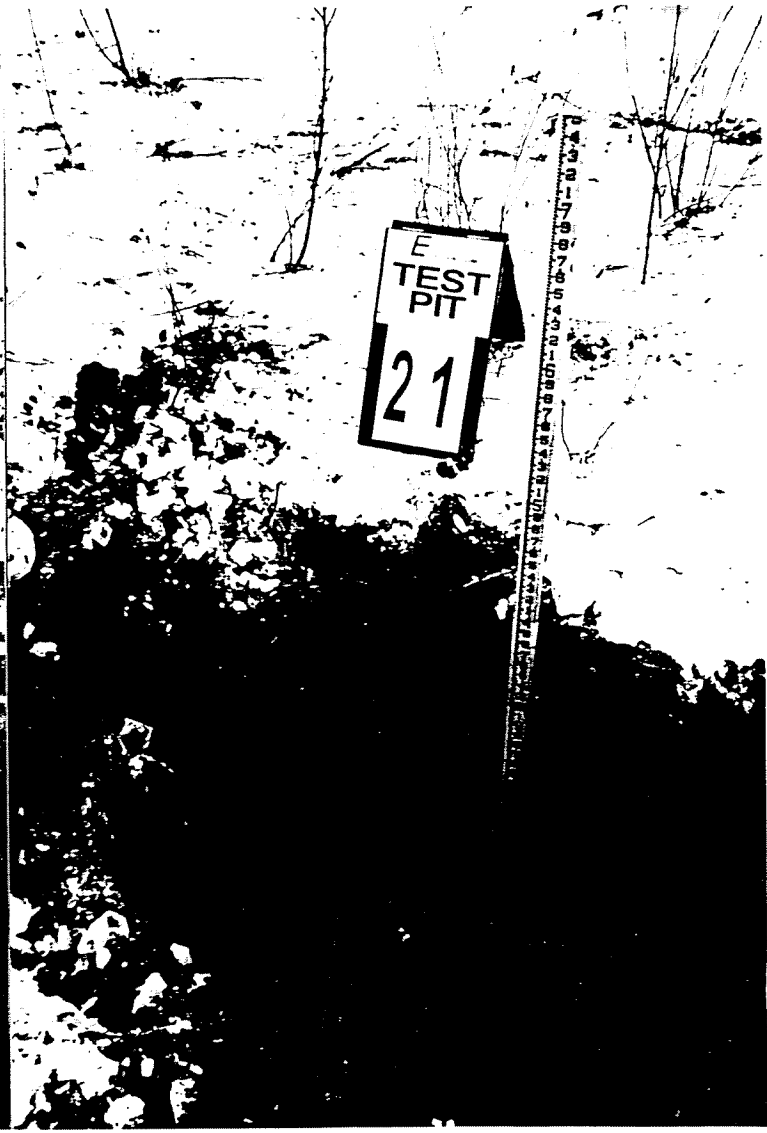
PHOTO 10 : Test Pit 21

\* Test Pit 21, is located at a distance of 175 feet southwest of Test Pit 5. The test pit was excavated to a depth of 4.1 feet. Topsoil and cinders were encountered to a depth of 1.5 feet. Clay was observed from a depth of 1.5 to 2.8 feet. Sandy clay was observed from a depth of 2.8 to 4.1 feet. No groundwater was observed in the excavation. In addition, no petroleum odors were observed. A photograph of this Test Pit can be found in Appendix B. After the excavation had been completed, a sample was obtained by compositing the soils from the entire depth of the excavation. The resultant sample was mixed, composited and placed in the appropriate, pre-cleaned and labeled sample containers. The sample containers were then placed on ice and delivered to the contract laboratory under a strict chain of custody. The samples from this test point were analyzed for the following parameters: volatile organic compounds, Method SW-846 8021; semi-volatile organic compounds, Method SW-846 8270; and TCLP lead, Method SW-846 3015/6010.

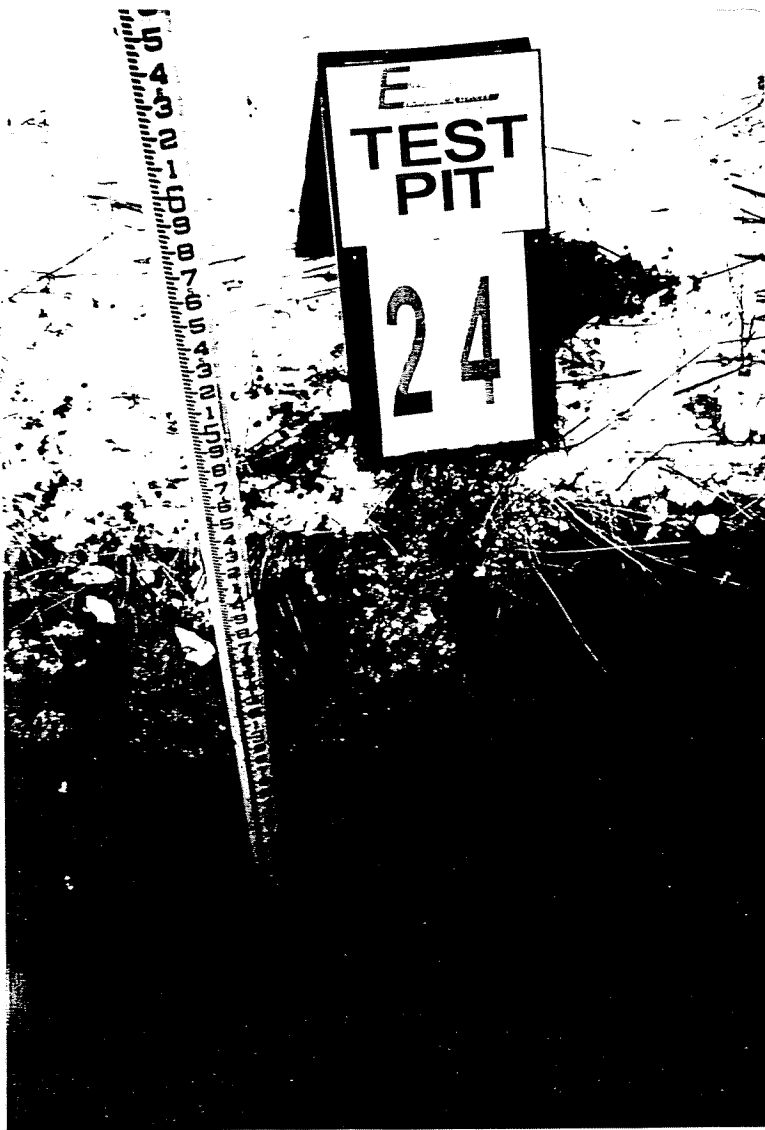
PHOTO 13 : Test Pit 24

\* Test Pit 24, is located at a distance of 100 feet northwest of Test Pit 5. The test pit was excavated to a depth of 4.3 feet. Topsoil, sand and debris were encountered to a depth of 1.3 feet. Cinders and slag were encountered from a depth of 1.3 feet to 2.1 feet. Beyond that point, sandy clay was observed. Petroleum contamination was first encountered at a depth of 1.6 feet. A strong petroleum odor was noted during the excavation. Groundwater began infiltrating the excavation at a depth of 1.6 feet. Gross petroleum contamination was noted floating on top of the groundwater in the excavation. A photograph of this Test Pit can be found in Appendix B.

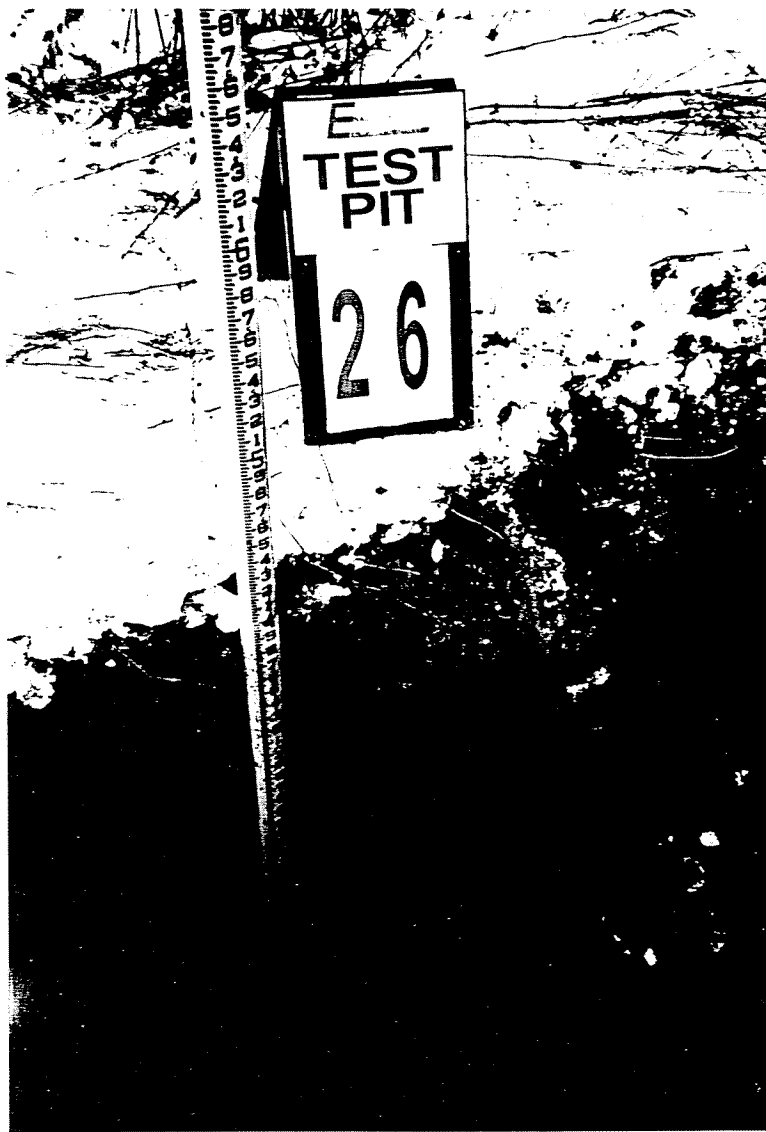
PHOTO 15 : Test Pit 26

\* Test Pit 26, is located at a distance of 175 feet north of Test Pit 5. The test pit was excavated to a depth of 4.2 feet. Topsoil was encountered to a depth of 1.0 feet. Sand was observed from a depth of 1.0 to 3.6 feet. Clay was encountered from 3.6 to 4.2 feet. No groundwater infiltration was observed. In addition, no petroleum odors were observed. A photograph of this Test Pit can be found in Appendix B.
