Phase I Environmental Site Assessment Report

Herbert F. Darling Site
99 Tifft Street
Buffalo, New York

August 2006

Buffalo Urban Development Corporation

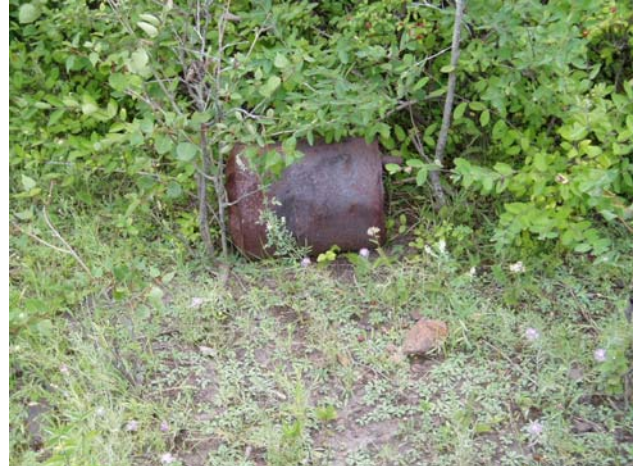
- Photo 1: Adjacent Property (CSX) looking west
- Photo 2: Adjacent property (CSX/BUDC) looking south
- Photo 3: Nearby property (Alt-Tifft LF/Marilla St. LF) looking east
- Photo 4: Gas can within heavy vegetation along eastern edge of property

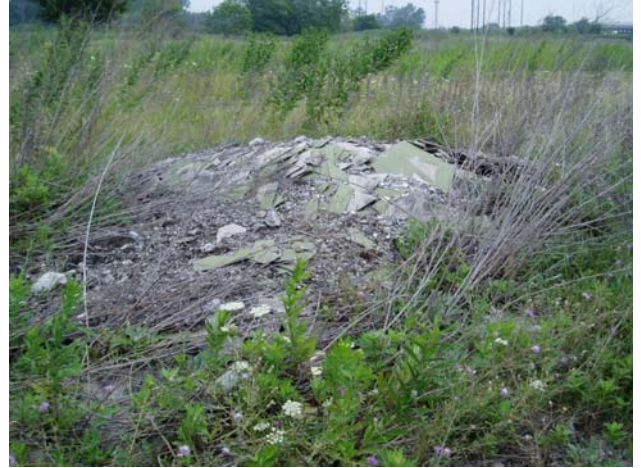
- Miscellaneous dumping was noted in various areas on-site. Materials observed included scrap automobile parts, household items, apparent asbestos house siding, and tires.

- Photo 1: Adjacent property across Tifft St. looking north
- Photo 2: Tile debris found on site looking north
- Photo 3: Large central soil pile on site looking west
- Photo 4: Soil/slag pile on northern side of subject property looking west

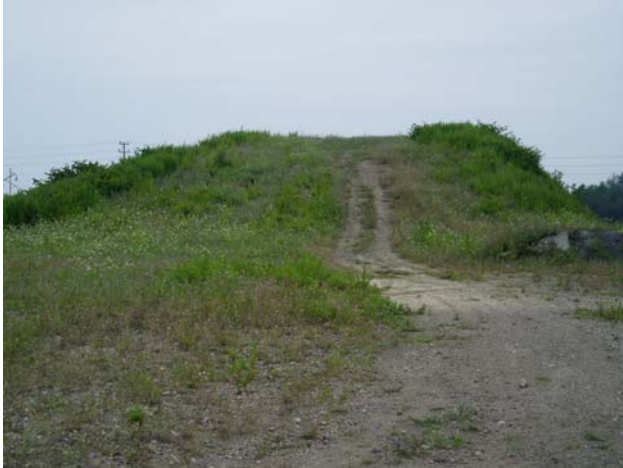
Photo 3:

- The subject site includes three large slag and soil/fill materials from an unknown source. Slag and other industrial fill materials contain highly variable and sometimes elevated concentrations of metals and semi-volatile organic compounds.
- Miscellaneous dumping was noted in various areas on-site. Materials observed included scrap automobile parts, household items, apparent asbestos house siding, and tires.
- Adjacent sites include the CSX property (historic railroad), Tifft Farms (portion; former landfill), St. Lawrence Cement and current/historic railroad properties.

- A Phase II ESA is recommended for the subject property. The Phase II ESA should include soil and slag/fill sample collection and analysis for VOCs, SVOCs, PCBs and metals and groundwater sample collection and analysis for VOCs and metals.
- Although outside the scope of this Phase I ESA, wetland vegetation and ponded water was noted on the northern portion of the Site. Prior to Site redevelopment, a general wetland boundary delineation is recommended to determine the area of the Site which is not developable due to the presence of (potential) wetlands.

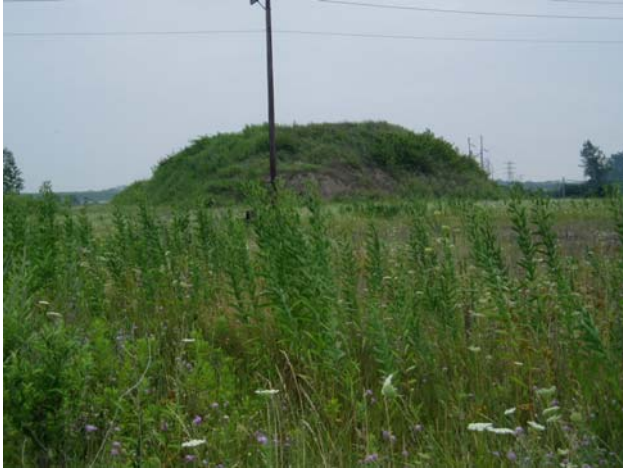
- Photo 1: Central soil pile looking from the east
- Photo 2: Slag pile on northern side of property
- Photo 3: Close up of slag pile surface
- Photo 4: Adjacent property Route 5 embankment

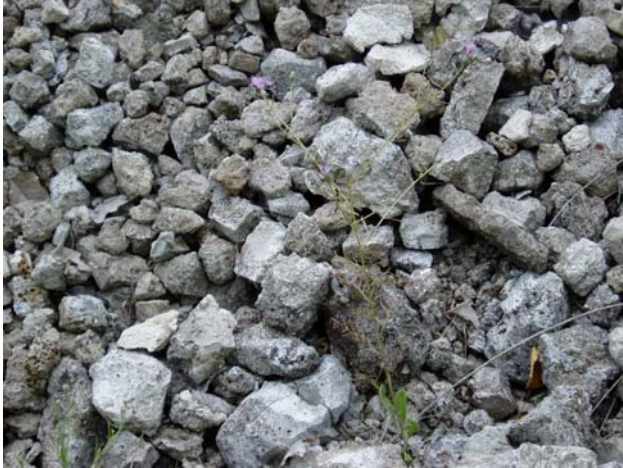
Photo 3:

- Historic slag sampling conducted by the NYSDEC indicated that elevated arsenic, barium and PCBs were noted within at least one slag sample on-Site.
- Possible dumping or landfill activities were noted on the north and south adjacent properties from at least the 1960s through 2005.

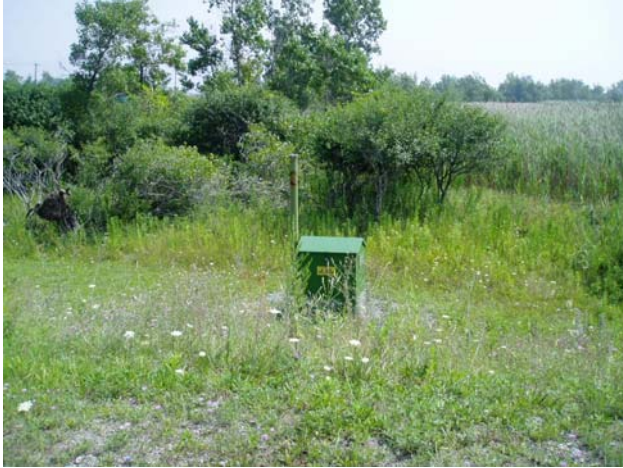
Photo 1: Gas pipeline in northwestern most corner of property looking east
