**Attachment A**  
**AMS Letter Report of**  
**Findings**

Re: **Radiological Gamma Walkover Survey  
310 Ship Canal Parkway Development – Subplot 4**

## **Surface Scan Measurements of 310 Ship Canal Parkway Site**

**Re: Surface Scan Measurements for 310 Canal Parkway Site**

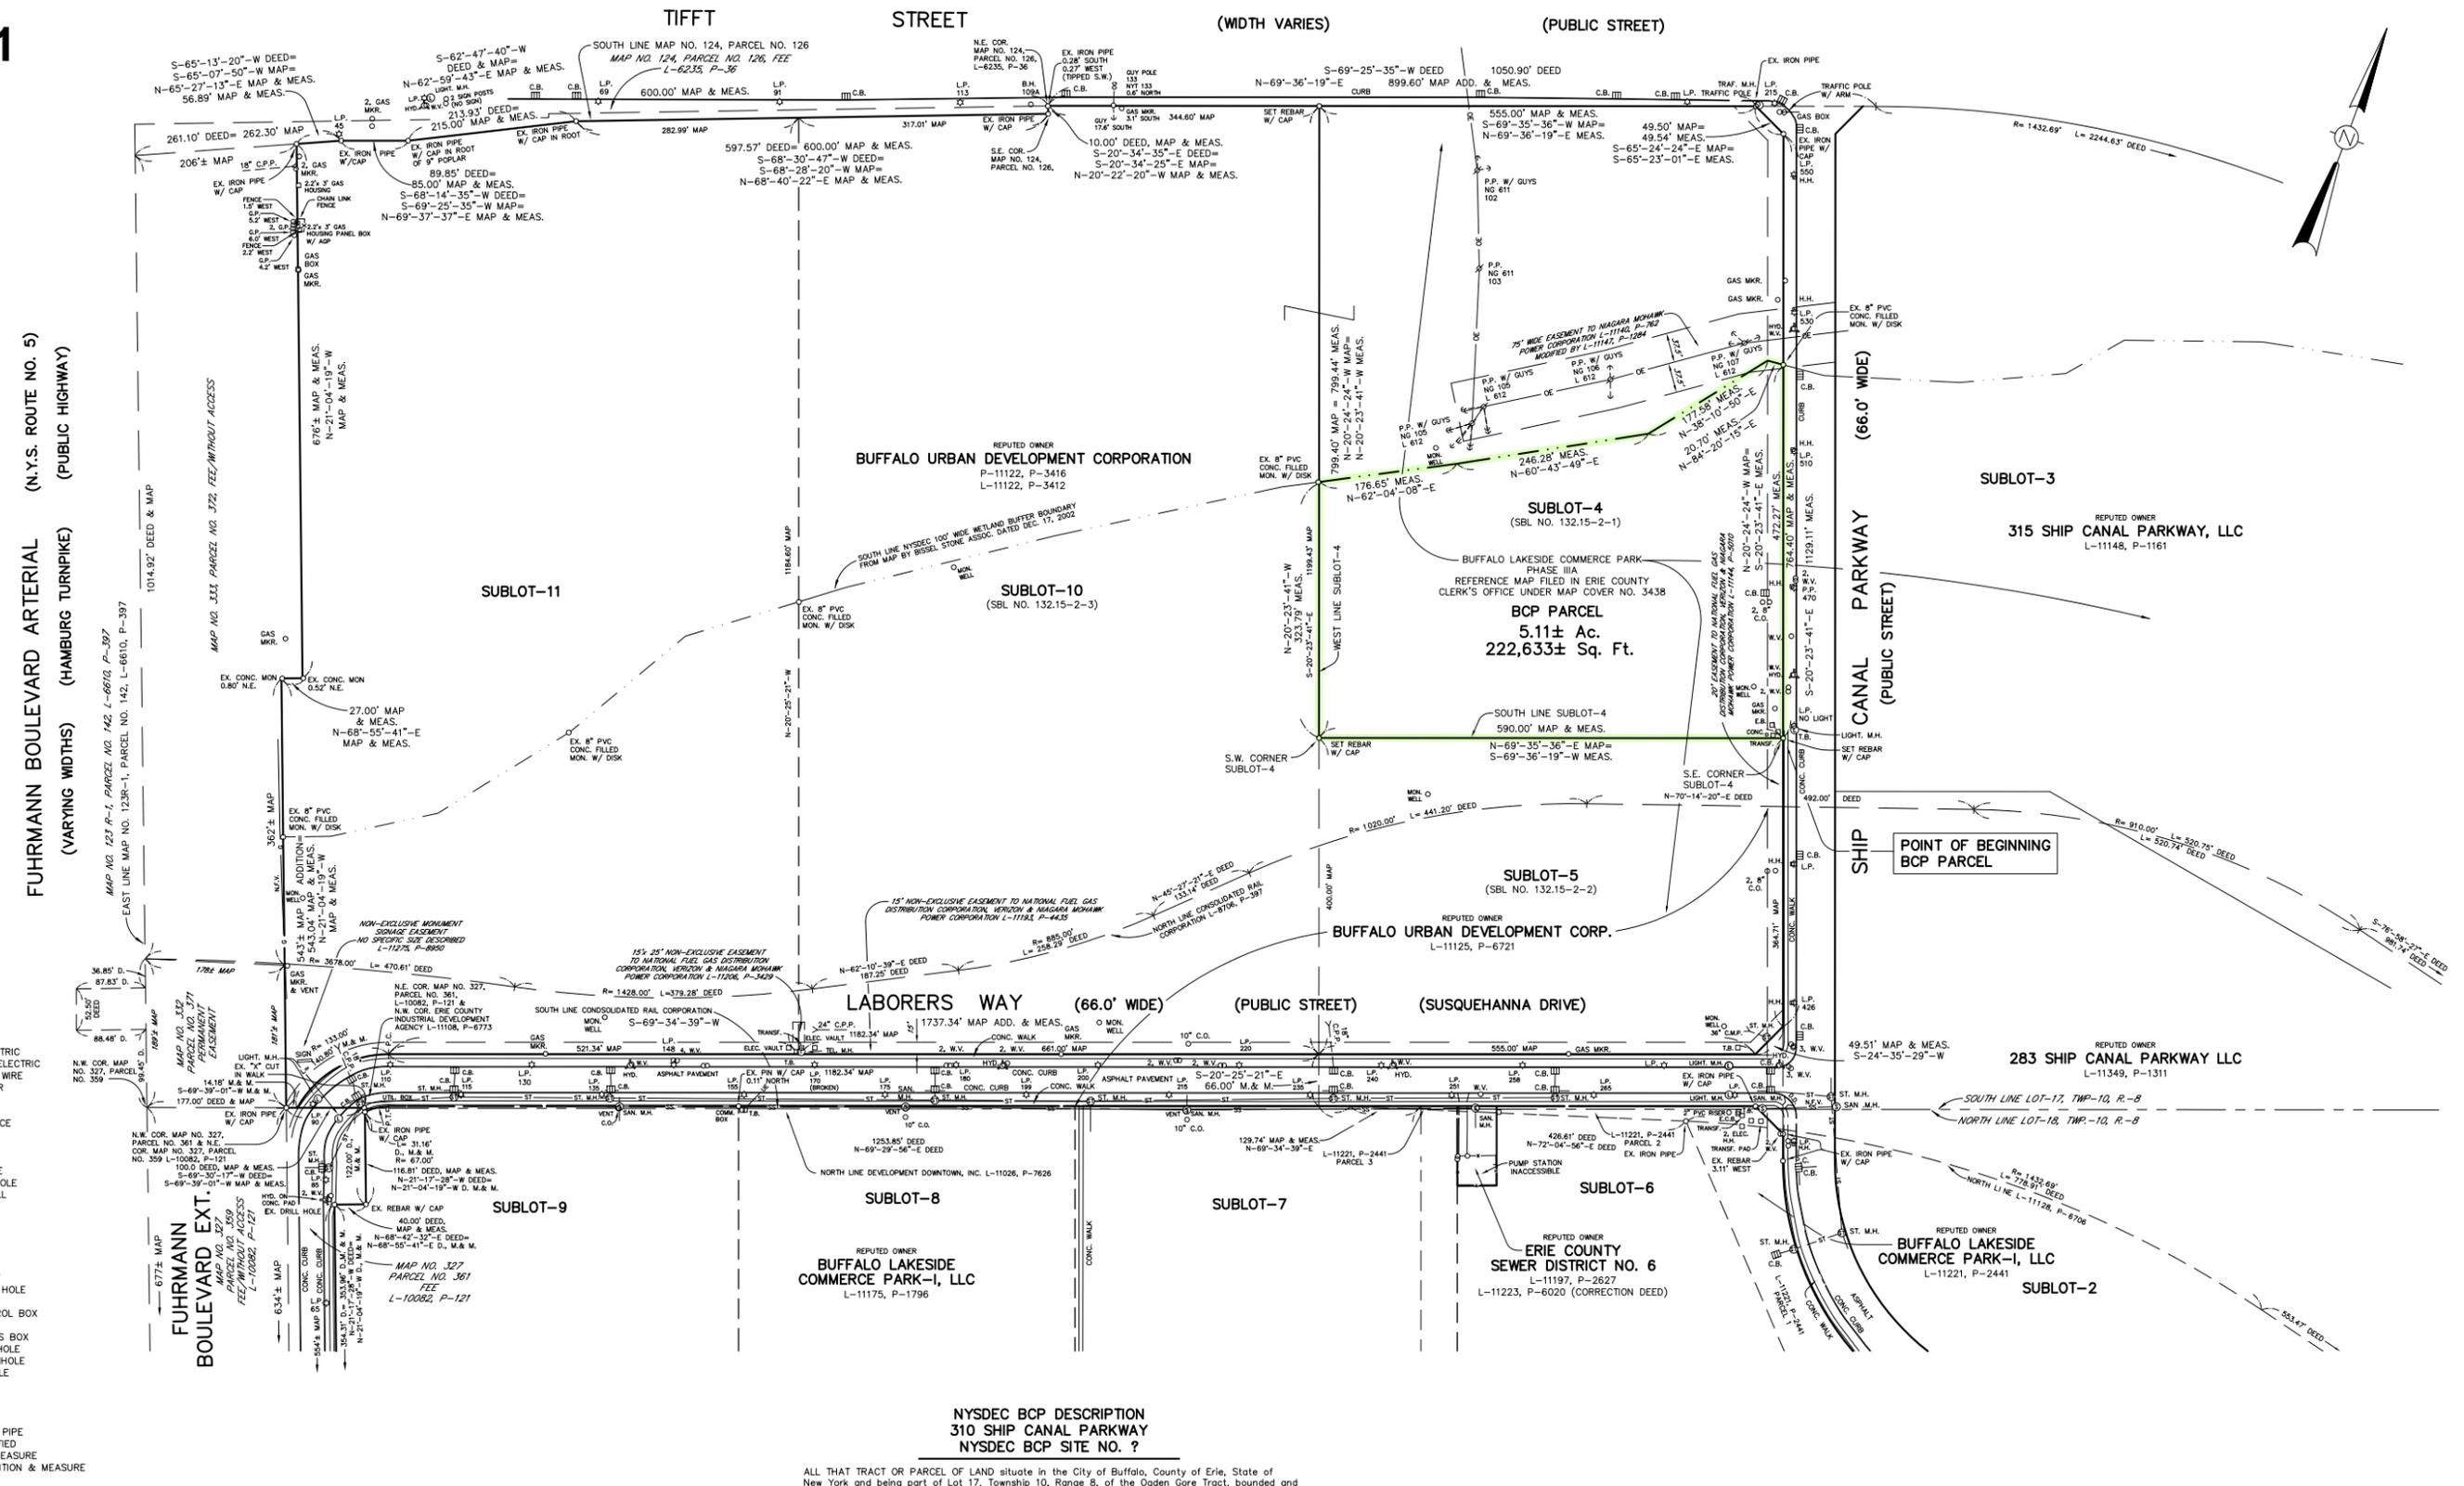
# FIGURE 1

Laborers Way, LLC has requested that C&S Engineers provide environmental investigation and consulting services related to the 310 Ship Canal Parkway Development (Site or Subplot 4), which is a part of the newly proposed Buffalo Lakeside Commerce Park in Buffalo, New York. The parcel is currently vacant and is approximately 5.1 acres in size. A survey of the property and the current defined BCP boundary can be seen on **Figure 1**.

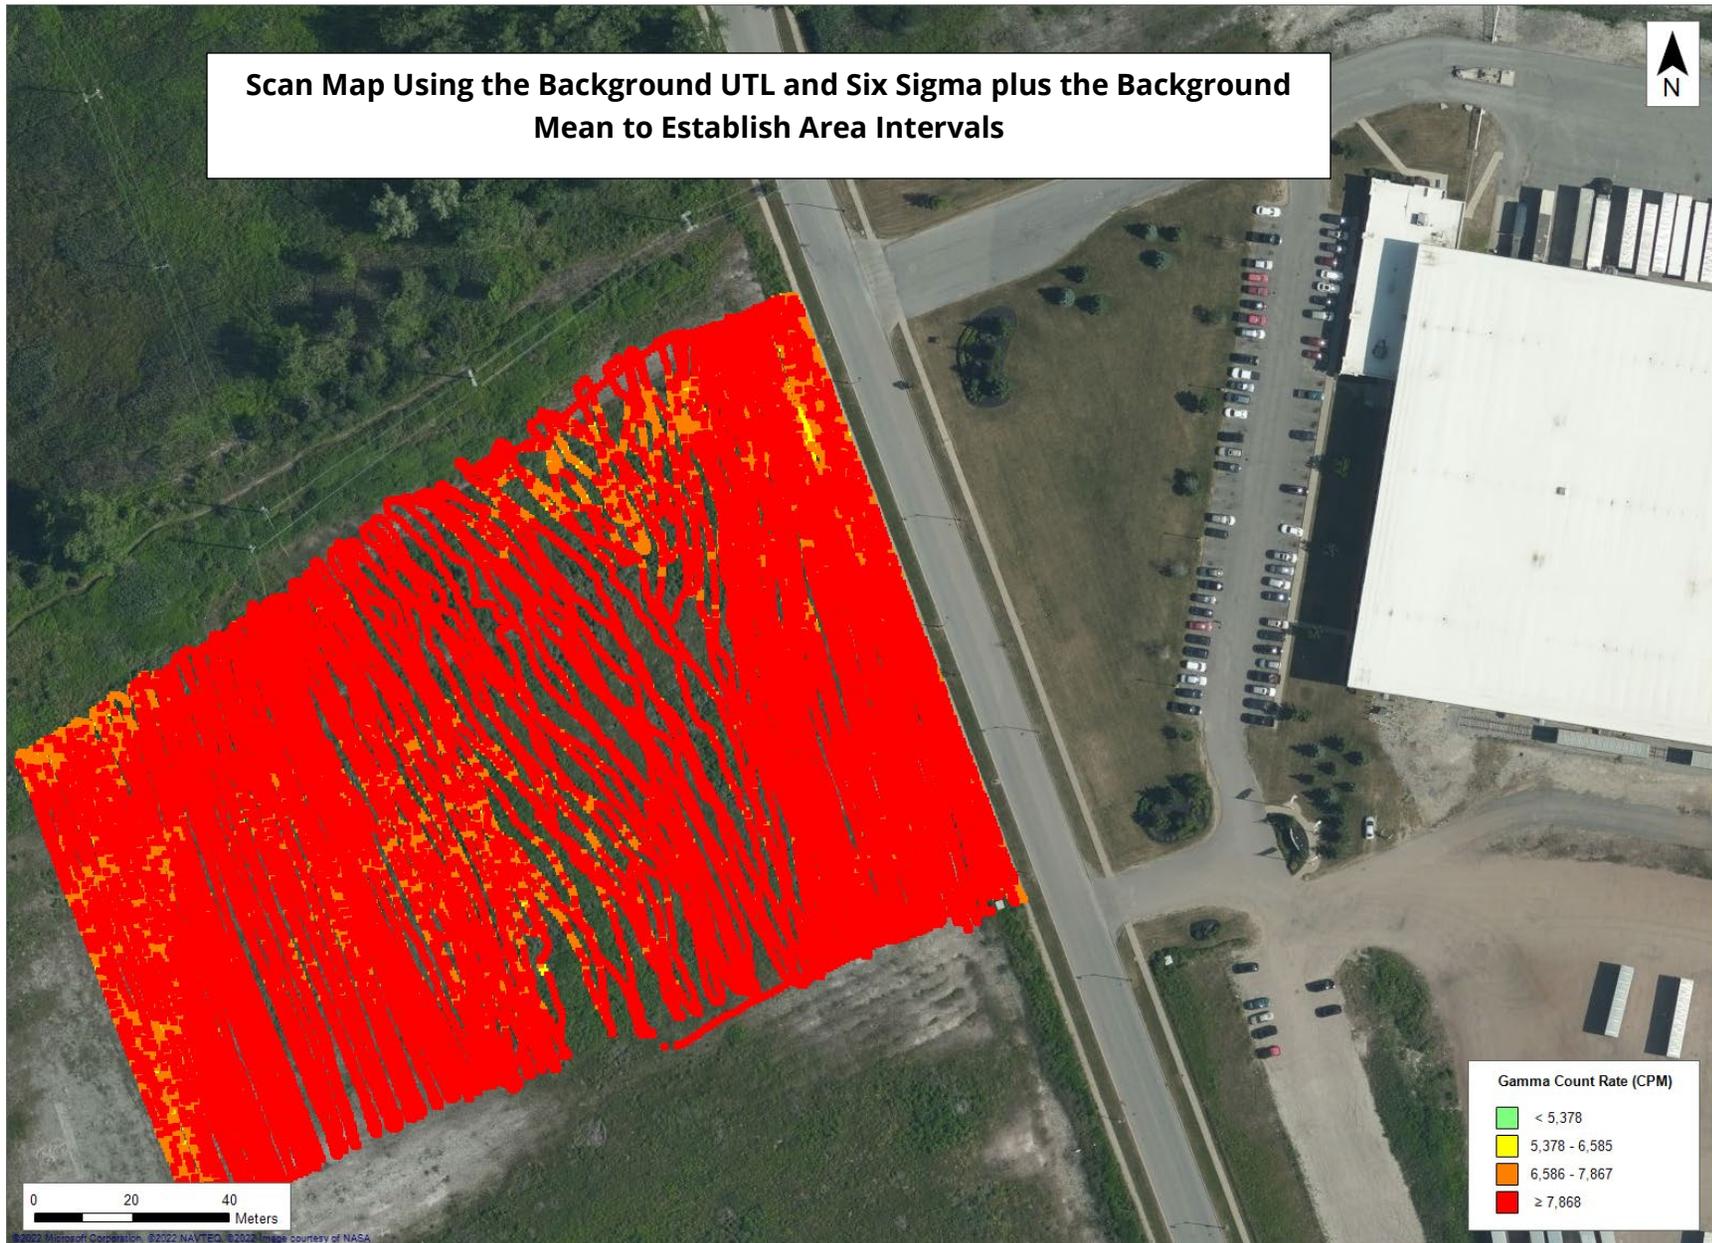
# FIGURE 2

- ACS' instrumentation logged over 28,000 readings and geolocated the readings onto aerial photographs, which are attached as **Figures 2** and **3**. The majority of the radiological readings collected during the gamma walkover survey ranged from approximately 5,000 cpm to over 18,500 cpm.

- AMS derived an Upper Tolerance Level (UTL) of 7,868 cpm. The was UTL used to delineate where contamination at concentrations greater than background were likely to be found. Most of the readings taken on the Site were above the UTL.

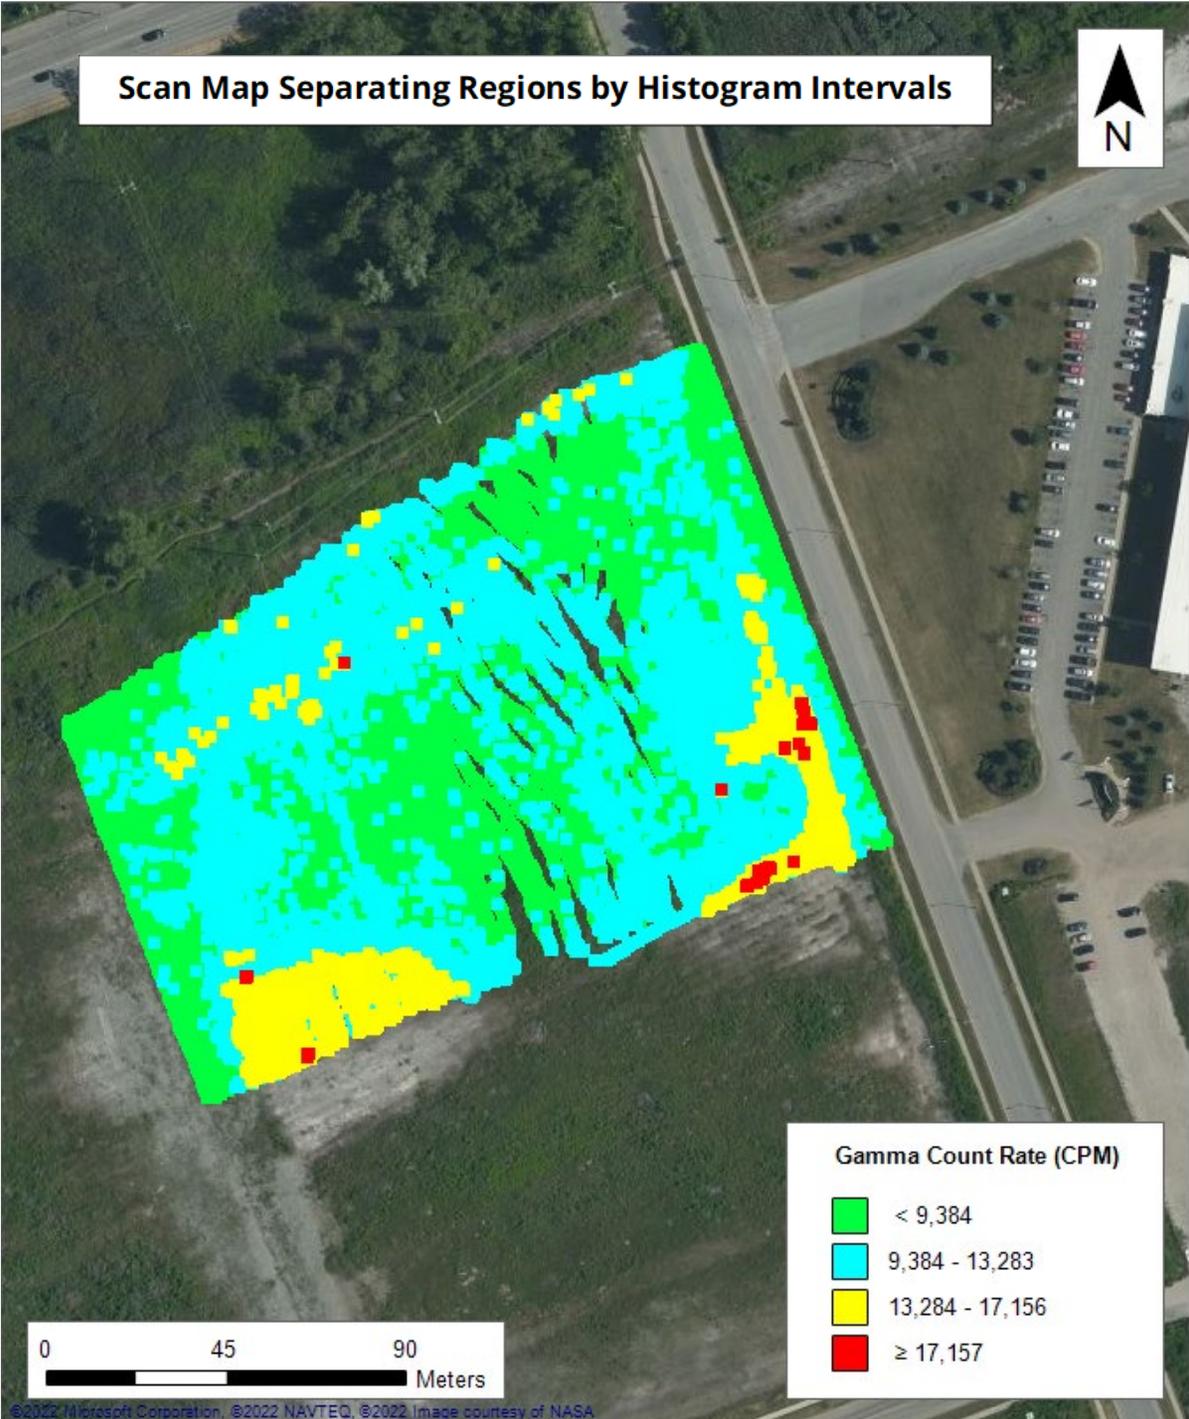
**FIGURE 3**

- Based upon the readings, AMS concluded that the Site has a relatively consistent and extensive layer of radiological impacted material at the surface. However, further interpreting the data as shown on **Figure 3** indicates that a majority of the Site appears to be at or just above two times the background level, which is the typical threshold used to evaluate the significance of radiological impacts.

- **Figure 3** depicts the areas shown to be greater than three times background in yellow and red. These areas are located in the south western and southeastern corners of the Site.

Because this investigation only included a surficial gamma walkover survey, C&S recommends the onsite monitoring be completed by a qualified radiological technician during all excavation work planned at depths deeper than 18 inches (i.e., foundation and utility line excavation).

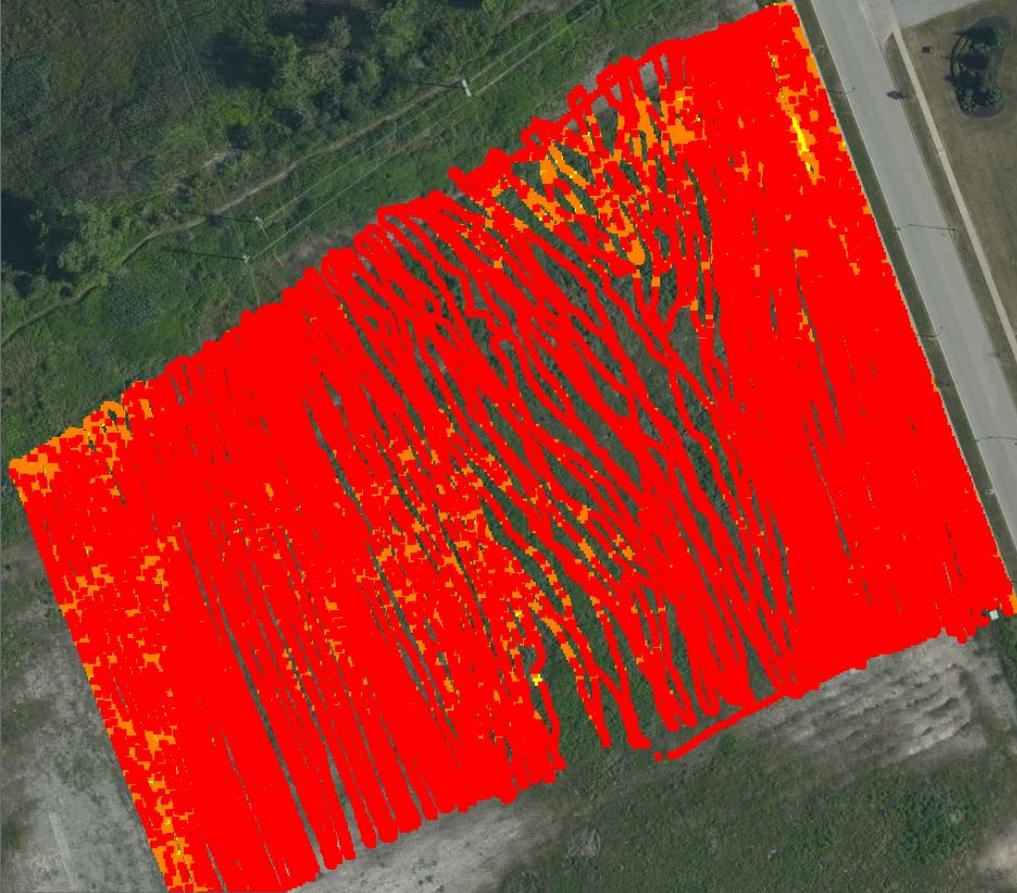
**Scan Map Using the Background UTL and Six Sigma plus the Background Mean to Establish Area Intervals**

The results were then transferred to an aerial photograph of the site and exhibited as colors based on use of background data to develop "bins" of count rate data. The first scan map shown in Attachment 1 was coded by using intervals related to the Upper Tolerance Level (UTL) of the background and the six sigma value above the background mean.

In Attachment 1 the first scan map figure shown indicates the site has a fairly extensive cover that contains radioactive materials greater than normal background concentrations. The Upper Tolerance Level (UTL) was used to delineate where contamination at concentrations greater than background were likely to be found. This is in keeping with use of the UTL as a measure when a contaminant is found to occur naturally in the soil and a means is needed to distinguish between natural background radioactivity and that occurring due to human activity.

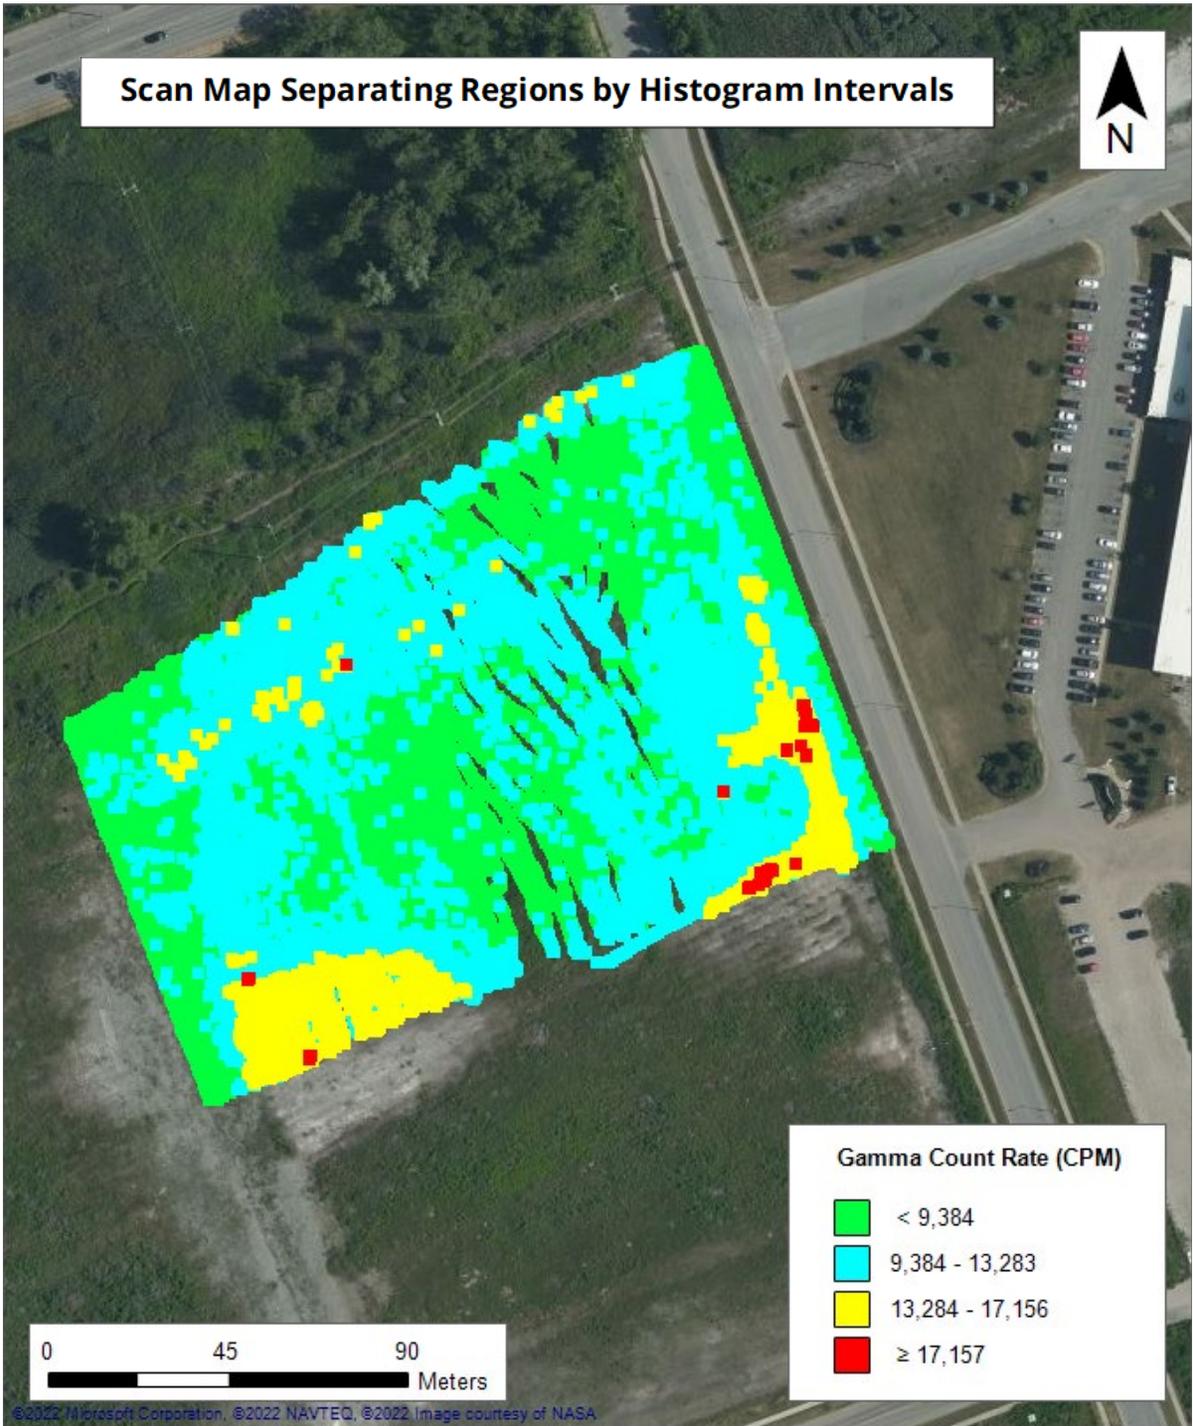
# Scan Map Separating Regions by Histogram Intervals

Because the site was known to contain radiological contaminants from steel slag used as fill, ACS's client also requested a map that would provide a better delineation of the areas significant levels of contamination. Intervals were then established using the Histogram data shown in Attachment 2 and a second map focusing on higher count rate values was created. The second scan map shown Attachment 1 has several sub areas (those in yellow and red) within the scan footprint that are greater than three times the background count rate.

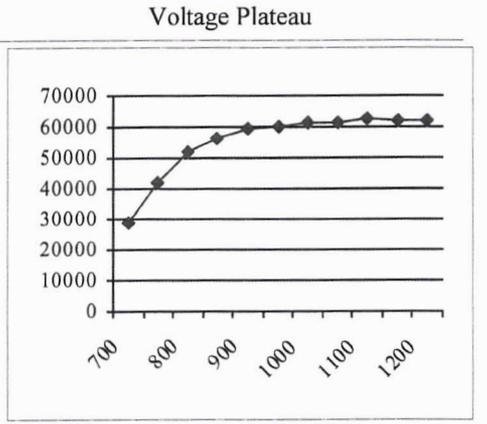
High Voltage	Source Counts	Background Counts	Net Counts
700	28445	2051	26394
750	42113	3995	38118
800	51749	6355	45394
850	56311	8044	48267
900	59179	8807	50372
950	60157	8854	51303
1000	60958	9084	51874
1050	61470	9240	52230
1100	62211	9265	52946
1150	61840	9258	52582
1200	62137	9295	52842

Recommended HV (VDC) 1,100
