# Final Engineering Report

3100 Clinton Street Site  
BCP Site No. C915339  
West Seneca, New York

B0450-019-001

3100 CLINTON STREET SITE  
NYSDEC SITE NUMBER: C915339  
WEST SENECA, NEW YORK

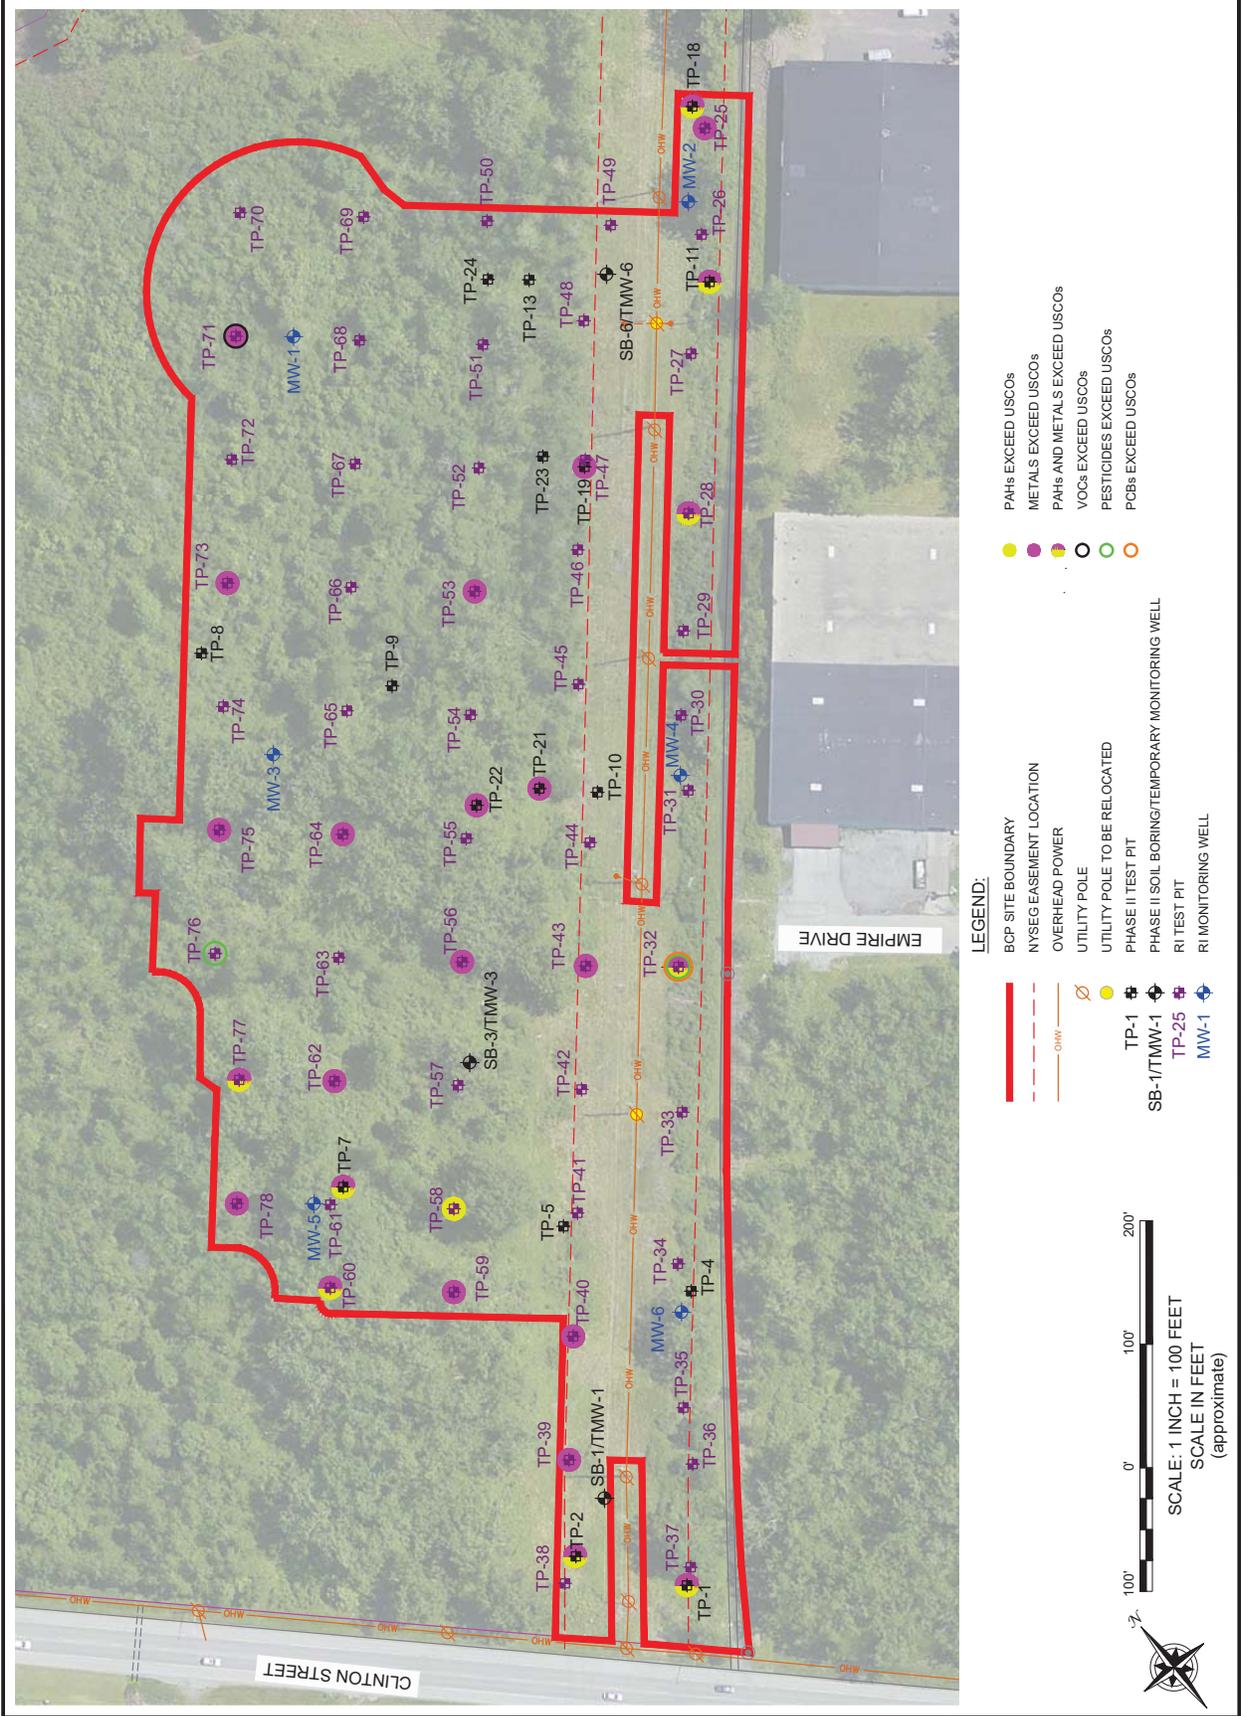
**FIGURE 3**

**PHASE II AND REMEDIAL INVESTIGATION LOCATIONS**

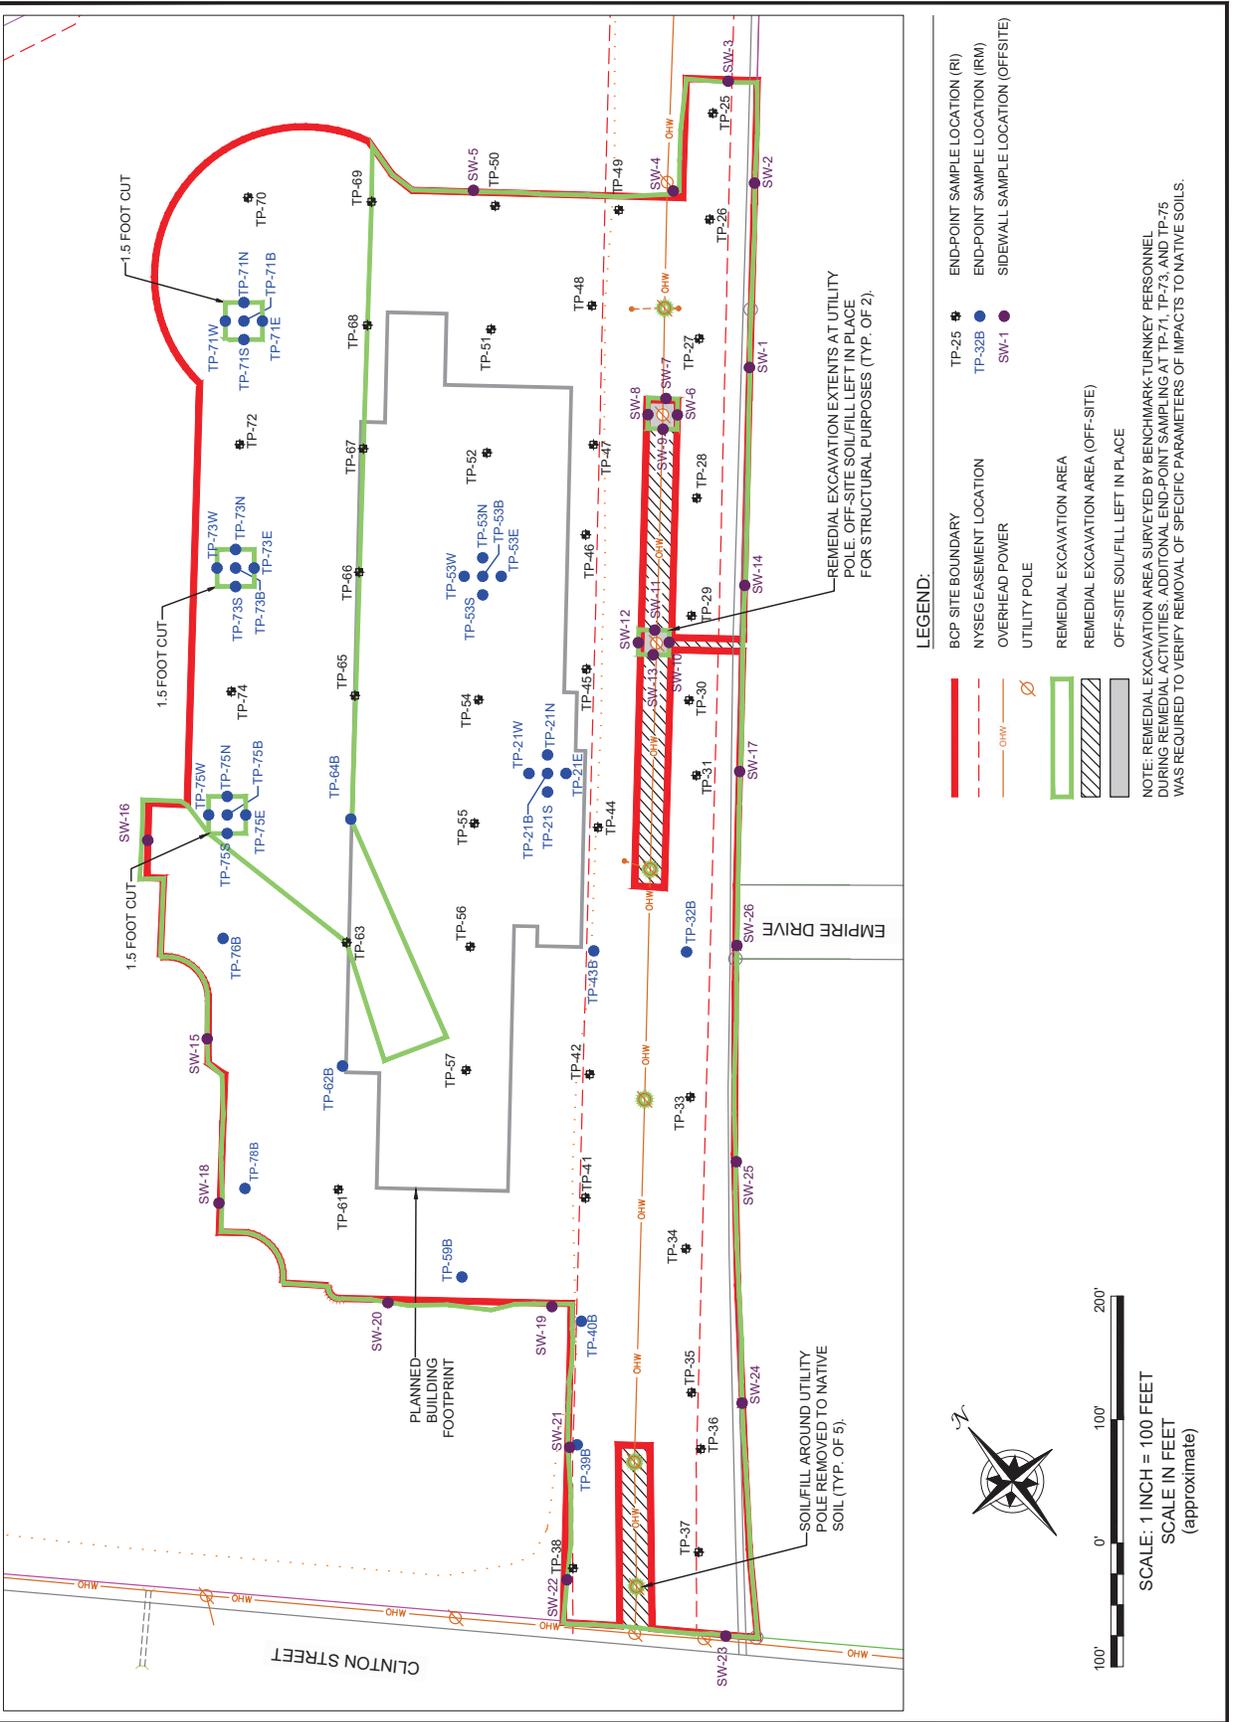
**IRM EXCAVATION AREA AND END-POINT SAMPLE LOCATIONS**

- Collection of seventy-three (73) post-excavation end-point samples during the RI and IRM activities representing bottom of excavation conditions. All end-point sample results are below USCOs (see Table 1 and Figure 4).

- Collection of twenty-six (26) post-excavation sidewall samples. All sidewall samples represent off-site conditions and analytical results remain in exceedance of USCOs and/or Commercial Use SCOs (CSCOs). Note that soil/fill surrounding two (2) utility poles within the NYSEG easement right-of-way within the northeastern portion of the Site was not fully excavated for structural purposes. The soil/fill left in-place represents off-site conditions and sidewall samples were collected from the north, south, east, and west sides of the poles (see Table 2 and Figure 4).

Figure 4 shows the approximate remedial excavation extents and locations of post-excavation end-point samples. Sidewall samples at excavation extents representing off-site conditions are included on Figure 4. Figures 5A and 5B show final depth of the excavation

Based on the initial IRM post-excavation results, additional soil/fill removal was required at five (5) post-excavation sample locations (TP-21, TP-53, TP-71, TP-73, and TP-75) as fill material was identified during mass excavation that was not previously identified in the RI (TP-71, TP-73, and TP-75), or fill material was observed deeper than surrounding native soils (TP-21 and TP-53). These areas were excavated in approximately 30’X30’ squares to delineate the area. The resampled sidewalls of the excavation locations were given the same initial sample identifier with each wall designated with its general coordinate direction (e.g. the northern sidewall of TP-21 became TP-21N). Table 1 summarizes end-point sample results and Figure 4 shows post-excavation end-point sample locations.

Twenty-six (26) sidewall samples were collected from just beyond the BCP boundary and represent off-site conditions. Exceedance of USCOS and/or CSCOS were reported by the laboratory for the offsite sidewall samples. Table 2 summarizes end-point sample results and Figure 4 shows post-excavation end-point sample locations.

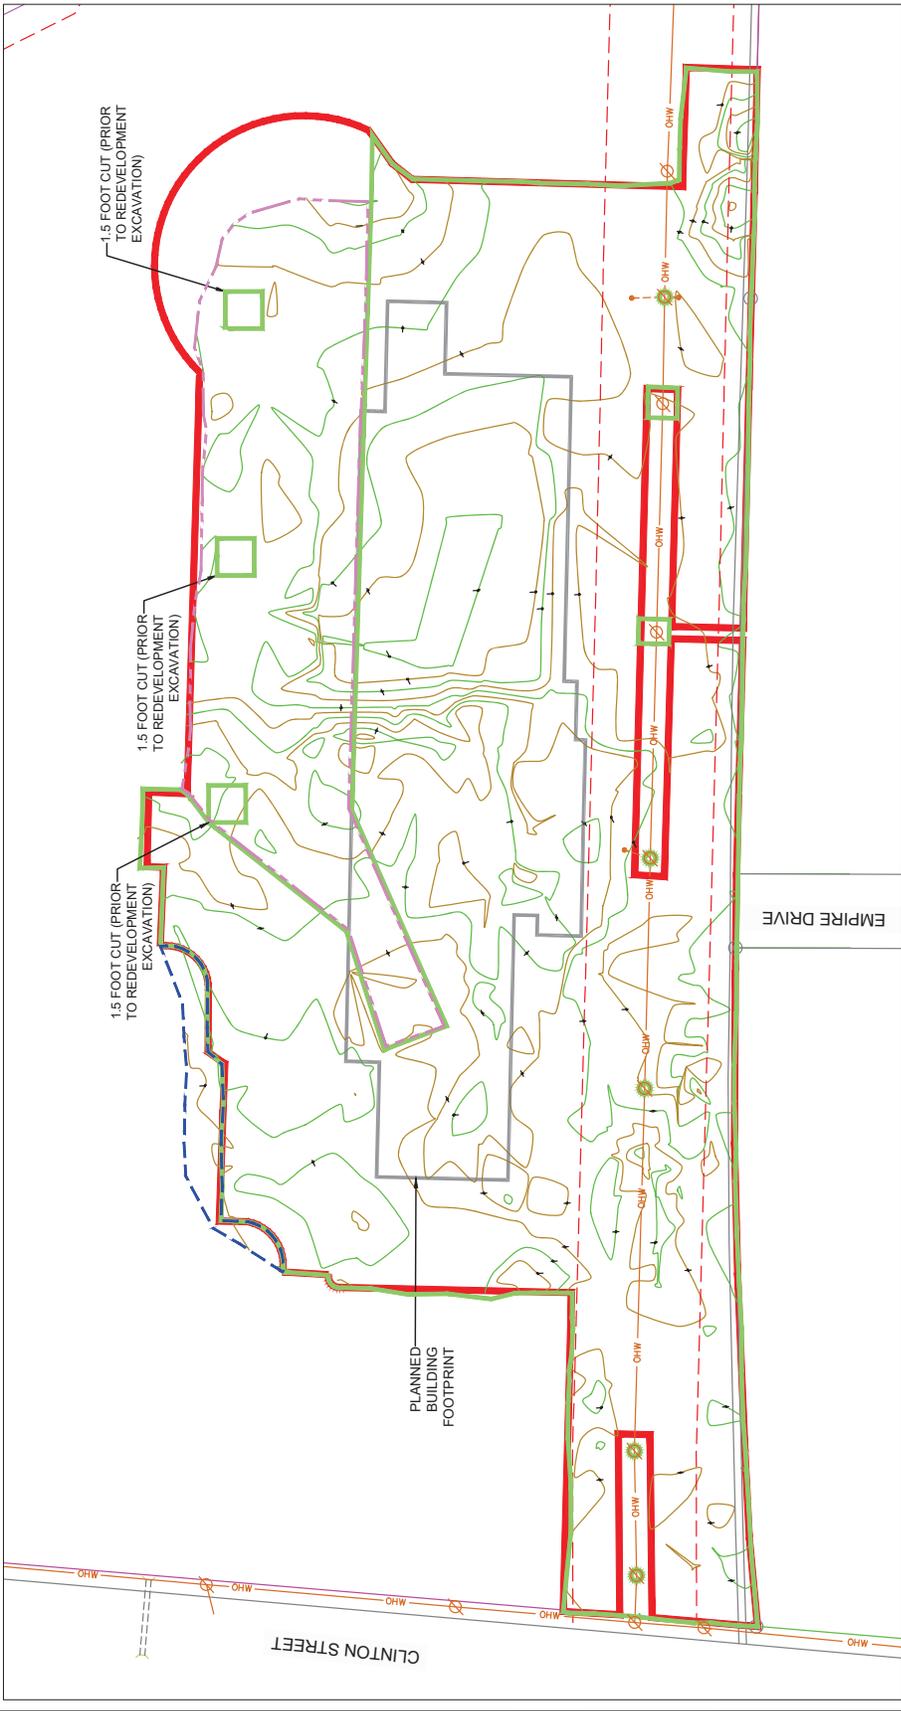
**FIGURE 5A**

**REMEDIAL EXCAVATION CONTOUR MAP**

- NOTES:**
1. ELEVATION OF BOTTOM OF REMEDIAL EXCAVATION IN FEET (DATUM NAVD 88)
  2. EXCAVATION AREA SURVEYED BY BENCHMARK-TURNKEY PERSONNEL DURING REMEDIAL ACTIVITIES.

the southwest corner of the BCP Site boundary for redevelopment purposes. Though not included within the BCP Site, the Volunteer elected to handle the similar soil/fill material and properly dispose at Waste Management's (WM) Chaffee Landfill located in Chaffee, New York (see Table 3 and Figures 5A and 5B).

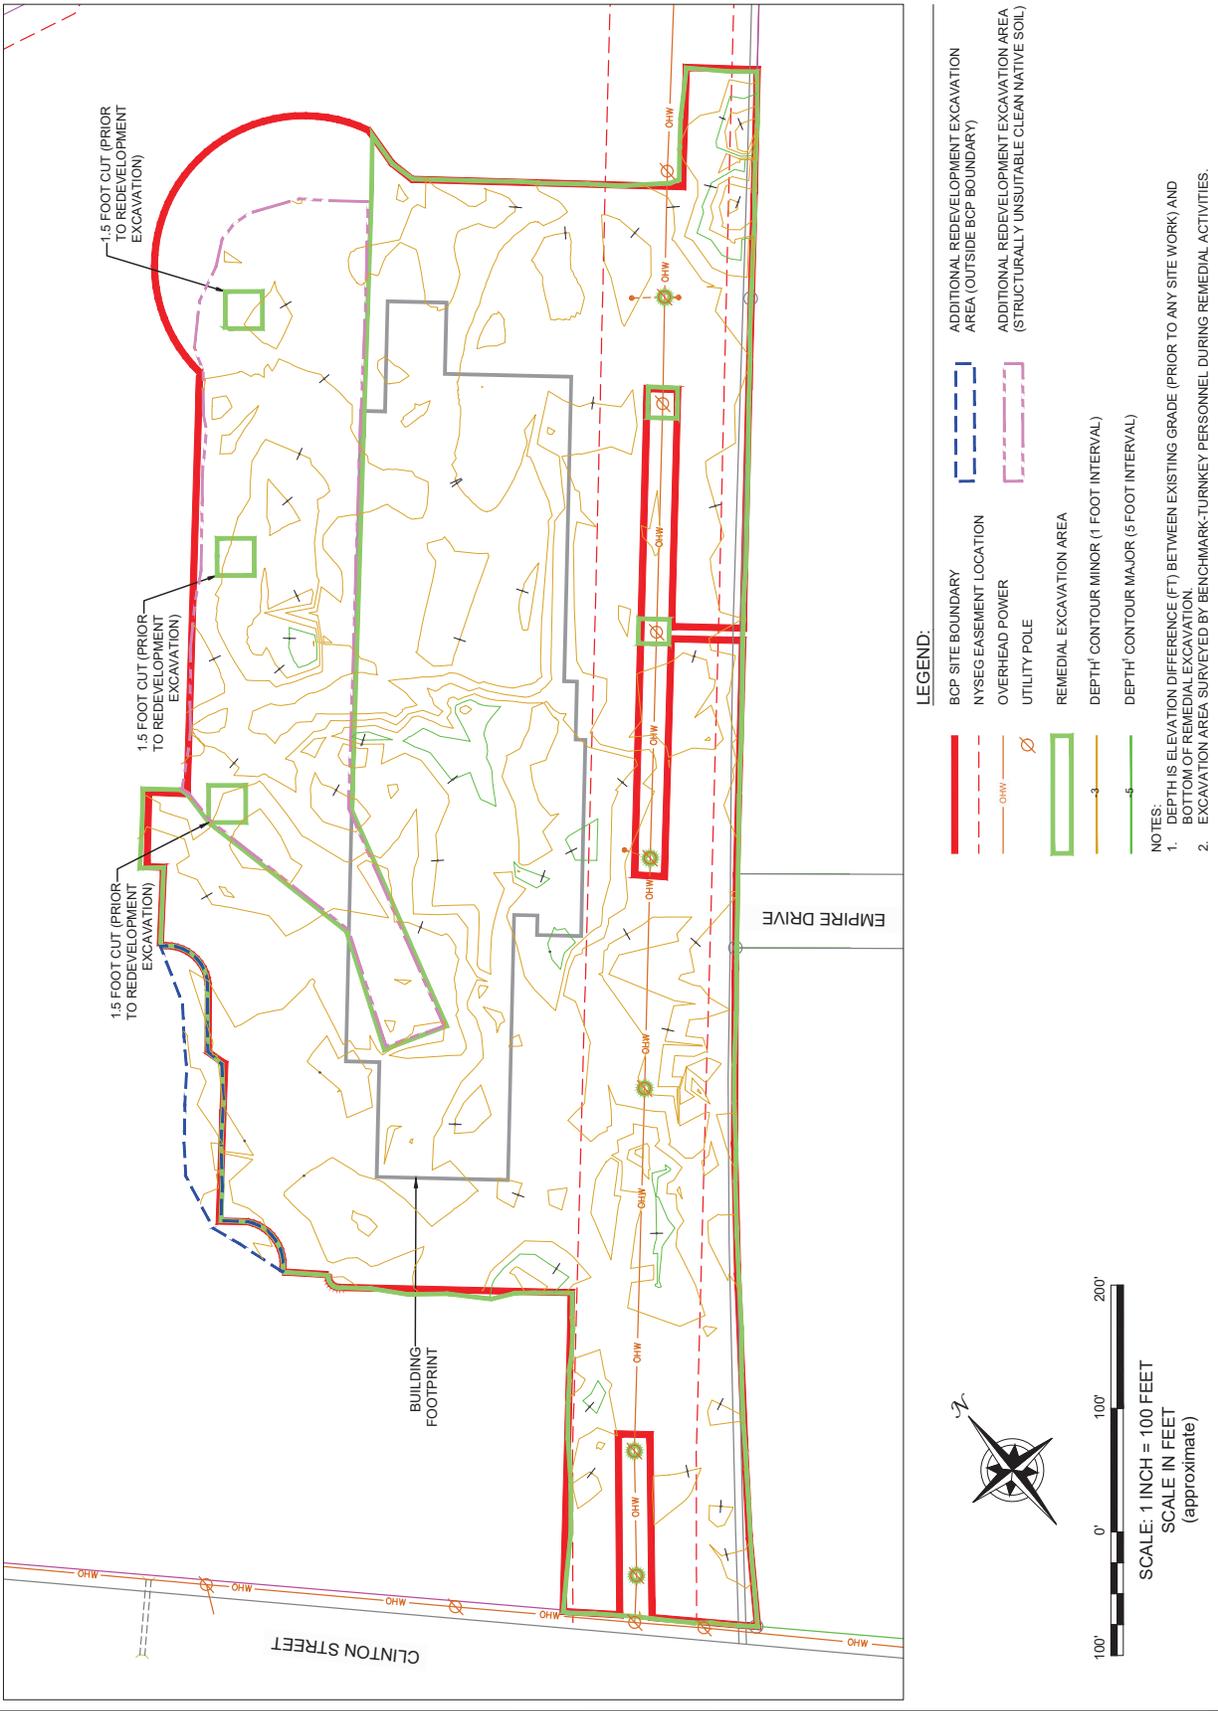
**FIGURE 5B**

**FINAL DEPTH OF EXCAVATION CONTOUR MAP**

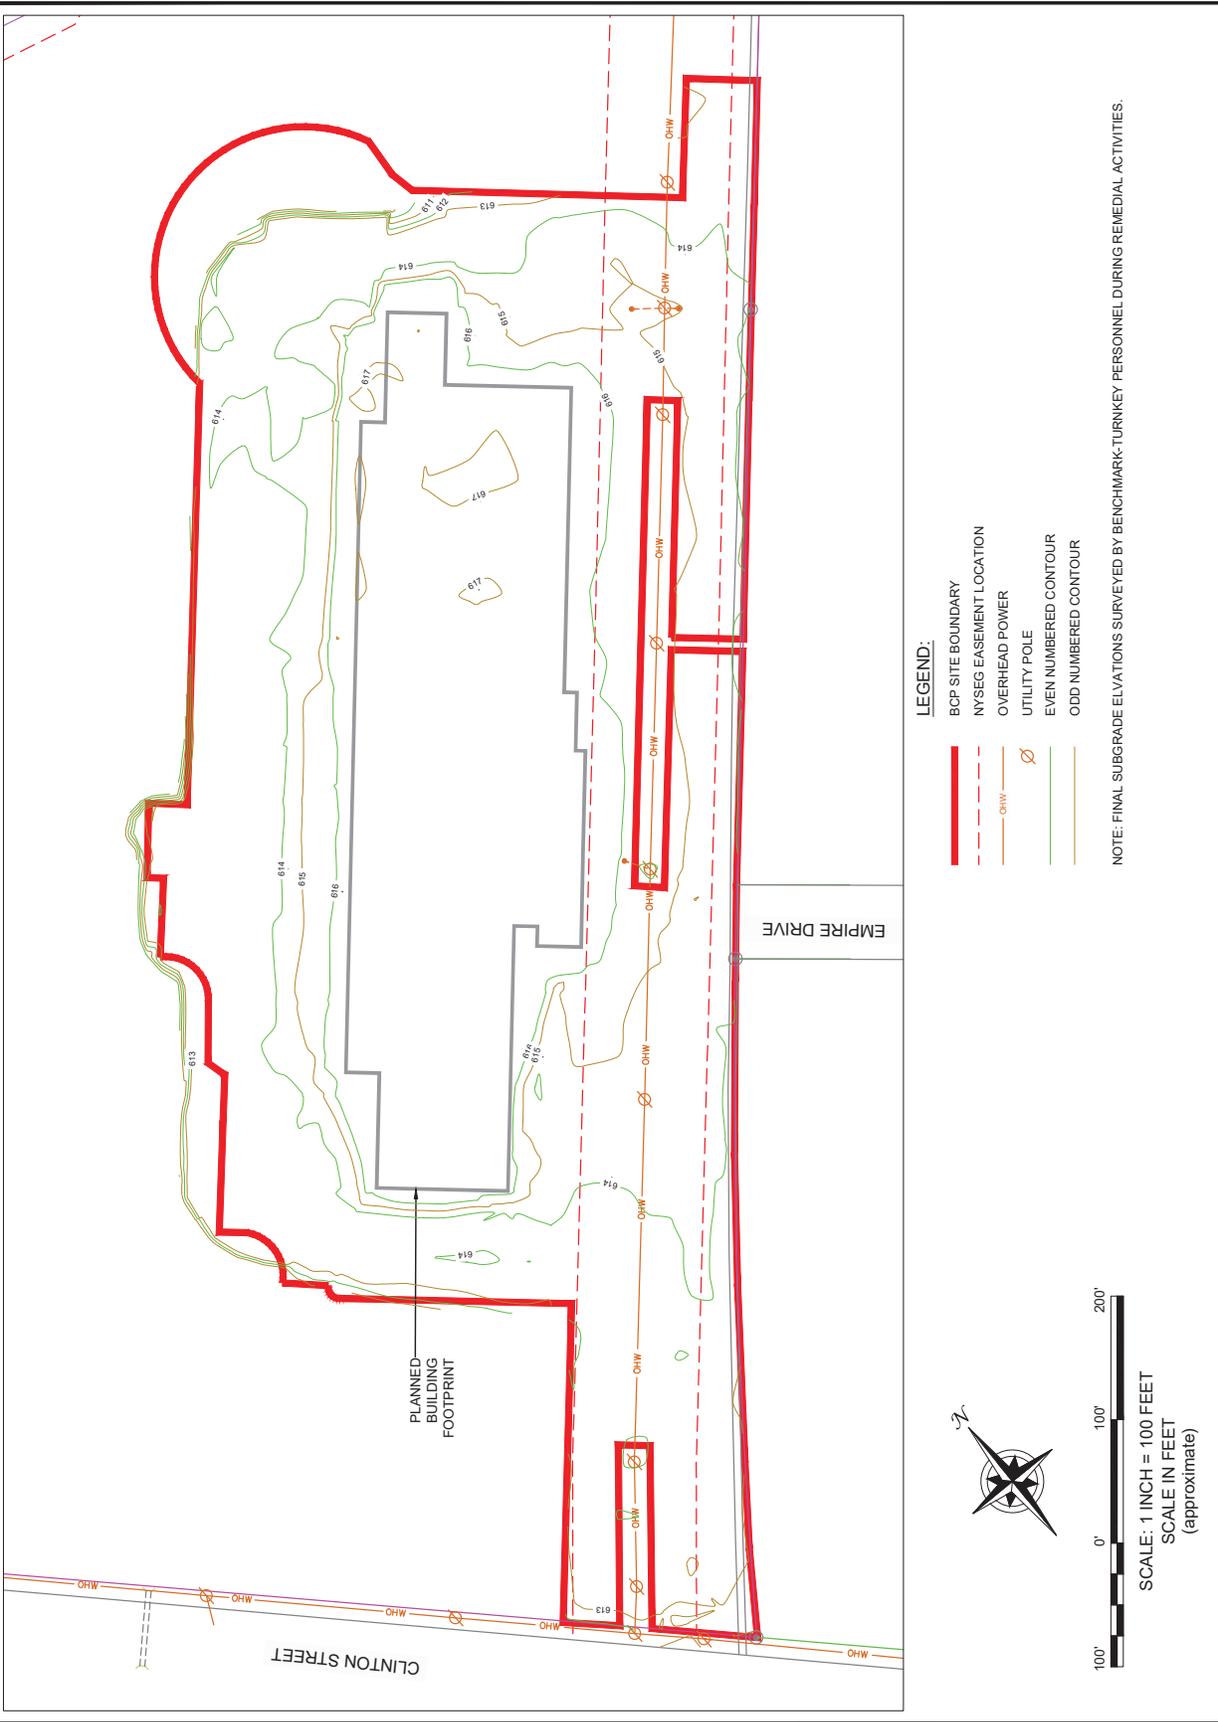
**FIGURE 6**

**FINAL SUBGRADE CONTOUR MAP**
